Architect's Field Report

19 March 2020

18059-AOI Academy of Innovation / Report Number 026

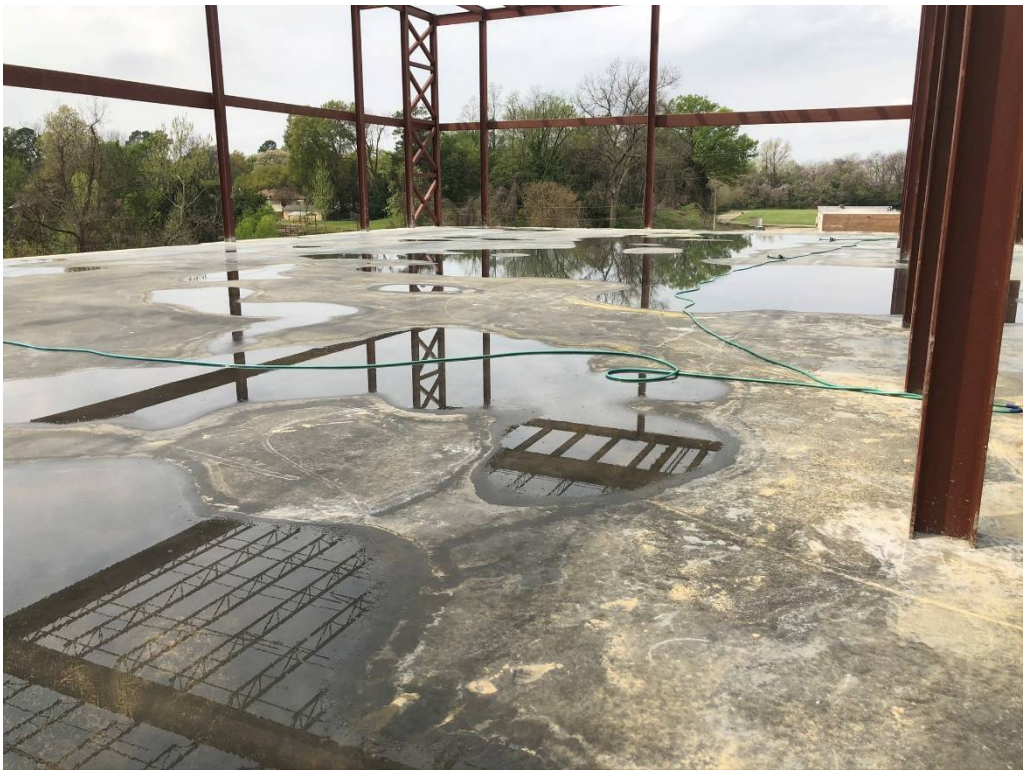
I reviewed concrete work from the most recent pour at the upper level of the west wing. There are many imperfections in the work as detailed in the accompanying photos. Some spots are flecking out and other appear to not be troweled at all. What can be done to repair/cleanup finish?

Figure 12 – West Upper Floor Slab

Items to Verify None
Action Required Make Recommendations on Repair of Concrete Finish
Report By:

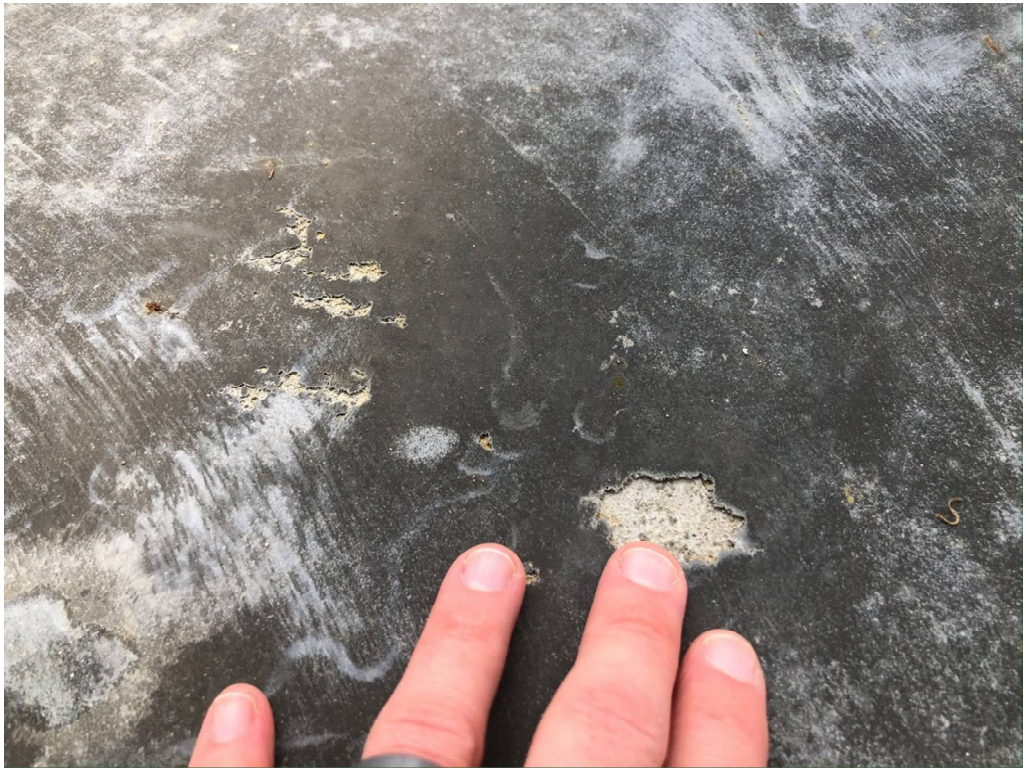
Figure 13 – Spalling at Concrete

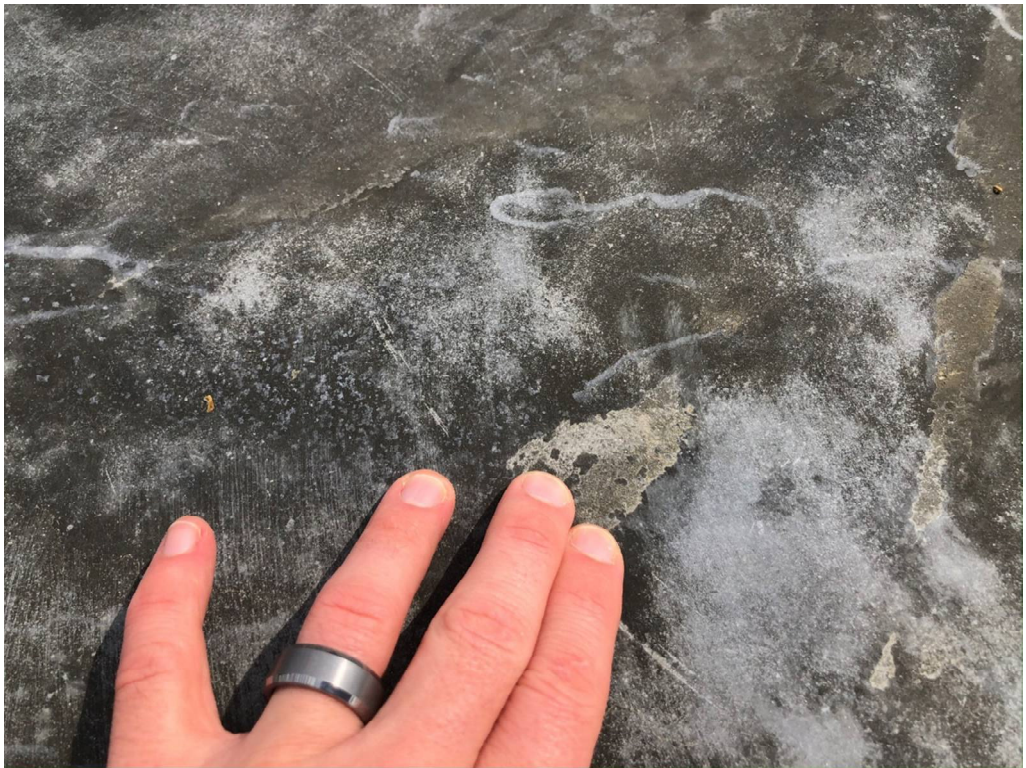
Figure 14 – Un-troweled Mark

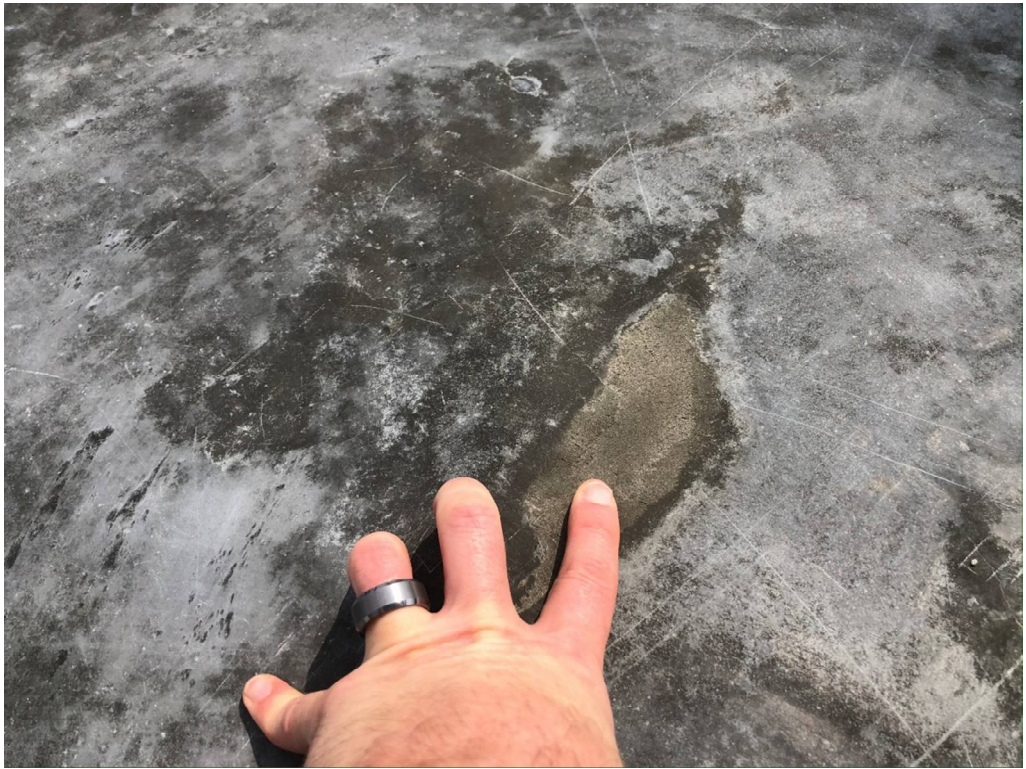
Figure 15 – Un-troweled Mark

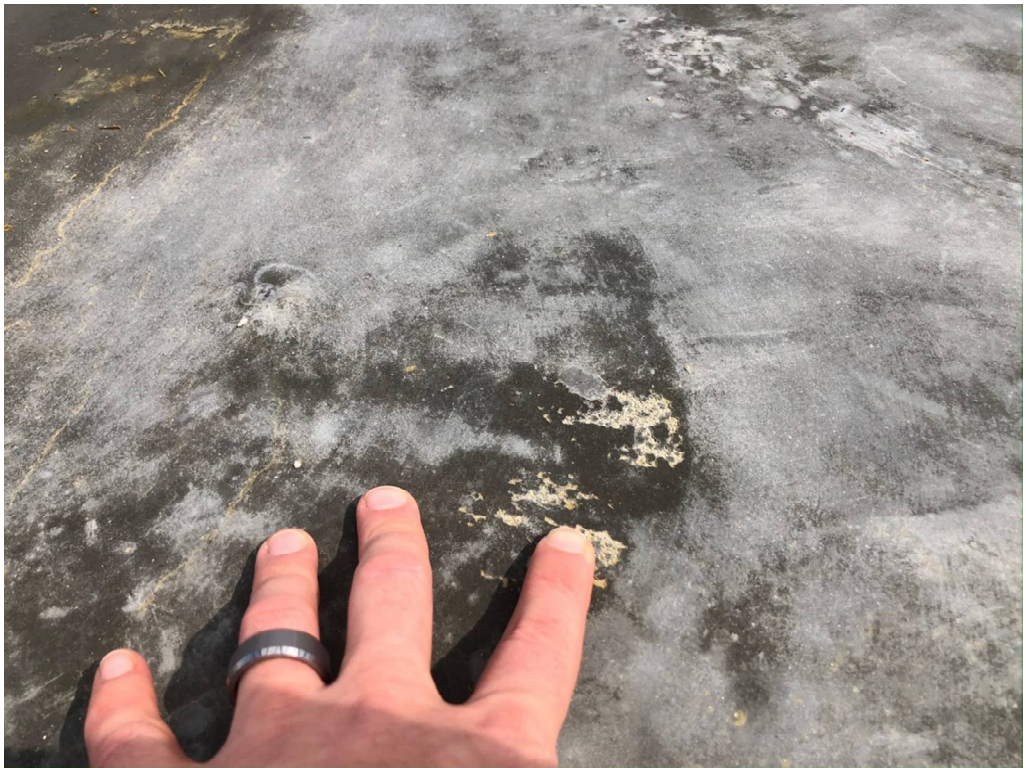
Figure 16 – Spalling at Concrete

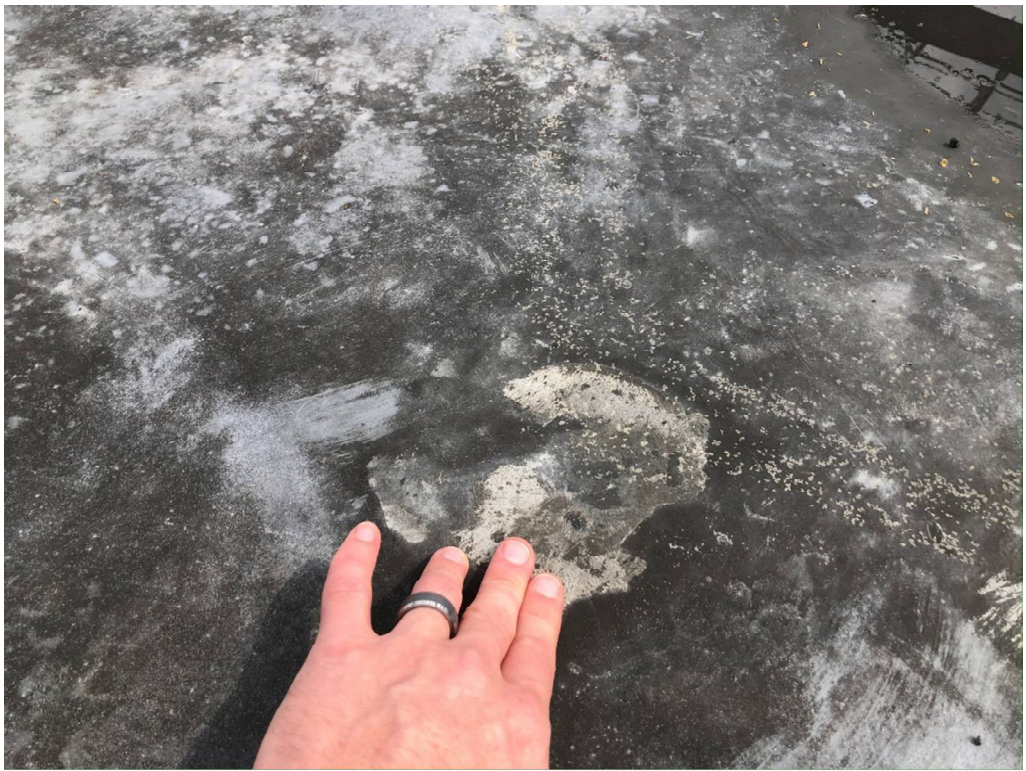
Figure 17 – Un-troweled Mark

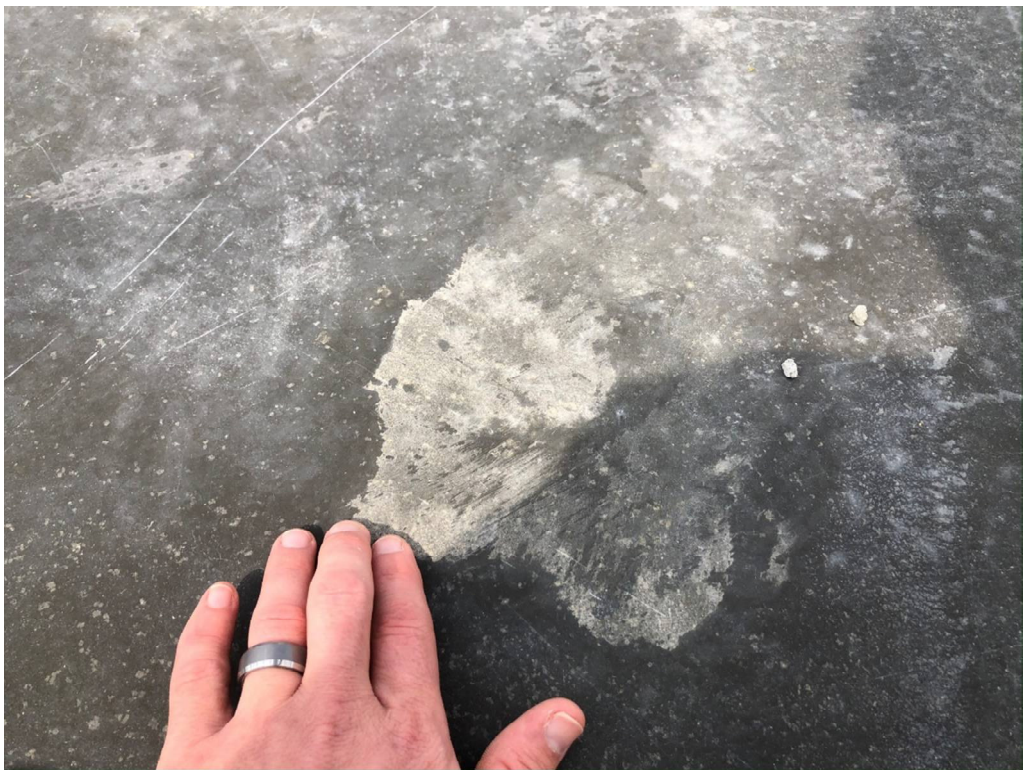
Figure 18 – Un-troweled Mark
