Architect's Field Report

201 Park Court, Suite B Ridgeland, MS 39157 P 601.790.9432 F 888.281.0547	27 March 2020 18059-AOI Academy of Innovation / Report Number 028
One Jackson Place, Suite 250 188 East Capitol Street Jackson, MS 39201-2100 P 601.352.5411 F 601.352.5362	Contract Century Construction Date / Time 26 March 2020 / 3:45 PM Weather / Temp Sunny intervals / 77 ° F Est % Complete 40% Sched Conformance + 71 days Work in Progress Exterior Liquid Applied Work Light Gauge Framing
161 Lameuse Street, Suite 201 Biloxi, MS 39530 P 228.374.1409 F 228.374.1414	Present at Site Joey Moore, CC Paul Purser, DBA Observations I arrived on site today and walked the site from the job site trailer and then west. I met the crew that is applying our water proof barrier. This work is being performed on the East section of building. I walked the upstairs section of this building and noted light gauge framing work is nearing completion in this area. At the upstairs bathrooms in the east section of structure (218 & 219), there is a large rust stain. I spoke with Joey Moore about this, and he mentioned that the area was to be tiled. He mentioned that they have made provisions so that this won't h

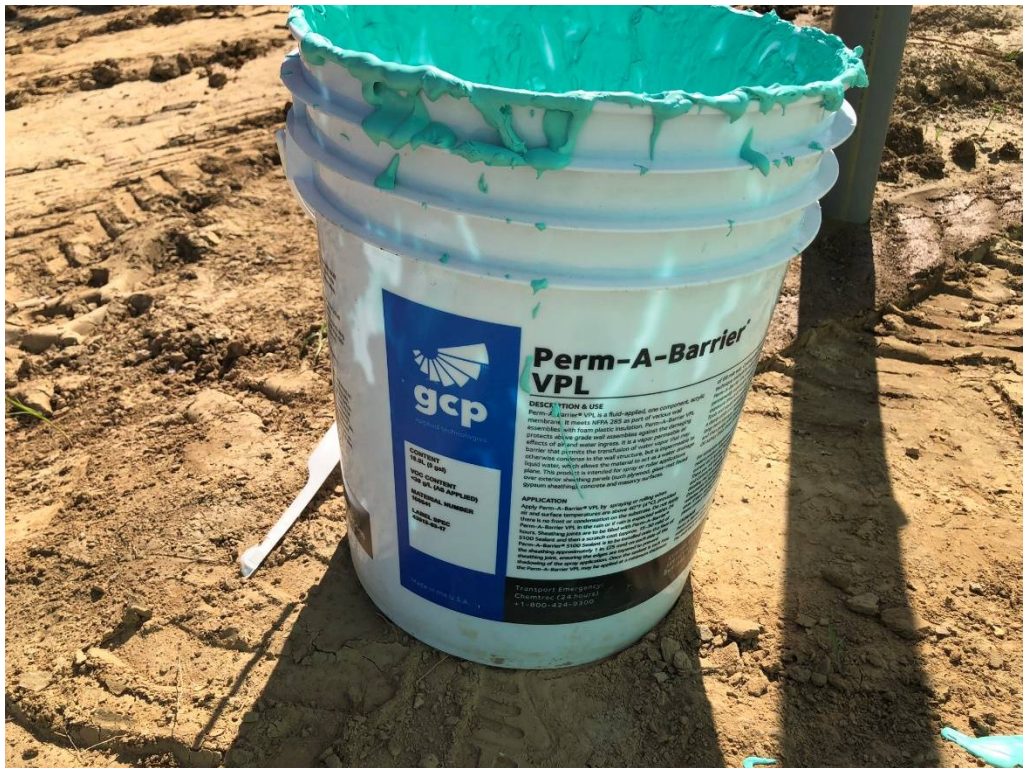
Figure 2 – Correct Vapor Barrier In Use

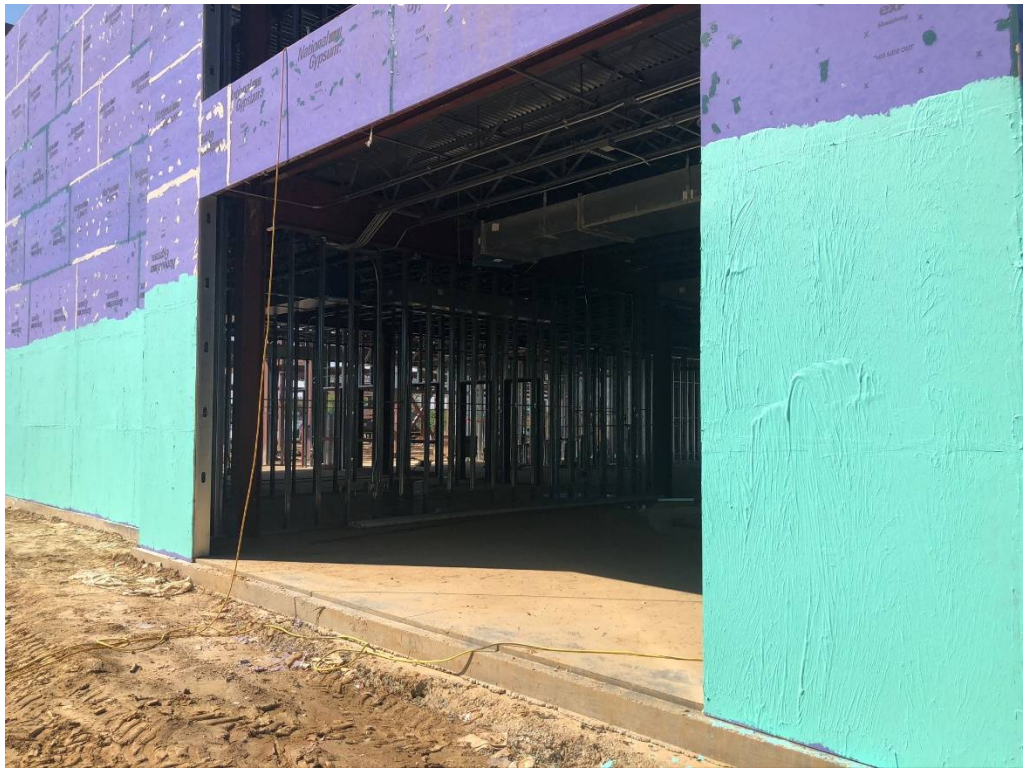
Figure 3 – Notes Joints Sealed and Liquid VB Applied

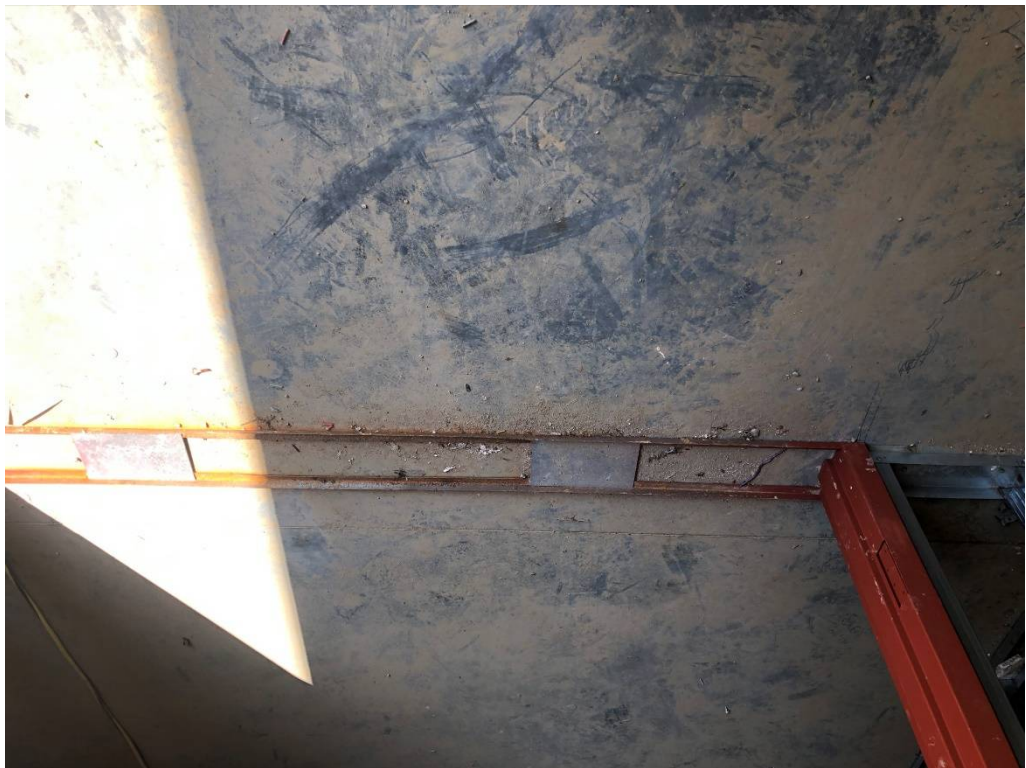
Figure 4 – Rust at Temporary Bracing Could Affect Concrete Finish if Not Cleaned Immediately

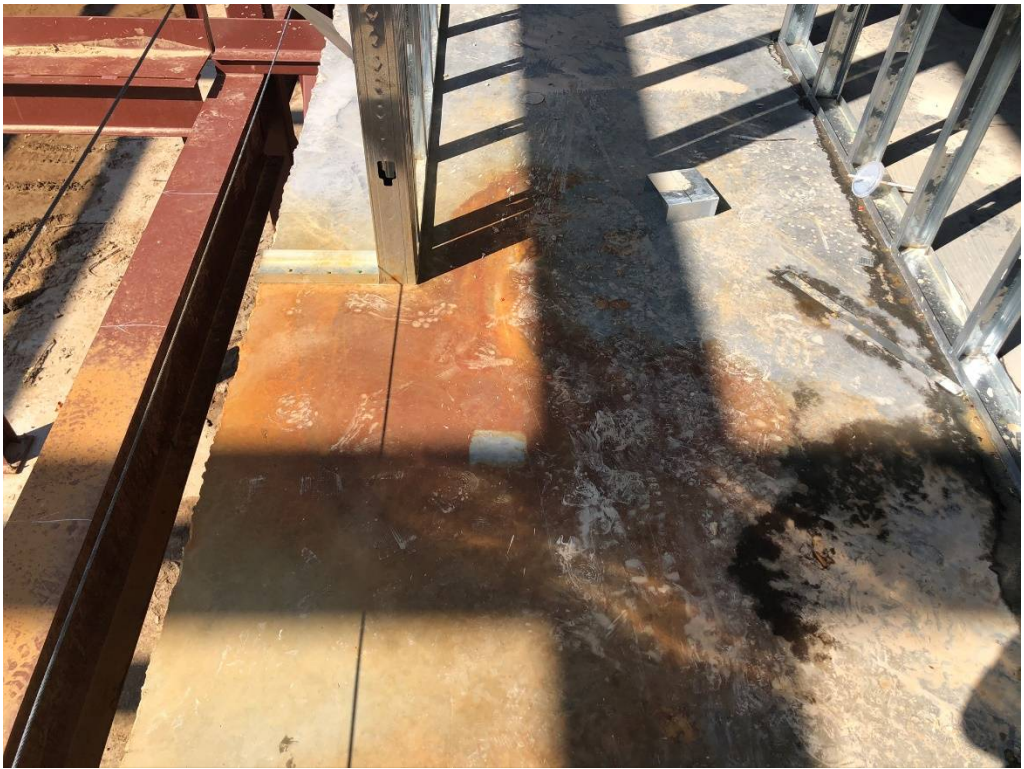
Figure 5 – Rust From Equipment Left in Weather (tiled is to be installed here)

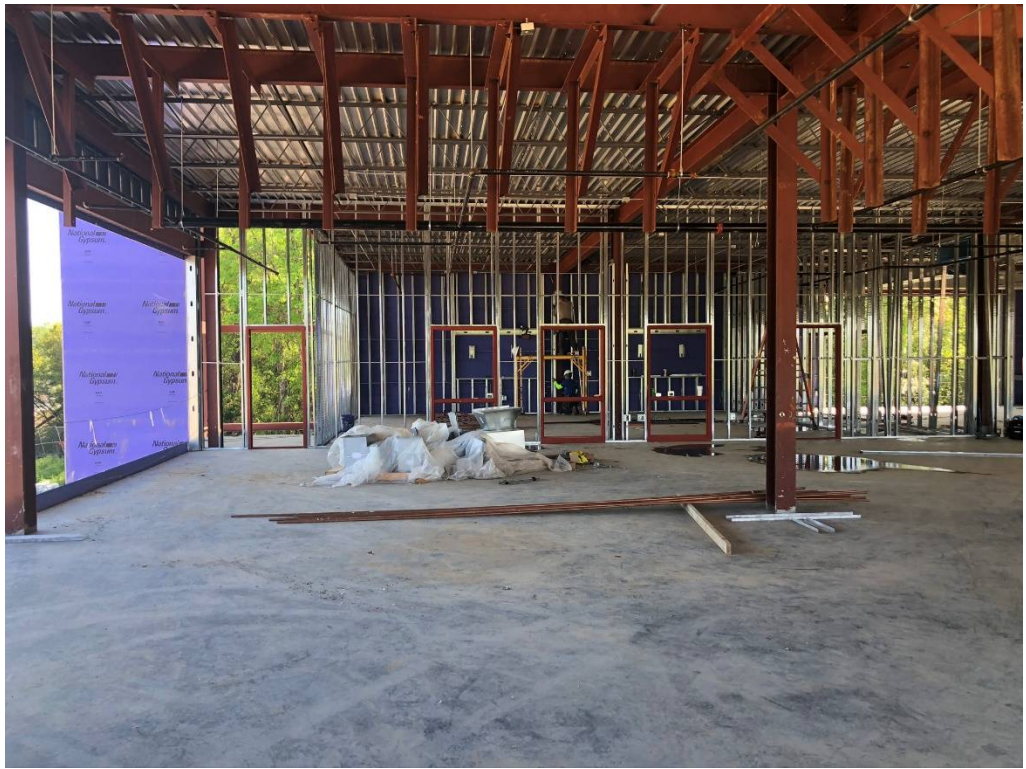
Figure 7 – Light Gauge Framing at Second Floor

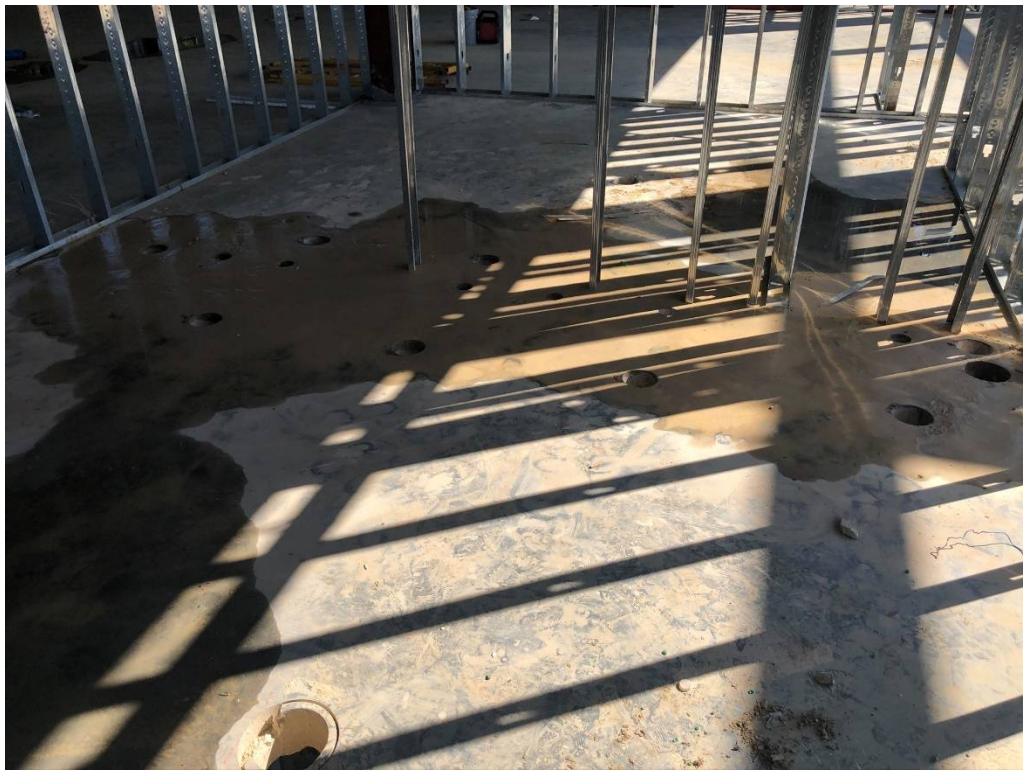
Figure 8 – Core Drilling @ 2nd Floor Bathroom Area

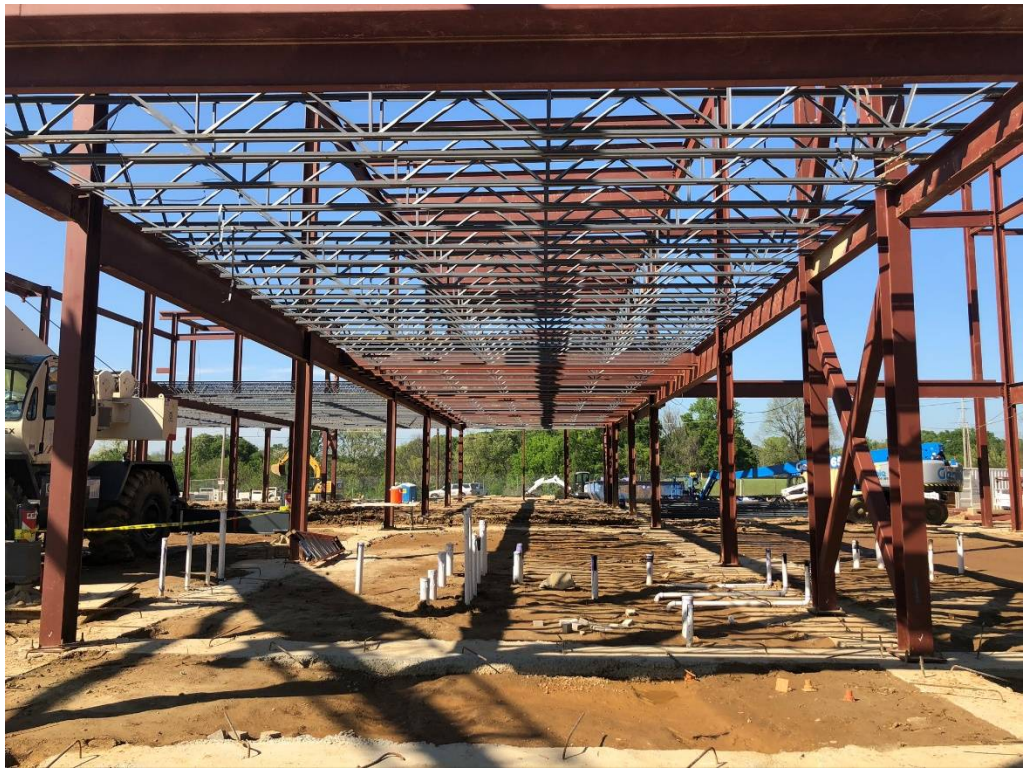
Figure 9 – Floor Joists in Central Section of Building

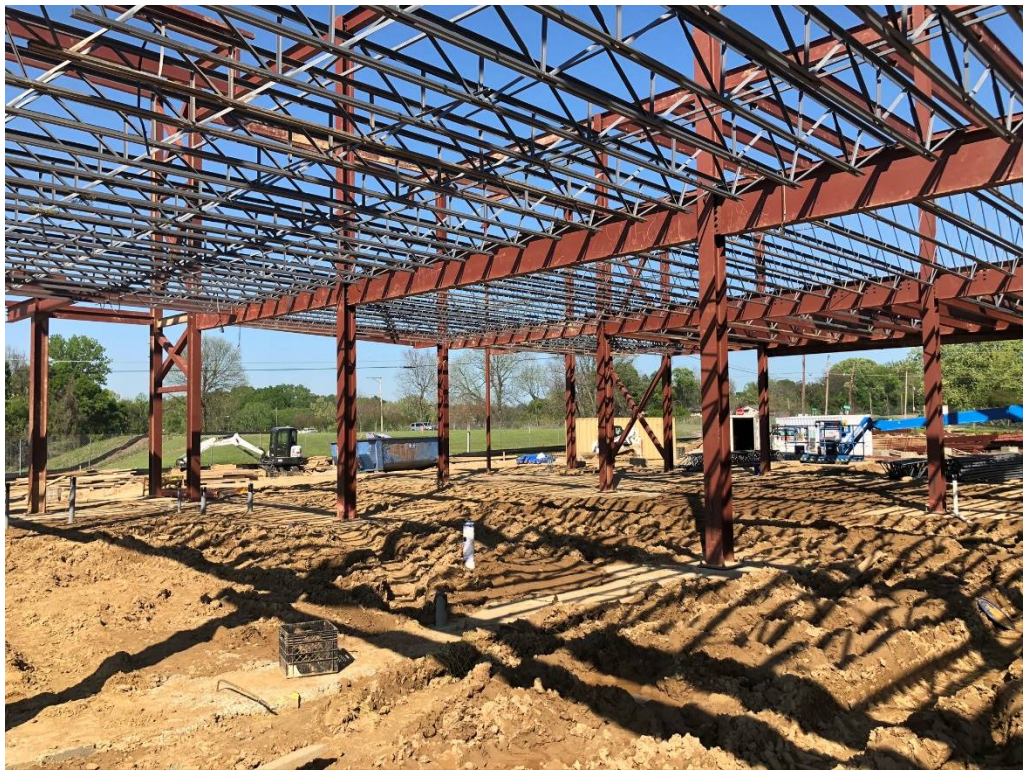
Figure 10 – Floor Joists in Central Section of Building

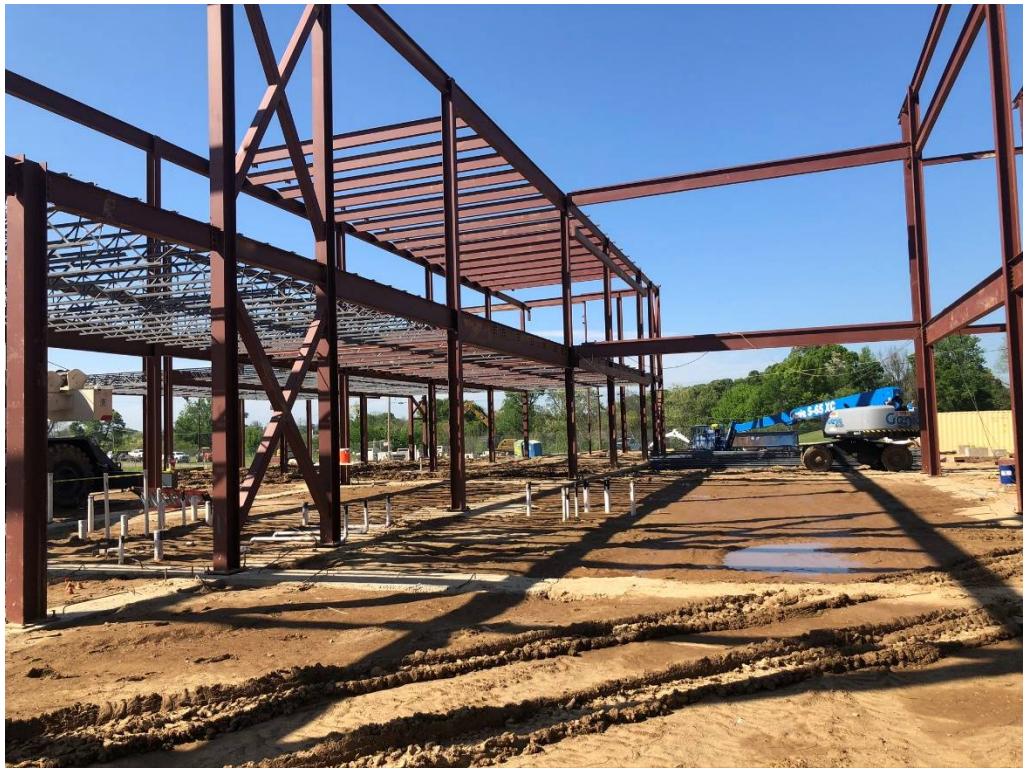
Figure 11 – Continued Steel Erection

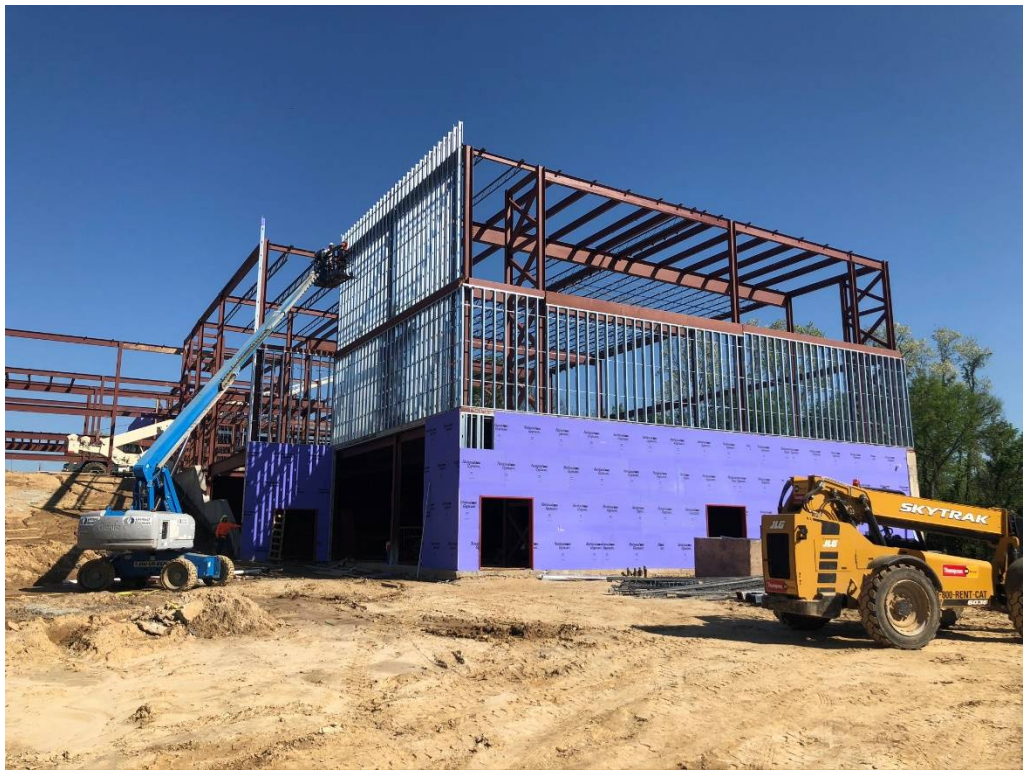
Figure 12 – Light Gauge Framing @ West Building Section
