## Architect's Field Report

02 April 2020

18059-AOI Academy of Innovation / Report Number 029

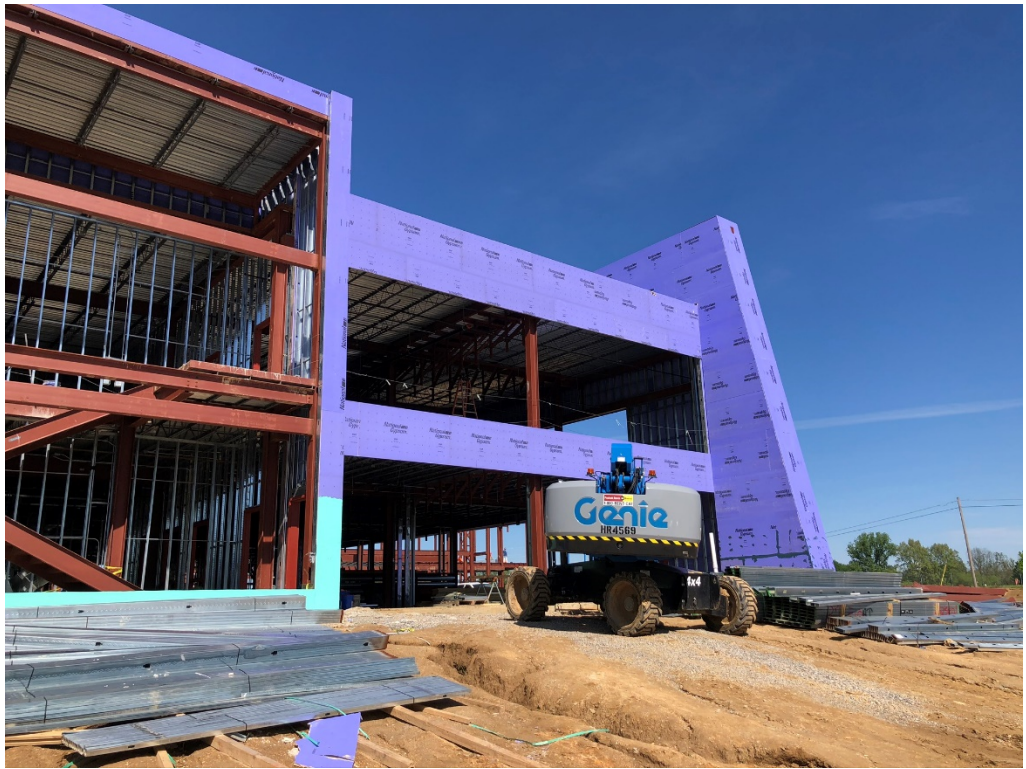
Figure 1 – East Structure

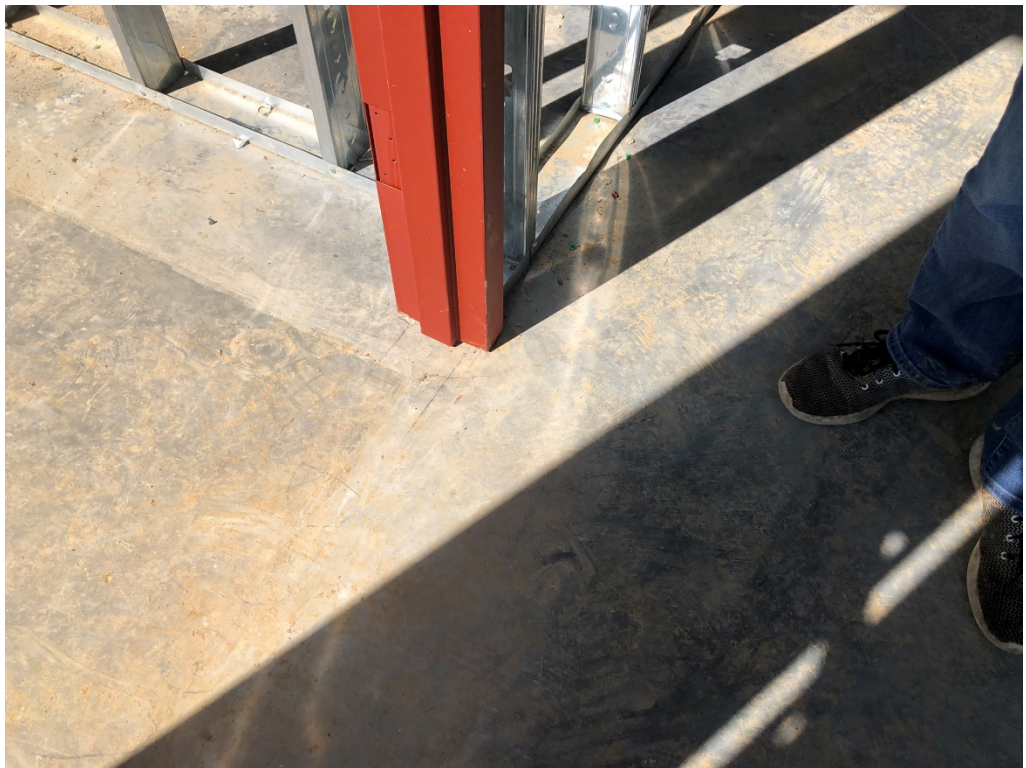
On our walk-thru, I noted where concrete has been installed at upper landing of the southeast corner of the main structure, that there is some undulation of the concrete where it meets the main slab. Also, a small stress crack has already started to appear here.

Figure 2 – Top Floor at East Section of Building where Concrete was poured after main slab showing stress crack and floor not entirely smooth and level here

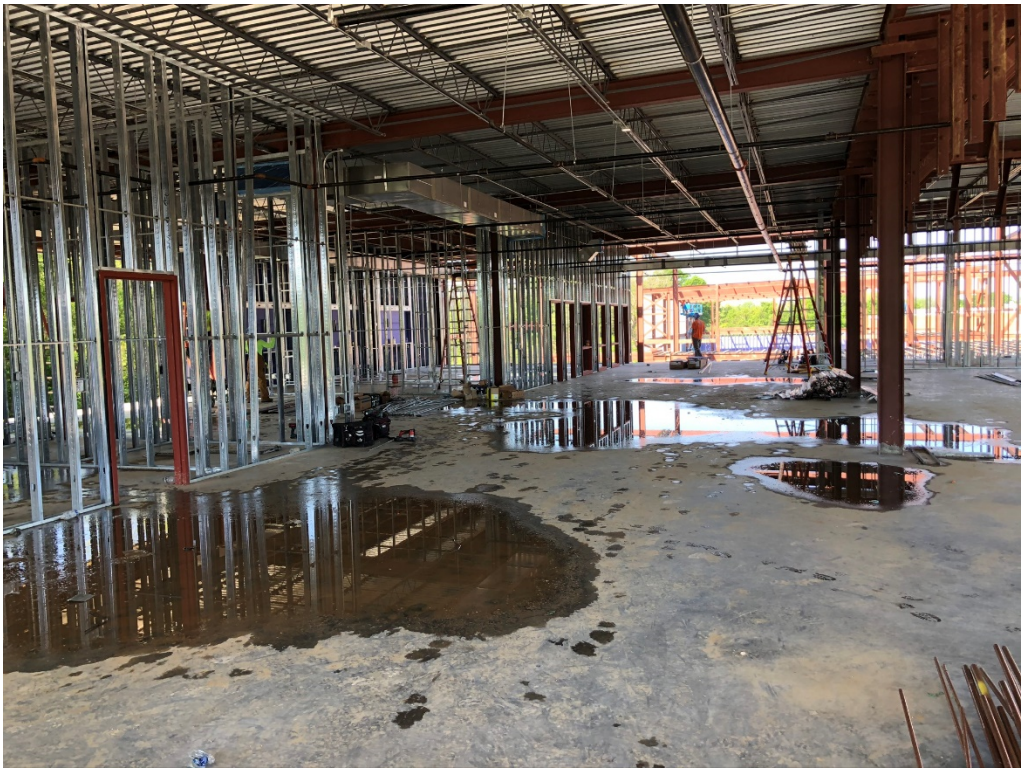
Figure 3 – Second Floor Continued Work

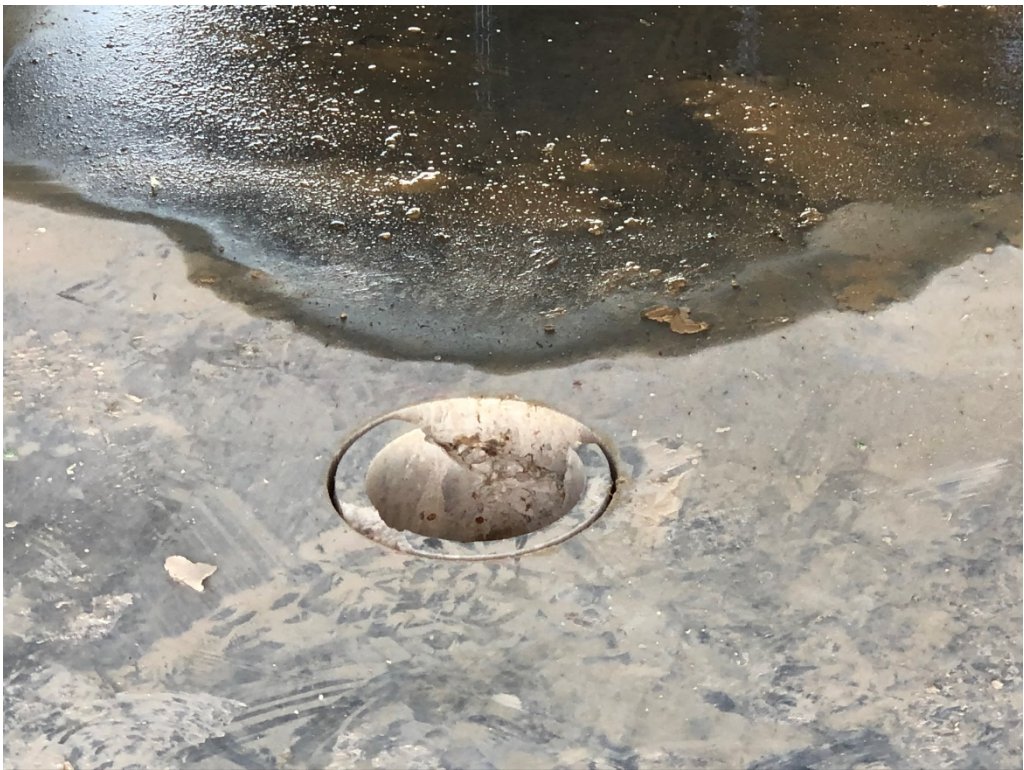
Figure 4 – Floor Drain at Upper Level 218

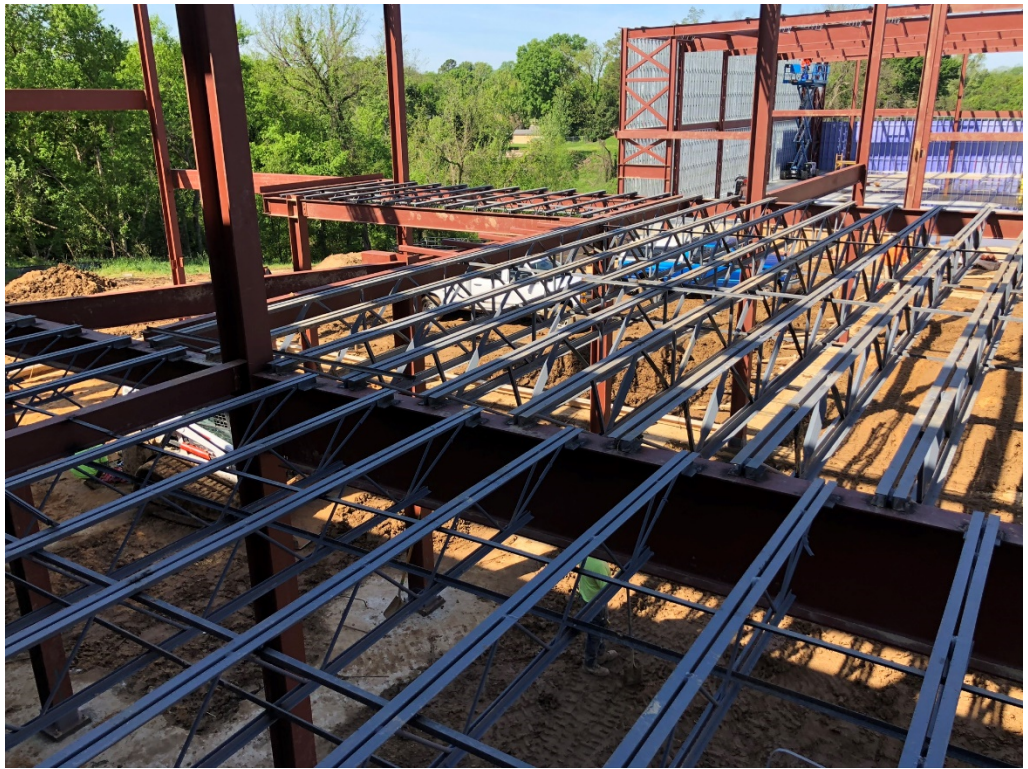
Figure 5 – Floor Joists Set

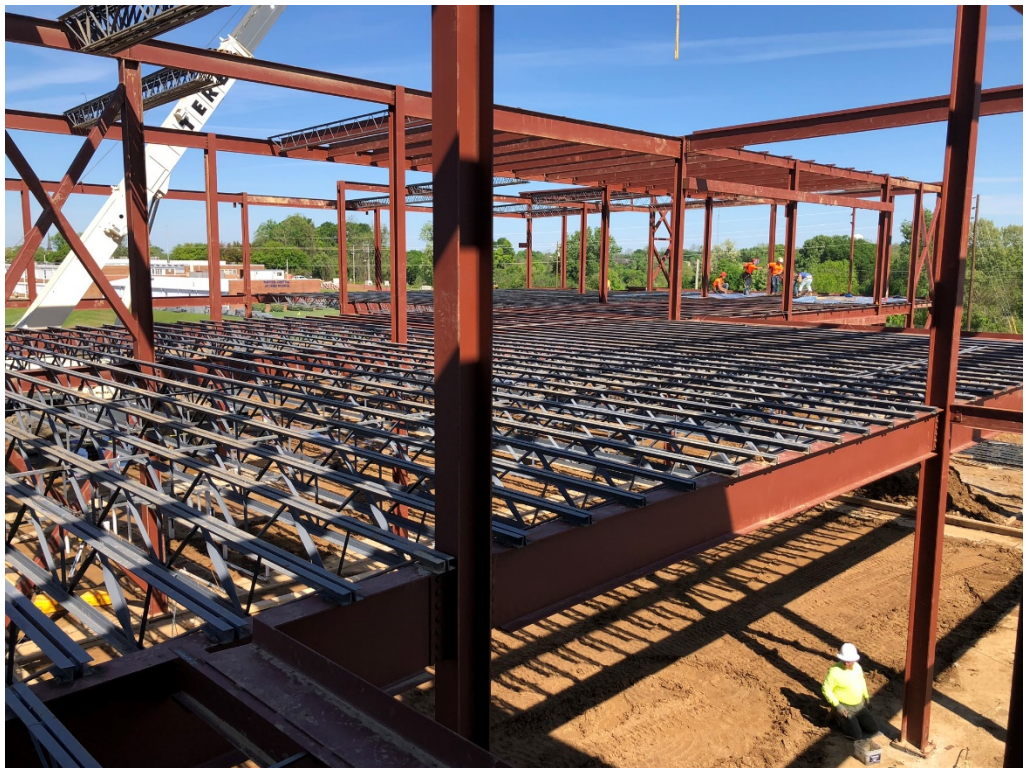
Figure 6 – Floor Joists Set

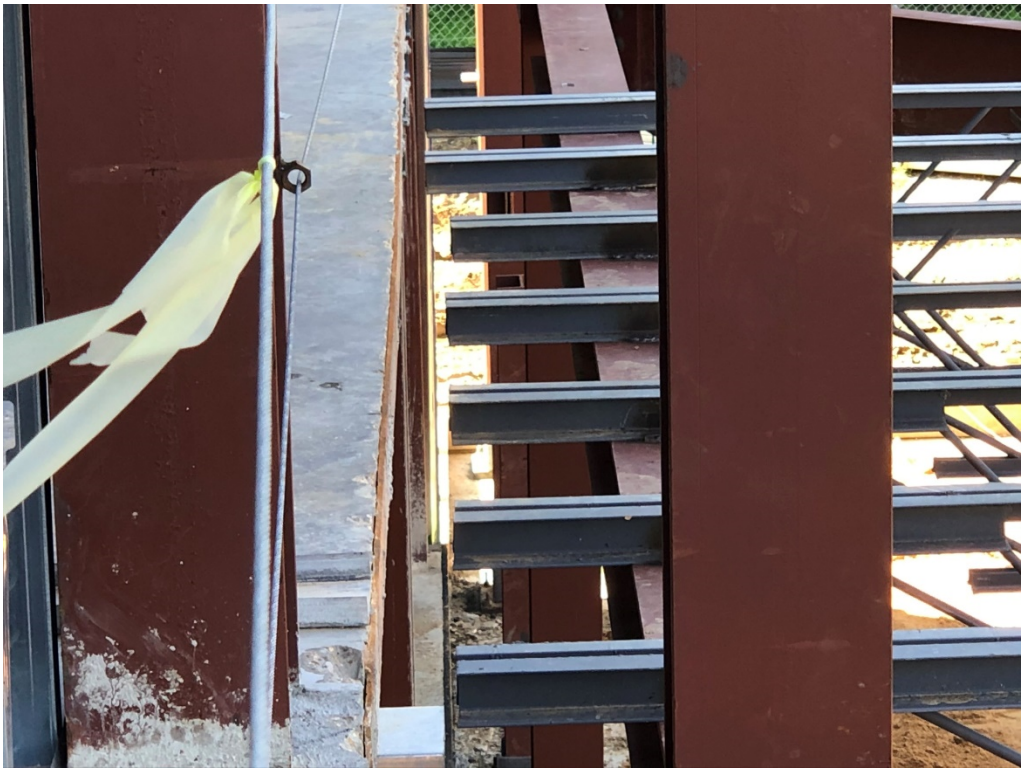
Figure 7 – Mis-aligned end joists

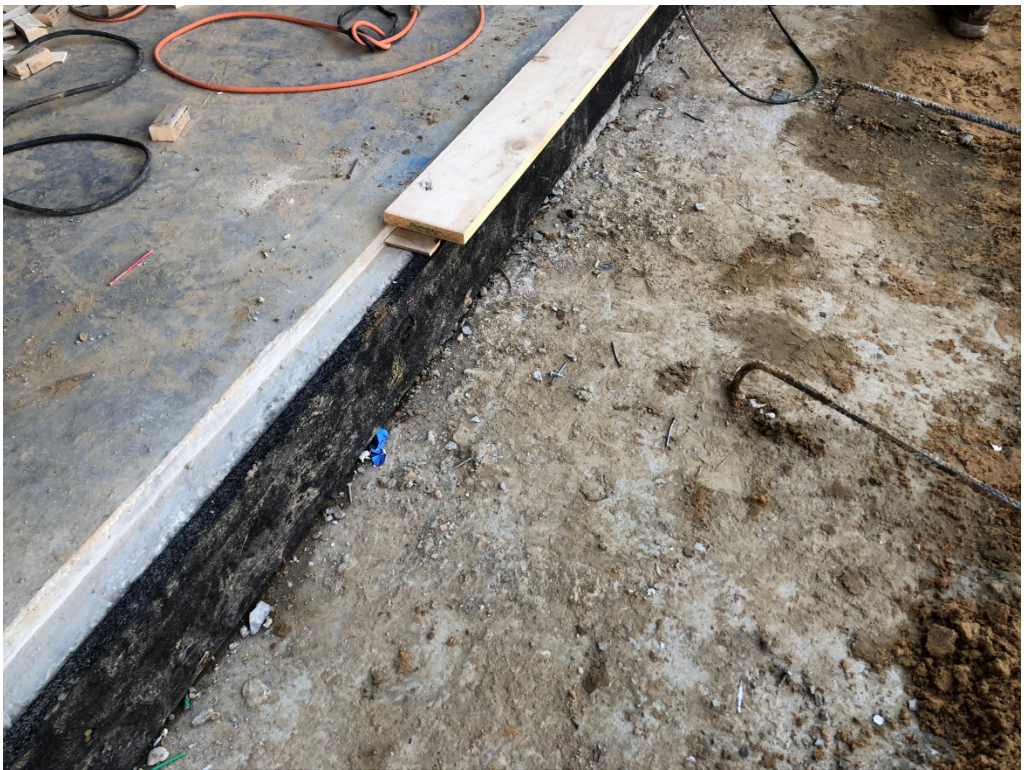
Figure 8 – Expansion Joint Installed

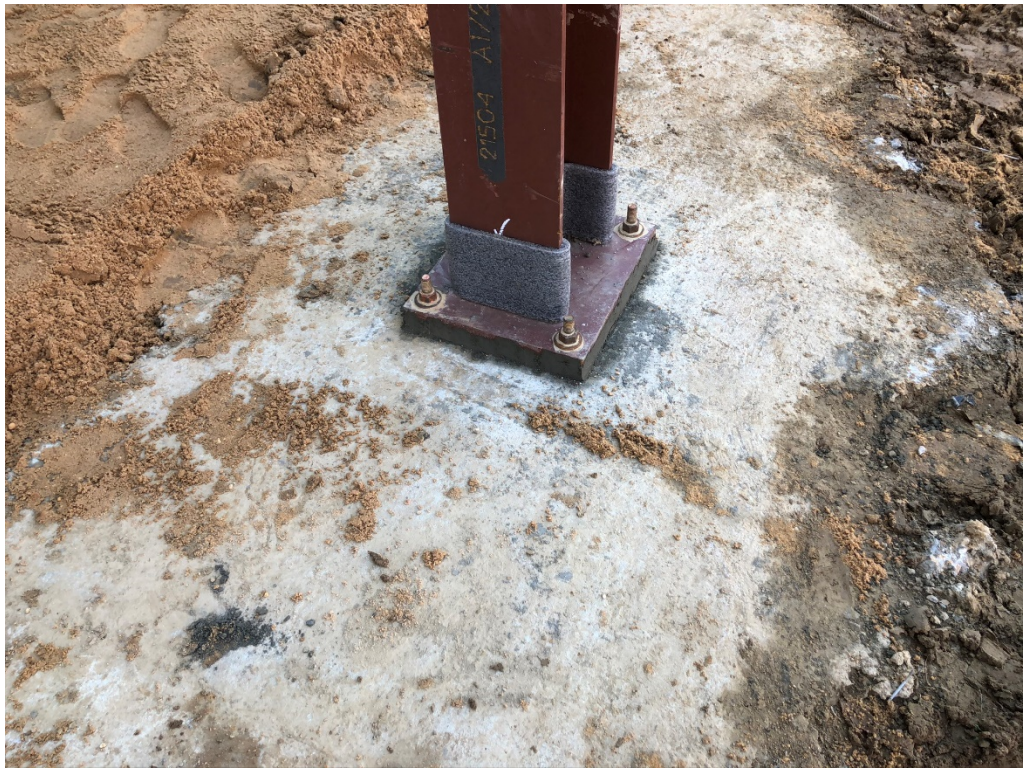
Figure 9 – Column Prepared for Concrete Pour

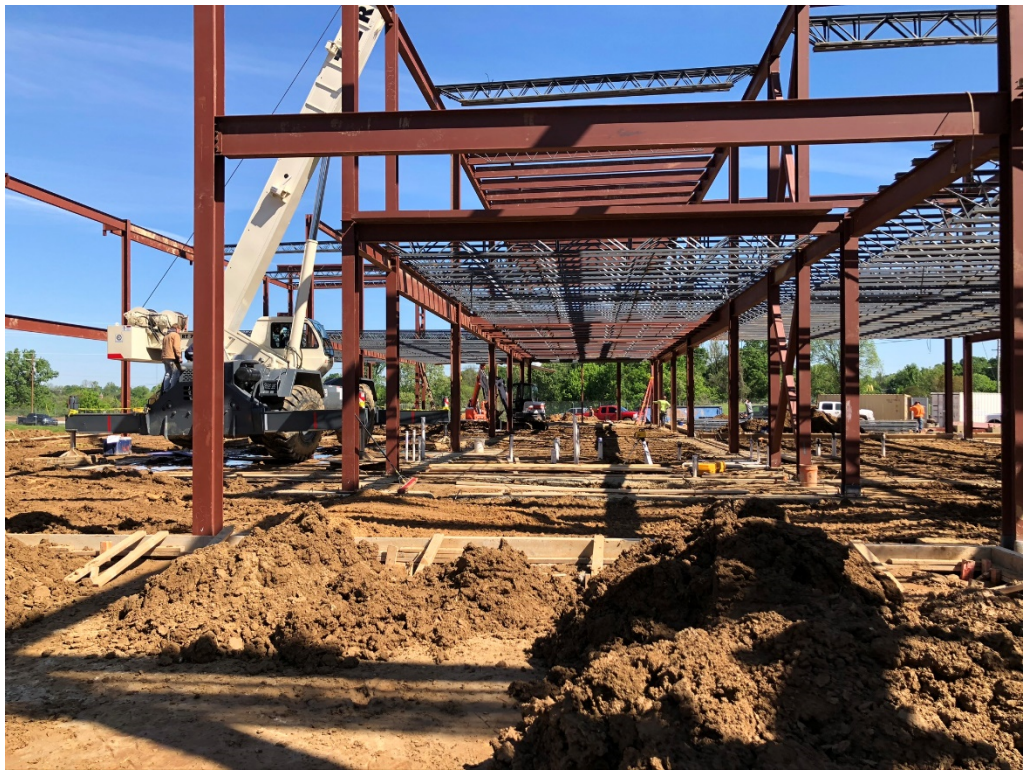
Figure 10 – Ground and Formwork Prep to Pour on Friday

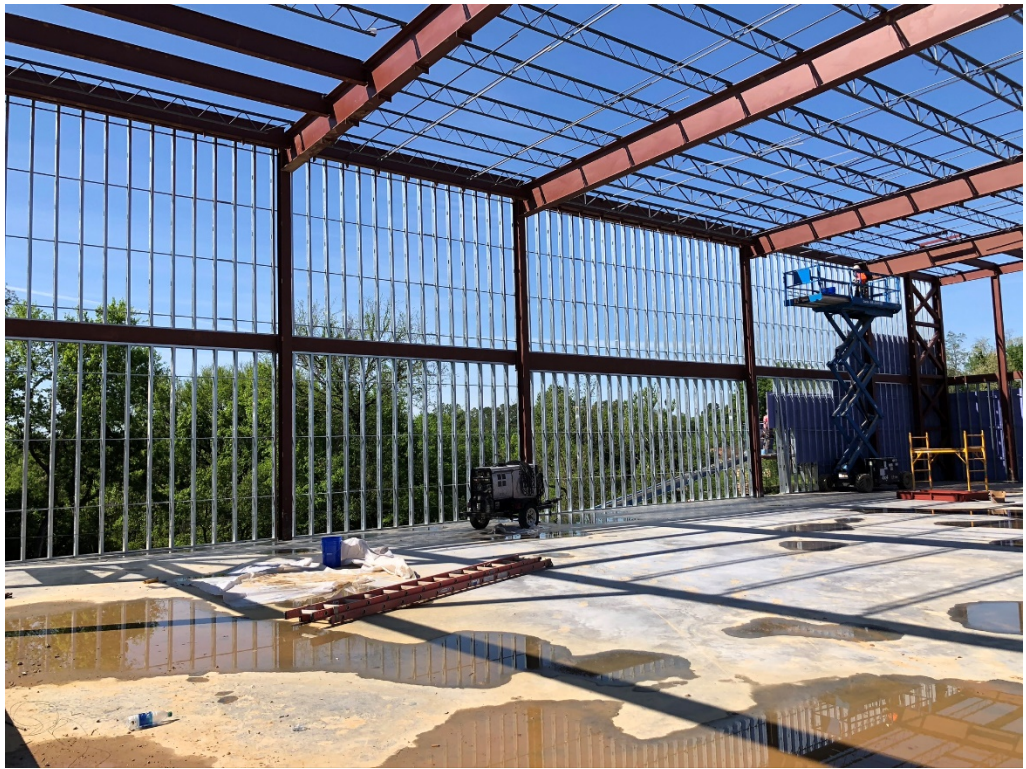
Figure 11 – Gym Area Framing

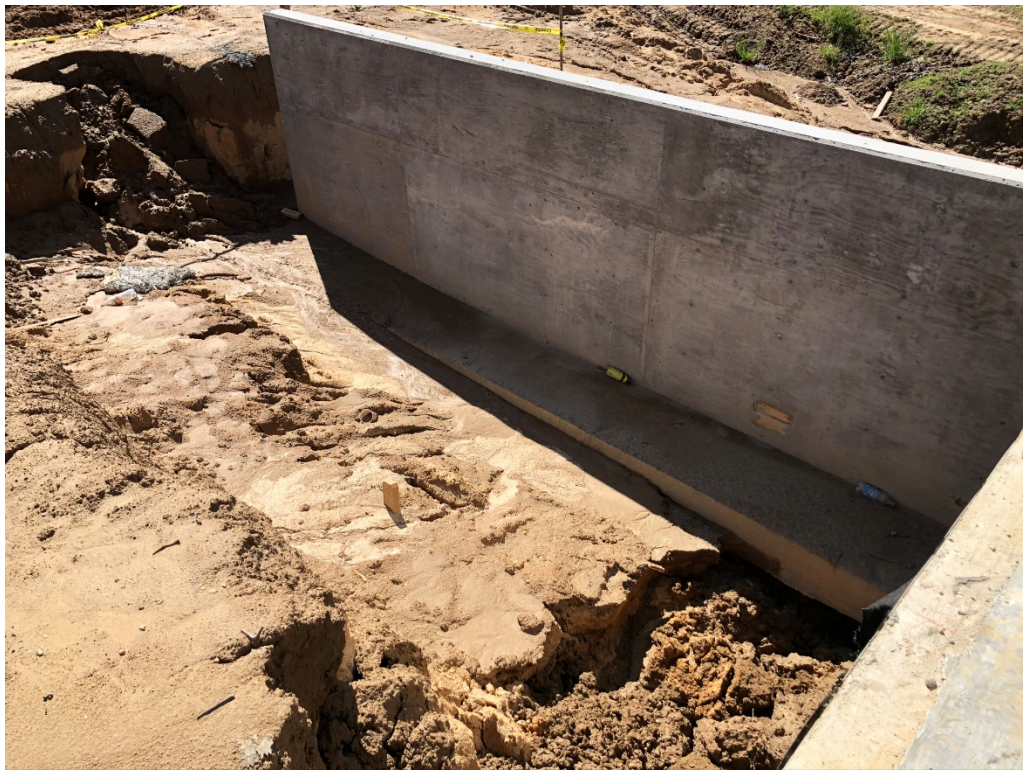
Figure 12 – Erosion under New Footing

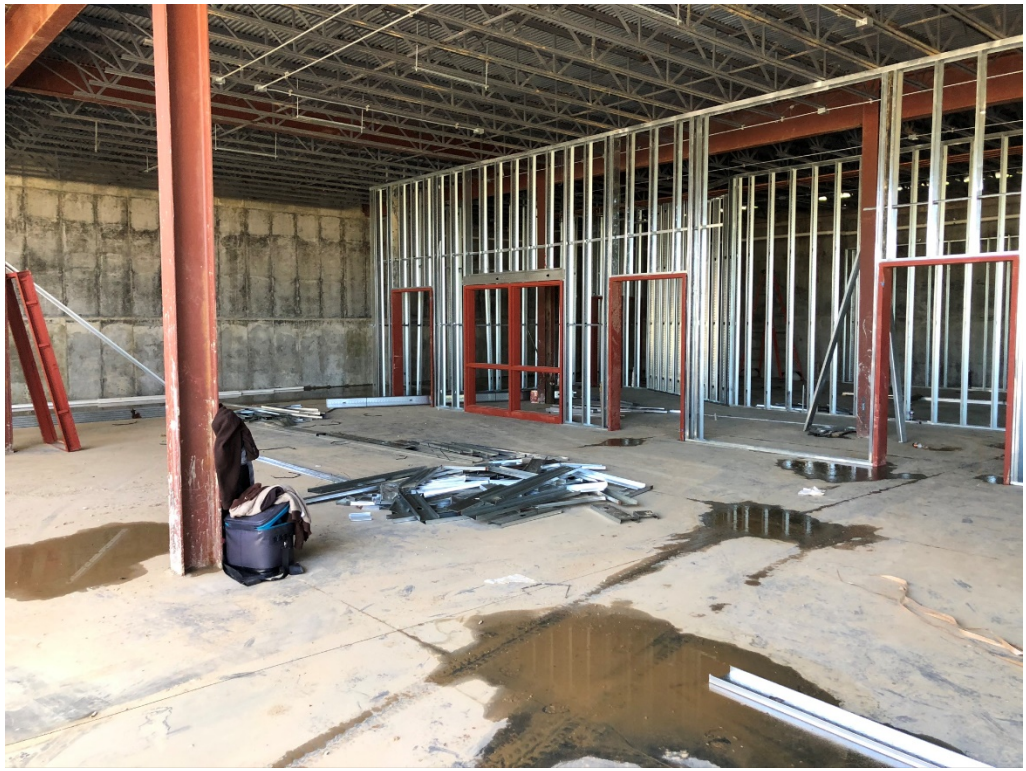
Figure 13 – Framing @ Cafeteria / Lower Level

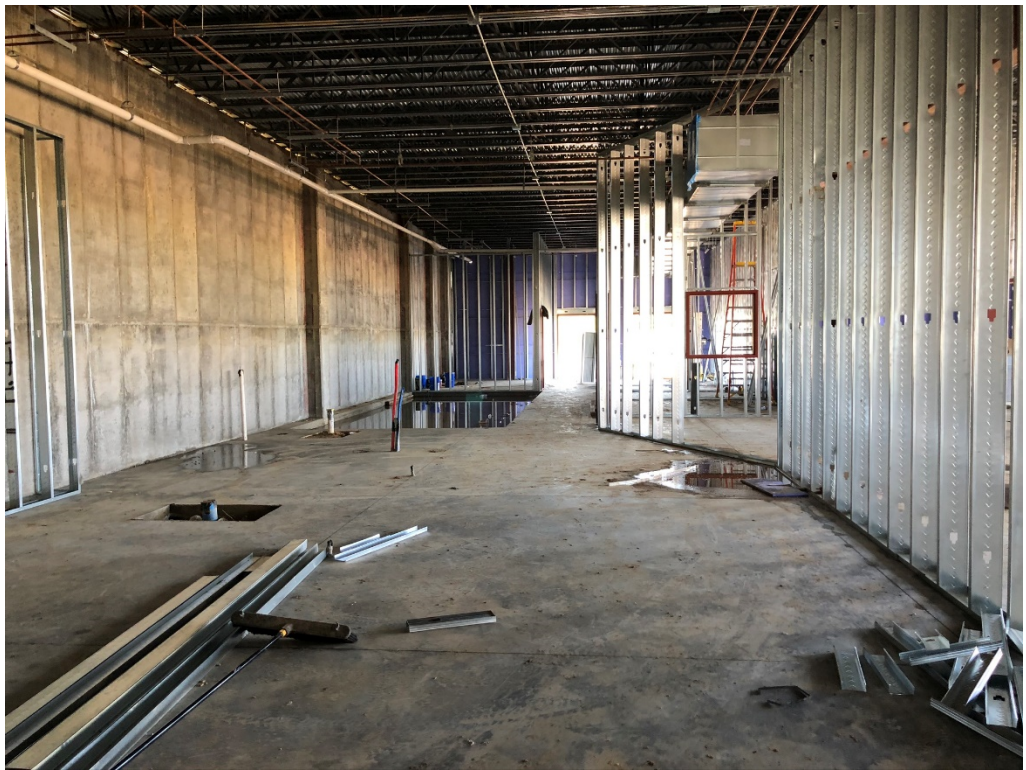
Figure 14 – Kitchen Area Framing

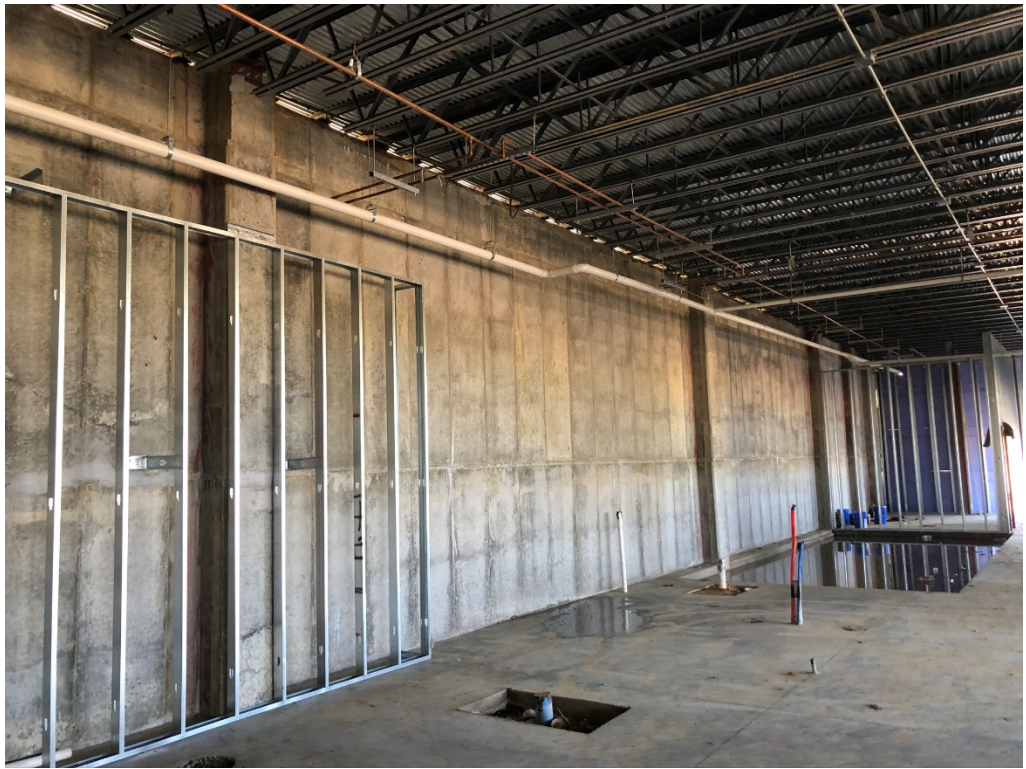
Figure 15 – Will You cut Through Concrete Foundation for Venting?

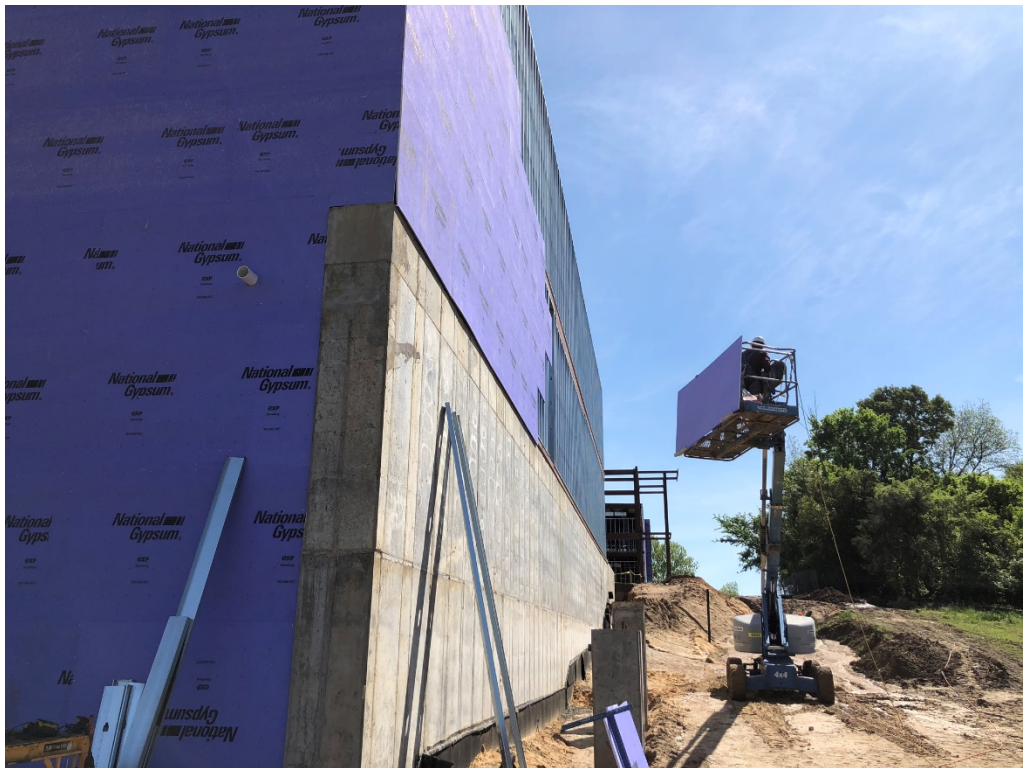
Figure 16 – Concrete and Gypsum Connection
