## Architect's Field Report

201 Park Court, Suite B Ridgeland, MS 39157 P 601.790.9432 F 888.281.0547	07 April 2020  18059-AOI Academy of Innovation / Report Number 030
One Jackson Place, Suite 250 188 East Capitol Street Jackson, MS 39201-2100 P 601.352.5411 F 601.352.5362	Contract Century Construction Date / Time 06 April 2020 / 11:30 AM Weather / Temp Overcast / 70 ° F Est % Complete 40% Sched Conformance + 71 days Work in Progress Gypsum Sheathing Installation Steel Joist Setting Mechanical & Plumbing Rough-INS
161 Lameuse Street, Suite 201 Biloxi, MS 39530 P 228.374.1409 F 228.374.1414	Present at Site Billy Burwell, CC Paul Purser, DBA  Observations I began my visit on the East end of the site. Plumbers were roughing in plumbing at toilets 118 & 119.  The central concrete slab was poured Friday and ponding is in use. There are a few rough patches (noted below) but overall, the pour looks good.  The erosion problem at the south Foundation wall has been addressed by pouring concrete into hole below the wall.  Gypsum Sheathing and Light gauge framing continues at the exterior of the west structure.

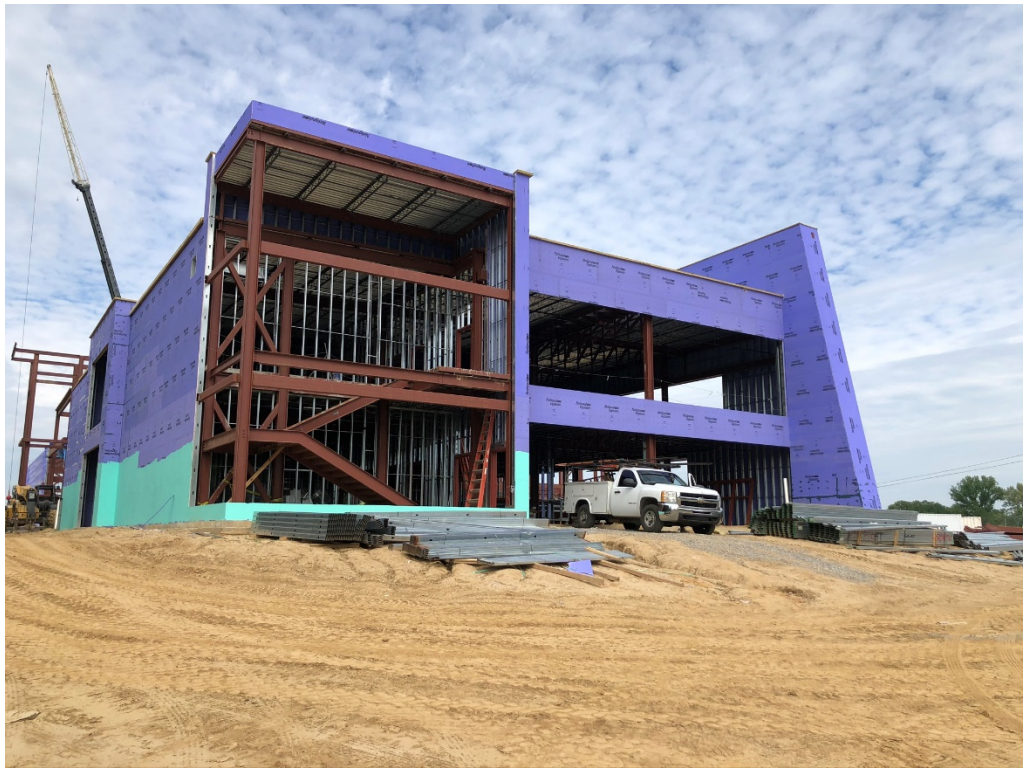
Figure 1 – East Structure

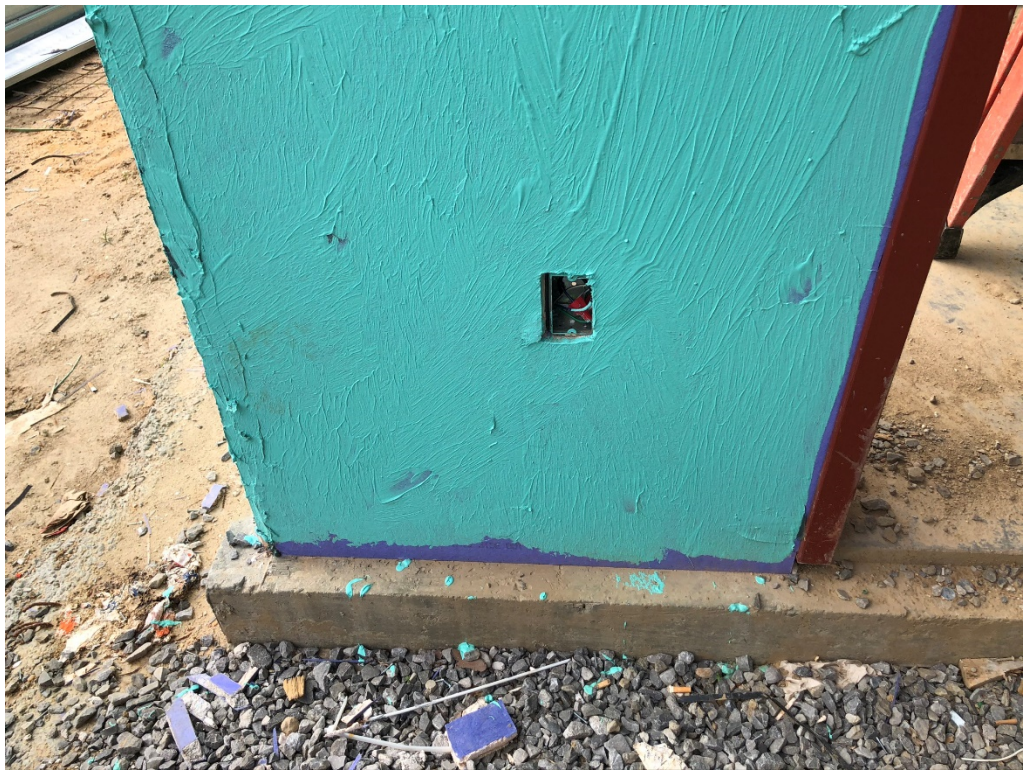
Figure 2 – Waterproofing touch up needed where smeared

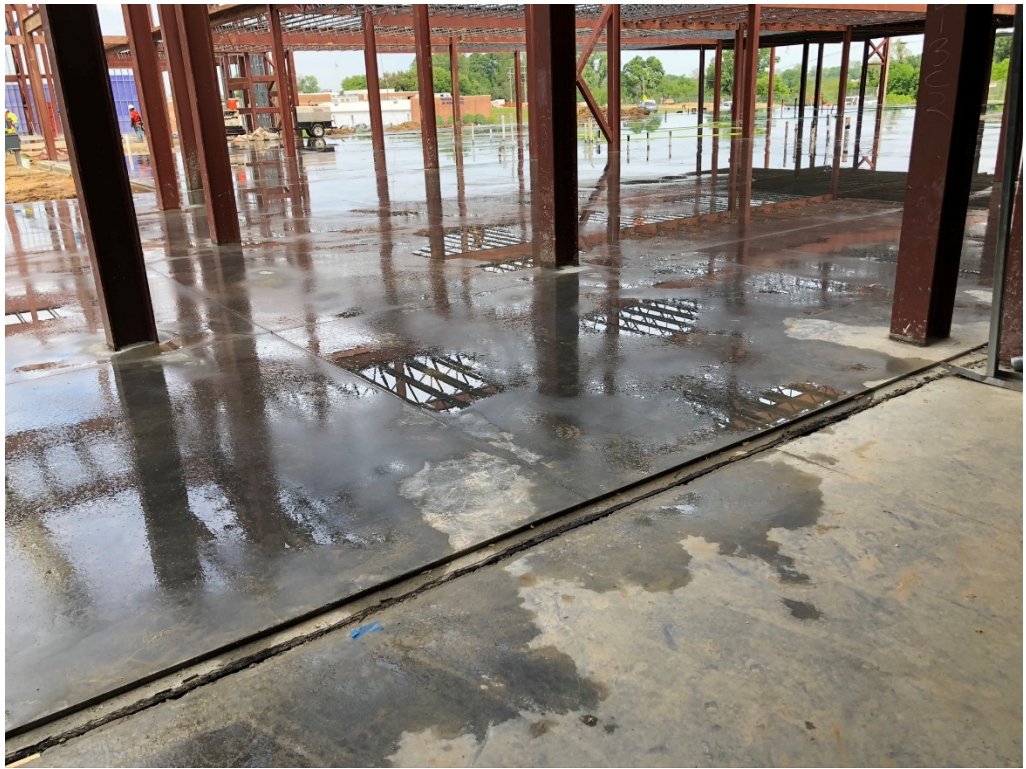
Figure 3 – Ponding Technique in use 4 days after pour

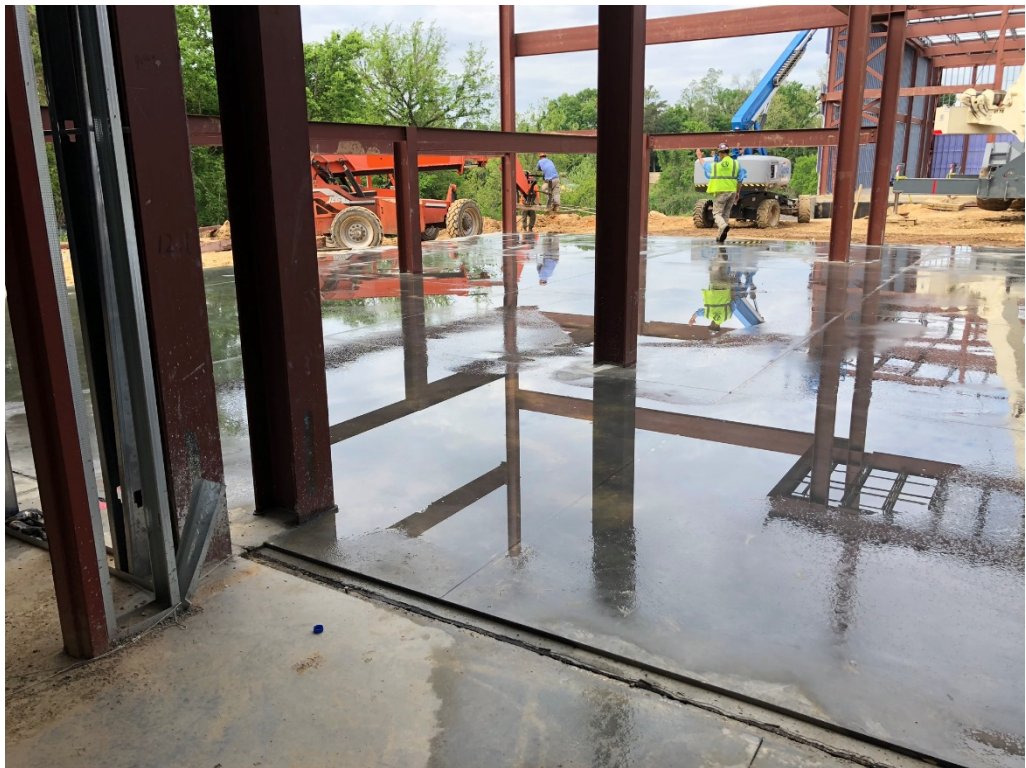
Figure 4 – Ponding Technique in use 4 days after pour

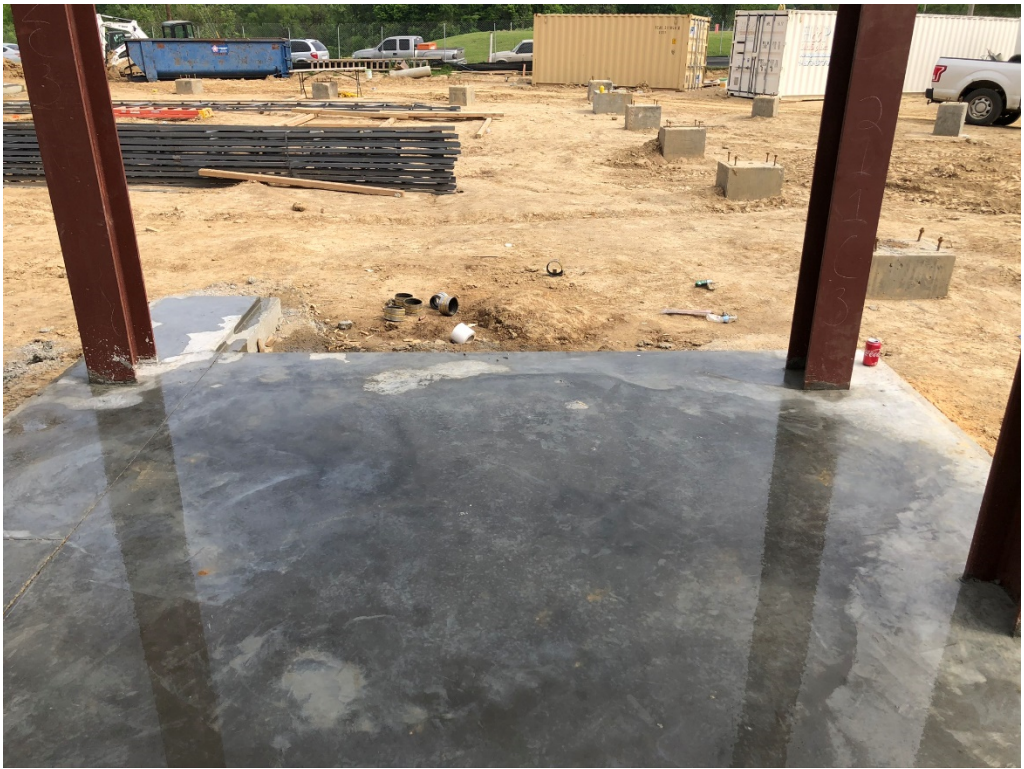
Figure 5 – North Section of New Slab

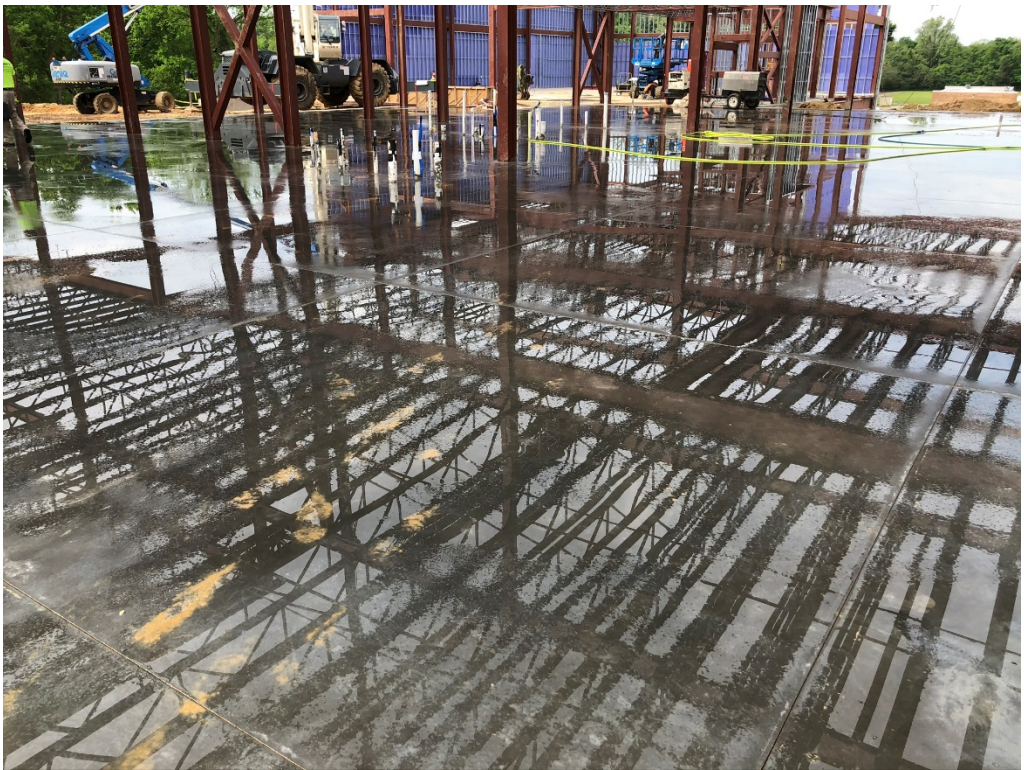
Figure 6 – Ponding Technique in use 4 days after pour

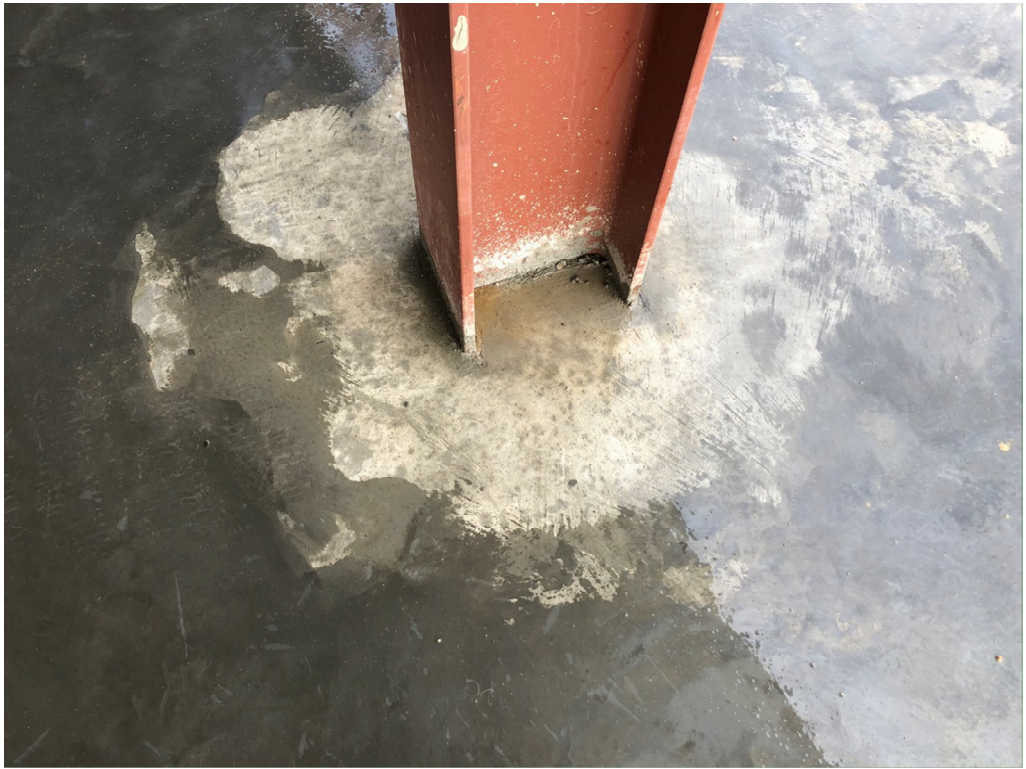
Figure 7 – Concrete @ North Column not troweled entirely smooth

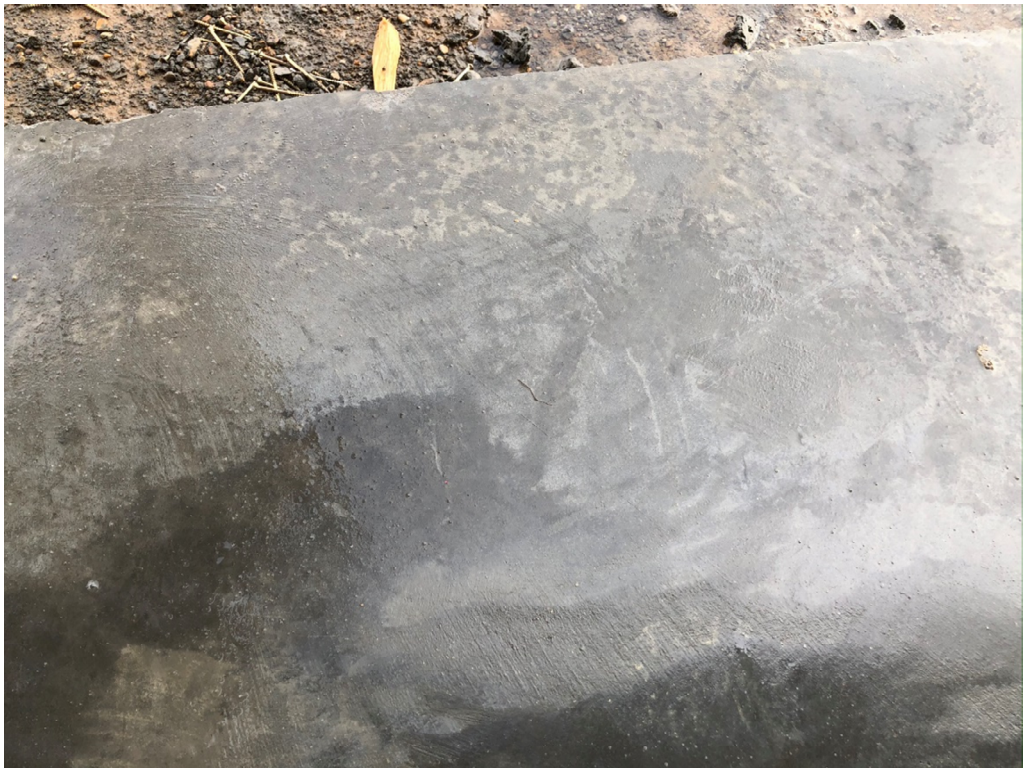
Figure 8 – North Edge of Slab Not Troweled Smooth (near Stairwell)

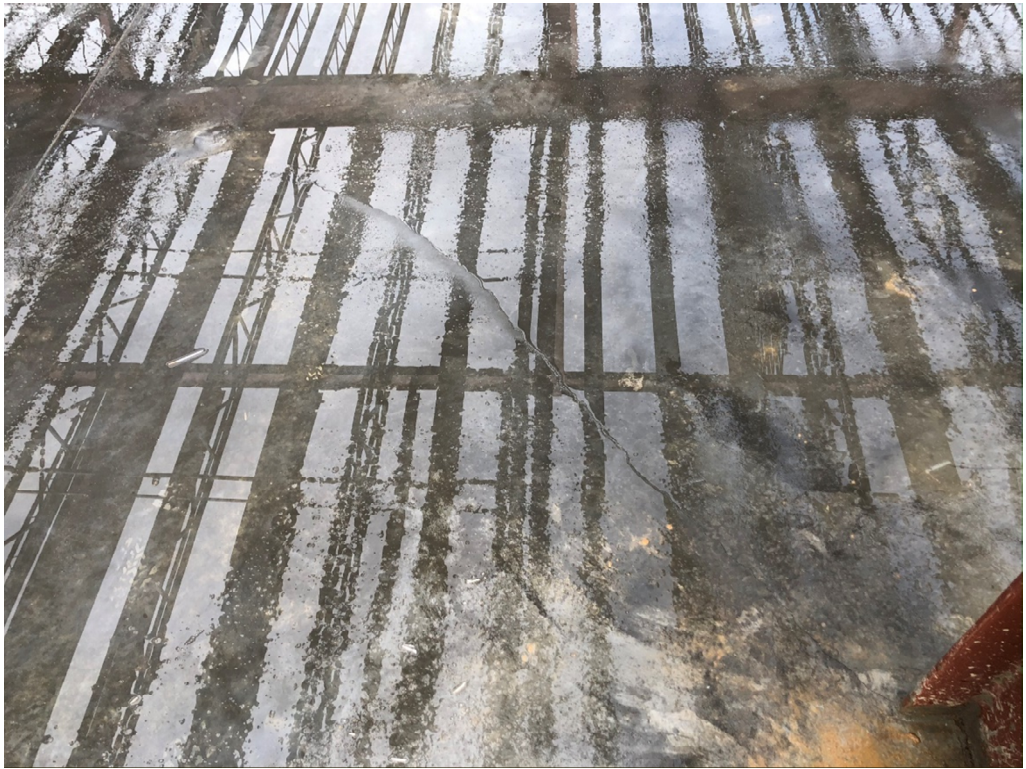
Figure 9 – Large Stress Crack @ Column NW of Room “Principal 104”

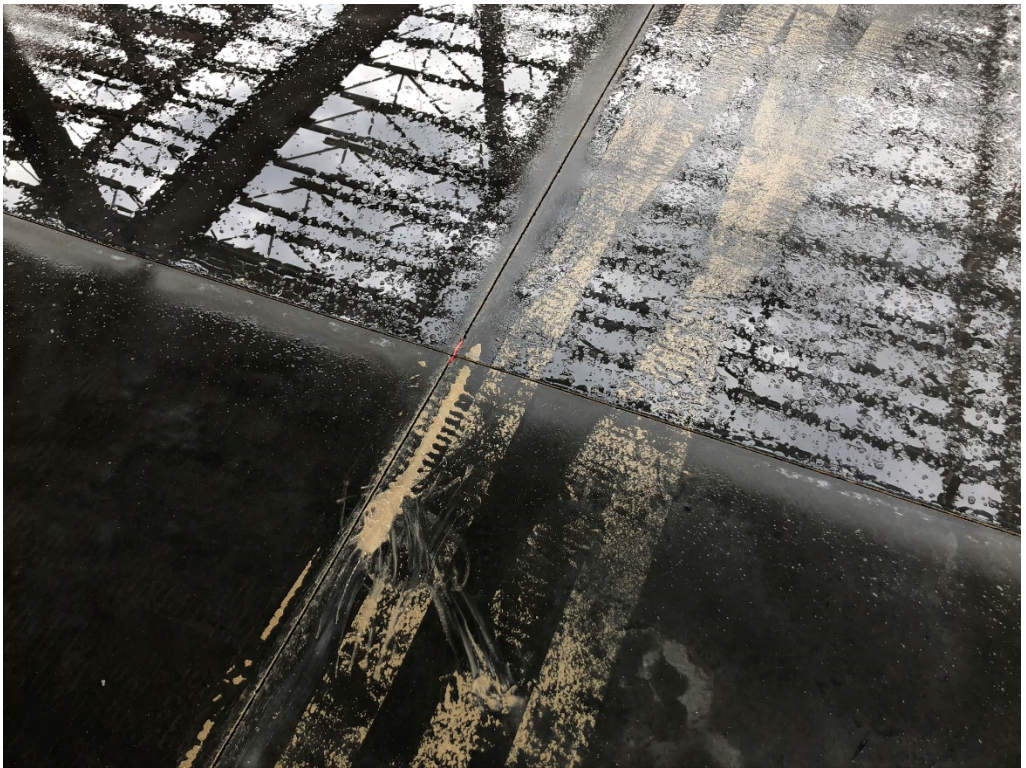
Figure 10 – Mortar Like Substance Tracked on Slab

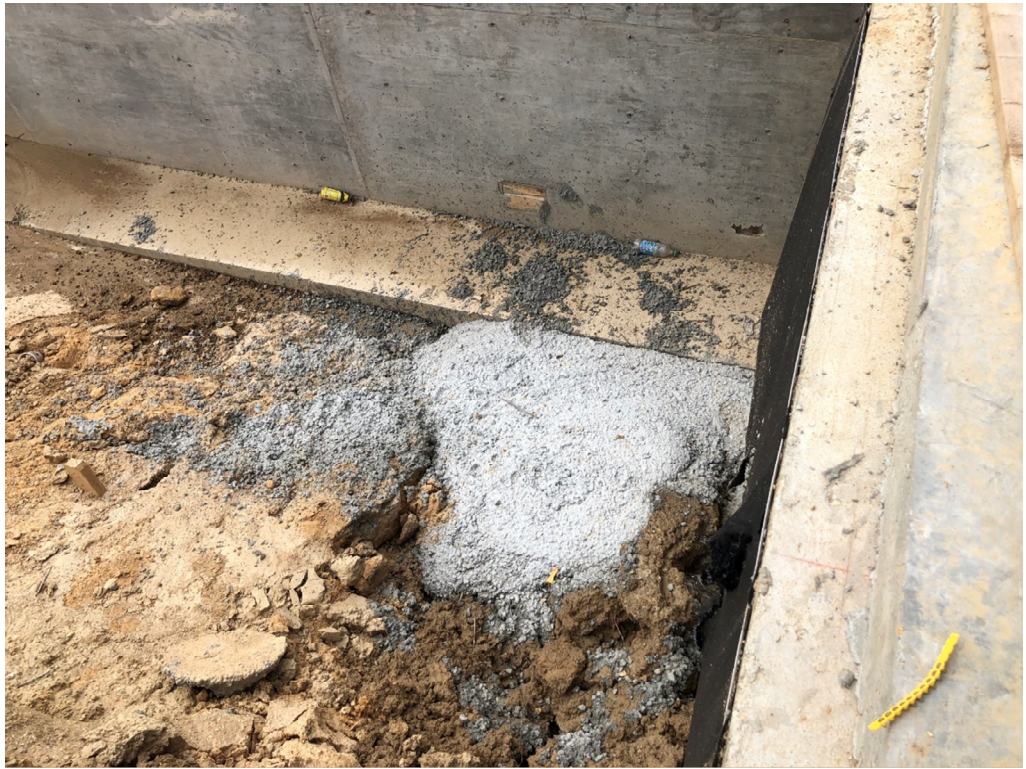
Figure 11 – Eroded area Filled with Concrete

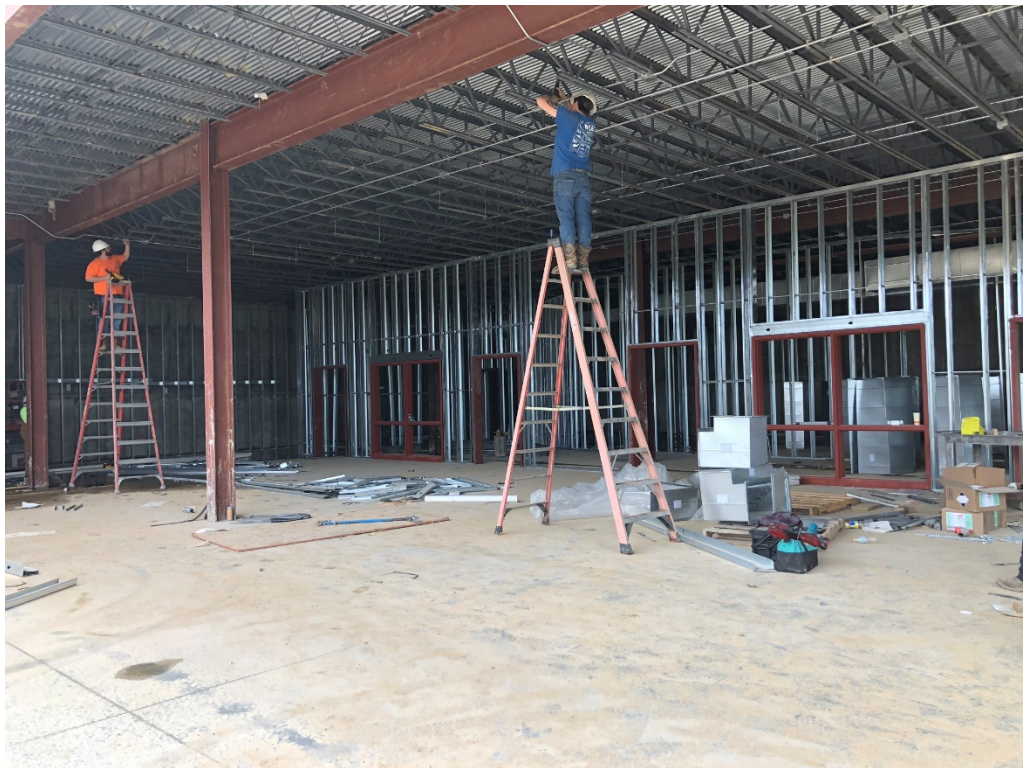
Figure 12 – Continued Rough-in Progress @ first floor cafeteria

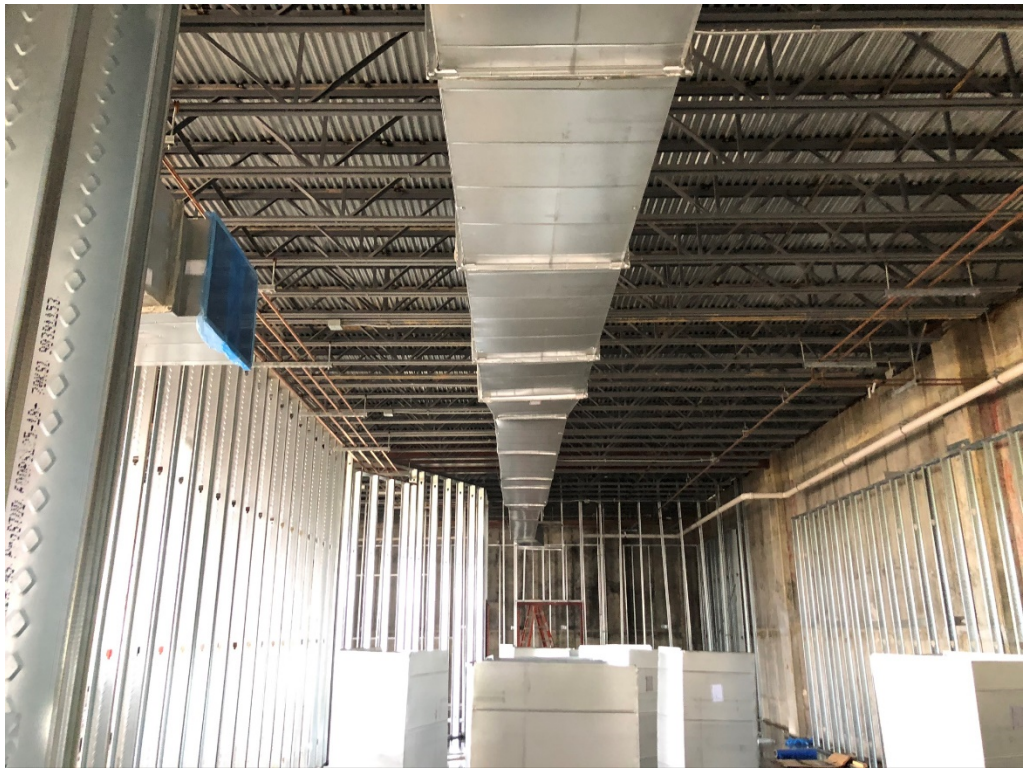
Figure 13 – Mech Rough in @ First Floor

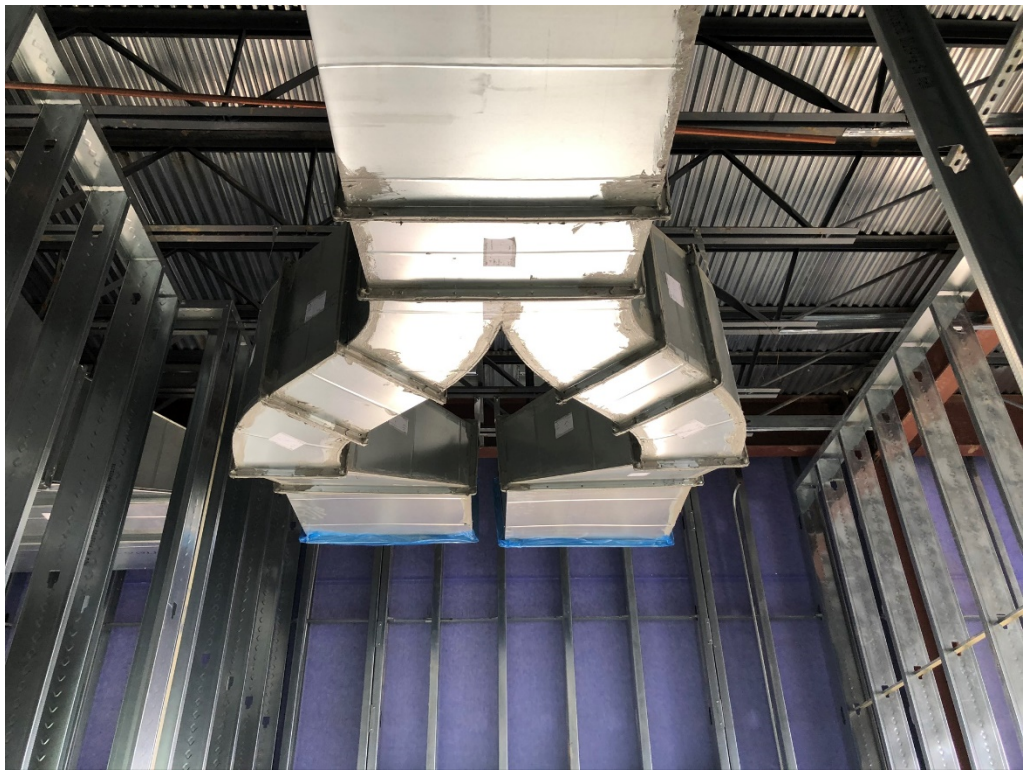
Figure 14 – Mech Rough in @ First Floor

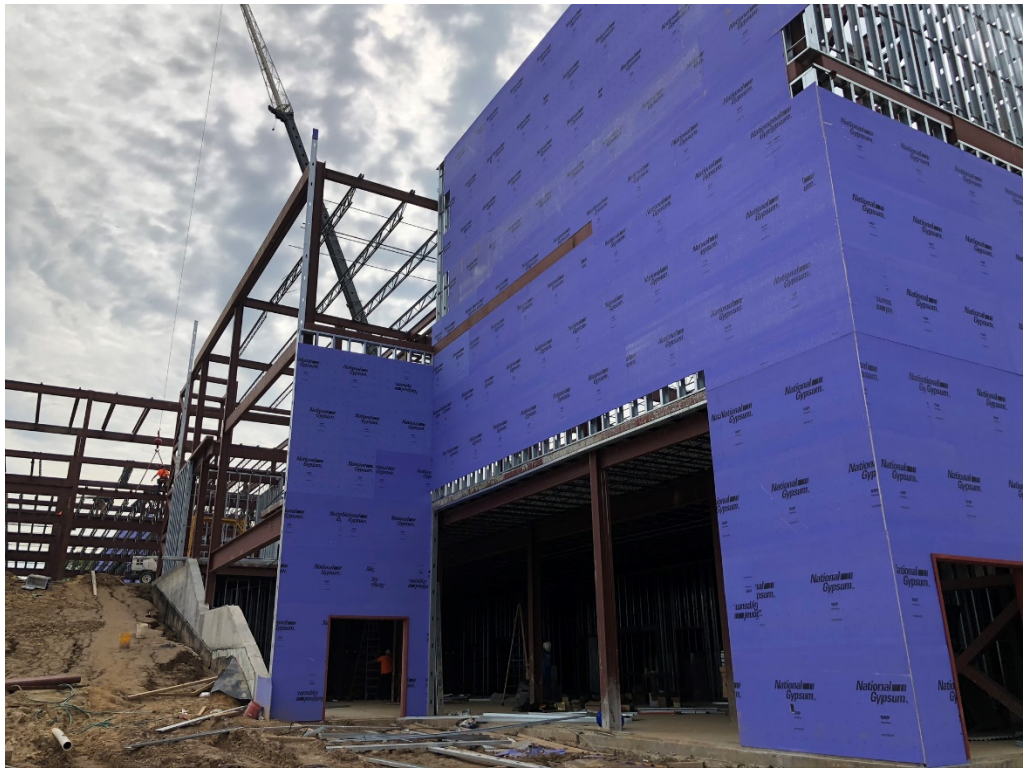
Figure 15 – Will You cut Through Concrete Foundation for Venting?

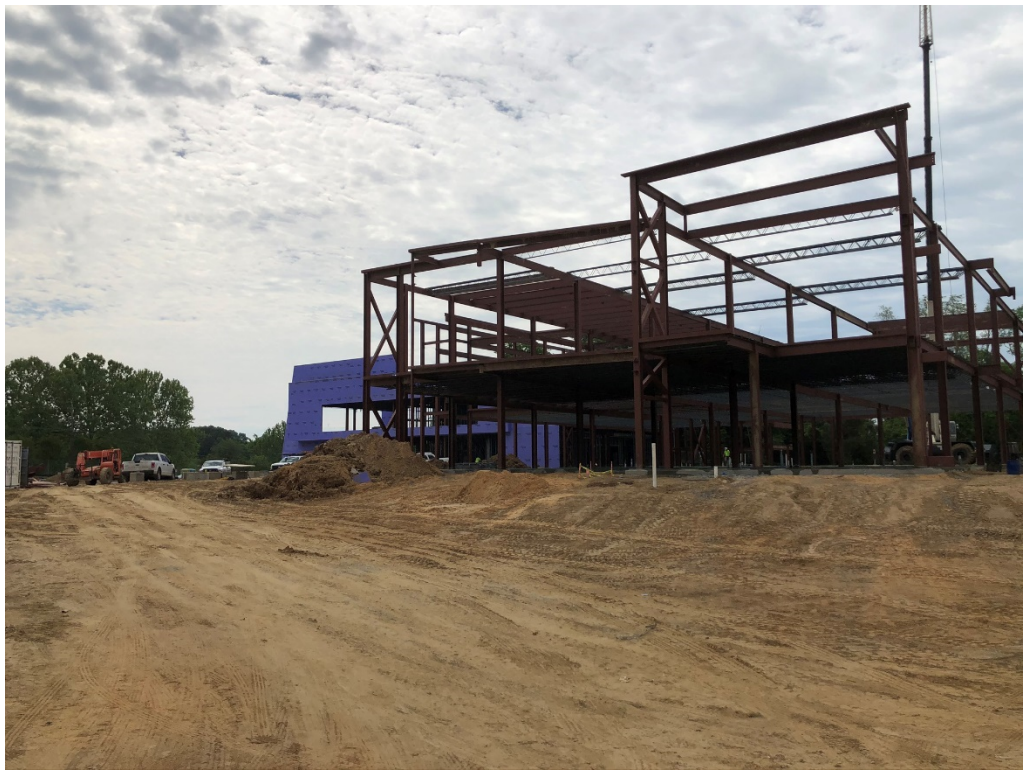
Figure 16 – Concrete and Gypsum Connection

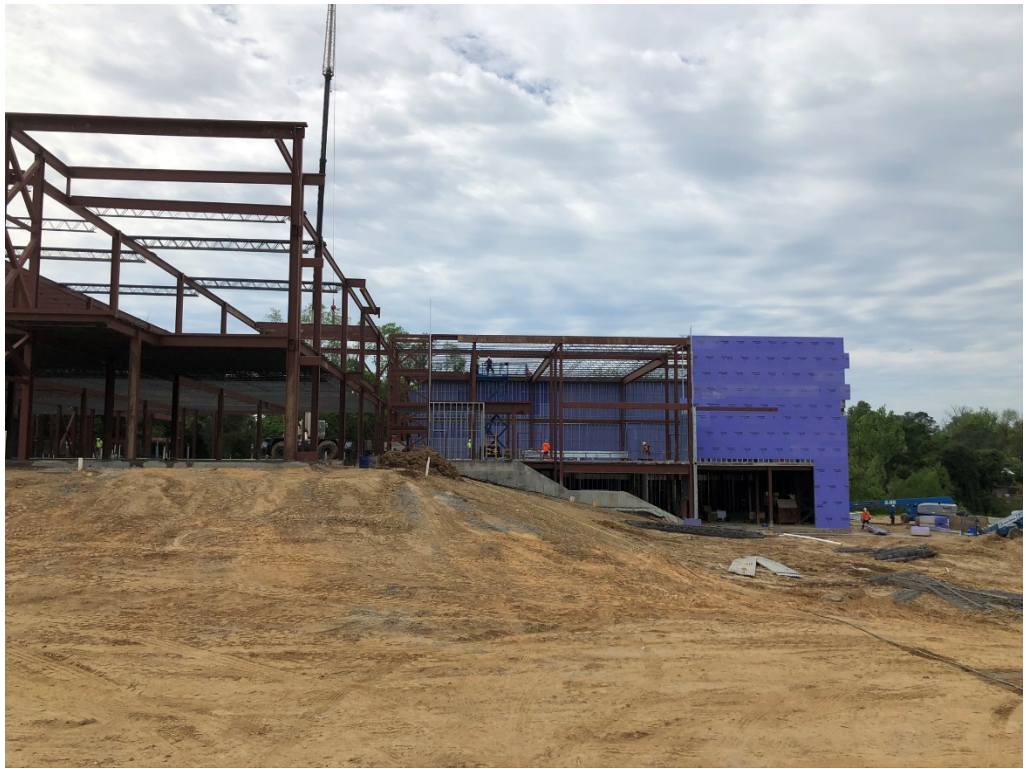
Figure 17 – NW of Site Looking SE

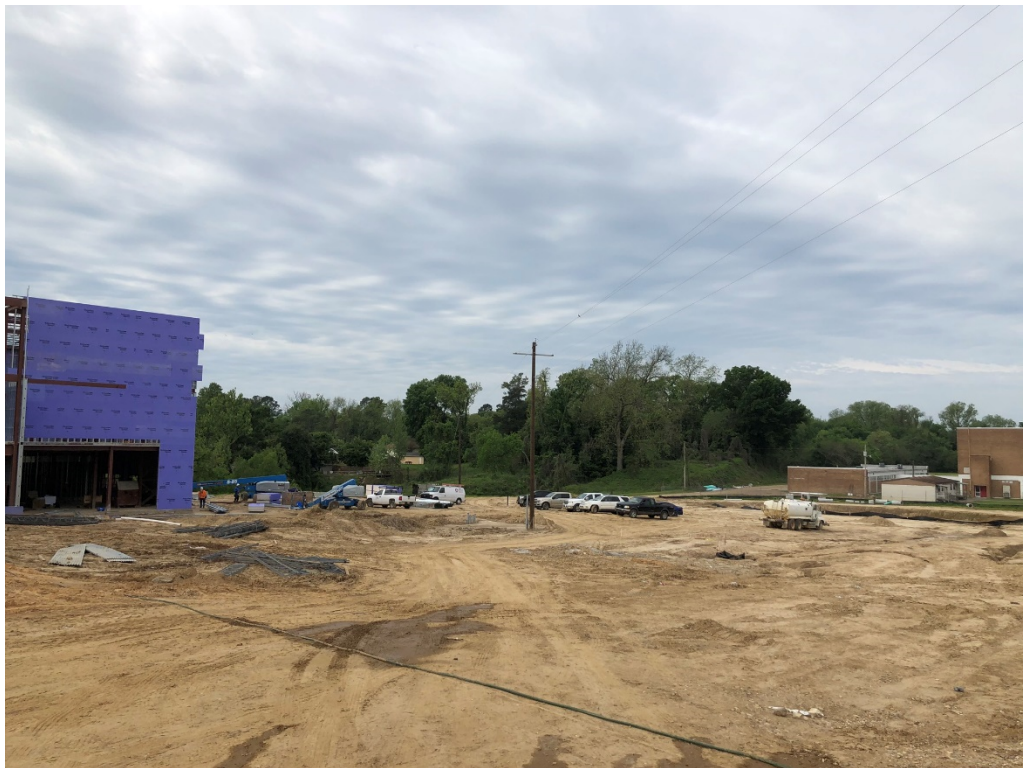
Figure 18 – NW of Site Looking E
