Architect's Field Report

16 April 2020

18059-AOI Academy of Innovation / Report Number 031

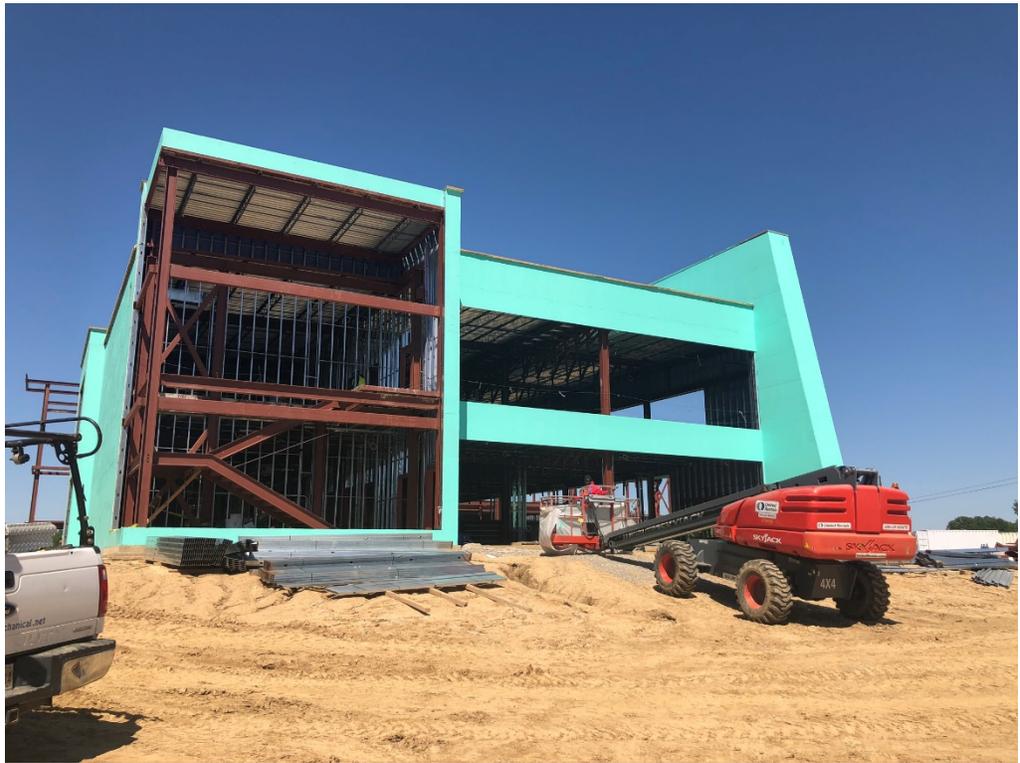
Figure 1 – East Structure

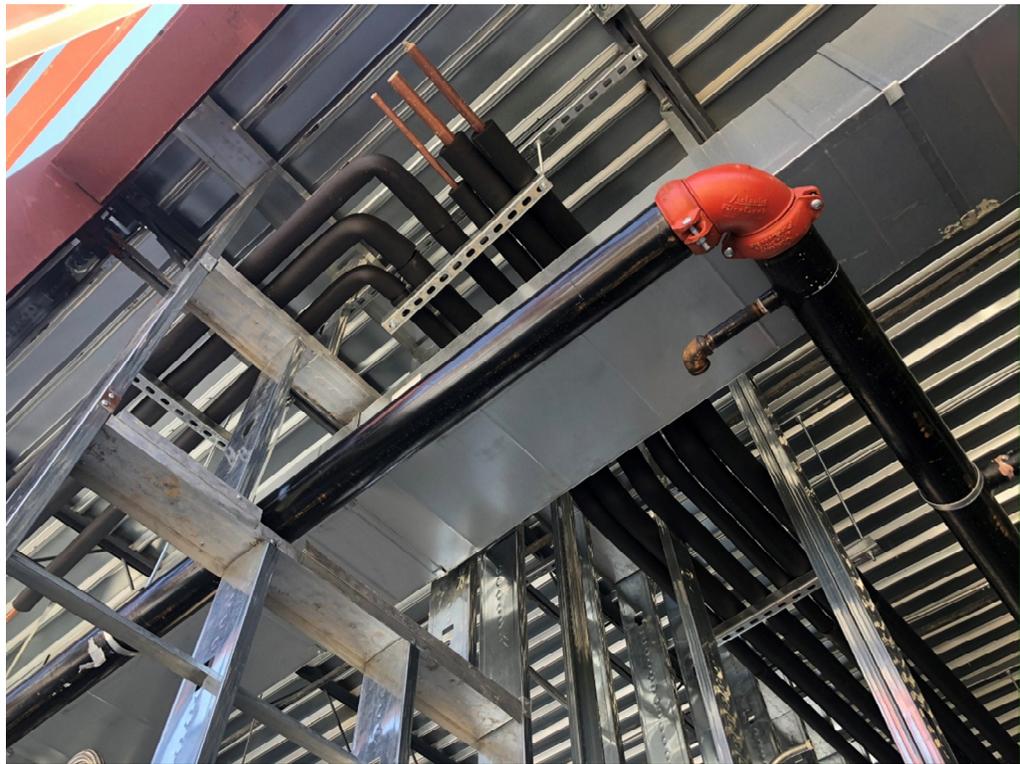
Figure 2 – Plumbing Below 219

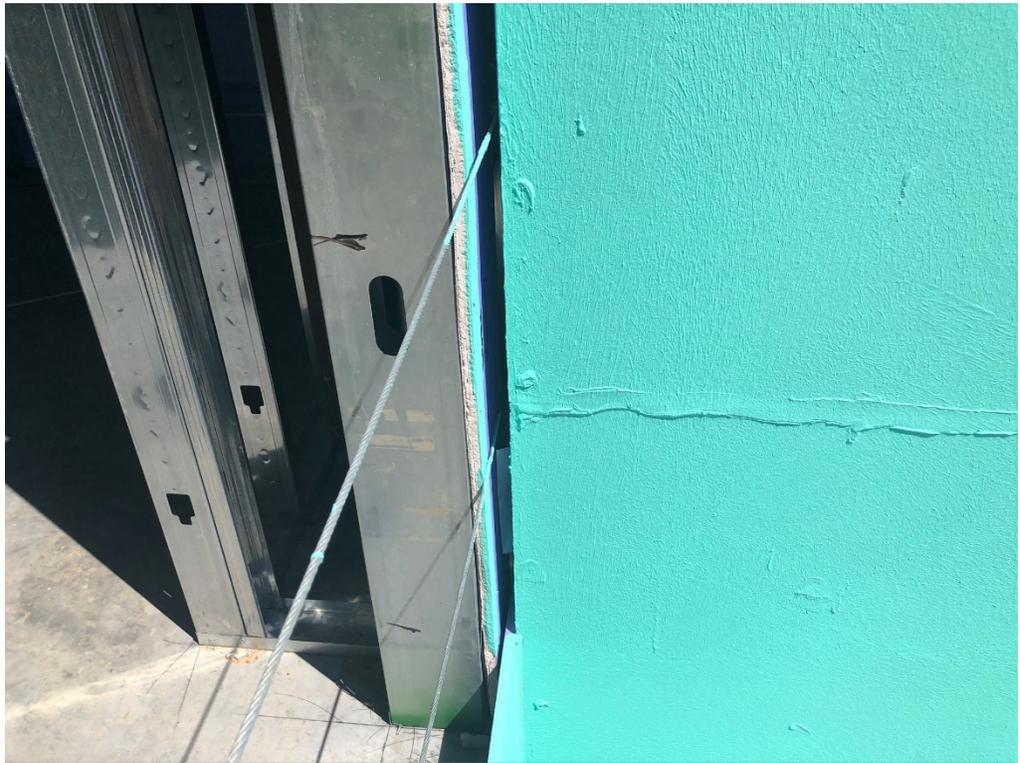
Figure 3 – Window Jamb @ 2nd Floor East Wall of Versatile Teaching Space 210

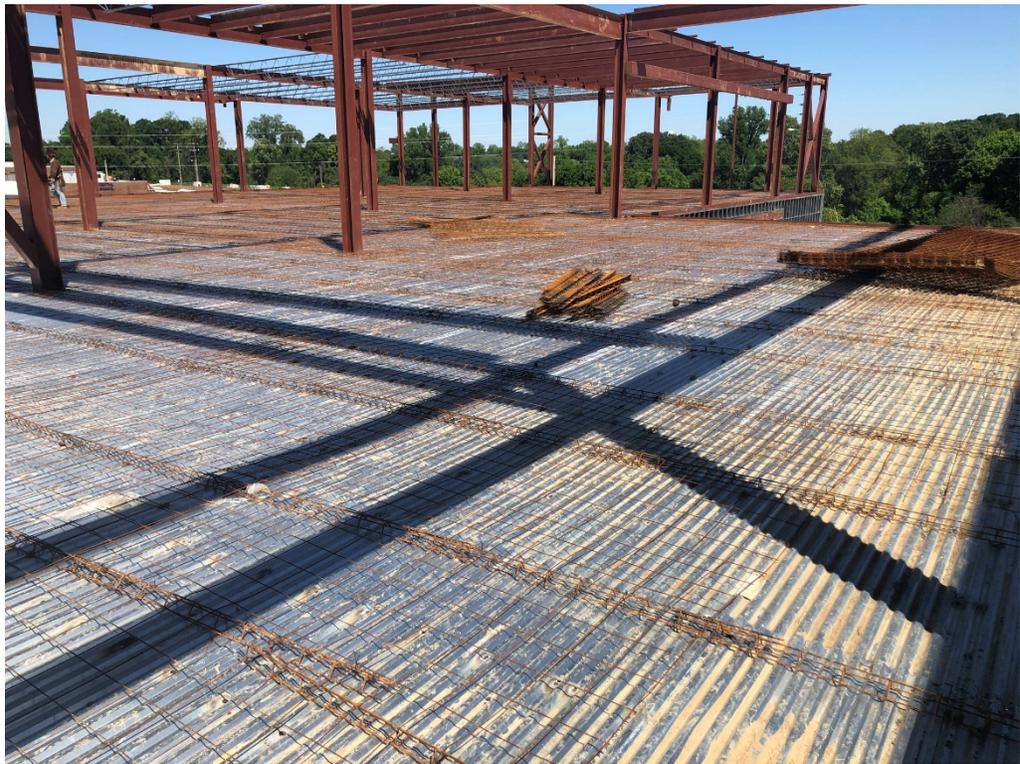
Figure 4 – Central Building Section 2nd Floor

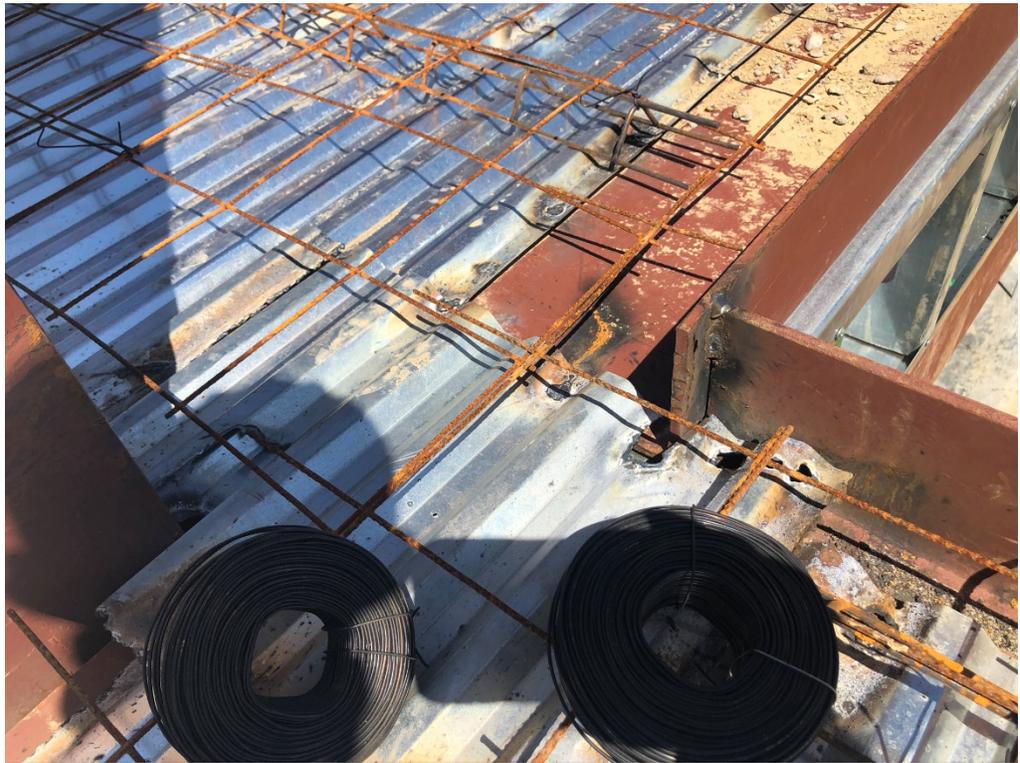
Figure 5 – Welded Corner 2nd Floor @ Conf. Room 206

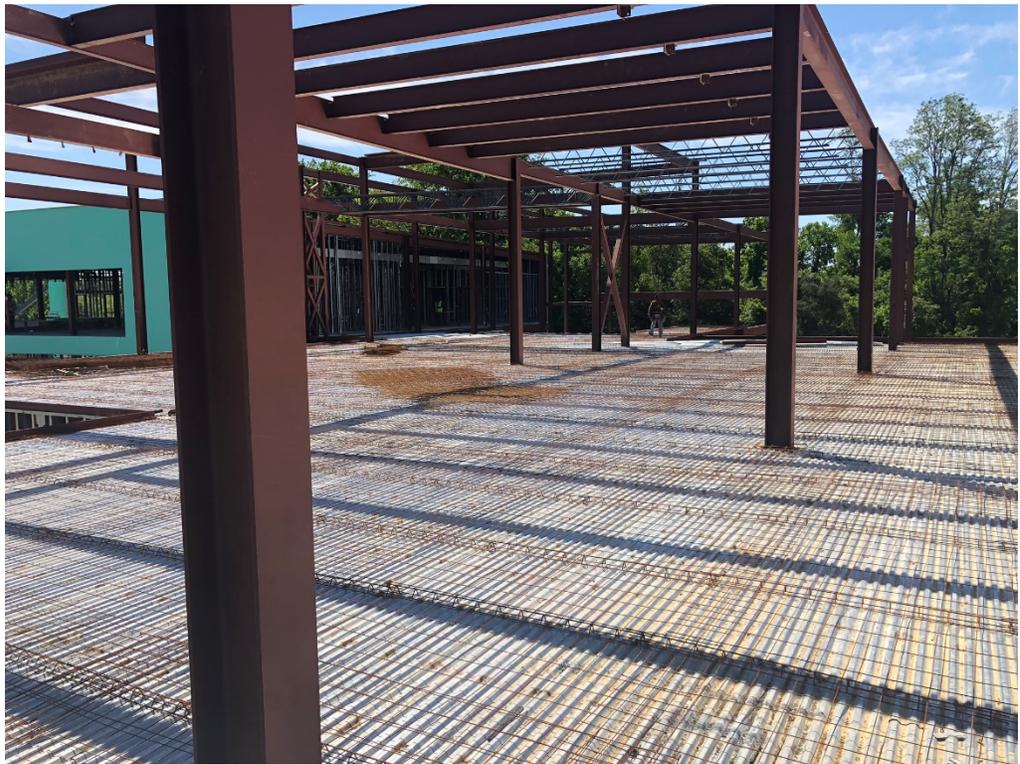
Figure 6 – Remesh Prep @ 2nd Floor Slab

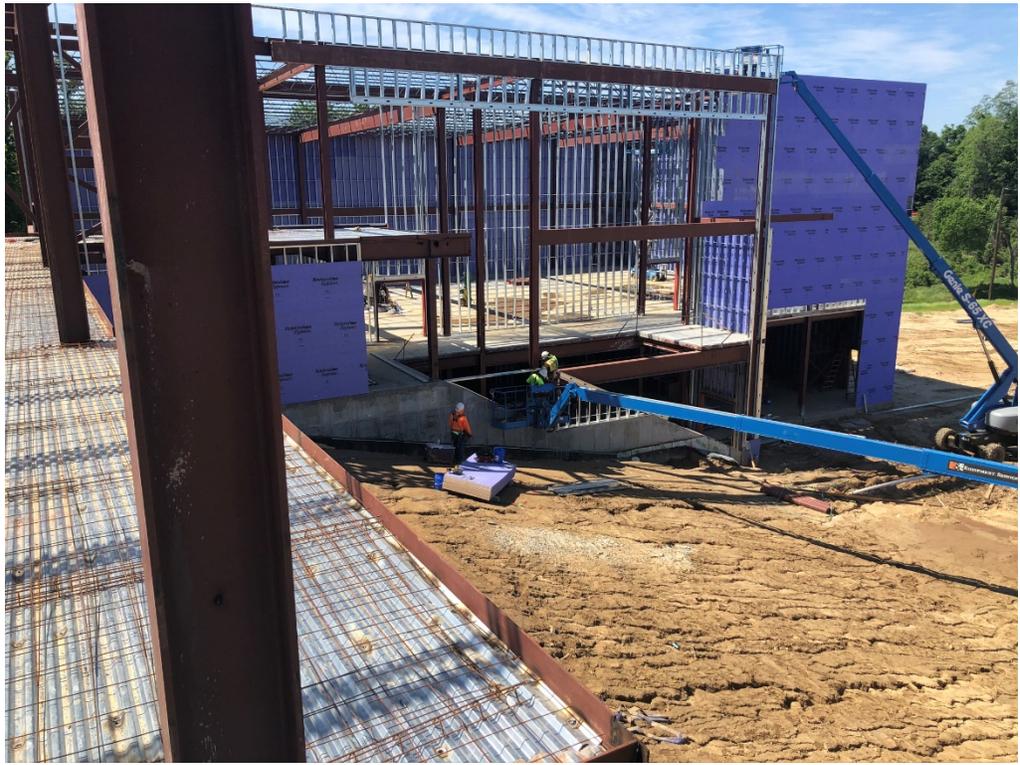
Figure 7 – North Elevation of West Building Section

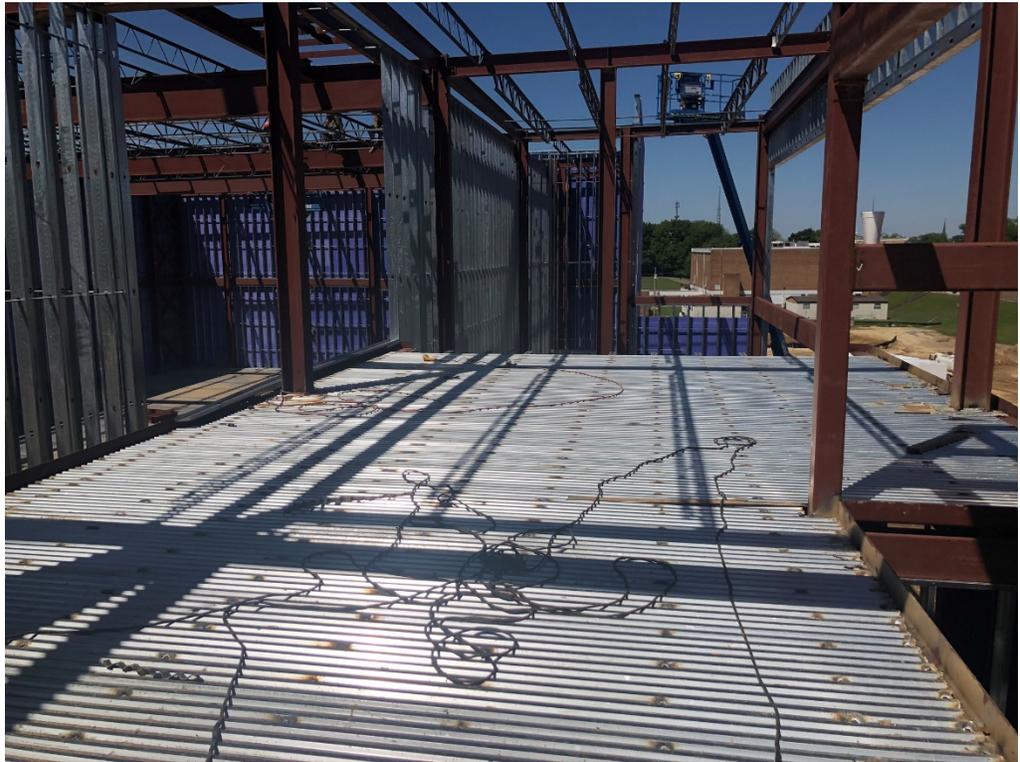
Figure 8 – Stairwell and Elevator Platform Top Floor

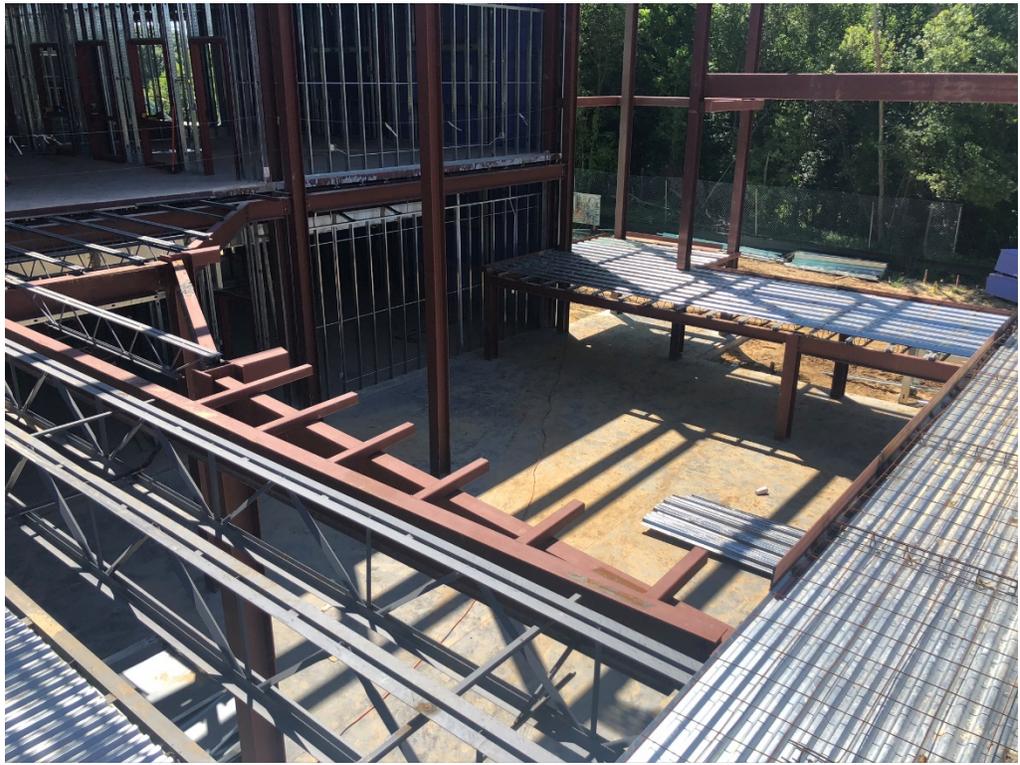
Figure 9 – Open Gathering Space, Building Center from 2nd Floor Lobby 250

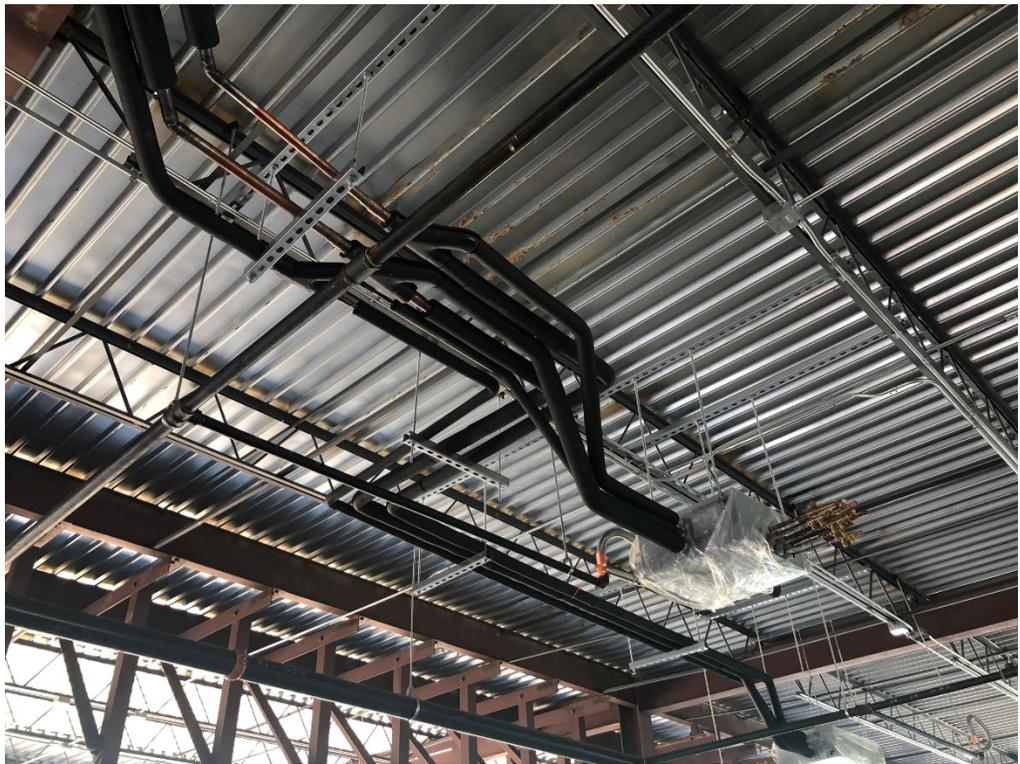
Figure 10 – Plumbing Rough In On-Going

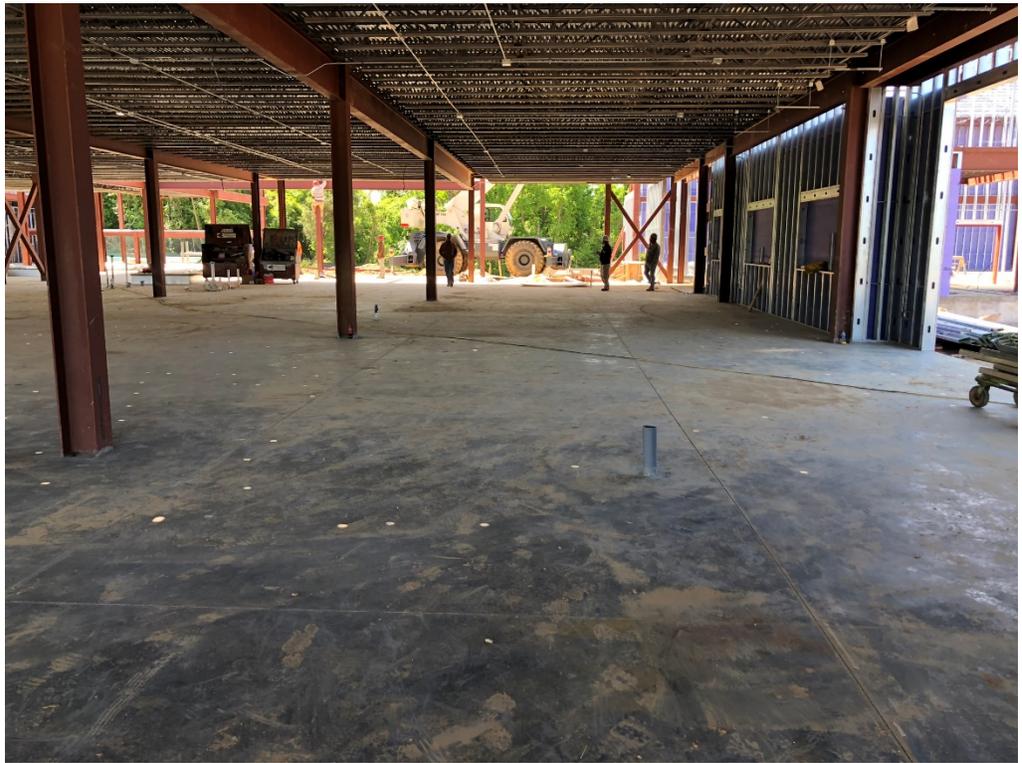
Figure 11 – Lab 123 Looking South

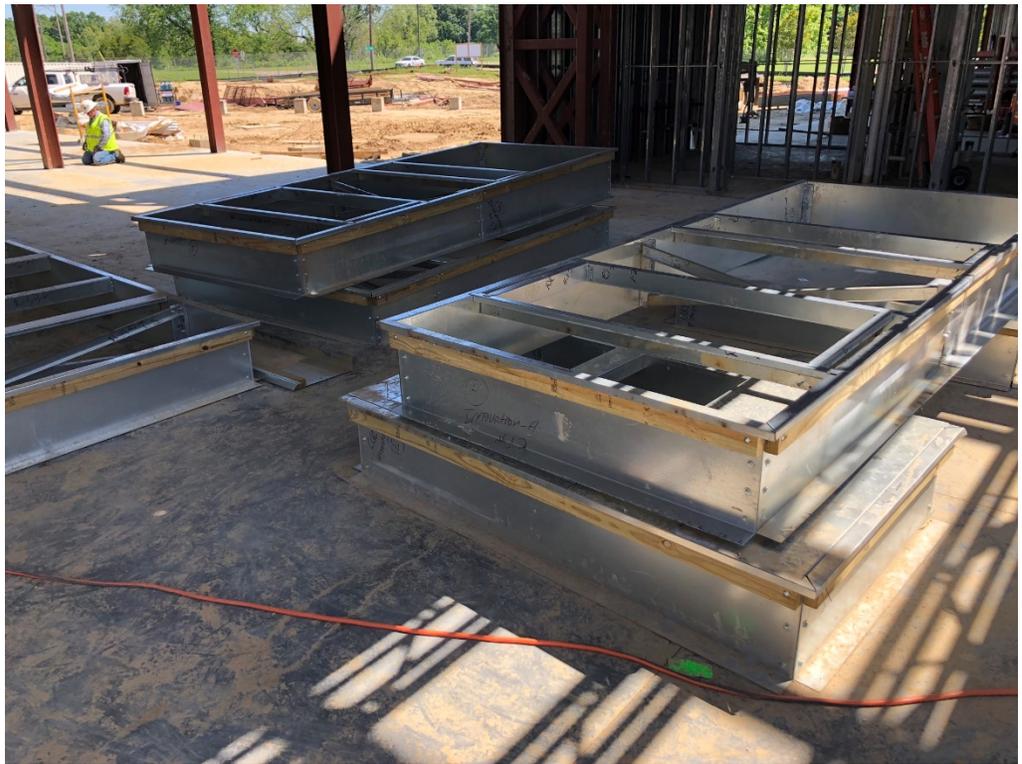
Figure 12 –Curbs on Site

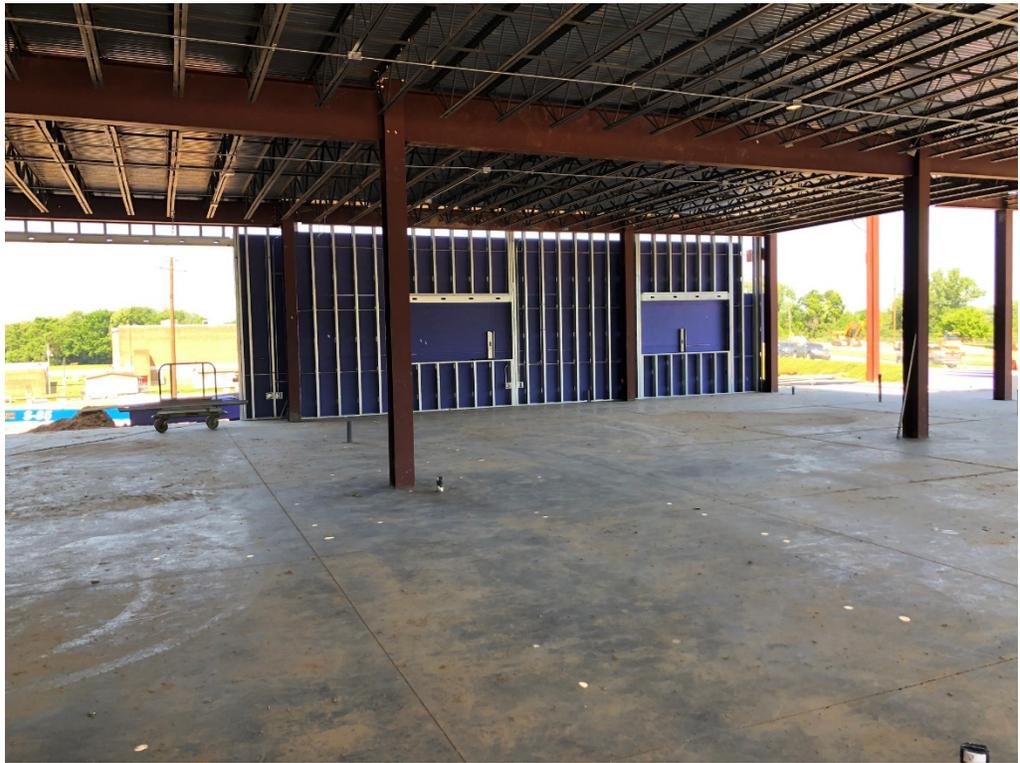
Figure 13 – Mech Rough in @ First Floor

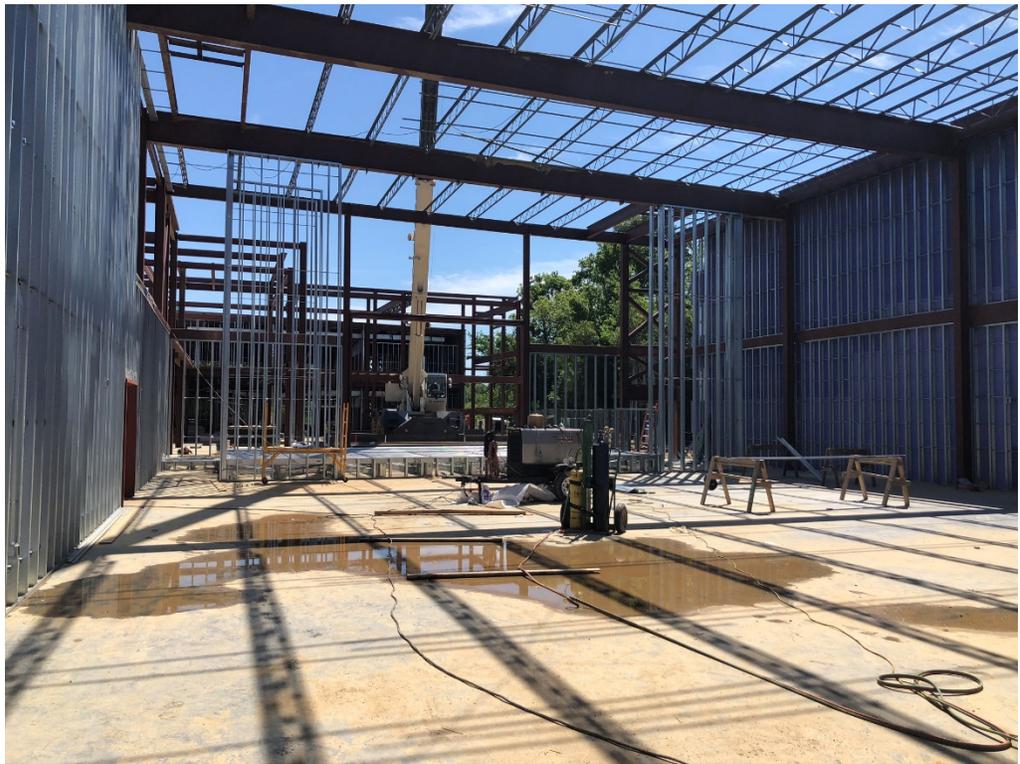
Figure 14 – Gym Framing Progress

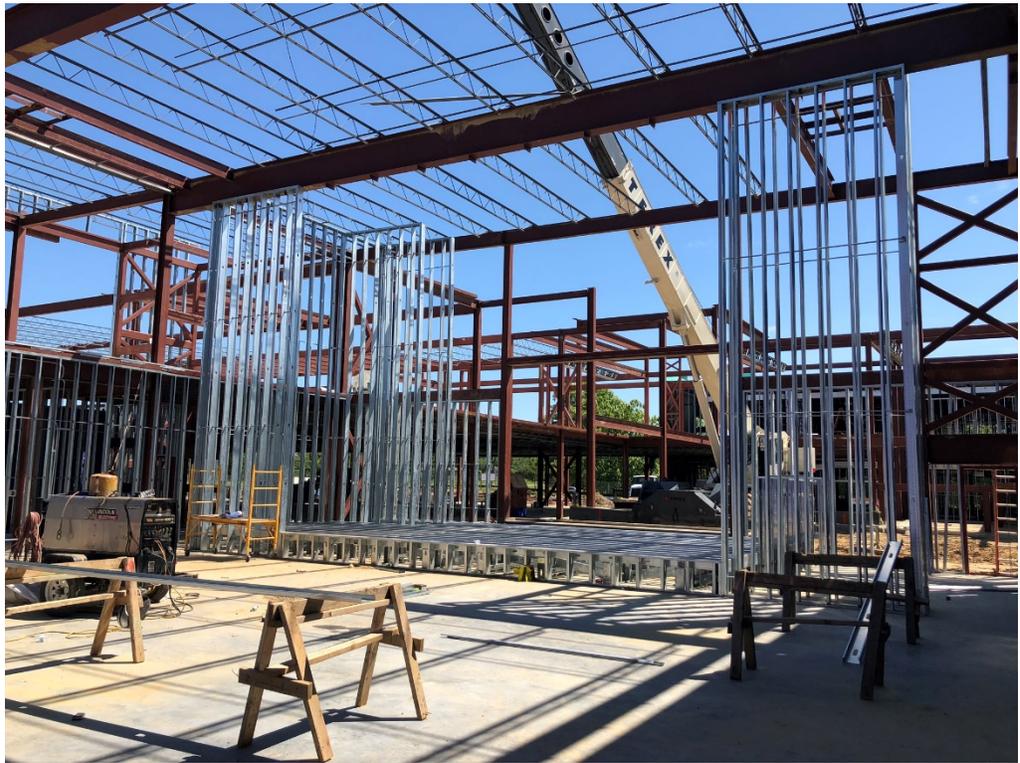
Figure 15 – Stage Framing Progress

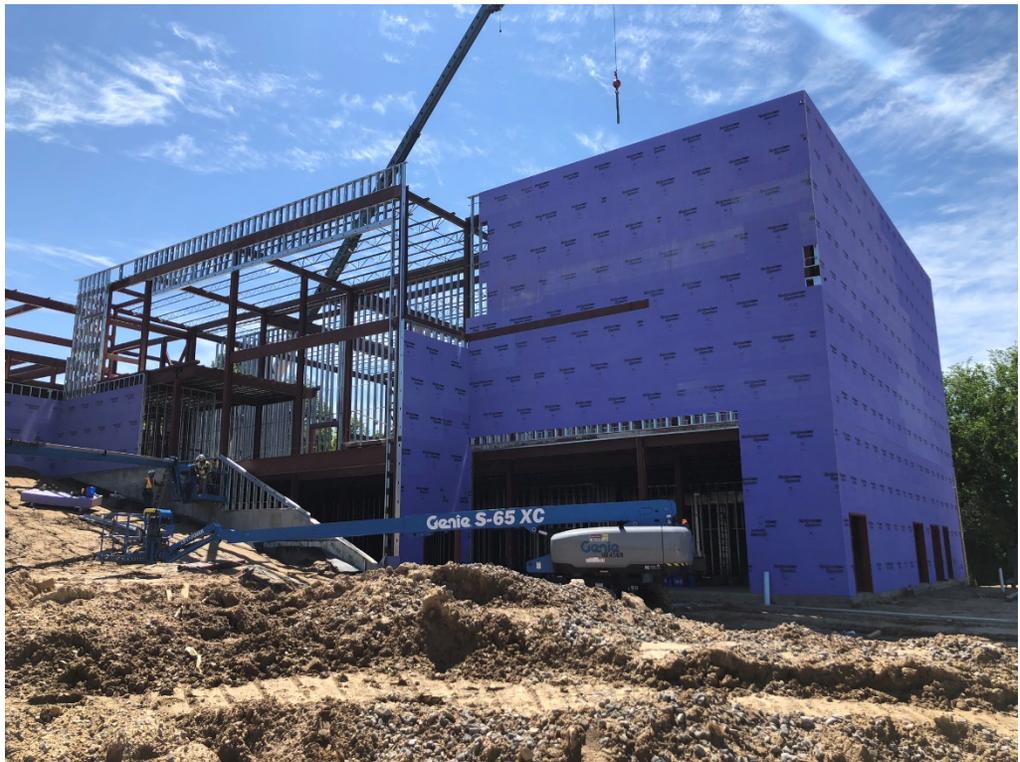
Figure 16 – North Elevation of West Building Section

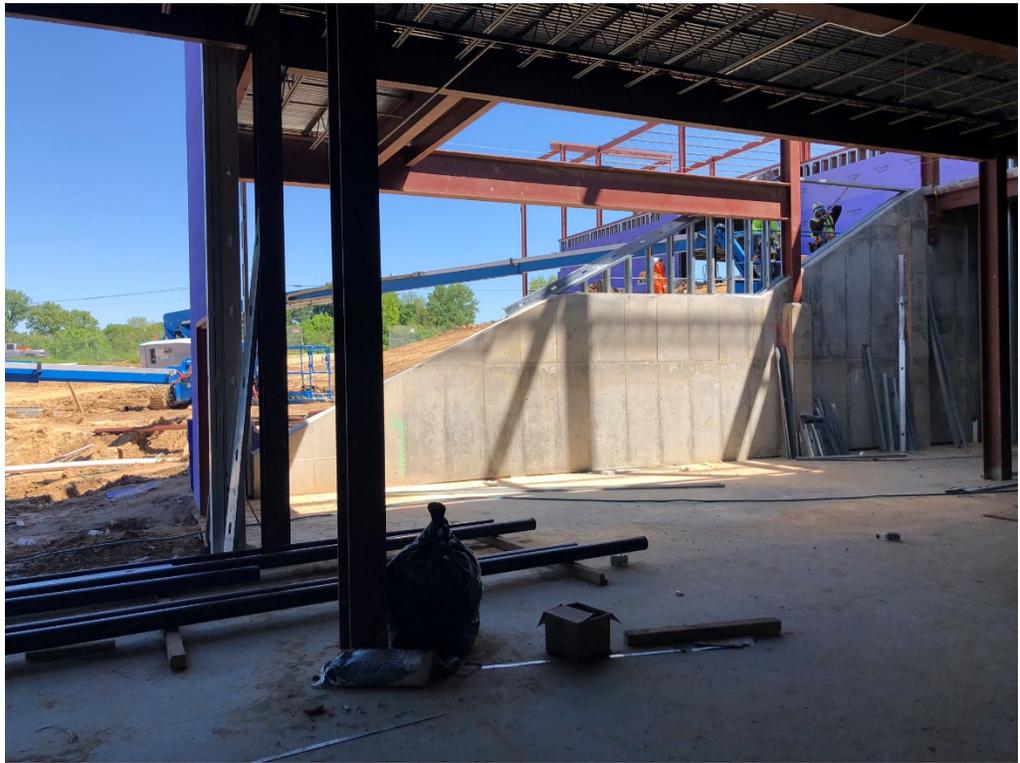
Figure 17 – Framing @ Concrete Wall Exterior

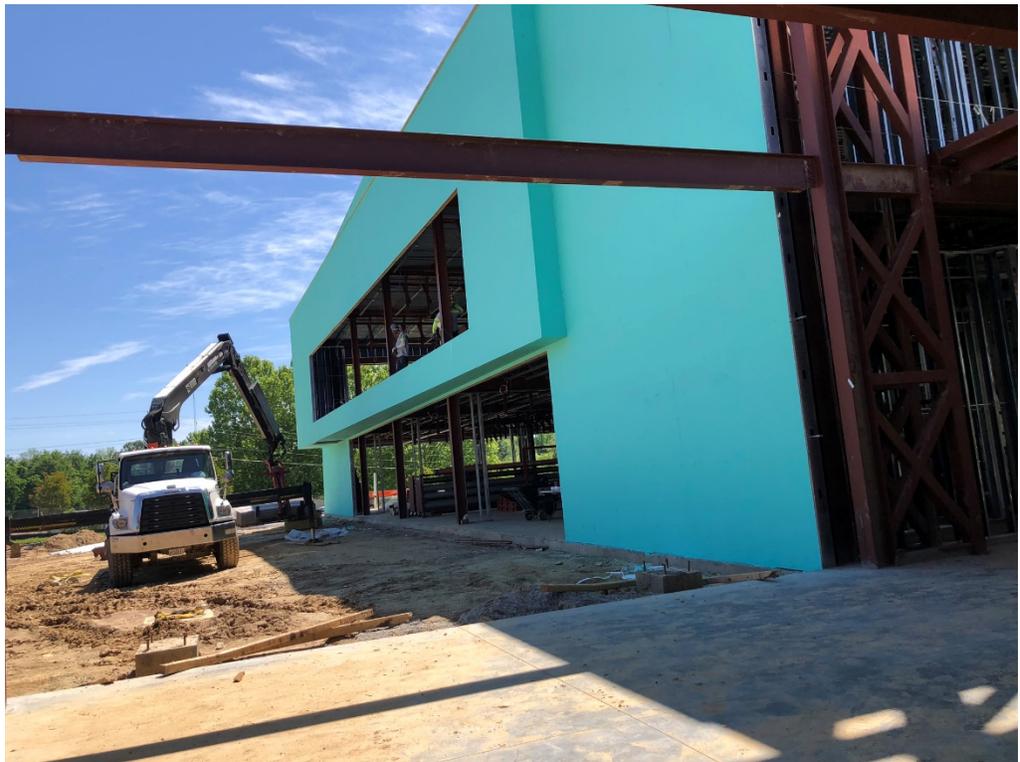
Figure 18 – Drywall Delivered to Second Floor East Building
