## Architect's Field Report

201 Park Court, Suite B Ridgeland, MS 39157 P 601.790.9432 F 888.281.0547	23 April 2020	
	18059-AOI Academy of Innovation / Report Number 032	
	Contract	Century Construction
One Jackson Place, Suite 250 188 East Capitol Street Jackson, MS 39201-2100 P 601.352.5411 F 601.352.5362	Date / Time	22 April 2020 / 3:30 PM
	Weather / Temp	Overcast / 66 ° F
	Est % Complete	40%
	Sched Conformance	+ 71 days
161 Lameuse Street, Suite 201 Biloxi, MS 39530 P 228.374.1409 F 228.374.1414	Work in Progress	Concrete Work Sheathing Install Mechanical & Plumbing Rough-INS
	Present at Site	Plumbing/Mechanical Subs Sheathing Crew Joey Moore, CC Billy Burwell, CC Paul Purser, DBA
	Observations	<p>Arriving on site I reviewed work on Upper slab, which was poured in the morning. Finishers were troweling about 15% of the slab and the other 85% had already setup and been complete.</p> <p>I met with Mr. Burwell on Site and Mr. Moore and everything seemed to be going well. They did not have any outstanding issues. Mr. Burwell Mentioned Glass would be on site within 3 weeks and this should keep them on schedule to getting dried in By Early June.</p> <p>Roof work on the East section of

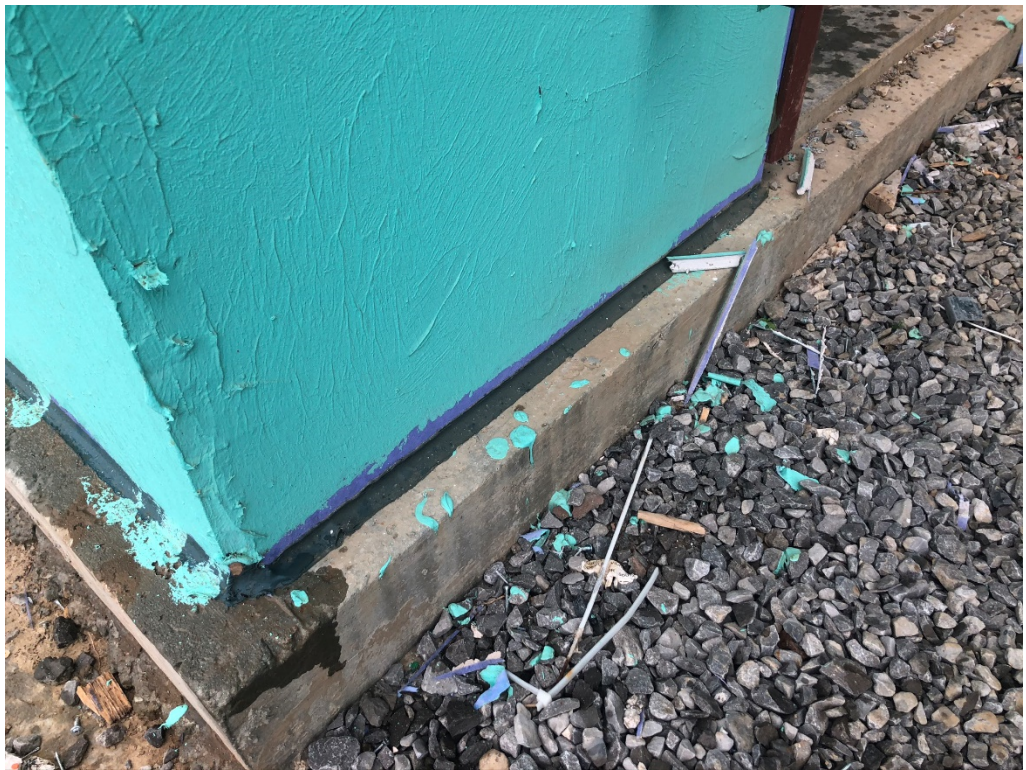
Figure 2 – Waterproofing Should be continuous to Corner

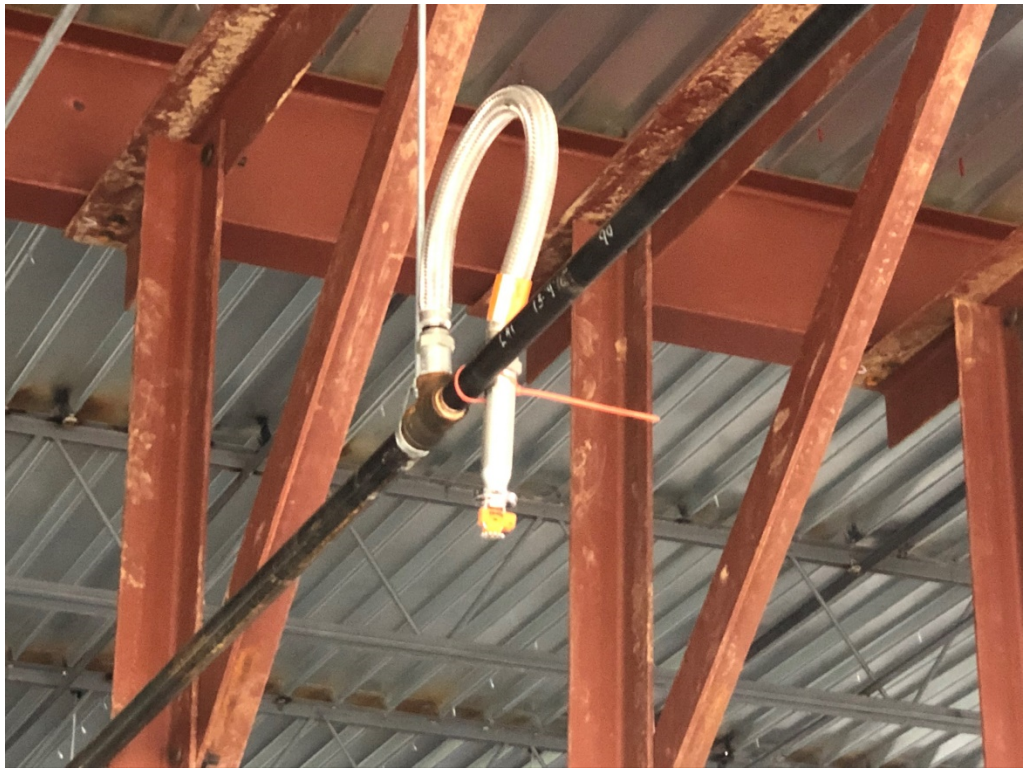
Figure 3 – Flex Drop for Sprinkler (typical and 90% complete in East structure)

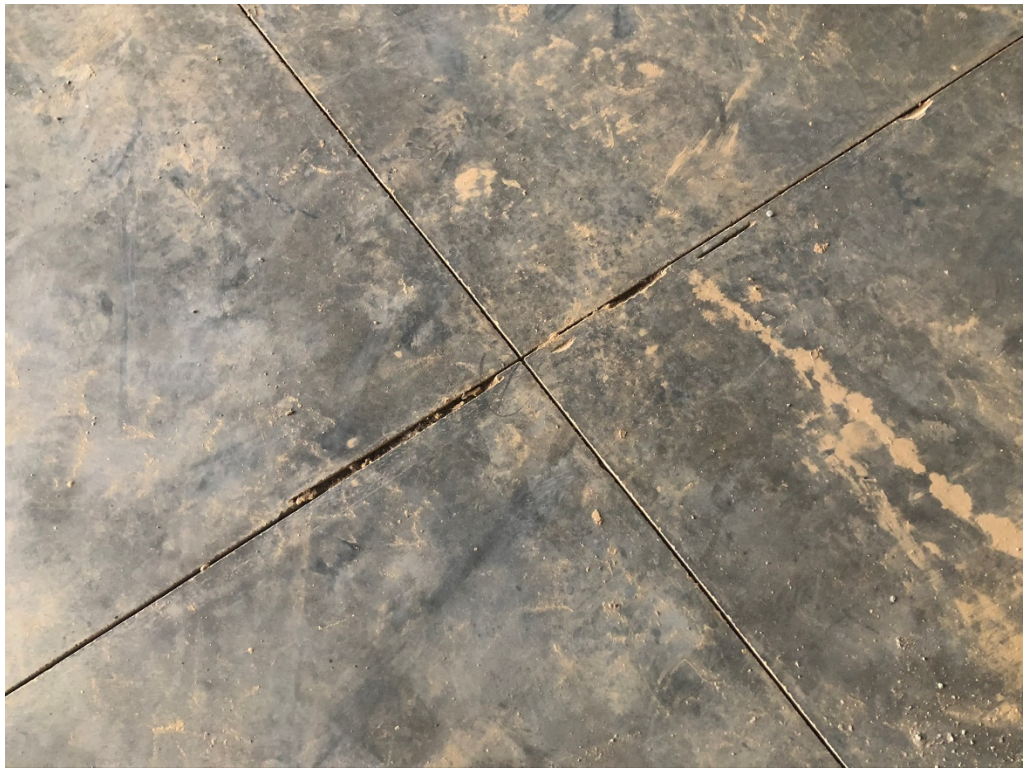
Figure 11 – Bad Saw Cut; Anyway to repair?
