Architect's Field Report

01 May 2020

18059-AOI Academy of Innovation / Report Number 033

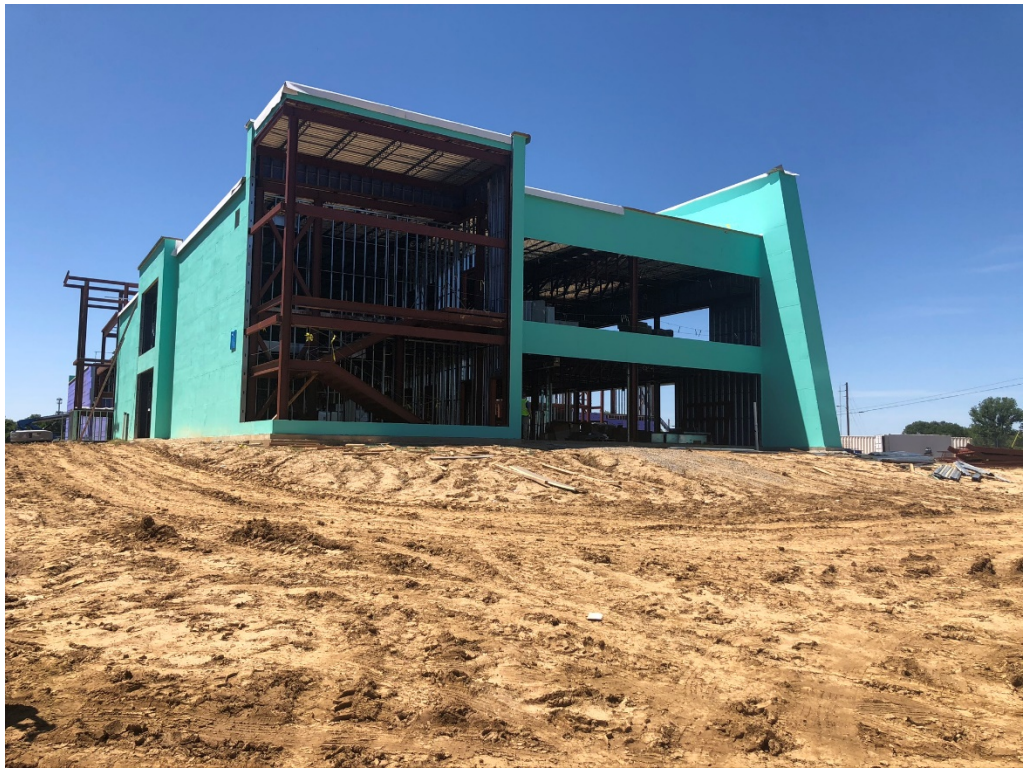
Figure 1 – East Structure

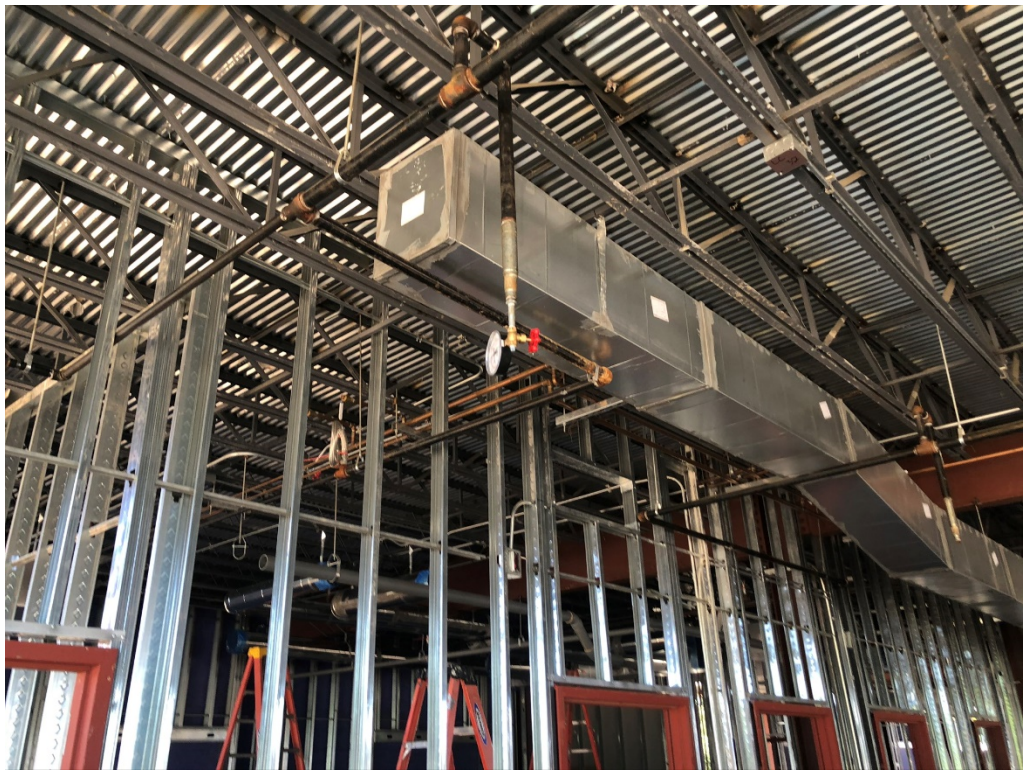
Figure 2 – Pressure Test on Sprinklers Ongoing in east section

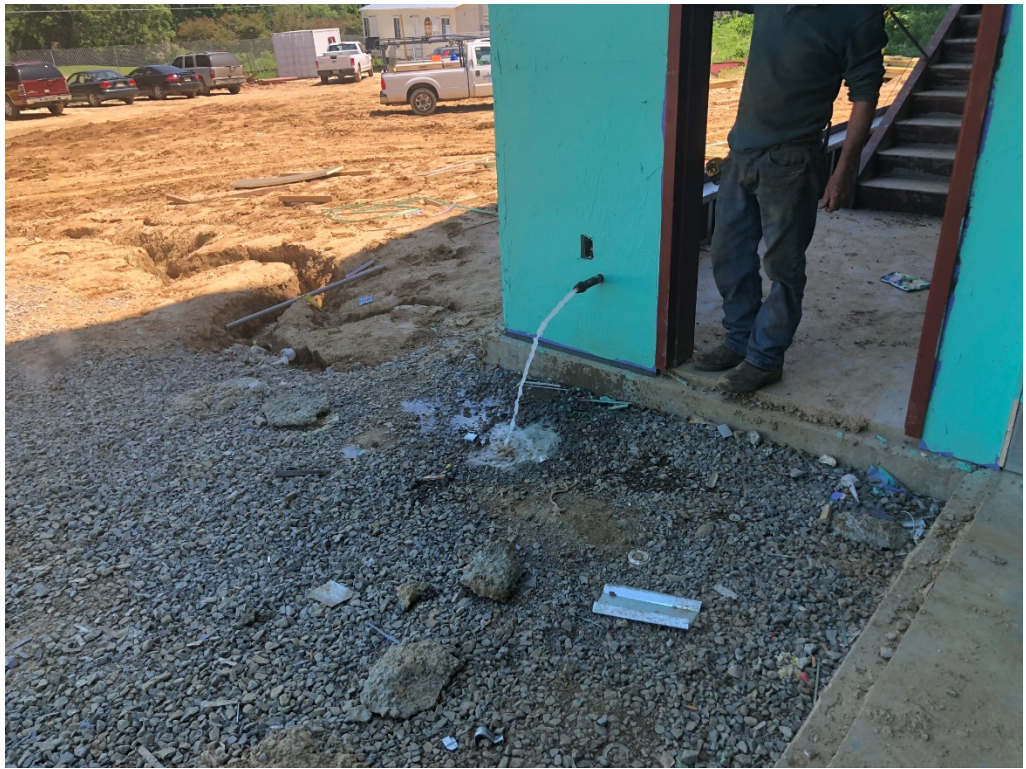
Figure 3 – Drain Outlet for Sprinklers

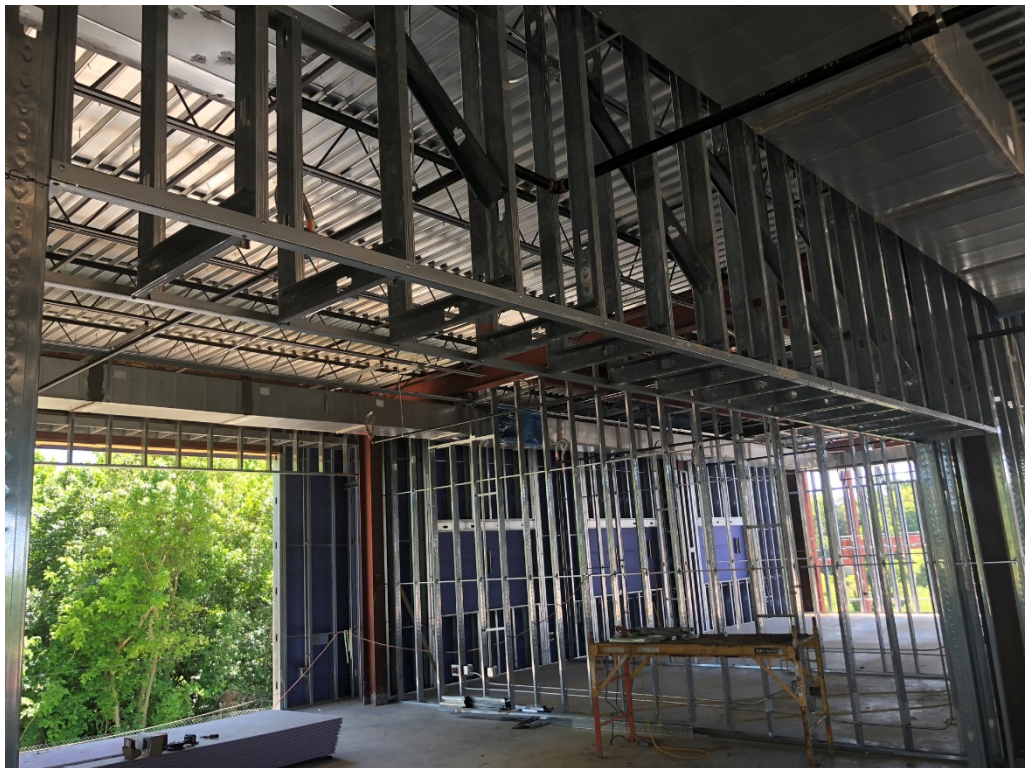
Figure 4 – Furr Downs Installed Throughout East Building Section

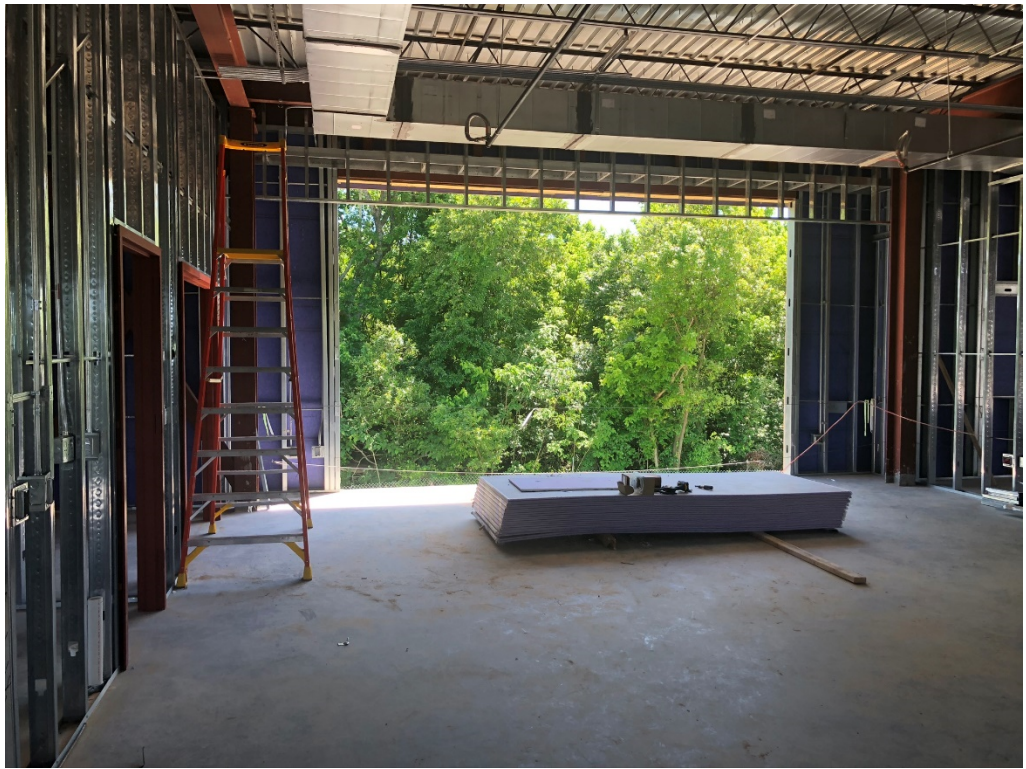
Figure 5 – Furr Downs also Installed at Windows

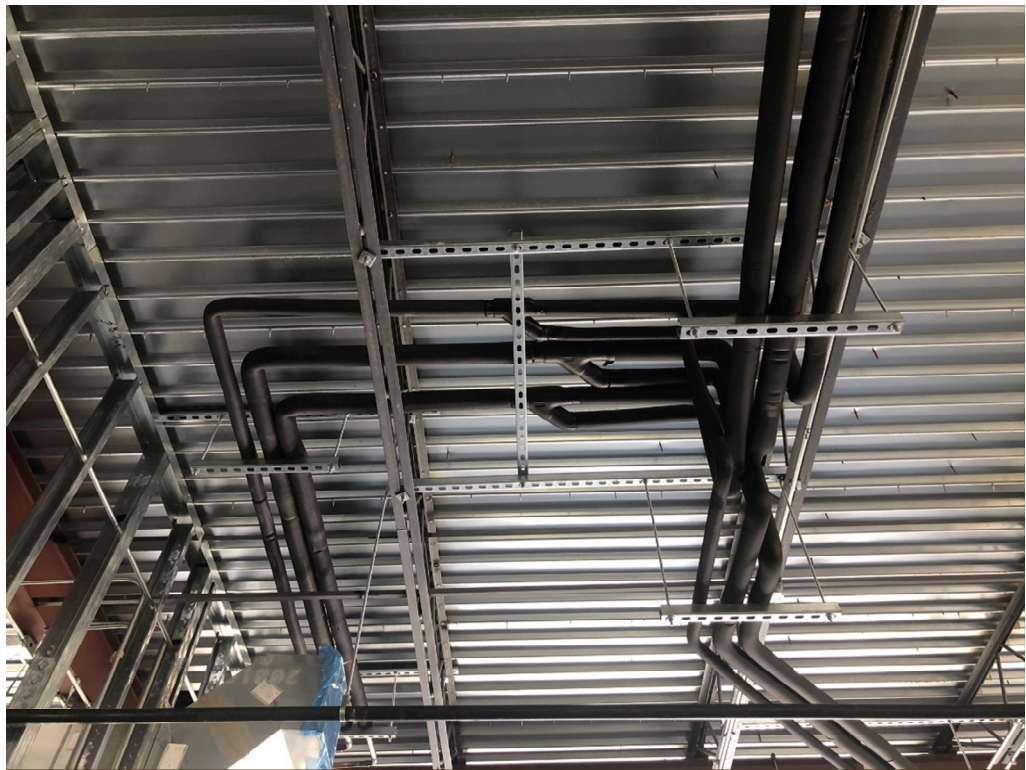
Figure 6 – Plumbing Rough In is Ongoing

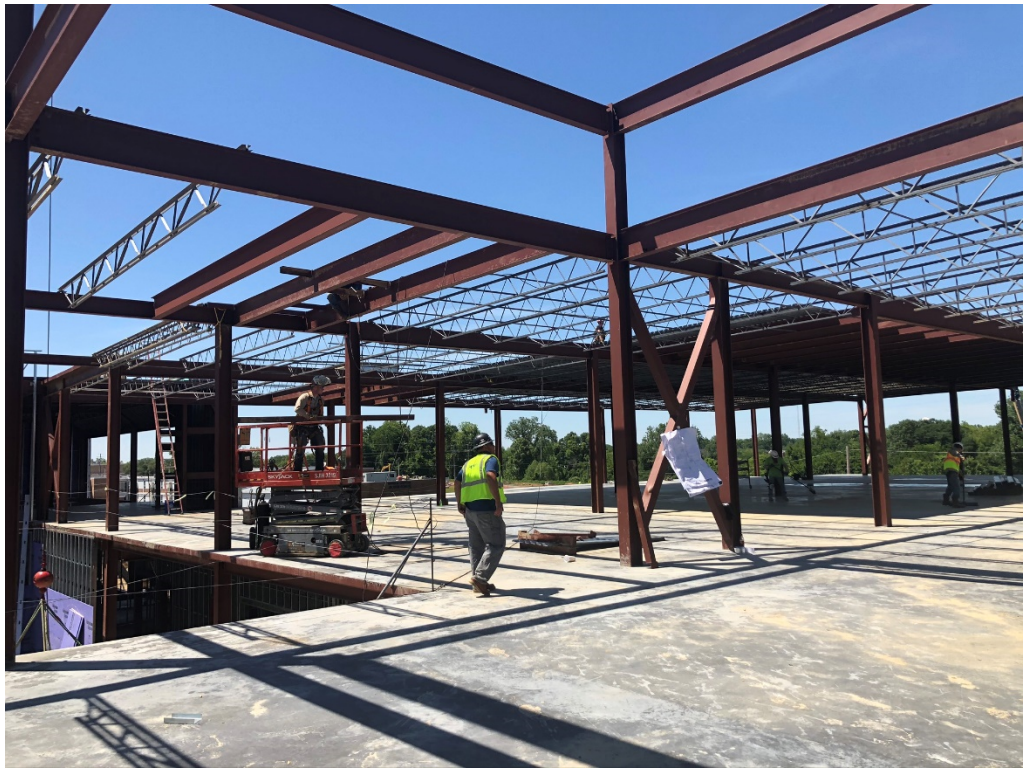
Figure 7 – Central Building Section Roof Framing

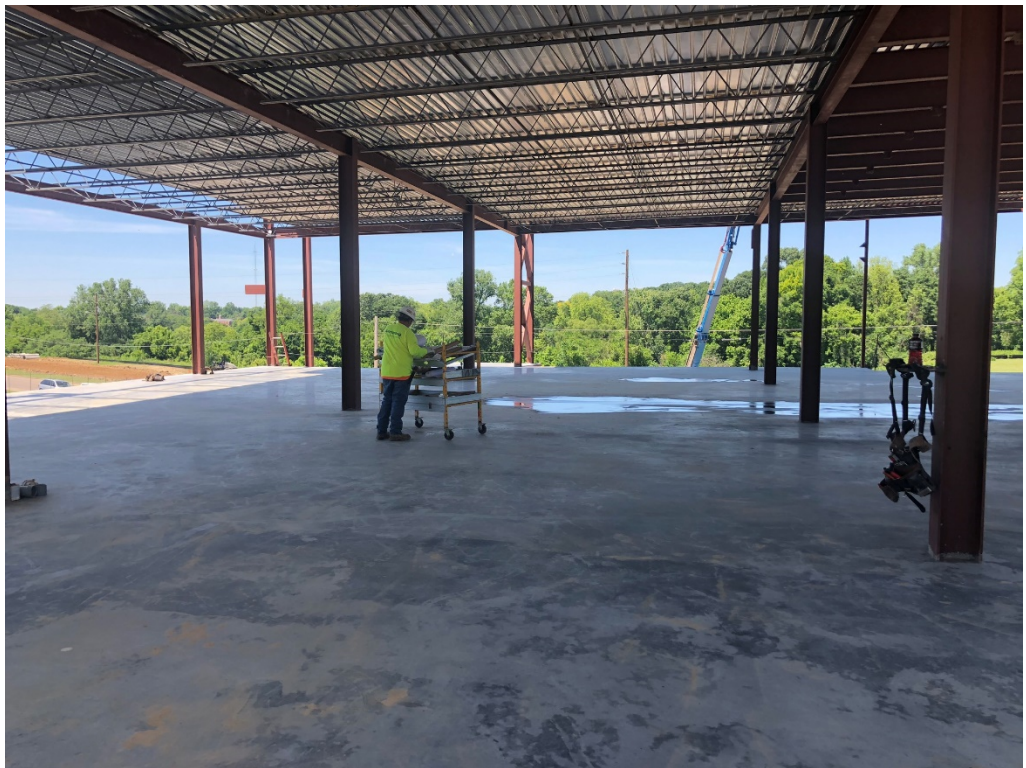
Figure 8 – Decking Installed at Central Roof Section

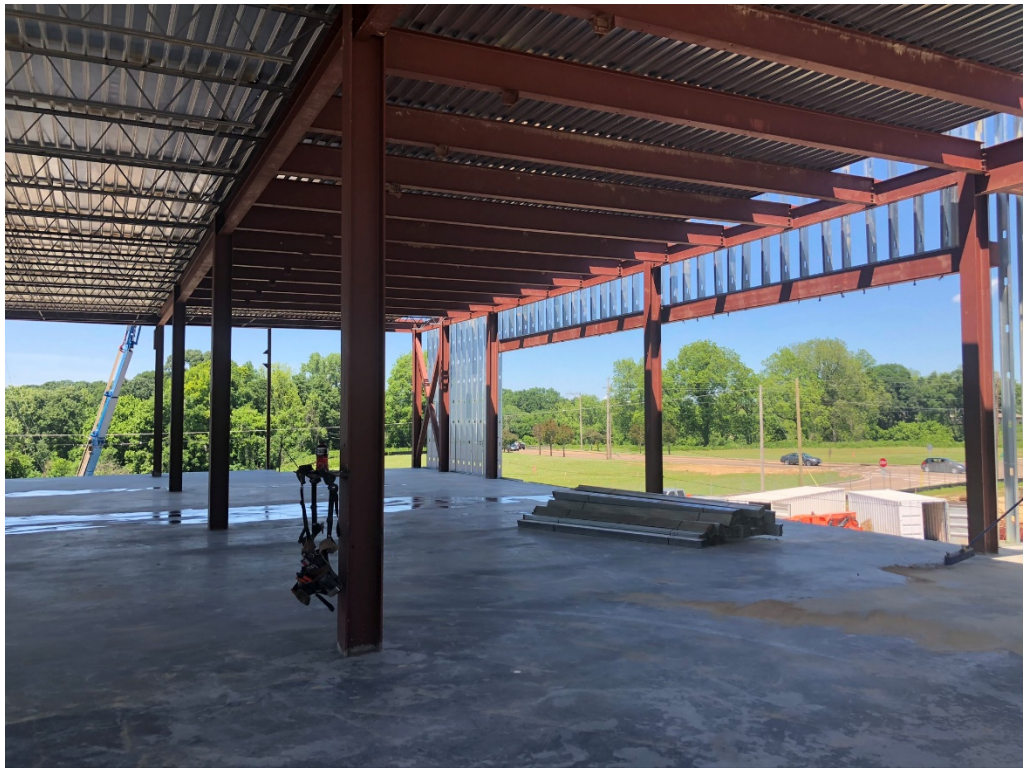
Figure 9 – Roof Decking Installed

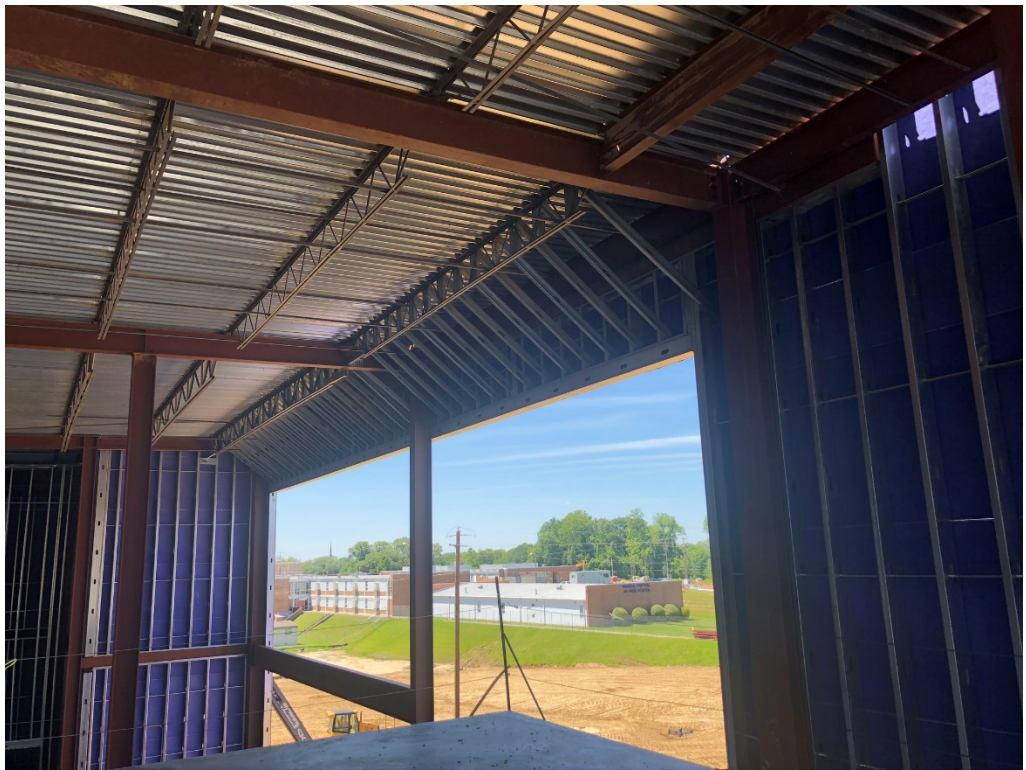
Figure 10 – Furr Down @ Stairwell

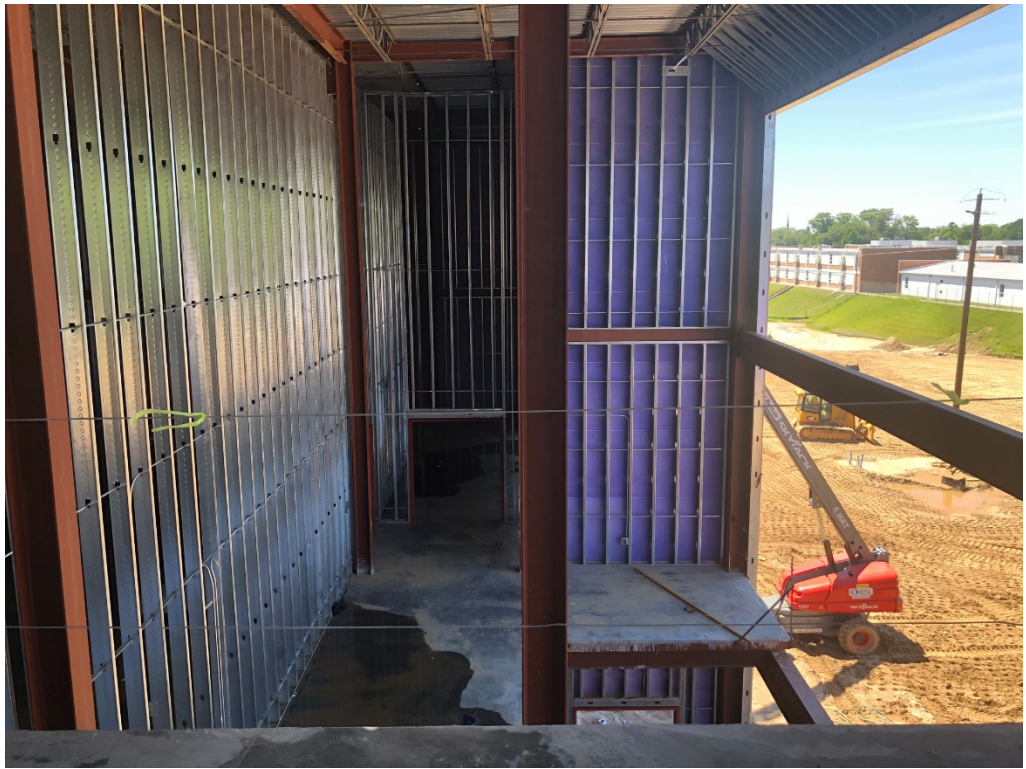
Figure 11 – Main Stairwell

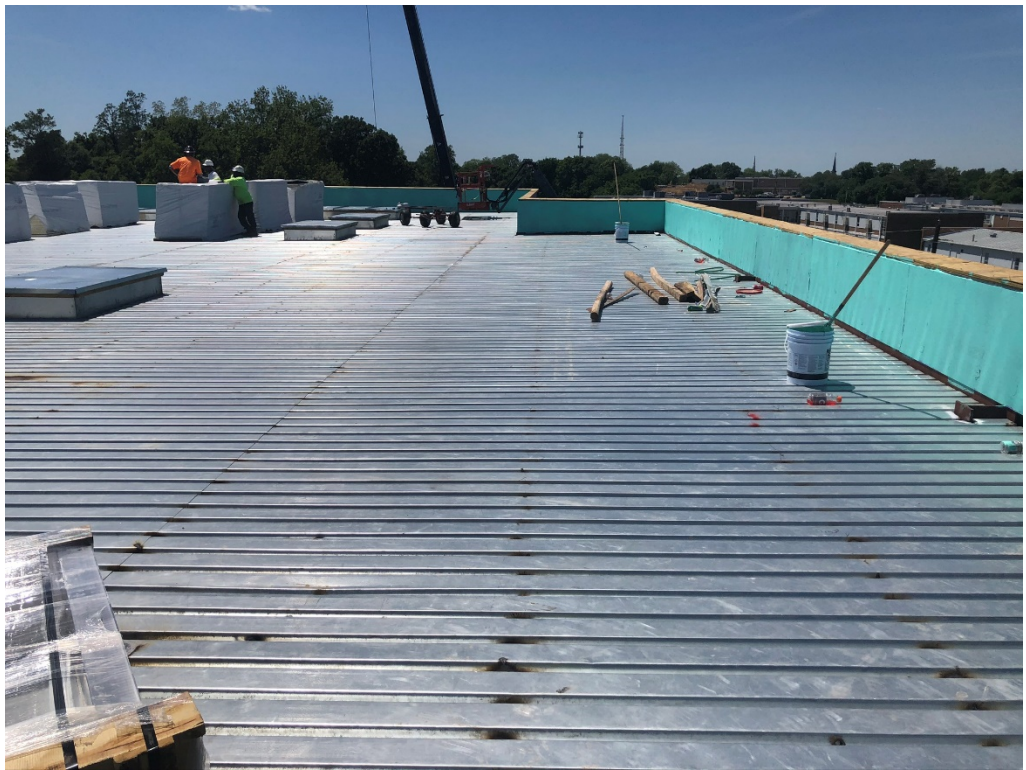
Figure 12 –Roof Work in West Section of Structure

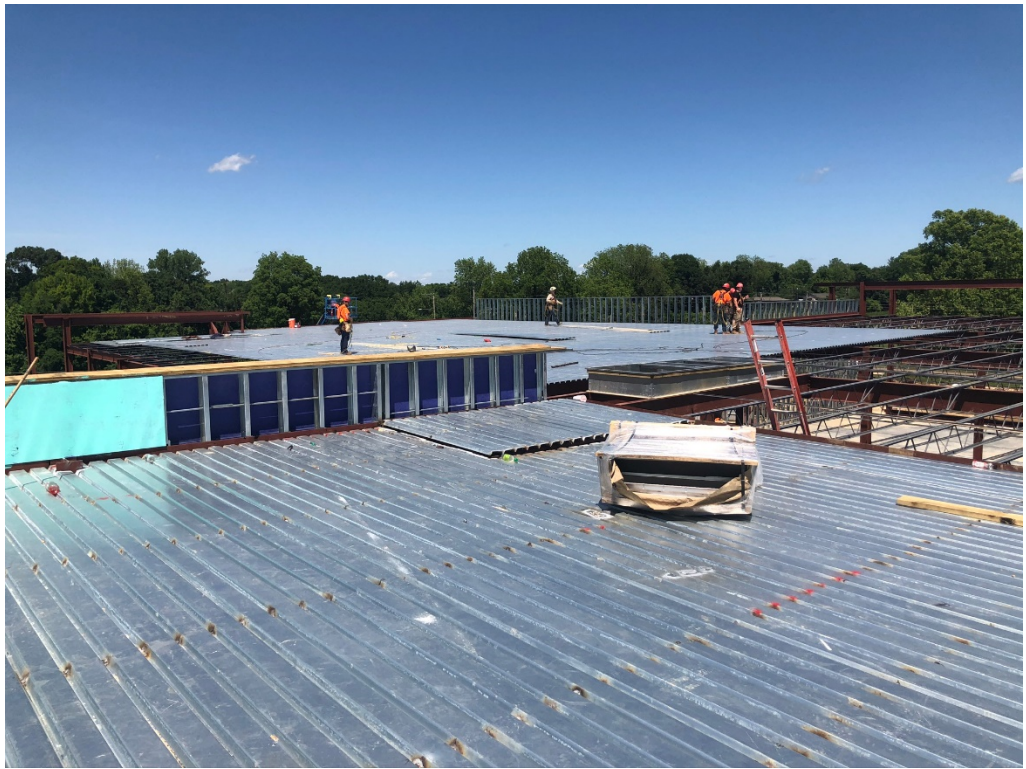
Figure 13 – Parapet Sheathing is Ongoing

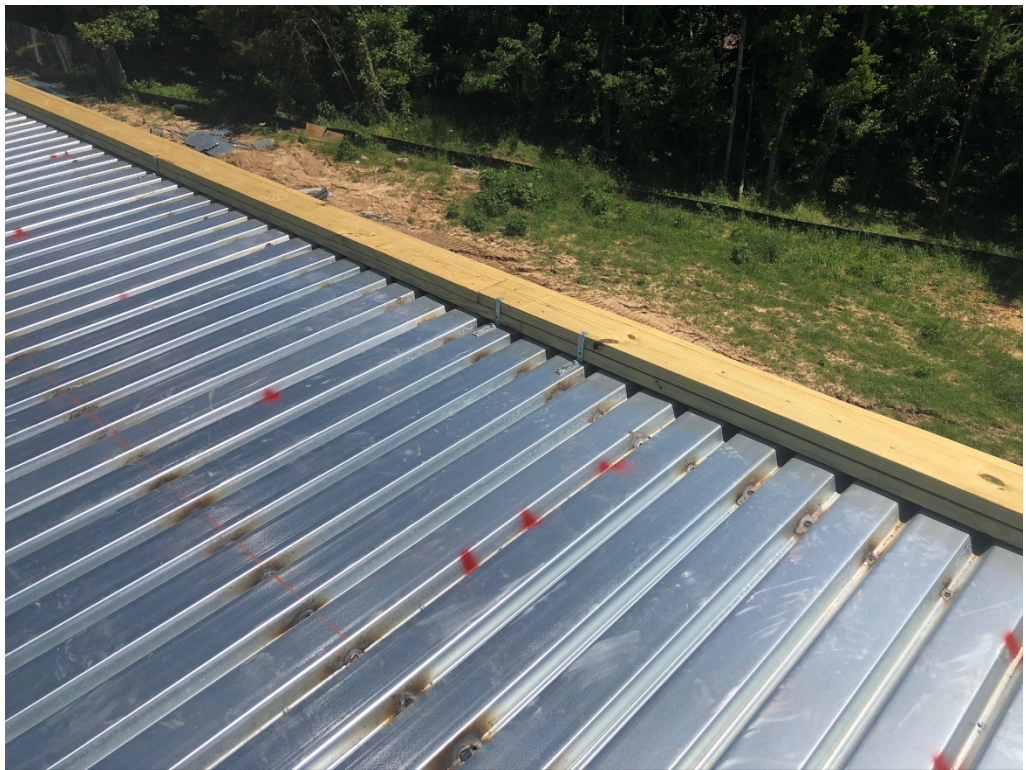
Figure 14 –Back Section of Roof @ West Building Section

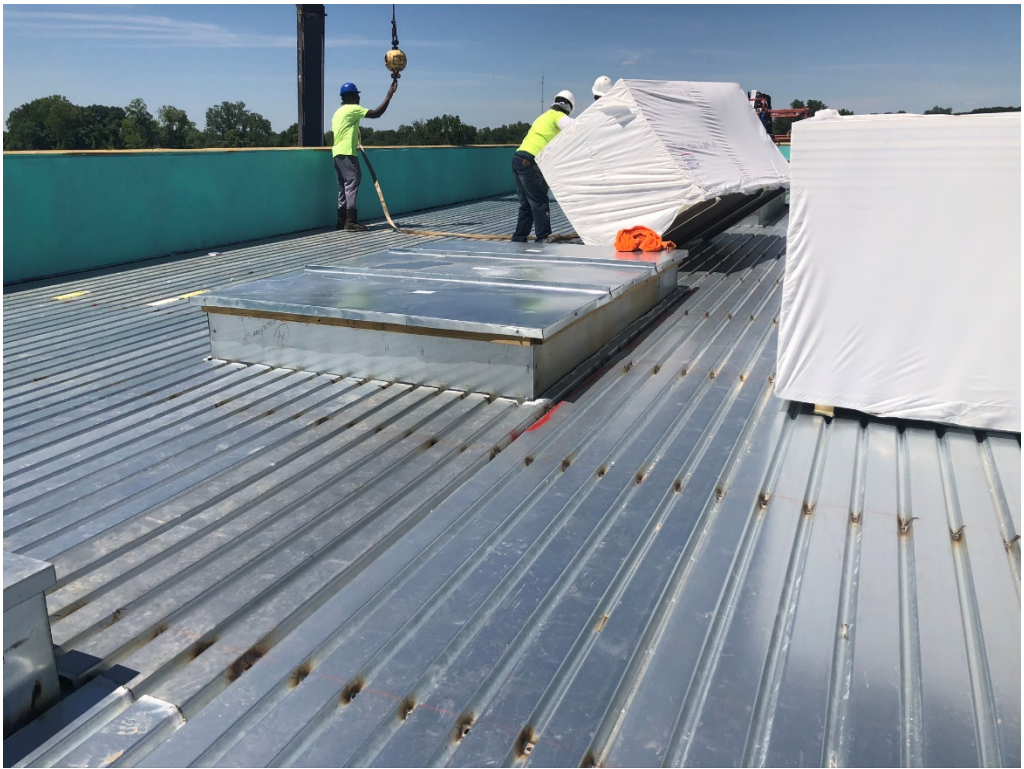
Figure 15 – Roofing Material Lifted

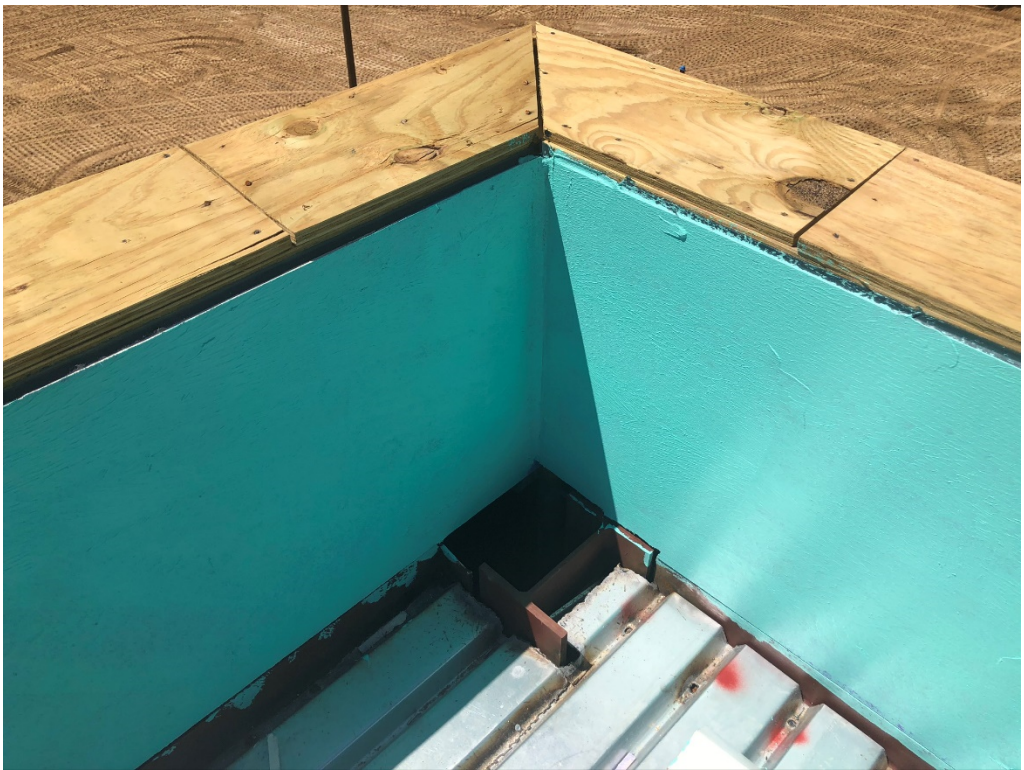
Figure 16 –Corner of Parapet Walls

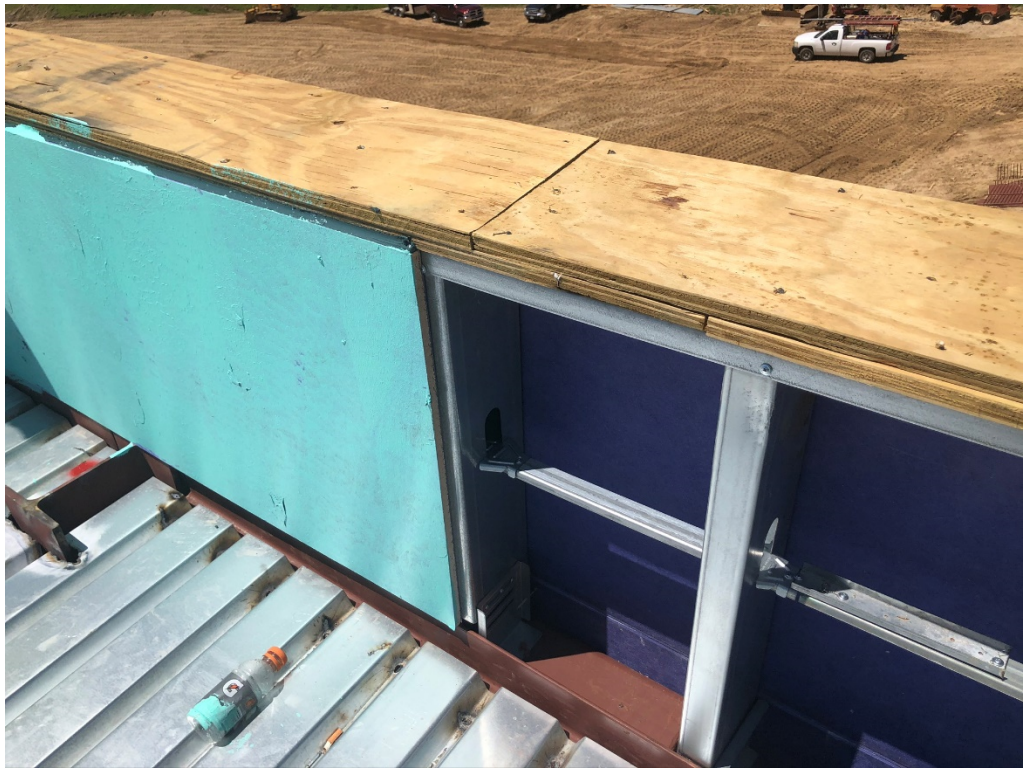
Figure 17 – Parapet Wall Section

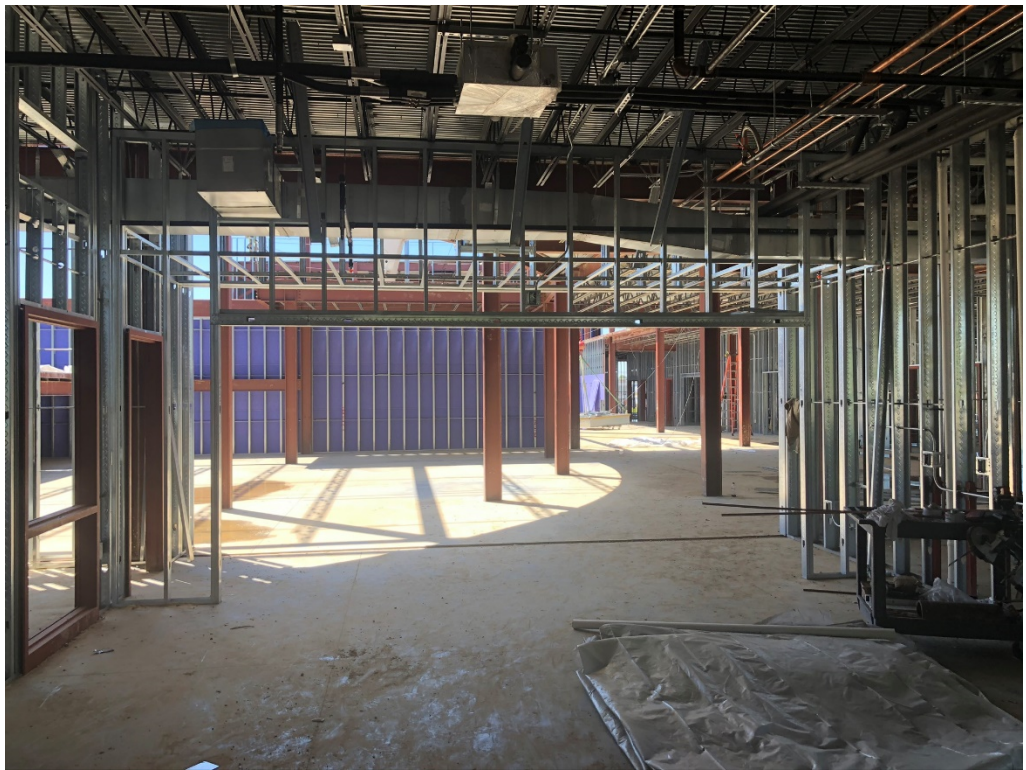
Figure 18 –Furr Downs and Interior Framing @ Middle Floor

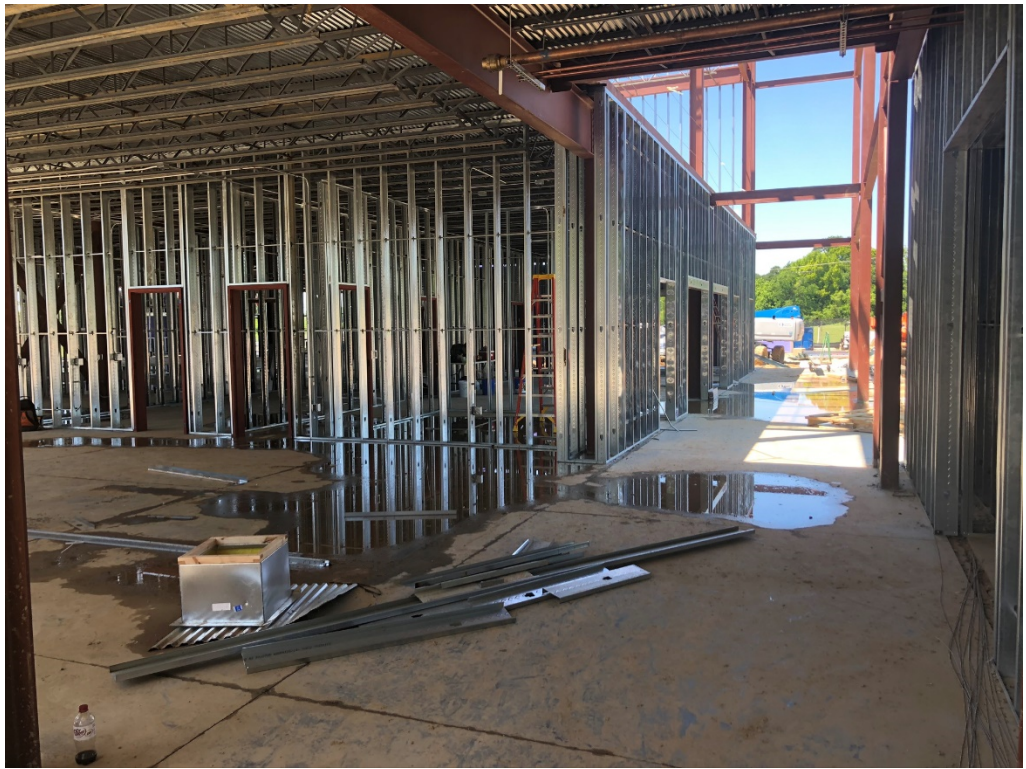
Figure 19 –Interior Framing @ Middle Floor: Corridor 153

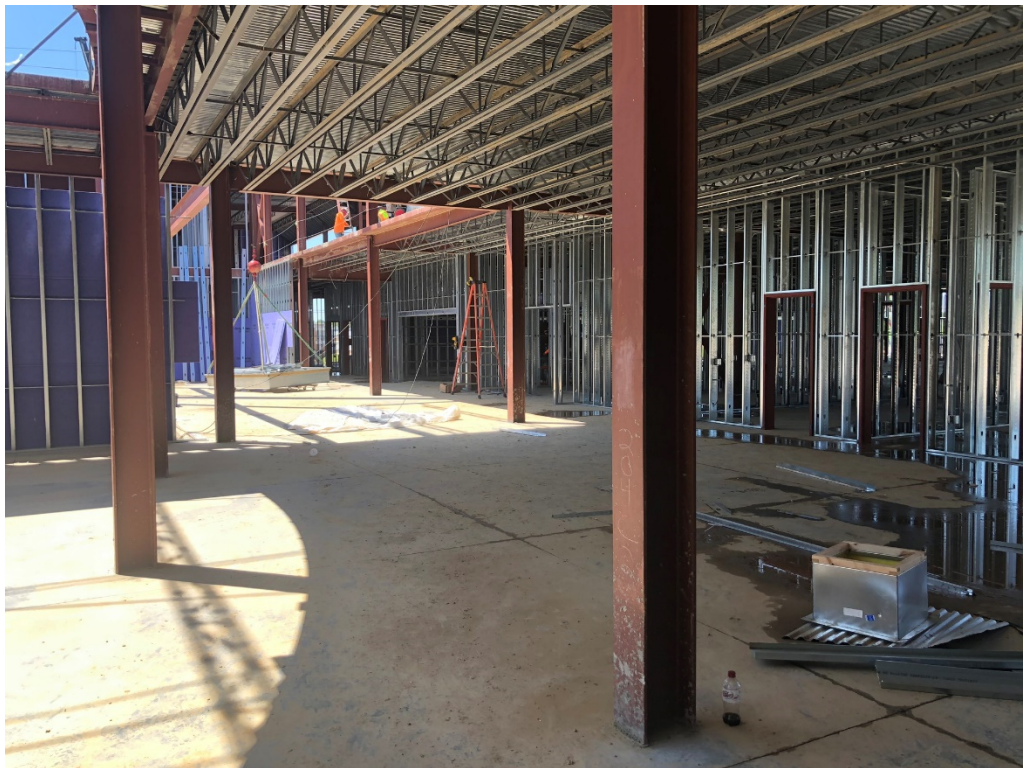
Figure 20 – Interior Framing @ Middle Floor: Lobby 150

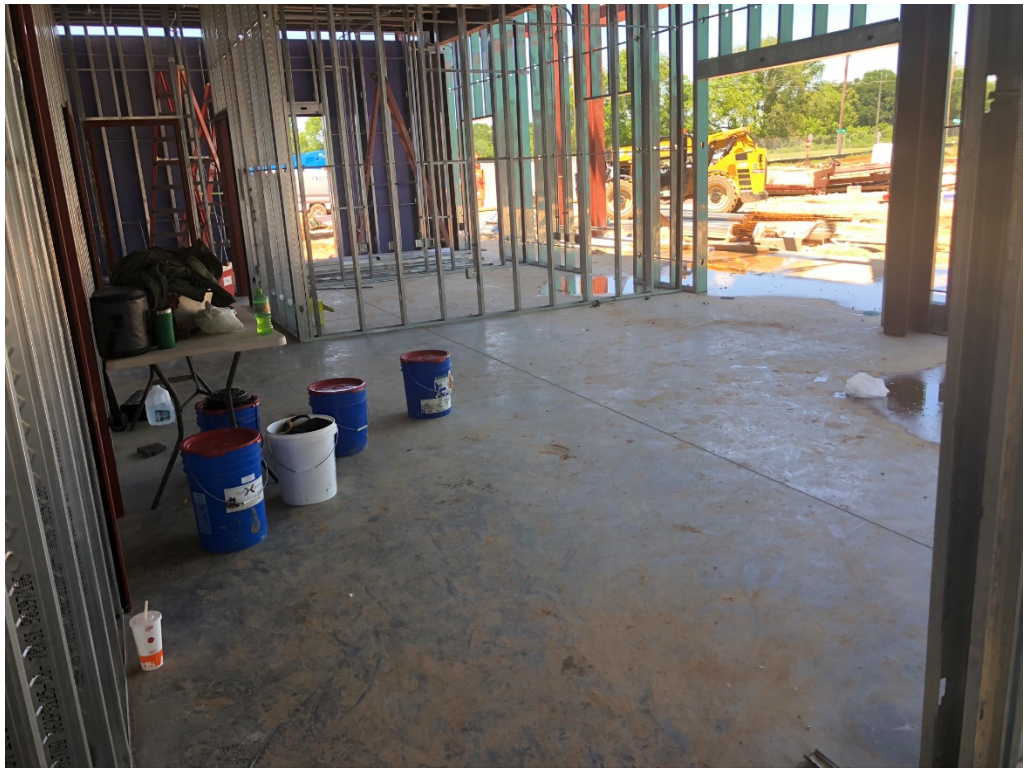
Figure 21 – Interior Framing @ Middle Floor: Reception 101

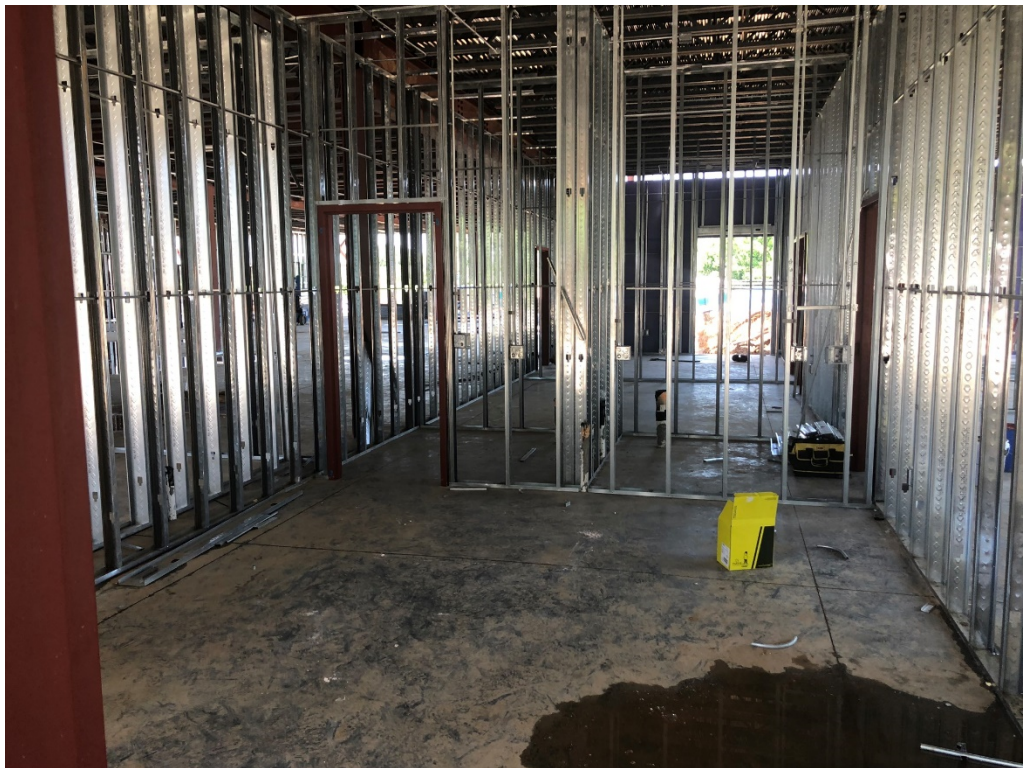
Figure 22 – Interior Framing @ Middle Floor: TWR 106

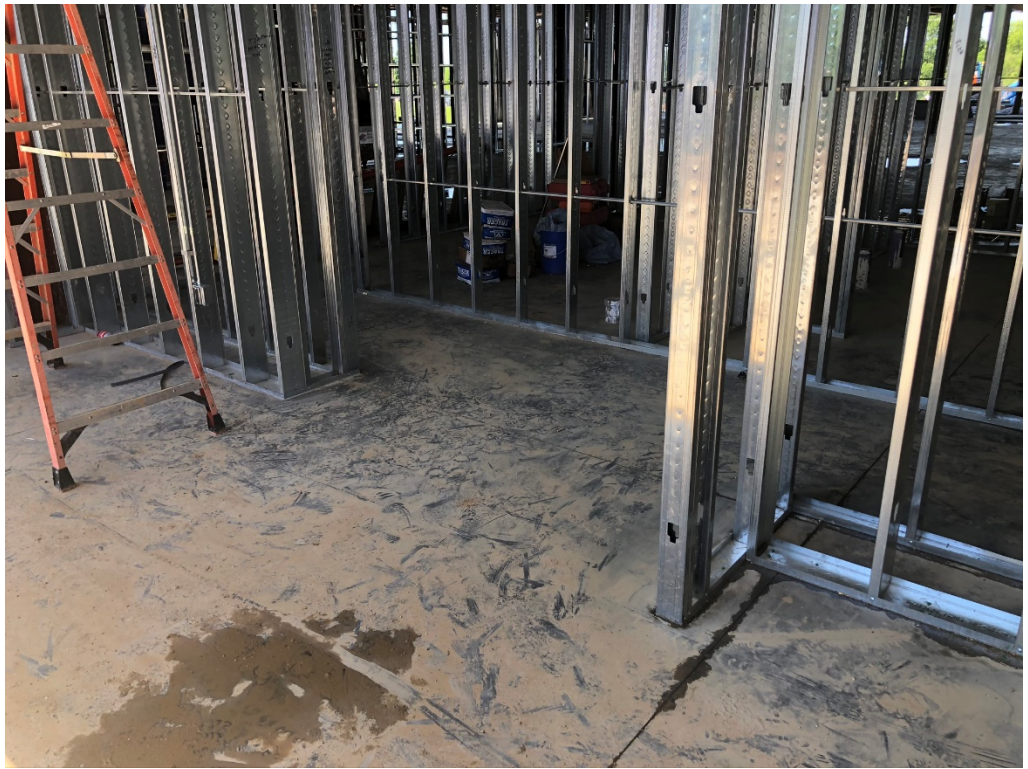
Figure 23 – Interior Framing @ Middle Floor: Bathrooms 128 & 129

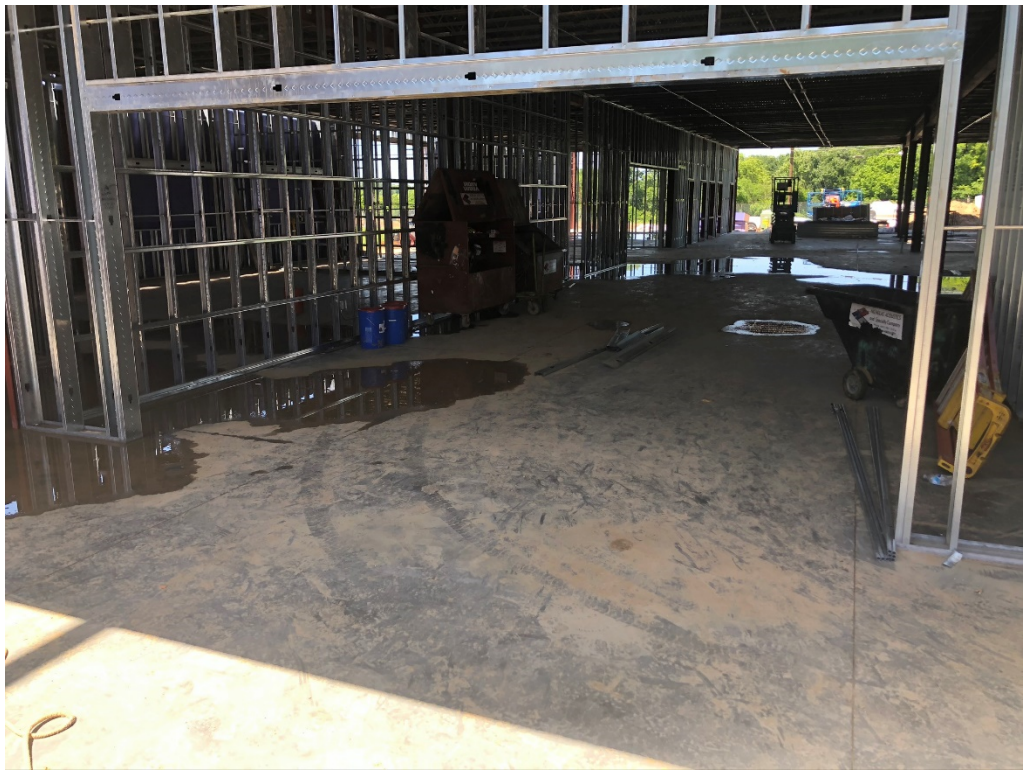
Figure 24 – Interior Framing @ Middle Floor: Entry to Teaching Space 120

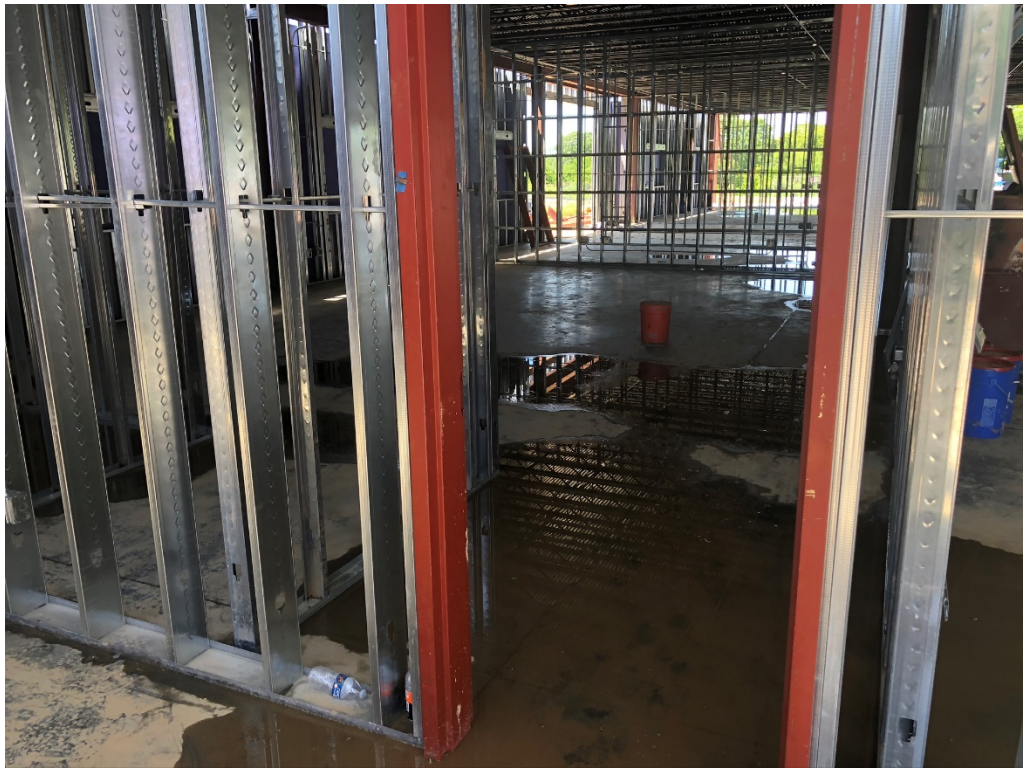
Figure 25 – Interior Framing @ Middle Floor: CorChorus 121

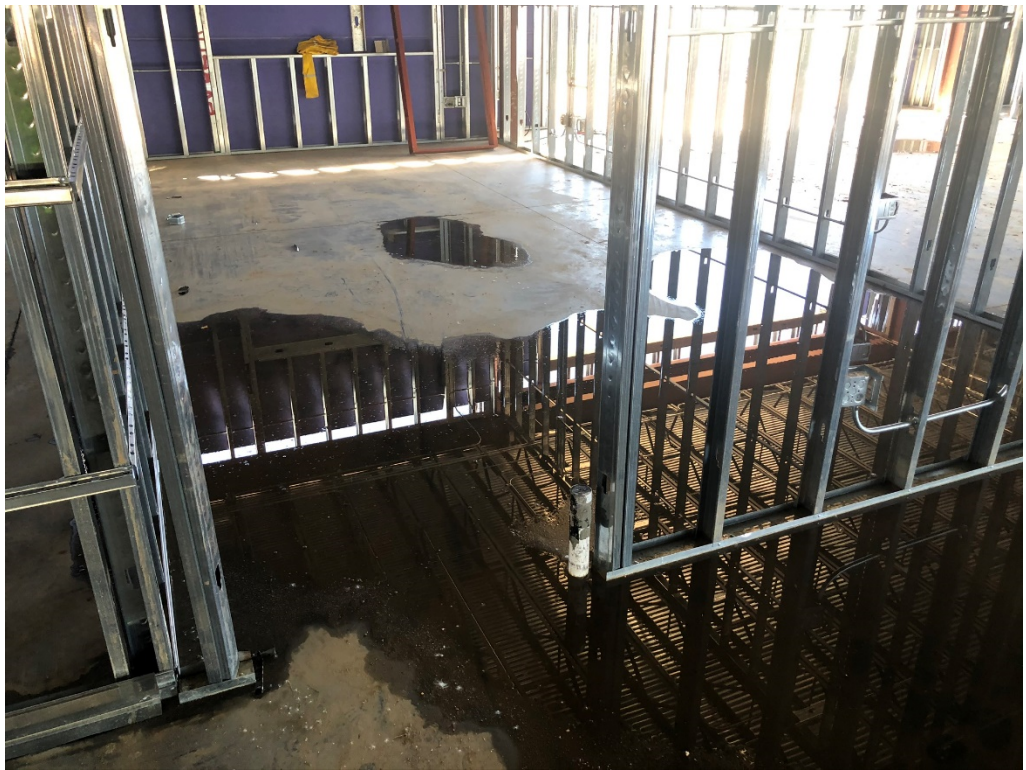
Figure 26 – Interior Framing @ Middle Floor: Sped 122

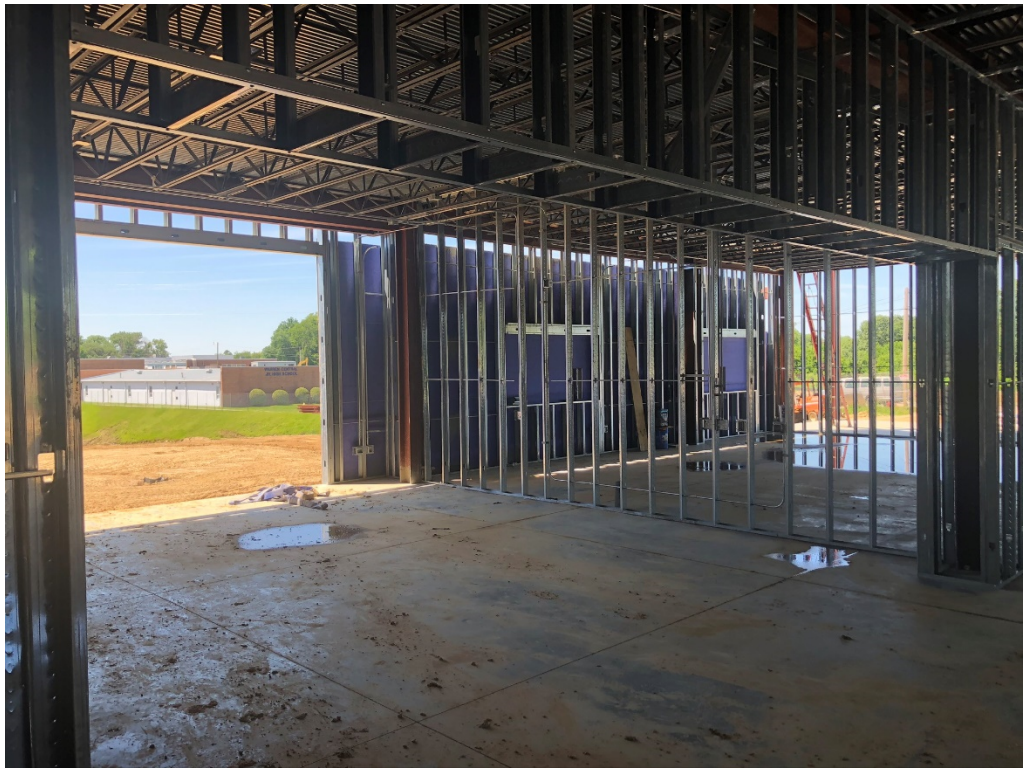
Figure 27 – Interior Framing @ Middle Floor: Teaching Space 120

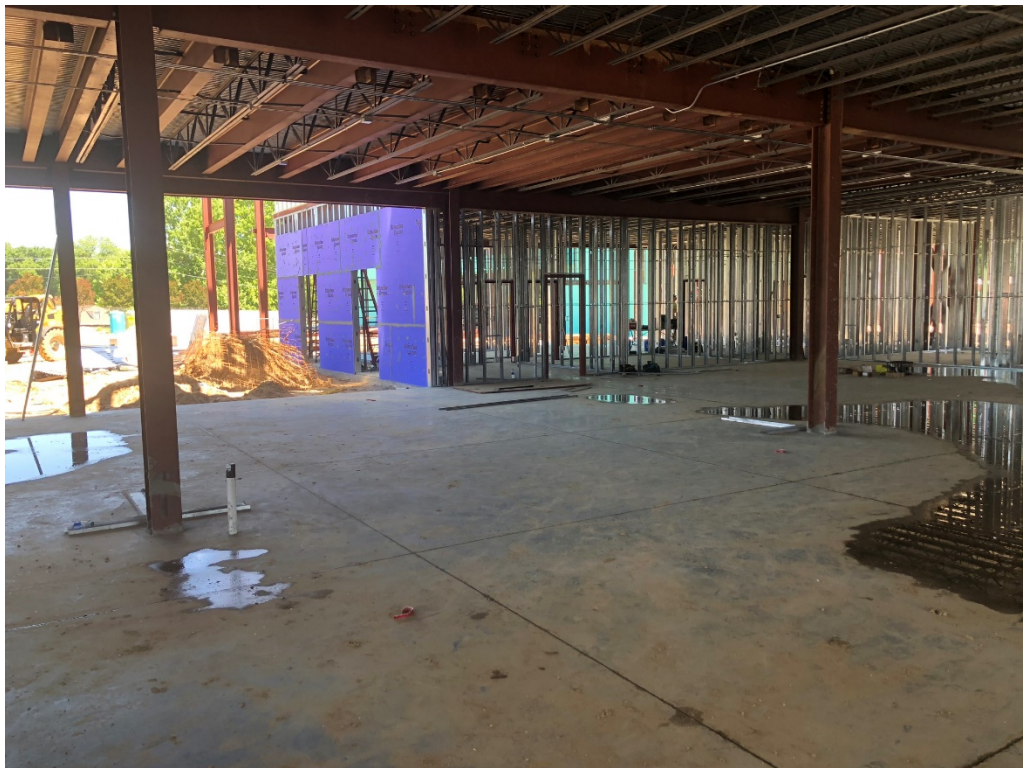
Figure 28 – Interior Framing @ Middle Floor: Teaching Space 120

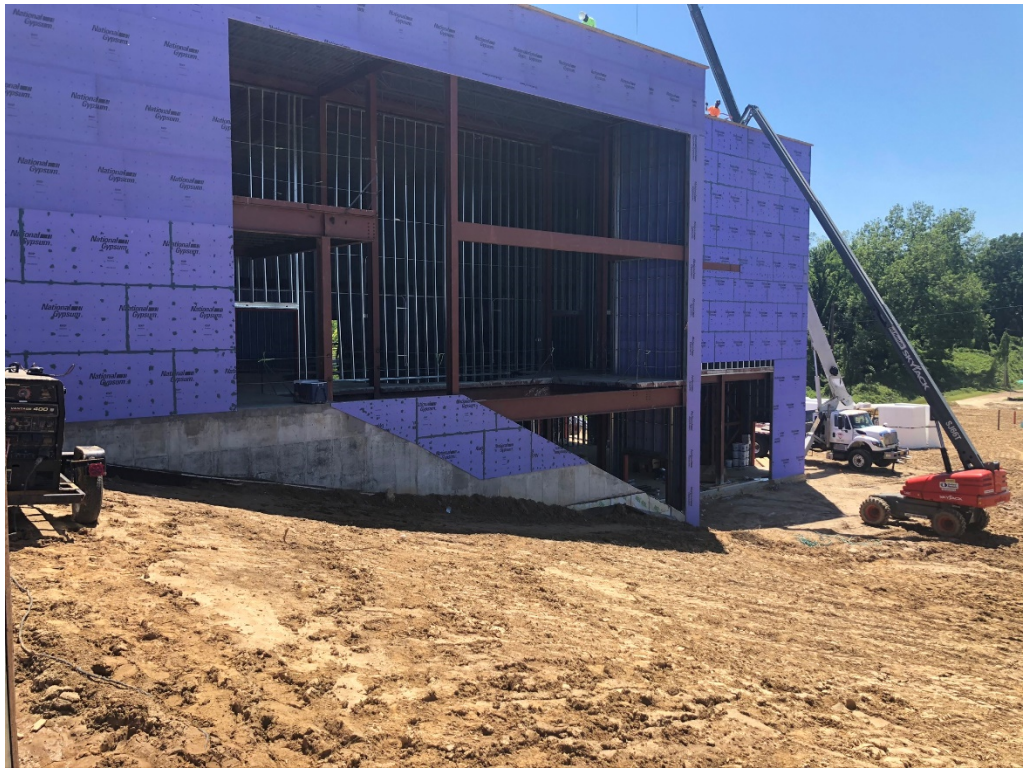
Figure 29 – Exterior Sheathing Is Ongoing
