Architect's Field Report

01 May 2020

18059-AOI Academy of Innovation / Report Number 033

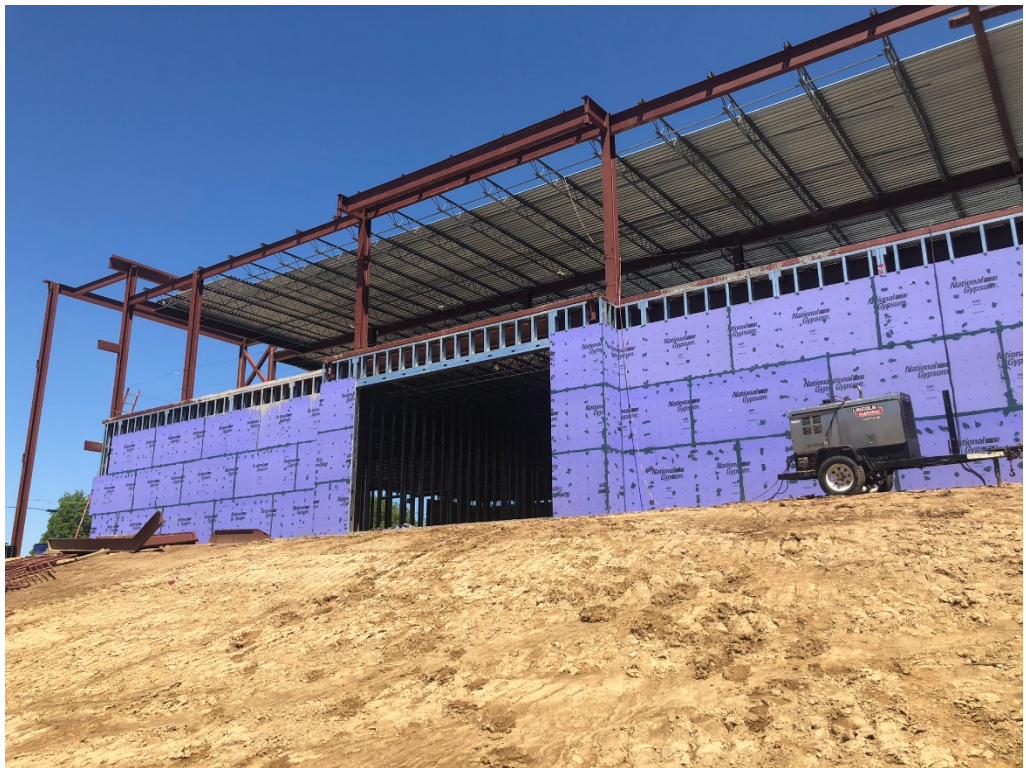
Figure 30 – Exterior Sheathing Is Ongoing

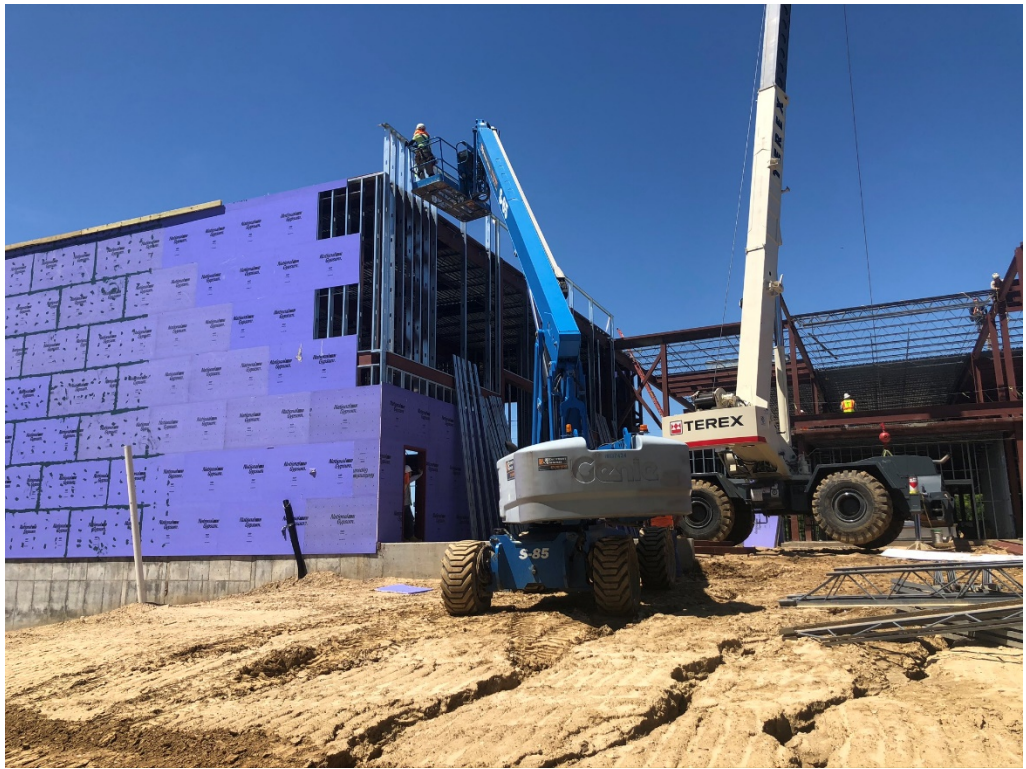
Figure 31 – South Elevation of Central Building Portion

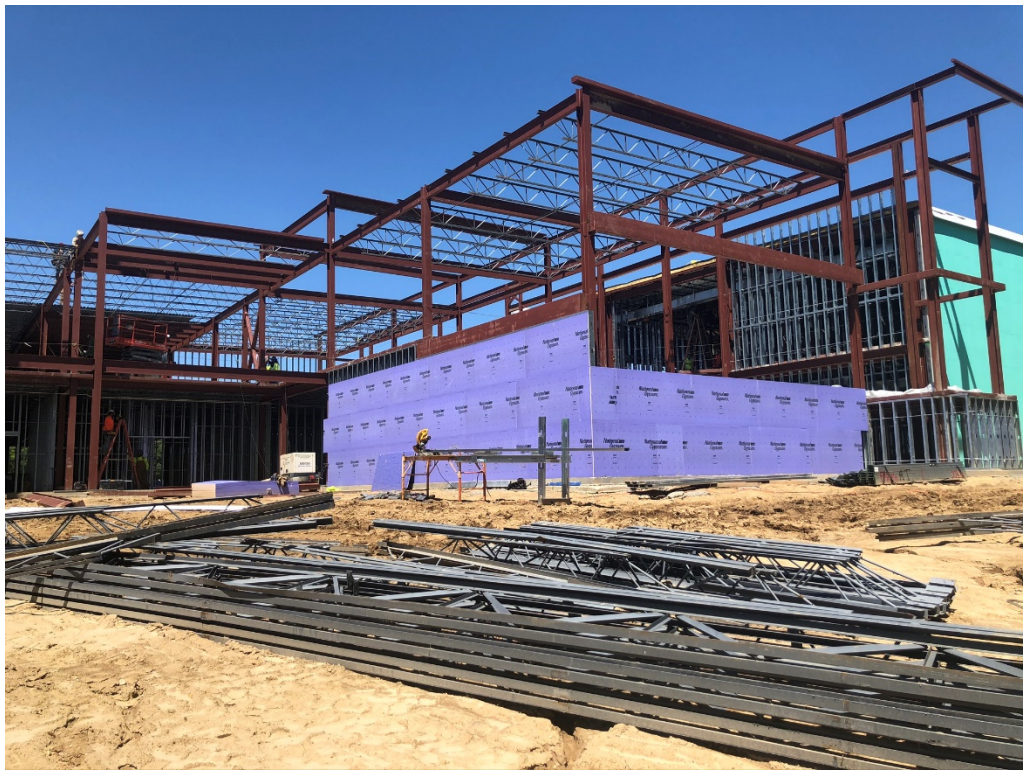
Figure 32 – South Elevation of Central Building Portion
