Architect's Field Report

08 May 2020

18059-AOI Academy of Innovation / Report Number 034

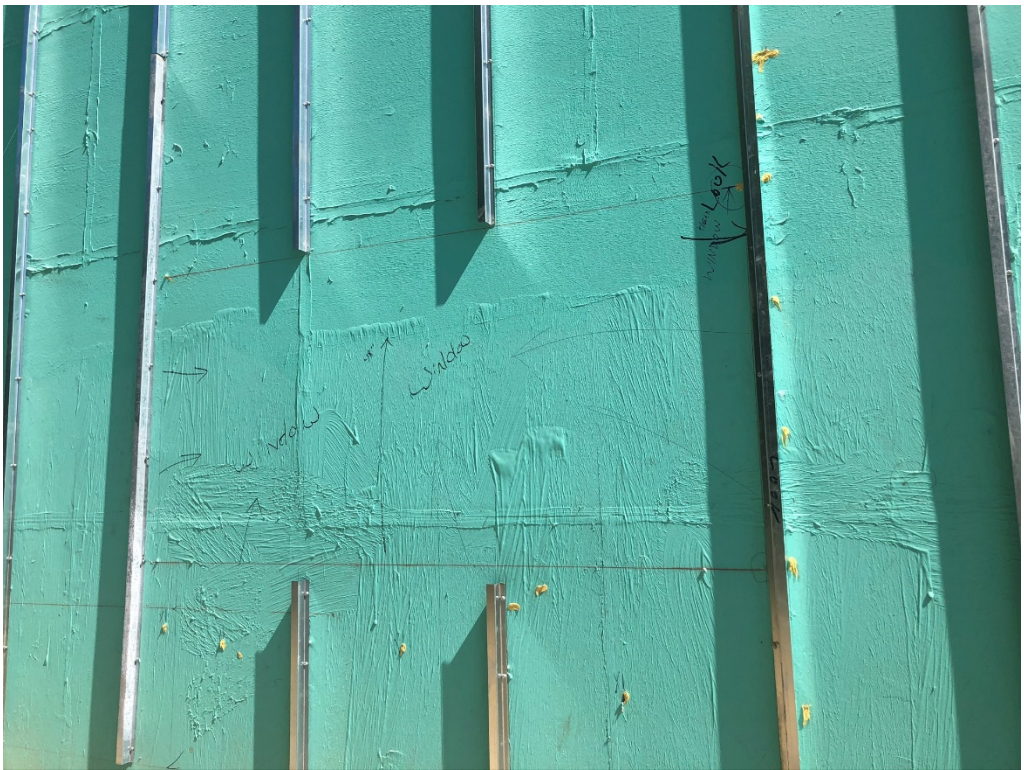
Figure 2 – Furring Installed at Waterproofed Exterior

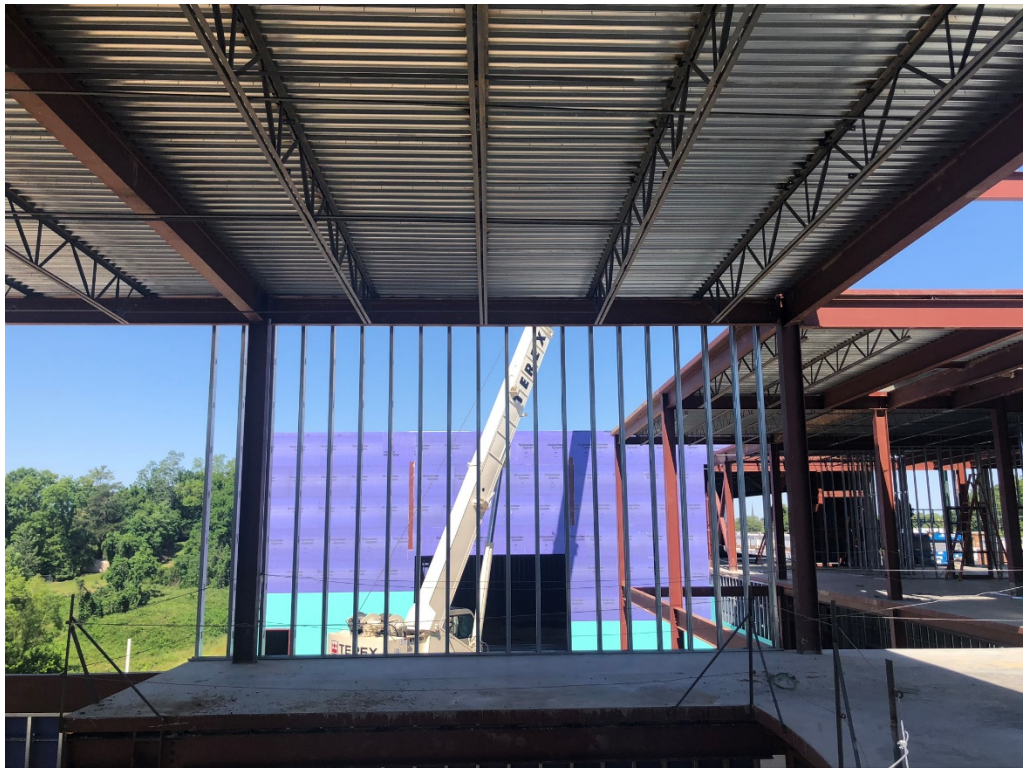
Figure 3 – Exterior Wall Light Gauge Framing Ongoing

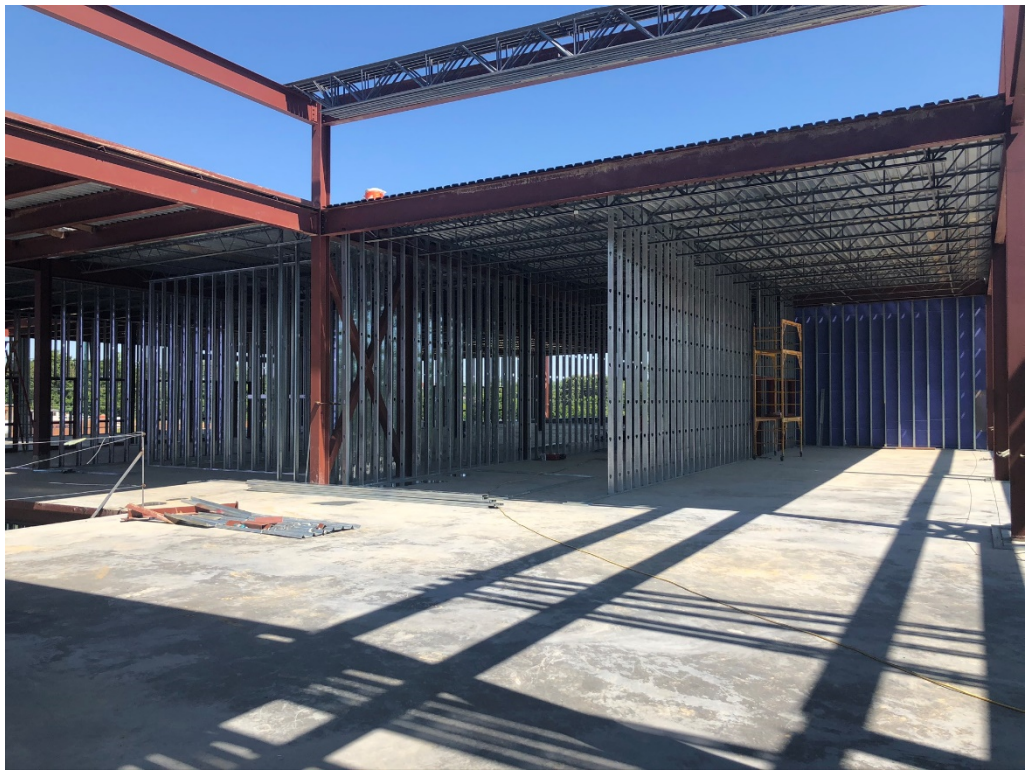
Figure 4 – Interior Framing at Upper Level in ongoing

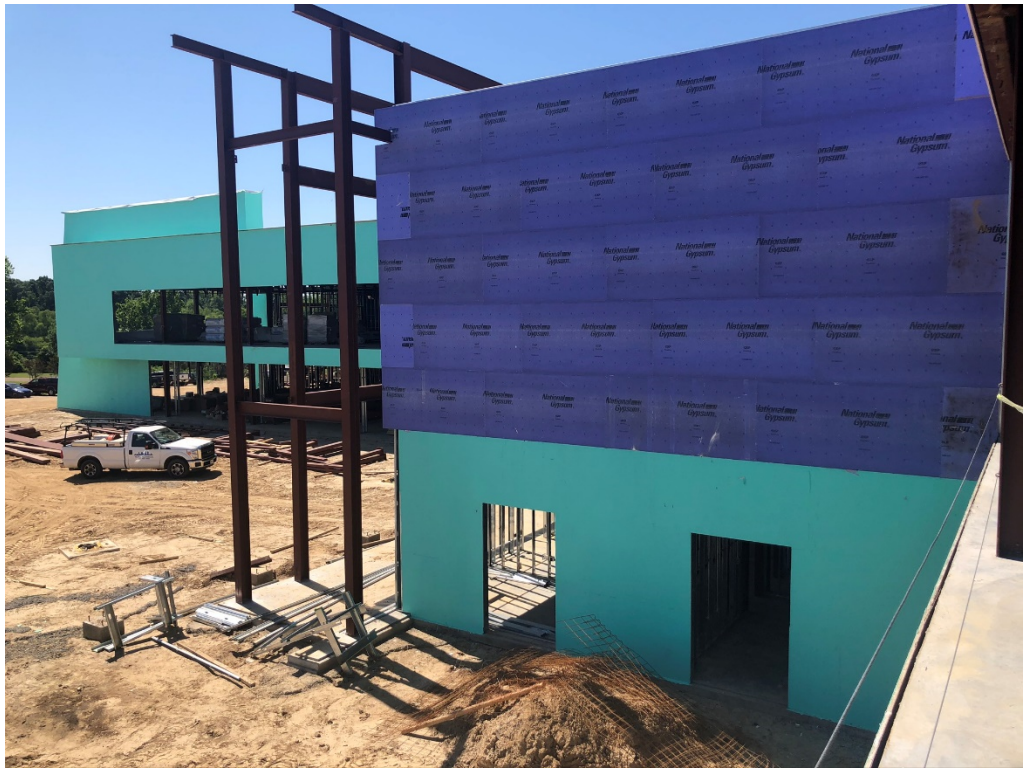
Figure 7 – Upper Level Looking SE; exterior sheathing is ongoing

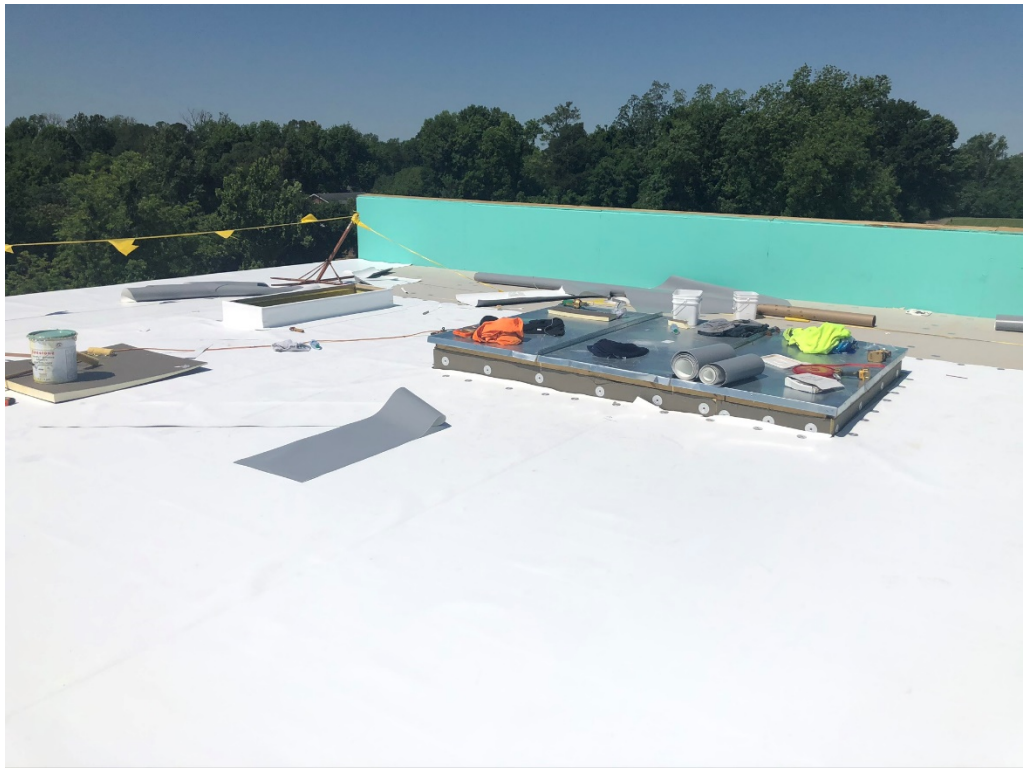
At the upper level, interior framing is ongoing but much progress has been made. Roofing on the West section of building is 75% complete.

Figure 13 – Roofing is Ongoing

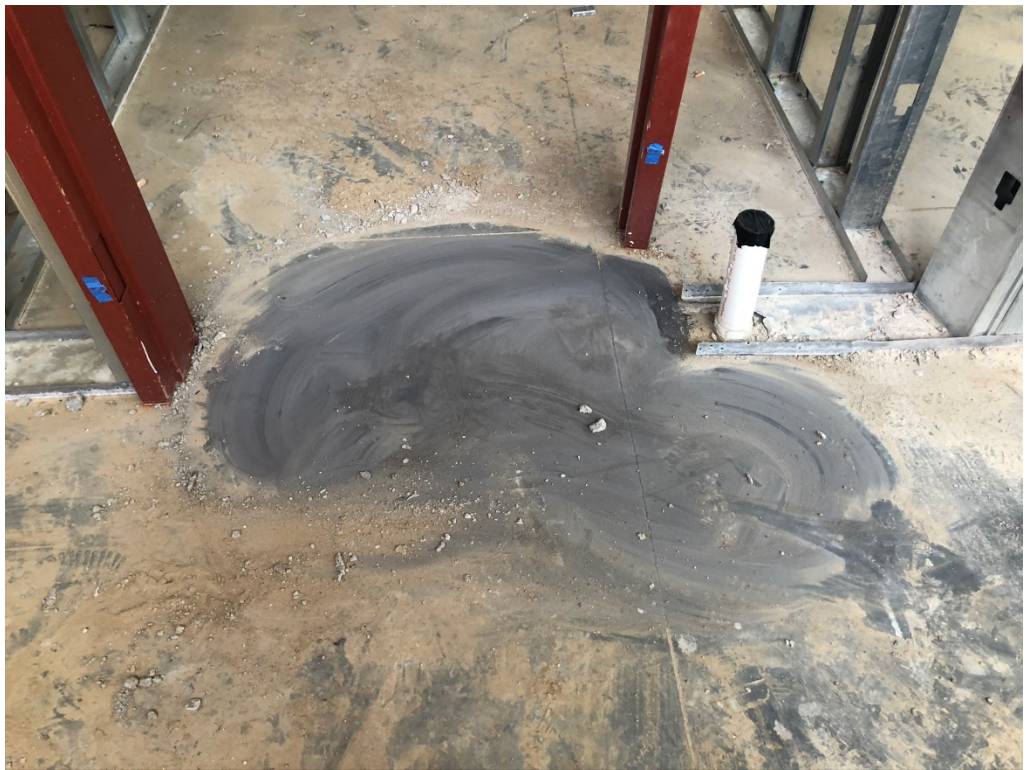
Figure 16 – A rough Patch has been made here (Data 126); Will this be Repaired Further?

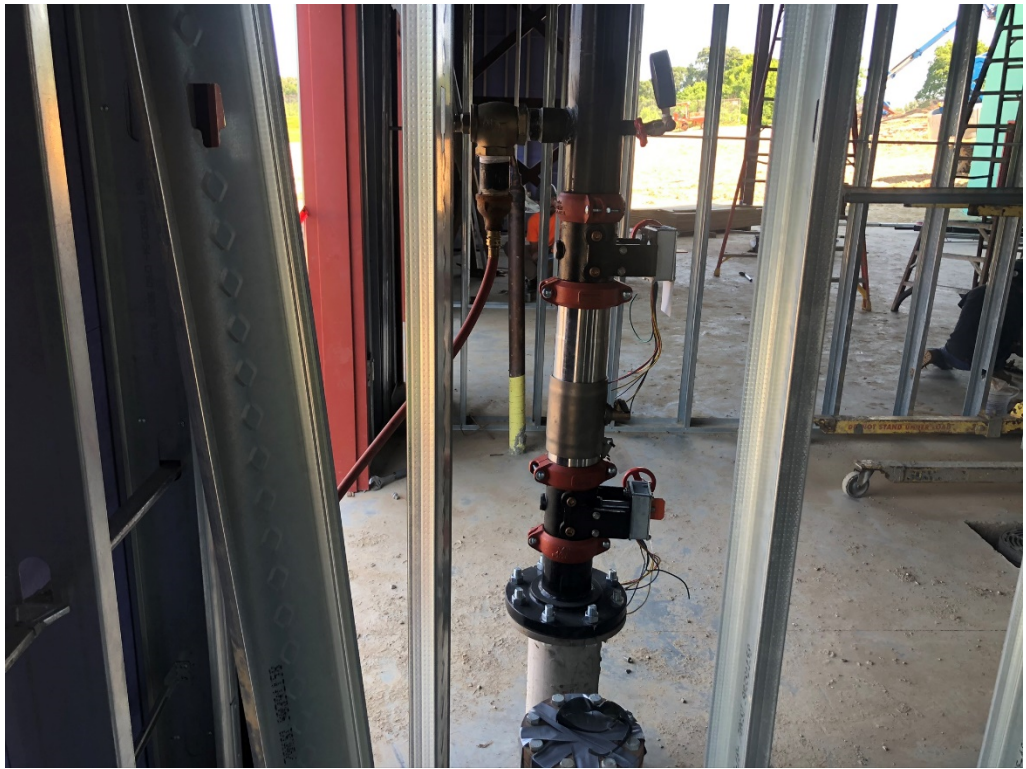
Figure 17 – Sprinkler System Work in Ongoing

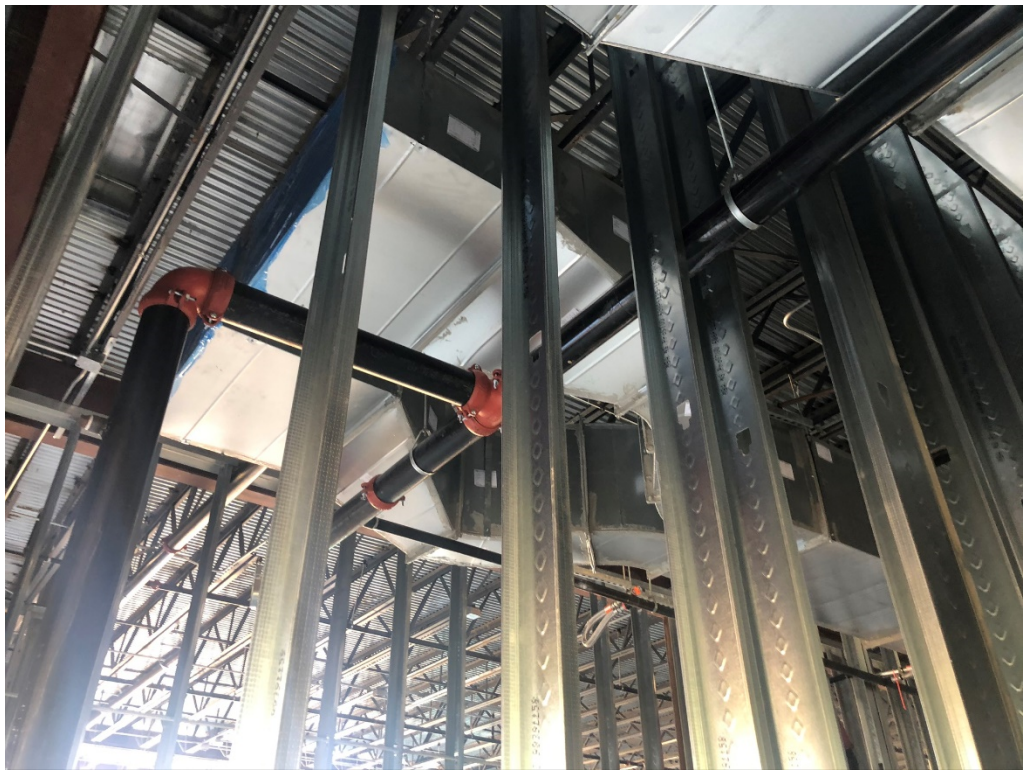
Figure 18 – Sprinkler System Work in Ongoing

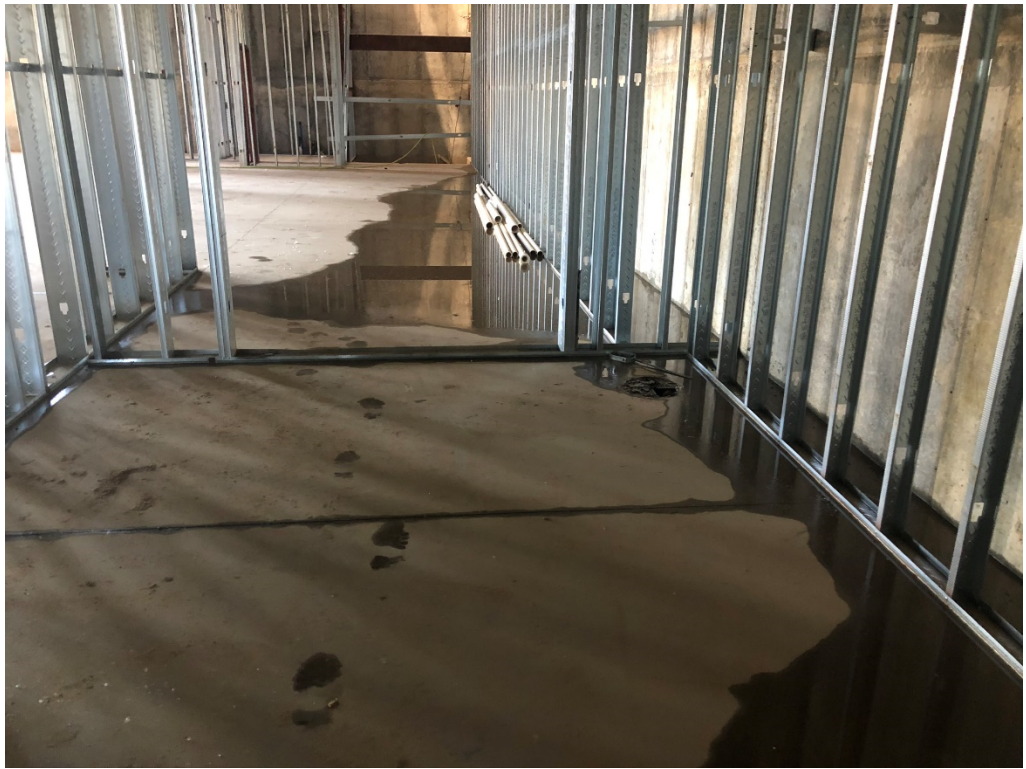
Figure 19 –Lower Level Foundation Wall; Water is most likely from rain intrusion
