Architect's Field Report

15 May 2020

18059-AOI Academy of Innovation / Report Number 035

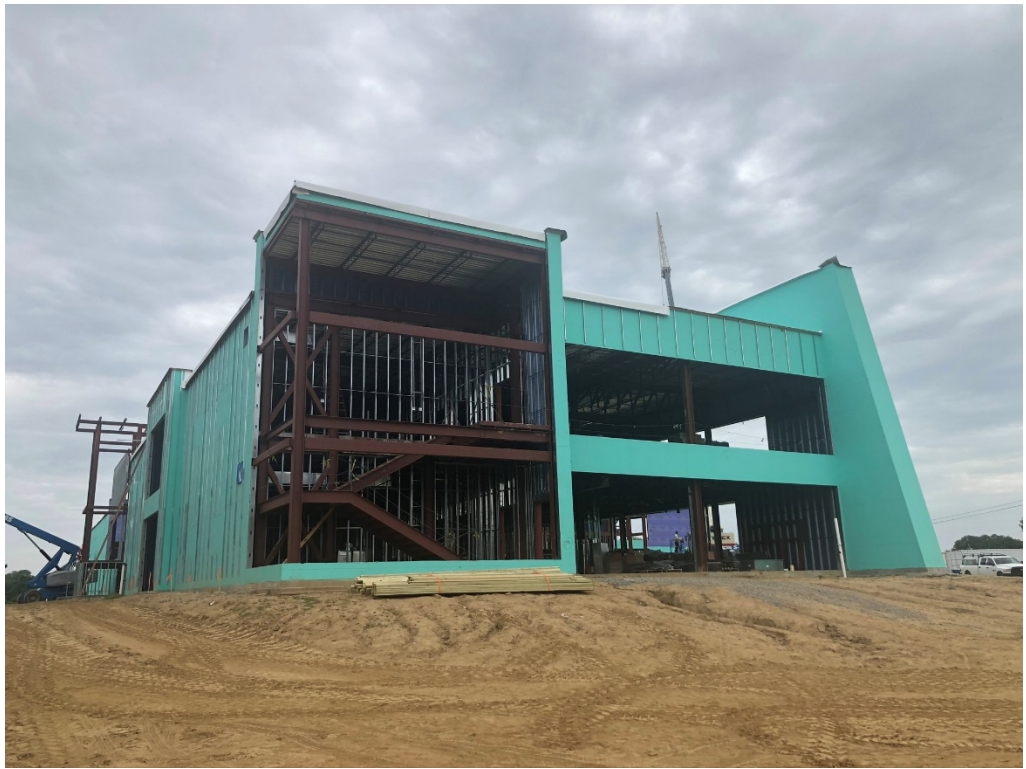
Figure 1 – East Structure

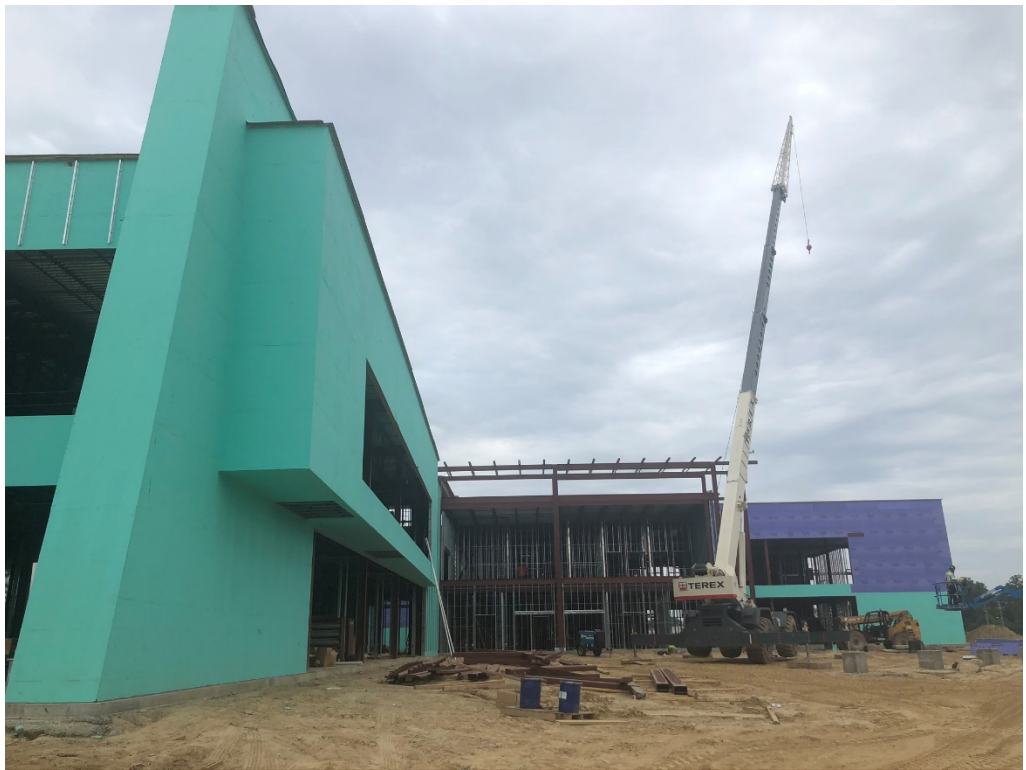
Figure 2 – East Structure North Elevation

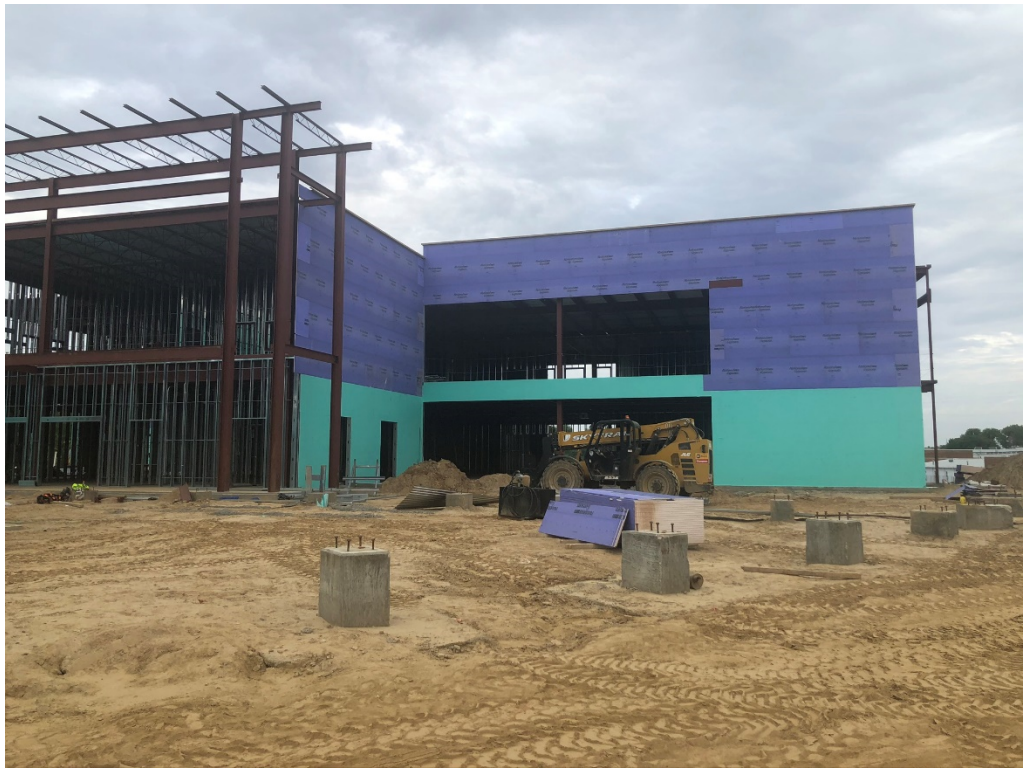
Figure 3 – North Structure Section, East Façade

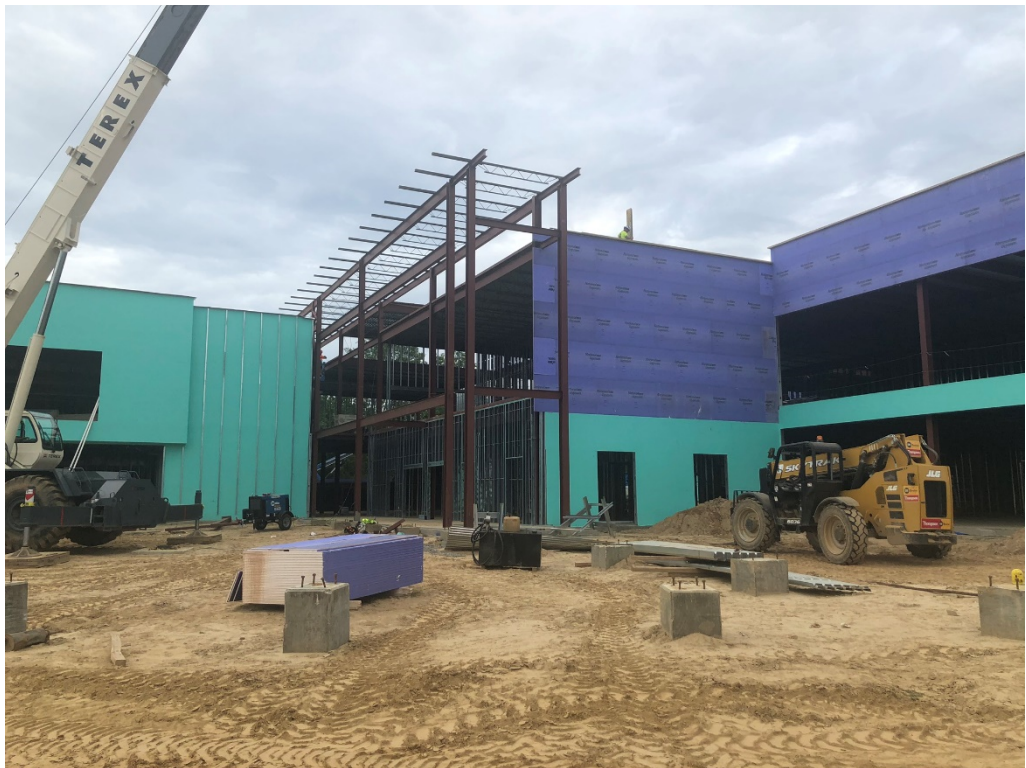
Figure 4 –Main Entry at North Drop Off

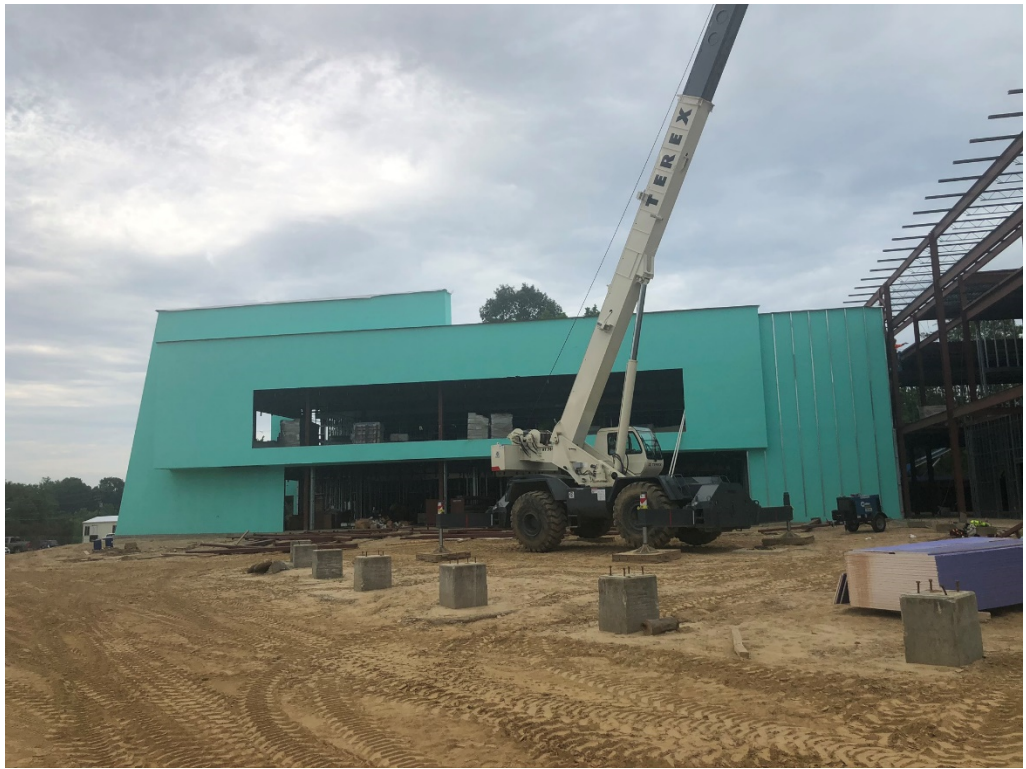
Figure 5 – North Façade, East Wing

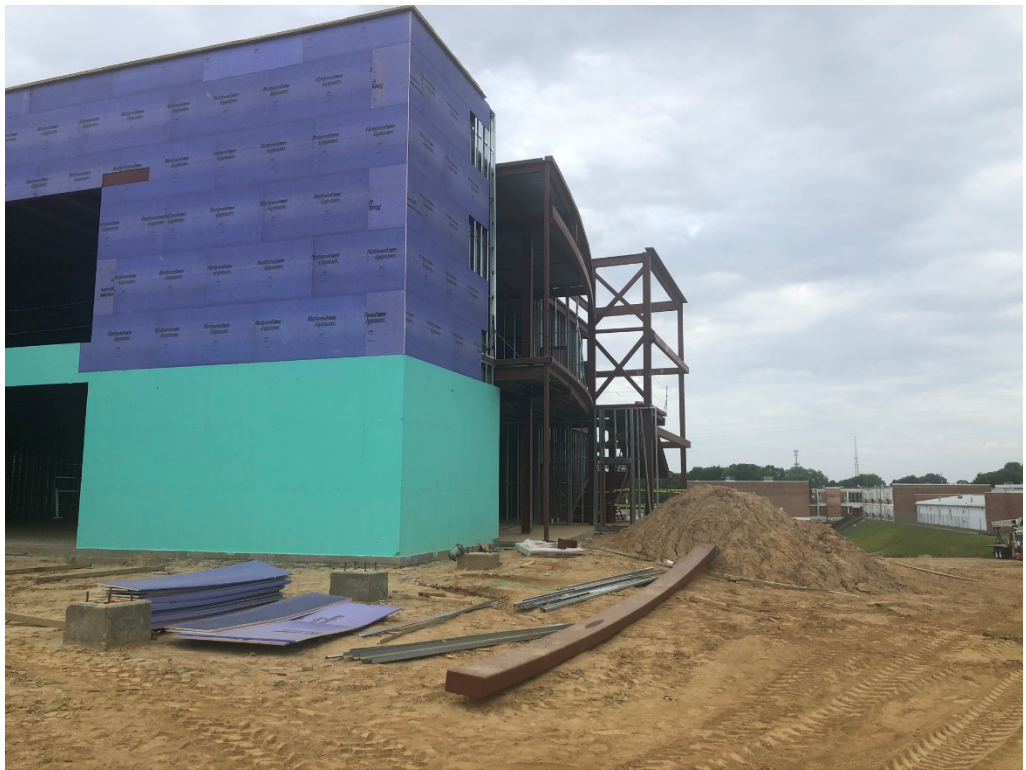
Figure 6 – North Section of Structure

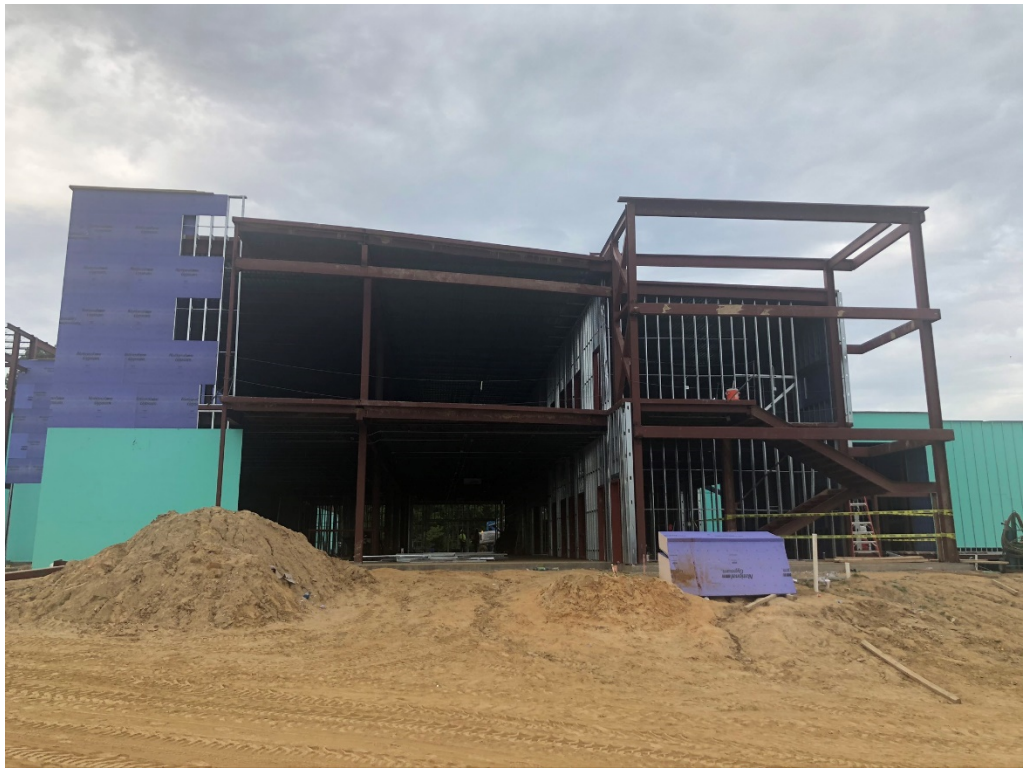
Figure 7 – North Façade at Center Section of Building

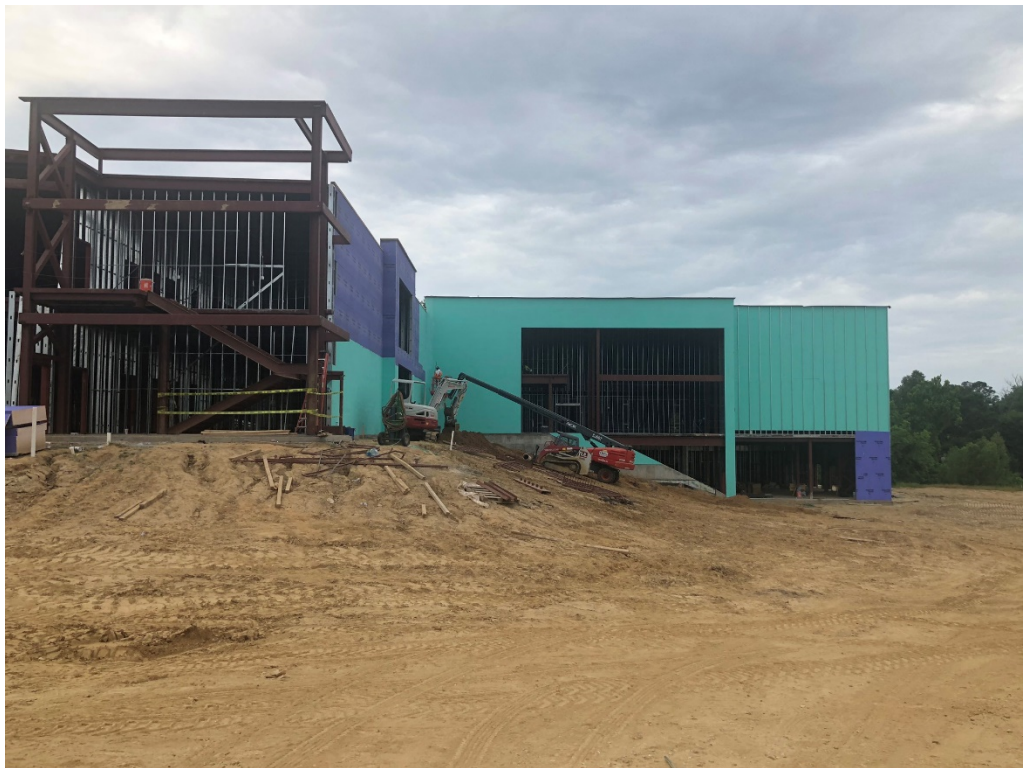
Figure 8 – North Façade at West Wing

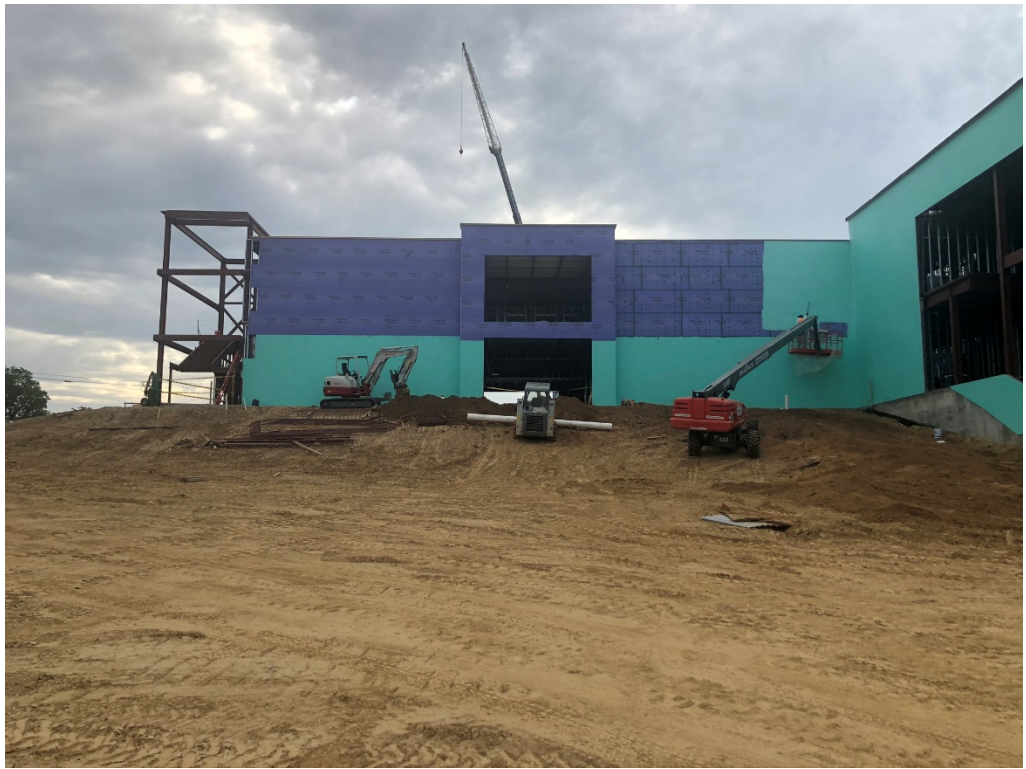
Figure 9 – West Façade at North Wing

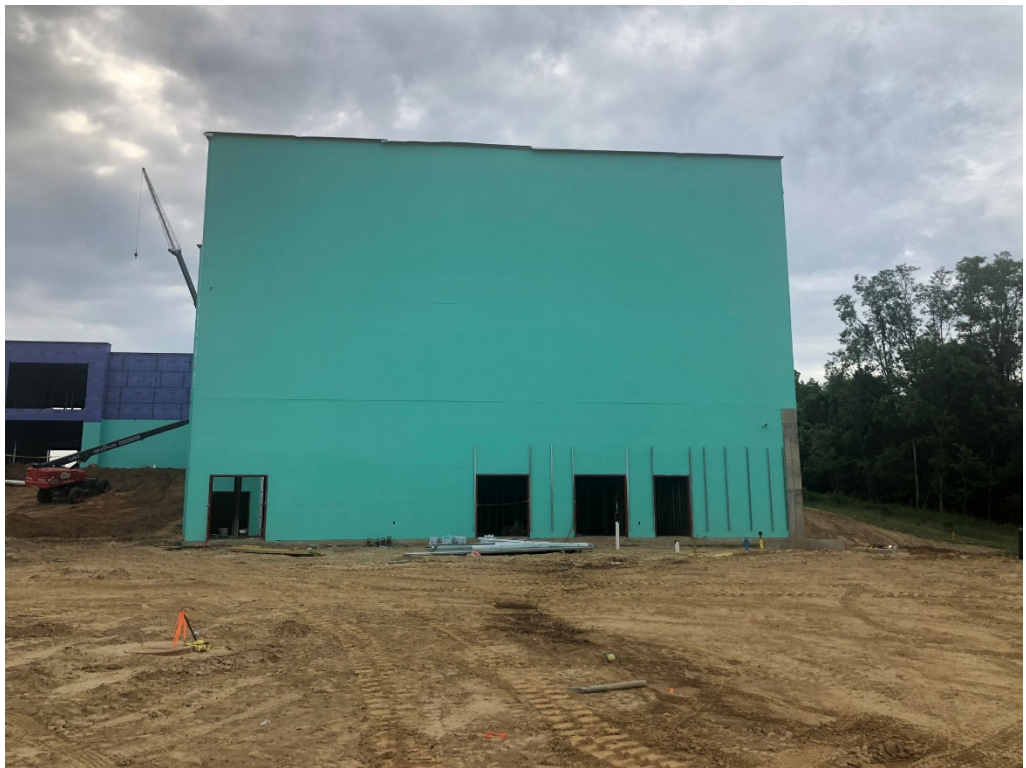
Figure 10 – West Façade at West Wing

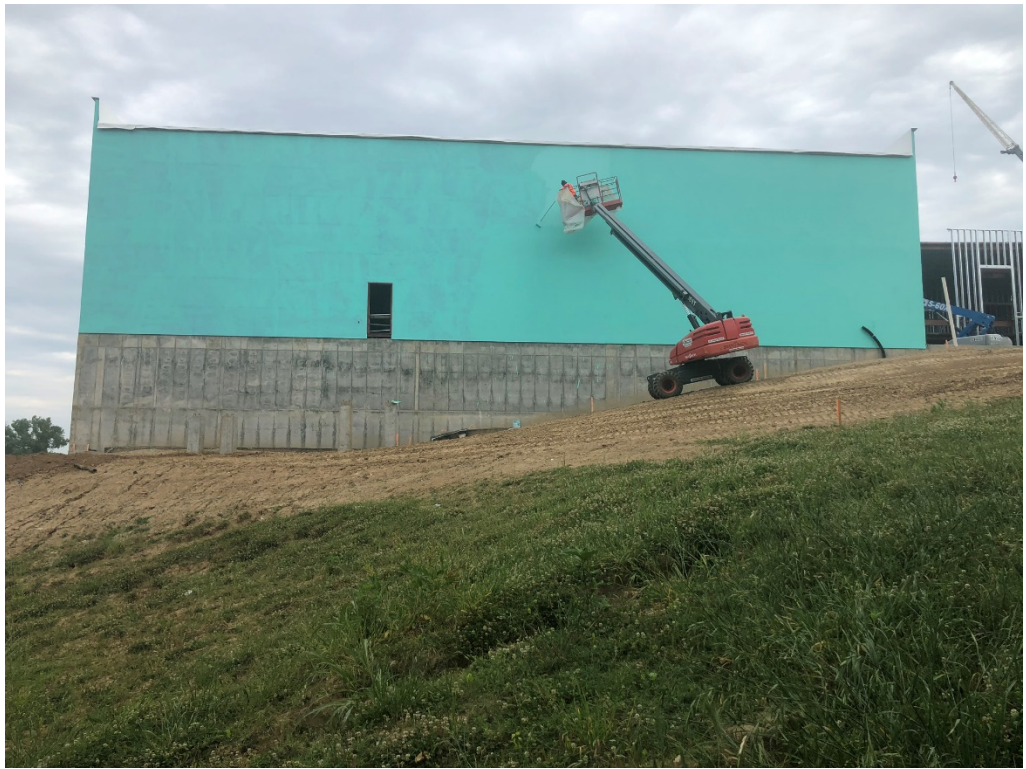
Figure 11 – South Façade at West Wing

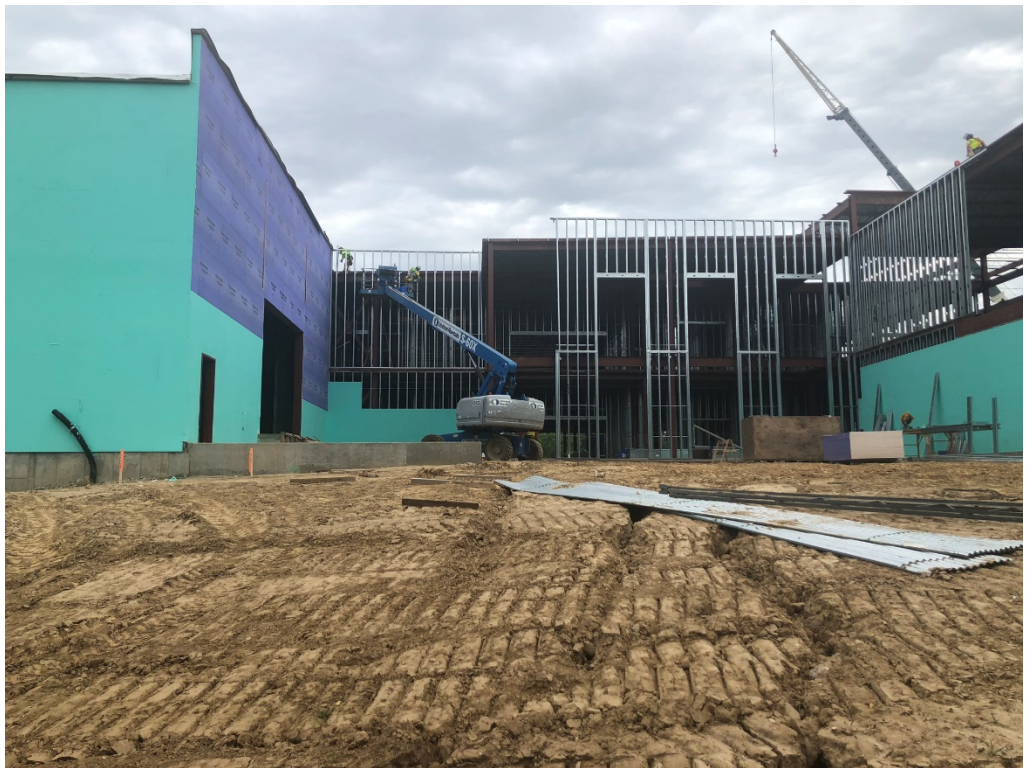
Figure 12 –South Façade at Center Building Section

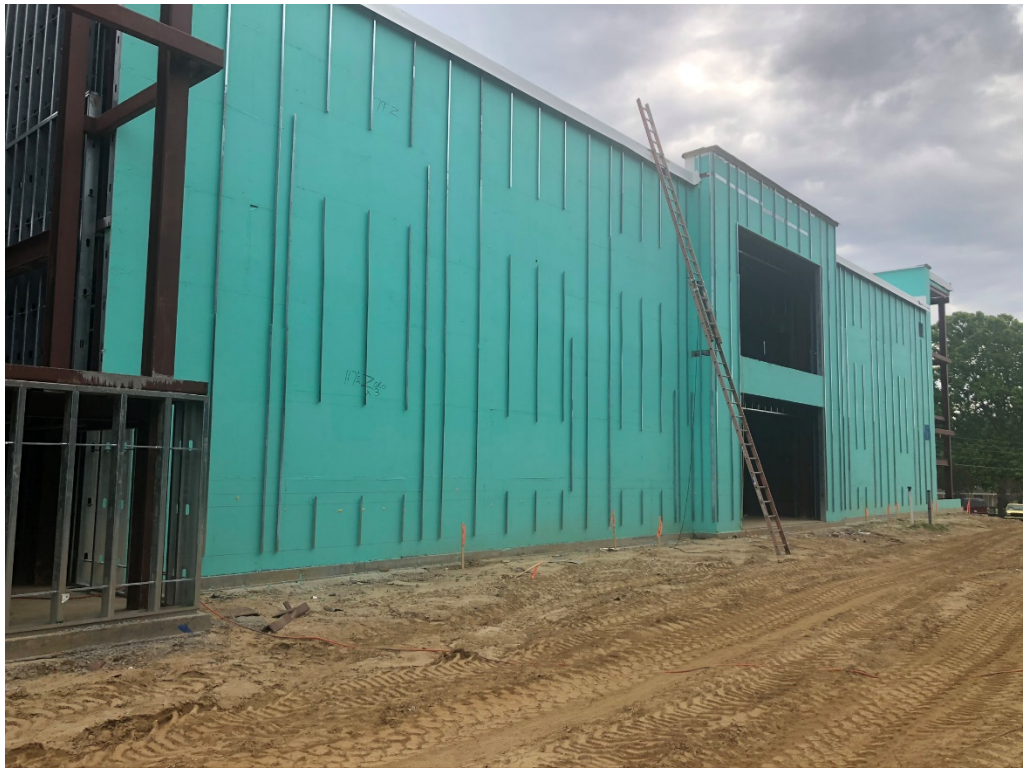
Figure 13 – South Façade at East Wing

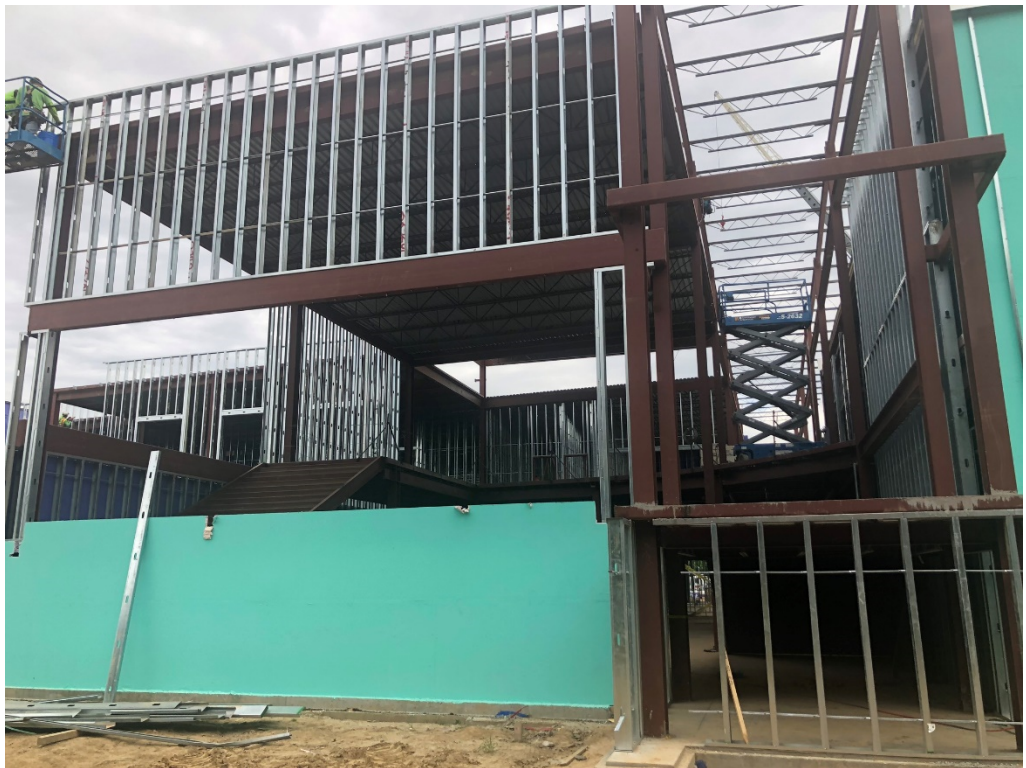
Observations Arriving, I walked the site from east to West and back at the exterior. Water proofing was currently in progress where sheathing has been installed. Exterior framing was also in progress.

Figure 14 –Framing Ongoing at Exterior Façade

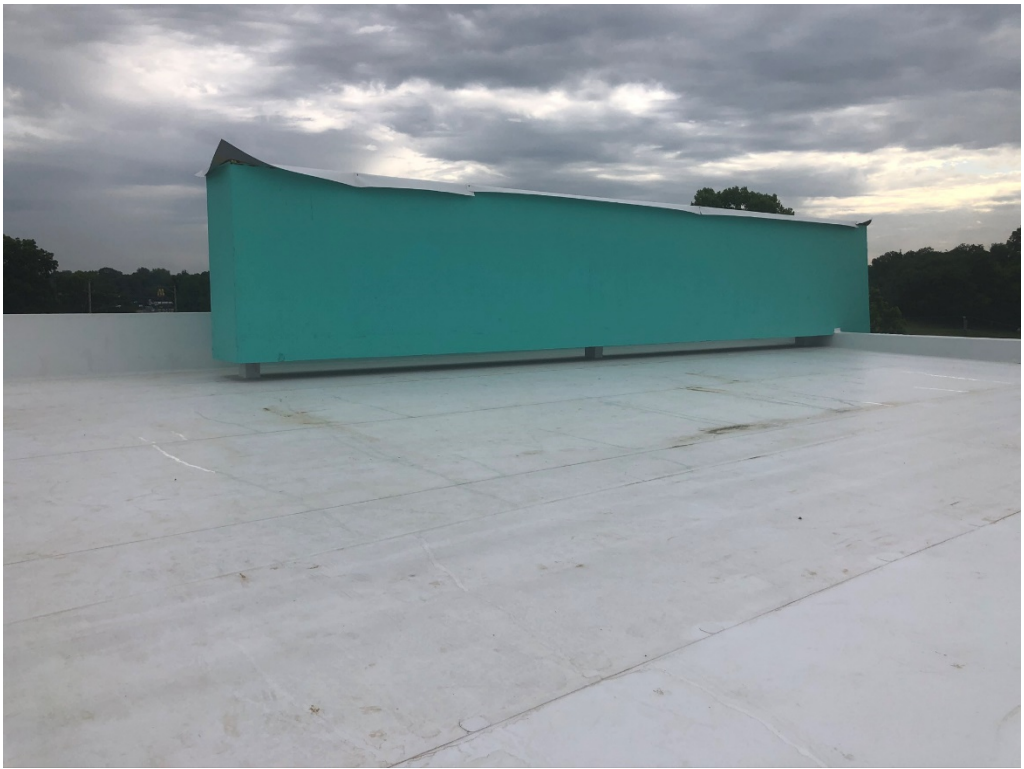
At the rear, I climbed a ladder to get to roof of East section of building. The Membrane is installed and appeared complete.

Figure 15 – East Wing Roof membrane Installed

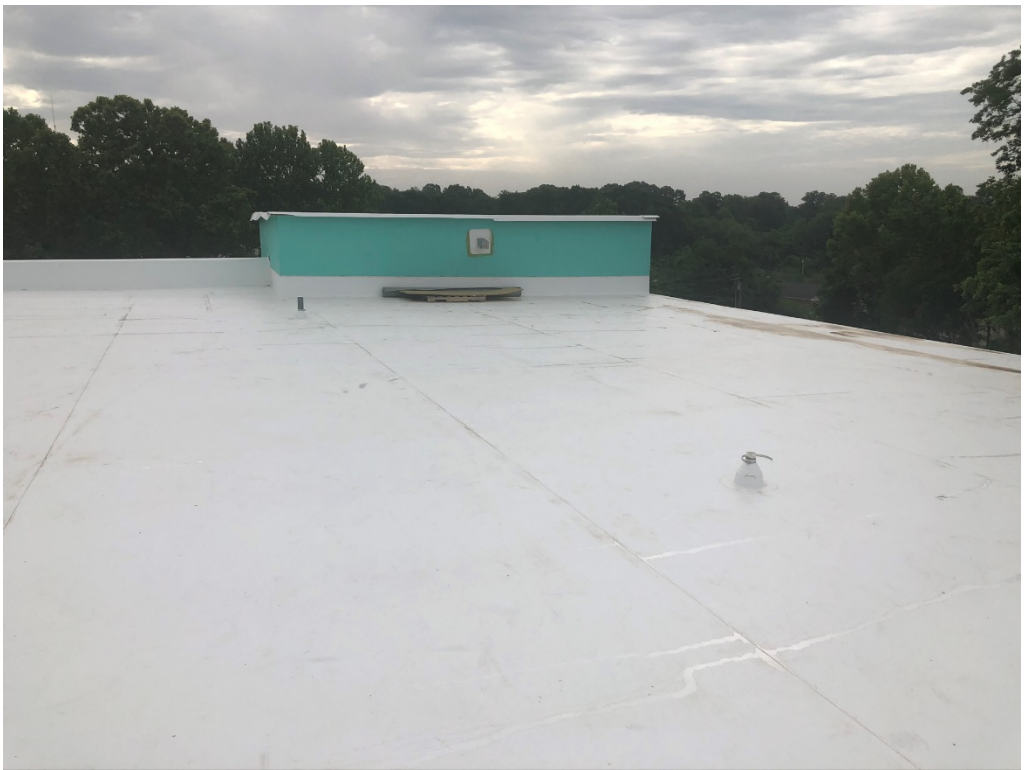
Figure 16 – East Wing Roof membrane Installed

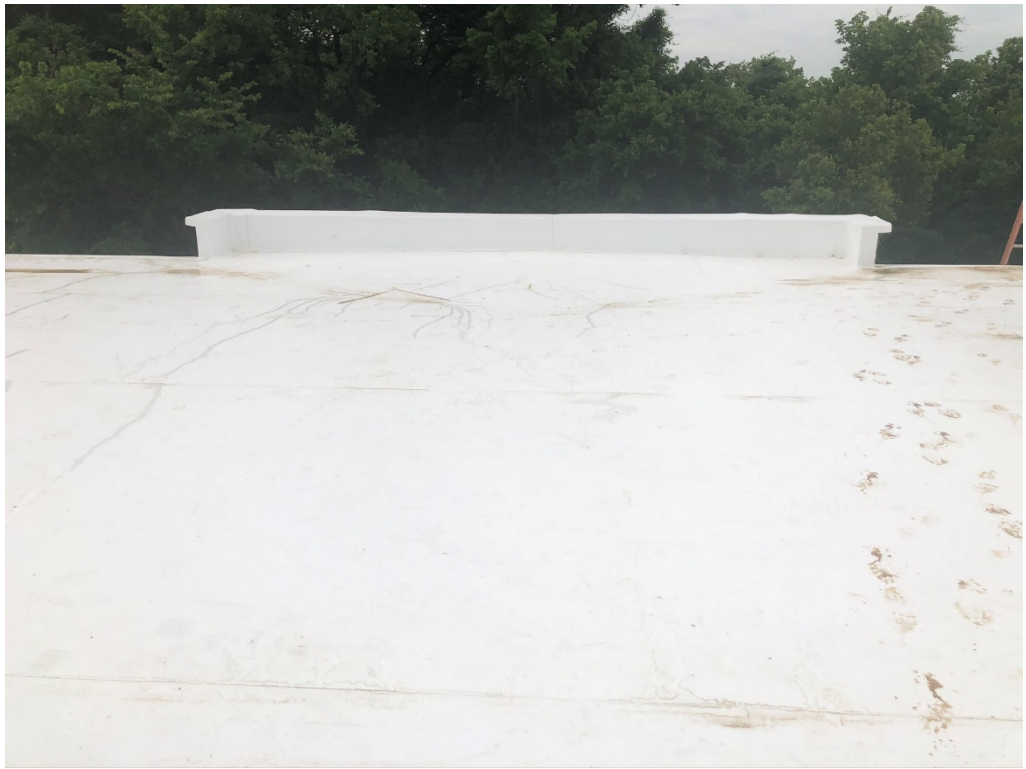
Figure 17 – East Wing Roof membrane Installed

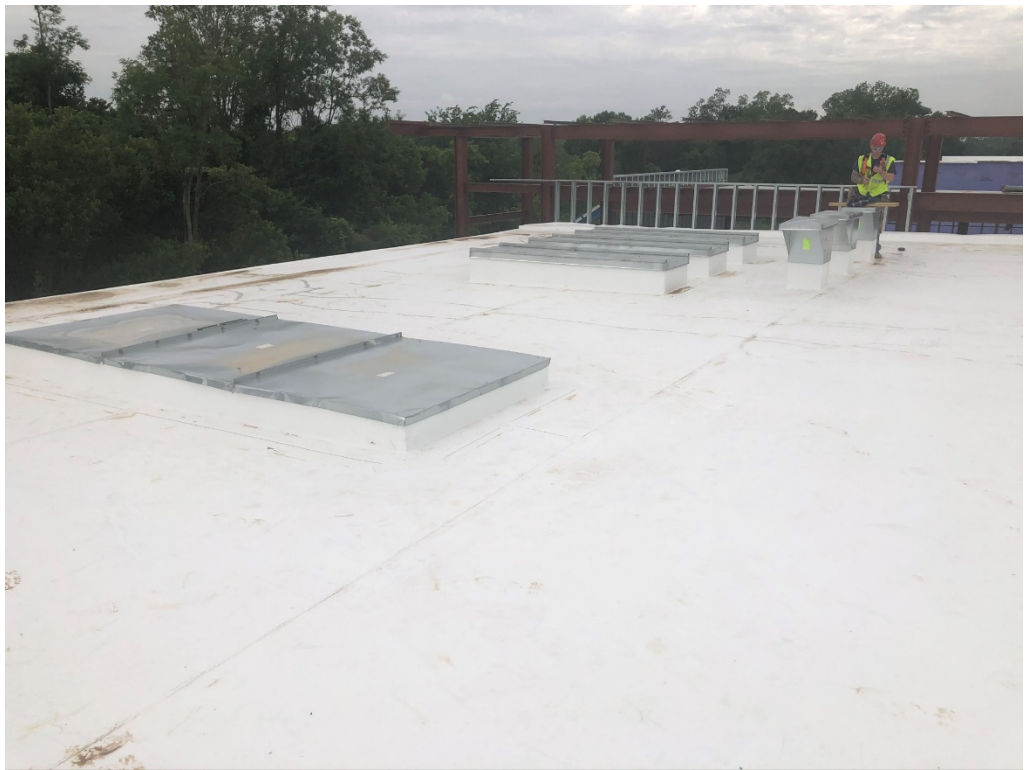
Figure 18 – East Wing Roof membrane and Curbs

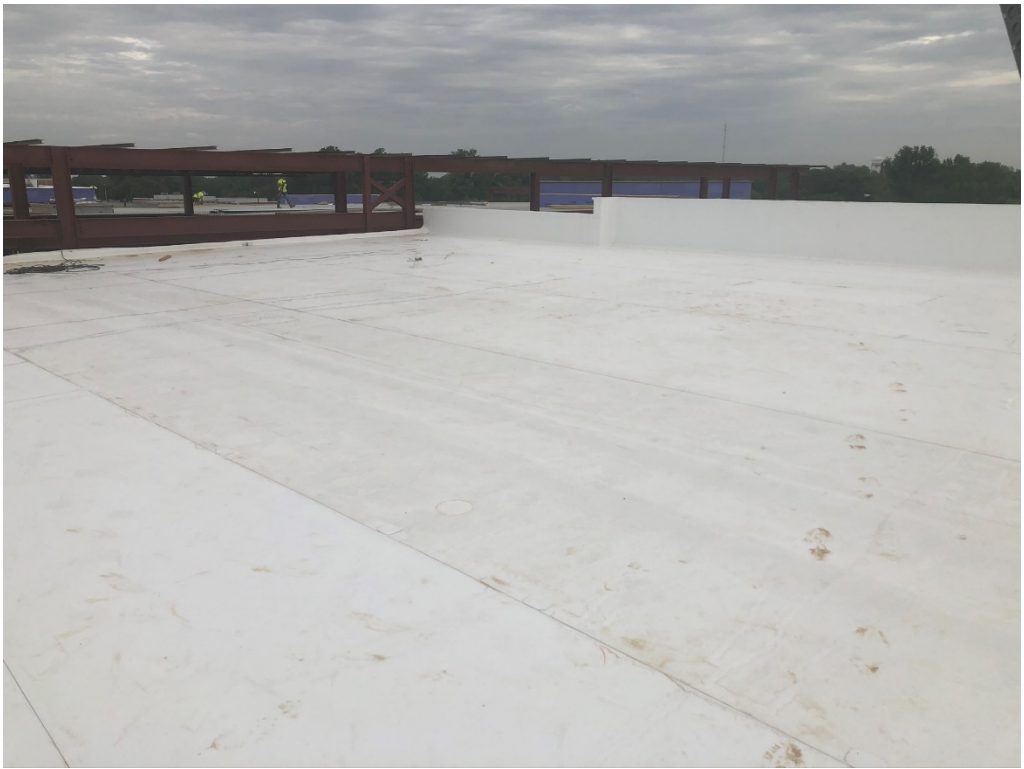
Figure 19 – East Wing Roof membrane Installed

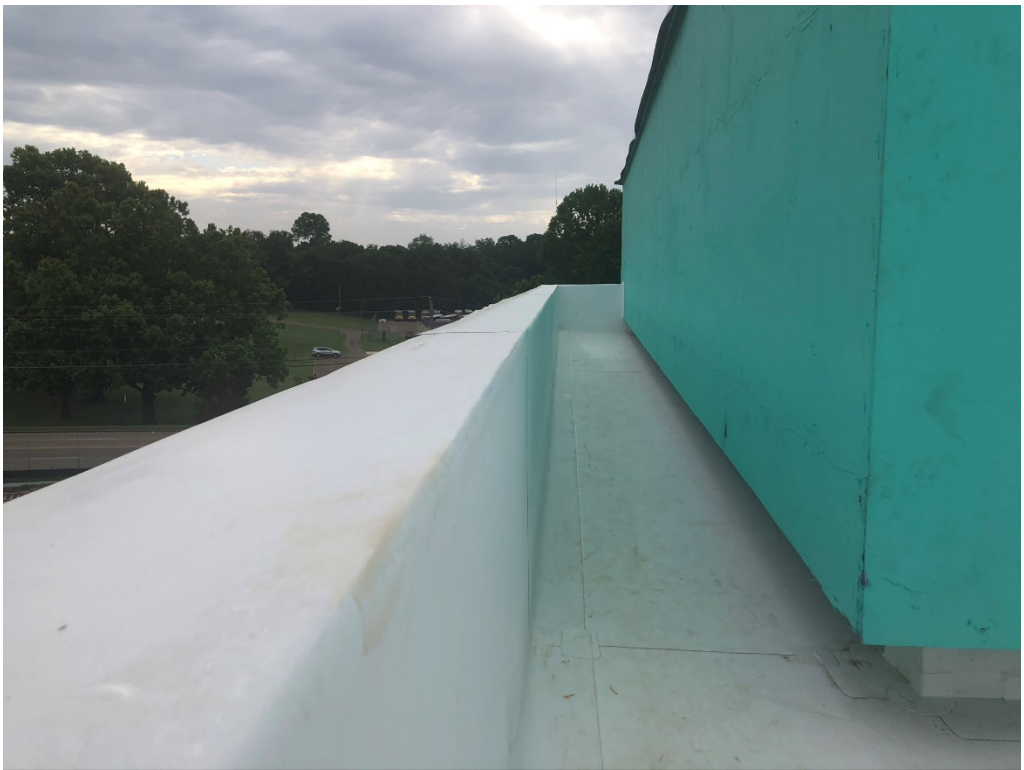
Figure 20 – North Parapet Wall at East Wing

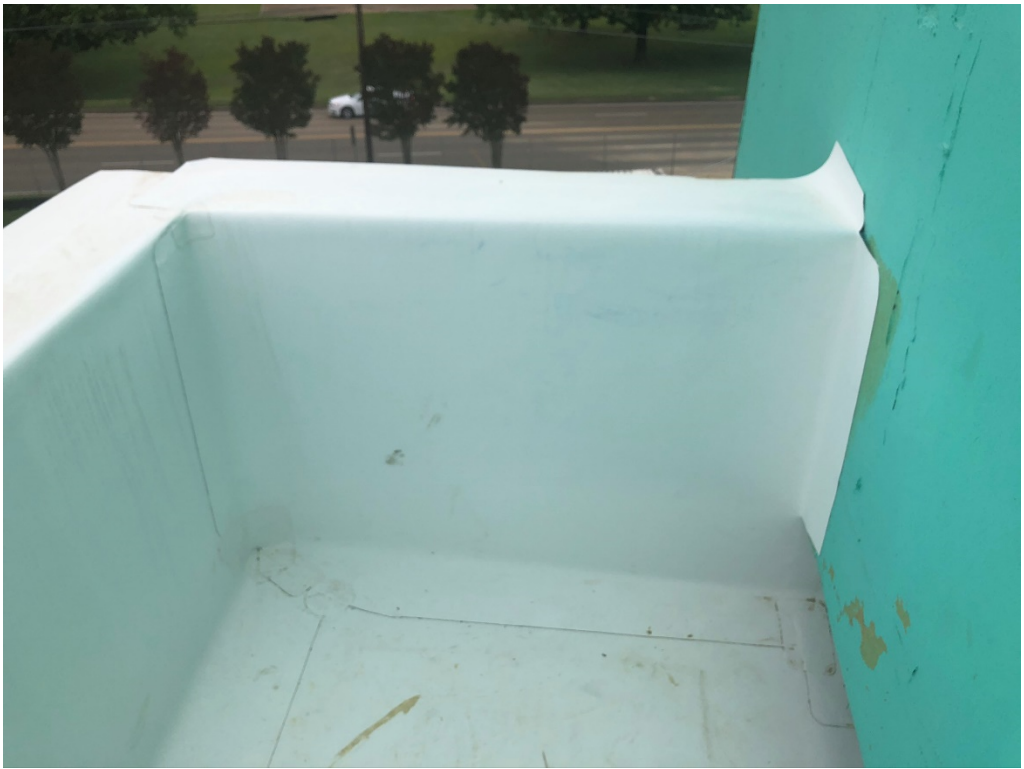
Figure 21 – Parapet Wall Detail to Sidewall Junction

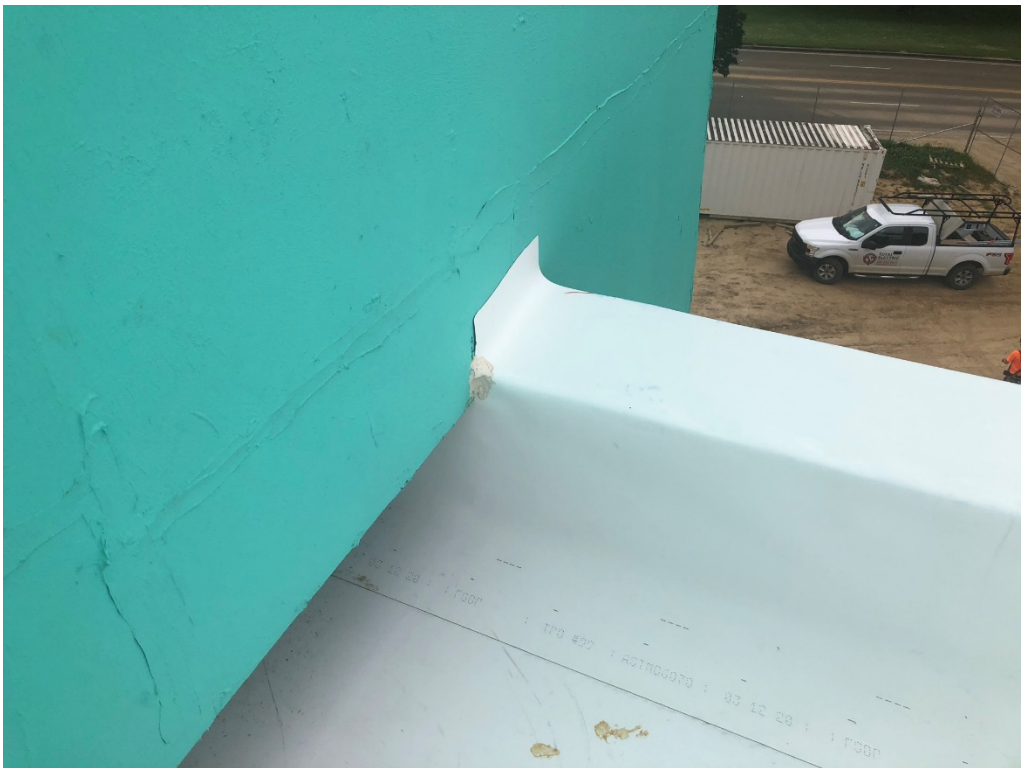
Figure 22 – Parapet Wall Detail to Sidewall Junction at East Side

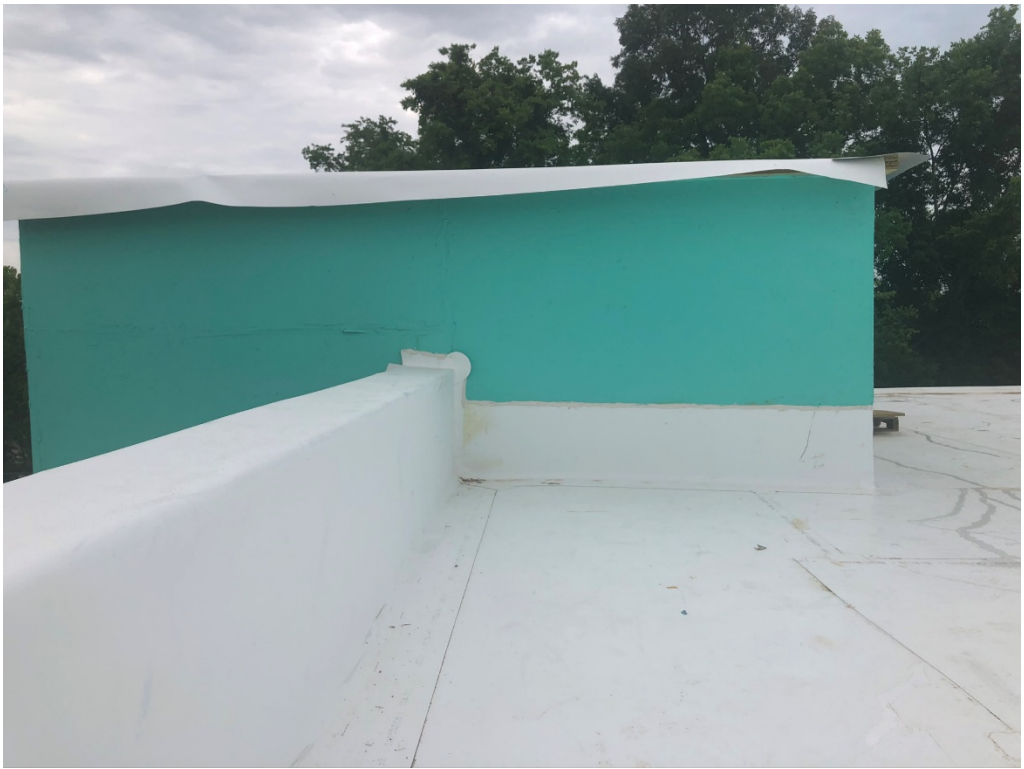
Figure 23 – Stair Well Roof Section

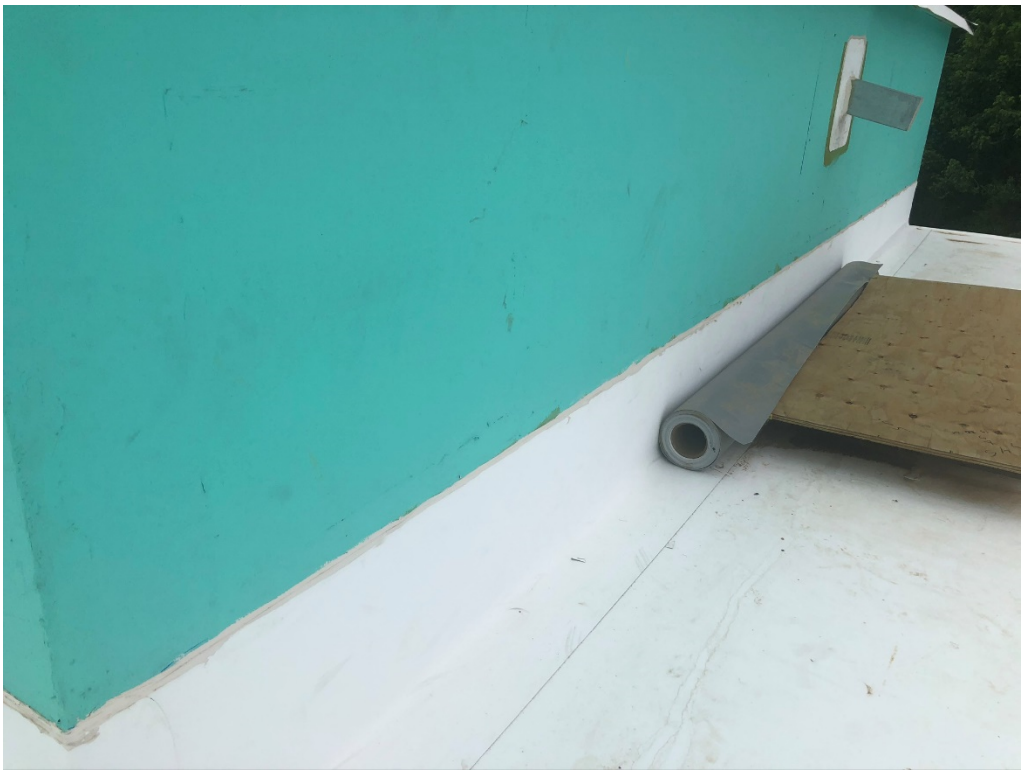
Figure 24 – Stair Well Roof Section Scupper Detail

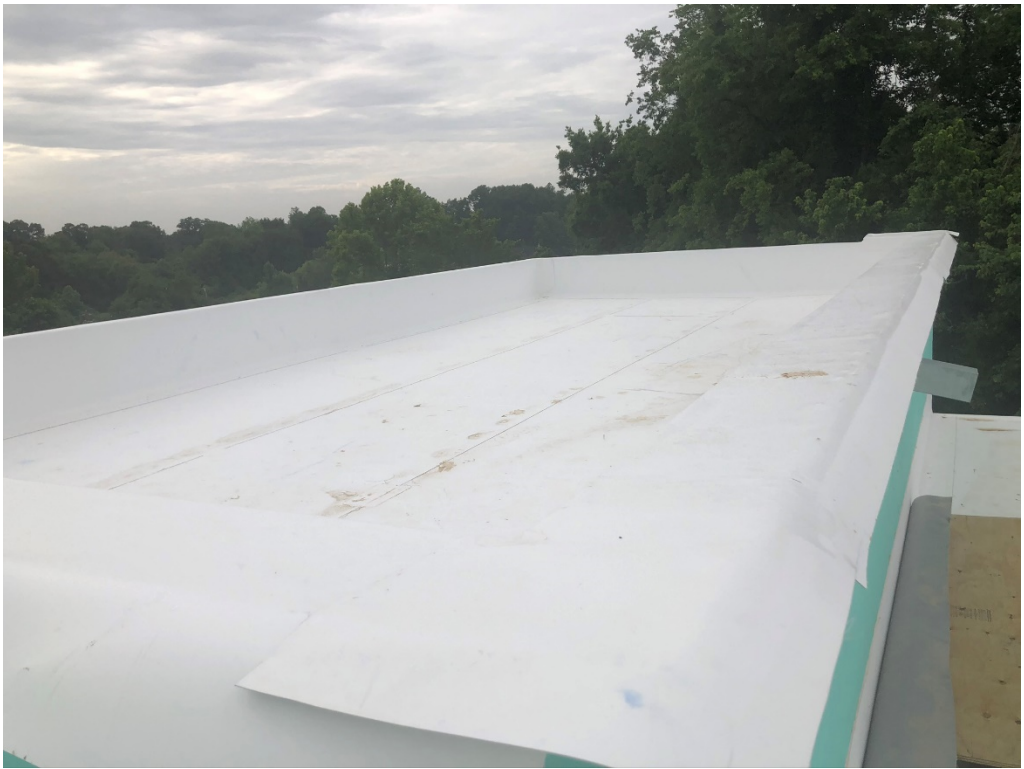
Figure 25 – Stair Well Roof Section

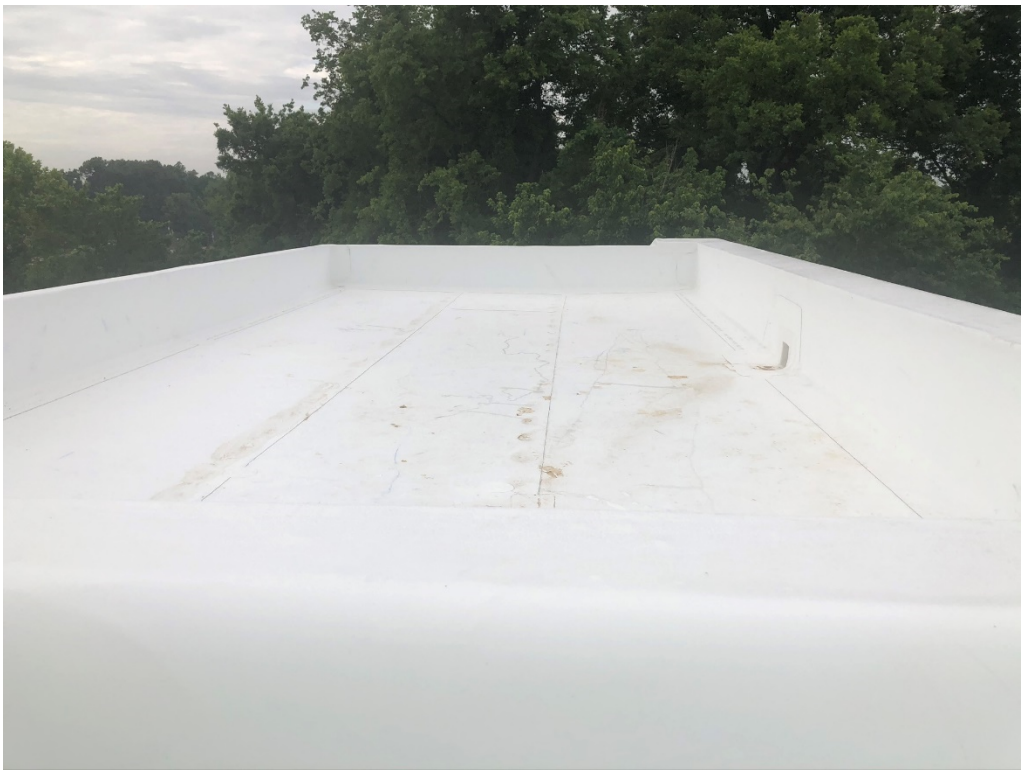
Figure 26 – Stair Well Roof Section

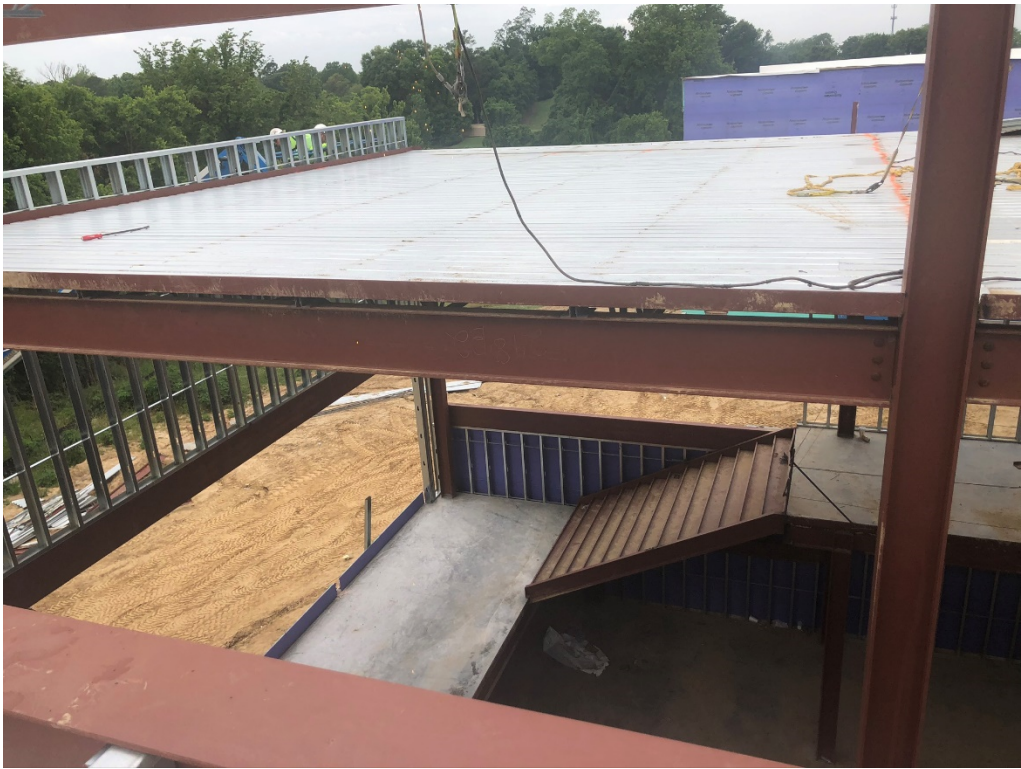
At the center section of the building, roof framing is ongoing but nearing completion.

Figure 27 – Metal Decking is Ongoing at Center Section of Building

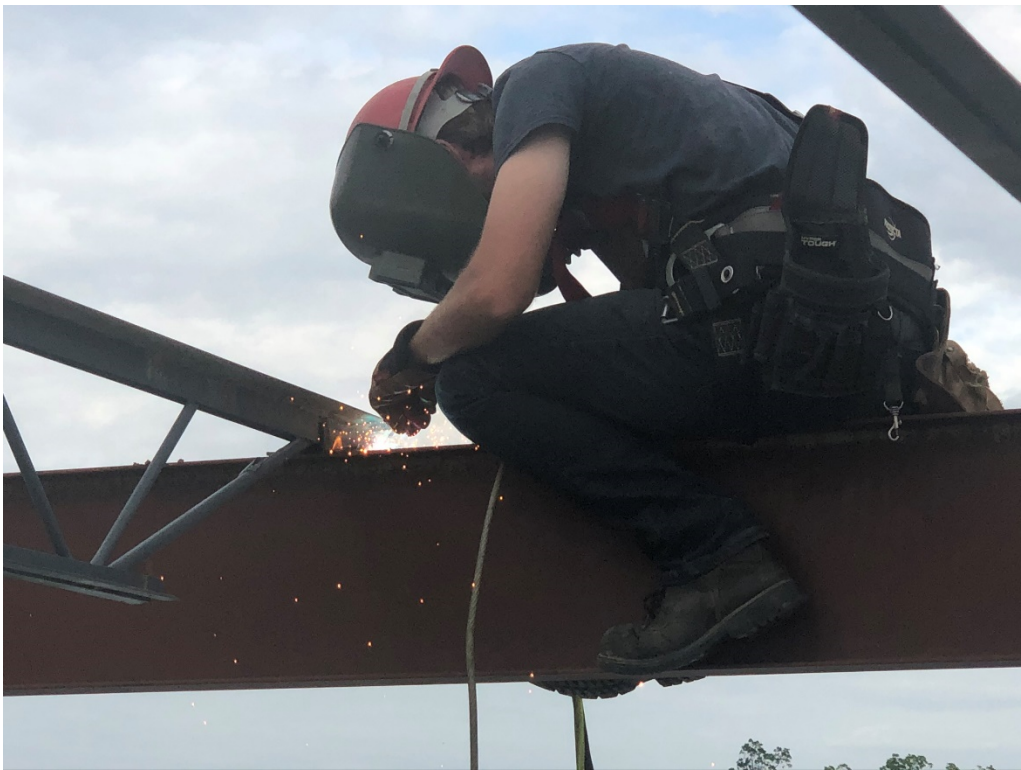
Figure 28 – Roof Joists Rafter Welding

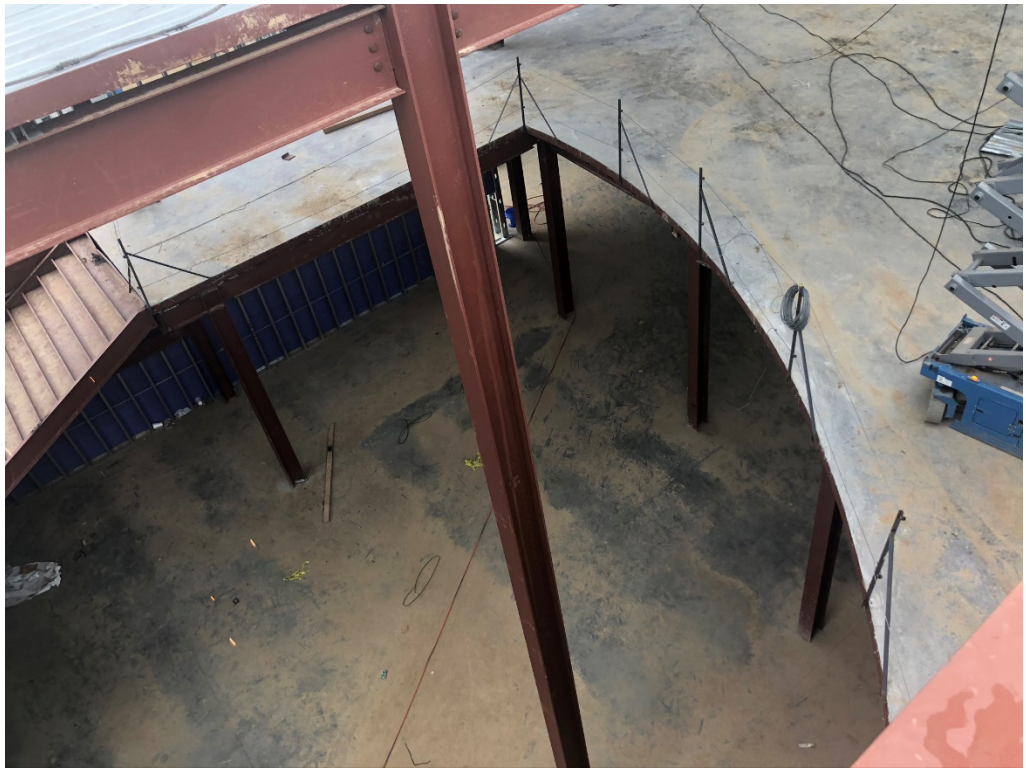
Figure 29 – Main Gathering Space: Curve Looks Good from Above
