Architect's Field Report

15 May 2020

18059-AOI Academy of Innovation / Report Number 035

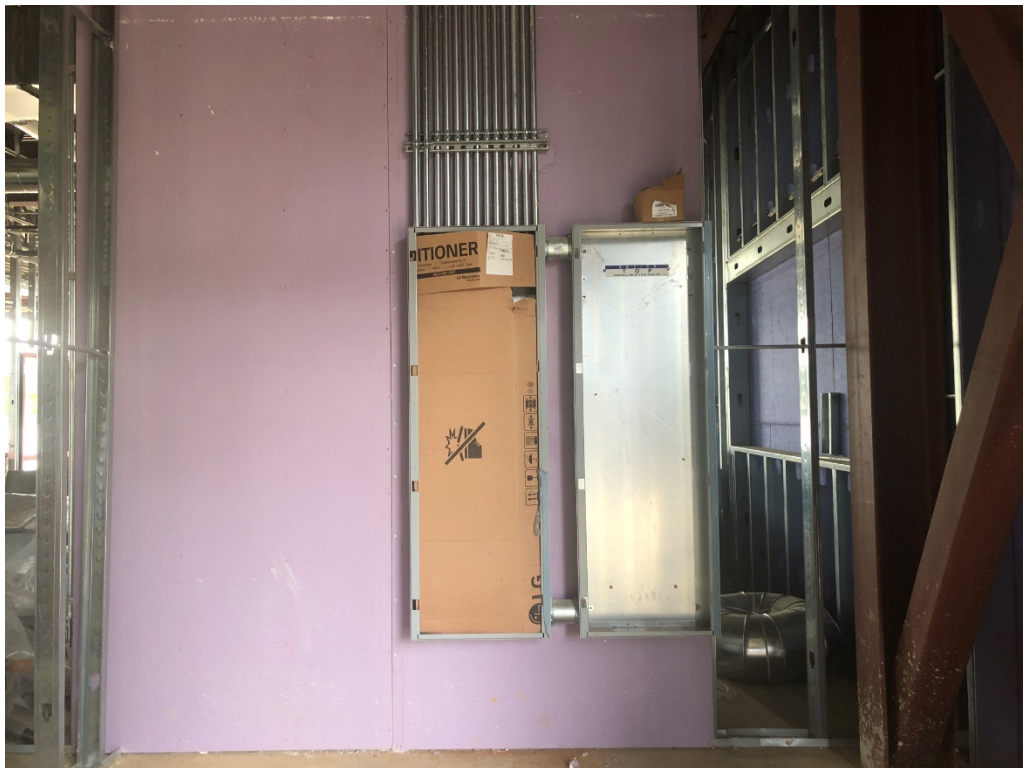
Figure 30 – Electrical Rough-IN is Ongoing

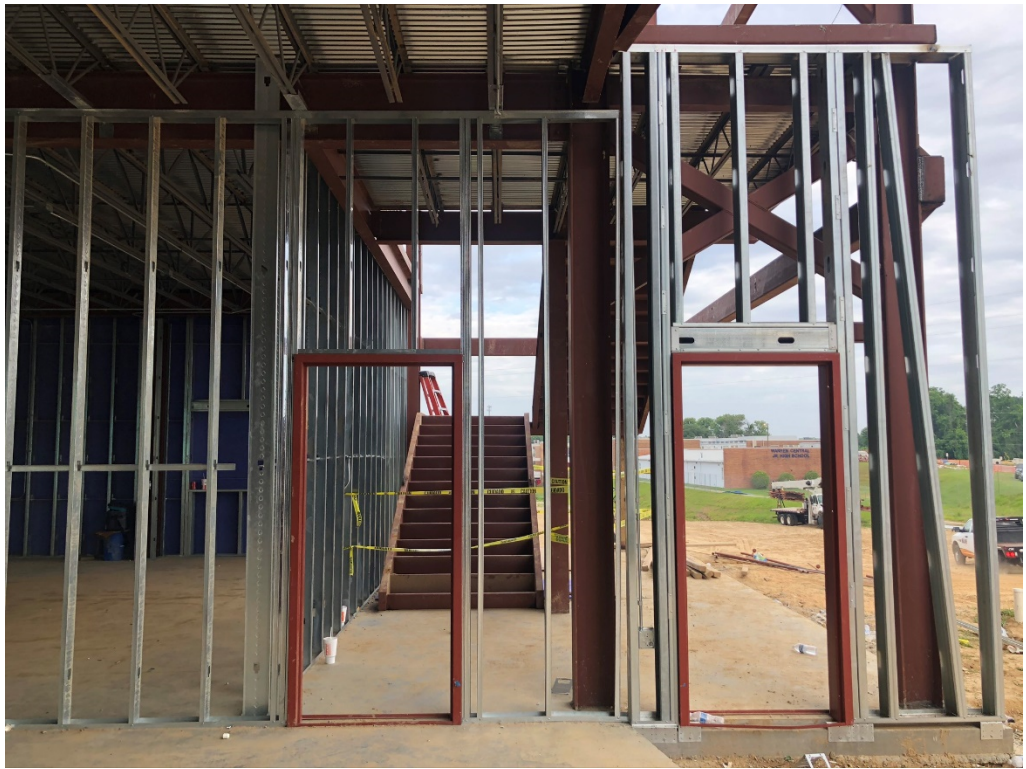
The north stair has been installed as well as the south main stair in the lobby area. These are awaiting concrete at treads.

Figure 31 – North Metal Stairs Installed

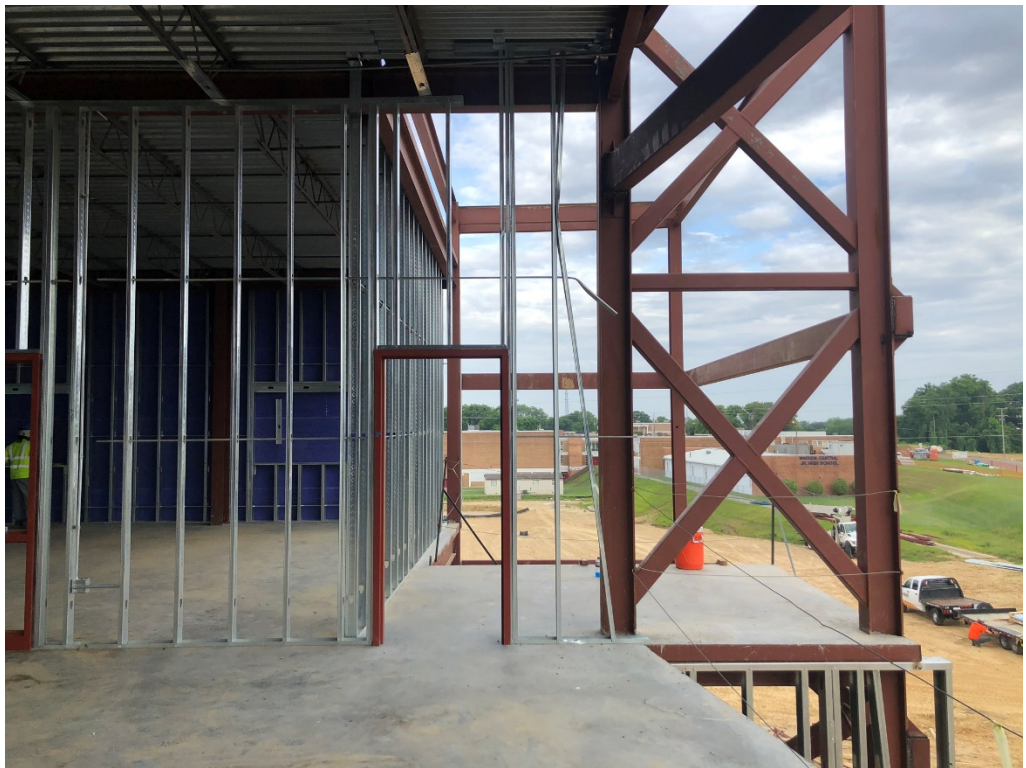
Figure 32 – North Metal Stairs Installed
