## Architect's Field Report

22 May 2020

18059-AOI Academy of Innovation / Report Number 036

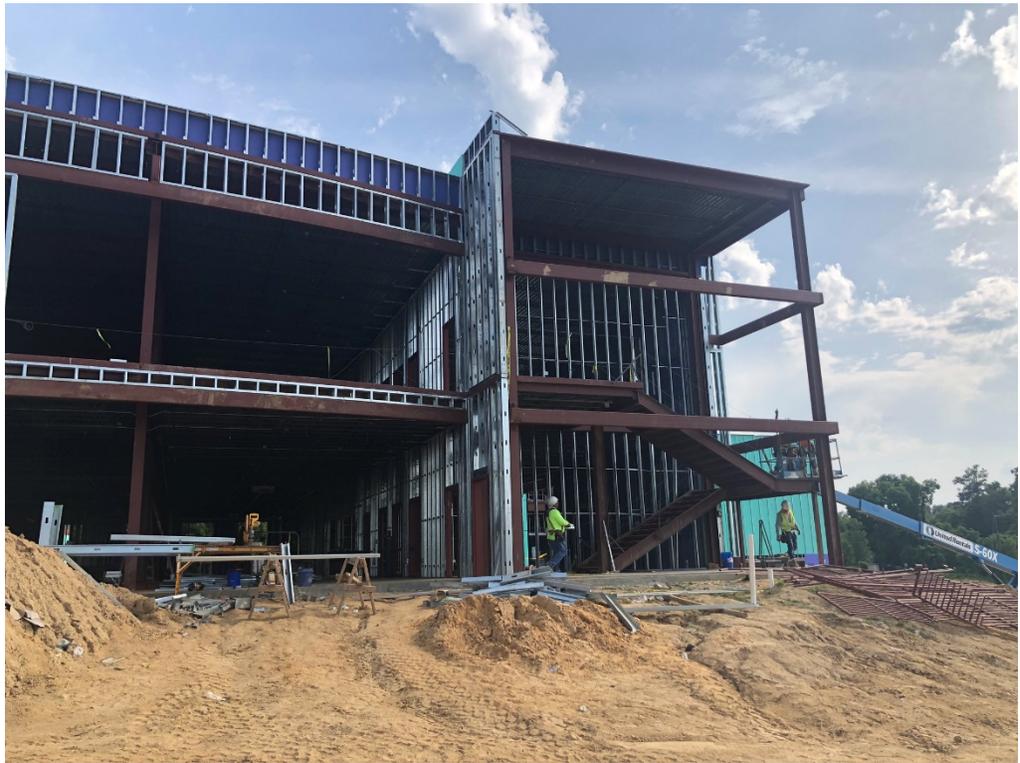
Figure 1 – North Structure Framing Ongoing

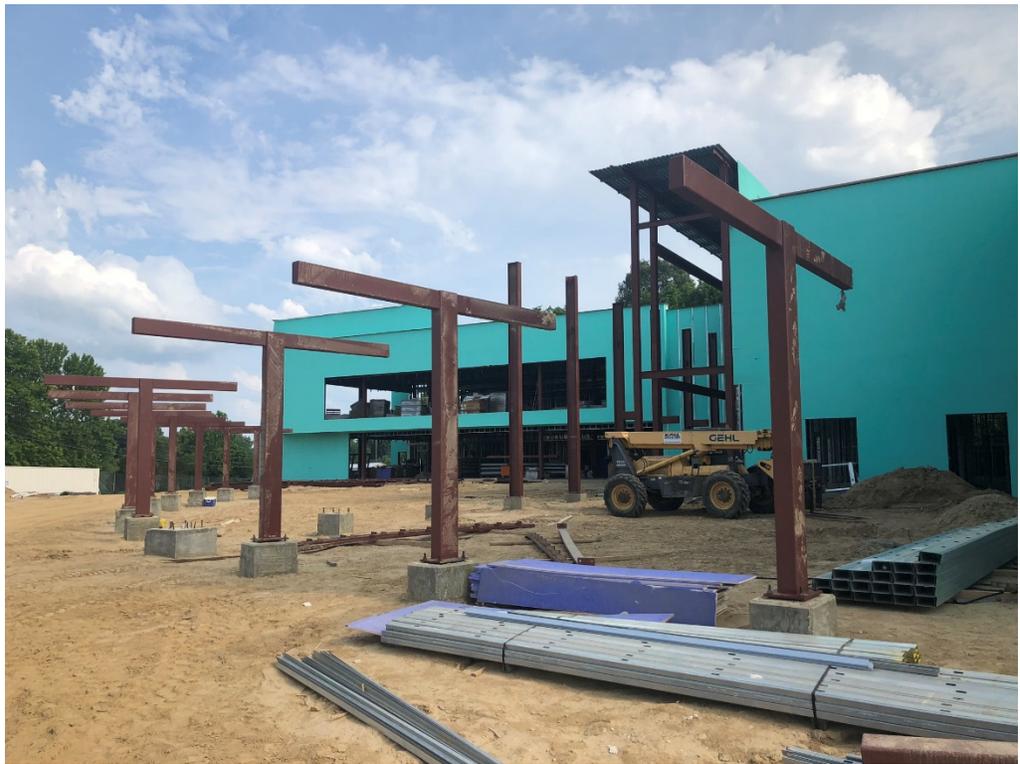
Figure 2 – Drop Off Awning Red Steel Partially Complete

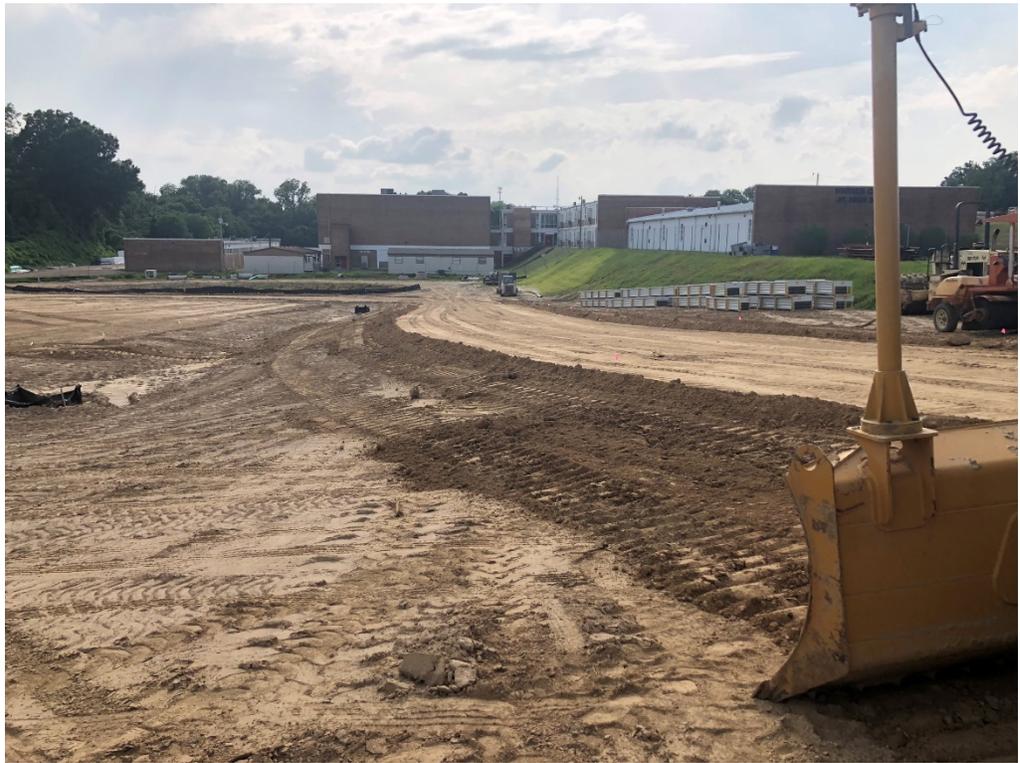
Figure 3 – Road and Parking Graded and Ready for Substrate

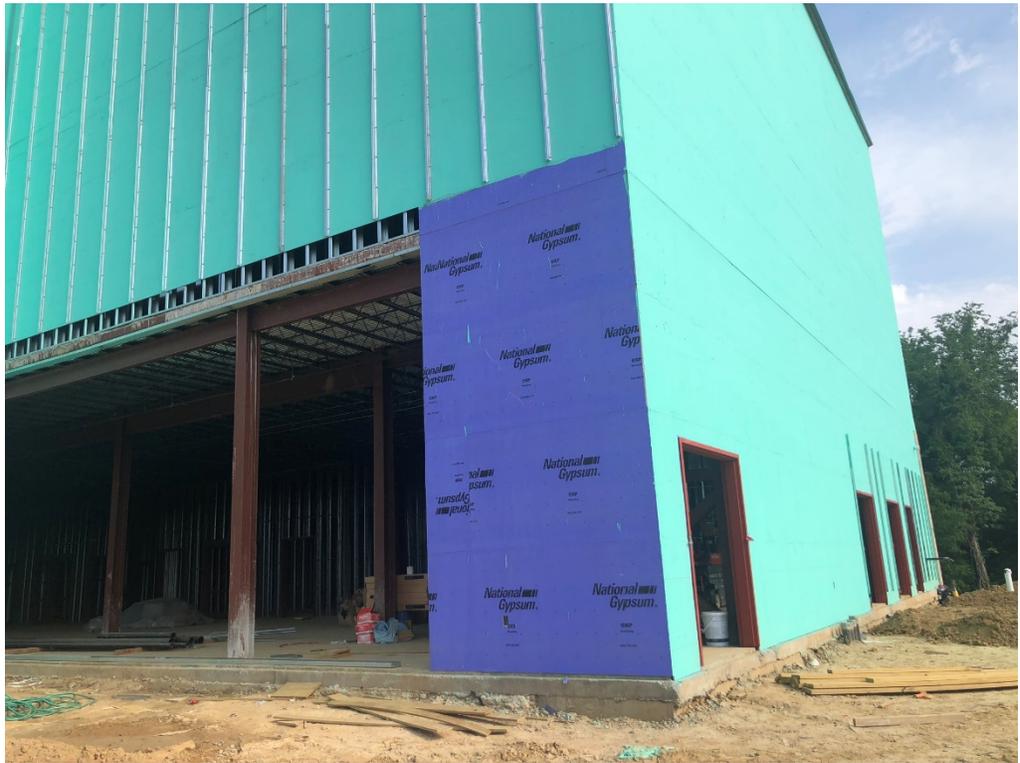
Figure 5 – West Structure Sheathing and Water Proofing Ongoing

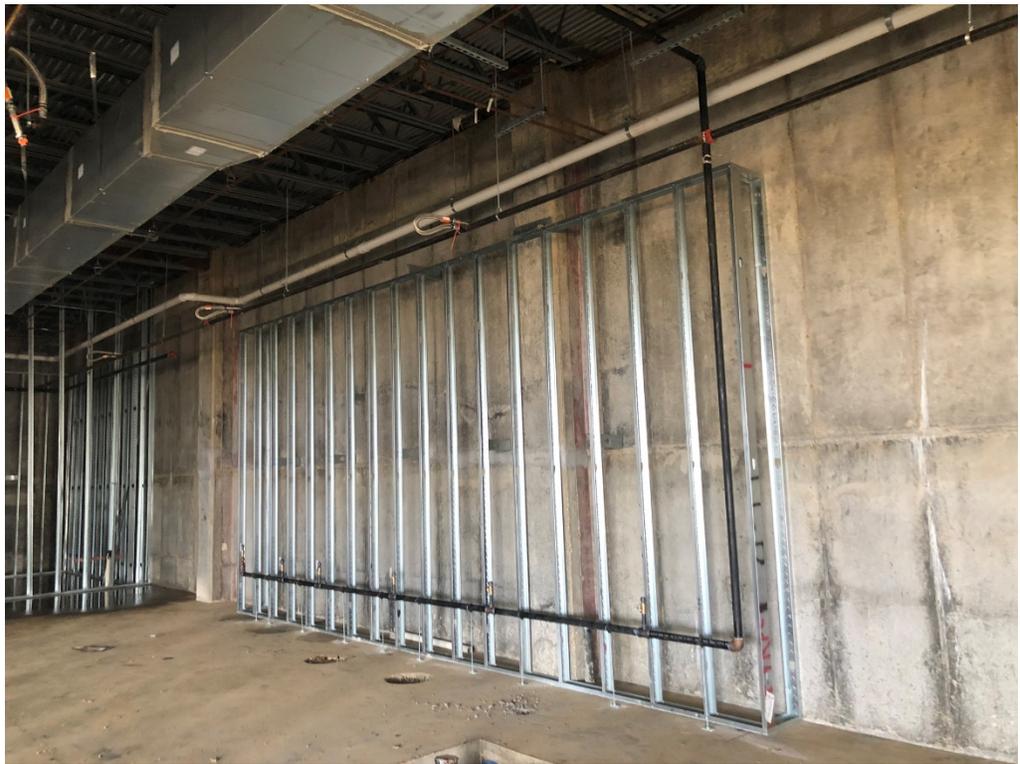
Observations I arrived onsite and entered from the North Entrance. Exterior Framing was in progress here. I walked the site in a counter clockwise pattern at the exterior. Gas Pipe progress has been made and is being tested at the lower level.

Figure 6 – Gas Pipe Installed at Kitchen

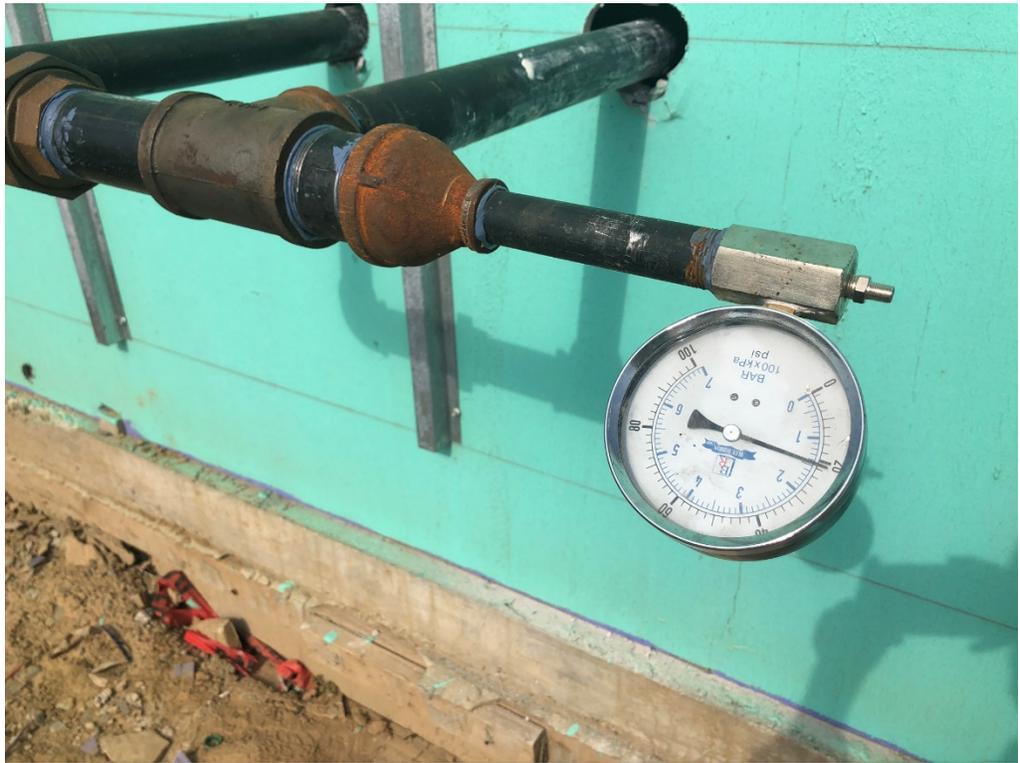
Figure 7 – Gas Pressure Test in Progress

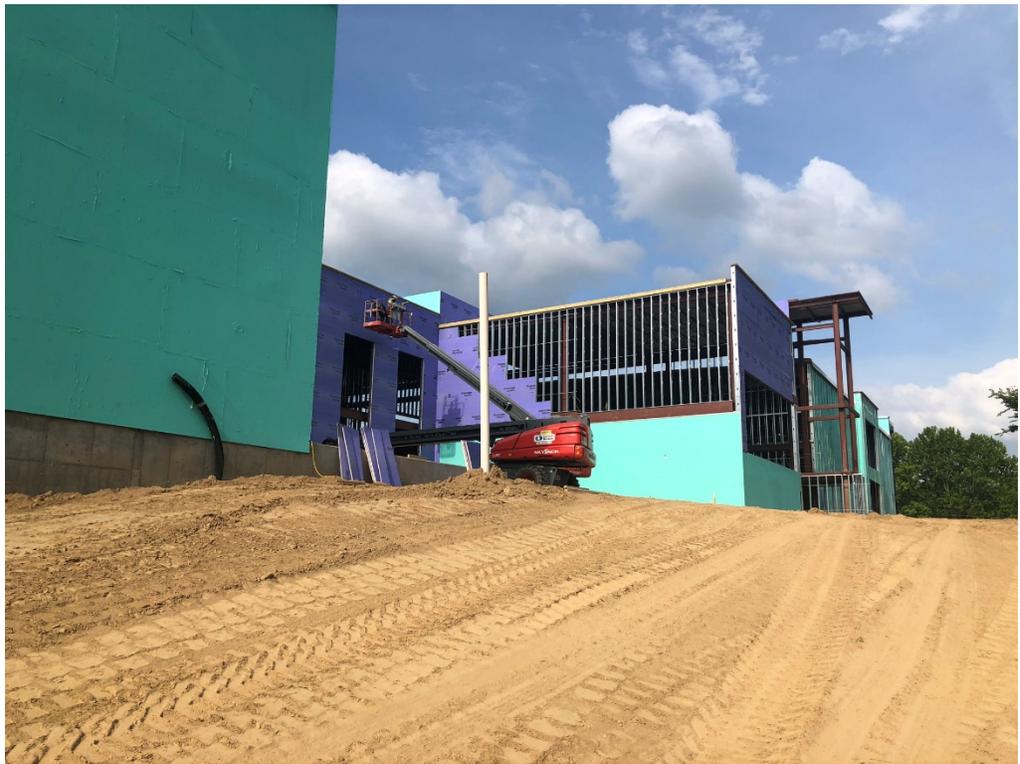
Figure 8 – South Façade Framing and Sheathing Ongoing

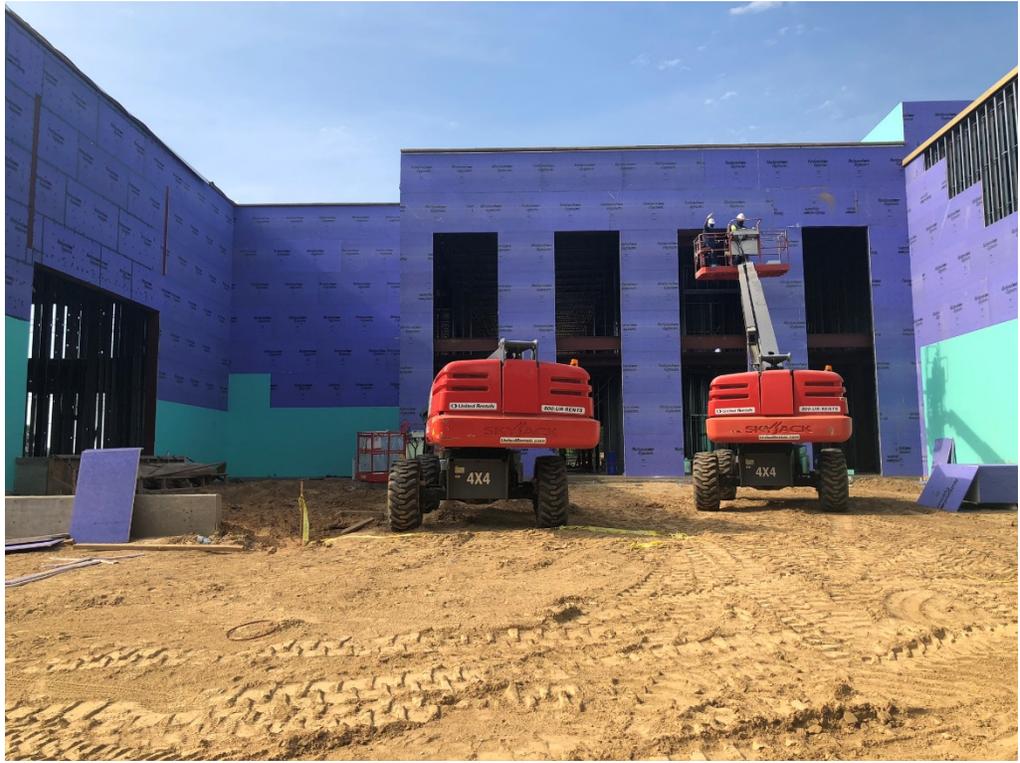
Figure 9 – South Courtyard Sheathing in Progress

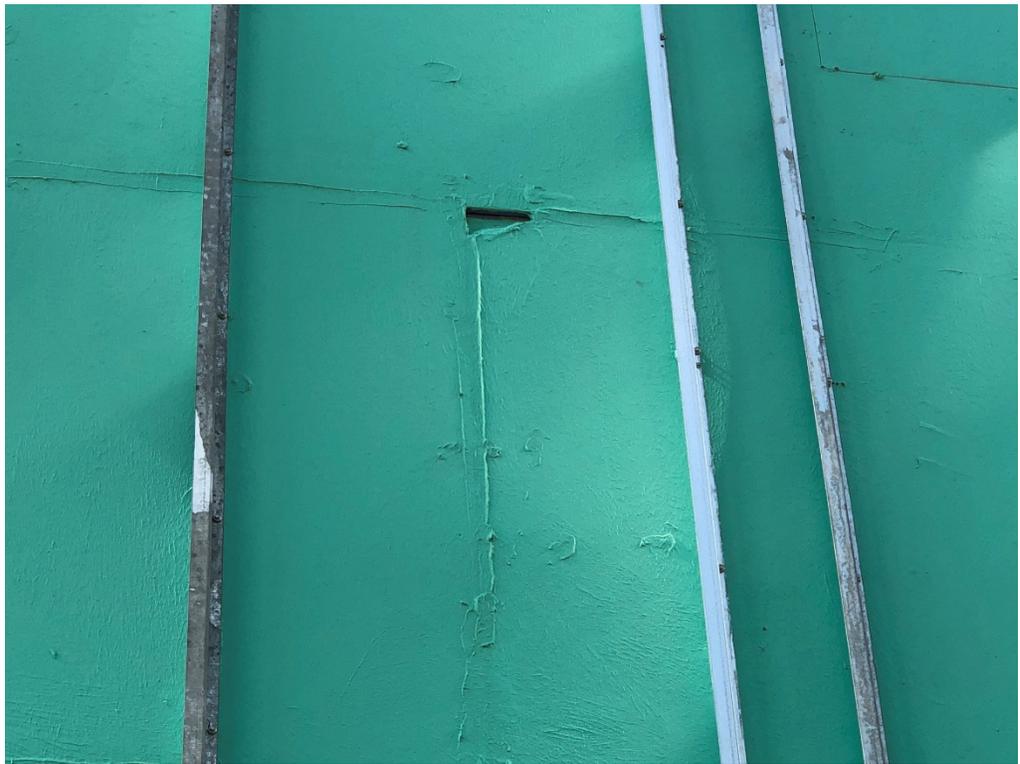
At the south courtyard, sheathing progress was ongoing. I noted some damage to exterior sheathing. I spoke with Billy Burwell, CC, about this and he mentioned that there were 3 spots to his knowledge that were damaged by an installer but that they would be repaired soon. He also mentioned that storefront should be here soon and that roofers should be working on completing the install next week.

Figure 10 – Some Damage to be Repaired at Sheathing on South Façade

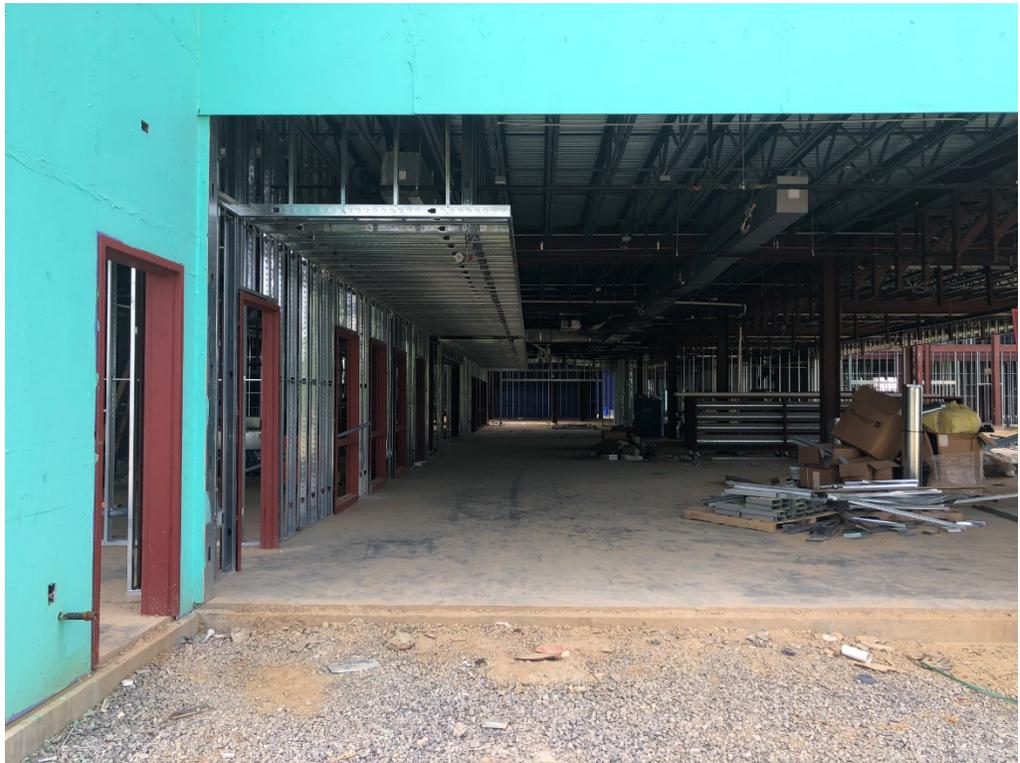
After walking the interior, it appears that light gauge framing is still in progress but that most of the interior walls are in place and only furr-downs and ceiling work remain.

Figure 11 – Interior Framing Ongoing

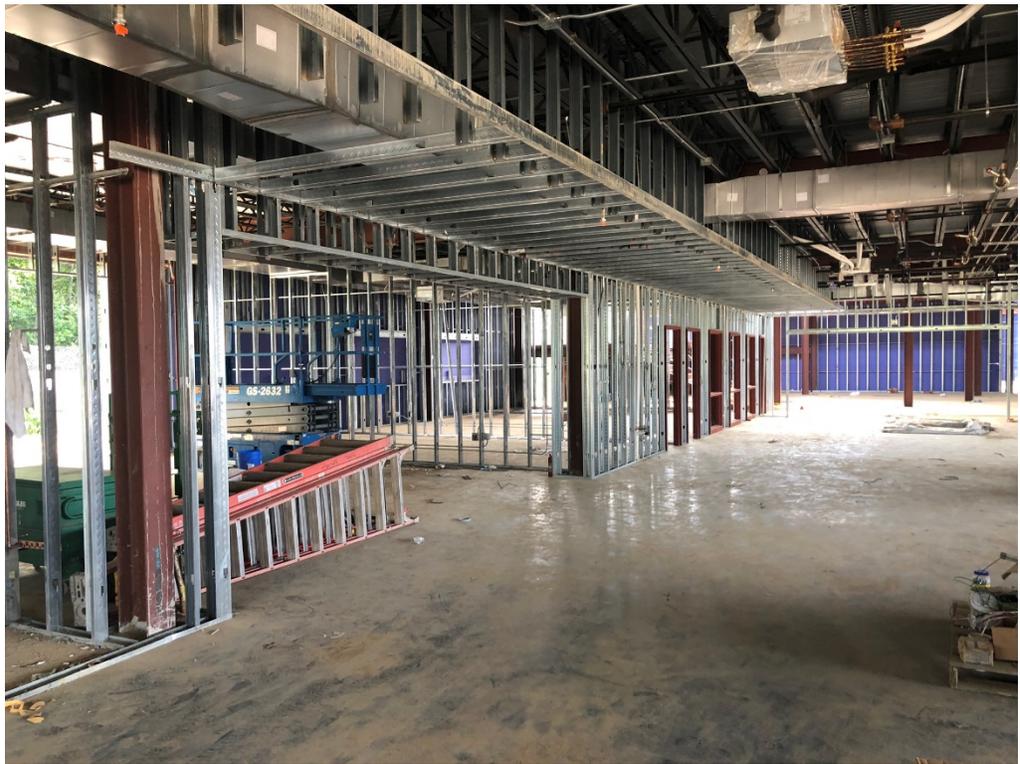
Figure 12 –Interior Framing Ongoing

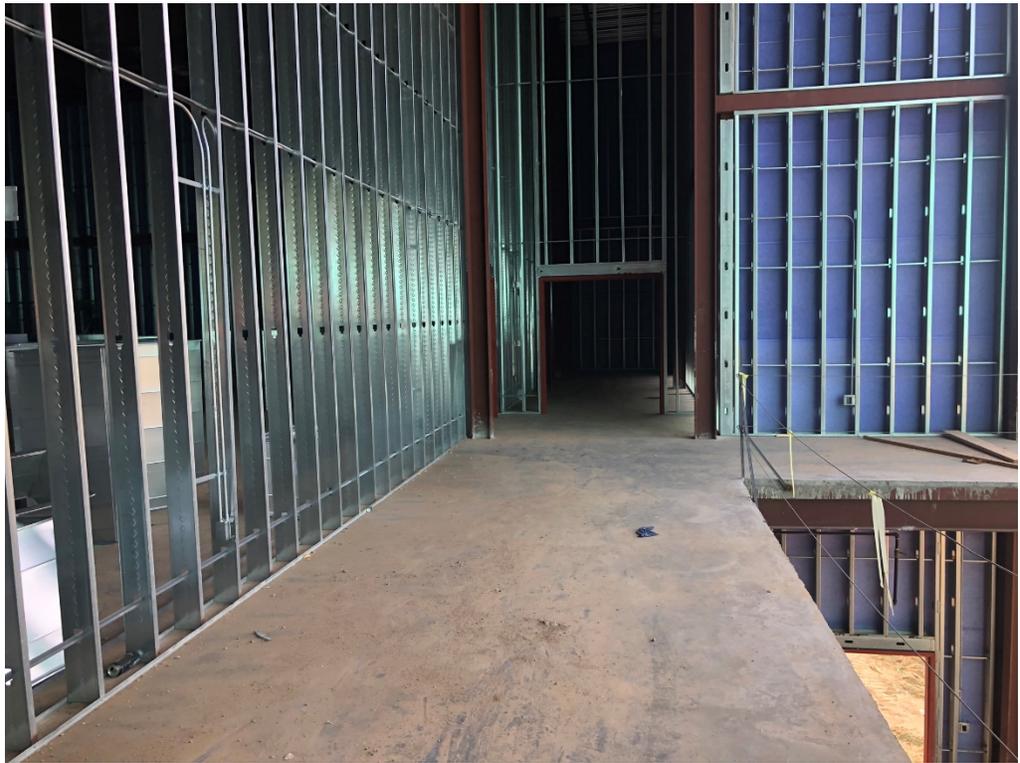
Figure 13 – Interior Framing Ongoing

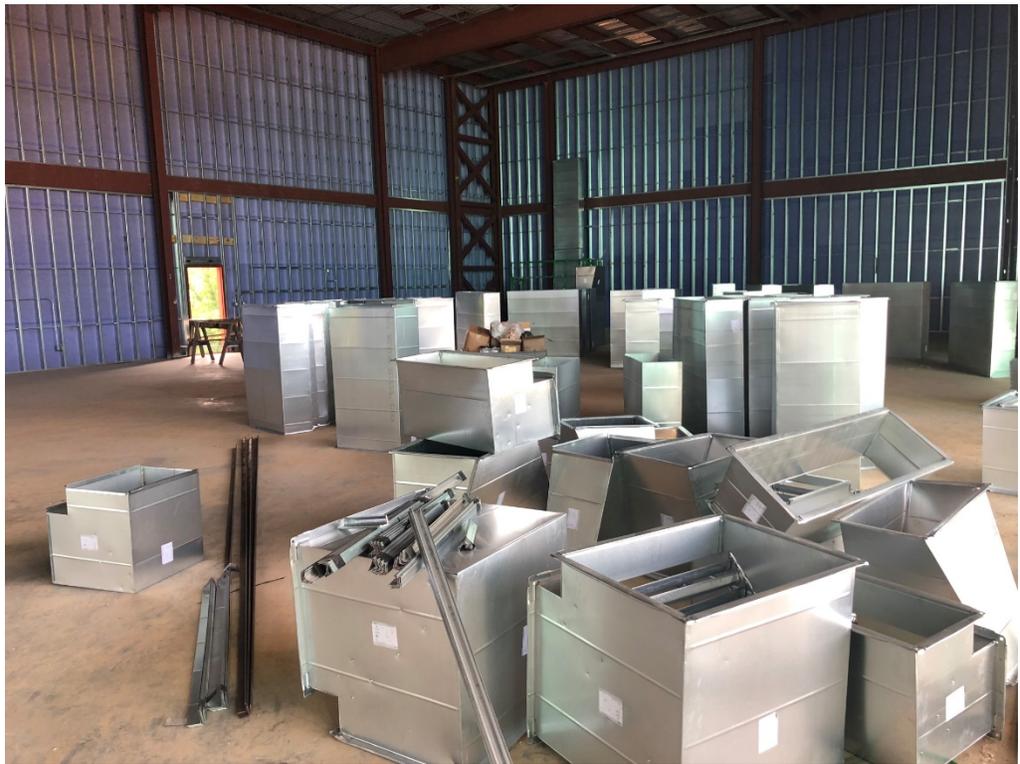
Figure 14 – Duct Installation at Gym in Progress
