## Architect's Field Report

201 Park Court, Suite B  
Ridgeland, MS 39157  
P 601.790.9432  
F 888.281.0547

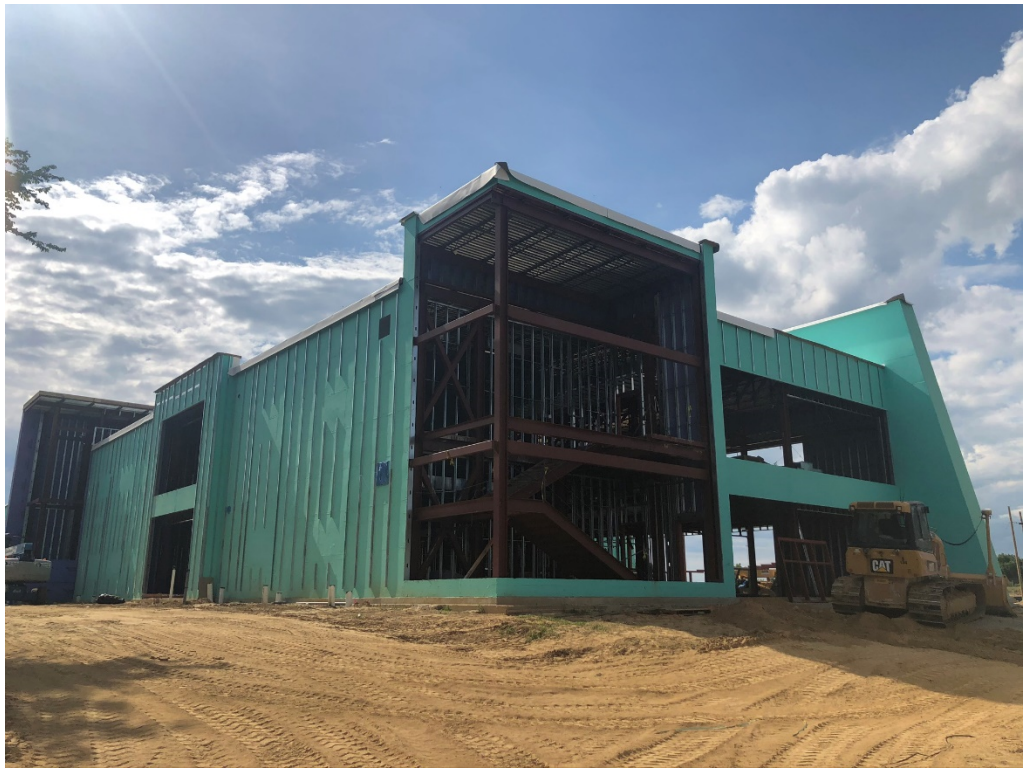
Figure 1 – East Building Ongoing

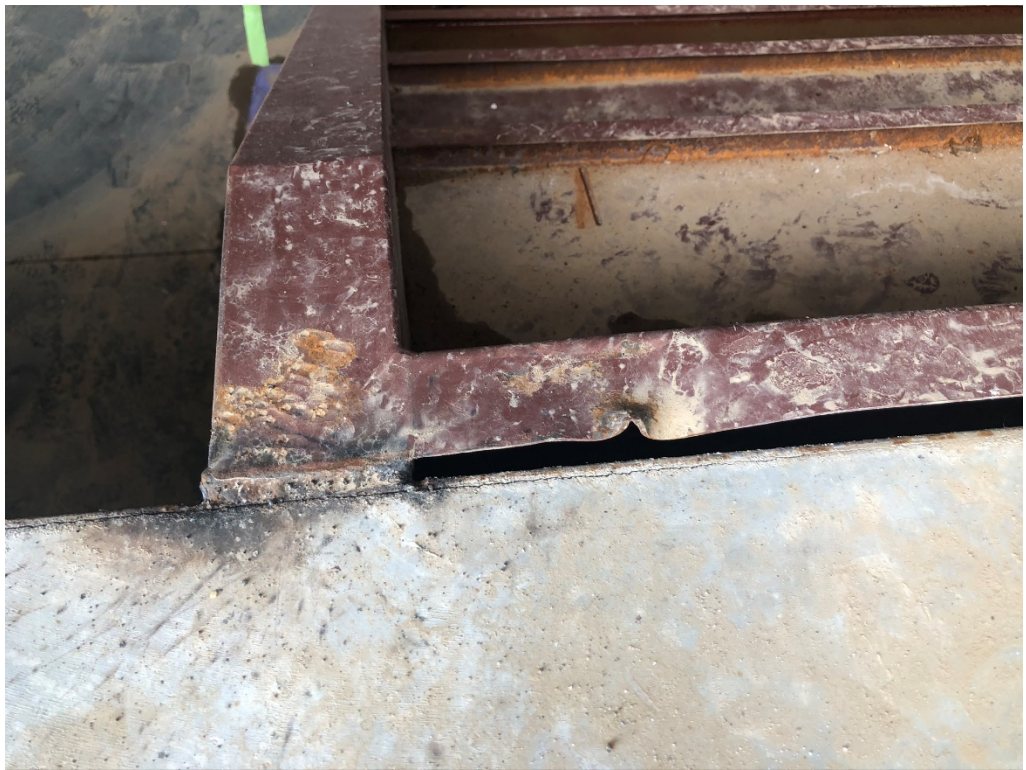
Figure 8 – Damage Noted at Metal Pan Stair

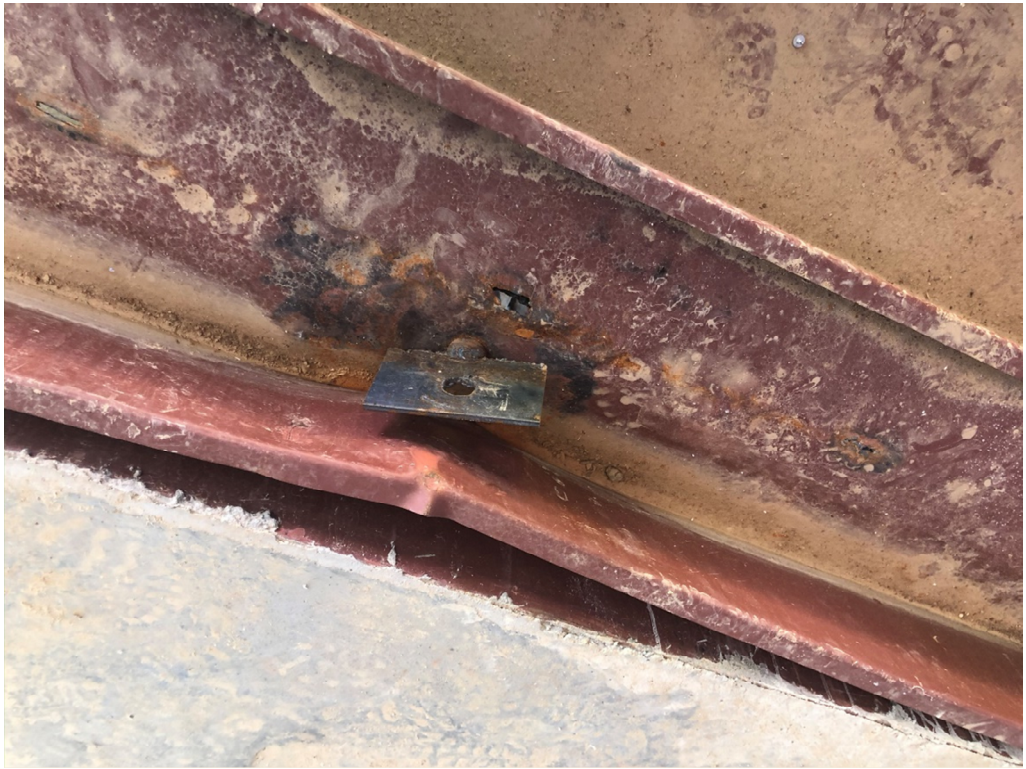
Figure 9 – Damage Noted at Metal Pan Stair

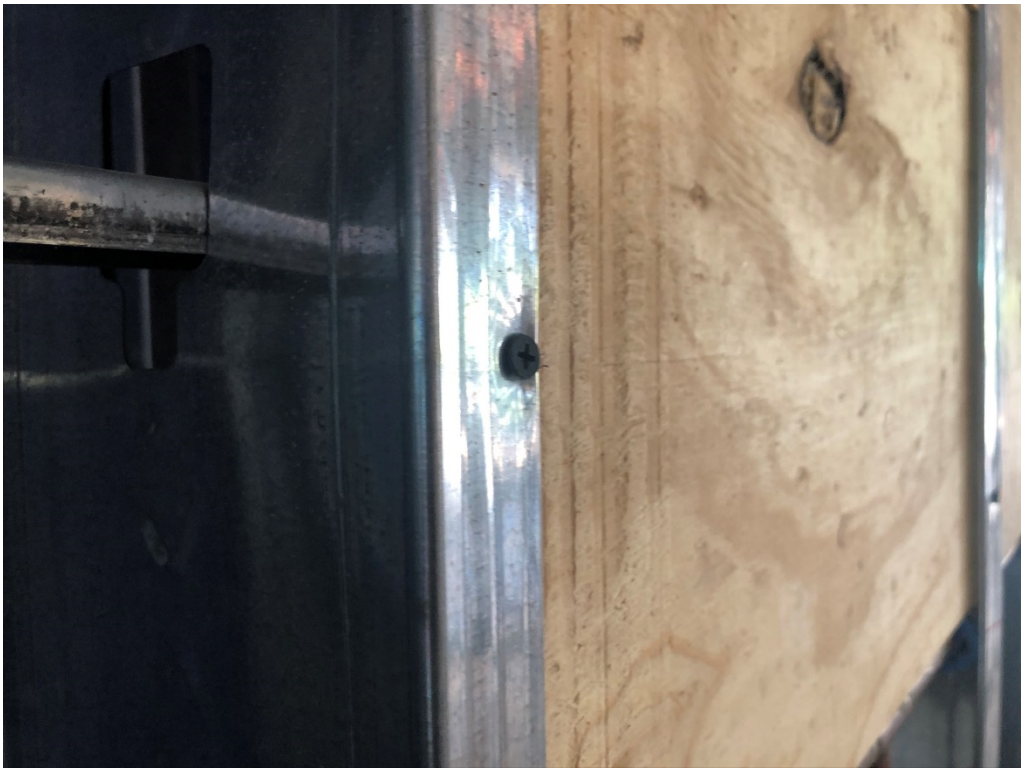
Figure 10 – Black Phosphate Screws used at Plywood Blocking
