Architect's Field Report

201 Park Court, Suite B Ridgeland, MS 39157 P 601.790.9432 F 888.281.0547	26 June 2020 18059-AOI Academy of Innovation / Report Number 040
One Jackson Place, Suite 250 188 East Capitol Street Jackson, MS 39201-2100 P 601.352.5411 F 601.352.5362	Contract Century Construction Date / Time 26 June 2020 / 11:30 AM Weather / Temp Clear / 85 ° F Est % Complete 60% Sched Conformance + 68 days Work in Progress Concrete Formwork Interior Framing Interior Drywall Mechanical Install
161 Lameuse Street, Suite 201 Biloxi, MS 39530 P 228.374.1409 F 228.374.1414	Present at Site Joey Moore, Century Construction Will Commarato, DBA Paul Purser, DBA Observations Arriving on site, I entered the structure at the North Entry. Foundation workers were installing rebar and remesh at the drop off location. I noted Aluminum storefront had begun and was in place at the lower levels in the North and East Structures. At the interior, drywall was being installed. Light gauge framing was ongoing as well.

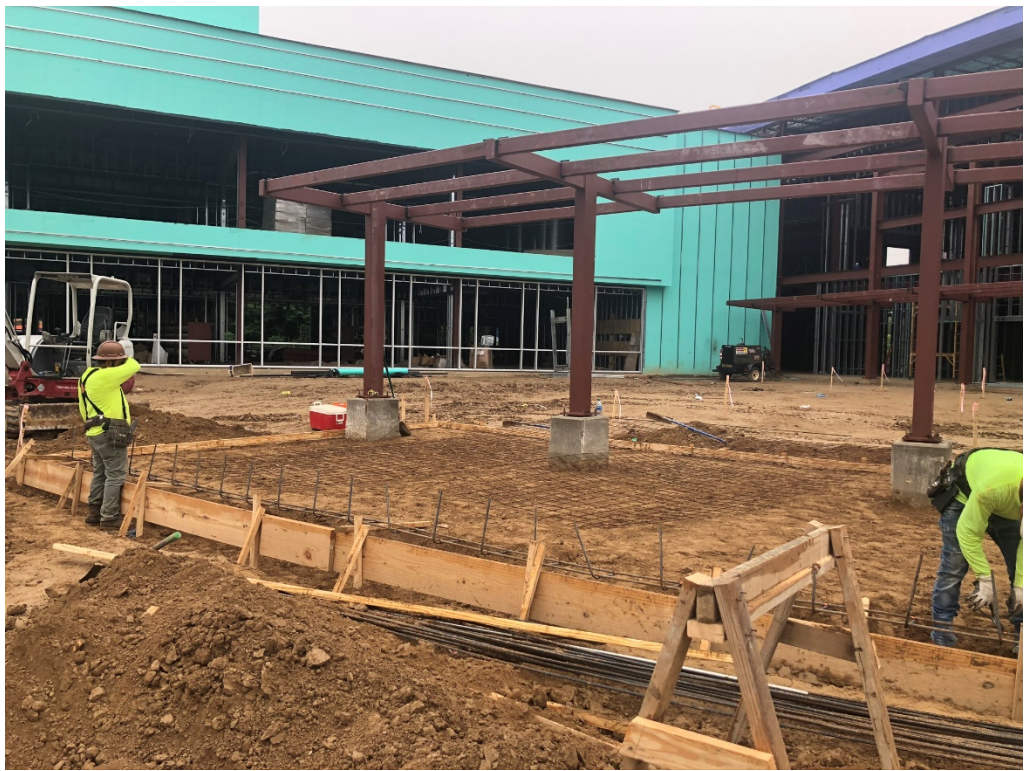
Figure 1 – Drop Off Concrete Reinforcing

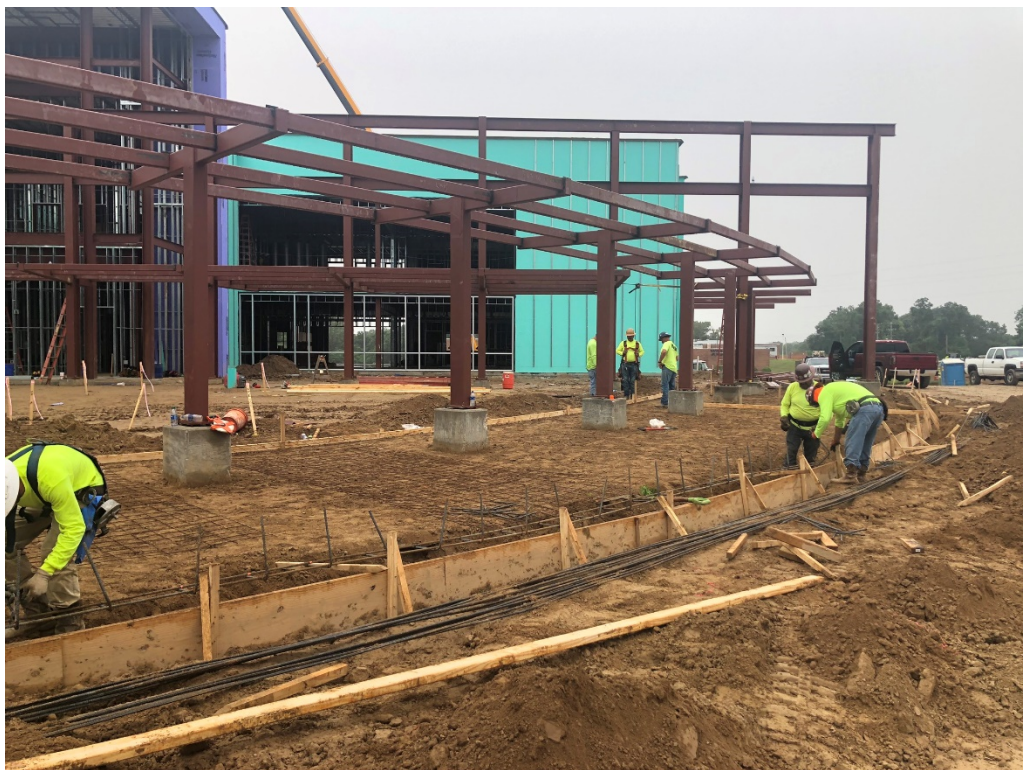
Figure 2 – Drop Off Concrete Reinforcing

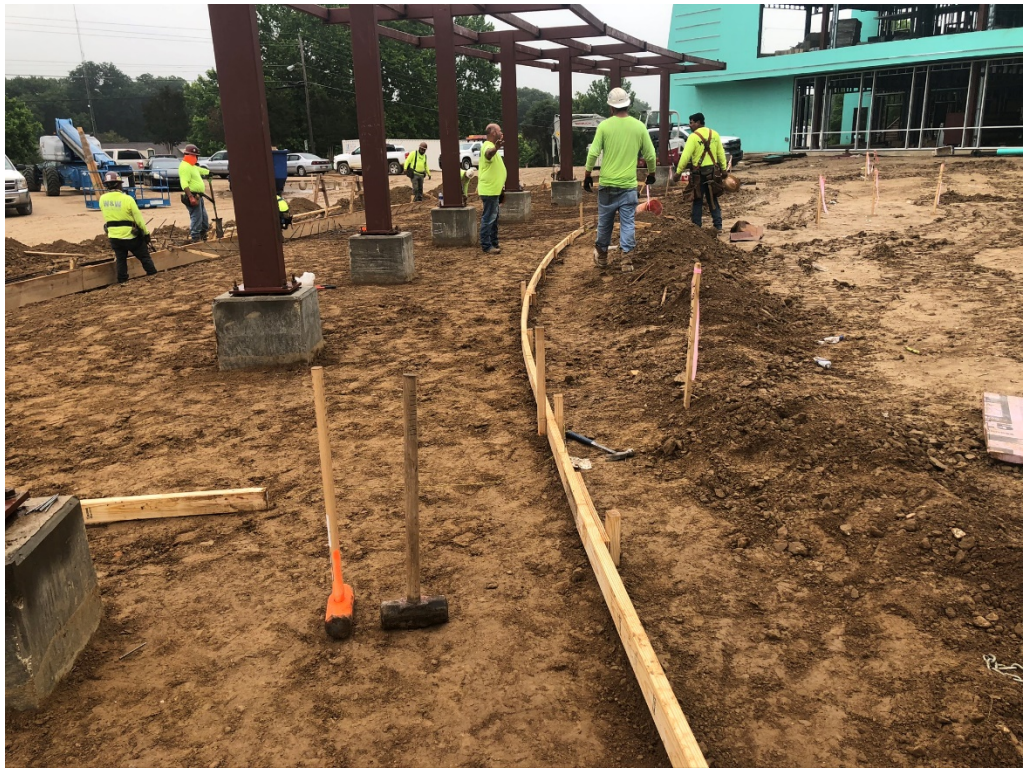
Figure 3 – Drop Off Concrete Form Curve

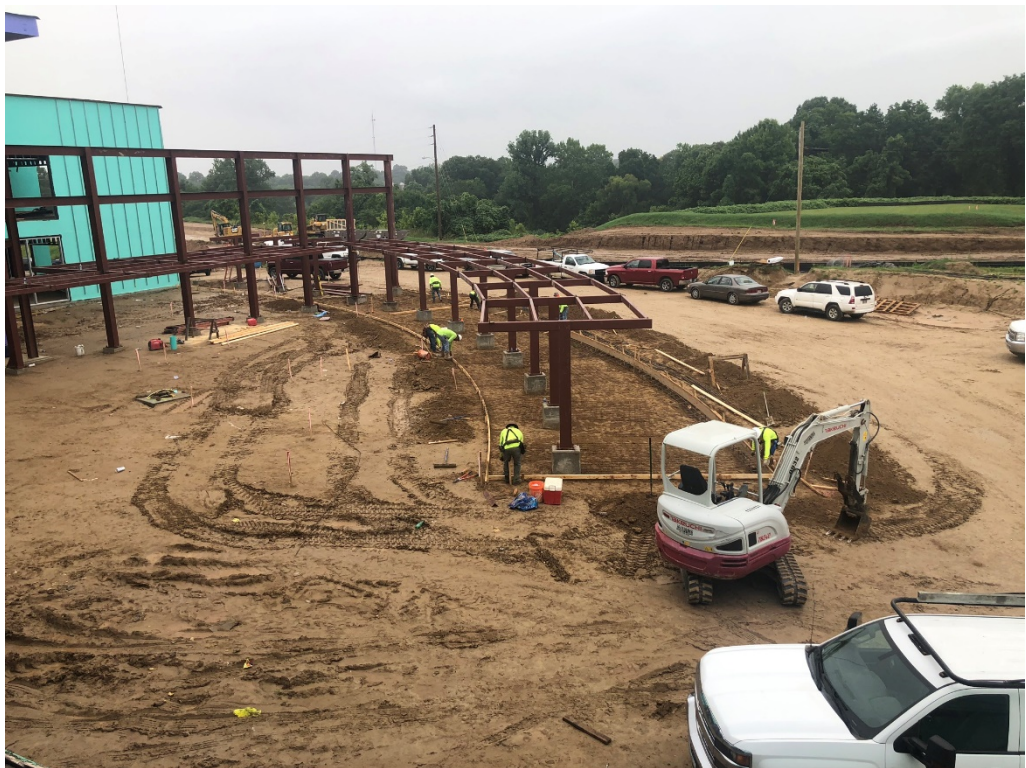
Figure 4 –Formwork from Above

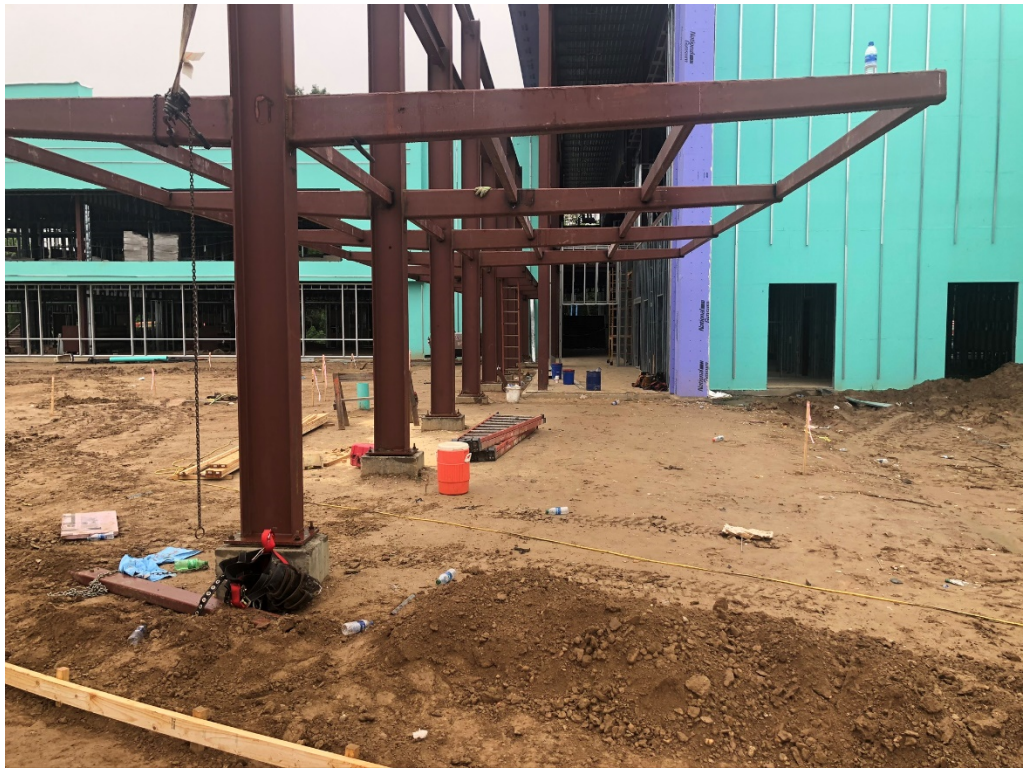
Figure 5 – Steel Framing @ Entry

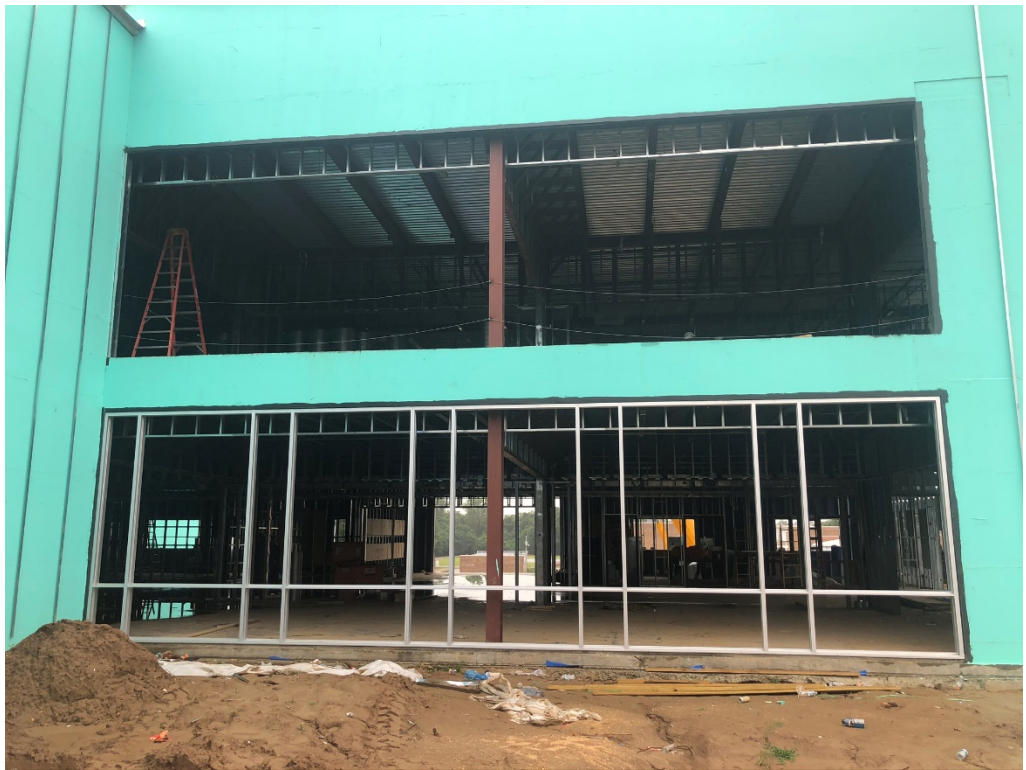
Figure 6 – Aluminum Storefront Installation is Ongoing

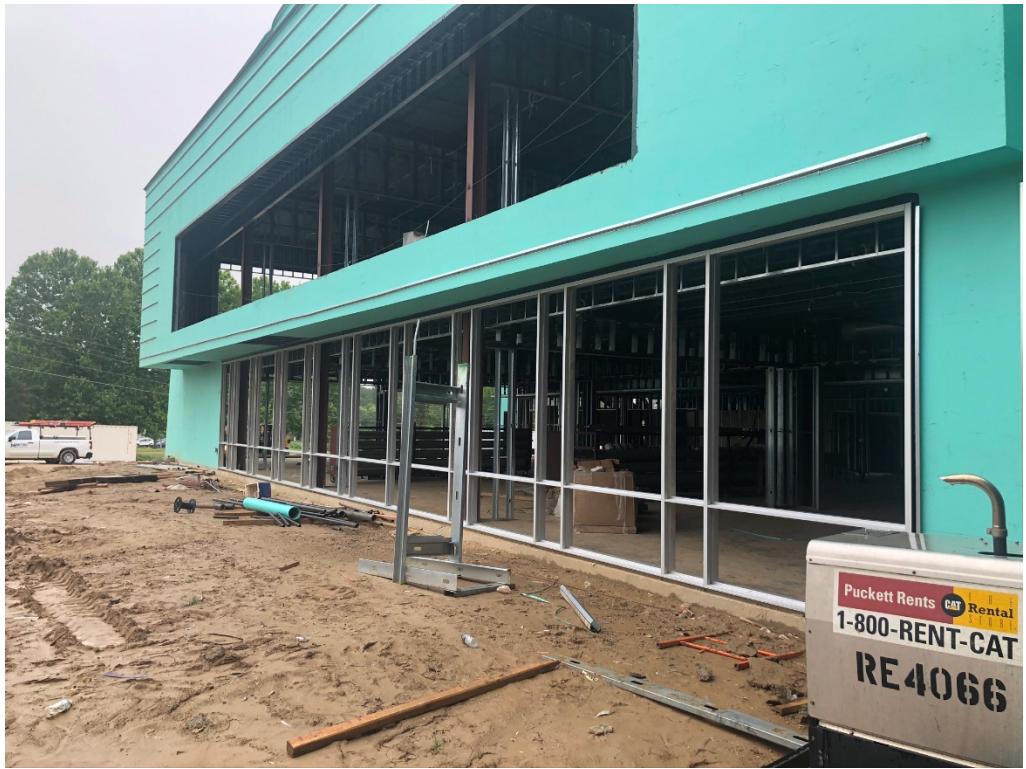
Figure 7 – Aluminum Storefront Installation is Ongoing

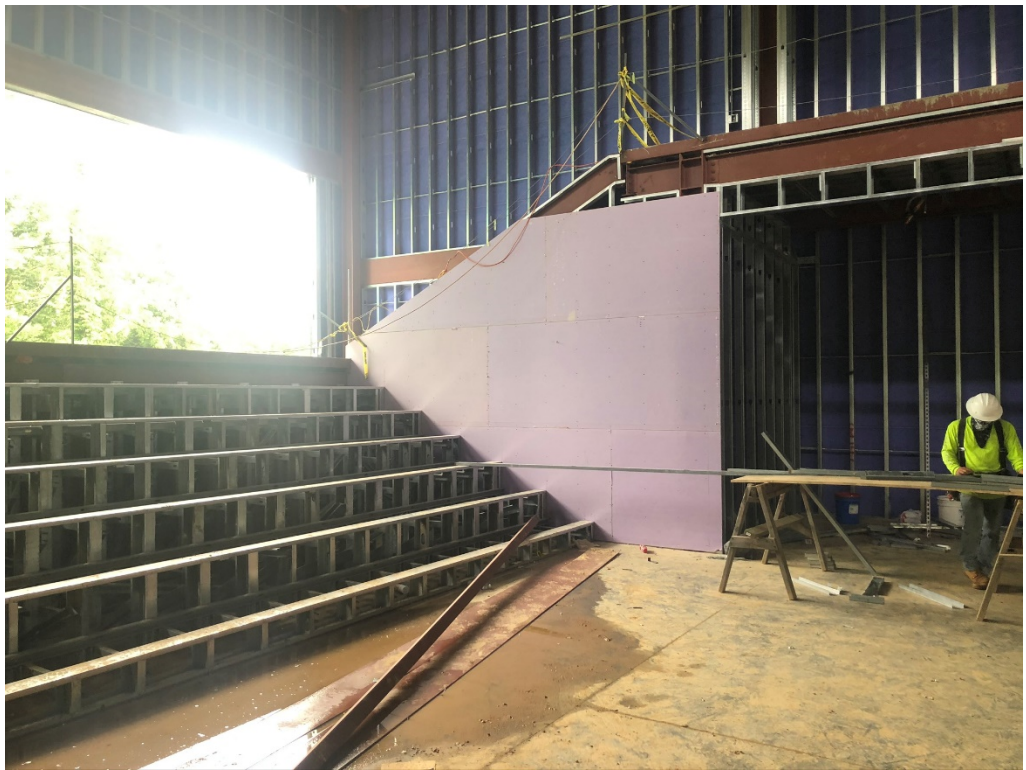
Figure 8 – Interior Drywall Work

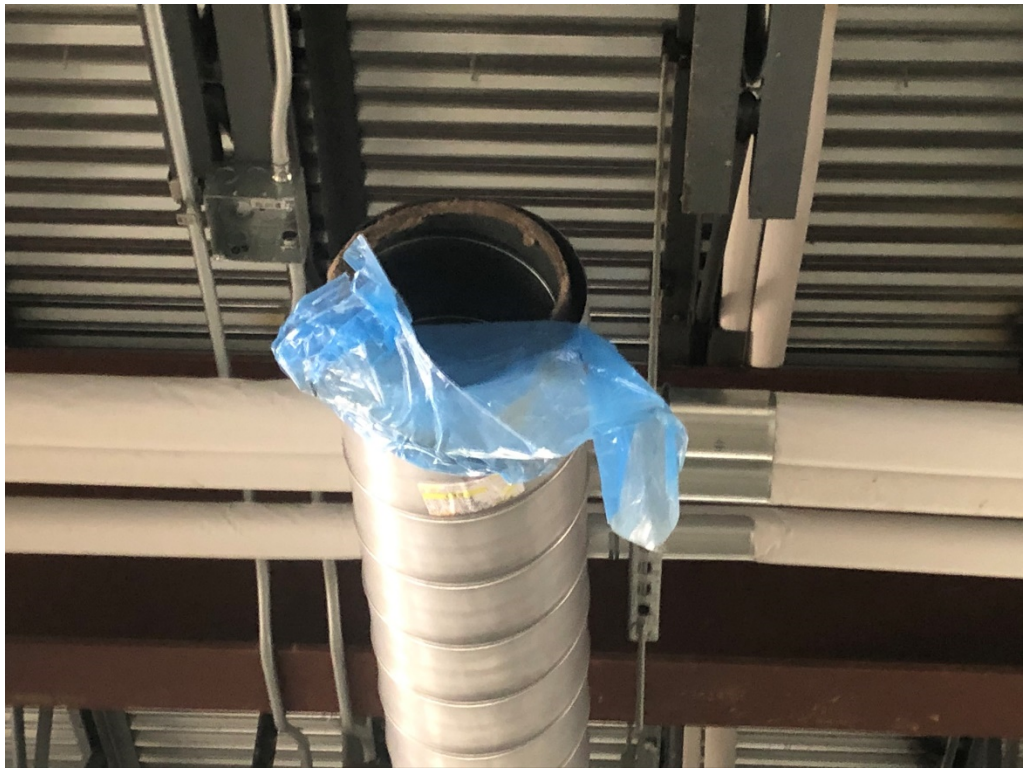
Figure 9 – Not Typical, but there was one uncovered Duct in East Building Lower Level

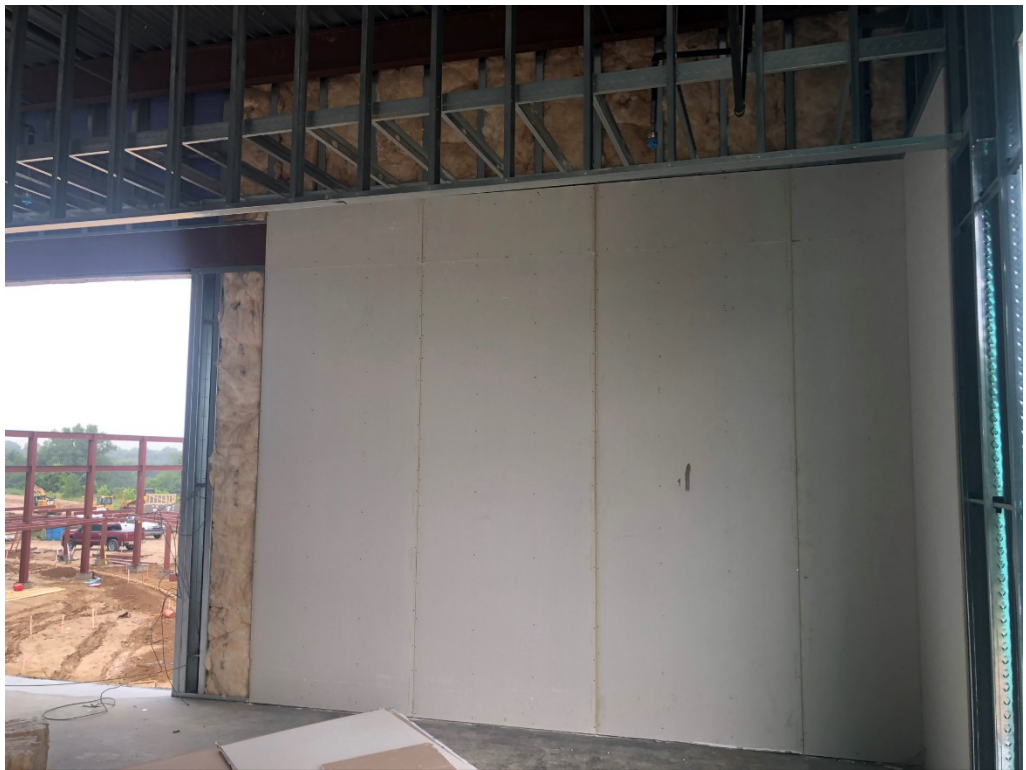
Figure 10 – Upper Level East Building Drywall and Insulation

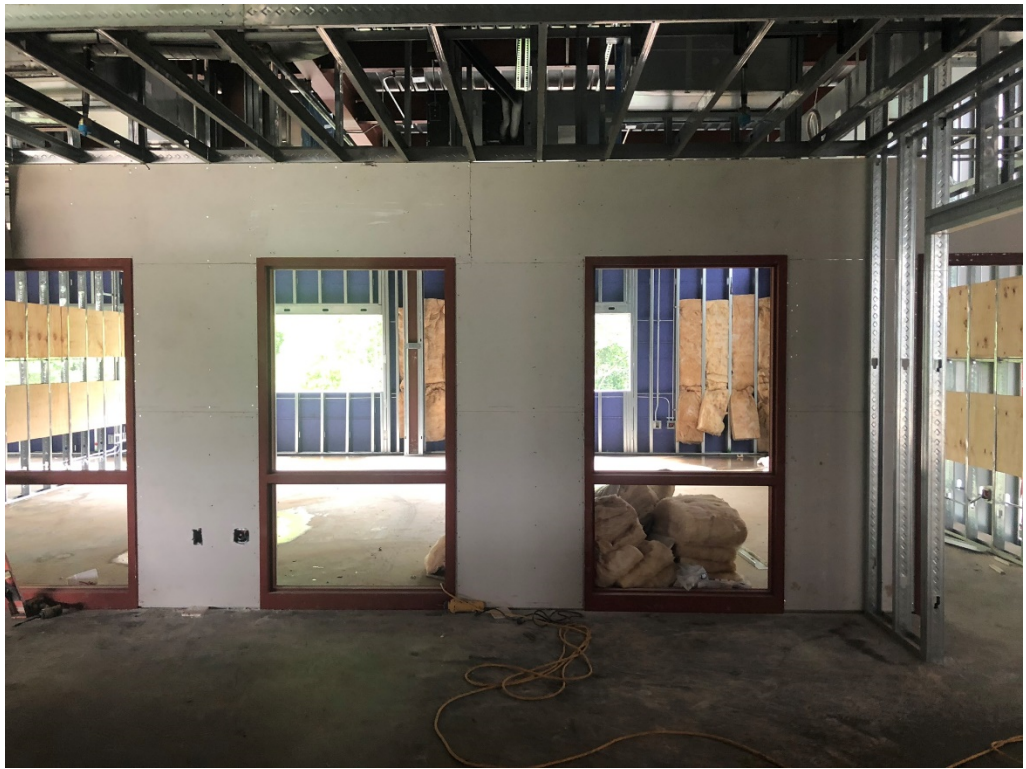
Figure 11 – Upper Level East Building Drywall and Insulation

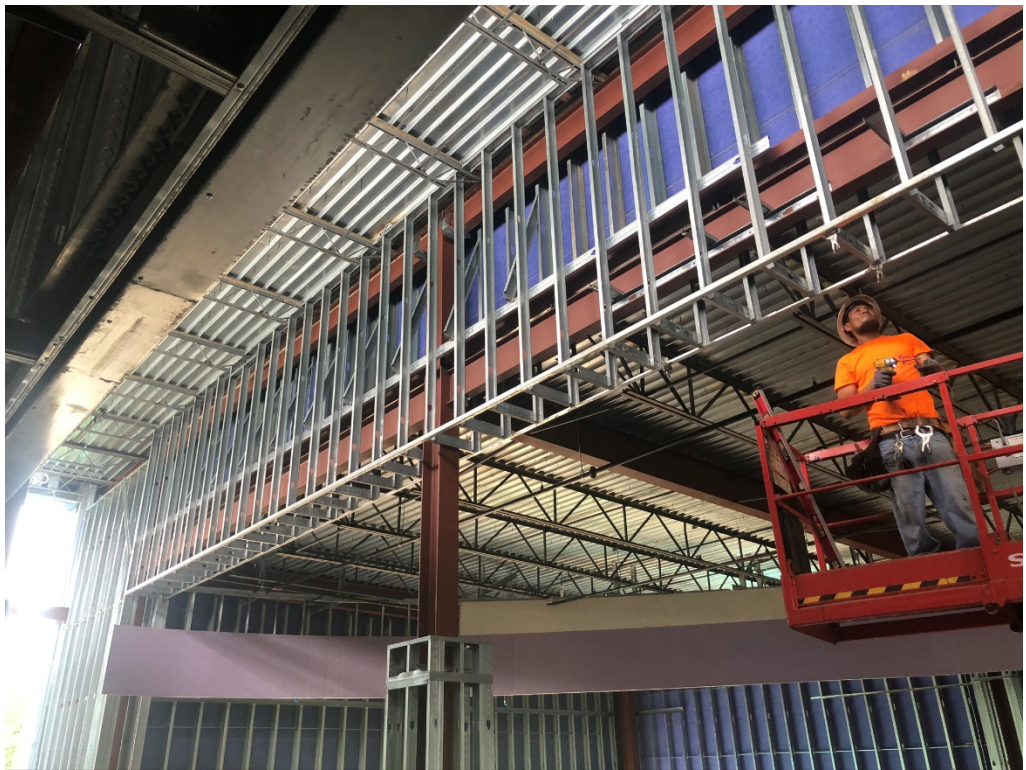
Figure 12 – Light Gauge Framing Furr Downs

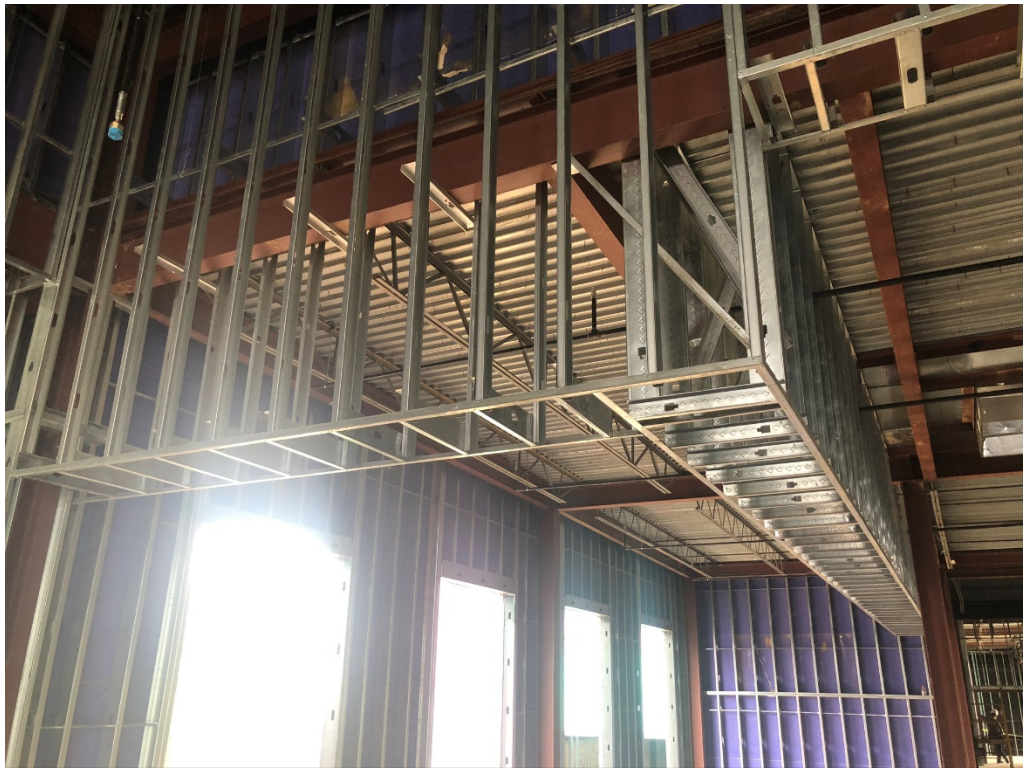
Figure 13 – Light Gauge Framing Furr Downs

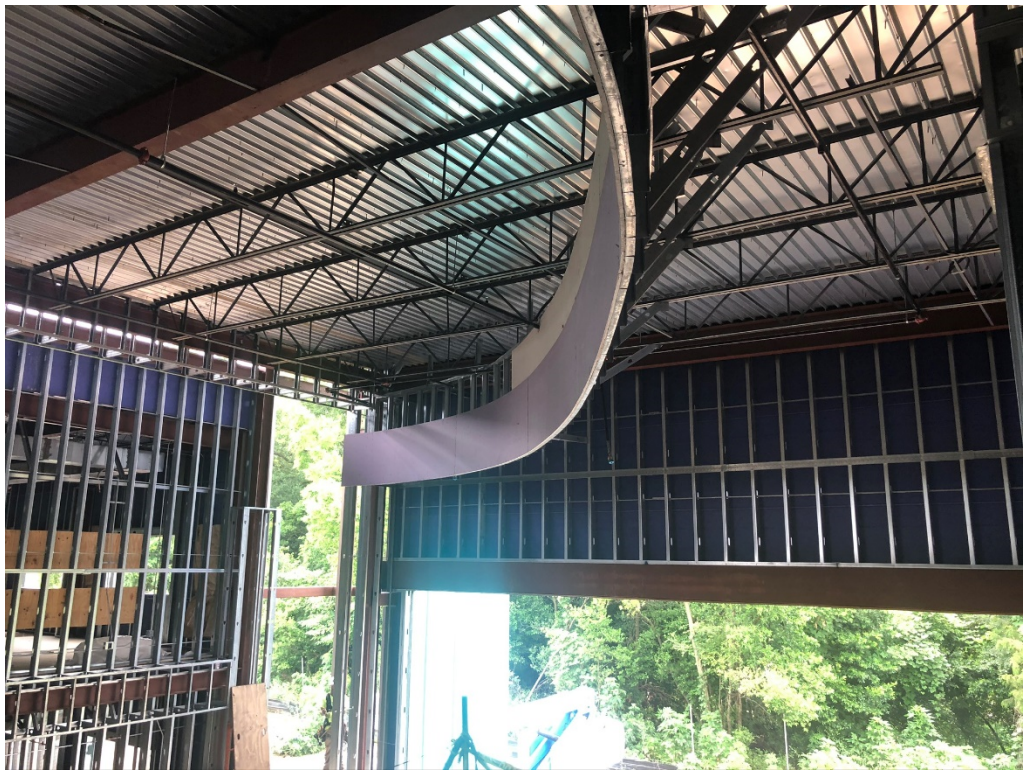
Figure 14 – Straight Portion of Curve Appears to be Corrected

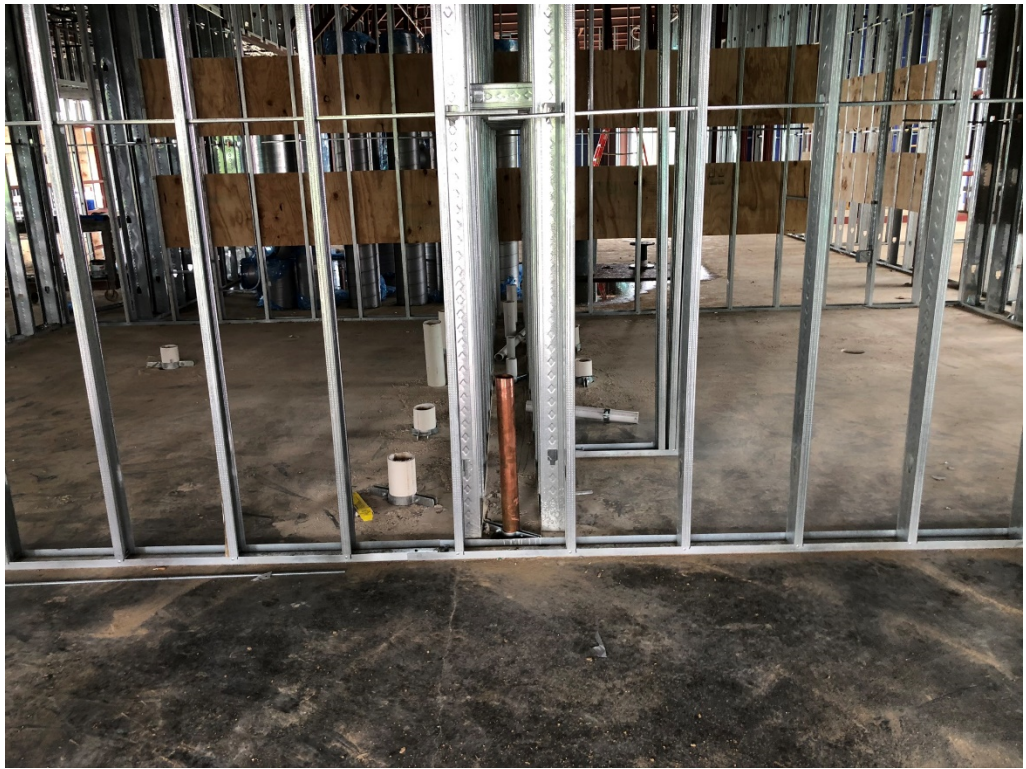
Figure 15 – Plumbing Rough in @ 228 & 229

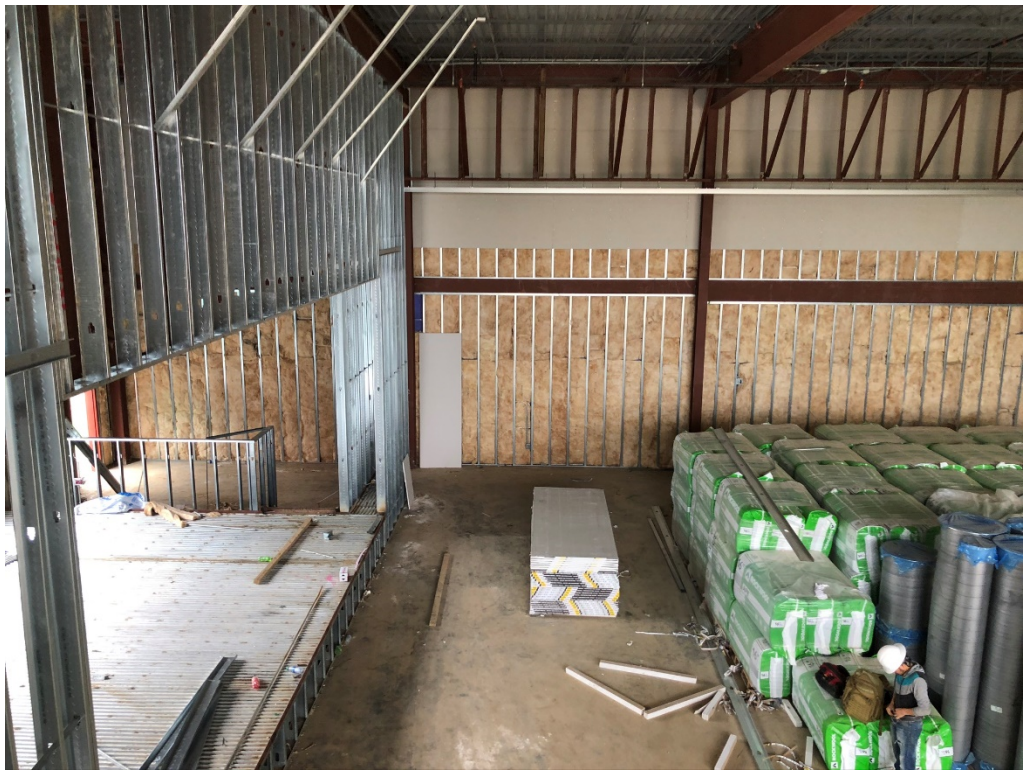
Figure 16 – Insulation & Framing @ Gym

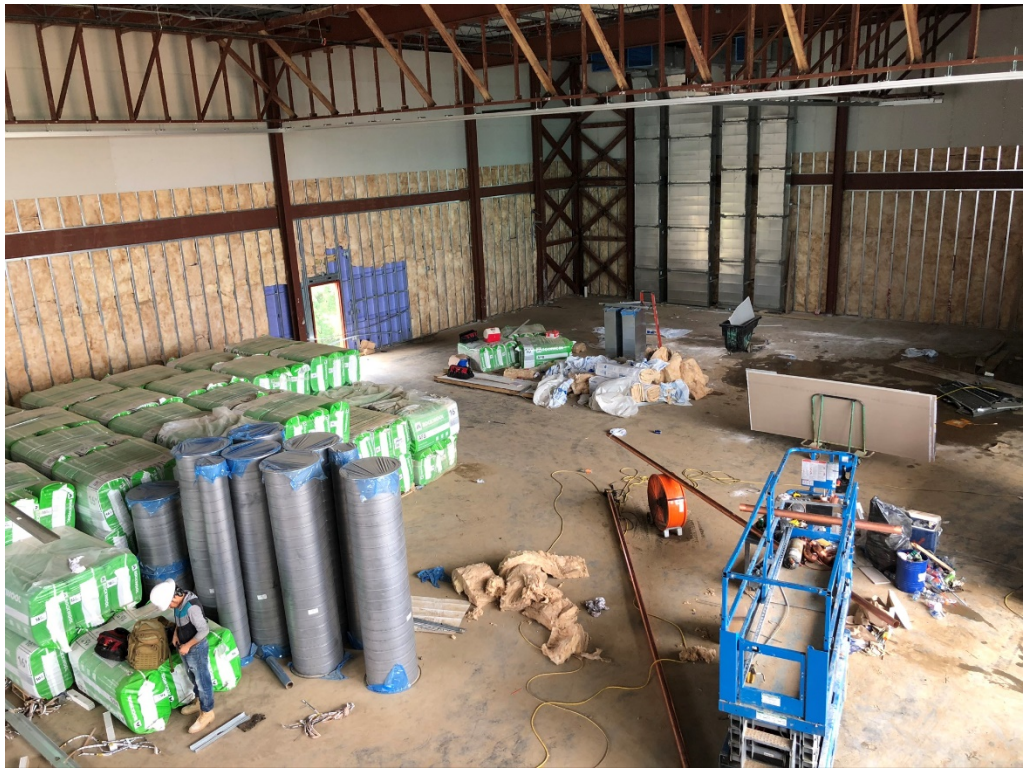
Figure 17 – Insulation & Framing @ Gym

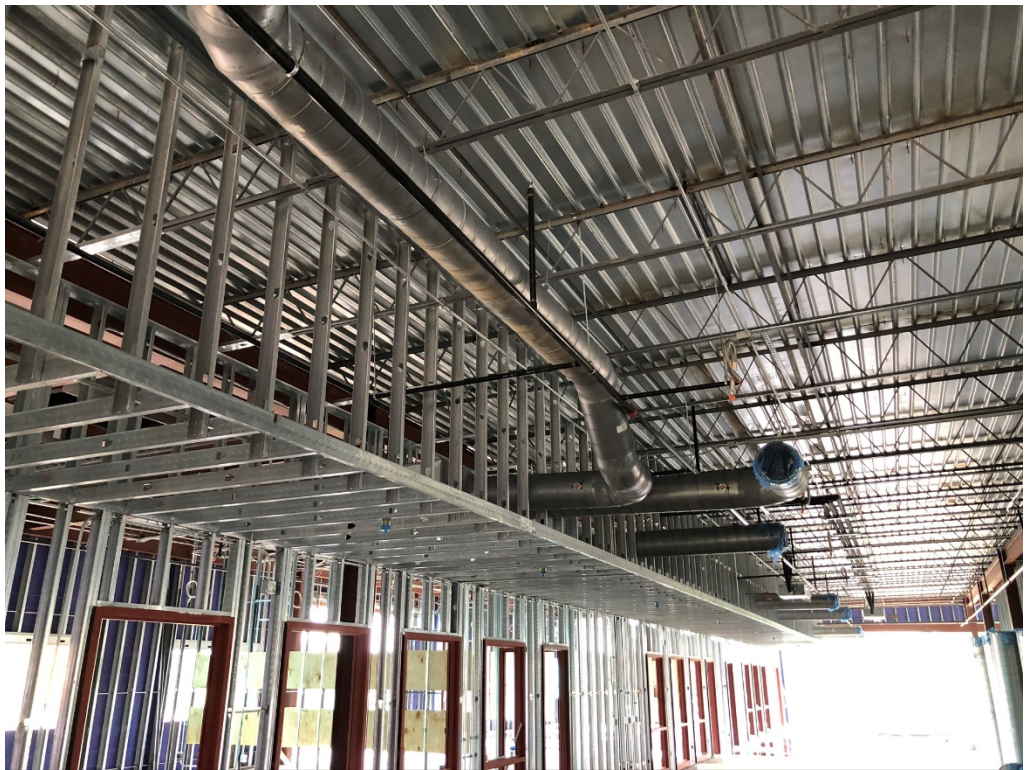
Figure 18 – Furr Down and Ducting Work @ Upper Level North Building

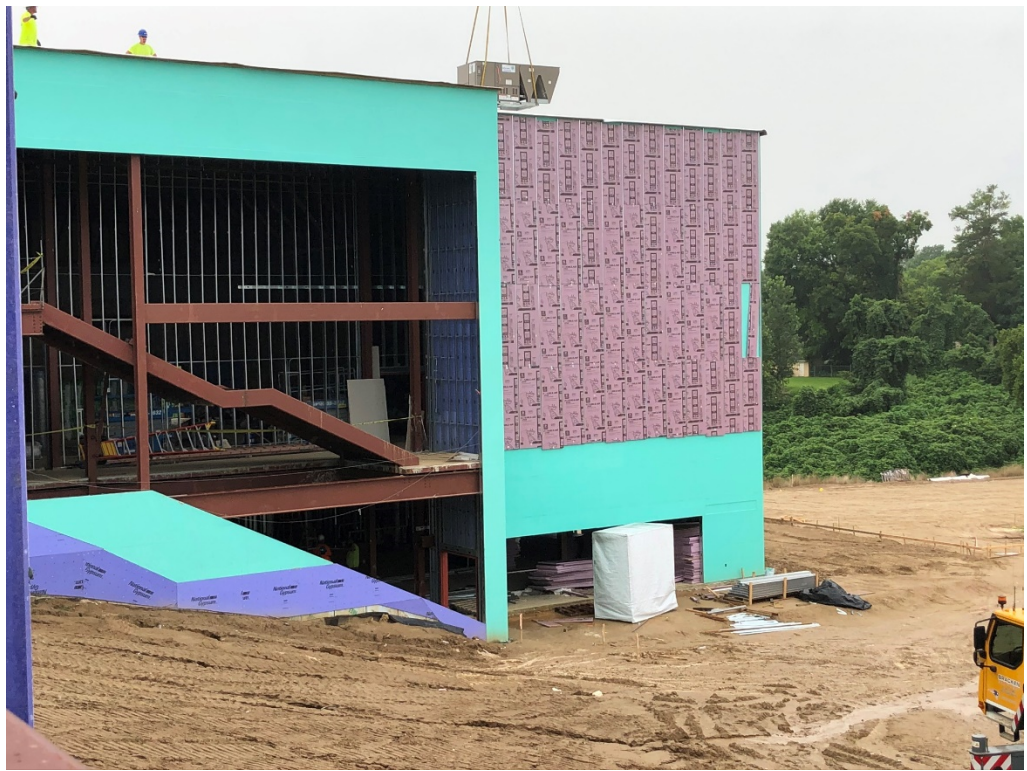
Figure 19 – Insulation Board Install @ Exterior Wall is Ongoing

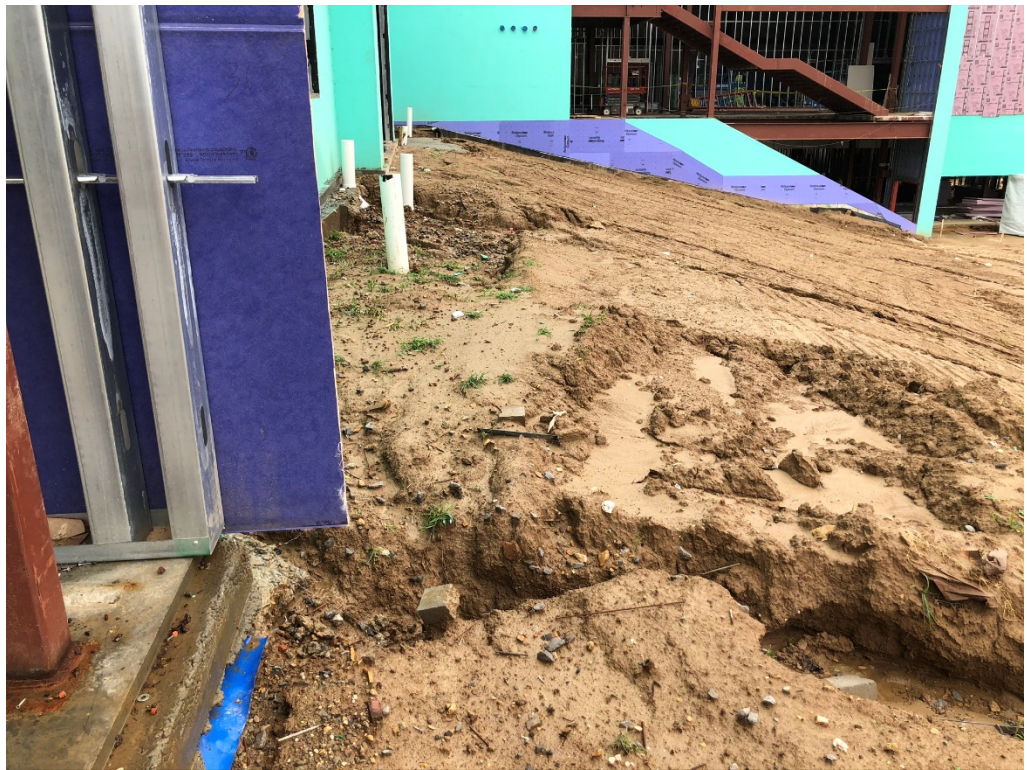
Figure 20 – Note Concrete @ Eroded area in Rear of Image
