Architect's Field Report

30 June 2020

18059-AOI Academy of Innovation / Report Number 041

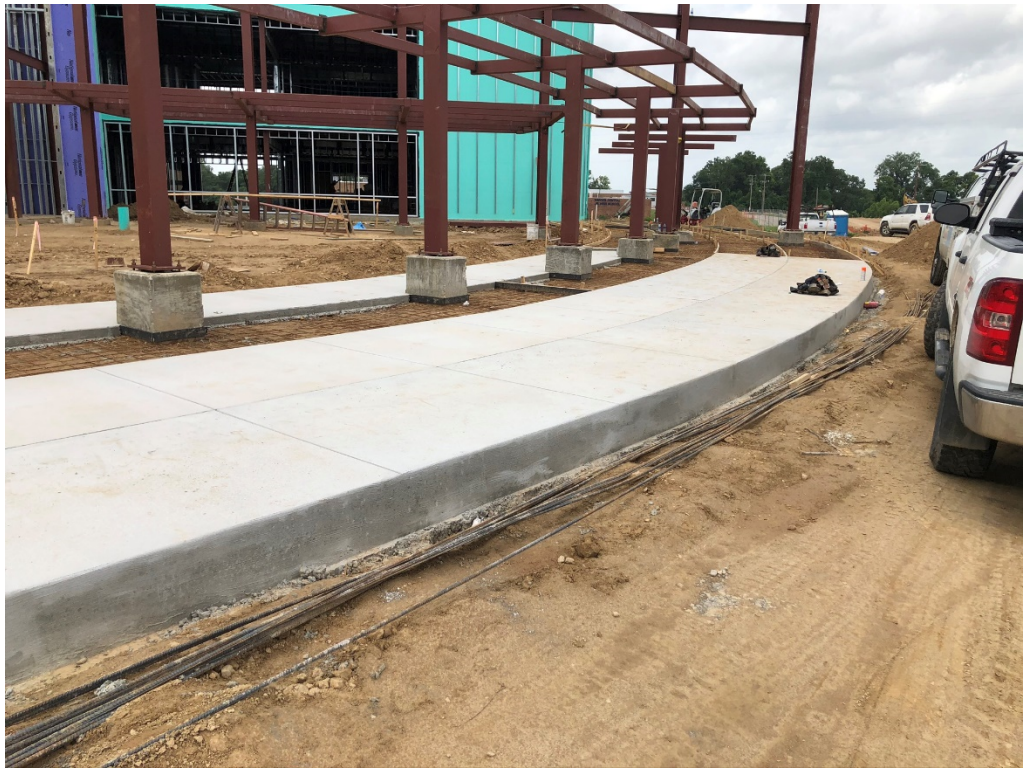
Figure 1 – Drop Off Concrete

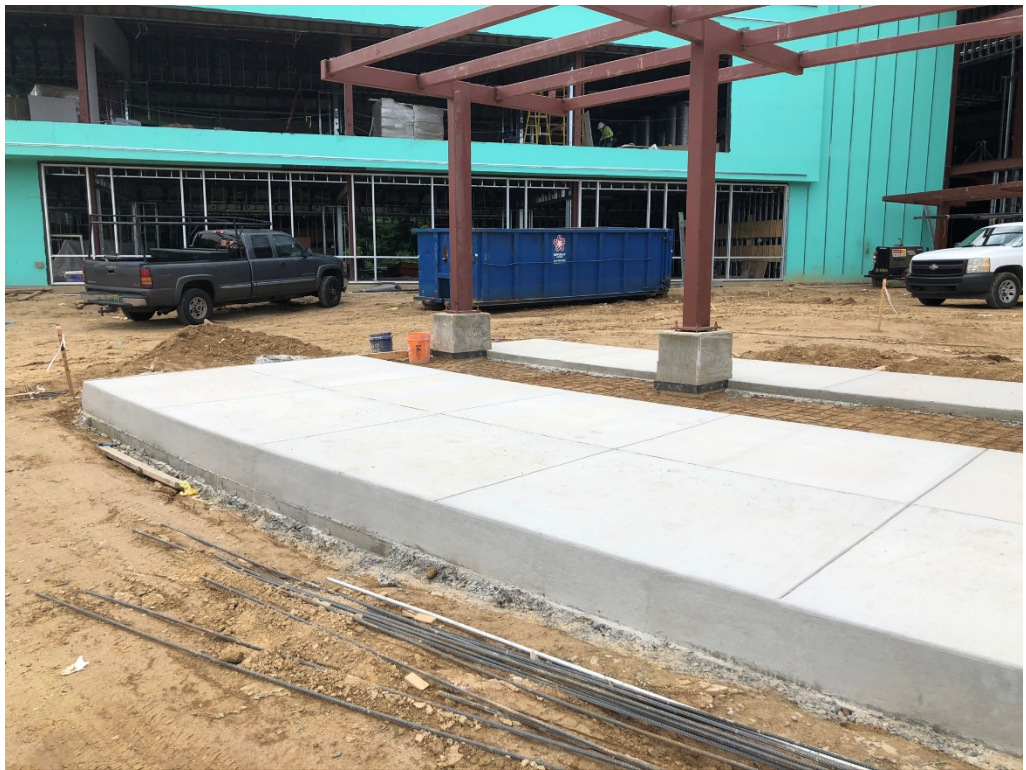
Figure 2 – Drop Off Concrete

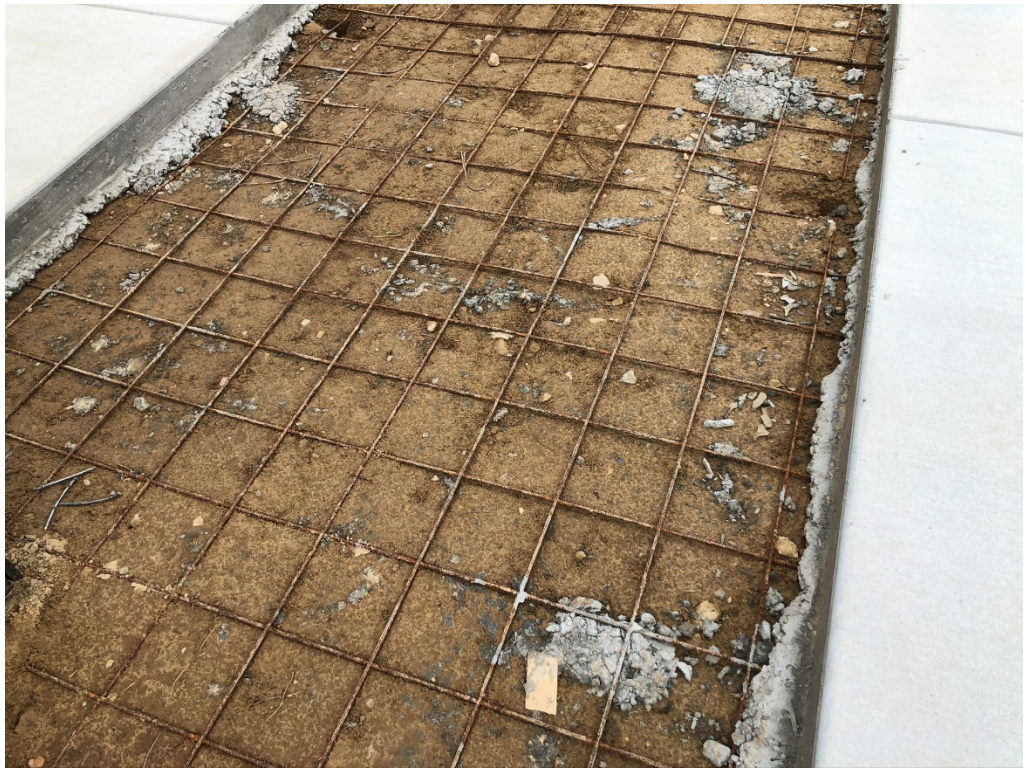
I noted at the entry that remesh at the newly poured concrete is installed too low in the slab and needs correction before pouring the rest of the concrete.

Figure 3 – Remesh at Sidewalk is Incorrectly Placed at the bottom of the Concrete

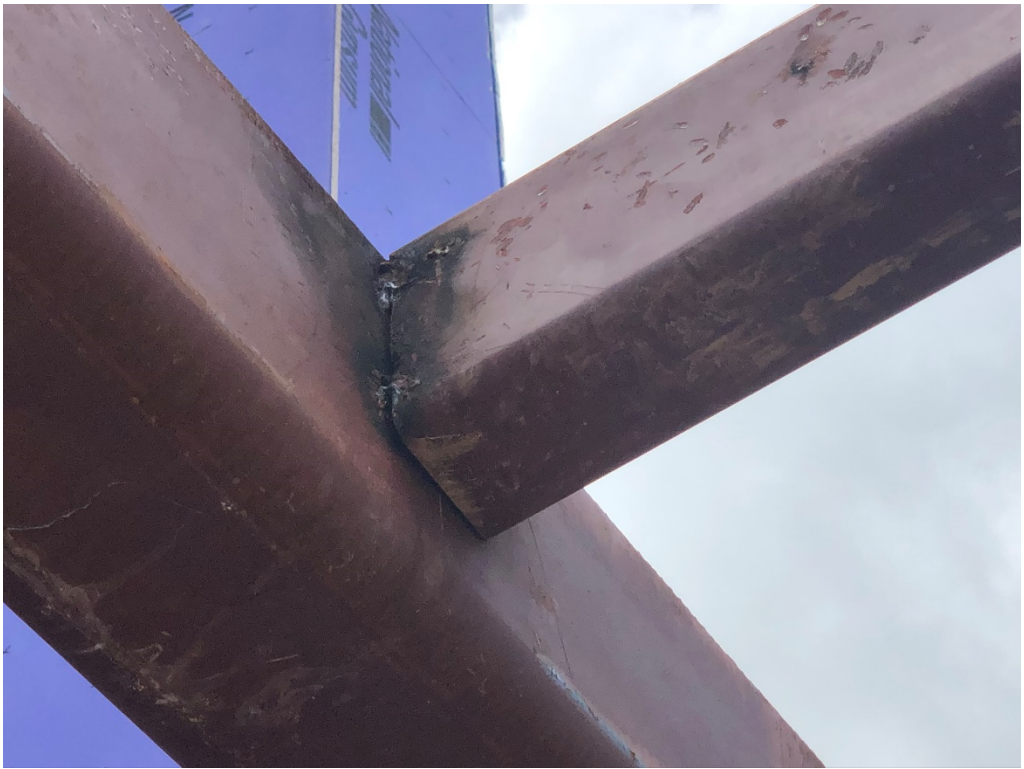
Figure 5 – Welds at Steel Canopy Should Be Continuous and Smooth Per S3.7

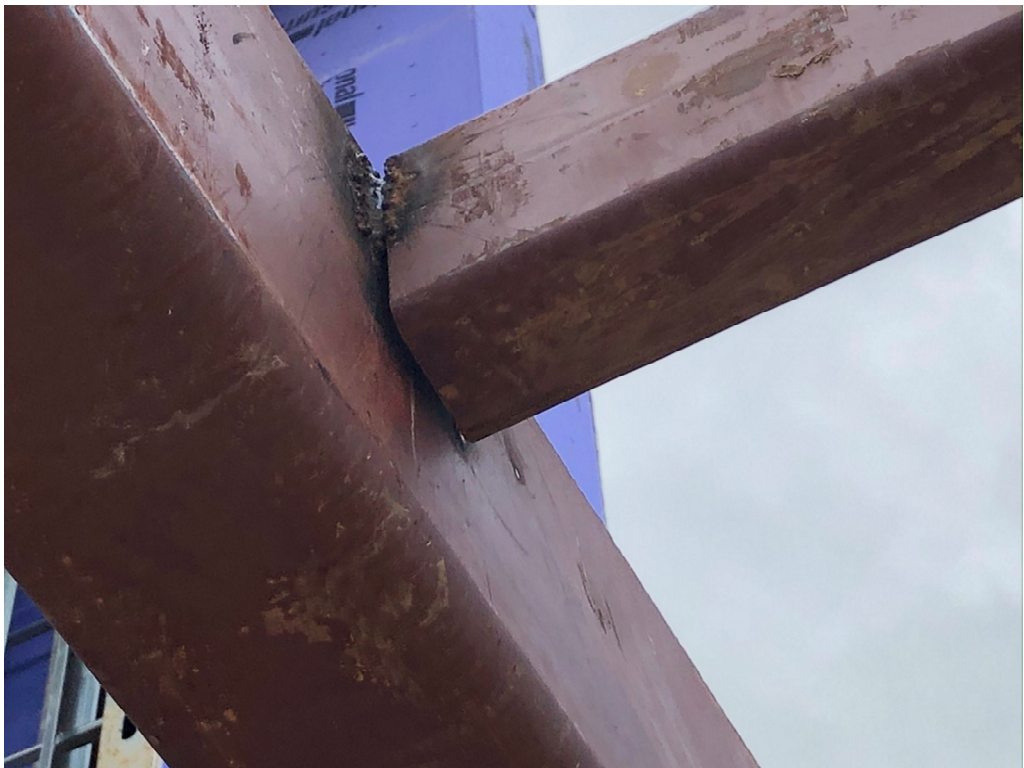
Figure 6 – Welds at Steel Canopy Should Be Continuous and Smooth Per S3.7

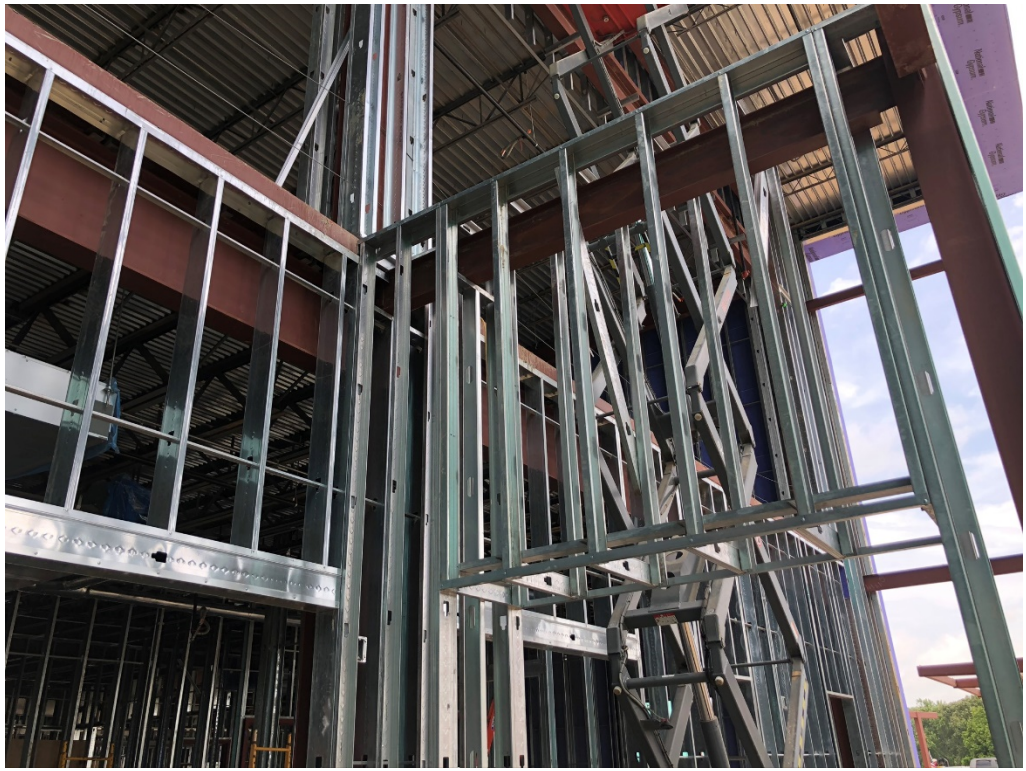
Figure 7 – Steel Light Gauge Framing is Ongoing

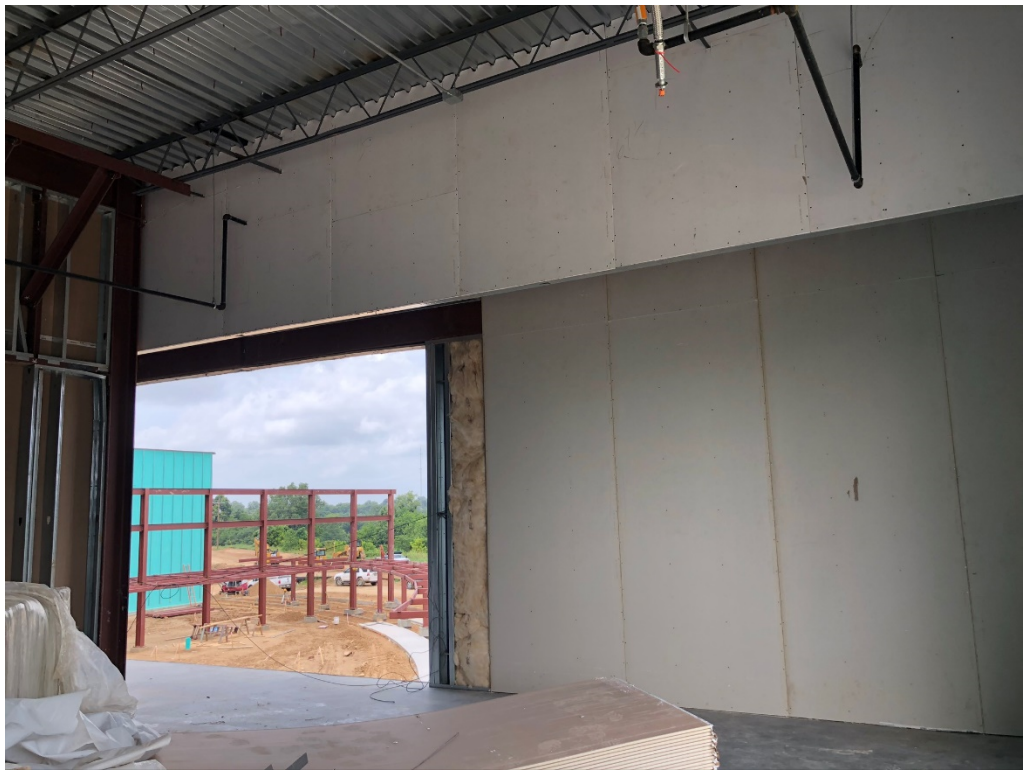
Figure 8 – Drywall Install is Ongoing

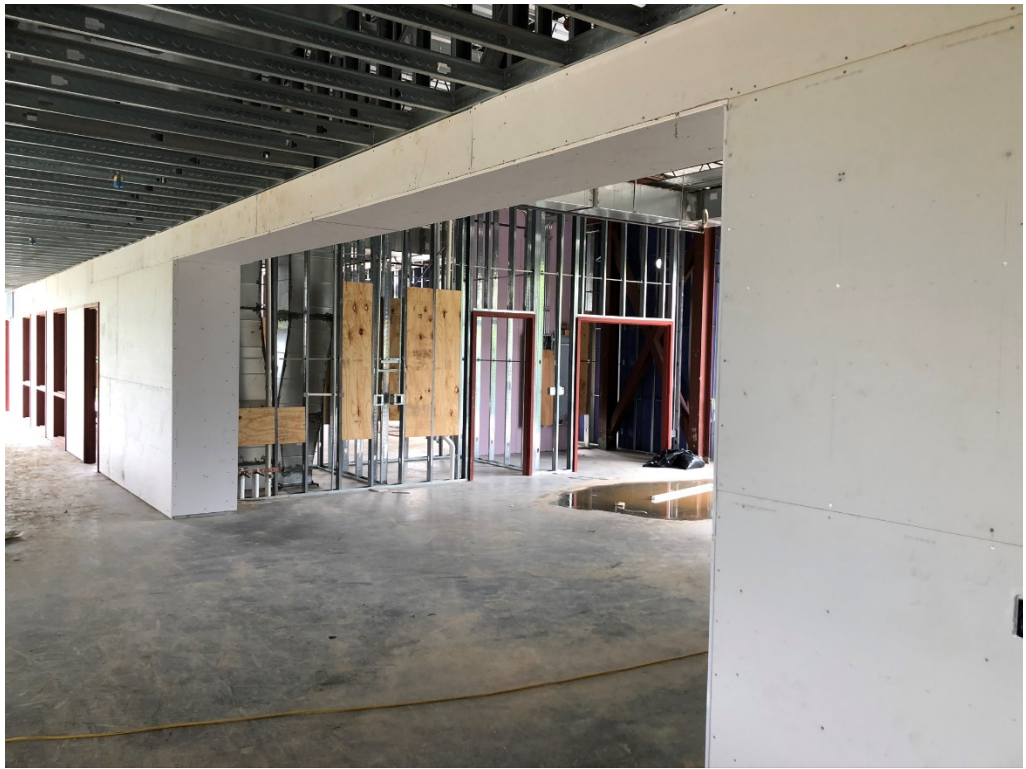
Figure 9 – Drywall Install is Ongoing

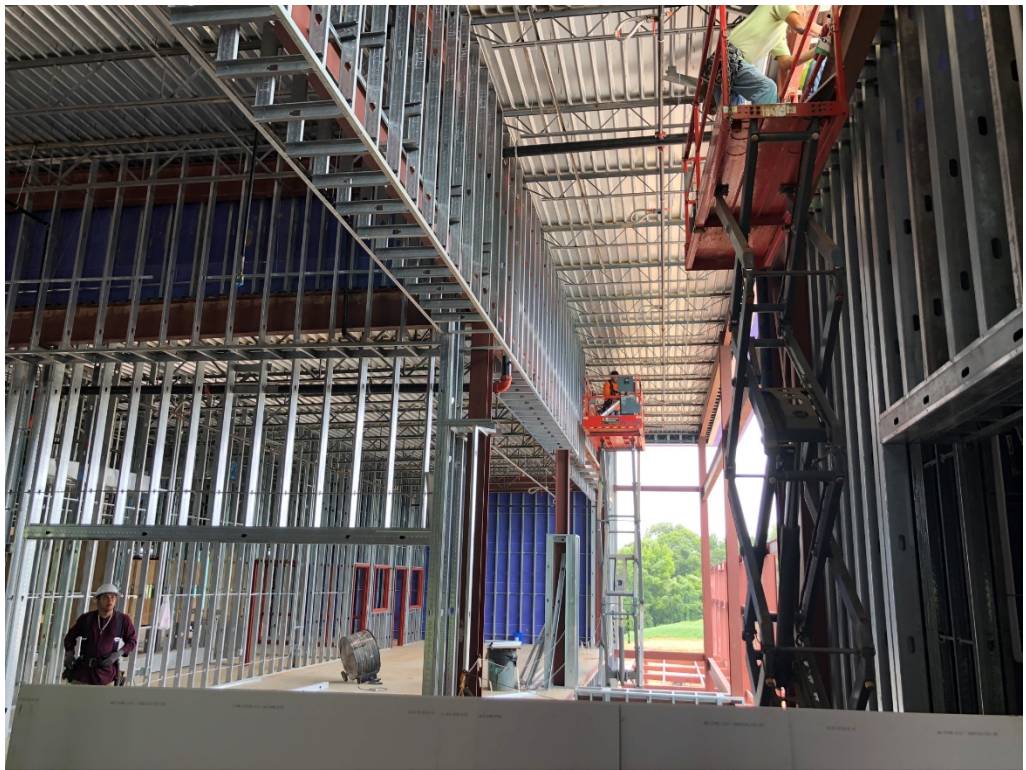
Figure 10 – Light Gauge Framing is Ongoing

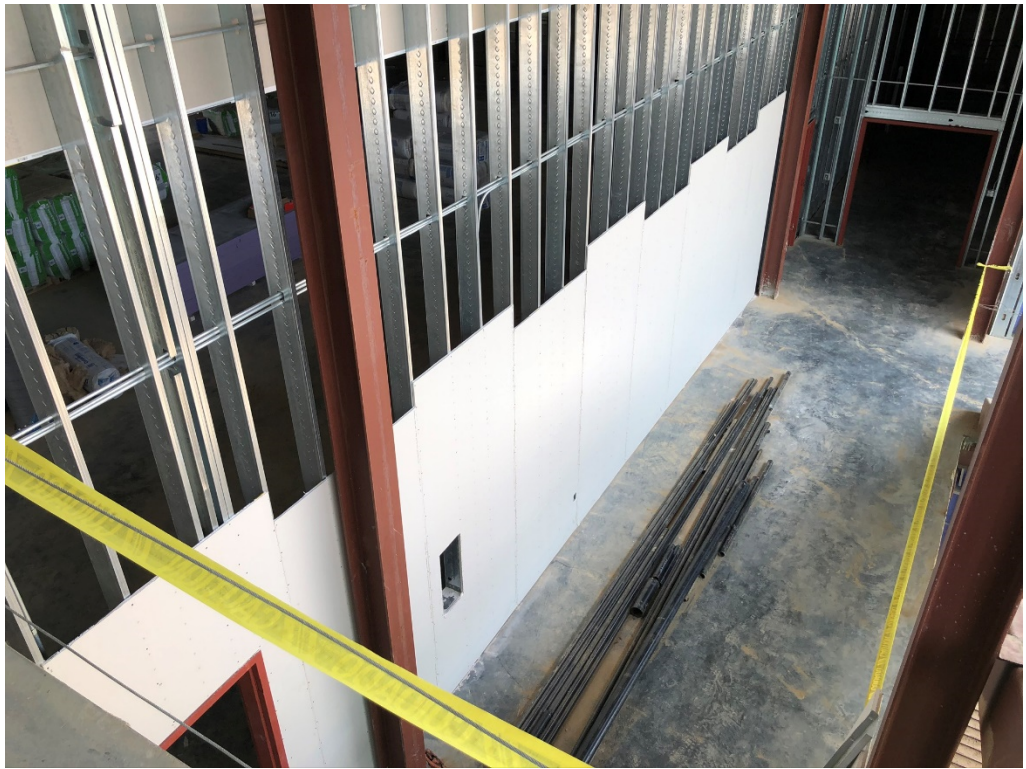
Figure 11 – Drywall Install at Gym

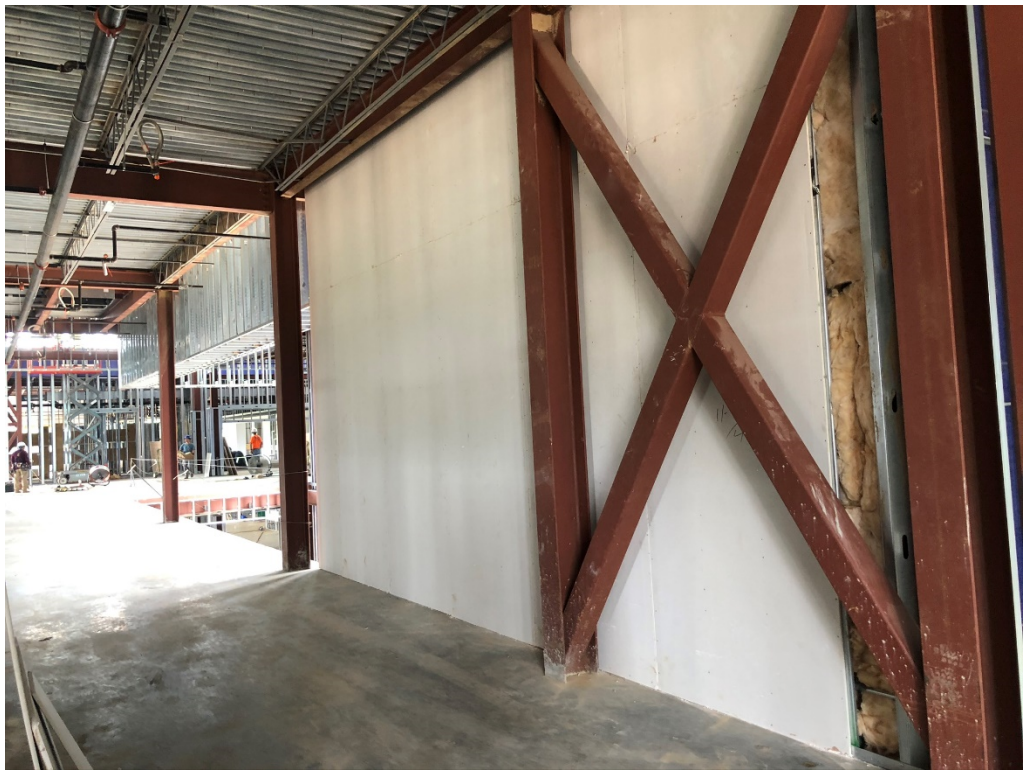
Figure 12 – Drywall Ongoing

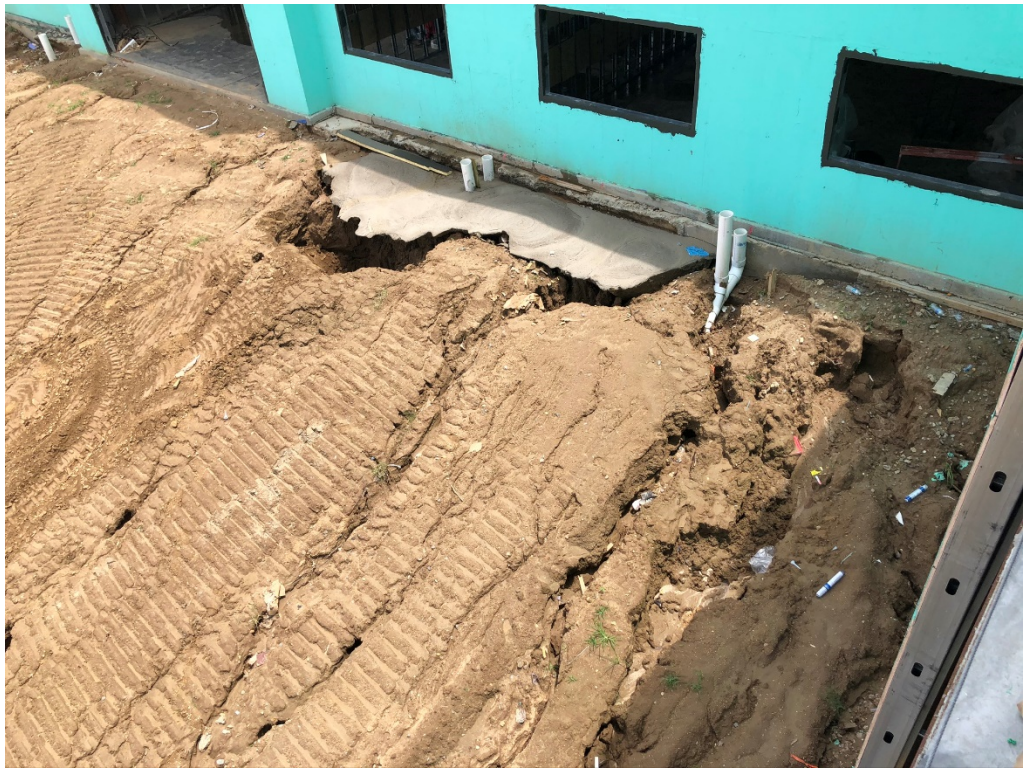
Erosion is also persisting at the West Elevation of the North section of Building.

Figure 13 – Erosion at North Structure Continues to be an Issue

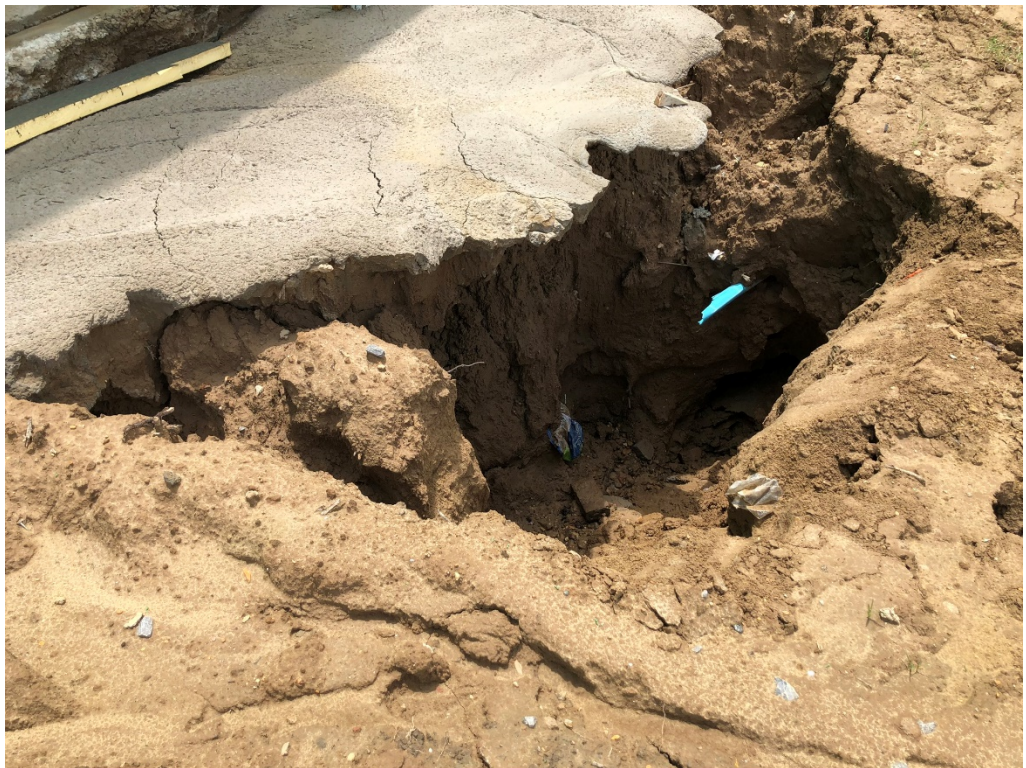
Figure 14 – Erosion at North Structure Continues to be an Issue

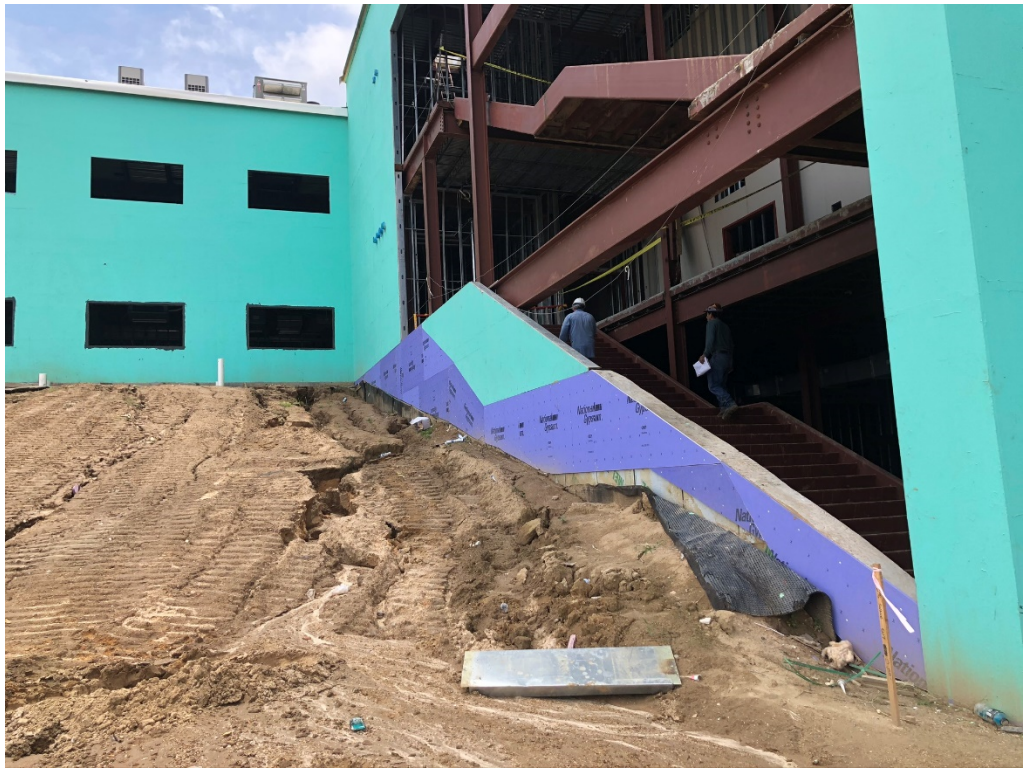
Figure 15 – Waterproofing is Ongoing

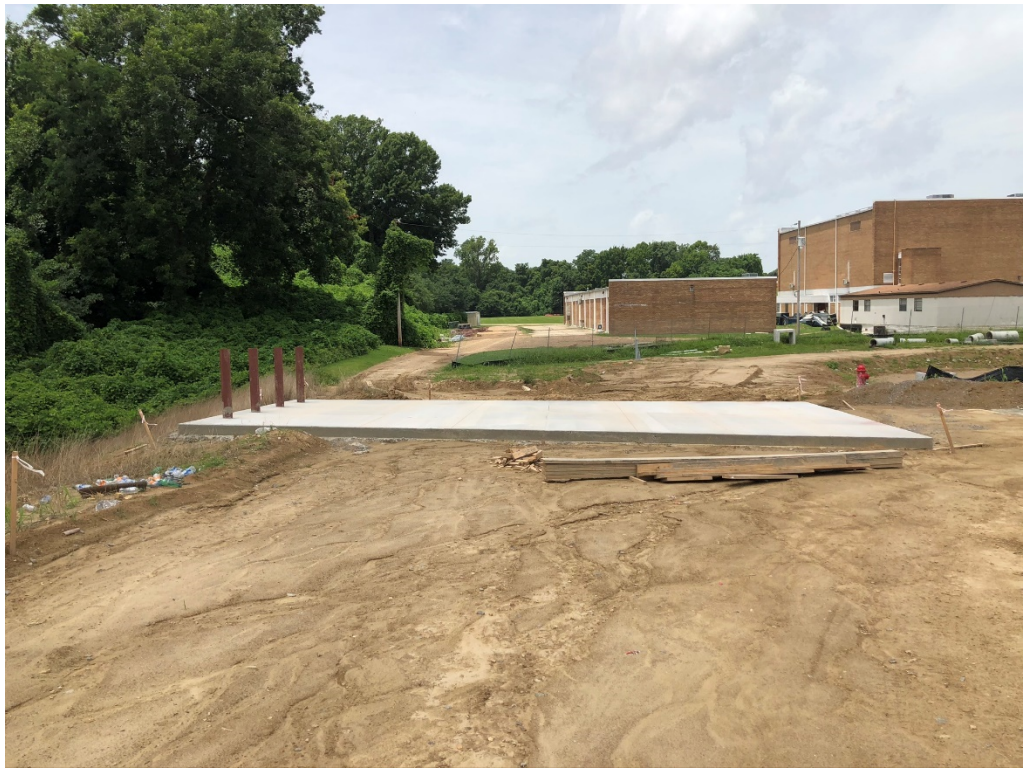
Figure 17 – Dumpster Pad Installed

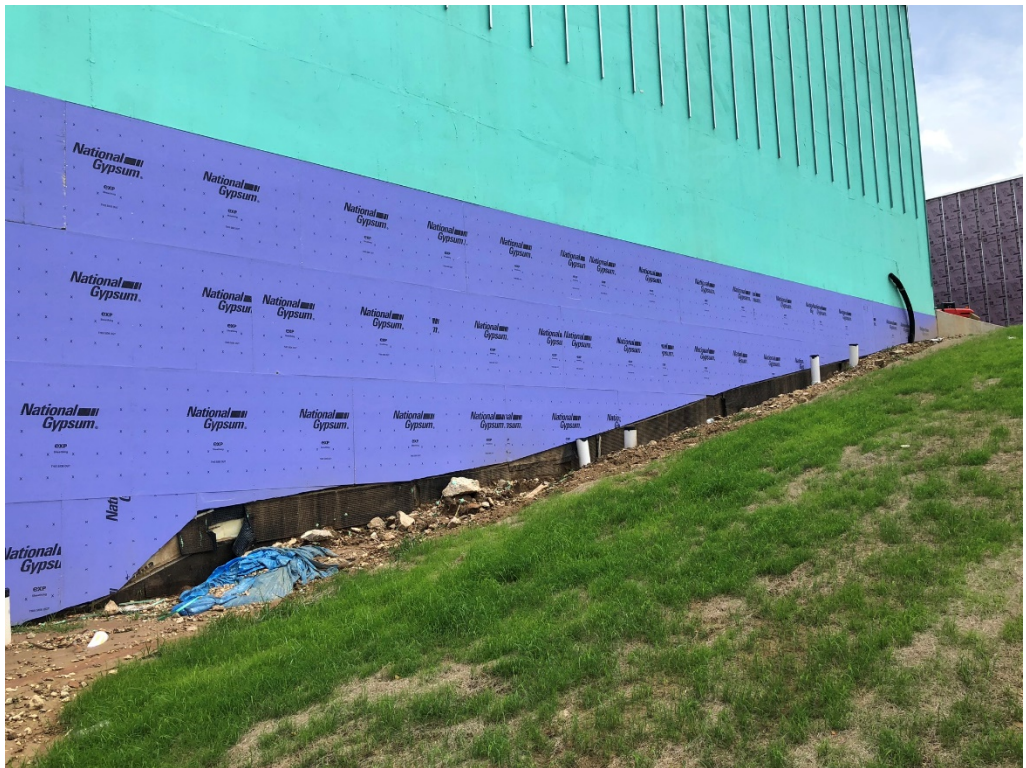
Figure 18 – Waterproofing is Ongoing
