## Architect's Field Report

201 Park Court, Suite B Ridgeland, MS 39157 P 601.790.9432 F 888.281.0547	24 July 2020  18059-AOI Academy of Innovation / Report Number 043
One Jackson Place, Suite 250 188 East Capitol Street Jackson, MS 39201-2100 P 601.352.5411 F 601.352.5362	Contract Century Construction Date / Time 23 July 2020 / 5:00 PM Weather / Temp Clear / 88 ° F Est % Complete 60% Sched Conformance + 68 days Work in Progress Dirt Prep for Asphalt Interior Concrete Work Metal Panel Installation Mechanical Install
161 Lameuse Street, Suite 201 Biloxi, MS 39530 P 228.374.1409 F 228.374.1414	Present at Site Paul Purser, DBA Observations Arriving on site, I noted glass installation has begun at installed storefront aluminum. Metal Siding Installation has also continued at the exterior.  Inside, light gauge framing continues at the gym and cafeteria. Some framing is deformed at the 2 <sup>nd</sup> floor top of stairs. This may have occurred with added weight of concrete to stair. These studs should be reset to correct this before drywall is installed.  Handrail Installation has begun and is ongoing throughout as well as drywall installation.  Asphalt installation is ongoing at the e

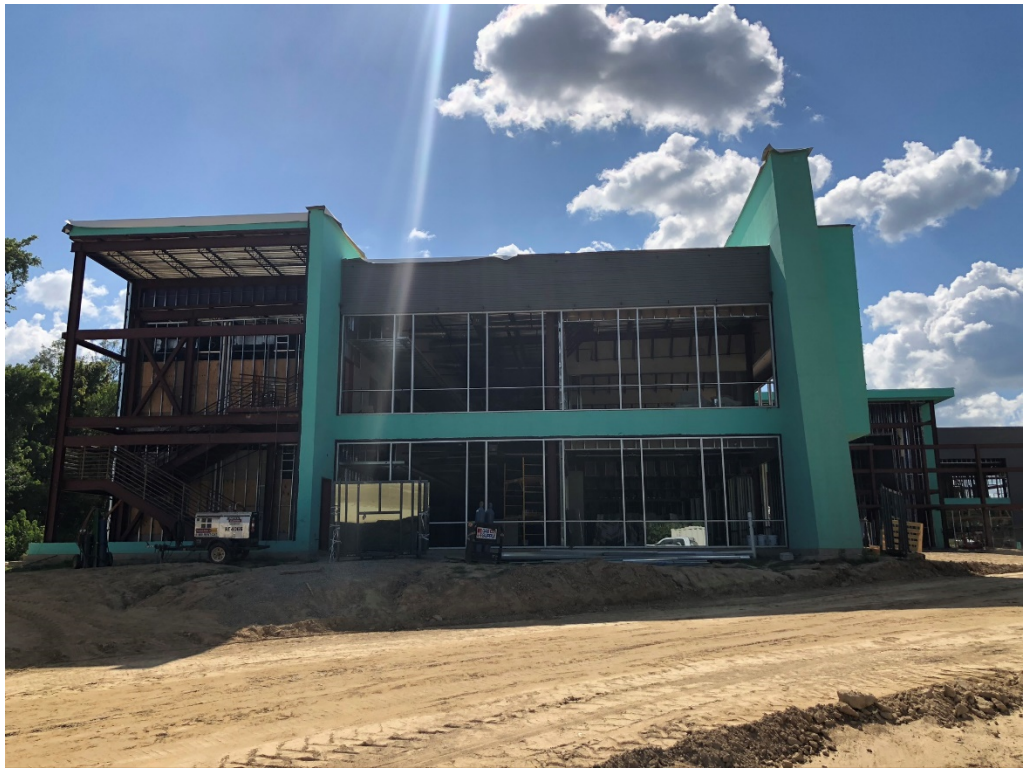
Figure 1 – East Structure

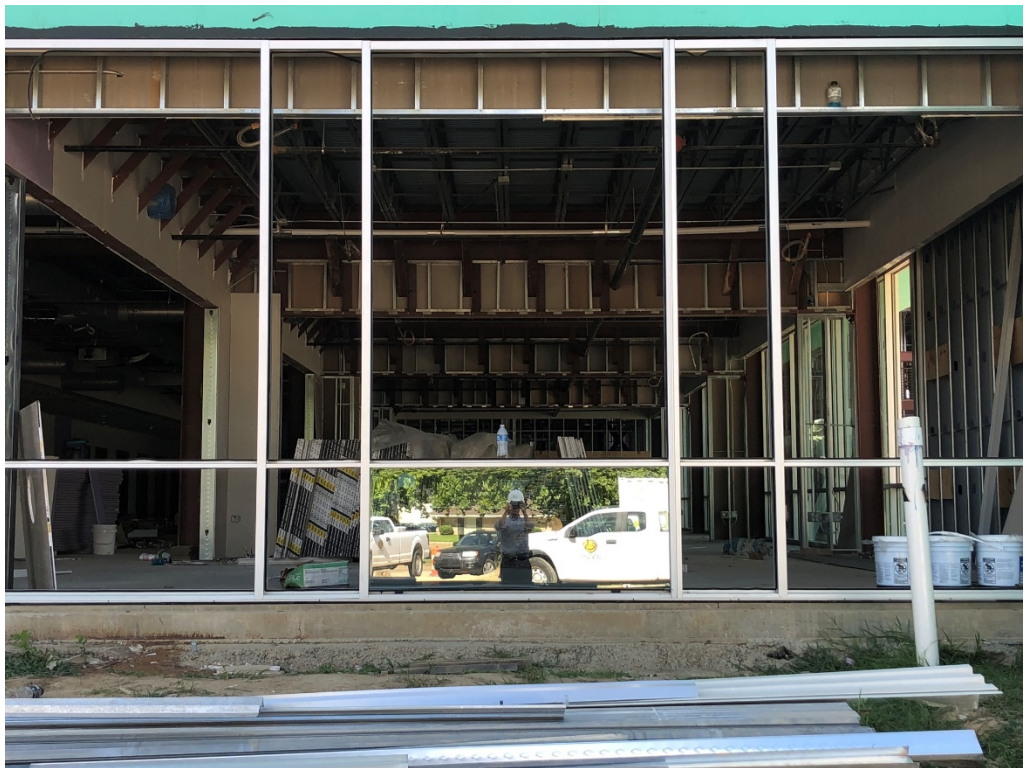
Figure 2 – Glass Installation has Begun

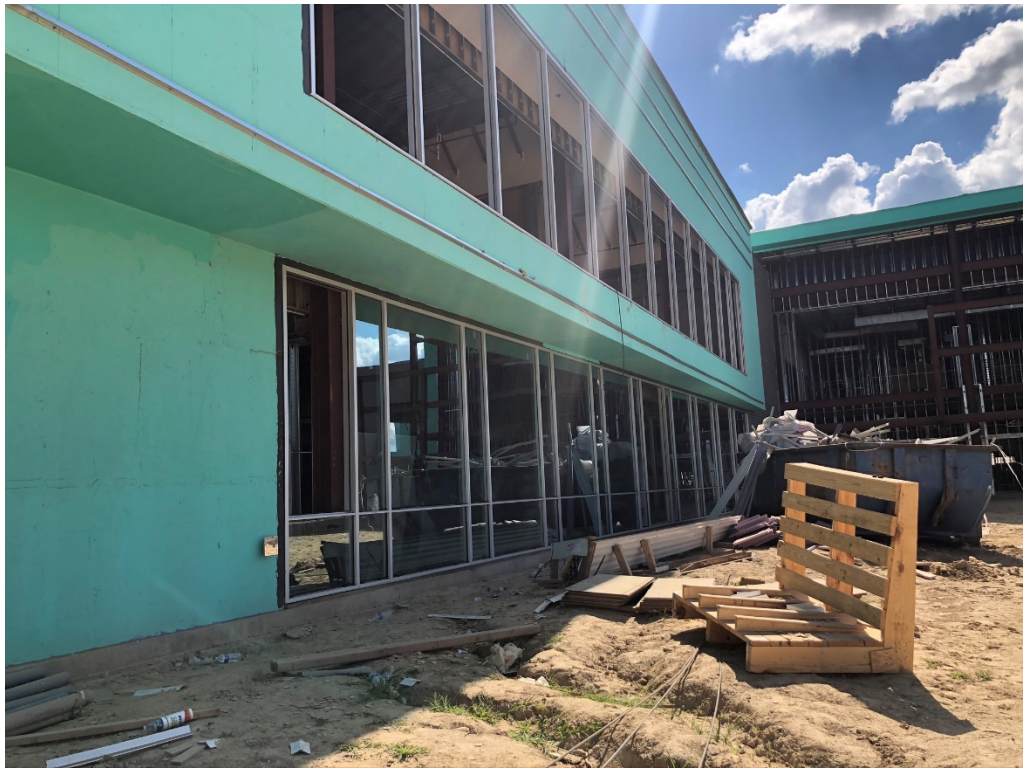
Figure 3 – Storefront Install is Ongoing

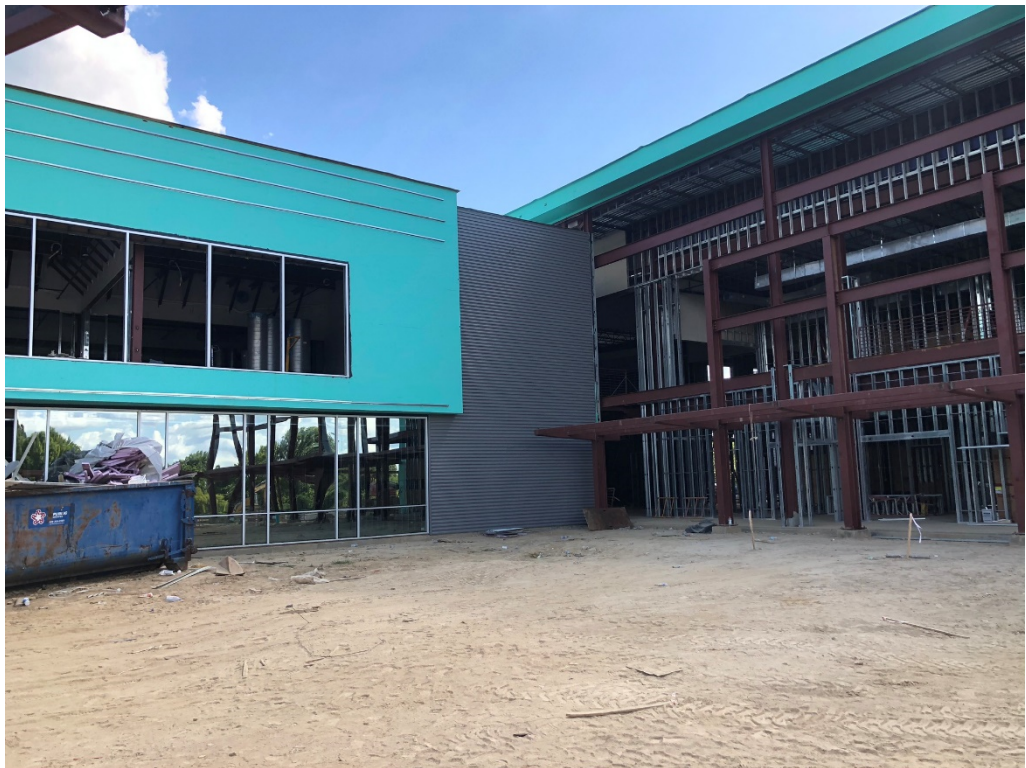
Figure 4 –Metal Siding Install is Ongoing

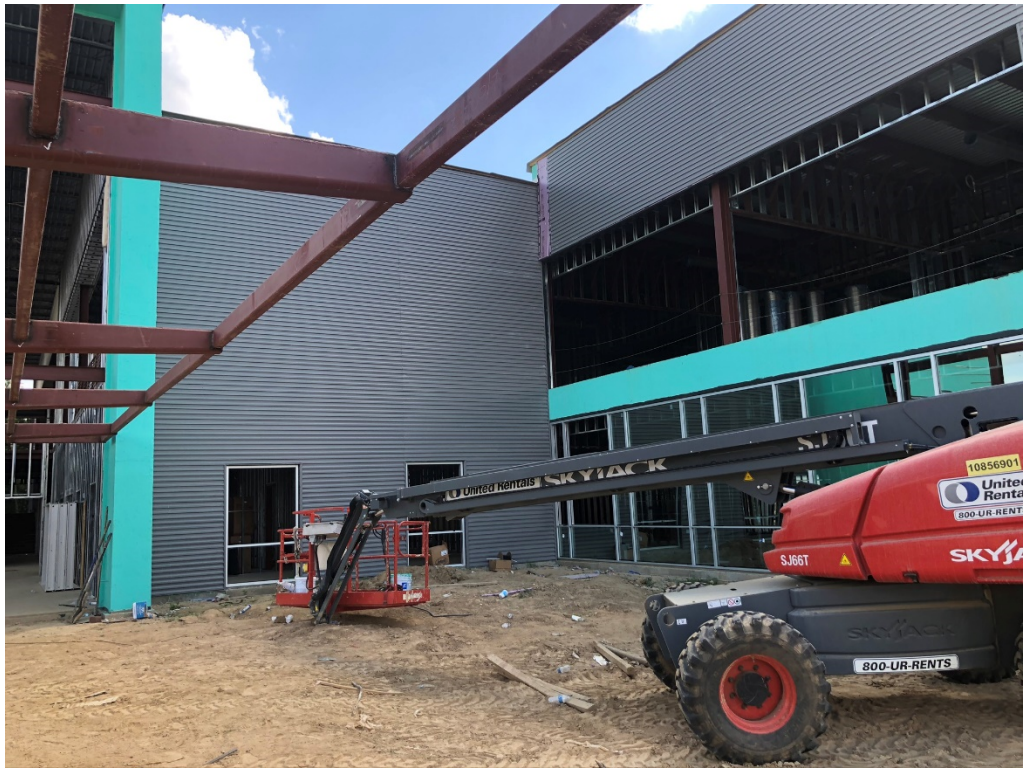
Figure 5 – Metal Siding Install is Ongoing

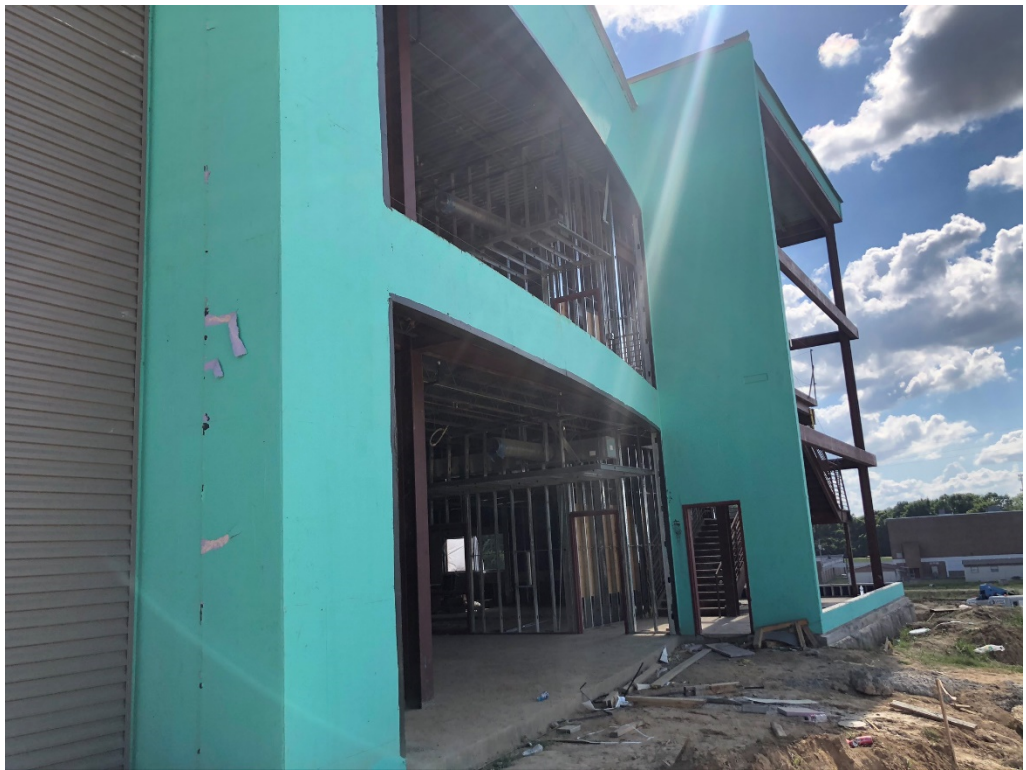
Figure 6 – North Facade

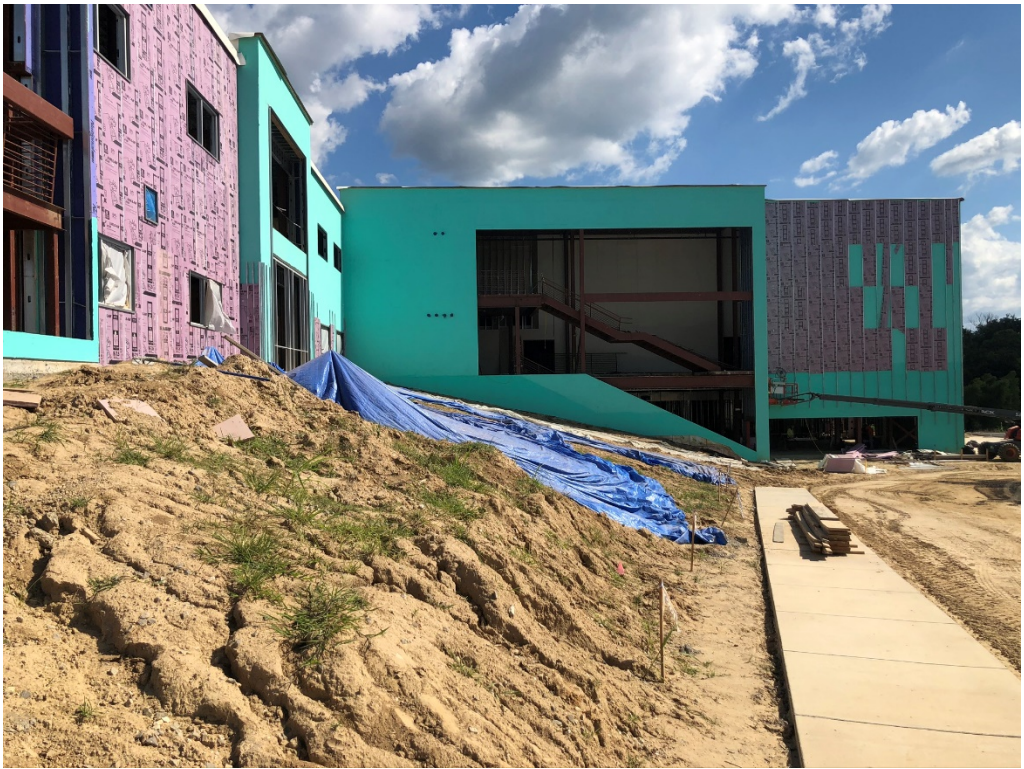
Figure 7 – West Structure

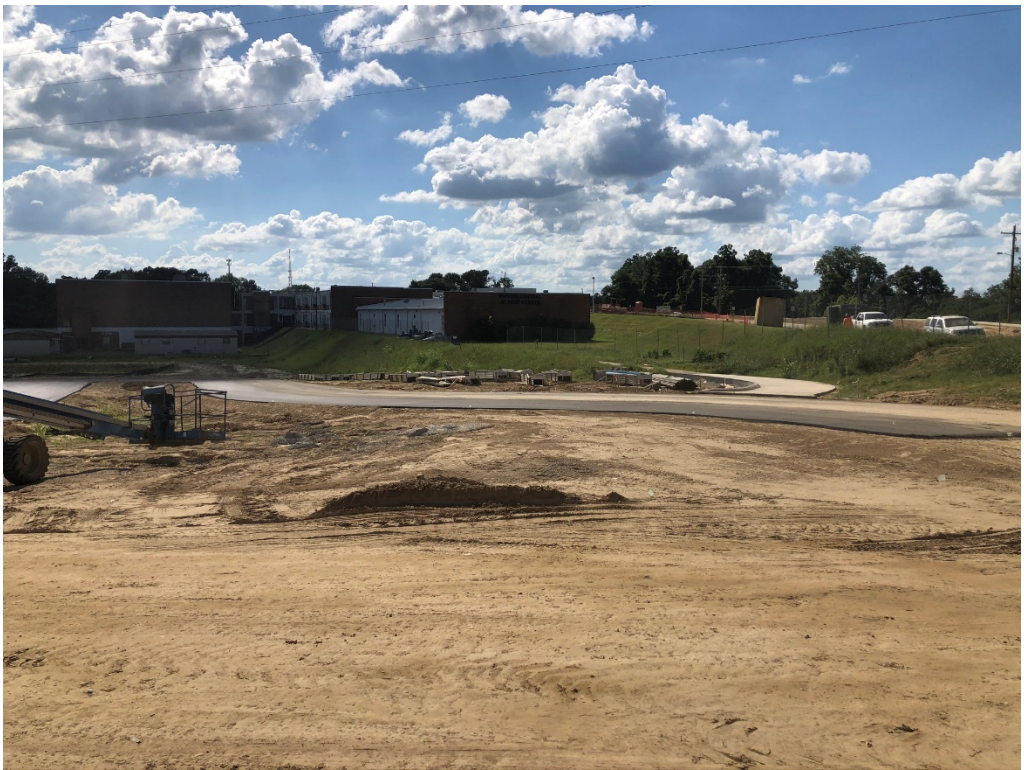
Figure 8 – Asphalt Installation is Ongoing

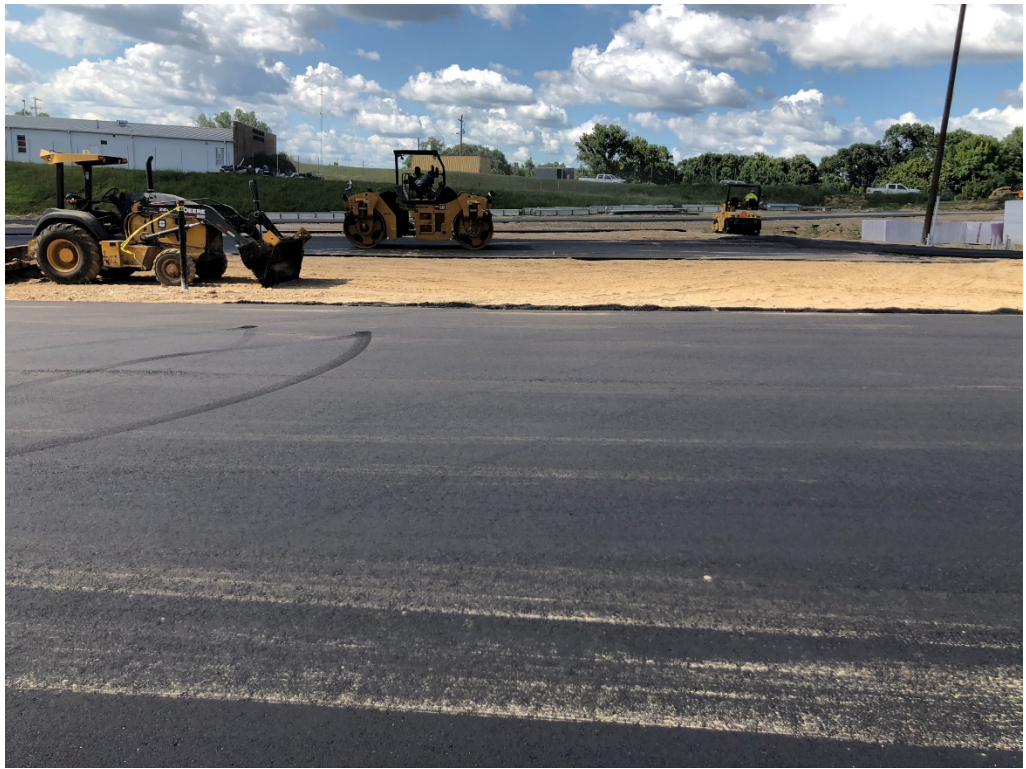
Figure 9 – Asphalt Installation is Ongoing

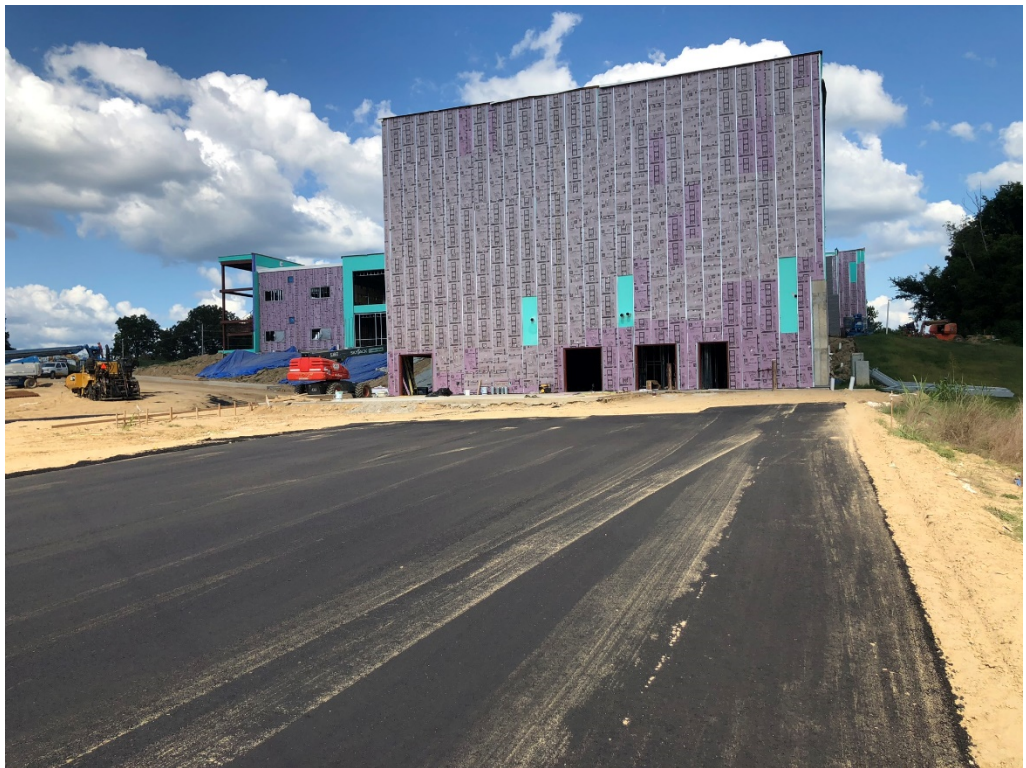
Figure 10 – Asphalt Installation is Ongoing

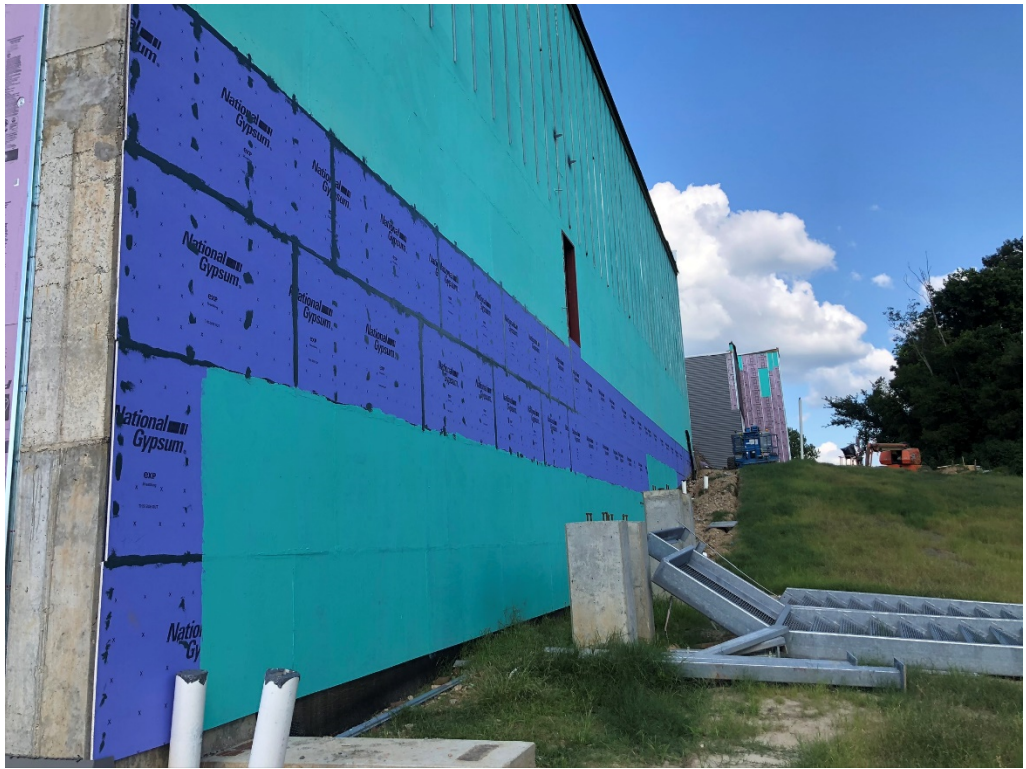
Figure 11 – South Façade of West Structure

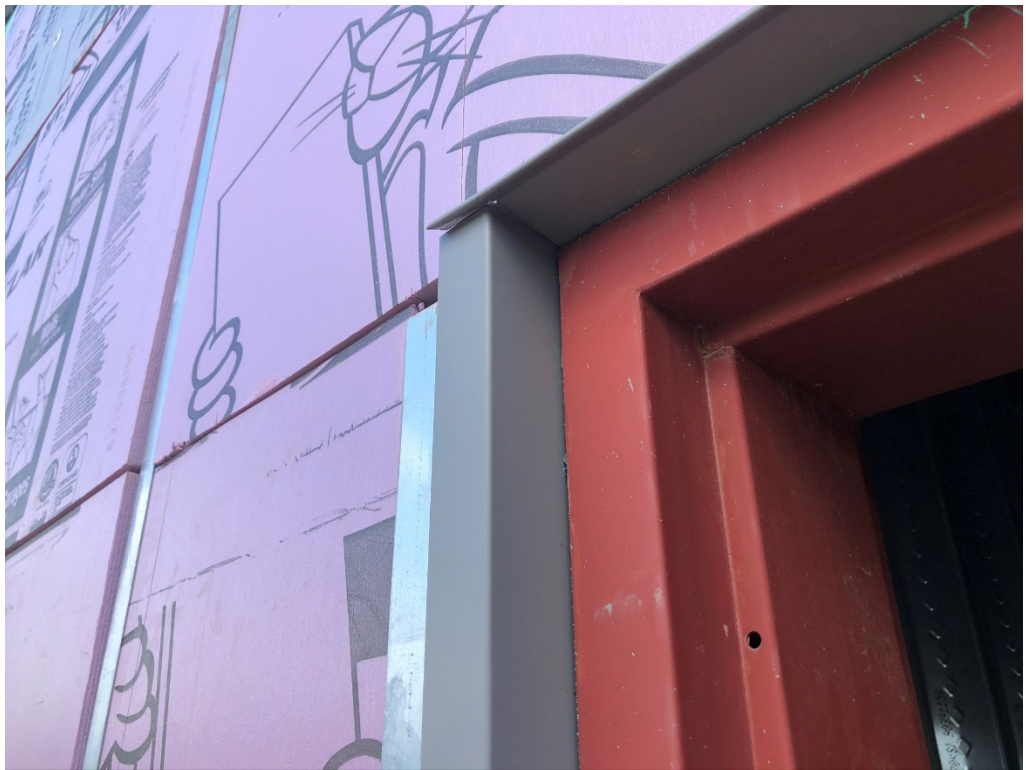
Figure 12 – Metal Trim Detail at Door

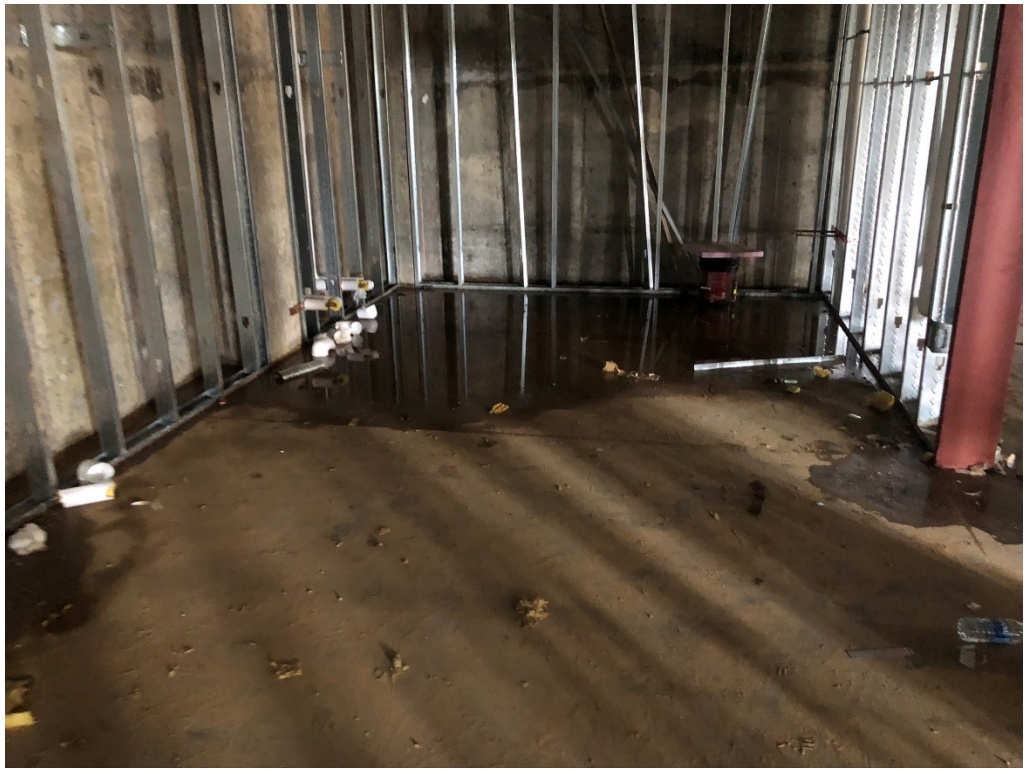
Figure 13 – Ponded water at Lower Level

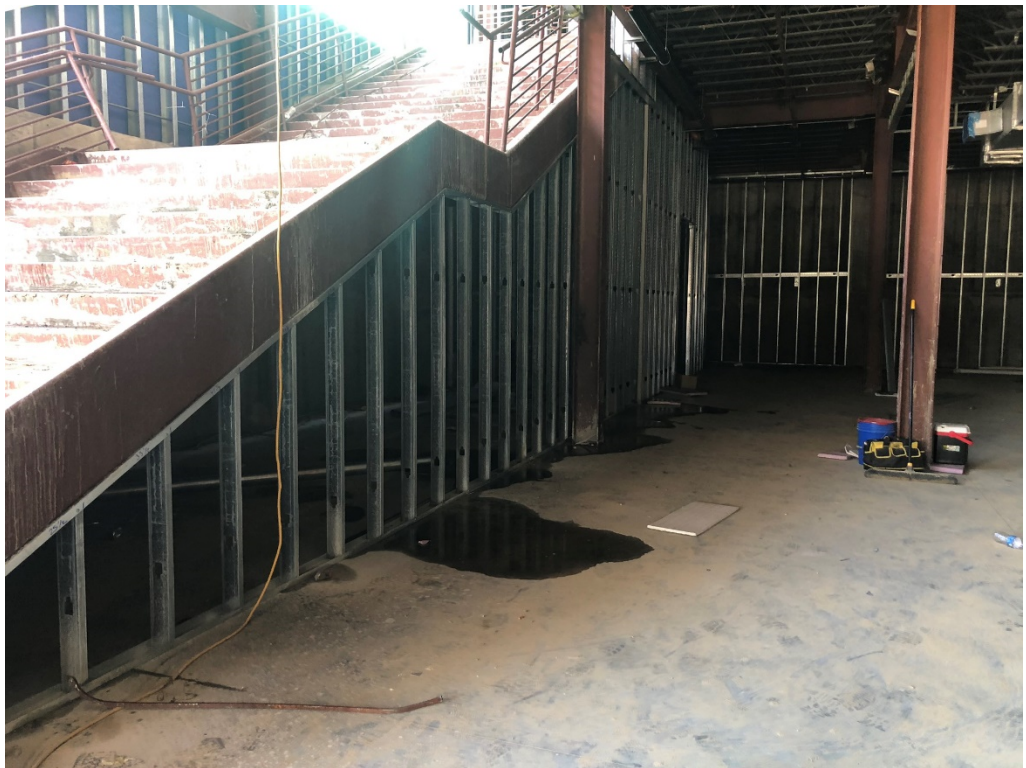
Figure 14 – Light Gauge Framing Under Main Stair

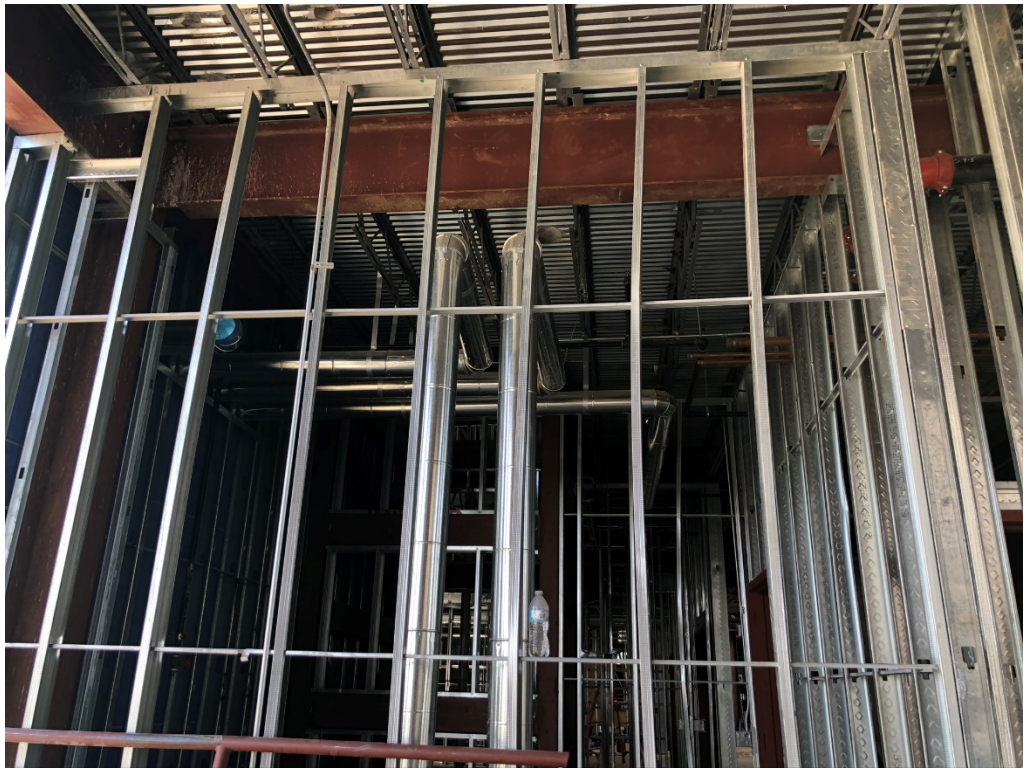
Figure 15 – Studs at 2<sup>nd</sup> Floor Top of Stair Deformed; Reset Before Drywall Installation

Items to Verify None Action Required Reset Deformed Metal Studs @ 2 <sup>nd</sup> Floor Top of Stair
	Report By:

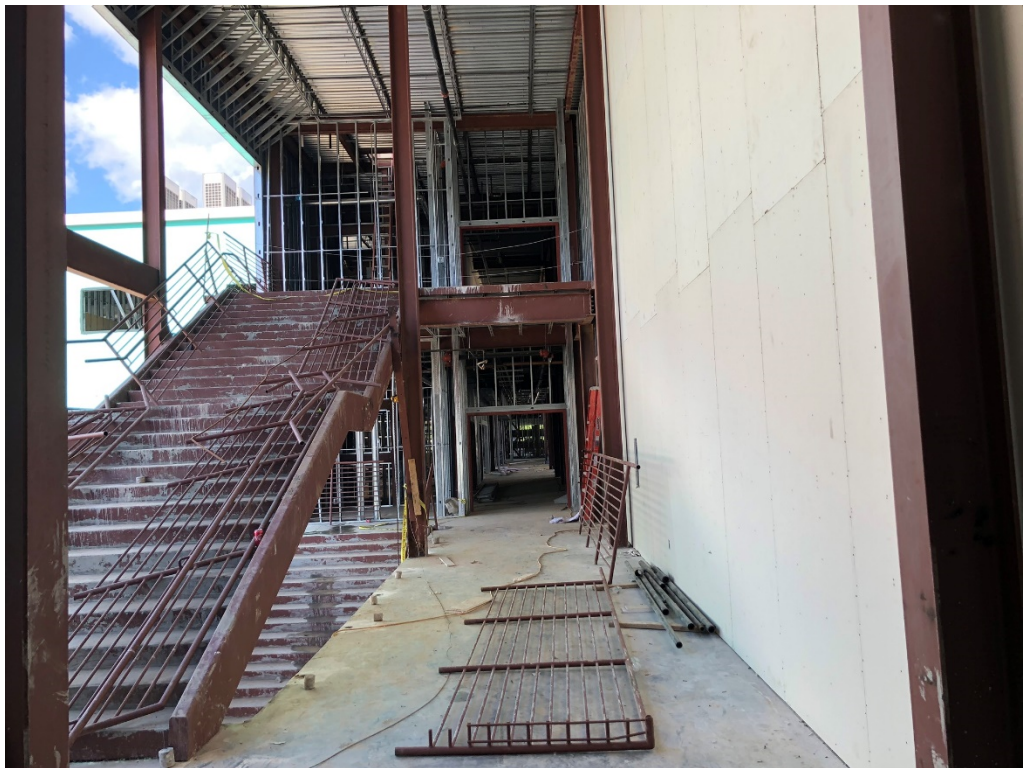
Figure 16 – Handrail Installation has Begun

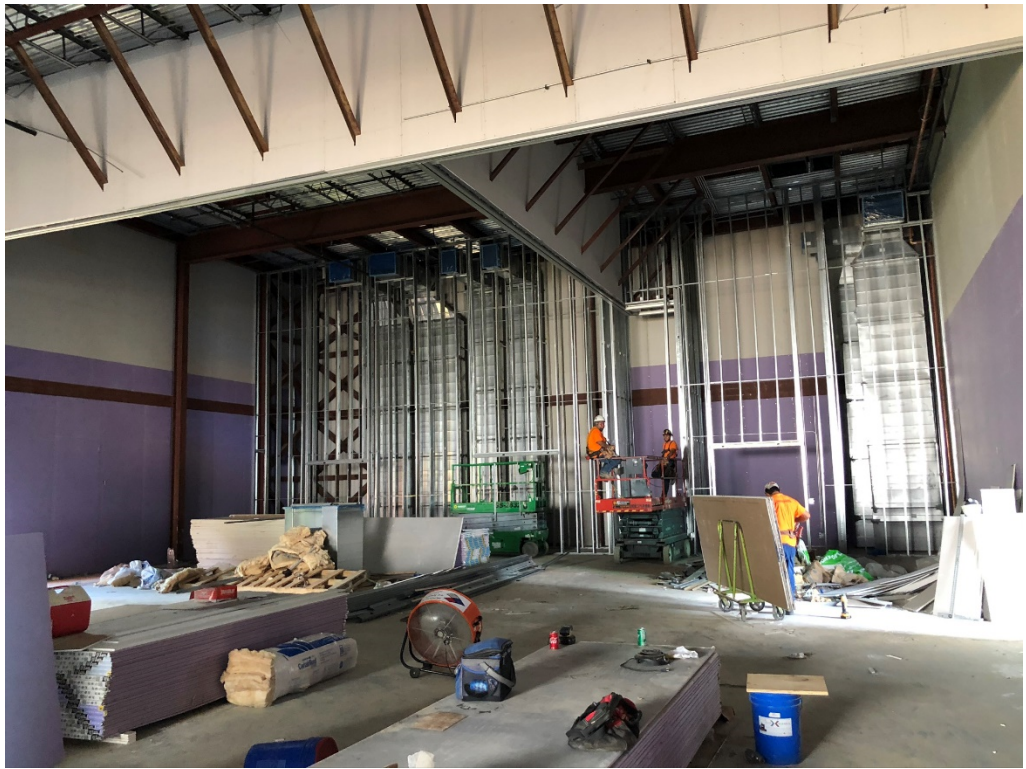
Figure 17 – Light Gauge Framing @ Gym

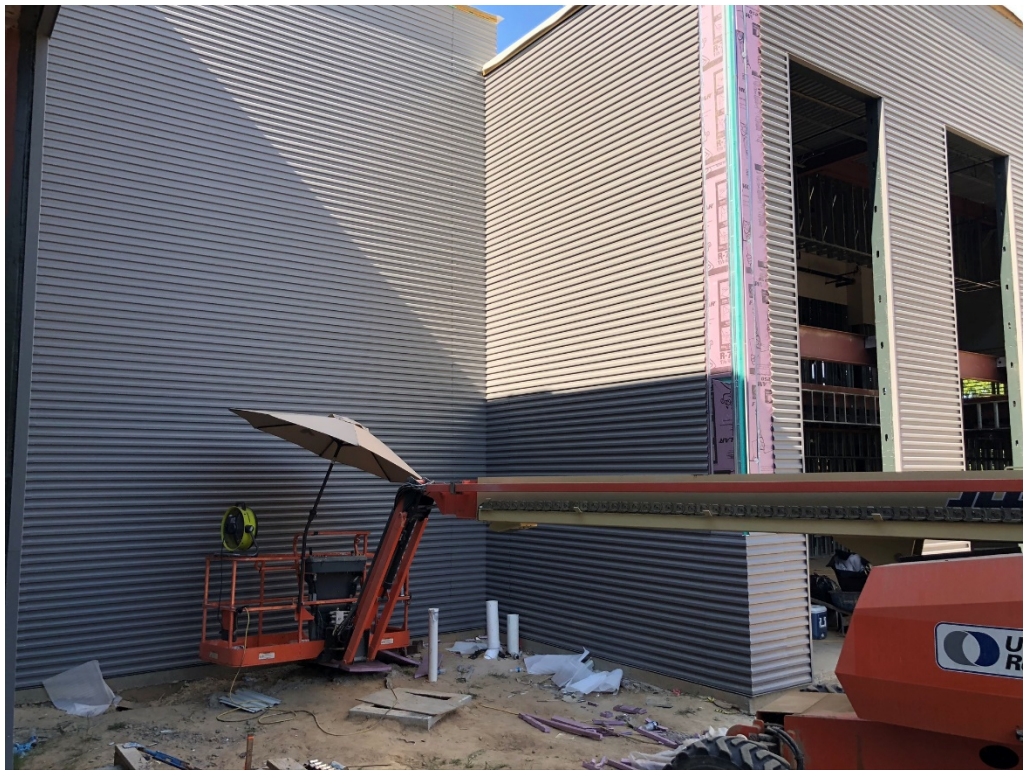
Figure 18 – Metal Panel Install at Rear Courtyard

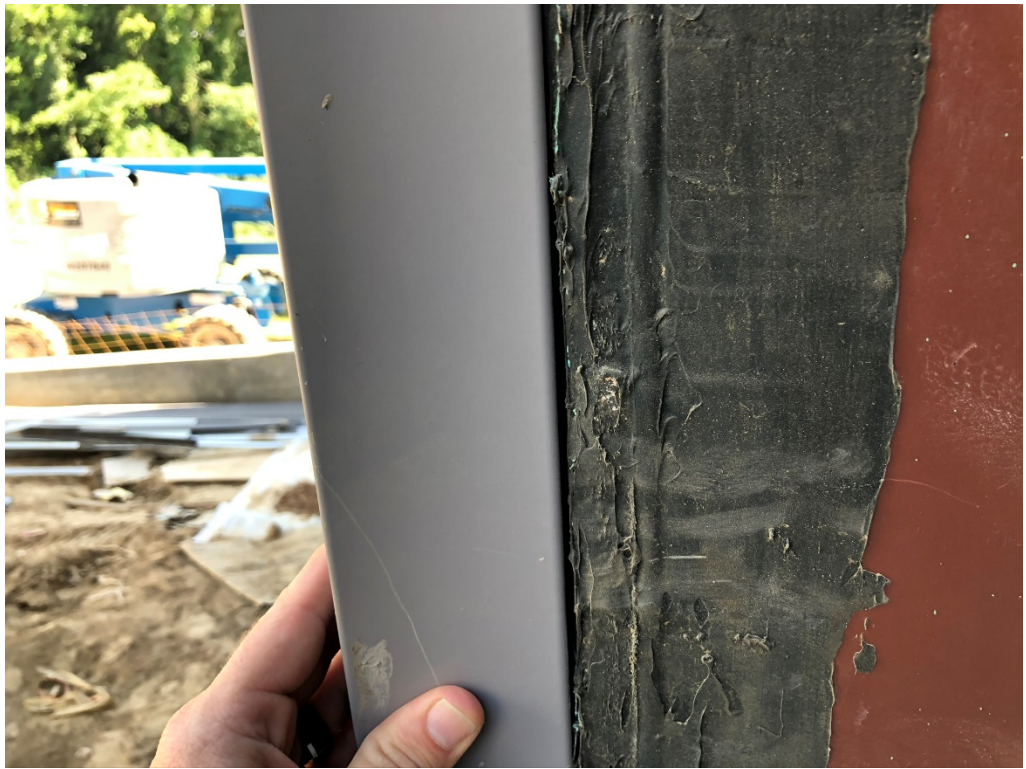
Figure 19 – Metal Trim and Jamb

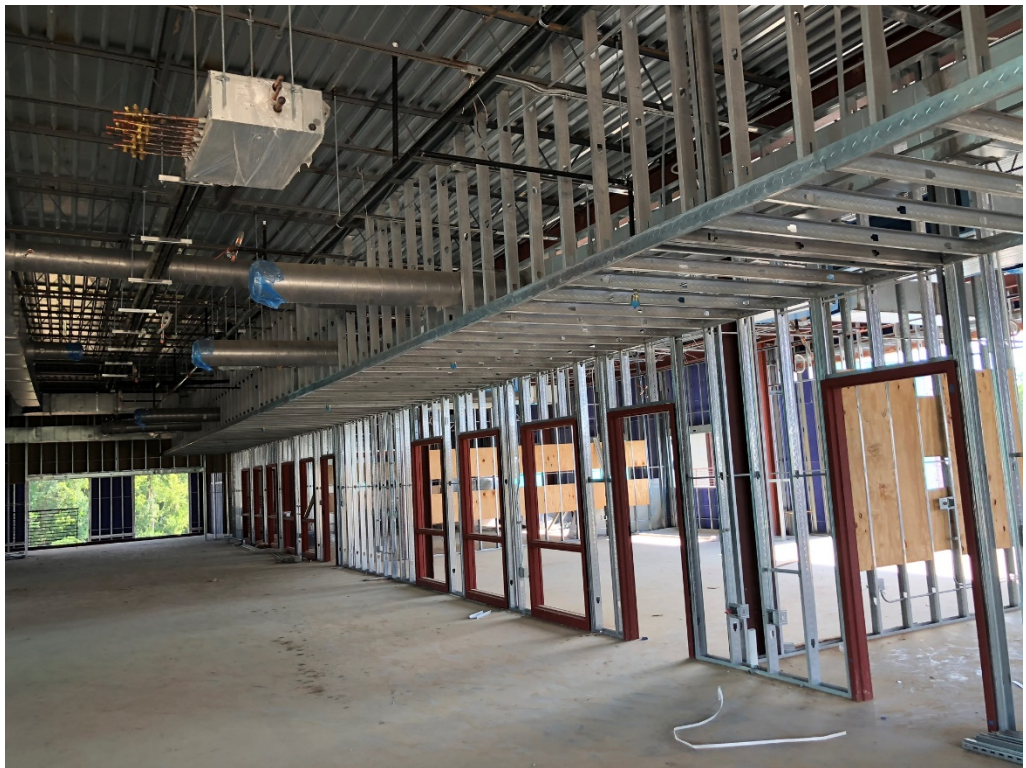
Figure 20 – 2<sup>nd</sup> Floor Versatile Teaching Space

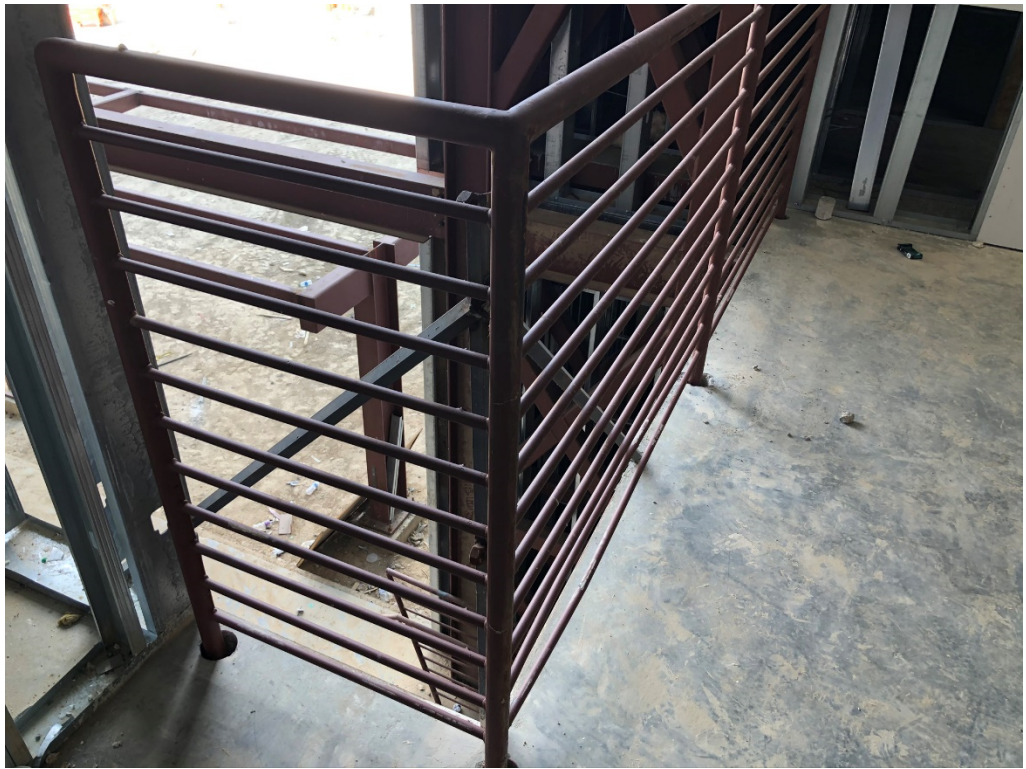
Figure 21 – Handrail Installation is Ongoing

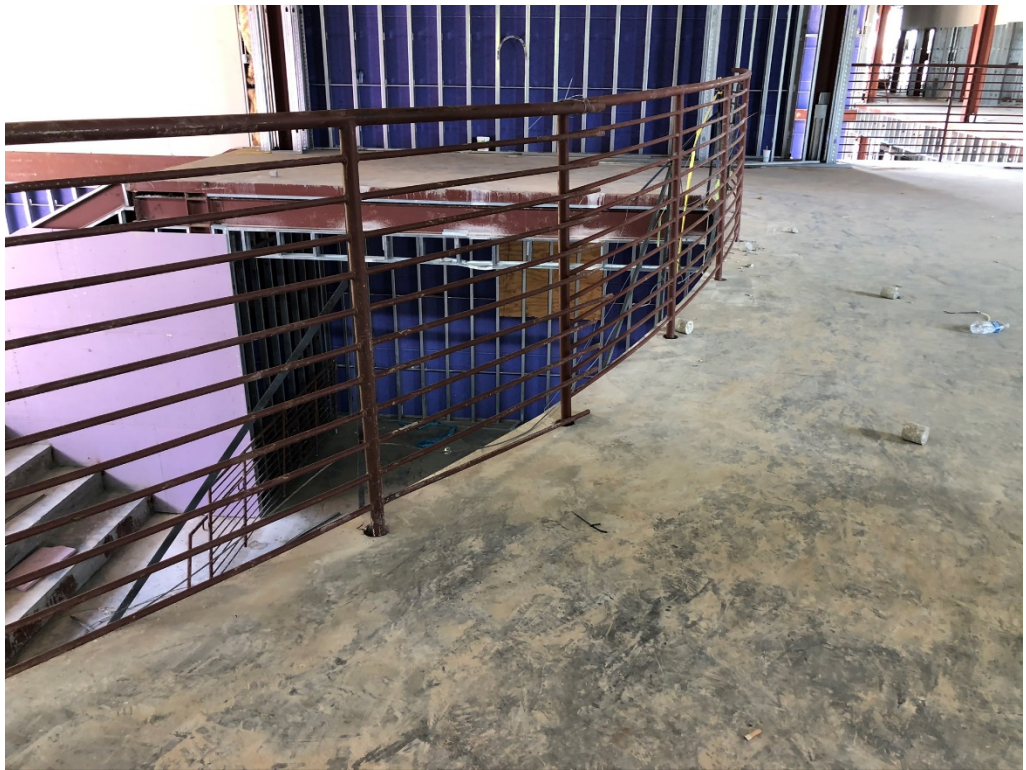
Figure 22 – Handrail Installation is Ongoing

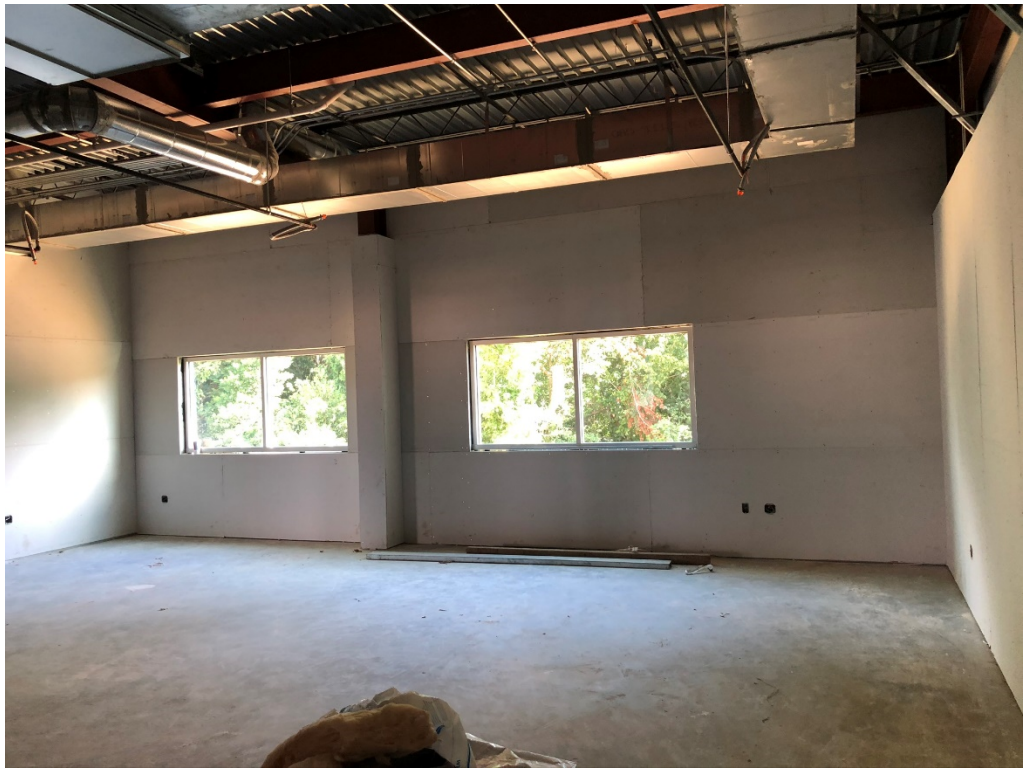
Figure 23 – Drywall Panel Installation at East Structure is Nearing Completion

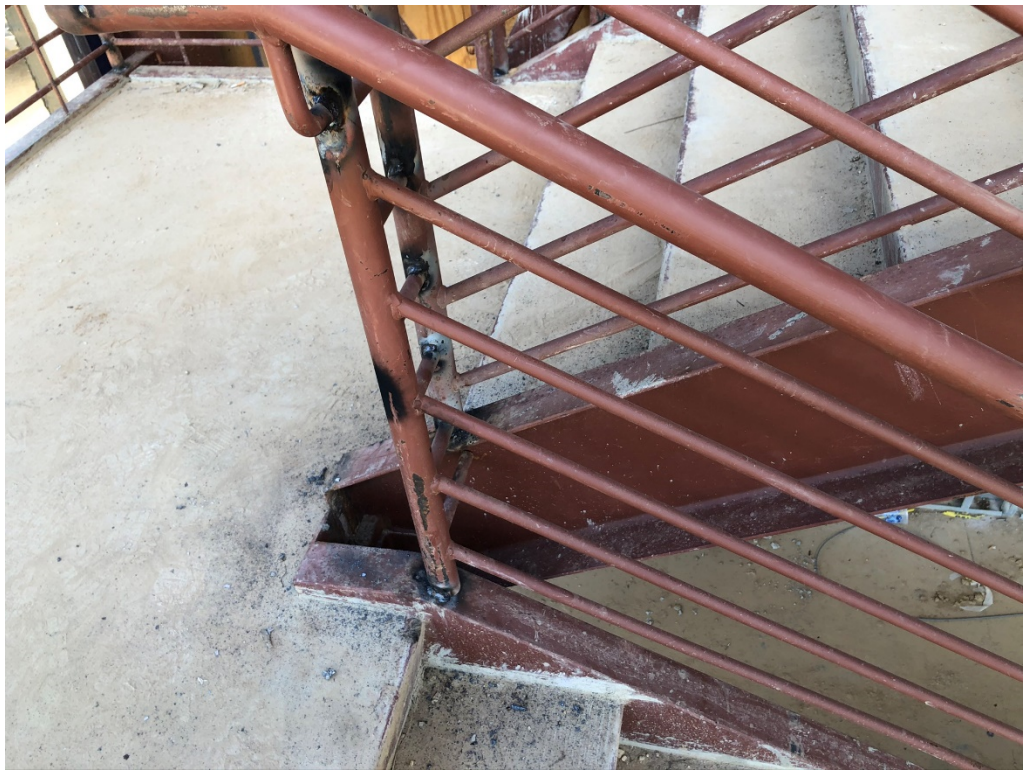
Figure 24 – Handrail Installation is Ongoing
