Architect's Field Report

05 August 2020

18059-AOI Academy of Innovation / Report Number 043

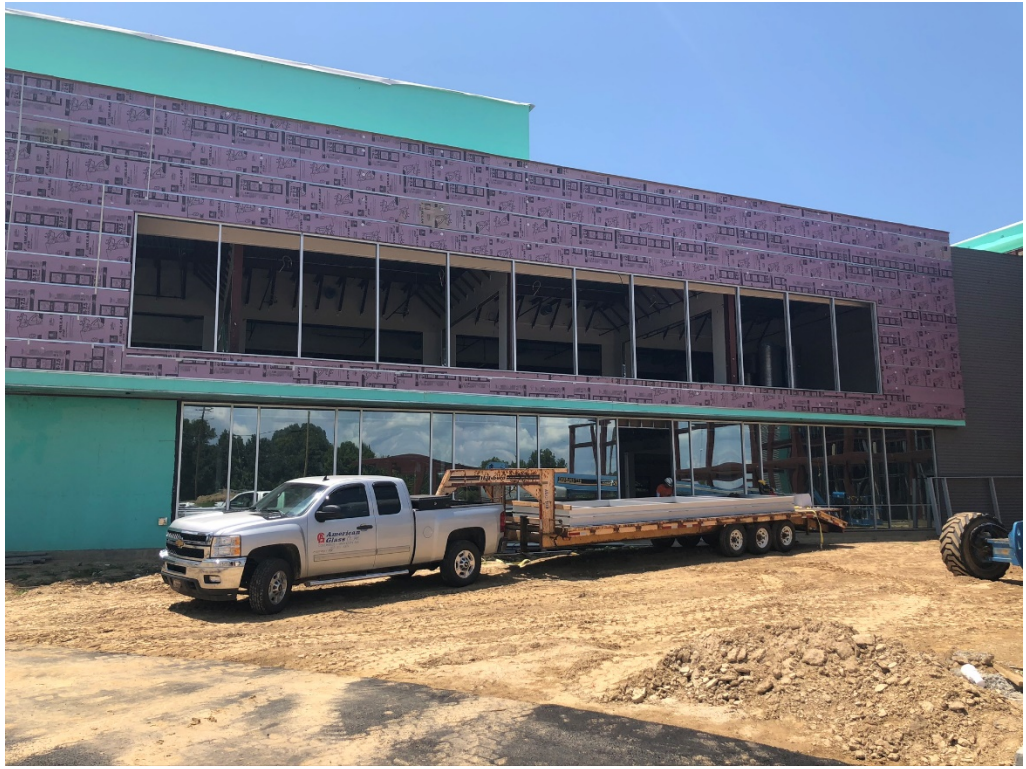
Figure 1 – Metal Siding Substrates Installed

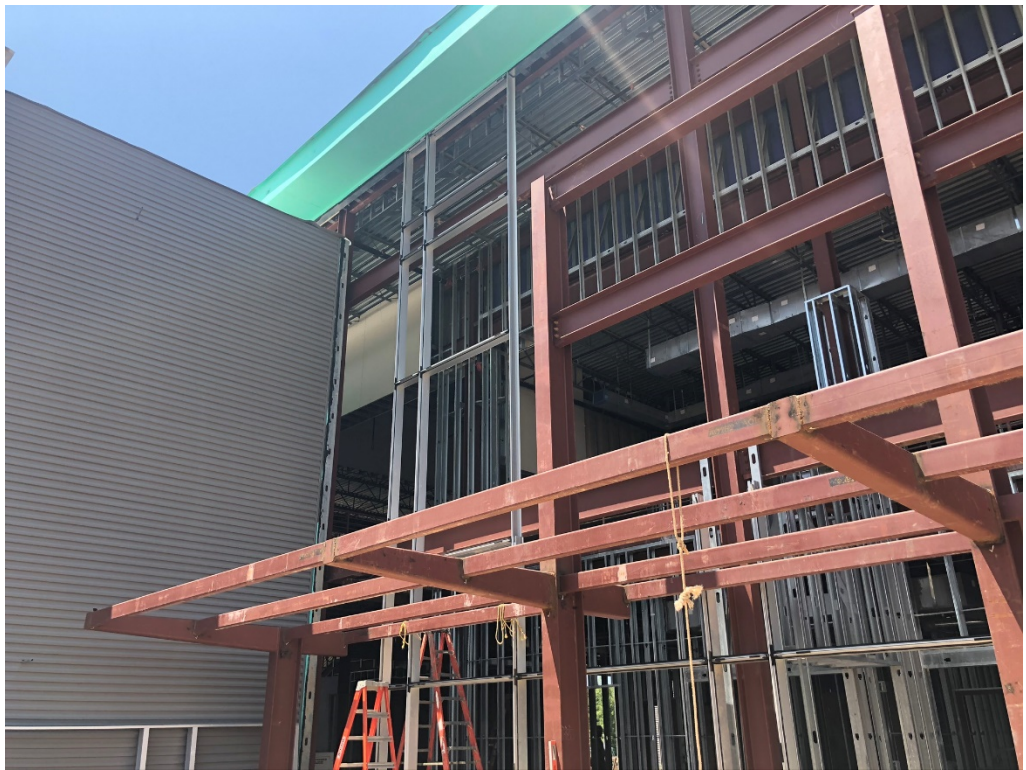
Observations I arrived on site, noting continued work on several fronts. High wall Aluminum Storefront installation has begun and is ongoing at the Entry Vestibule. Also, glazers were on site installing glass at previously installed storefront framing. Inside, Electricians and plumbers were working throughout the North structure.

Figure 2 – Aluminum Storefront at Entry Vestibule

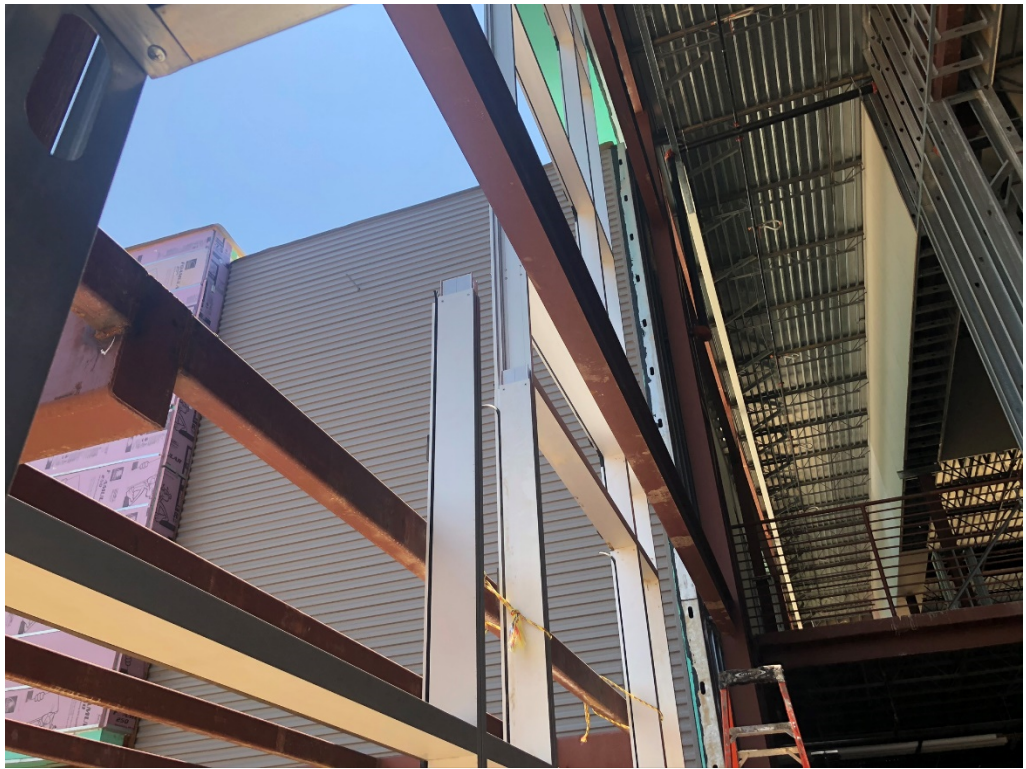
Figure 3 – Aluminum Storefront in Progress

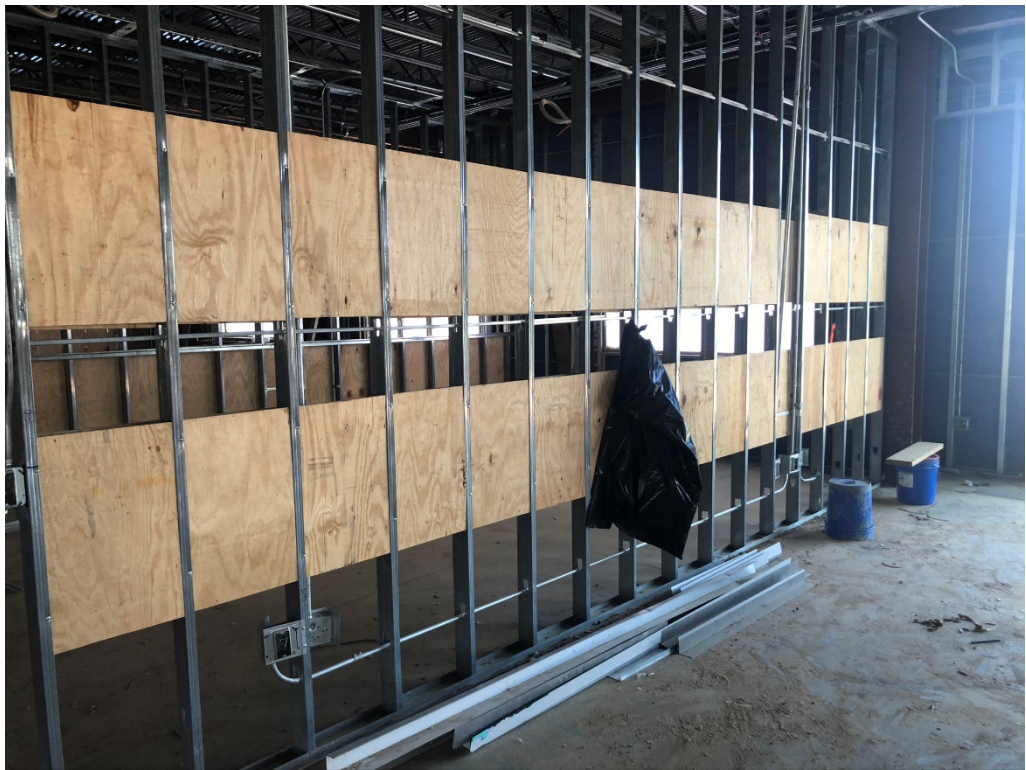
Figure 4 –Blocking Installed at Versatile Teaching Spaces

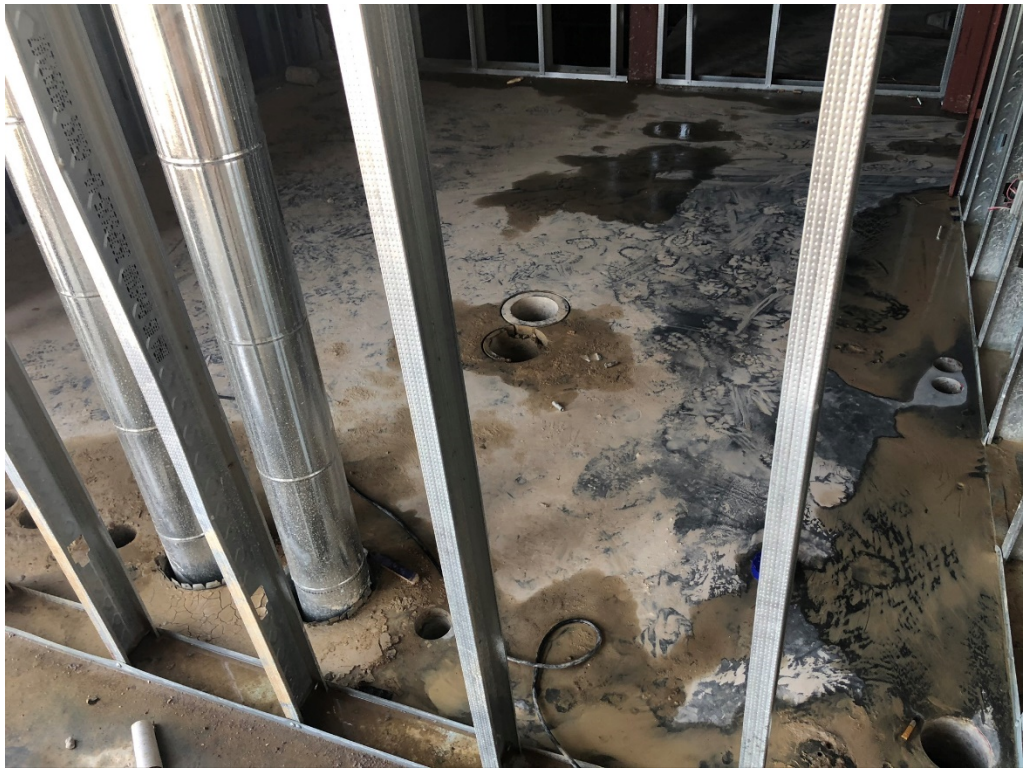
Figure 5 – Core Drills at 2nd Floor Bathroom

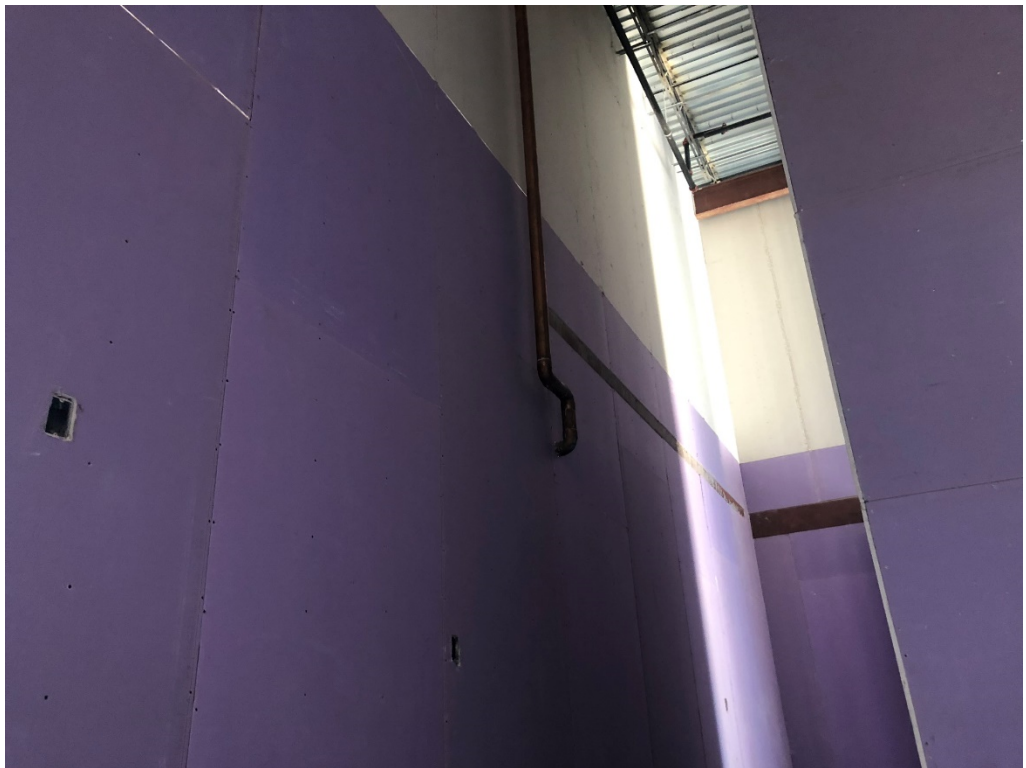
Drywallers were taking lunch in the gymnasium where up to 80% of drywall has been installed. In the east structure, drywall hanging appears near completion.

Figure 6 – Drywall Installed at Gym

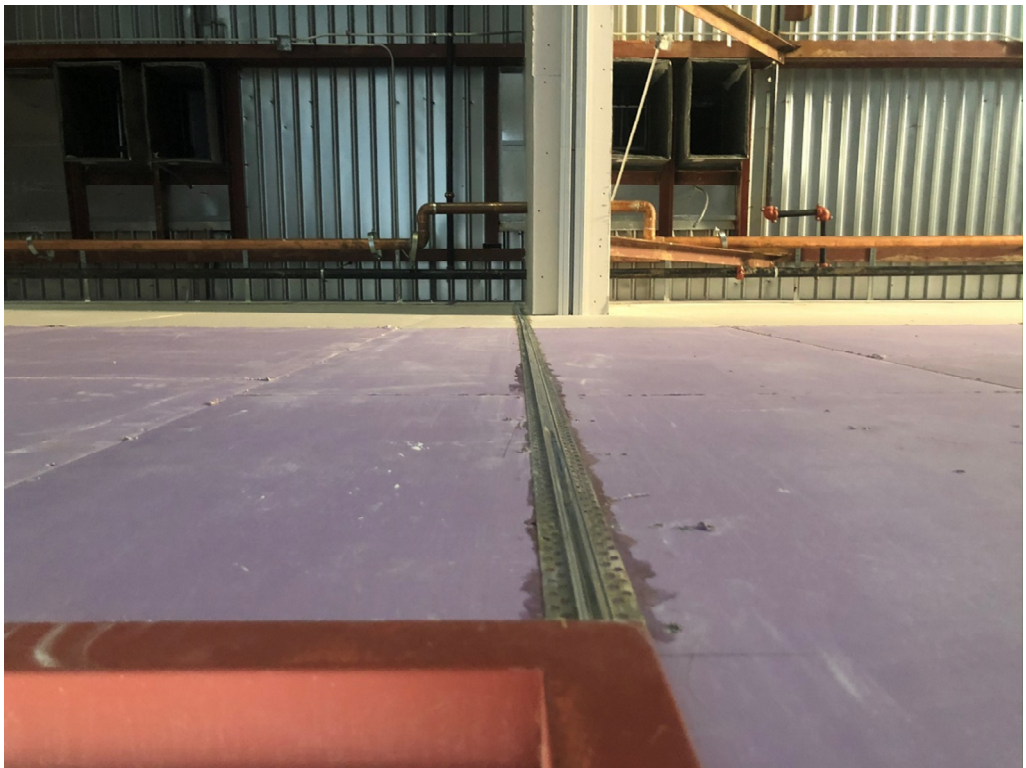
Figure 7 – Drywall Reveal Installed at Gym

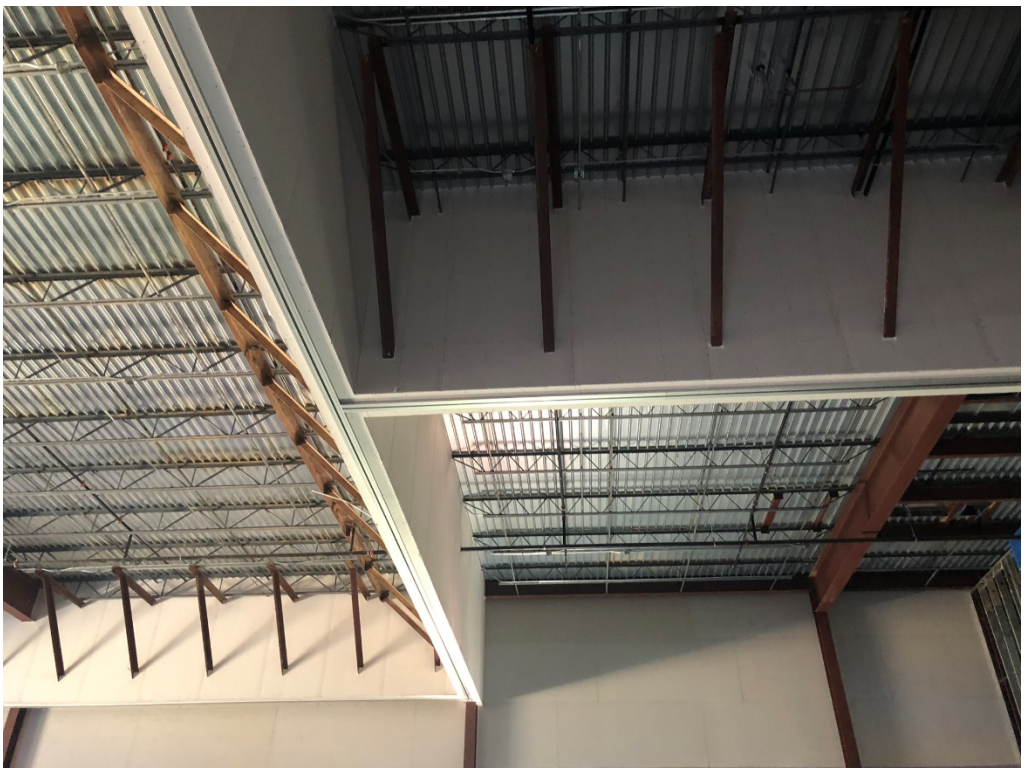
Figure 8 – Moveable Partitions Track Installed

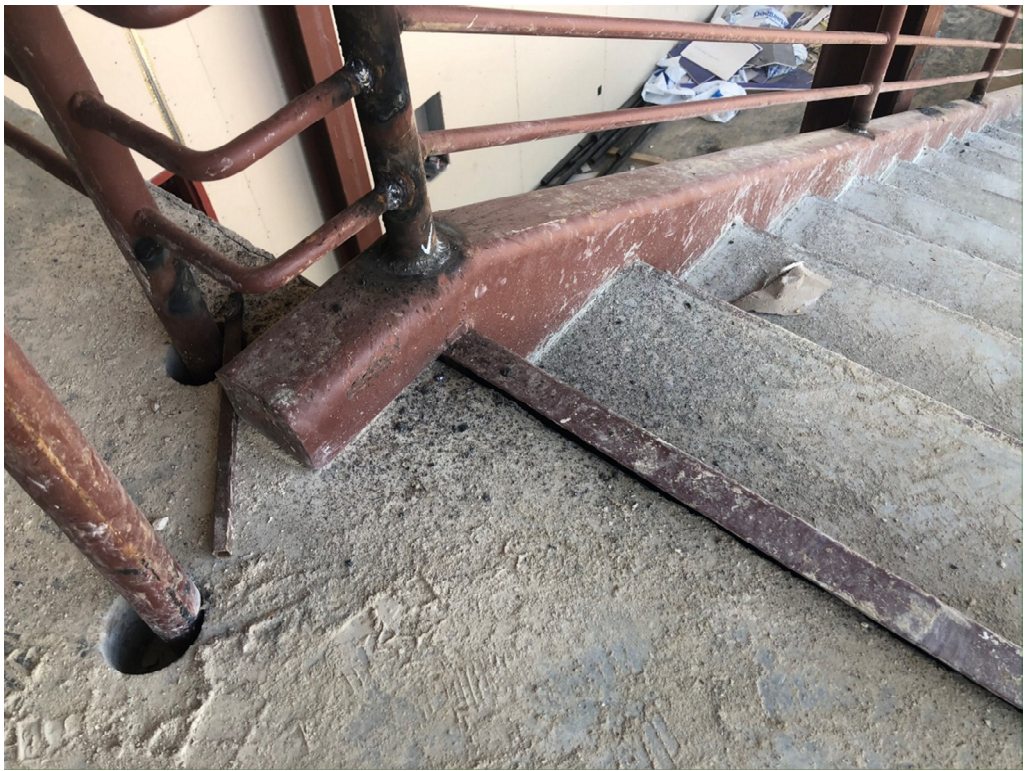
Figure 9 – Lip at Main Stair and 3rd Floor (Recommendations to correct?)

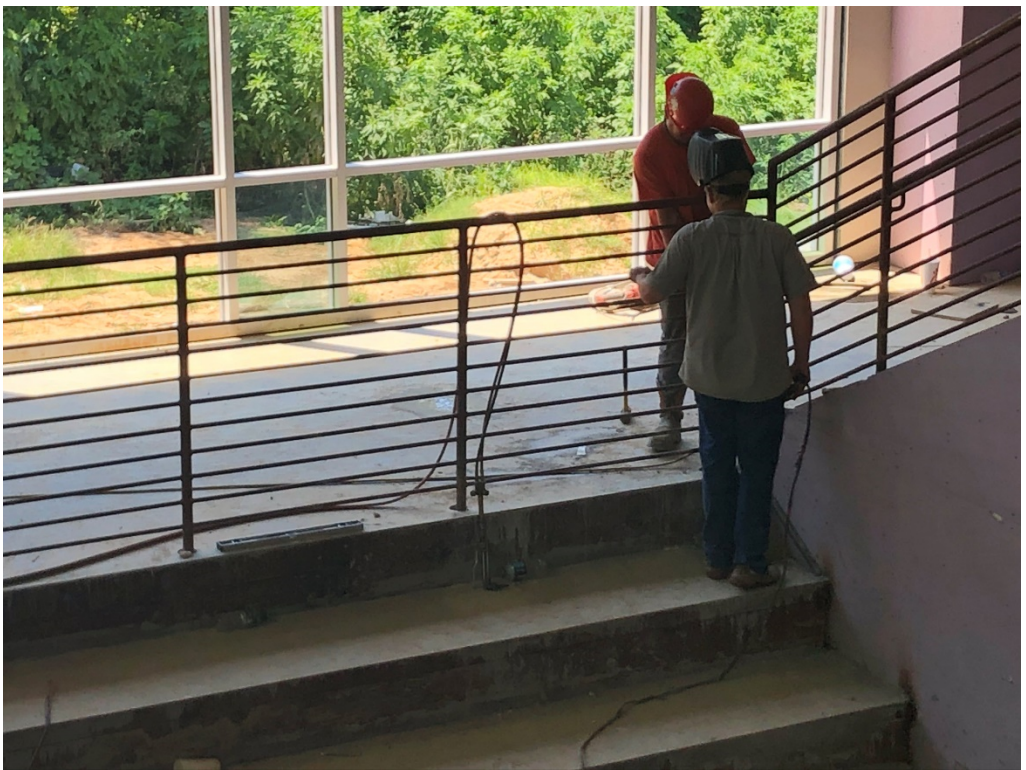
Welders were working in the main lobby installing handrail.

Figure 10 – Handrail Work is Ongoing

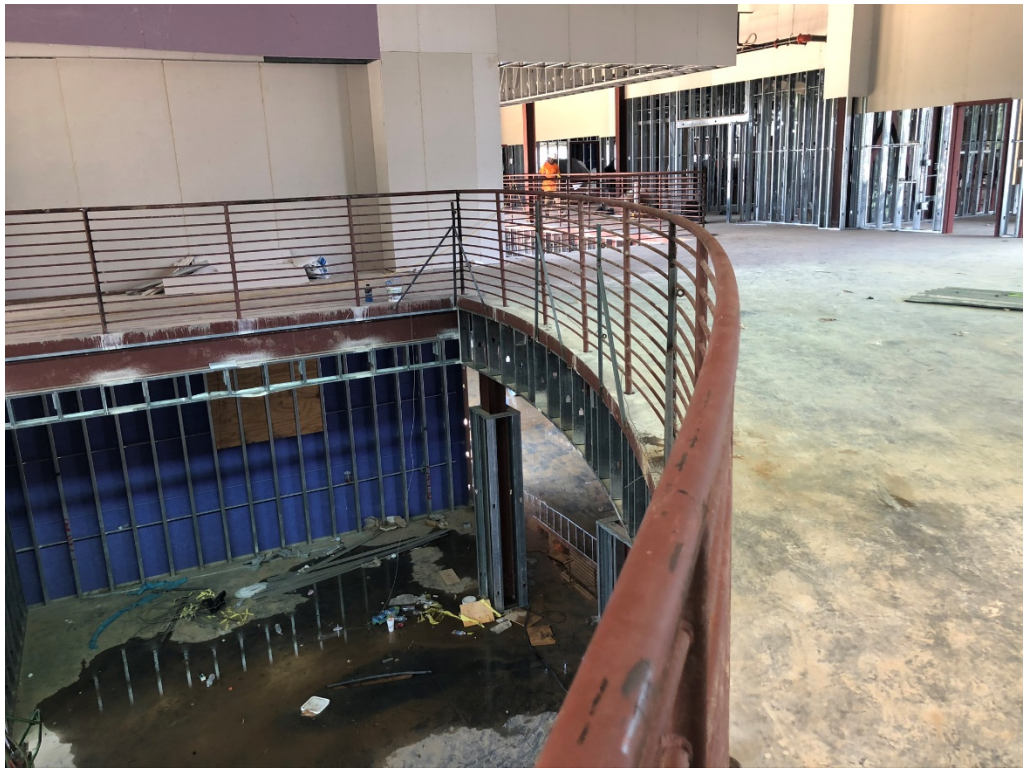
Figure 11 – Installed Curved Handrail

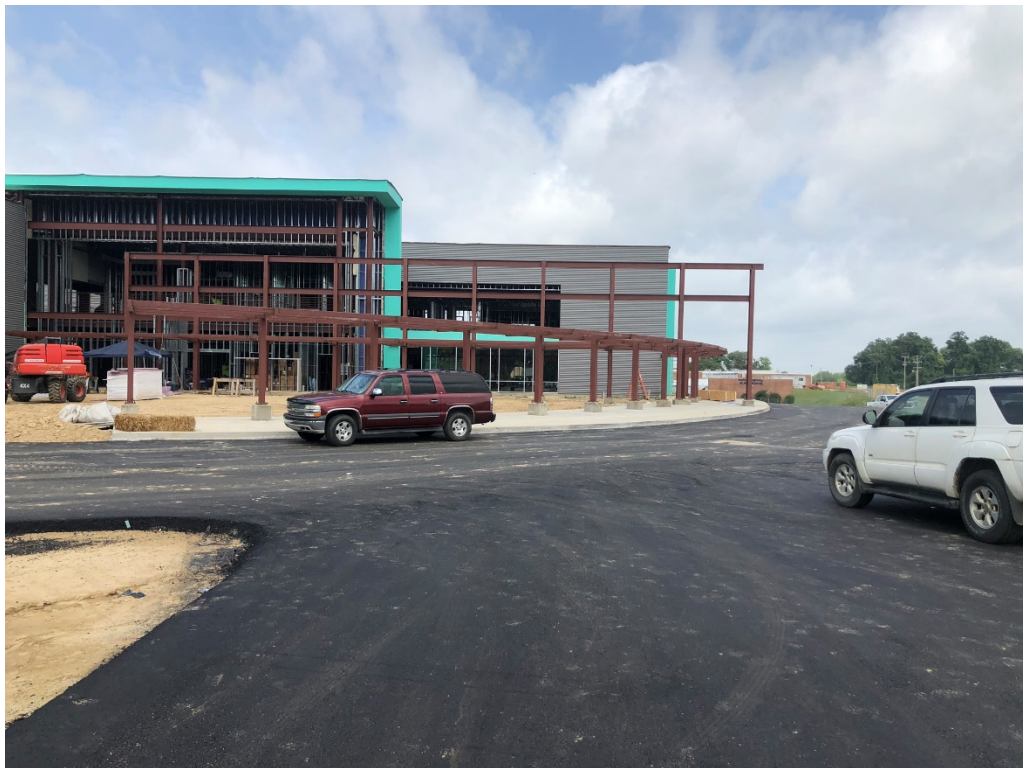
Figure 12 – Asphalt Installed at Drive

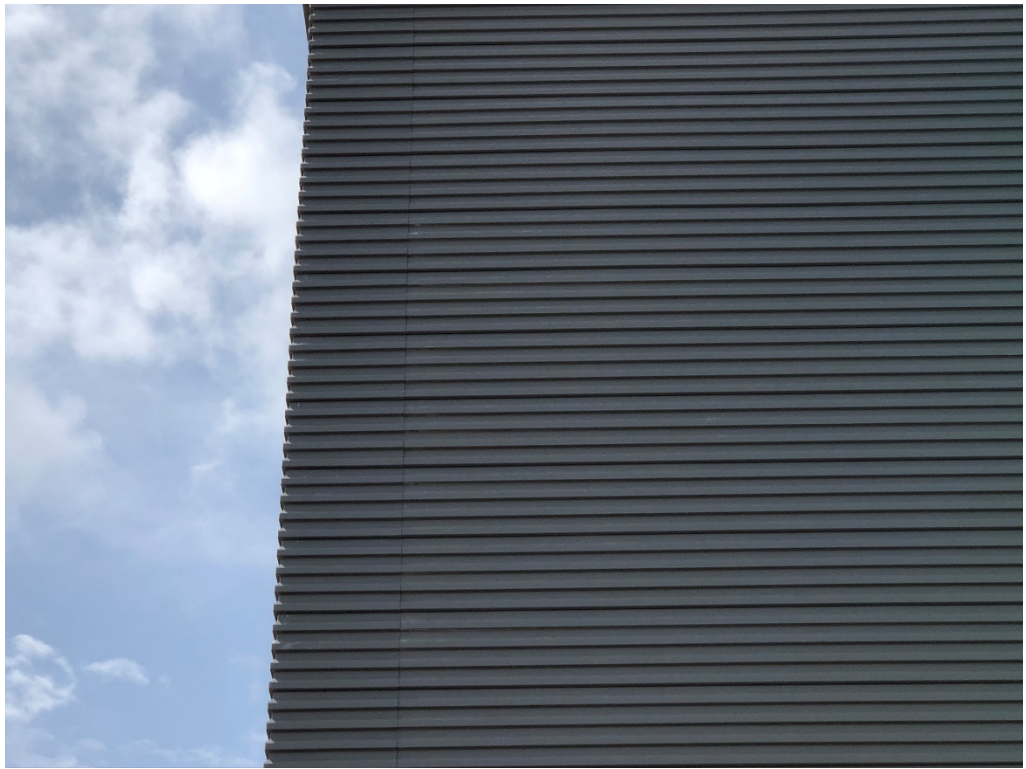
Figure 13 – Mitered Corners at Metal Siding

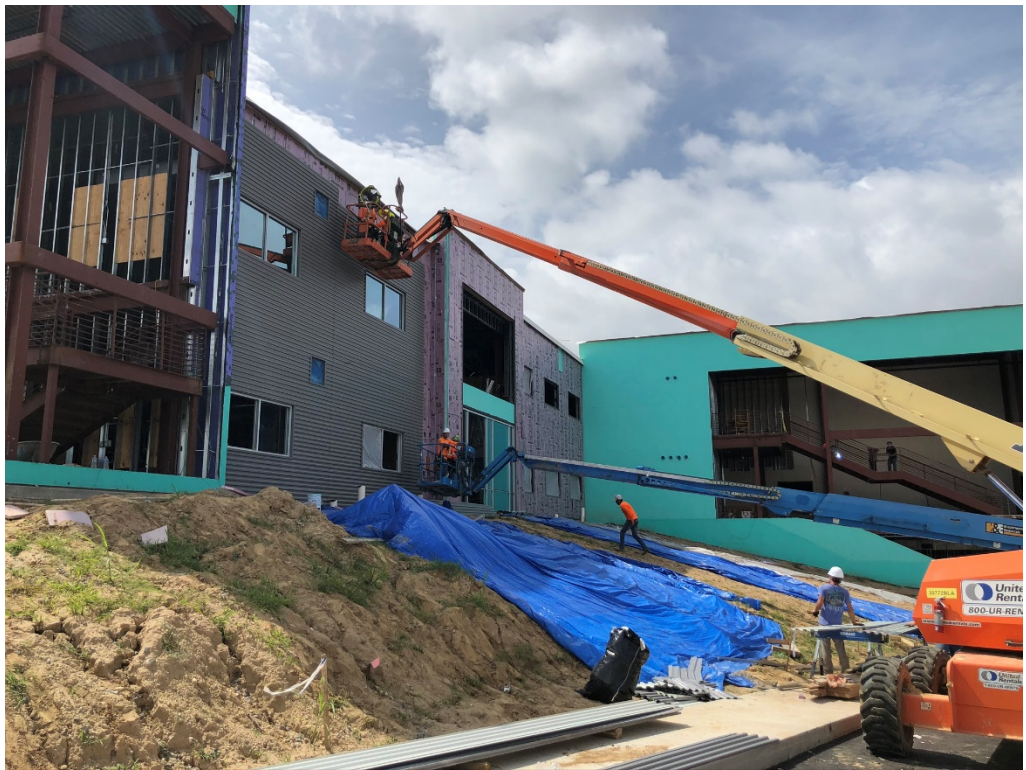
Figure 14 – Metal Siding Install is Ongoing

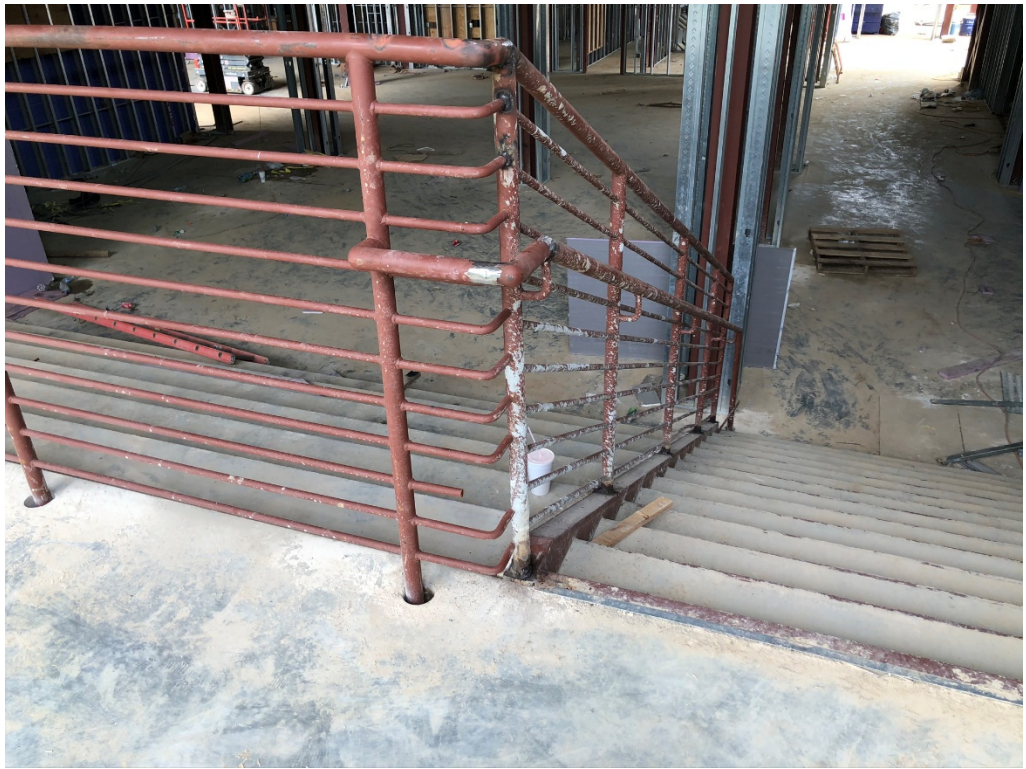
Figure 15 – Welded Handrail Corner at Main Lobby

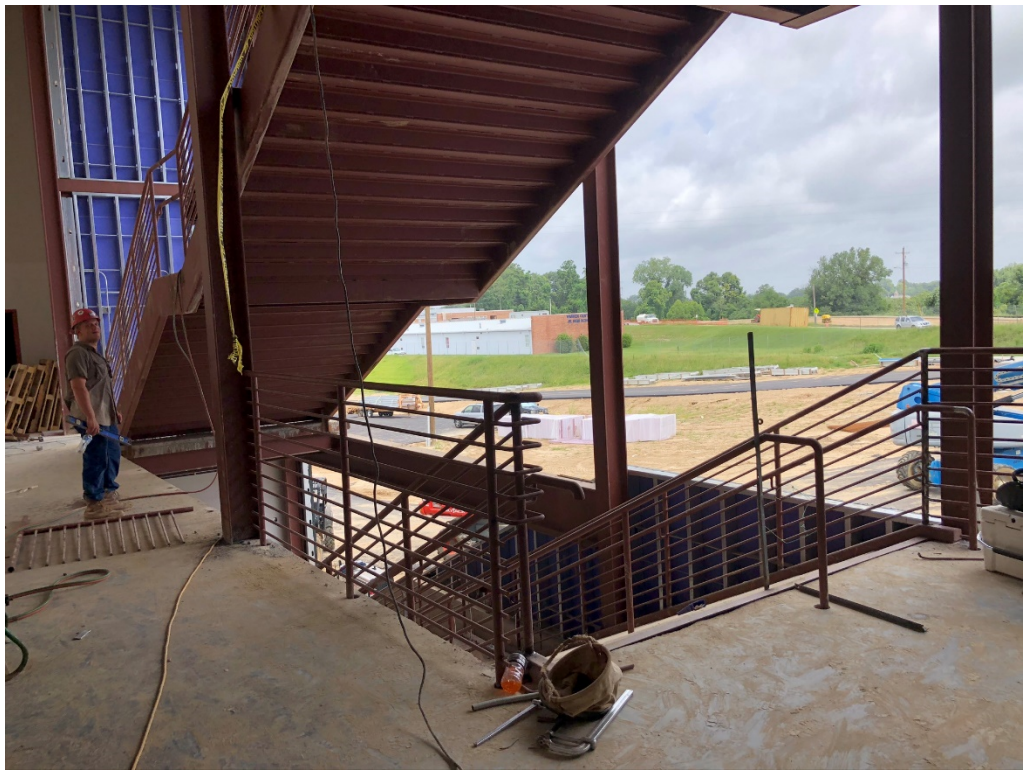
Figure 16 – Handrail Installation at Main Stair
