Architect's Field Report

27 August 2020

18059-AOI Academy of Innovation / Report Number 044

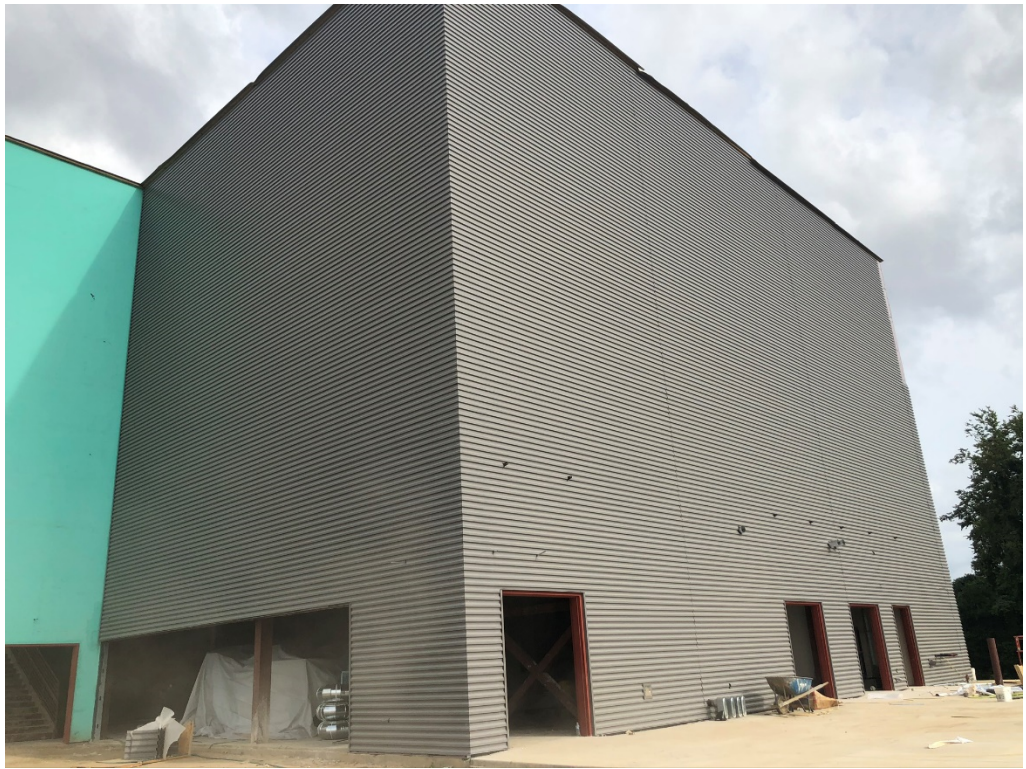
Figure 1 – Metal Siding Installed

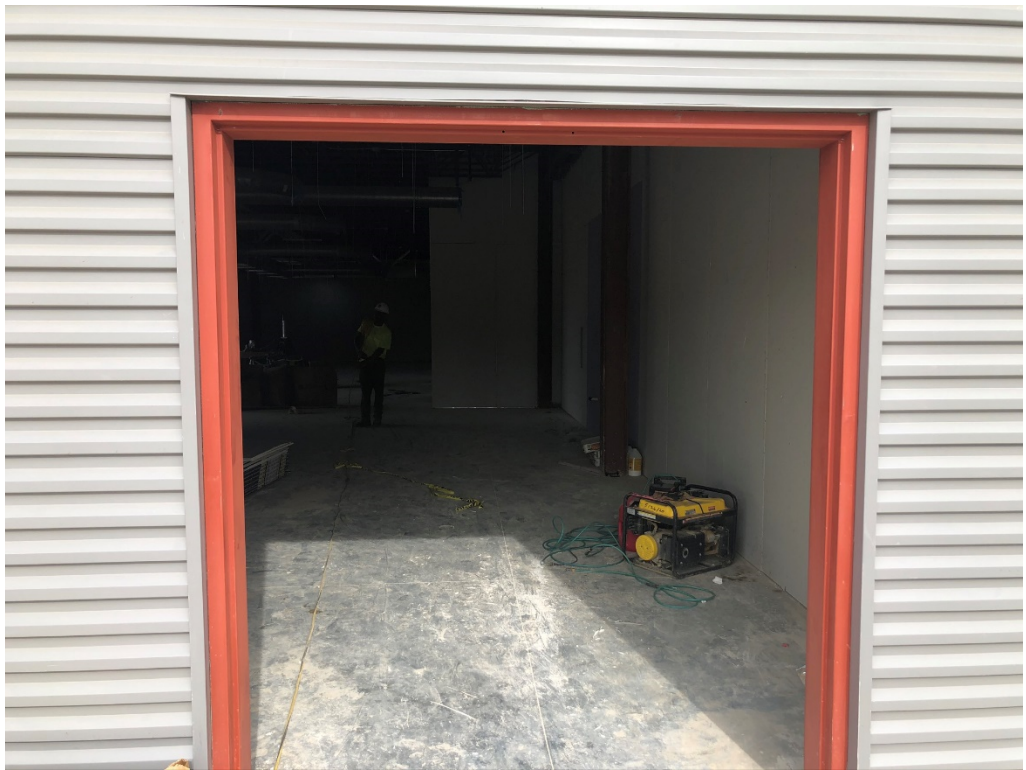
Figure 2 – Door Trim Detail

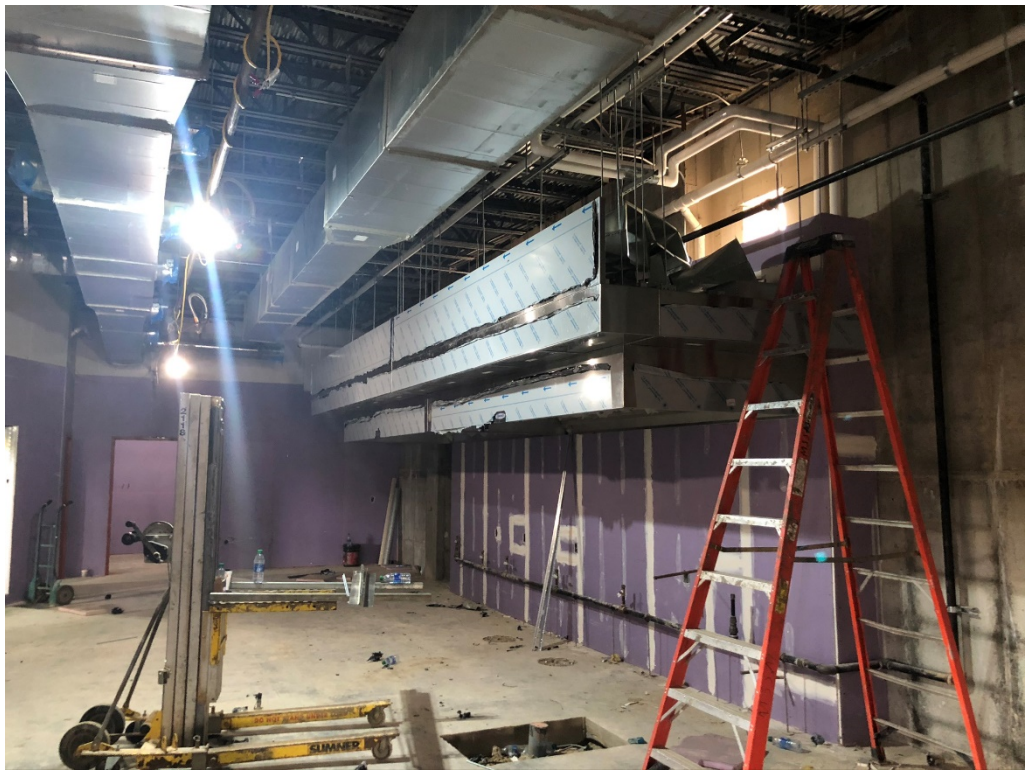
Observations Arriving on site, I entered the building from the bottom floor at the west building. At the kitchen, the commercial vent hood has been set in place. Concrete board and drywall is also being hung in this space.

Figure 4 –Vent Hood Set In Place

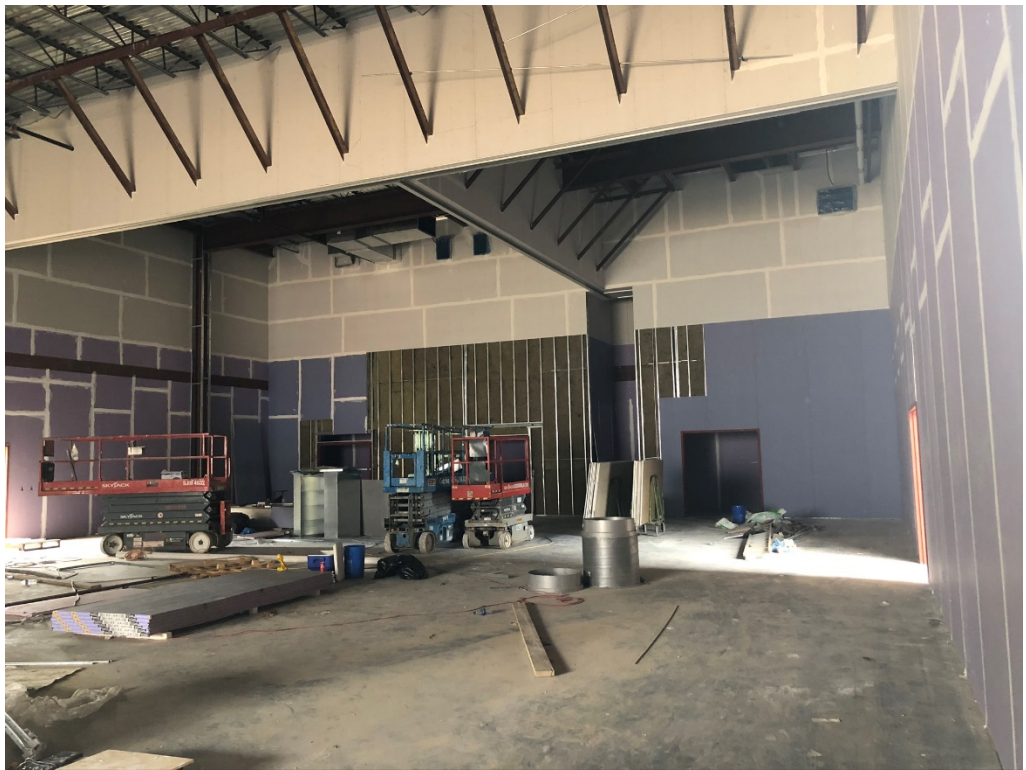
At the second level, drywall is being finished. Mudwork at the gym is taped and ongoing. Many classrooms are partially mudded and some public spaces have mud work begun.

Figure 6 – Gym Drywall Mud Work

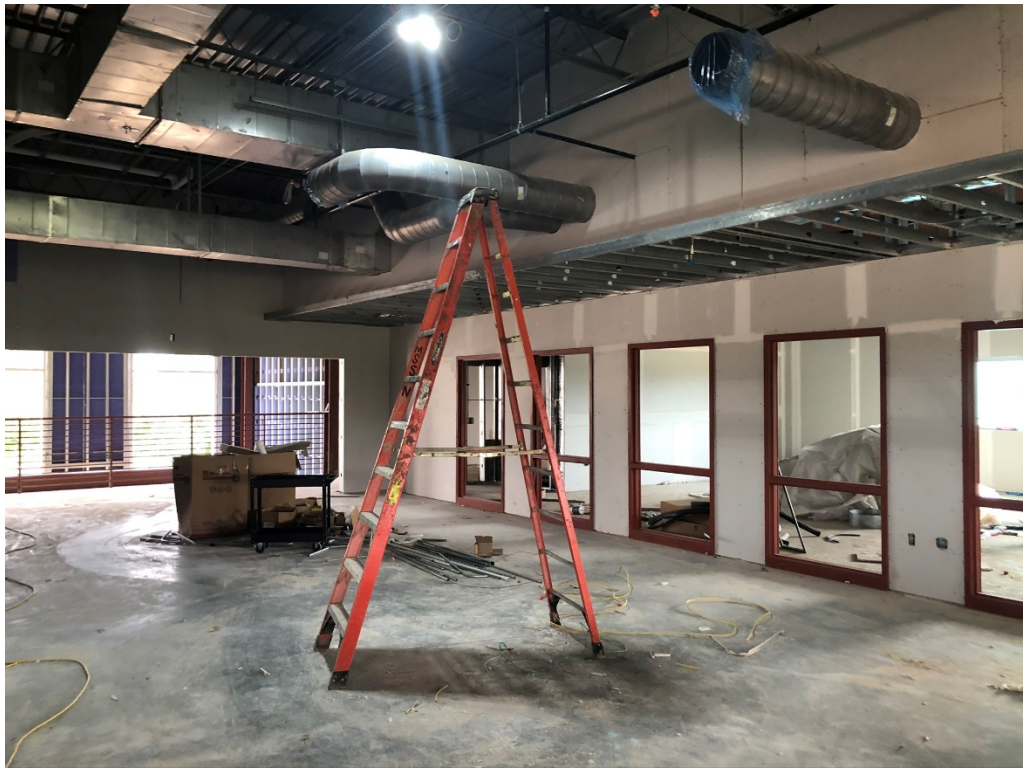
Figure 9 – HVAC Ducting Is On Going

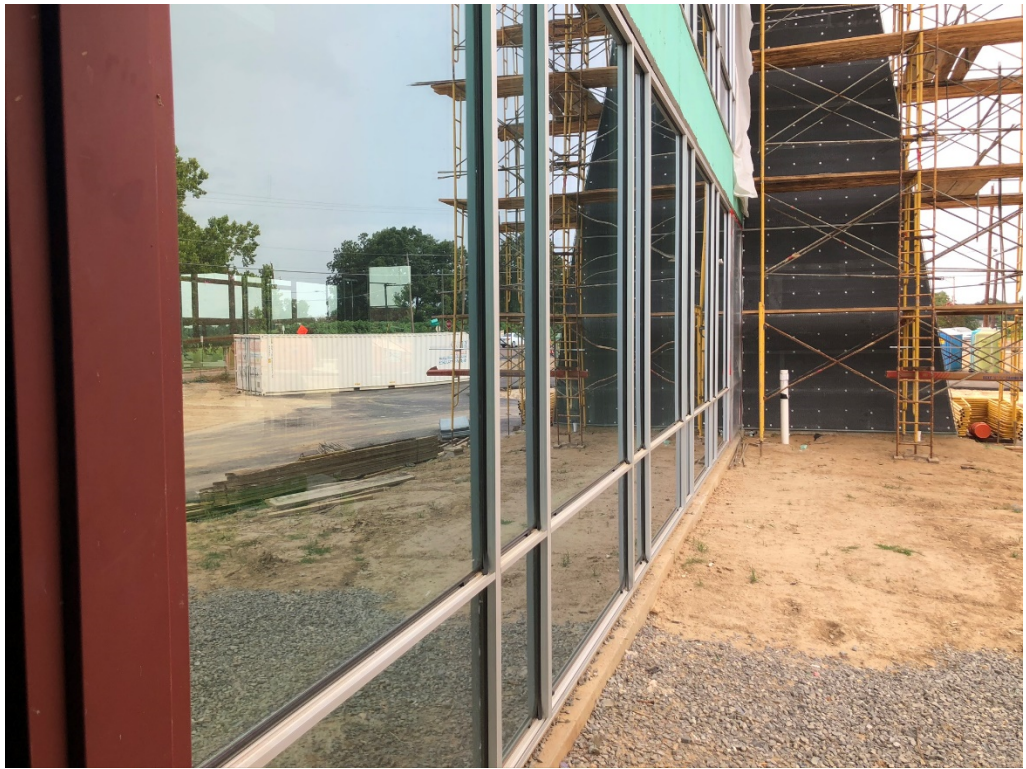
Figure 11 – East Elevation Glass Installed

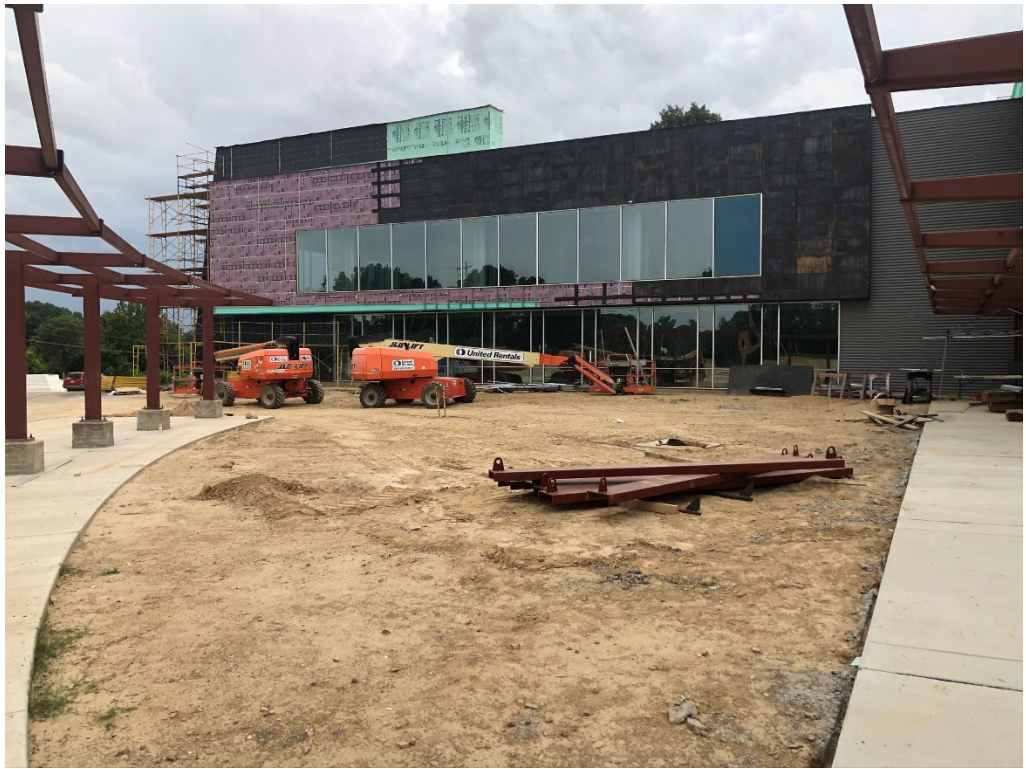
At the North elevation of the eastern most section of building, there is a glass panel that is off-colored. This Panel requires replacement.

Figure 13 – North Elevation Metal Siding Installation is Ongoing; at the second level furthest panel to the right, glass is off colored and requires replacement
