Architect's Field Report

201 Park Court, Suite B Ridgeland, MS 39157 P 601.790.9432 F 888.281.0547	04 September 2020 18059-AOI Academy of Innovation / Report Number 045
One Jackson Place, Suite 250 188 East Capitol Street Jackson, MS 39201-2100 P 601.352.5411 F 601.352.5362	Contract Century Construction Date / Time 02 September 2020 / 5:00 PM Weather / Temp Partly cloudy / 90 ° F Est % Complete 60% Sched Conformance + 68 days Work in Progress Mechanical Installation Drywall Finishing Courtyard Layout Exterior Panel Installation Exterior Stucco Substrates Installation
161 Lameuse Street, Suite 201 Biloxi, MS 39530 P 228.374.1409 F 228.374.1414	Present at Site Joey Moore, CC Paul Purser, DBA Observations Arriving on site, I entered the building from the north; installers were at work putting together metal panels at the exterior. Inside, bathrooms are ongoing. Concrete board has been installed in many of them and is nearing completion. In the gymnasium, finishers were at work. Drywall is nearing level 3 completion in this space. At the exterior rear courtyard, concrete work is ongoing. Seating Walls have been formed and poured. Layout for the remainder of the concrete work in ongoin

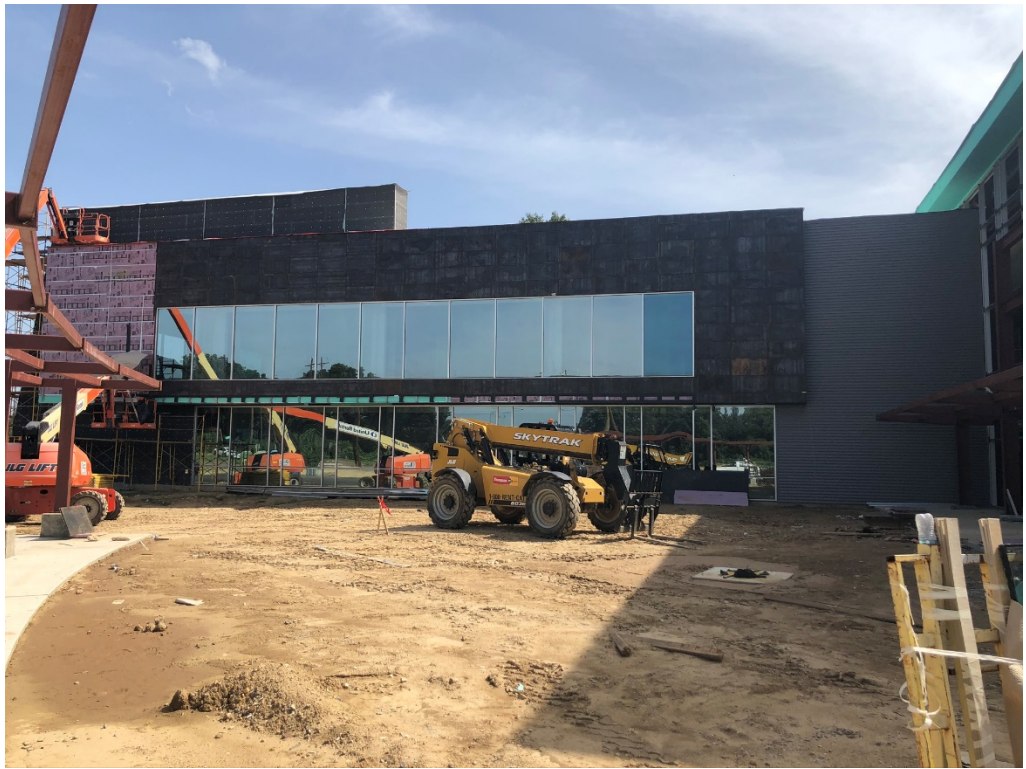
Figure 1 – Metal Siding Installed

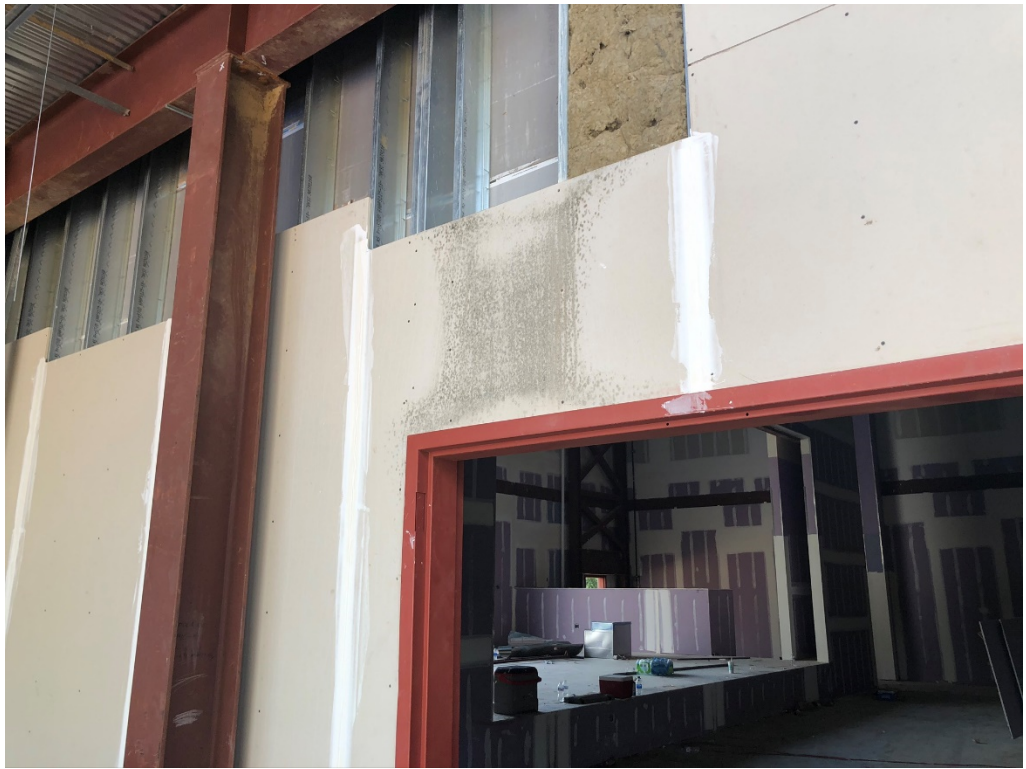
Figure 9 – Mildewed Drywall Panel Requires Remediation

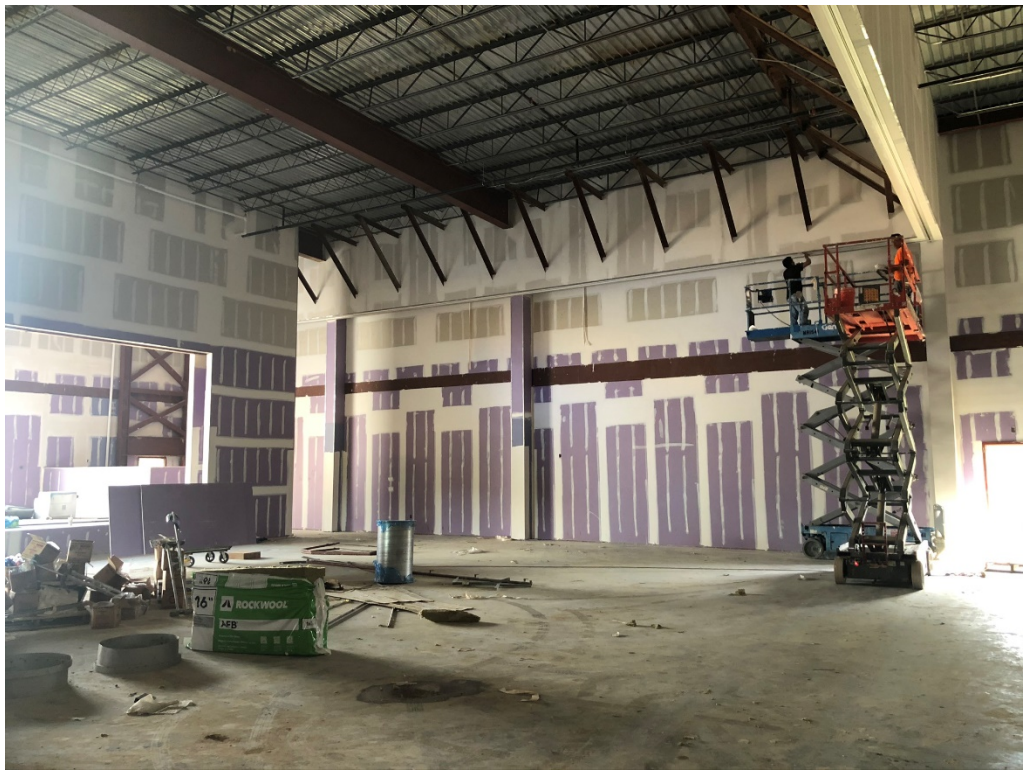
Figure 10 – Gym Drywall Finishing

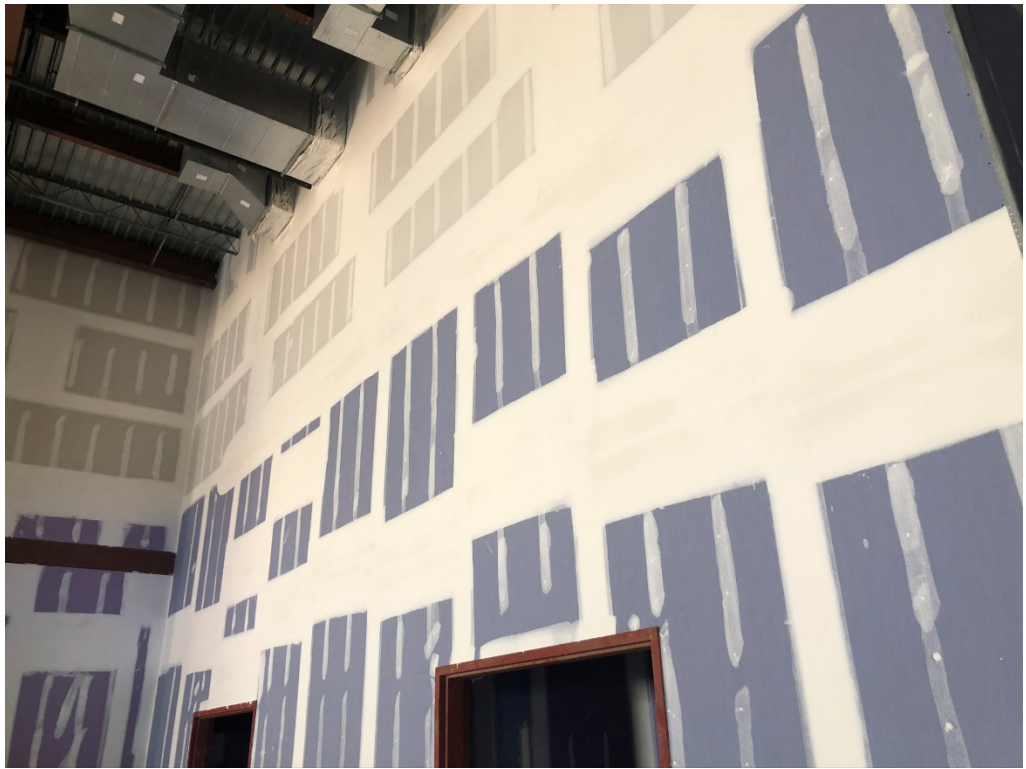
Figure 11 – Gym Drywall Finishing

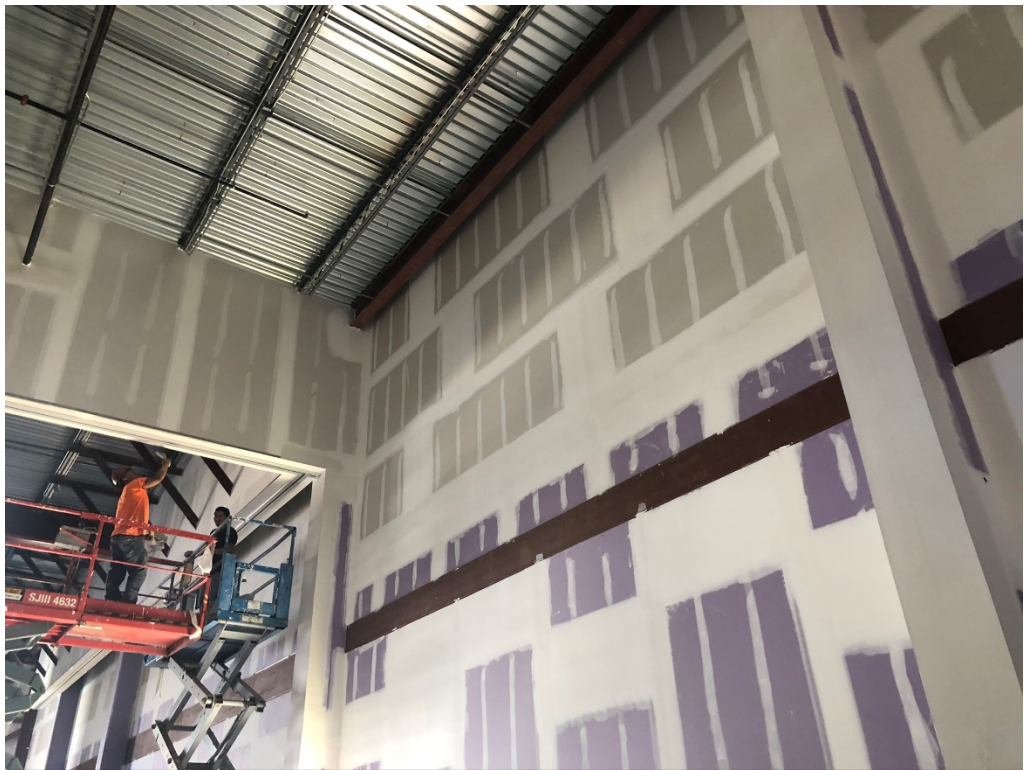
Figure 12 – Gym Drywall Finishing

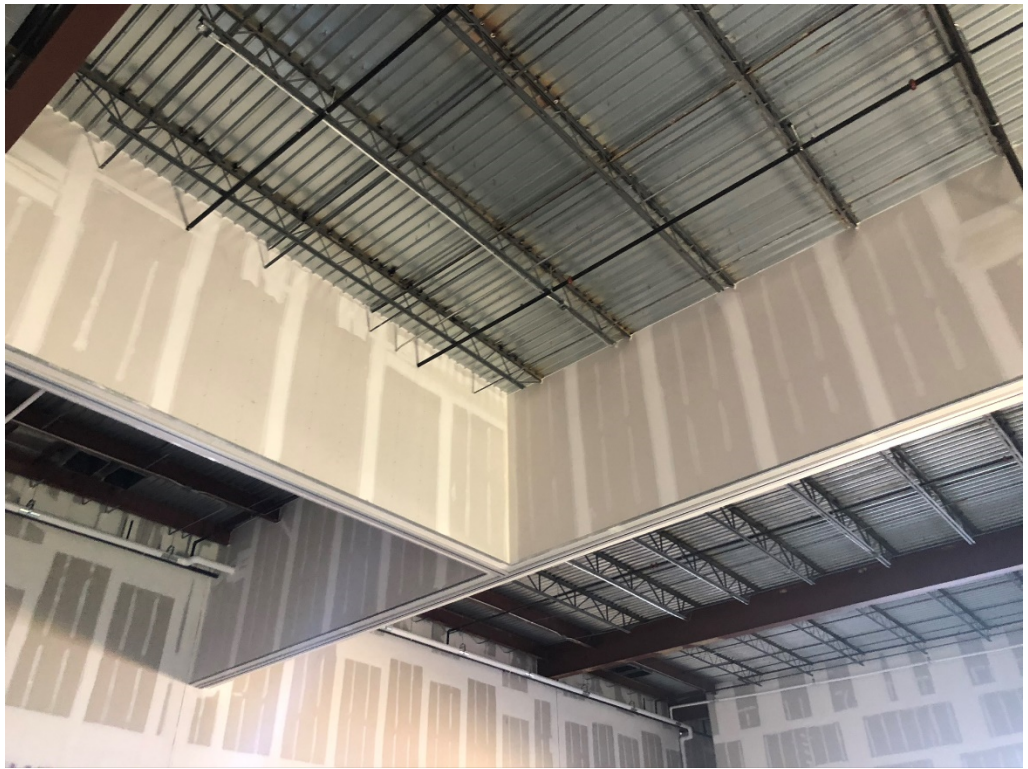
Figure 13 – Gym Drywall Finishing

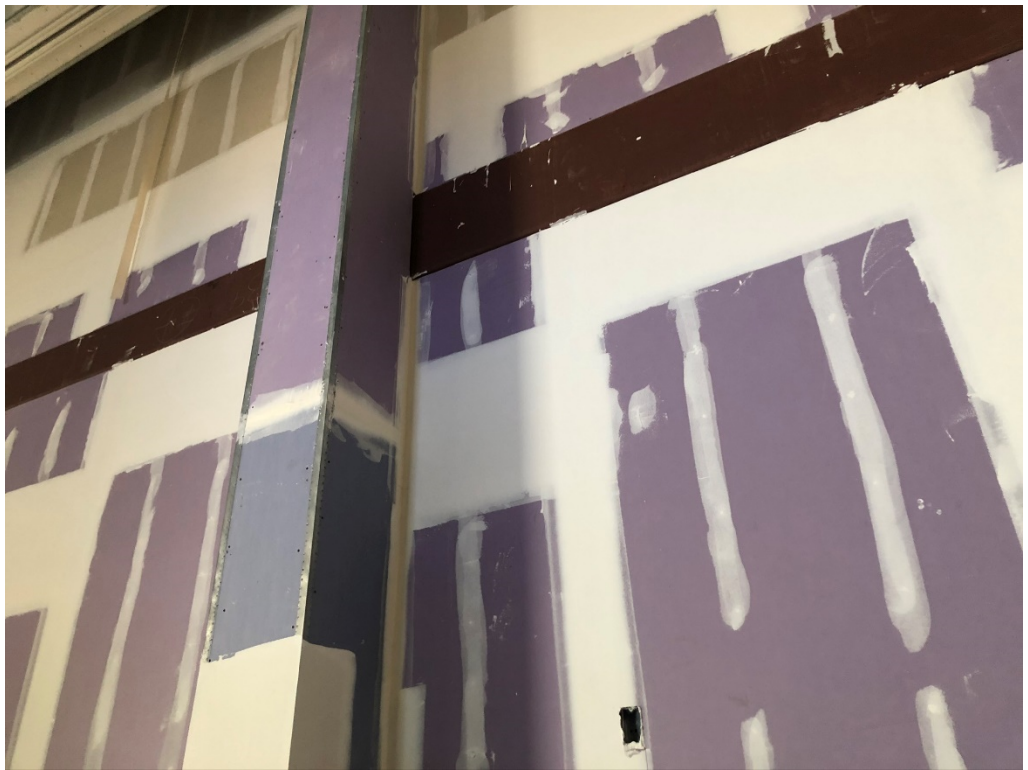
Figure 14 – Gym Drywall Finishing

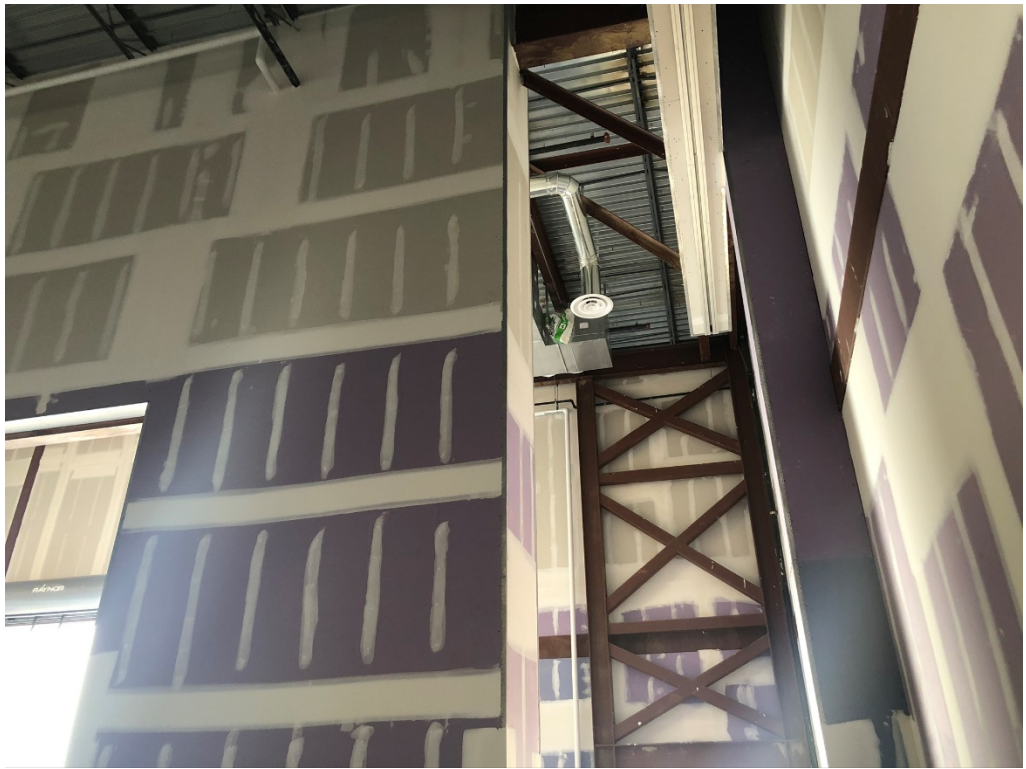
Figure 15 – Gym Drywall Finishing

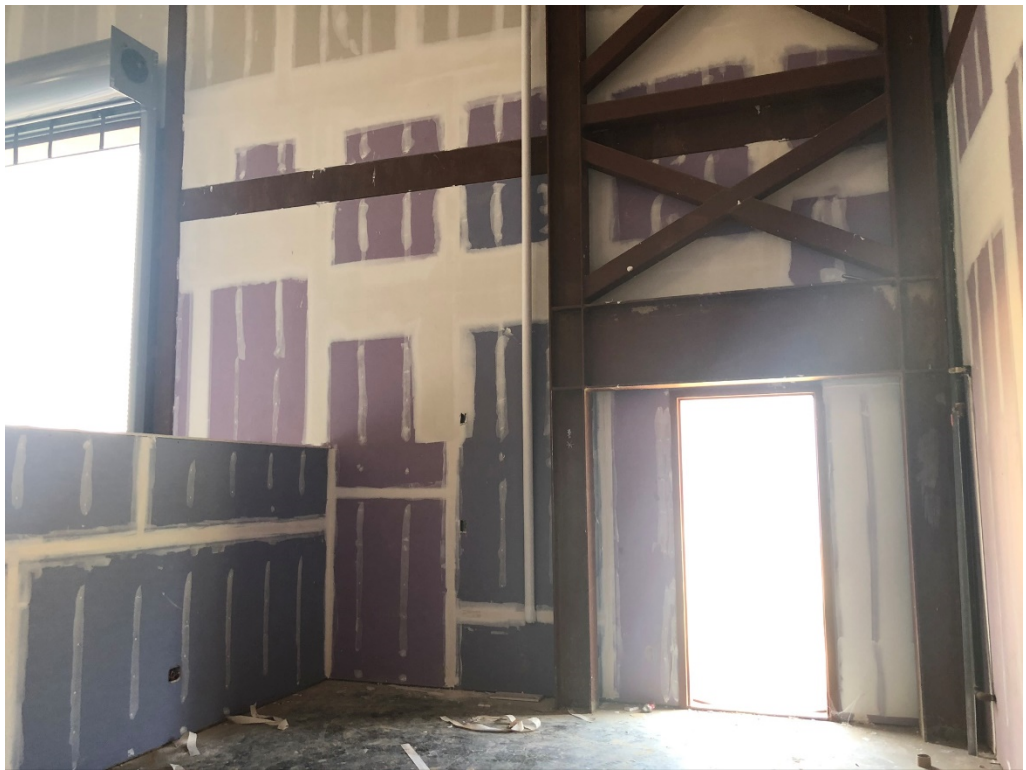
Figure 16 – Gym Drywall Finishing

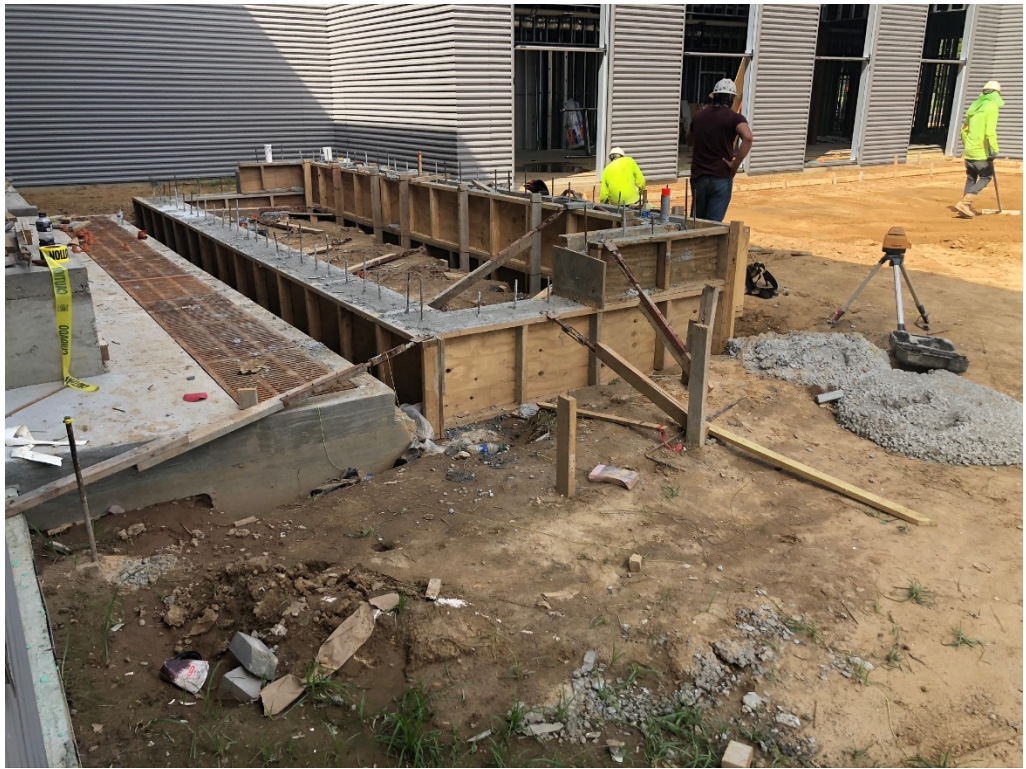
Figure 17 – Concrete Work at Rear Courtyard

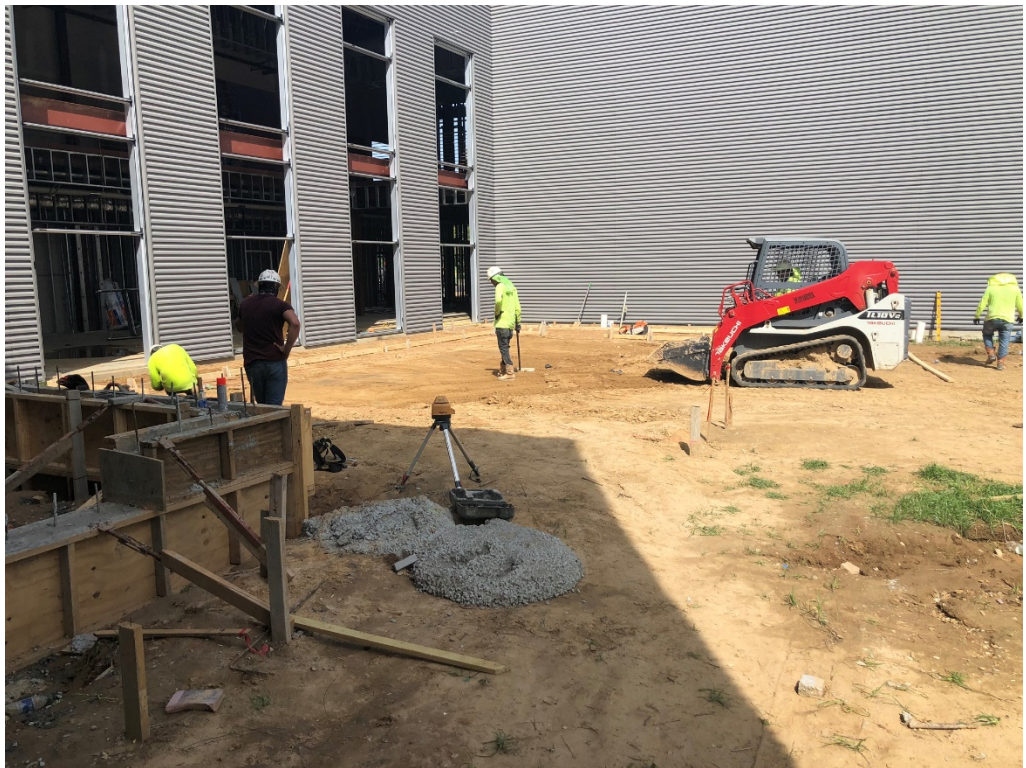
Figure 18 –Rear Courtyard Layout

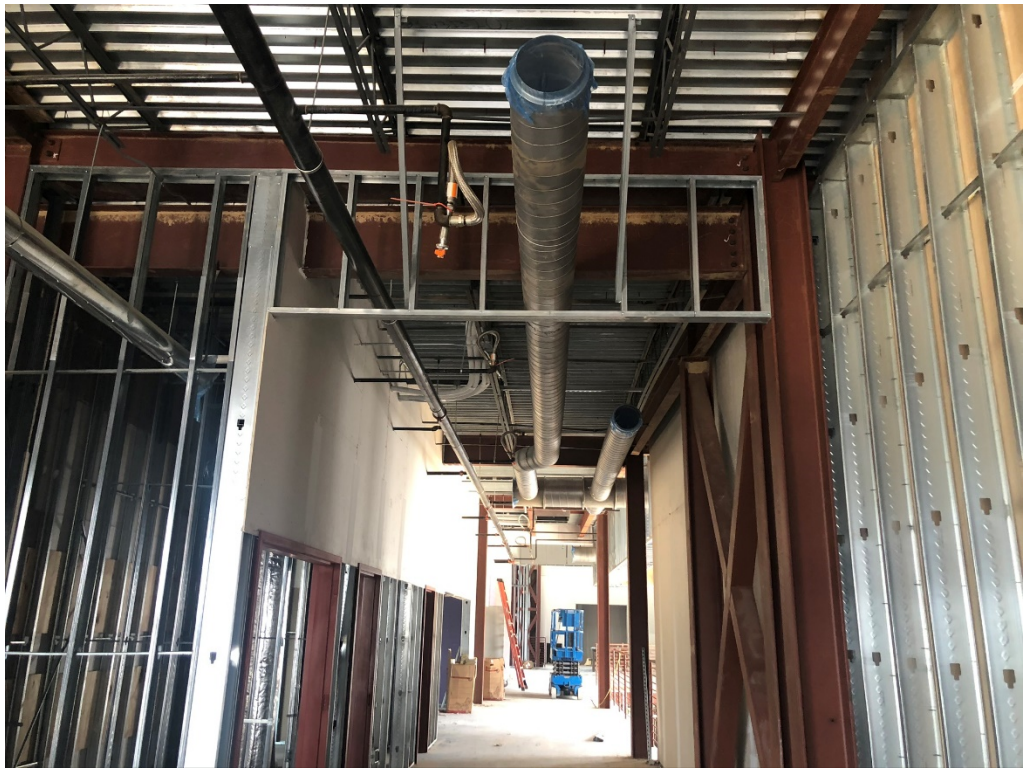
Figure 19 – HVAC is Ongoing

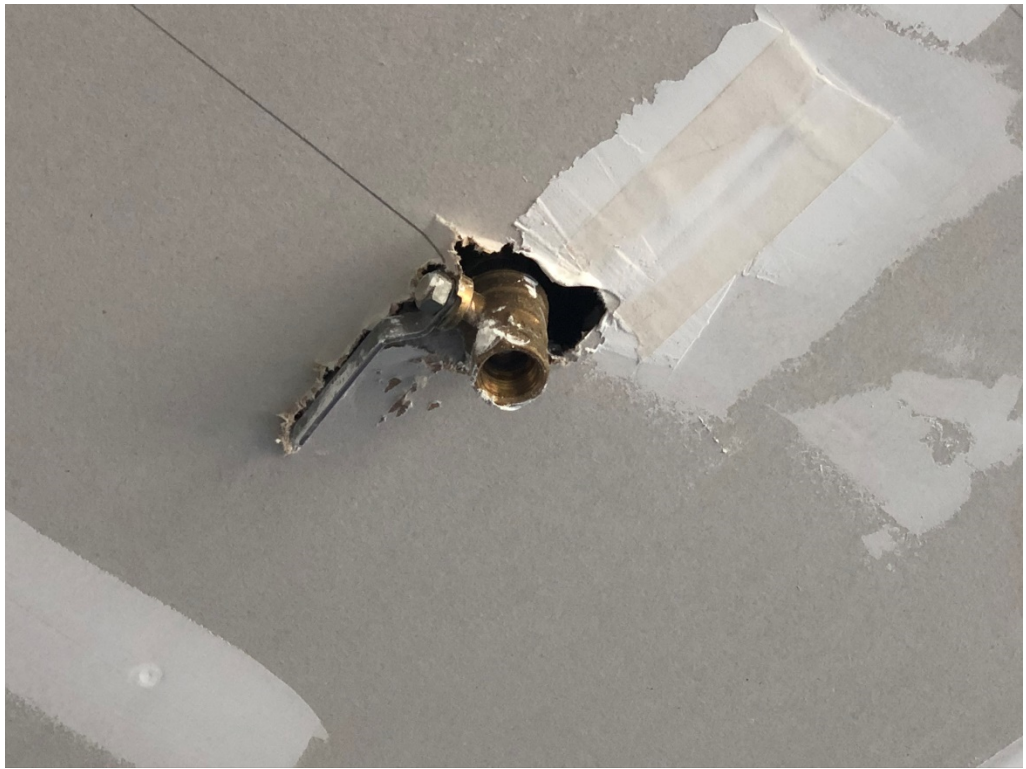
Figure 25 – Conflict with Cut Off (Is this a permanent installation?)

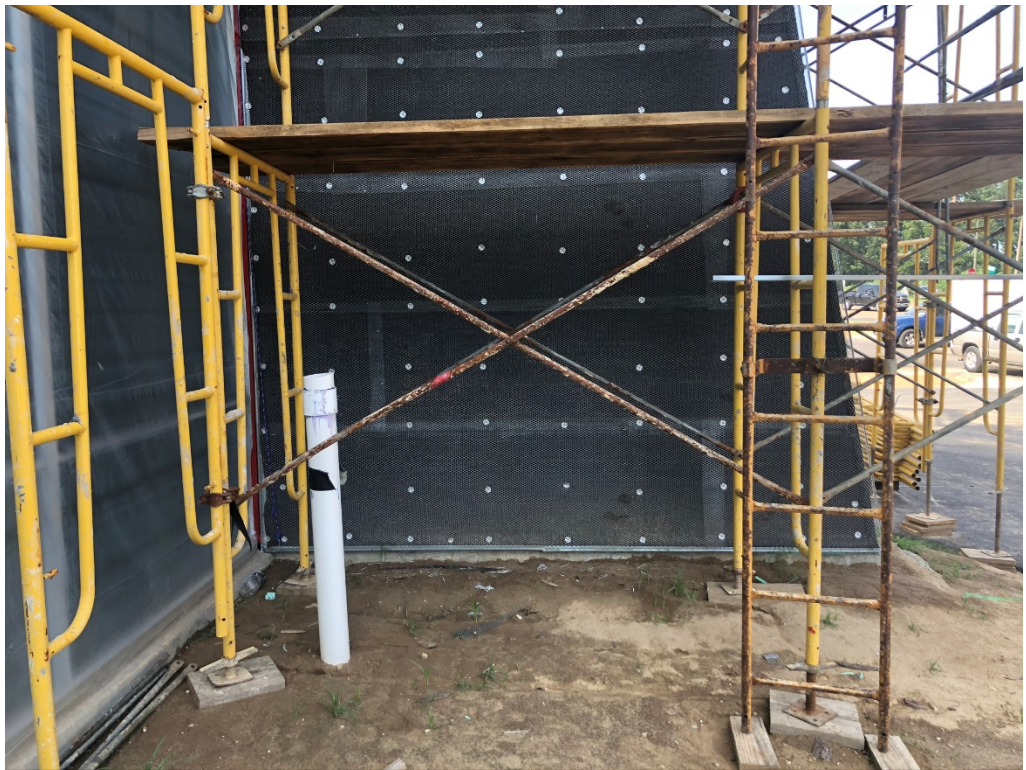
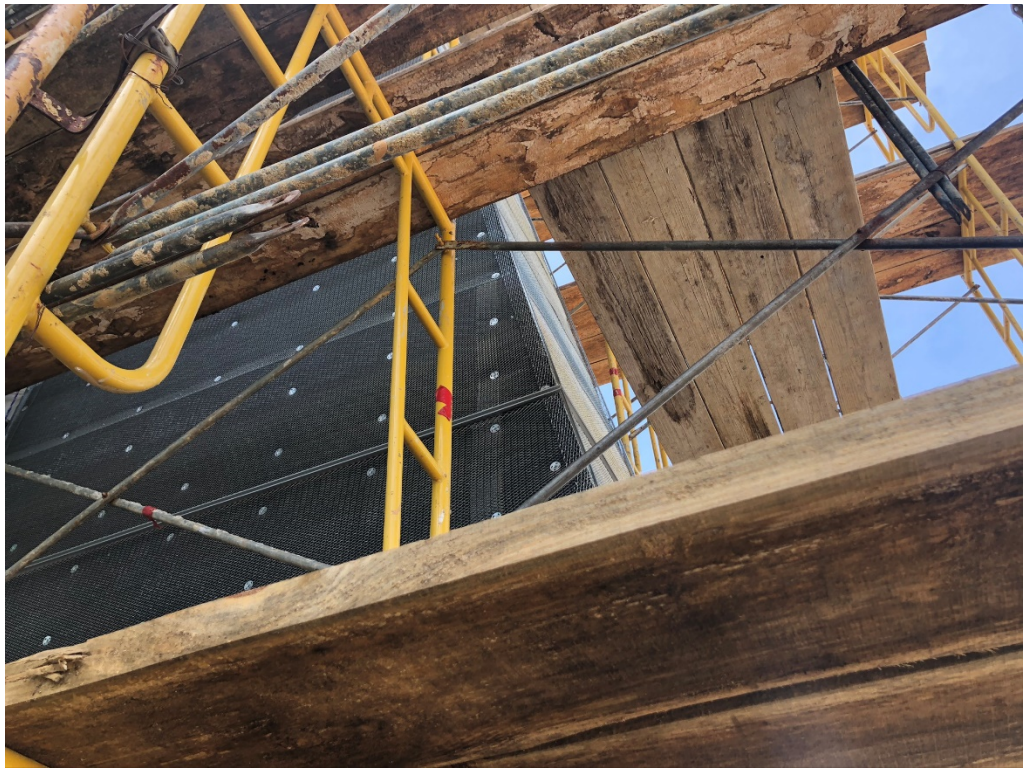
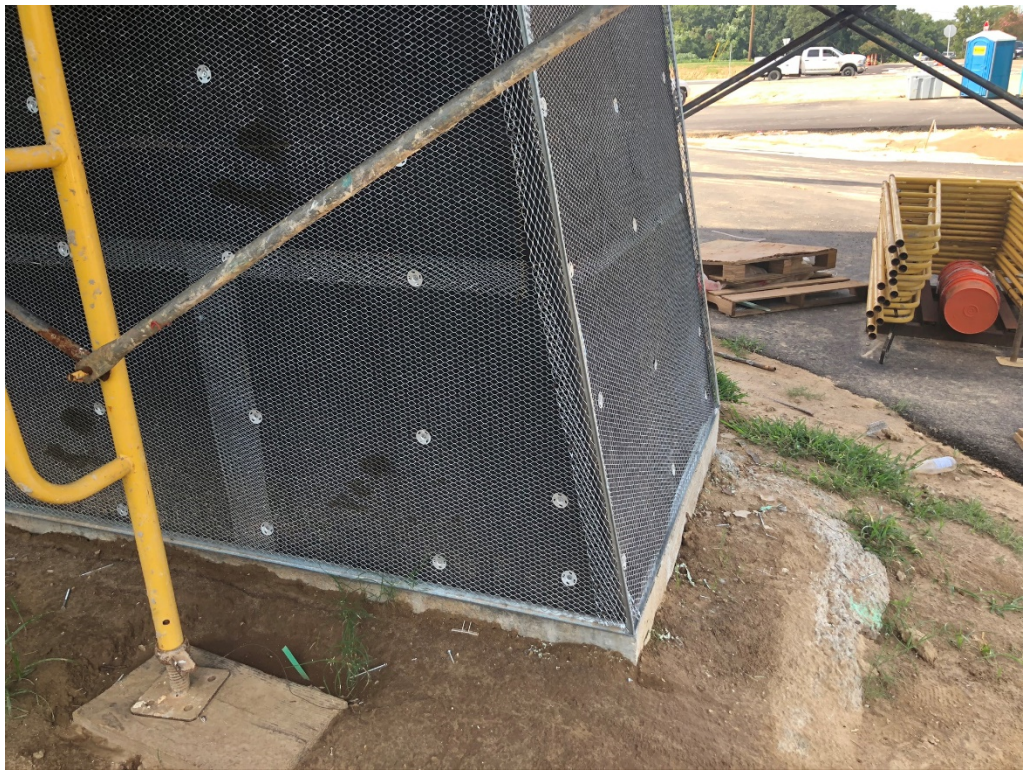
Figure 26 – Stucco Lathe Installed

Figure 27 – Stucco Lathe Installed

Figure 28 – Stucco Lathe Installed
