Architect's Field Report

18 September 2020

18059-AOI Academy of Innovation / Report Number 046

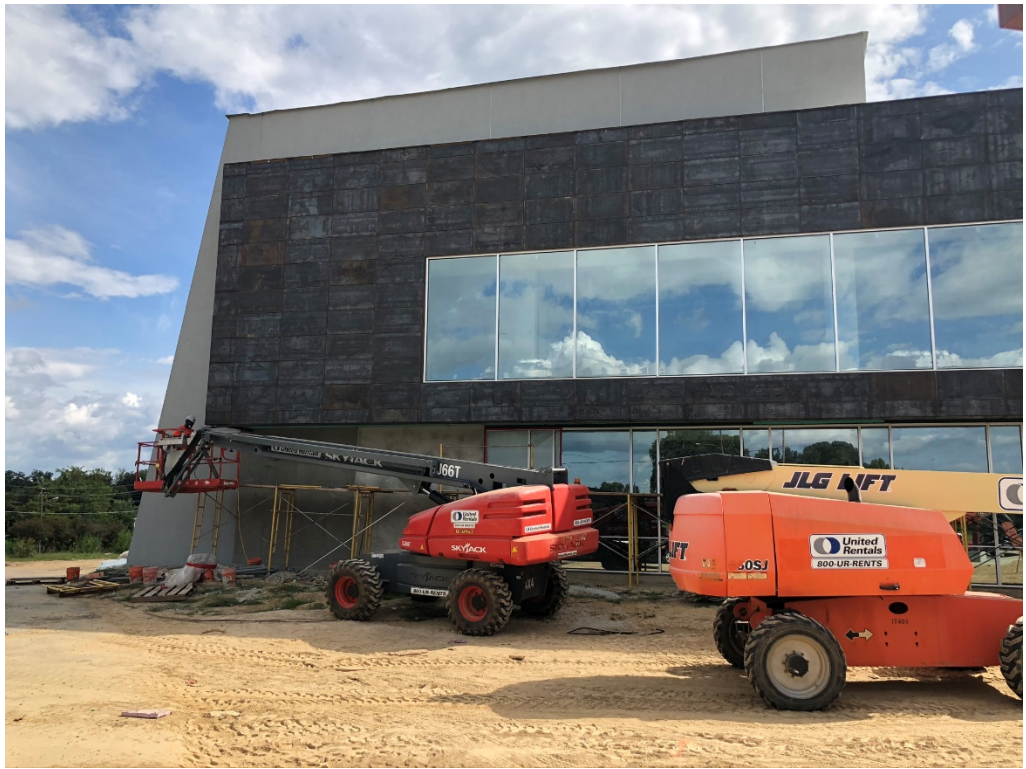
Observations Arriving on site, I noted Steel Paneling was nearing completion at the North façade of the east side of the building. One worker on a man lift was trimming out the final few panels.

Figure 1 – Metal Siding Installed

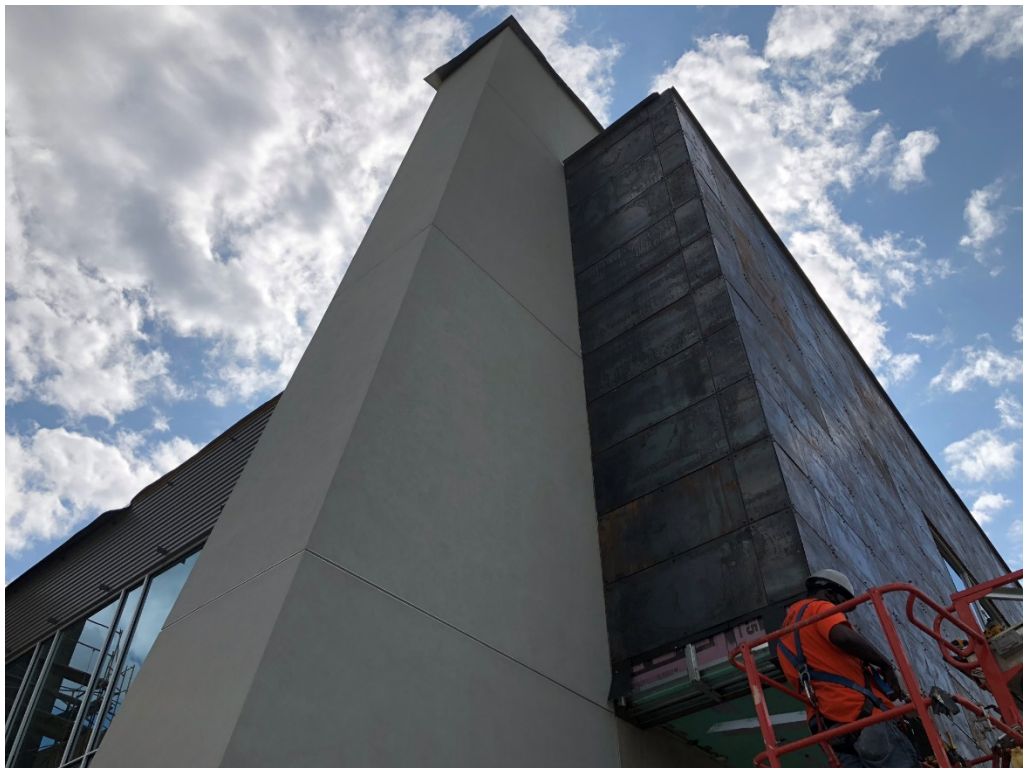
Stucco work at the same location has been completed and appears smooth and straight. Workers has reassembled scaffold to the south corner of the east façade and have begun stucco work there.

Figure 2 – Stucco Complete at Corner

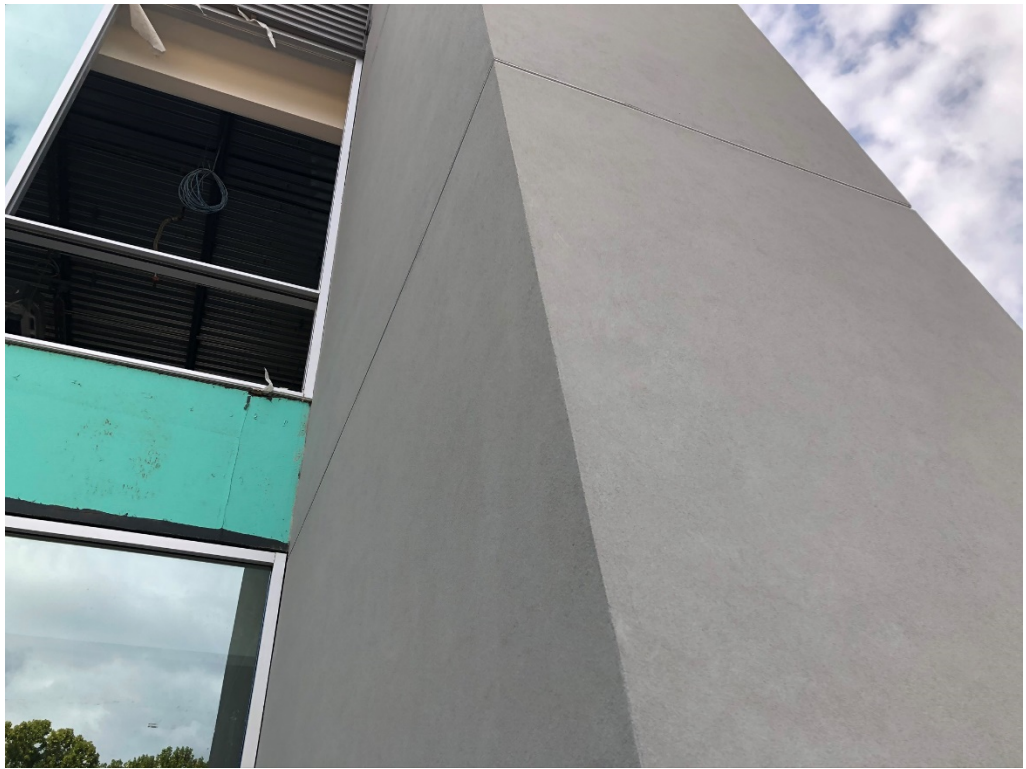
Figure 3 – Corners appear Straight and of good workmanship

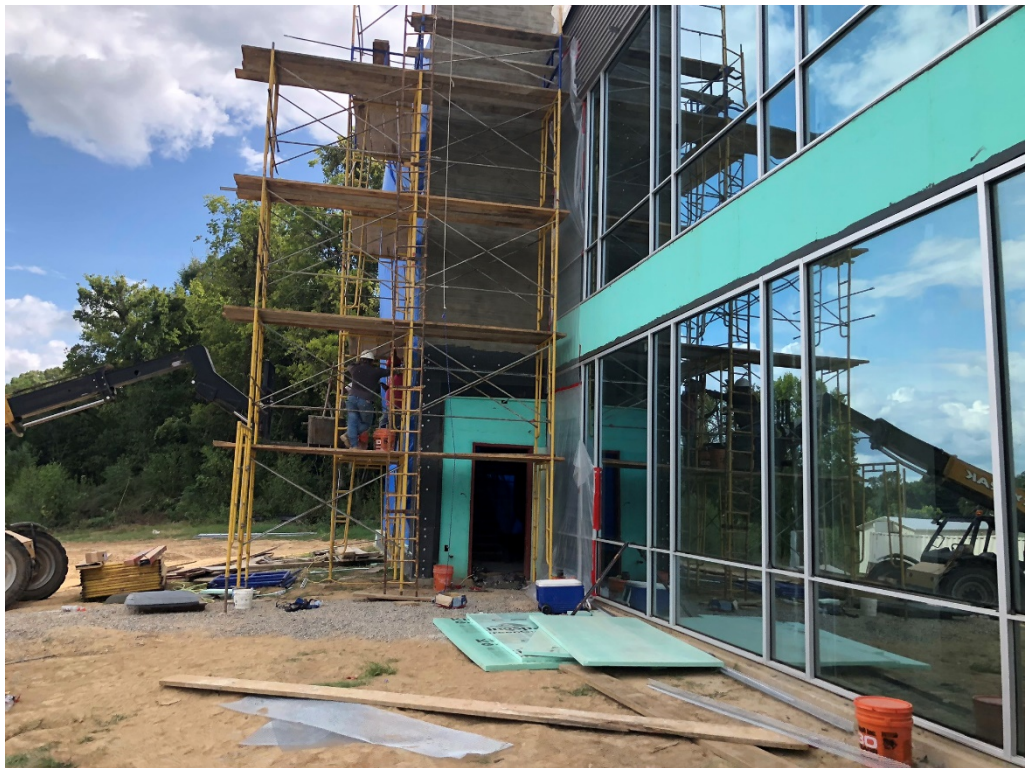
Figure 4 –Stucco at South Corner Ongoing

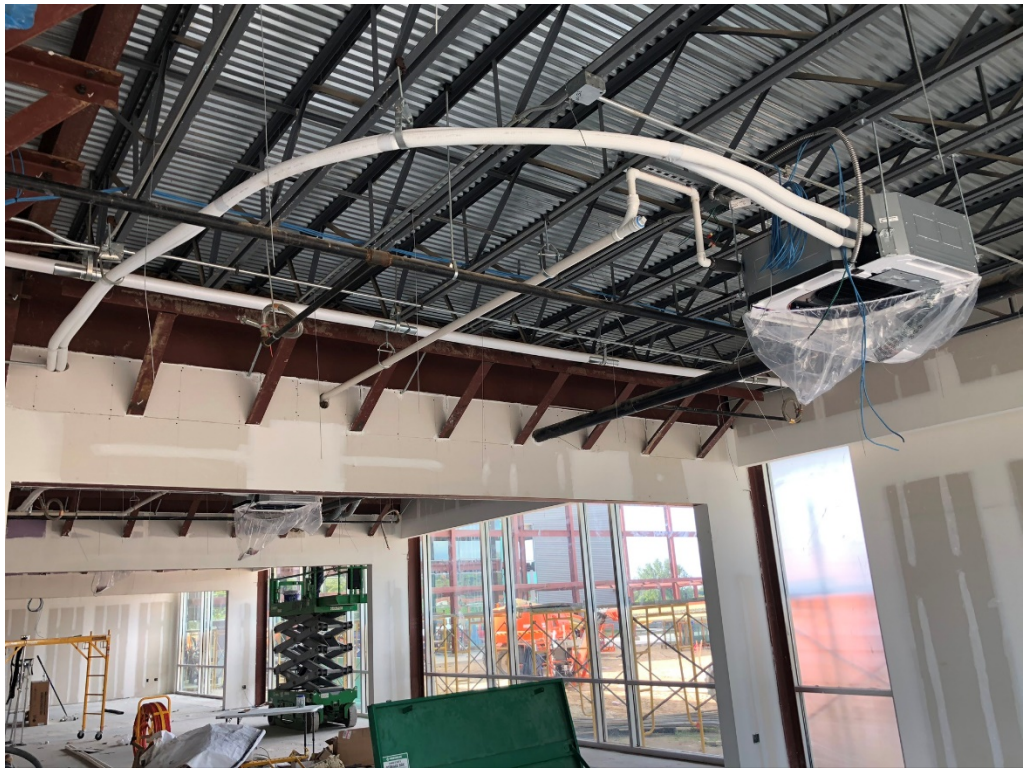
At the bottom floor, metro mechanical workers are fitting duct and continuing install of mechanical systems.

Figure 5 – HVAC Lines Installed

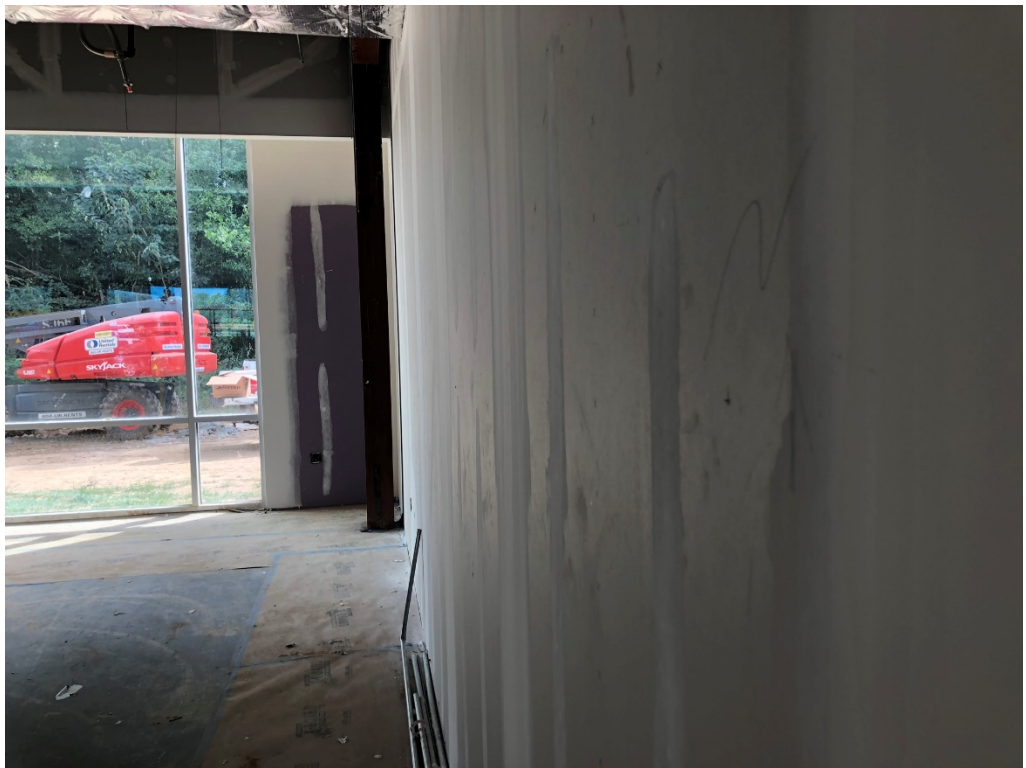
Figure 6 – Drywall Finishing is Ongoing

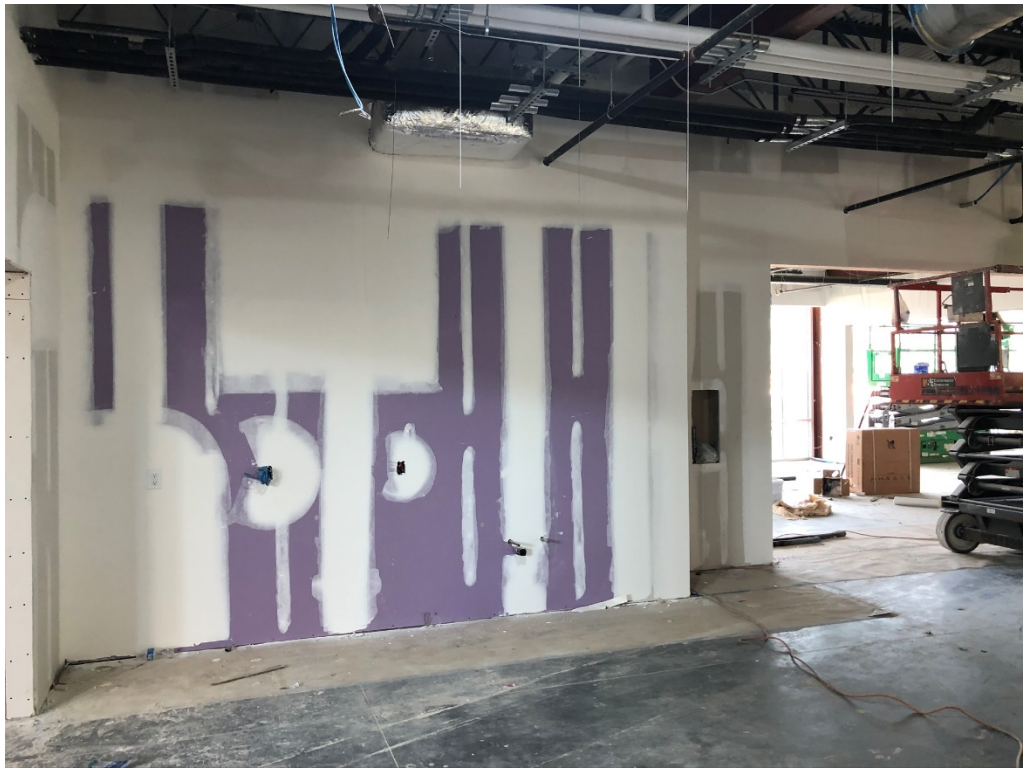
Figure 7 – Drywall Finishing is Ongoing

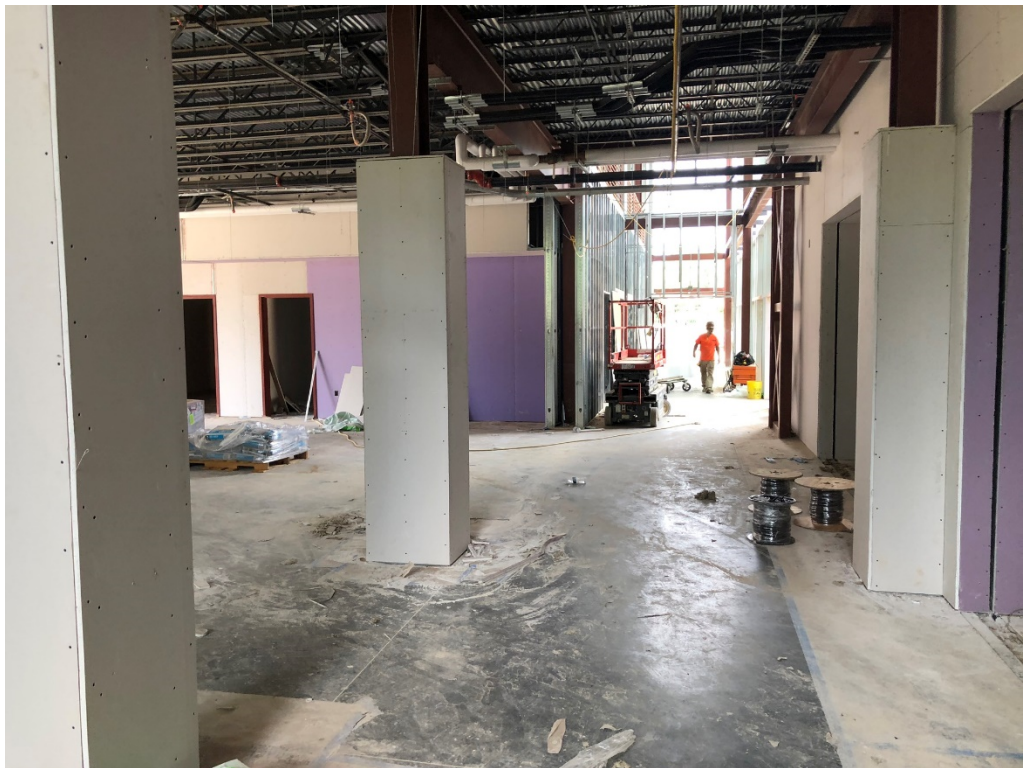
Figure 8 – Drywall Installation is Ongoing

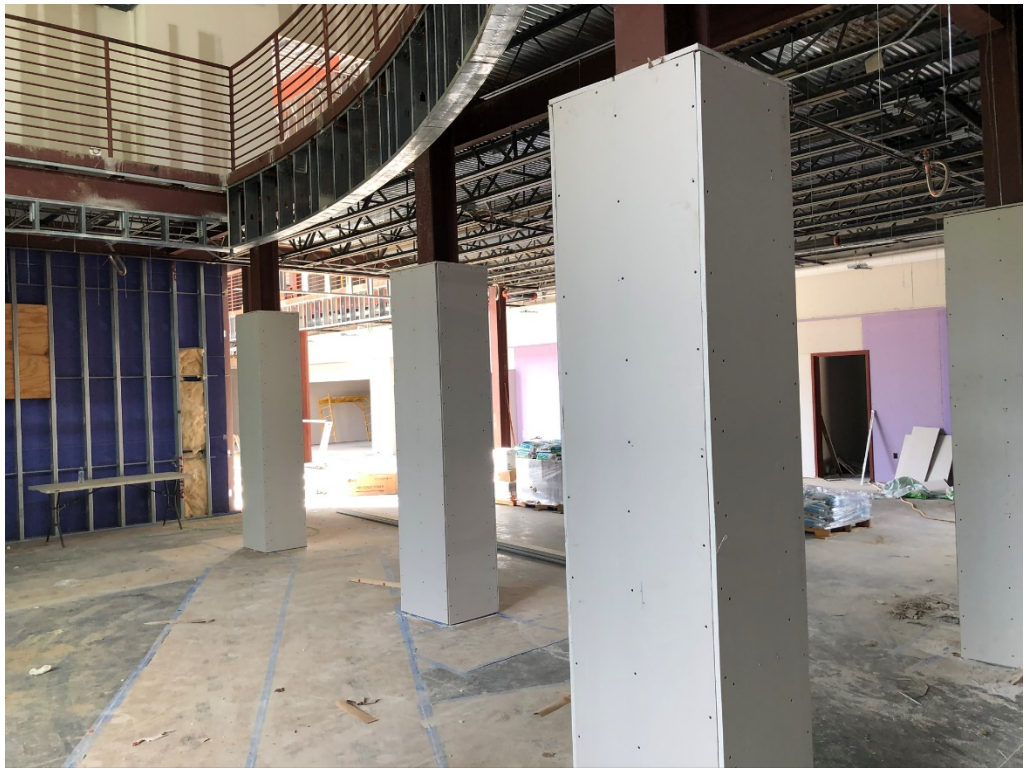
Figure 9 – Drywall Installation is Ongoing

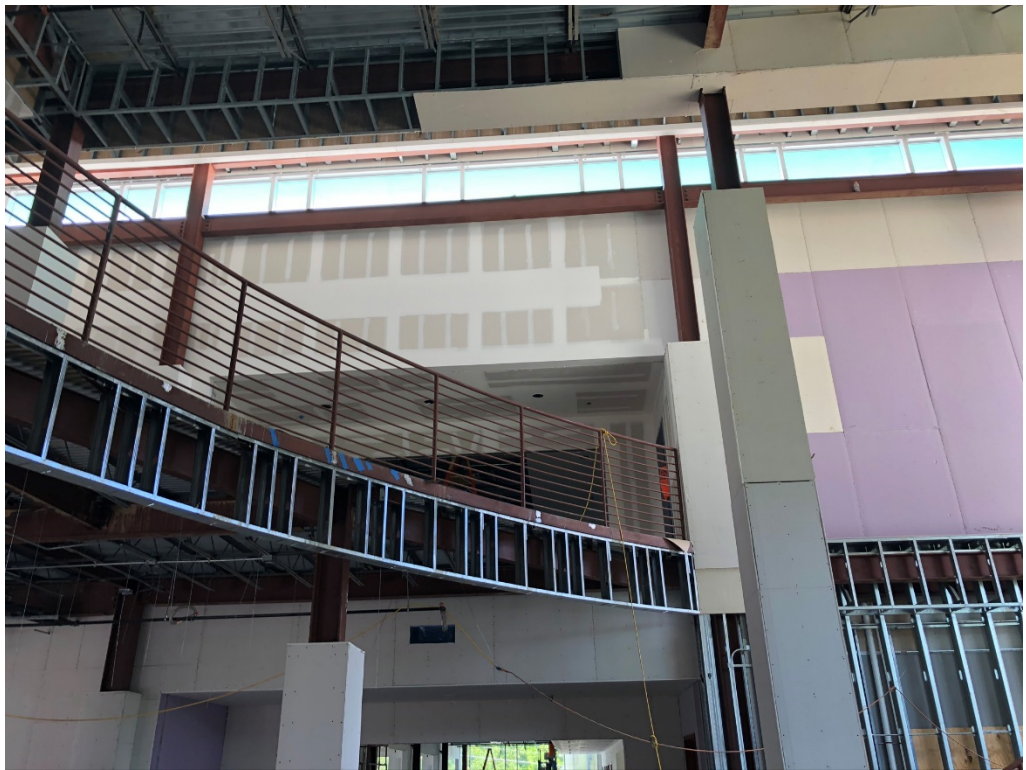
Figure 10 – Drywall Installation is Ongoing

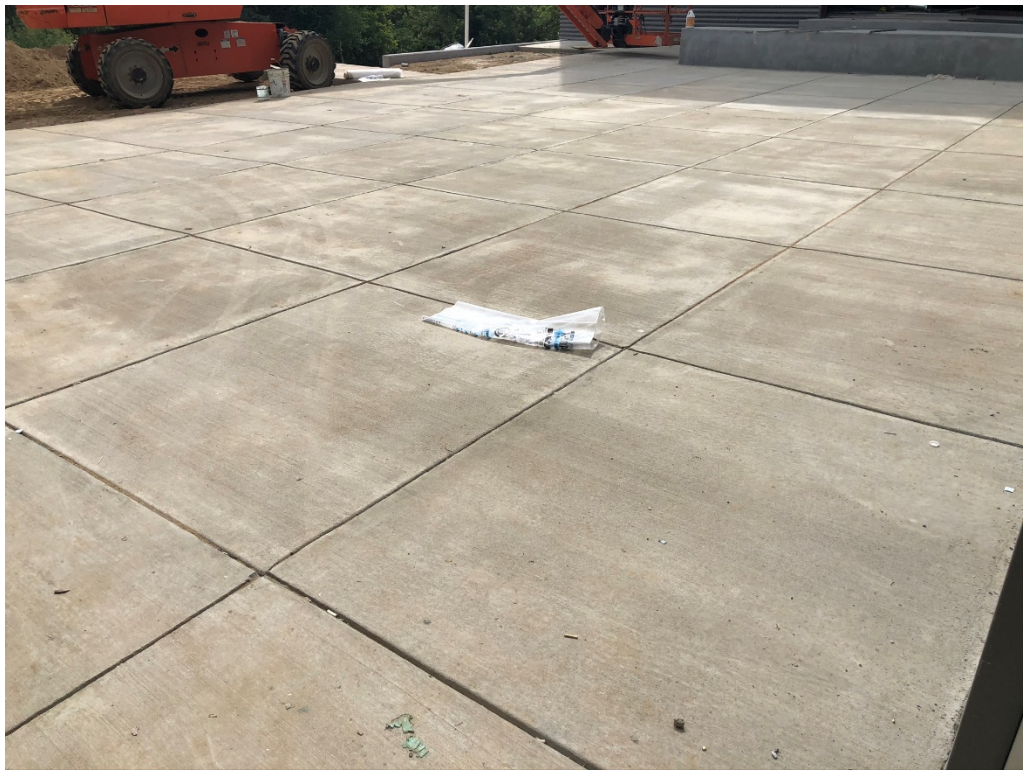
Figure 12 – Exterior Courtyard Concrete Work

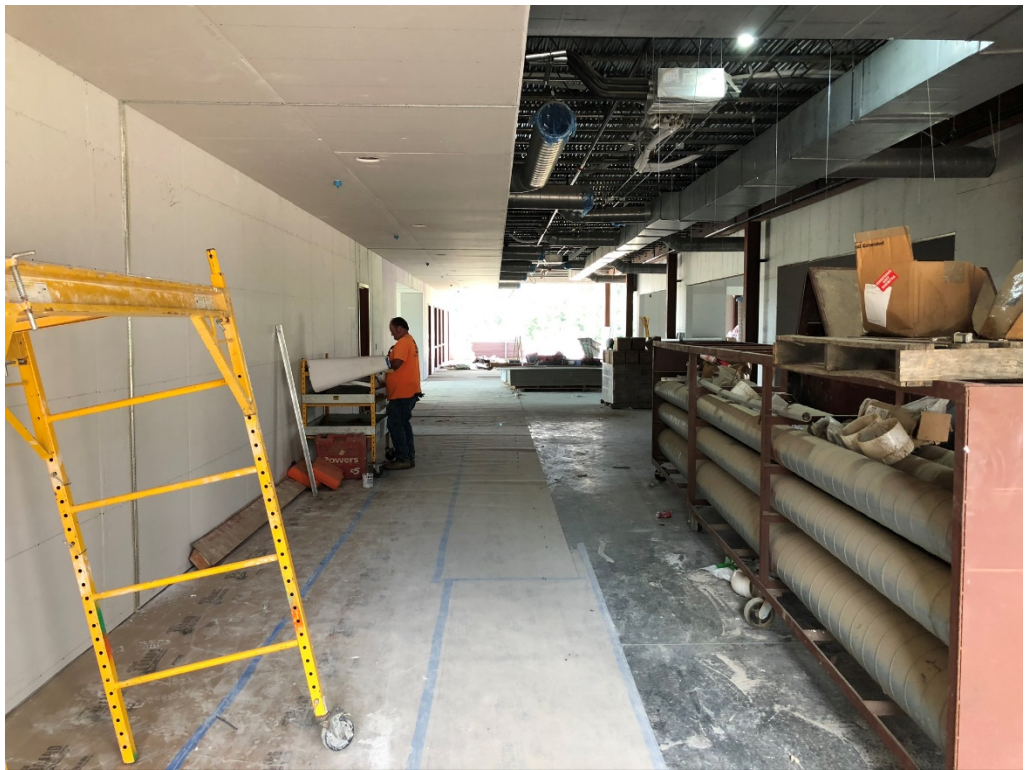
Figure 14 – Drywall Installation is Ongoing

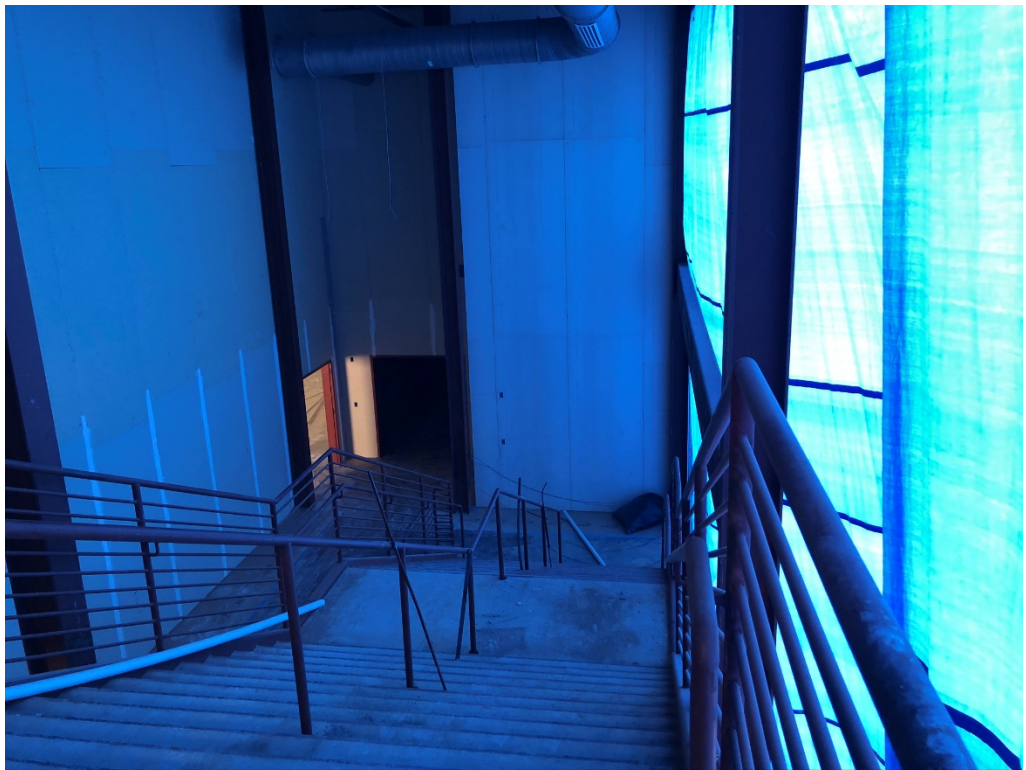
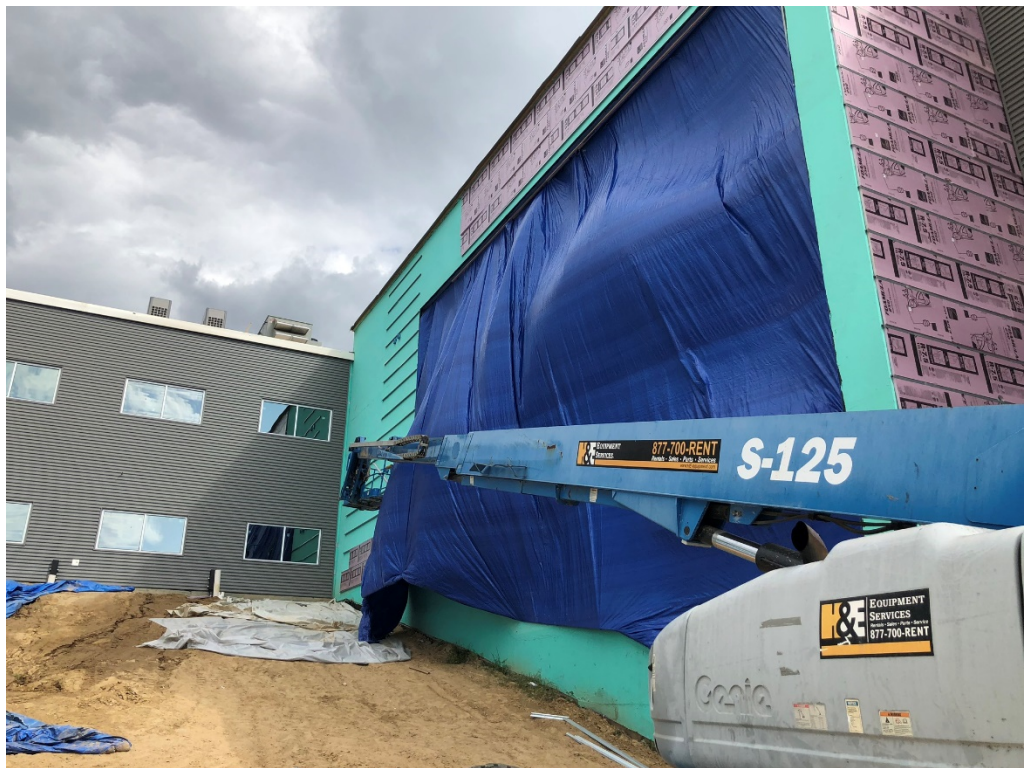
Figure 16 – Tarp has Been Installed to Protect Large Multi-Story Stair Space

Figure 17 – Tarp has Been Installed to Protect Large Multi-Story Stair Space

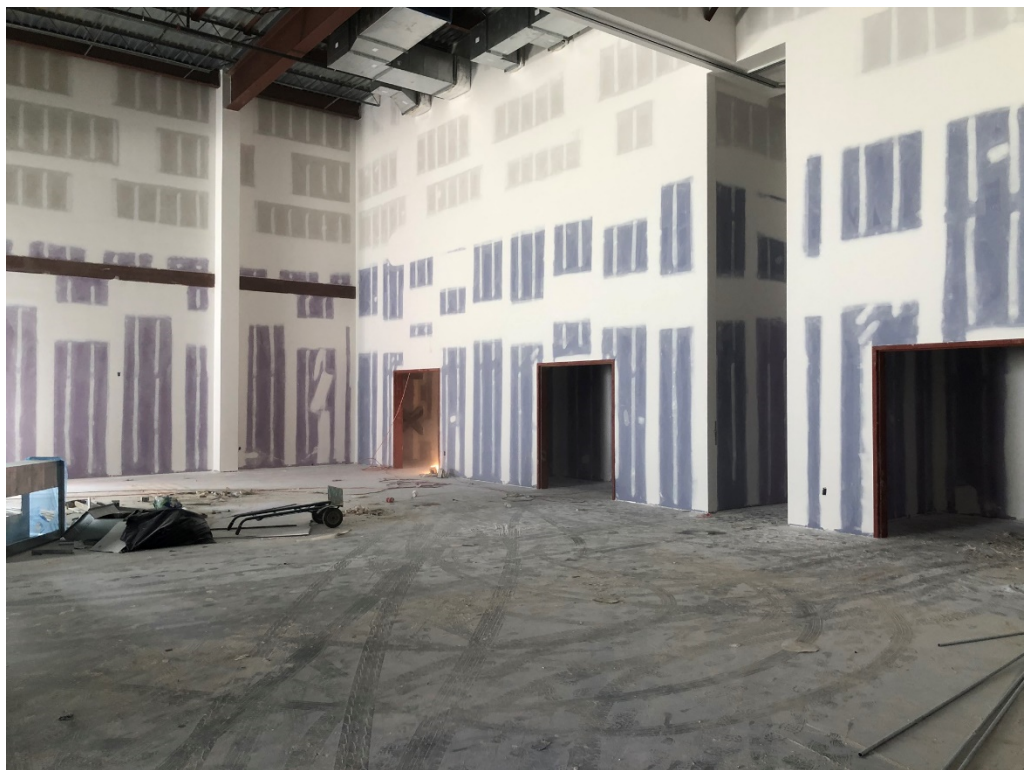
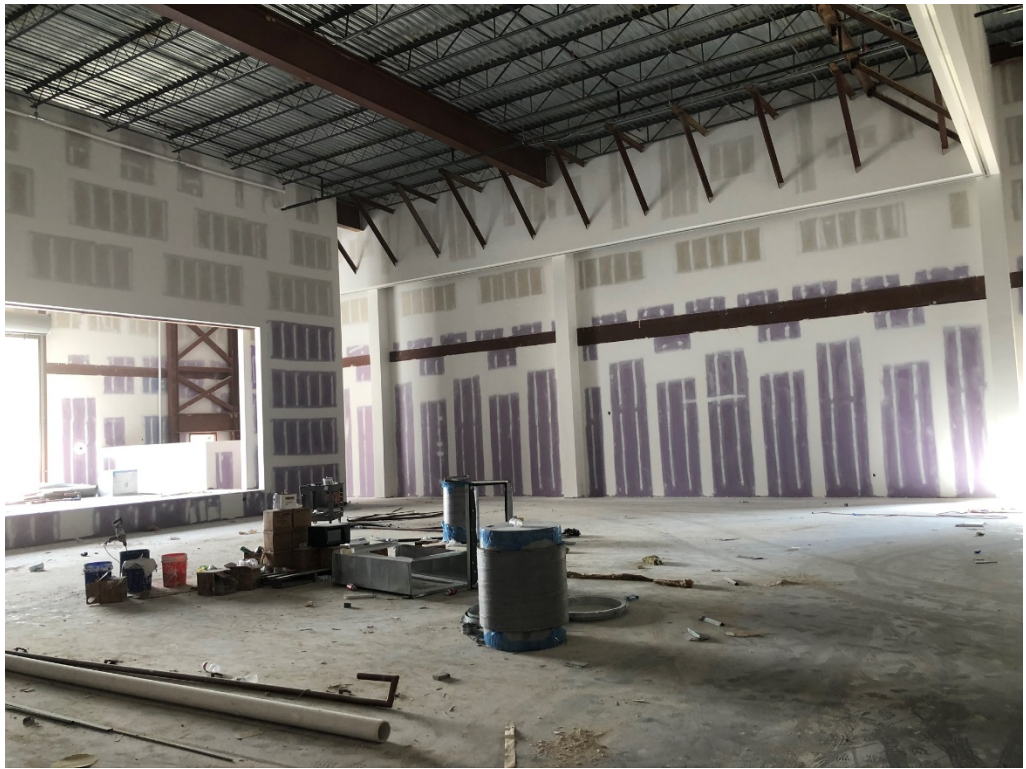
Figure 18 –Auditorium Drywall Finishing is Ongoing

Figure 19 – Auditorium Drywall Finishing is Ongoing

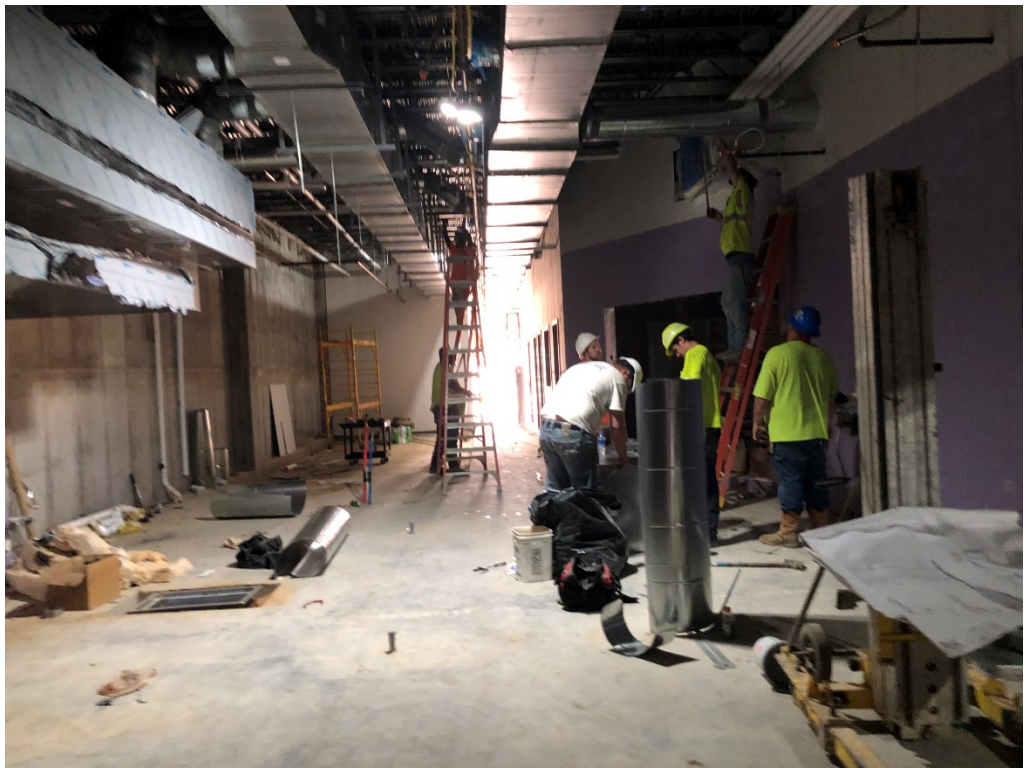
Figure 20 – Mechanical Work at Cafeteria Kitchen
