Architect's Field Report

25 September 2020

18059-AOI Academy of Innovation / Report Number 047

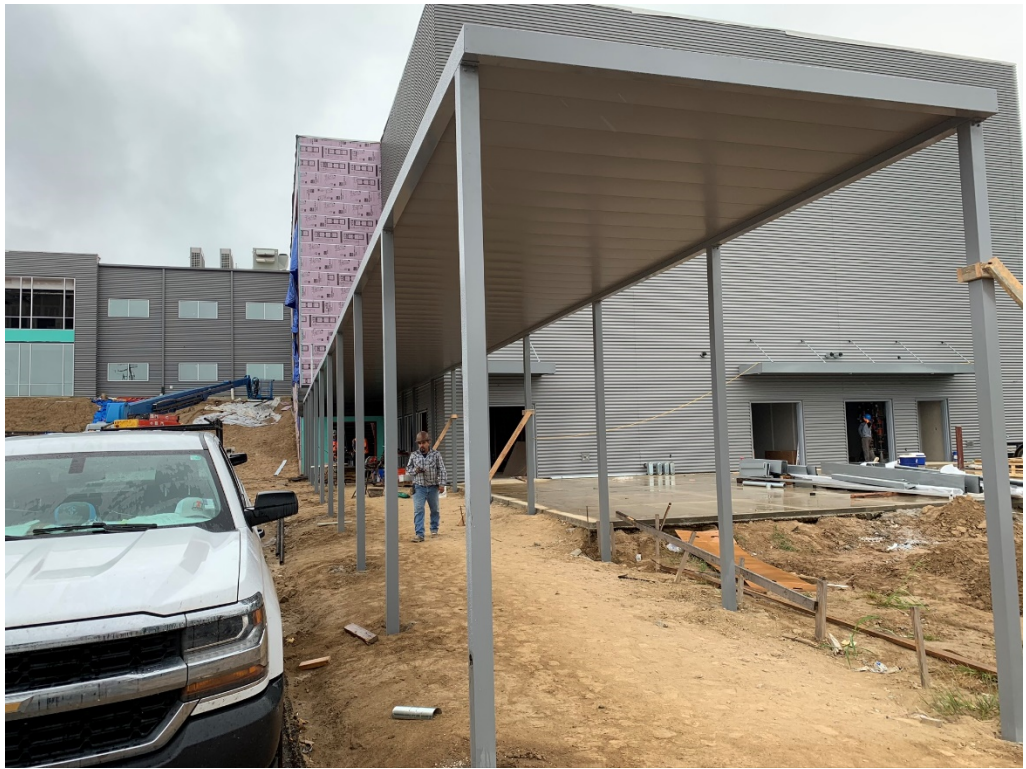
Figure 1 – Metal Drop Off Awning Installed

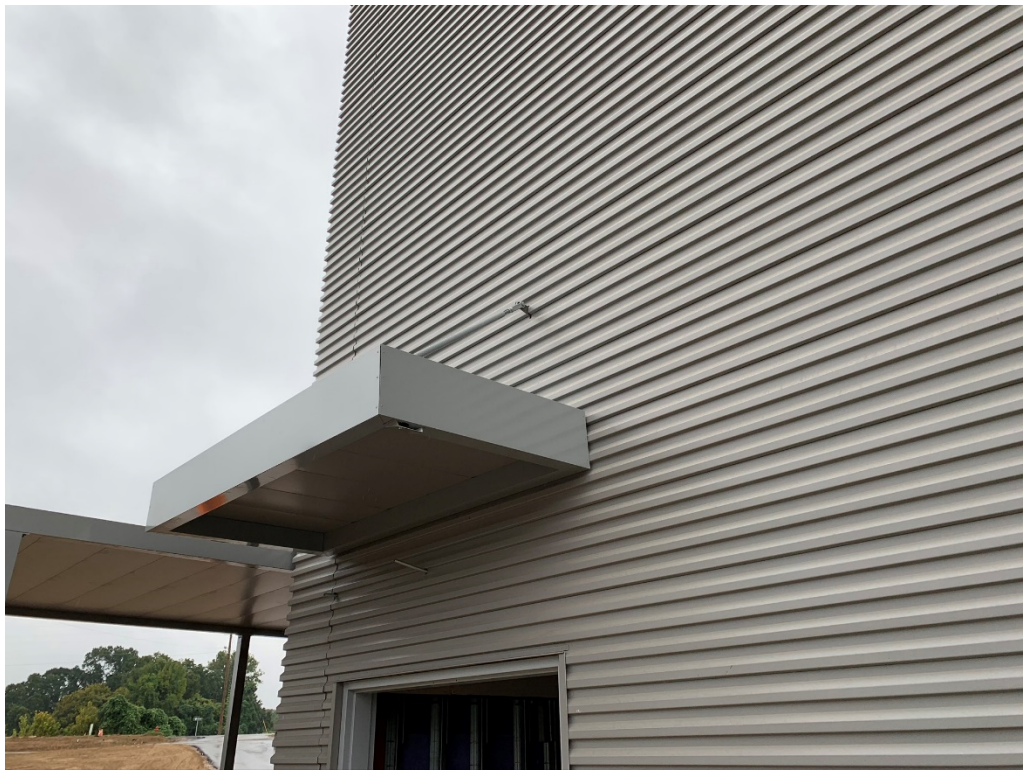
Figure 2 – Awnings Installed

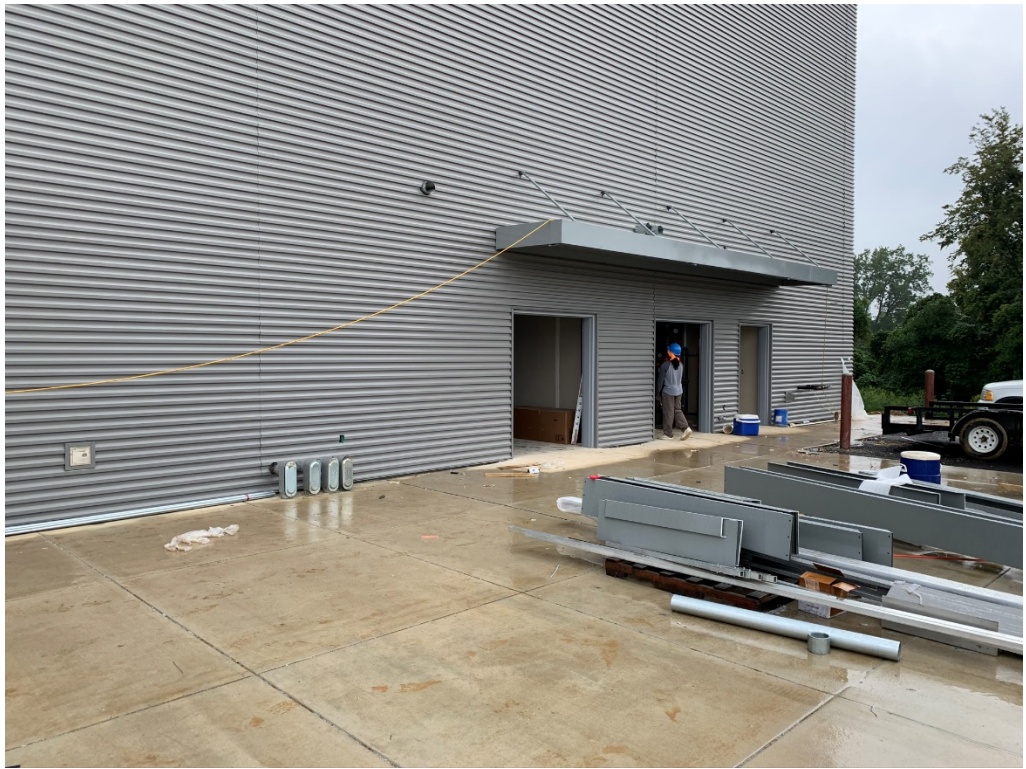
Figure 3 – Awnings Installed

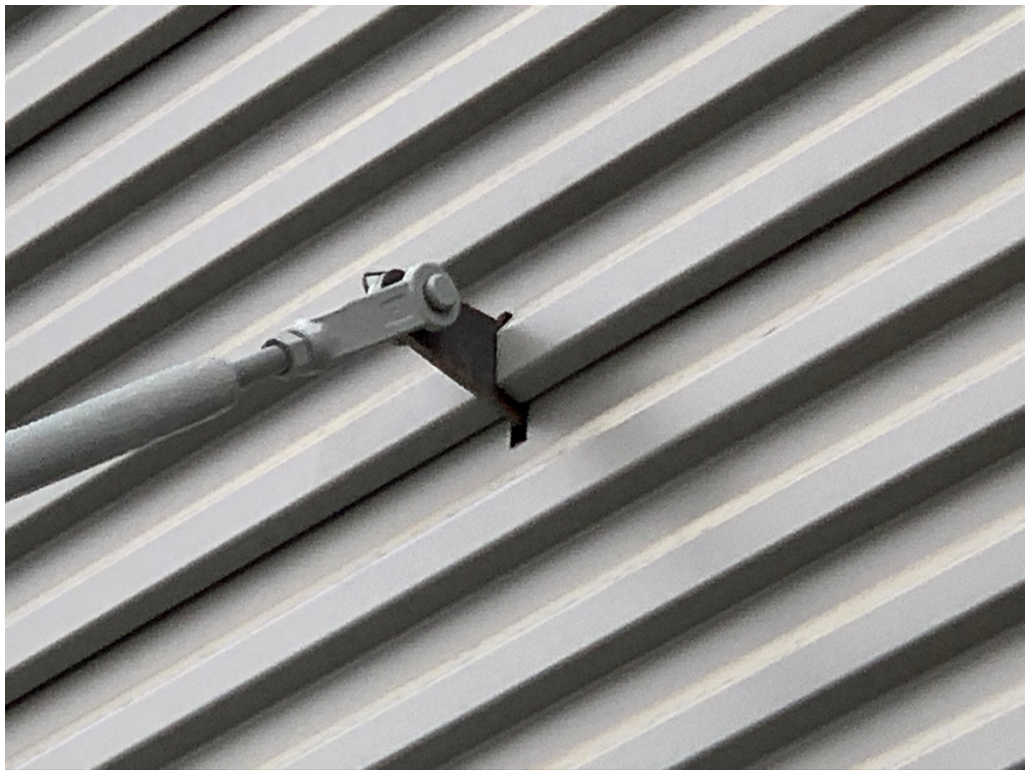
Figure 4 –Bracket Intersection with Siding

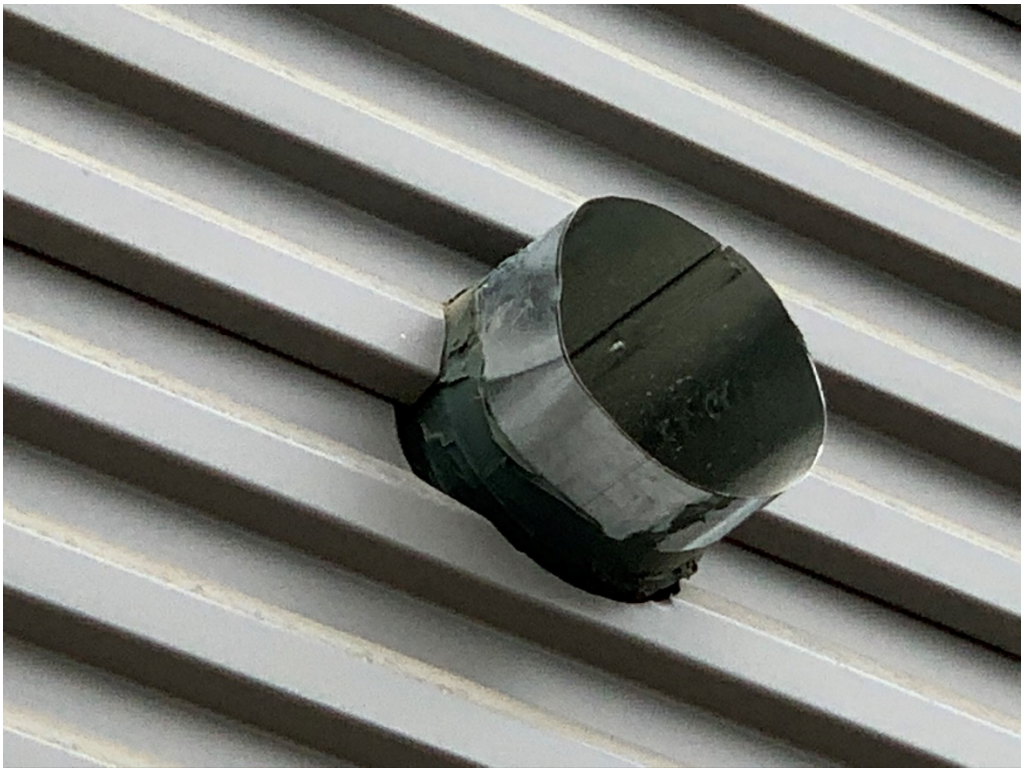
Figure 5 – Duct Intersection with Siding

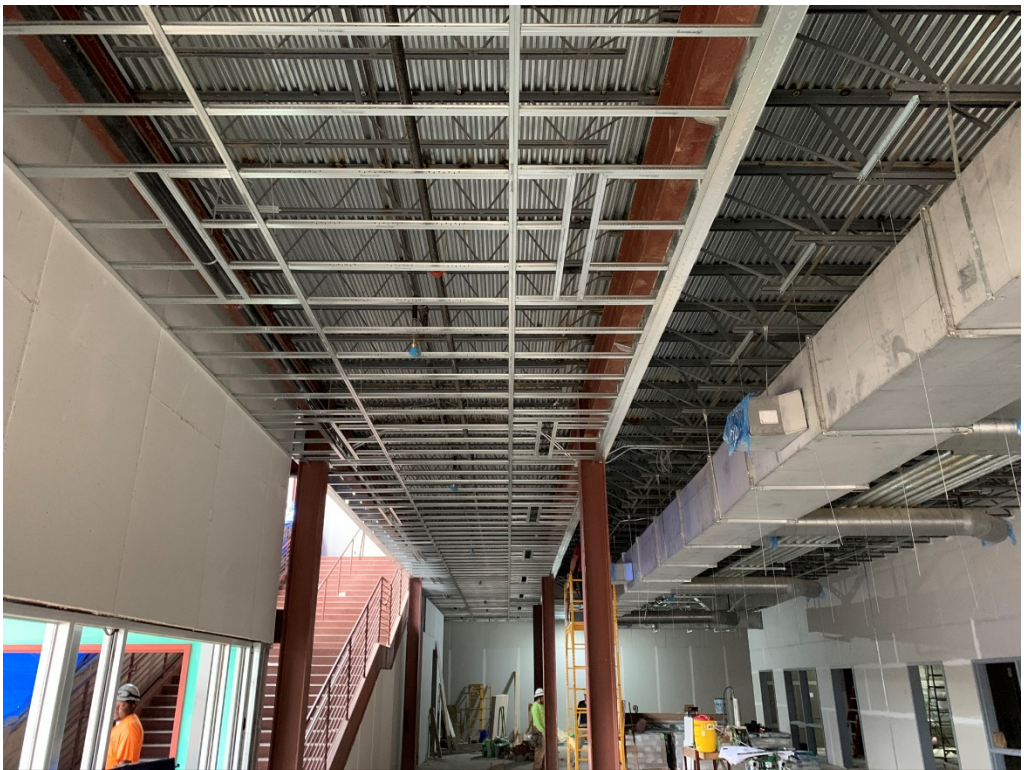
Figure 6 – Grid work at Cafeteria

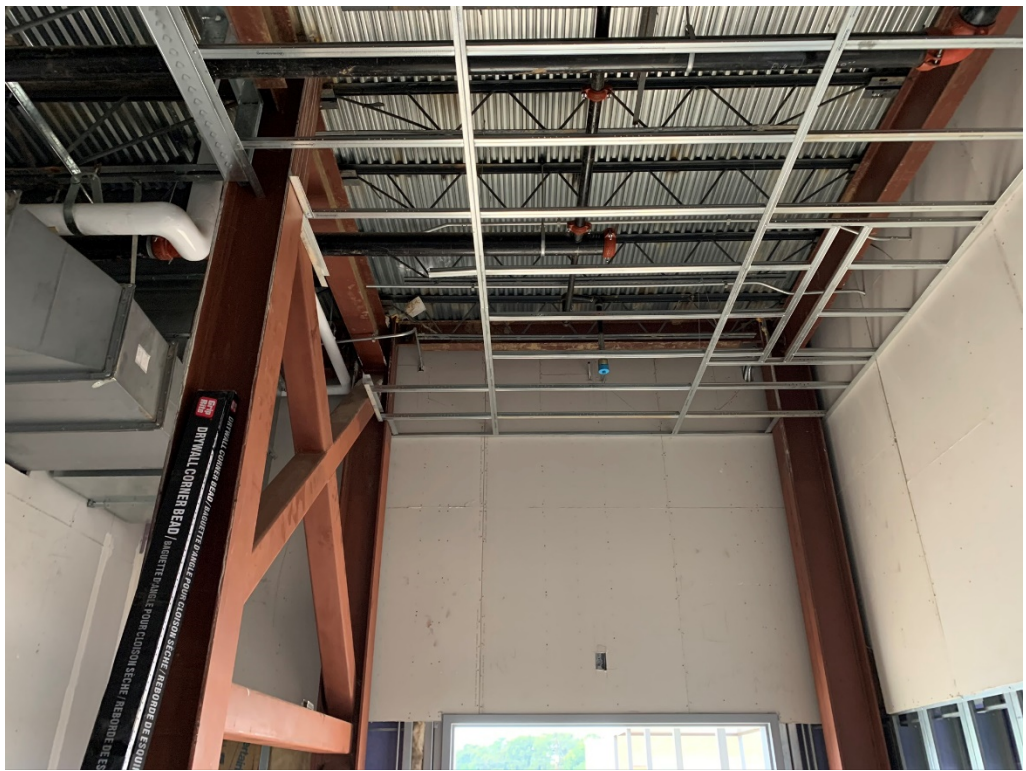
Figure 7 – Grid work at Cafeteria

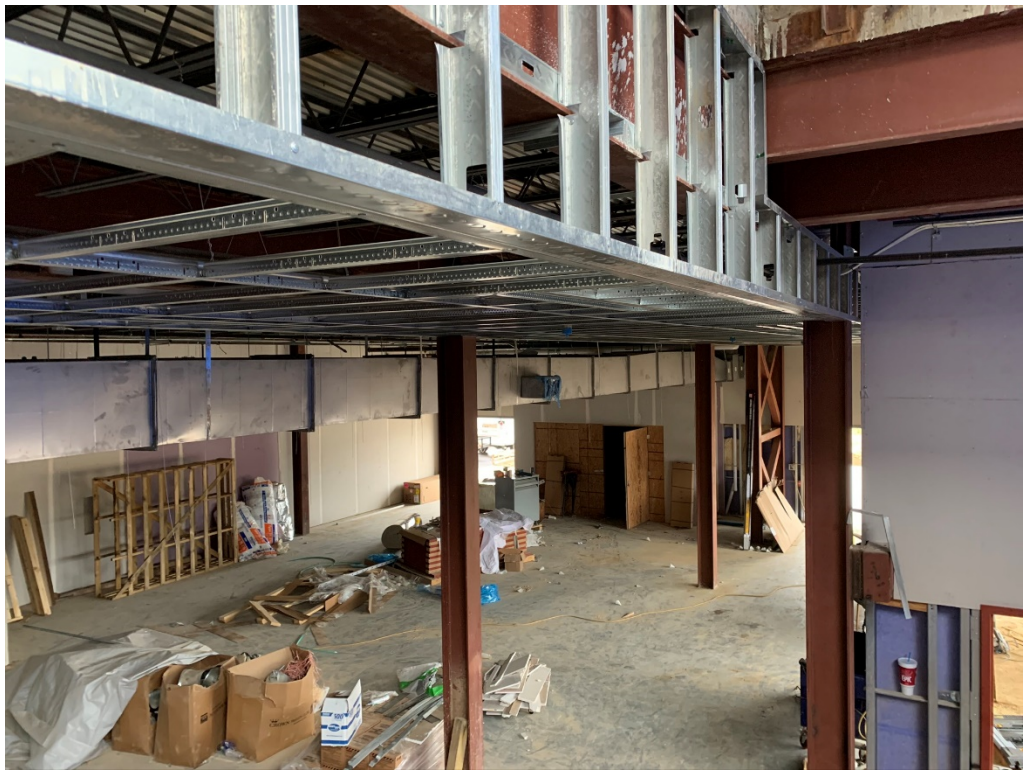
Figure 8 – Grid work at Cafeteria

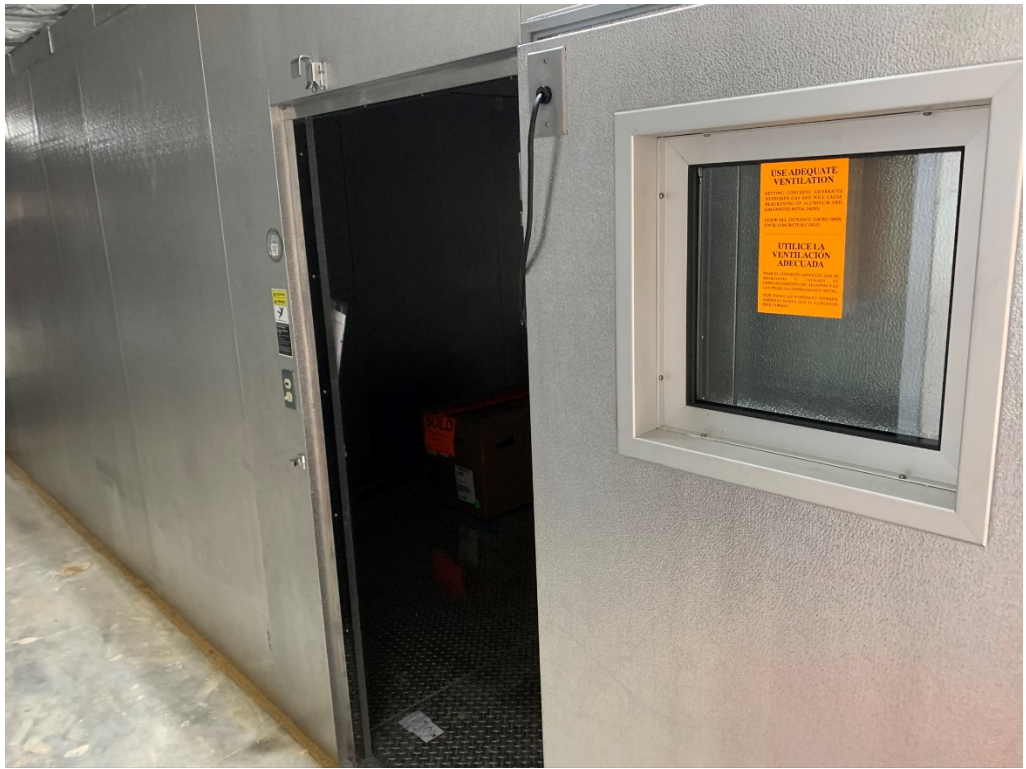
Figure 9 – Cooler Installed

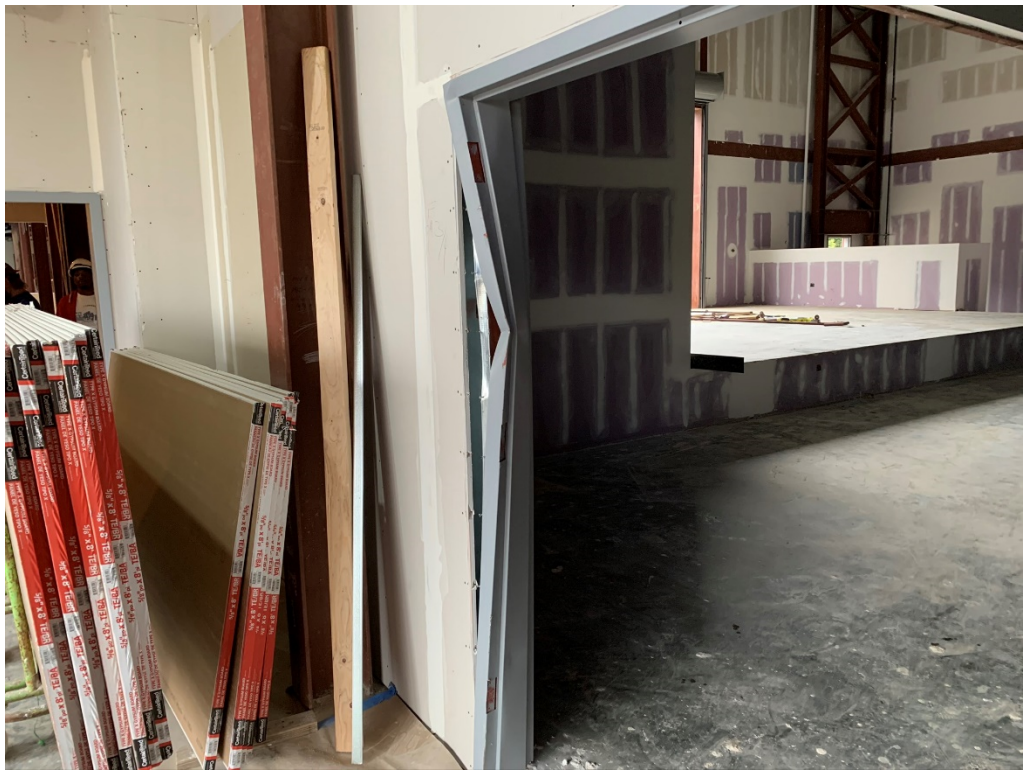
Figure 10 – Damaged Door Jamb at Gym

Action Required Replace Damaged Door Jamb at Auditorium.

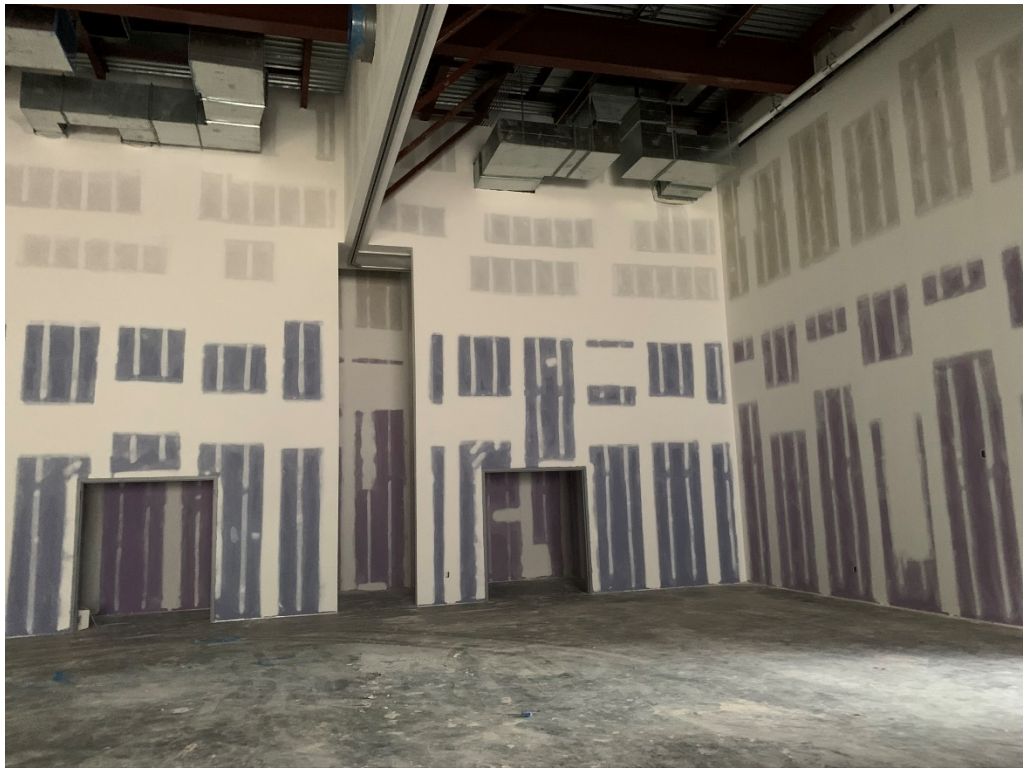
Figure 11 – Gym Ready for Paint

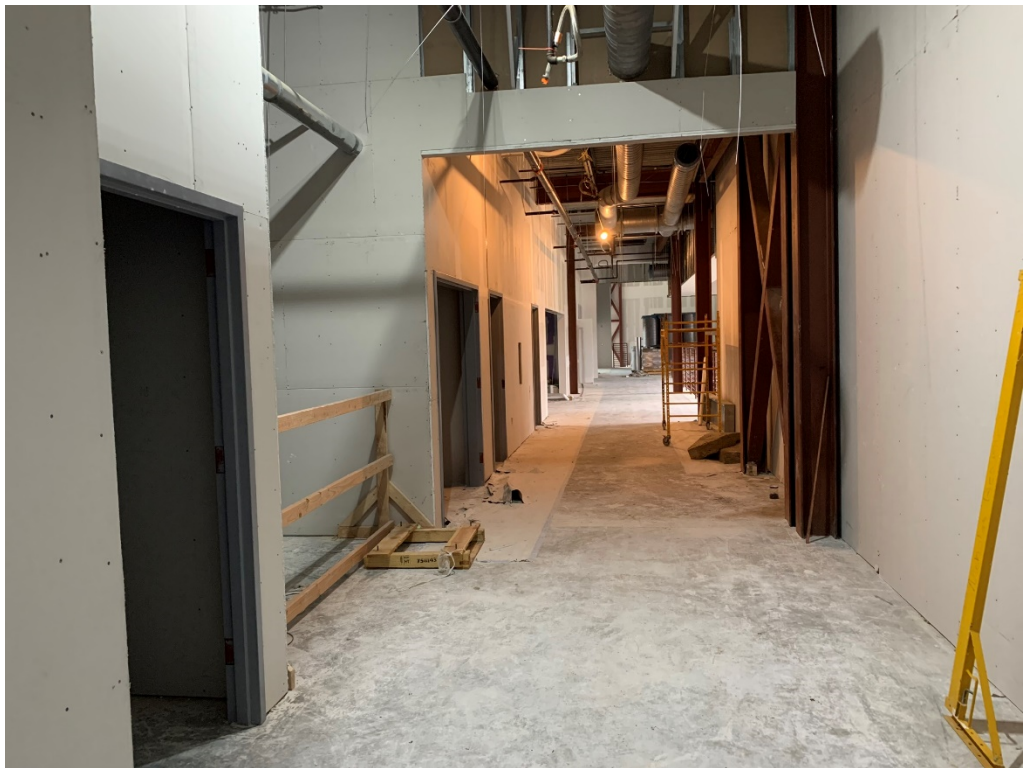
Figure 12 – 3rd Hall Near Elevator Vestibule

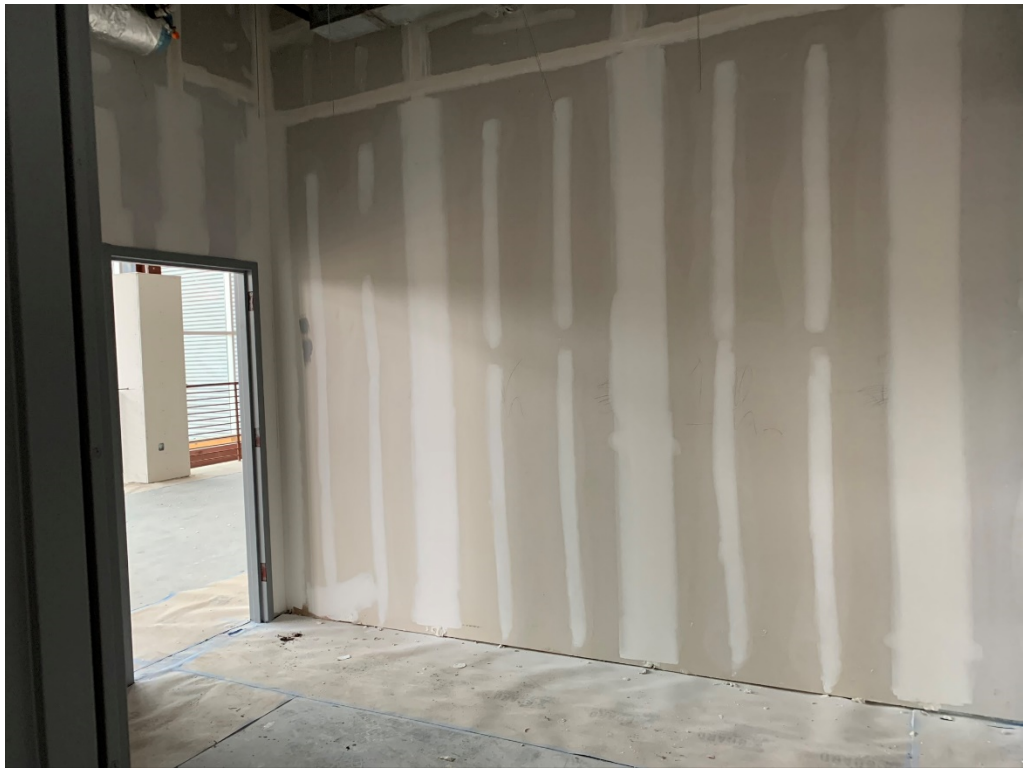
Figure 13 – 3rd Floor Conference Area

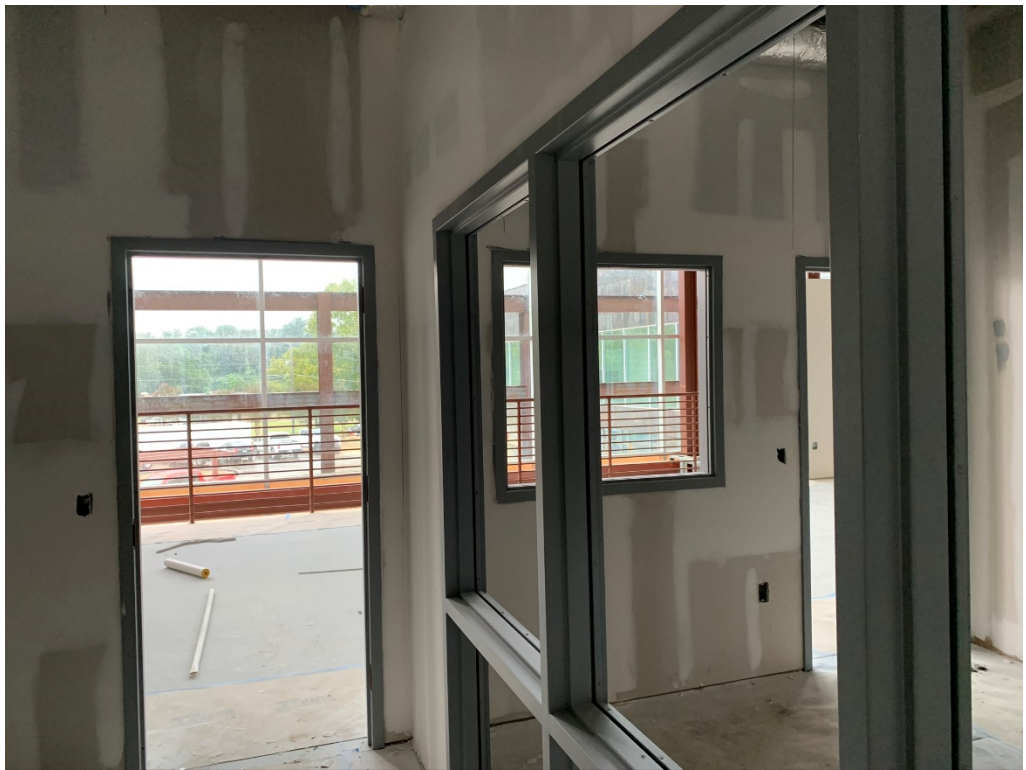
Figure 14 – 3rd Floor Conference Area

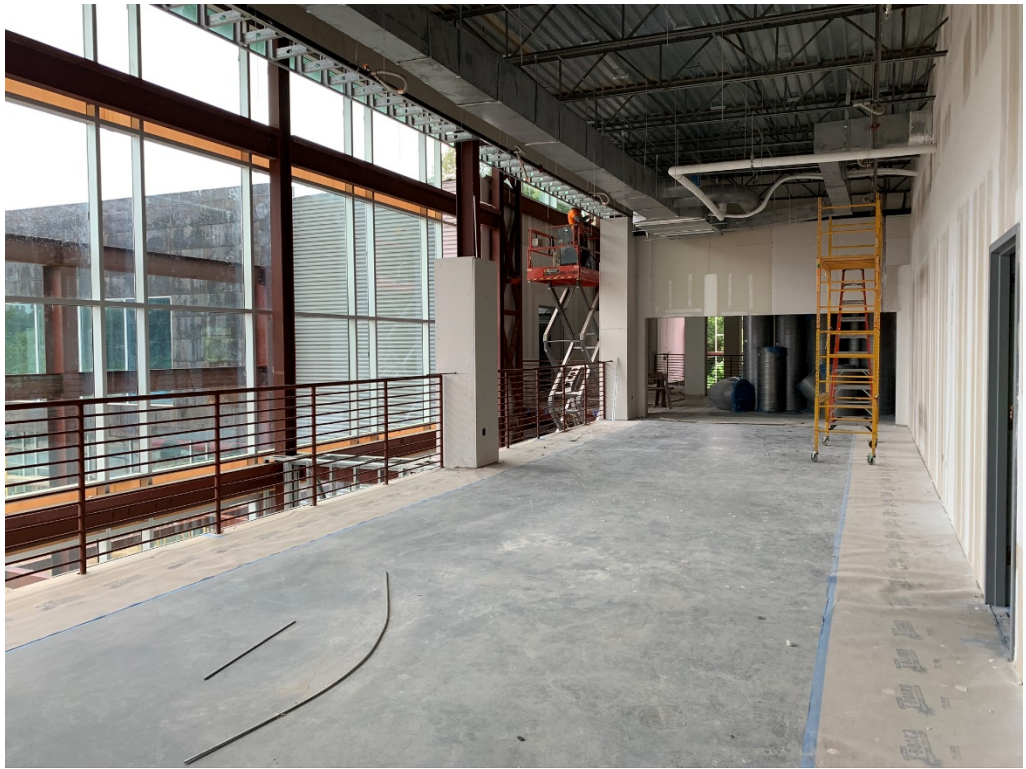
Figure 15 – Multi-Purpose at 3rd Floor

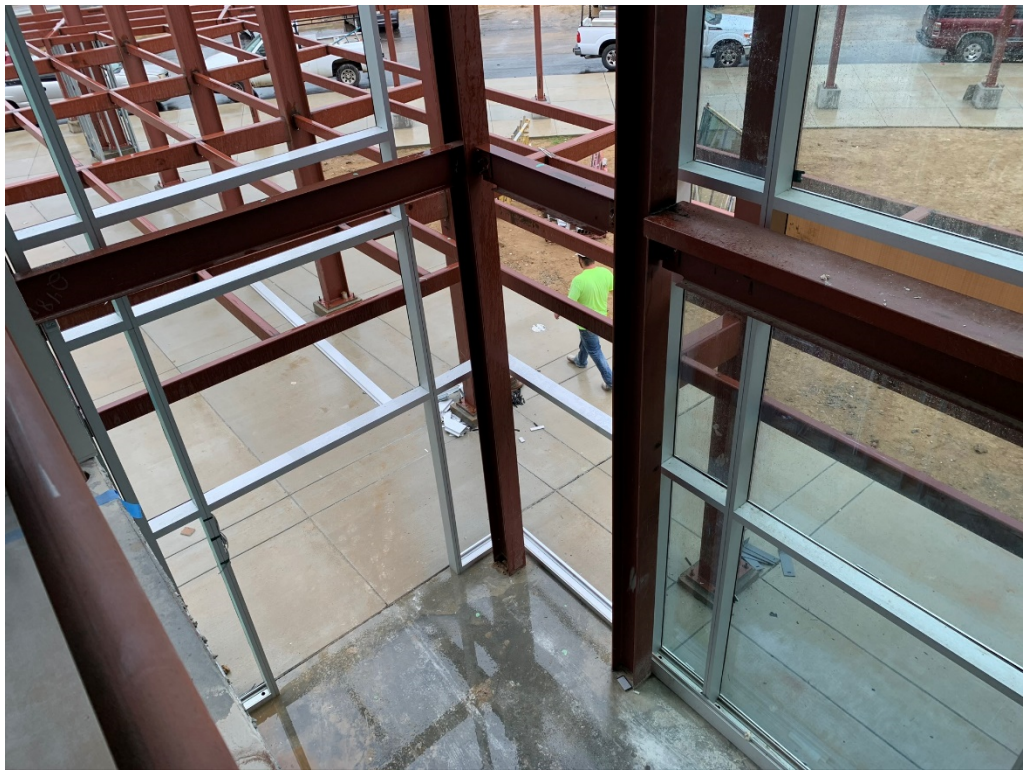
Figure 16 – Curtain Wall Progress Continues

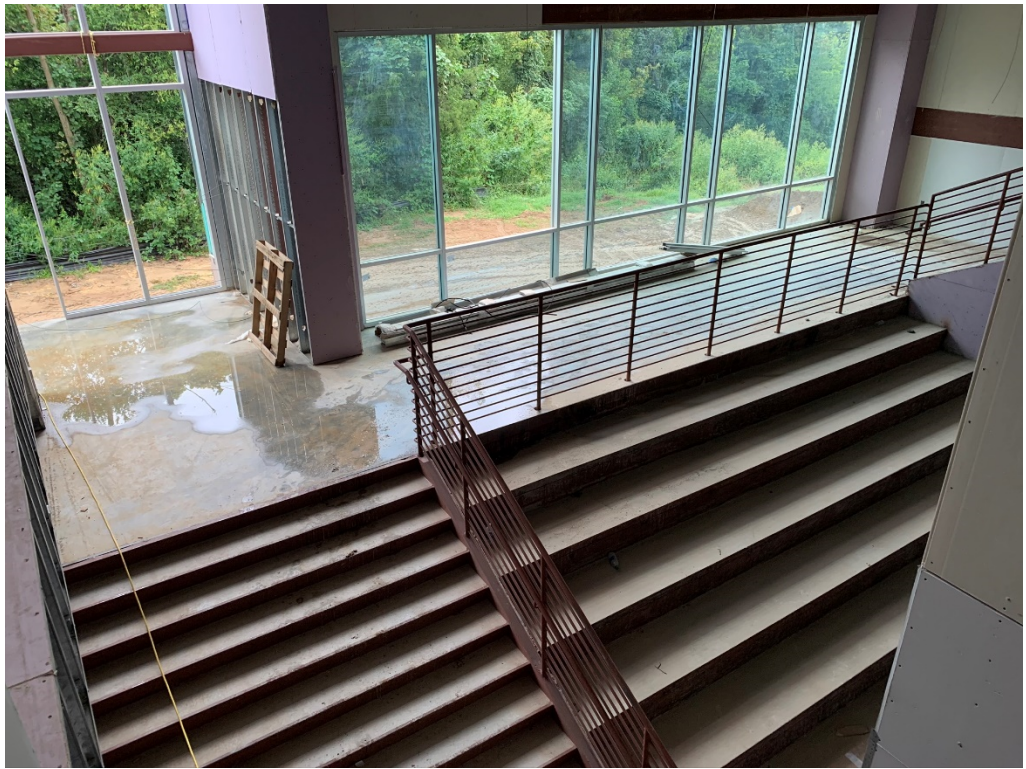
Figure 17 – Glazing Impeding Drywall Installation Here

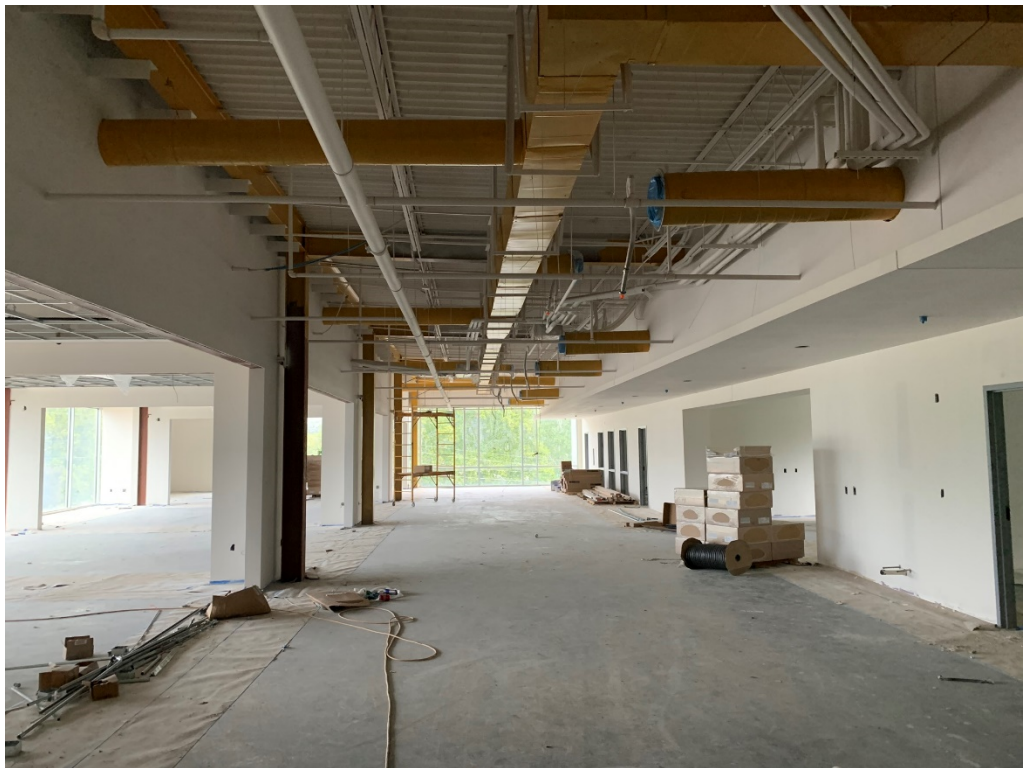
Figure 18 – Paint at 3rd Floor Versatile Teaching Space 210

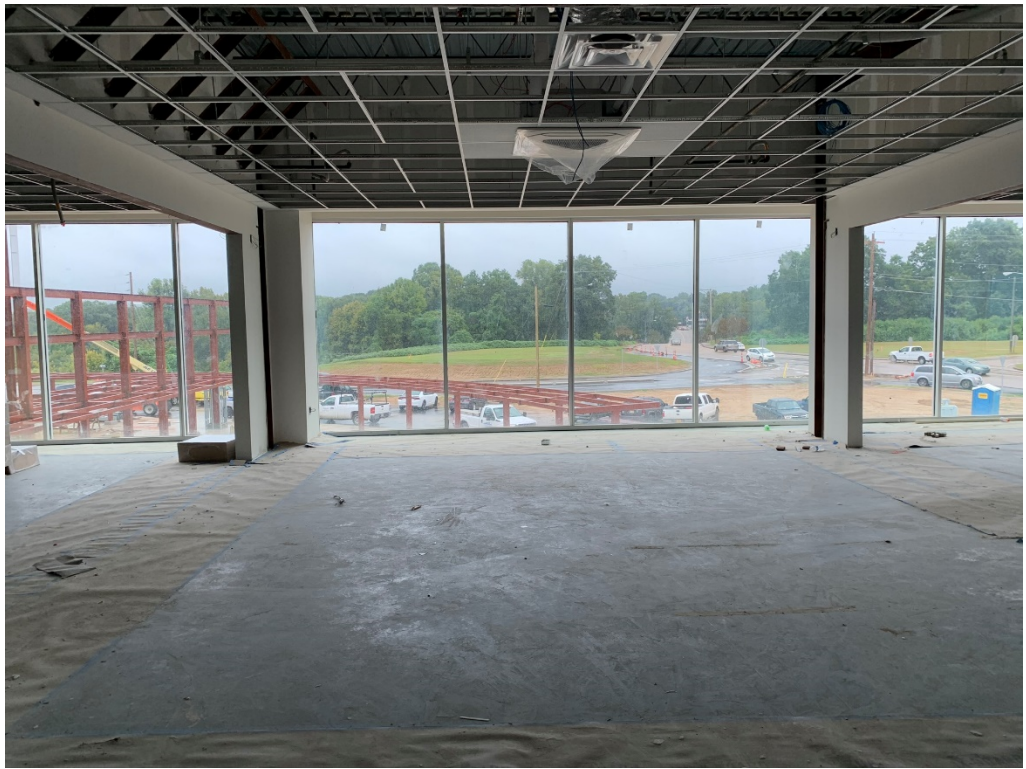
Figure 19 – Versatile Teaching Space 210 Grid Ready for Ceiling Tile

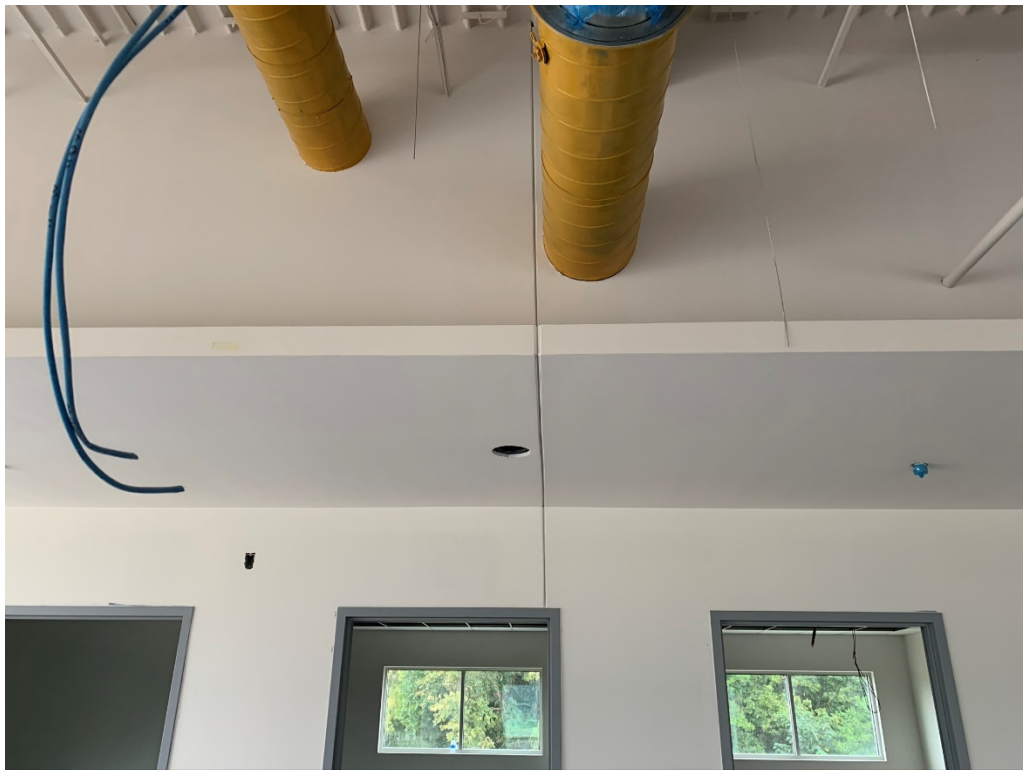
Figure 20 – Paint and Drywall at Versatile Teaching Space 210

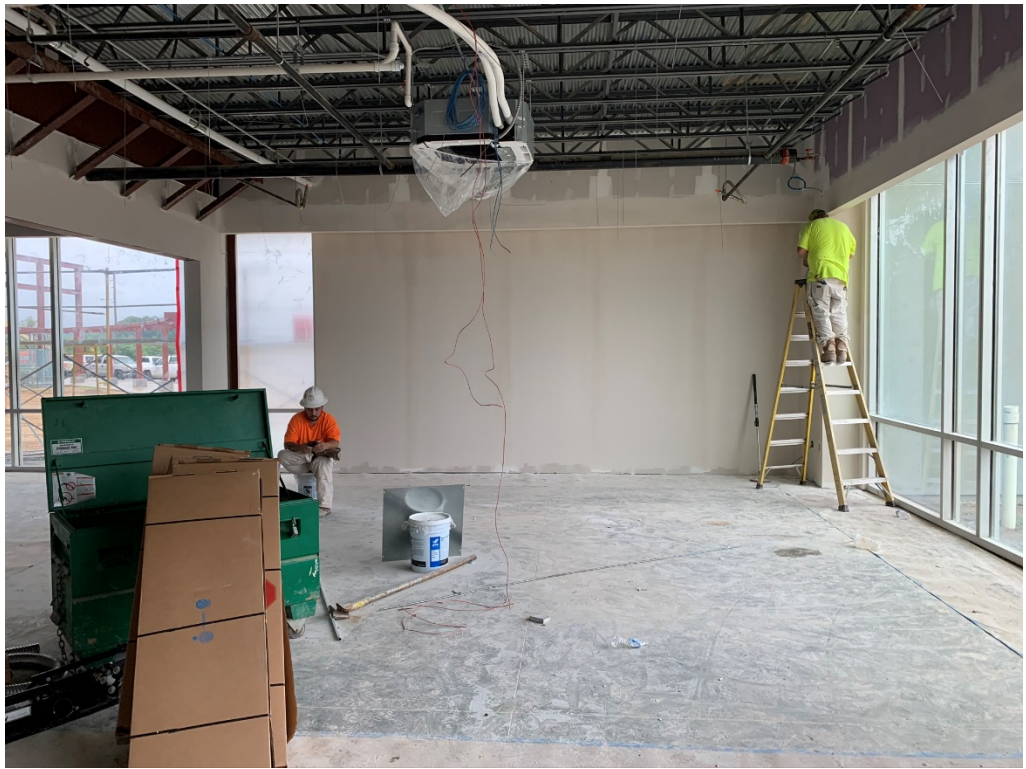
Figure 21 – Versatile Teaching Space 110 Paint is Ongoing

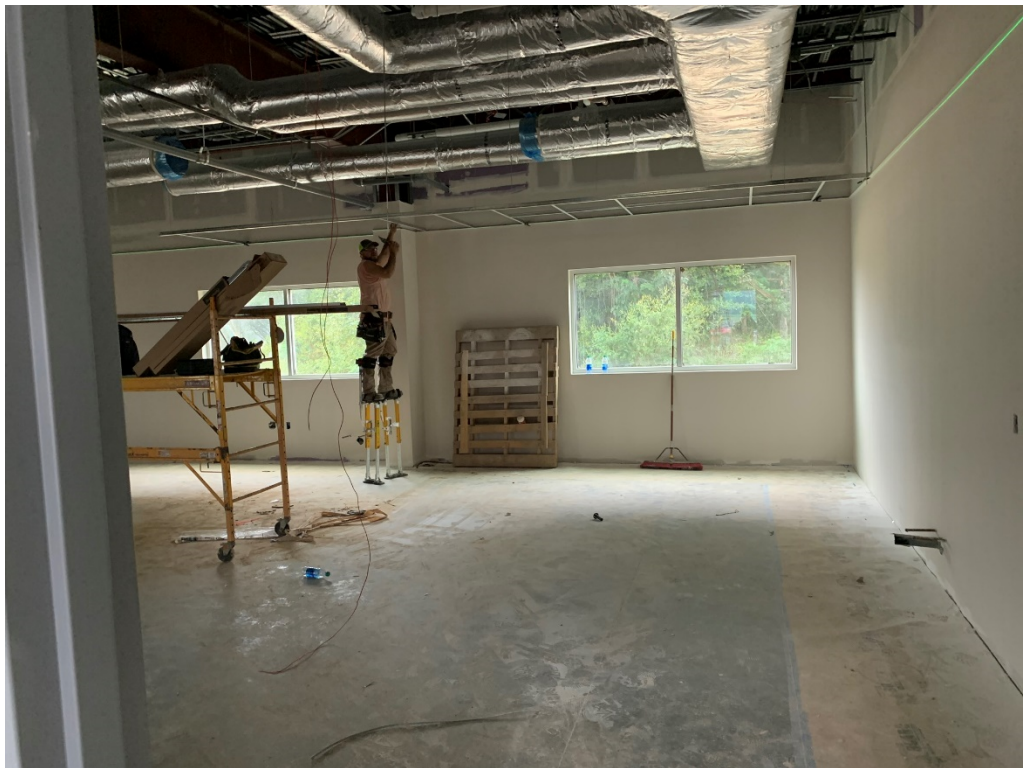
Figure 22 – Classroom Grid Install is Ongoing
