Architect's Field Report

17 October 2020

18059-AOI Academy of Innovation / Report Number 047

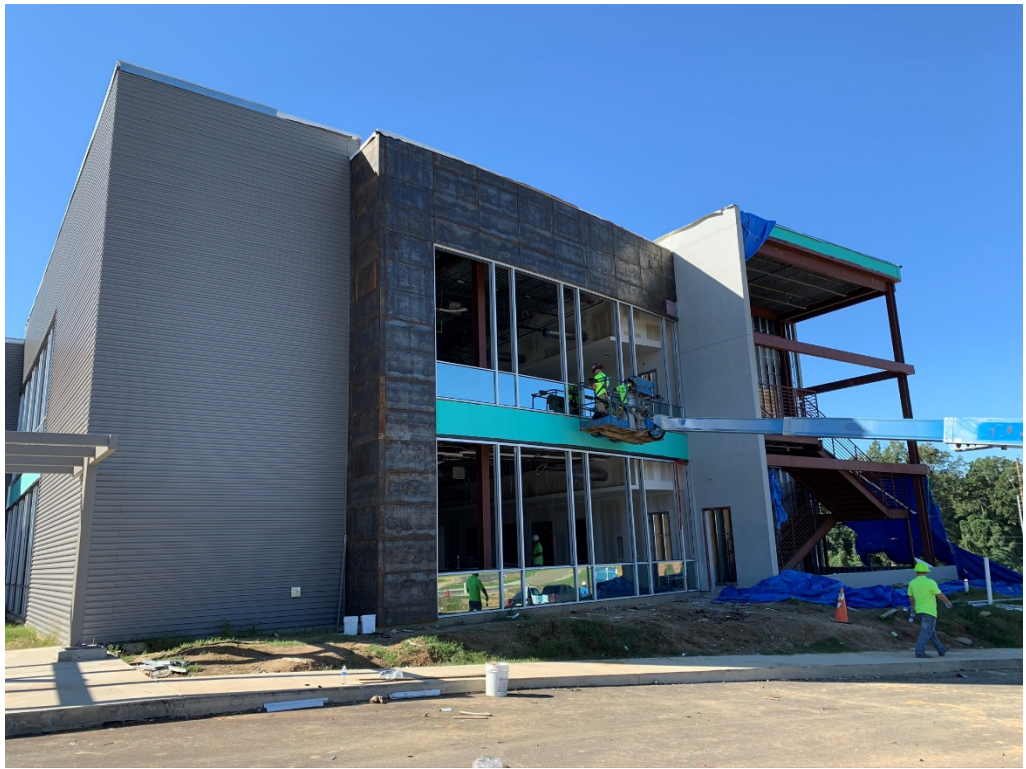
Figure 1 – North Central Façade of Structure (Glazing Install)

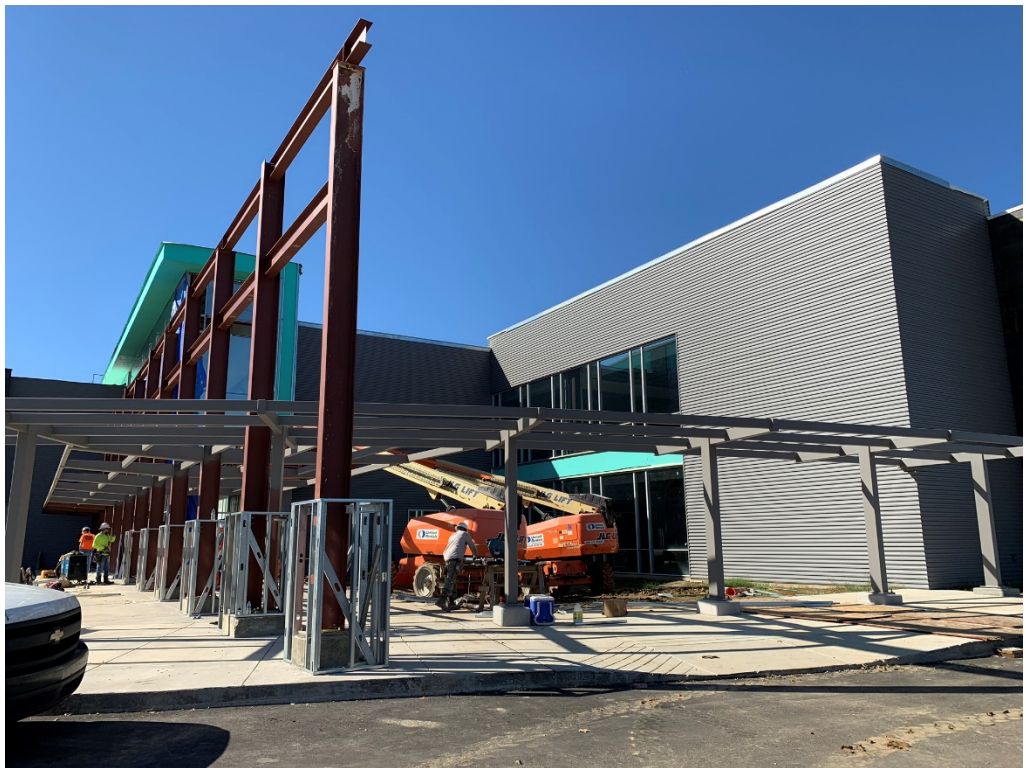
Figure 2 – Progress at Car Drop Off

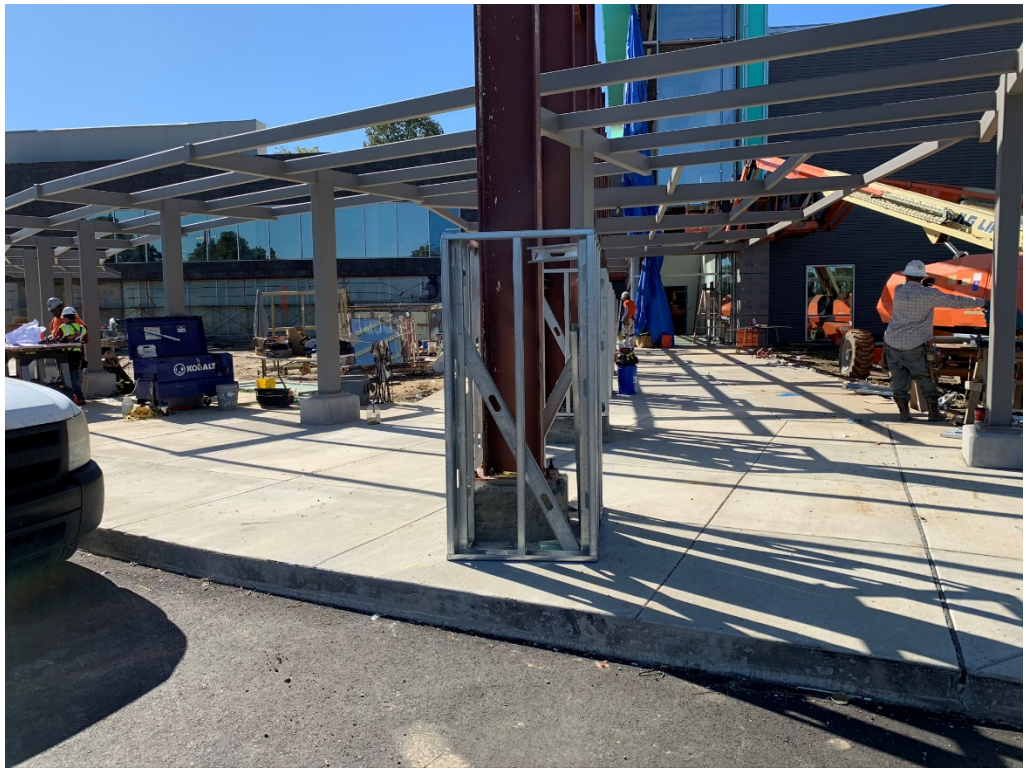
Figure 3 – Framed Plinths

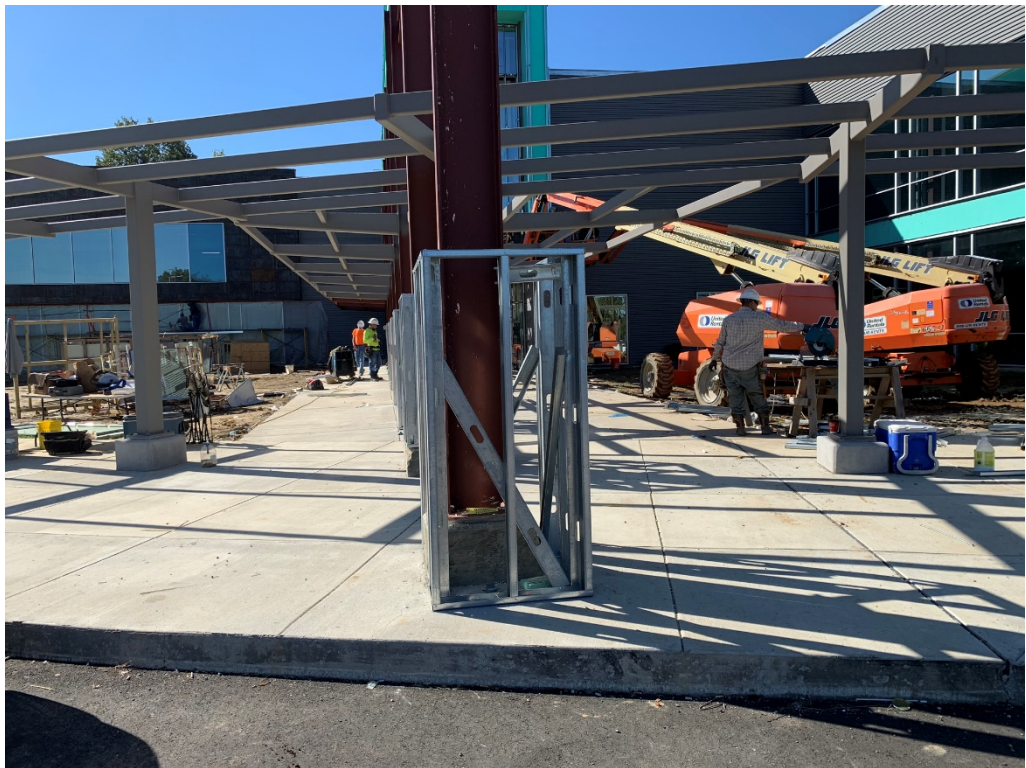
Figure 4 – Framed Plinths

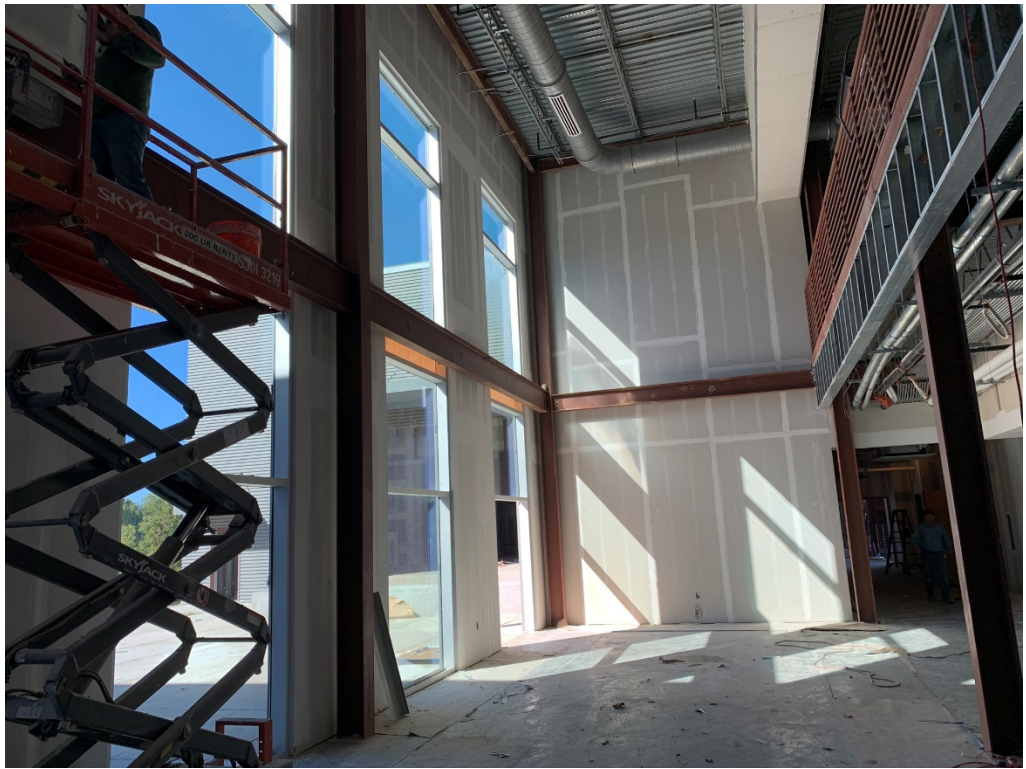
Figure 15 – Drywall Finishing is Ongoing

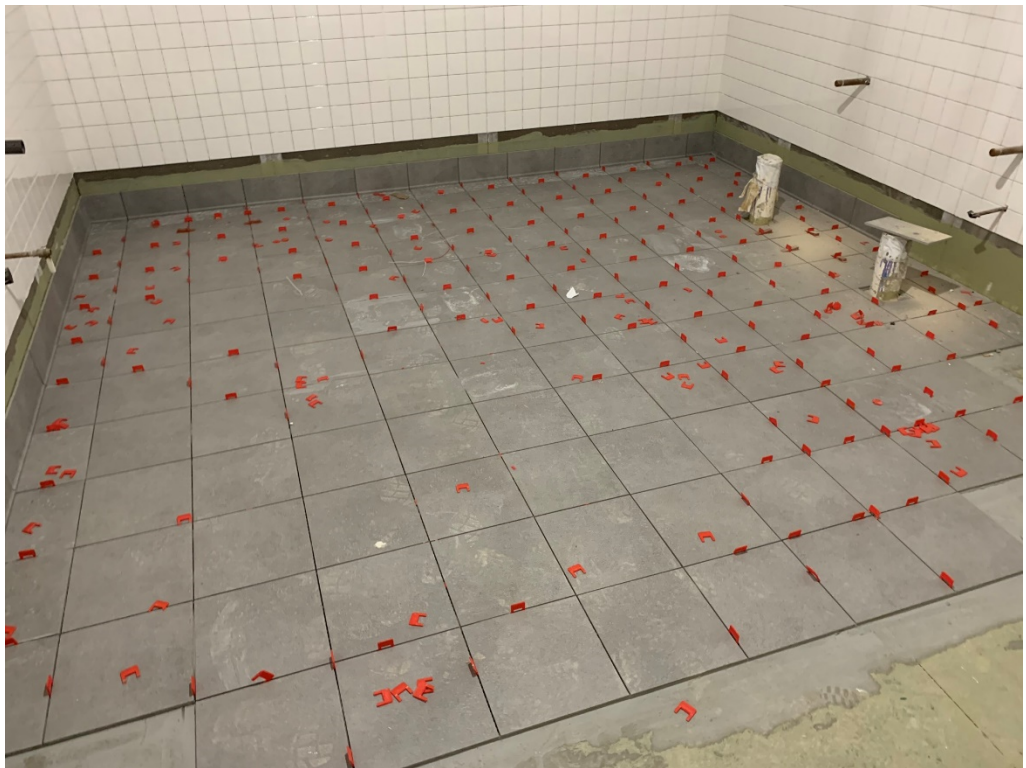
Figure 16 – Tile is Ongoing

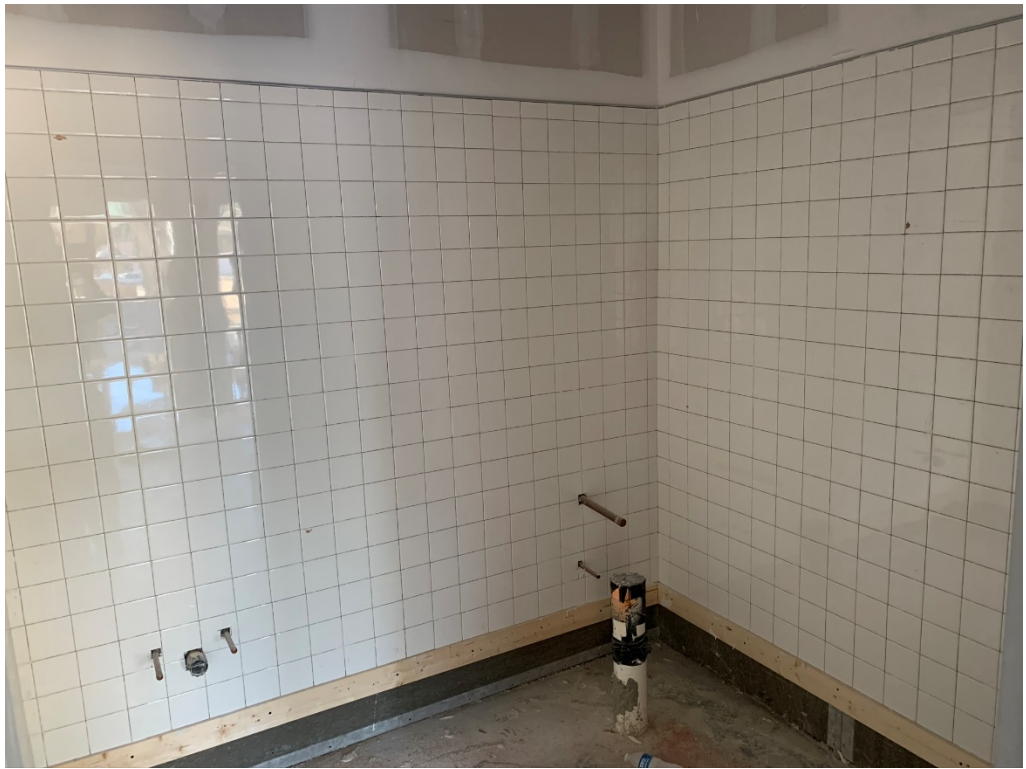
Figure 17 – Tile is Ongoing

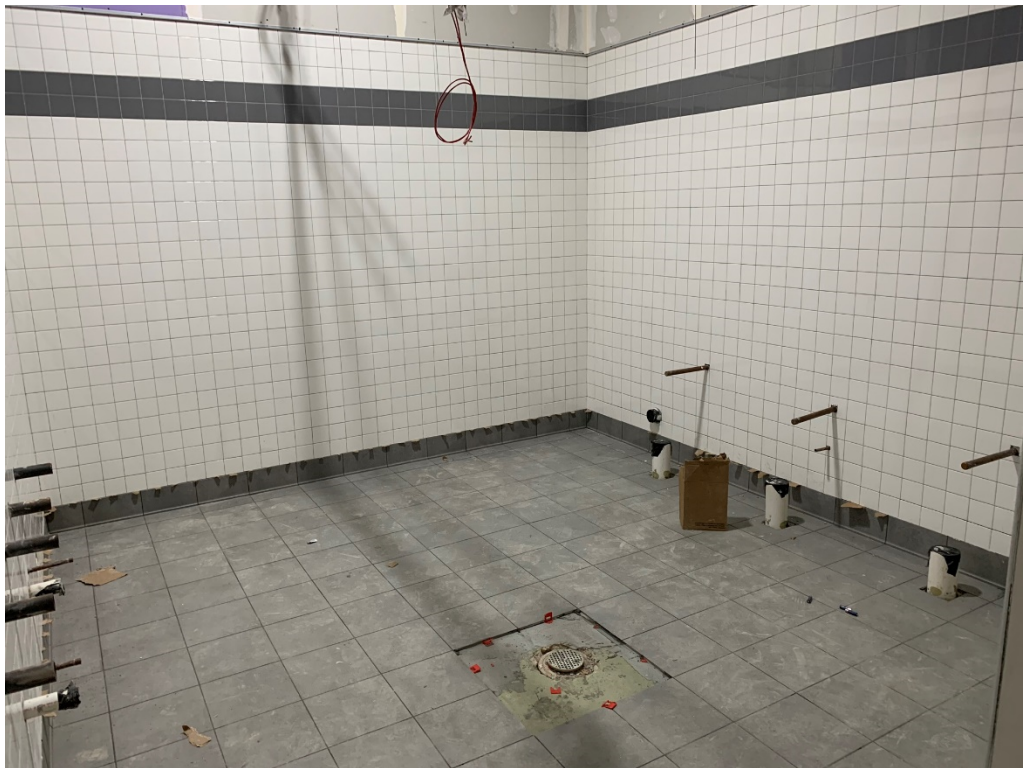
Figure 24 – Upstairs Bathroom Tile is nearing Completion

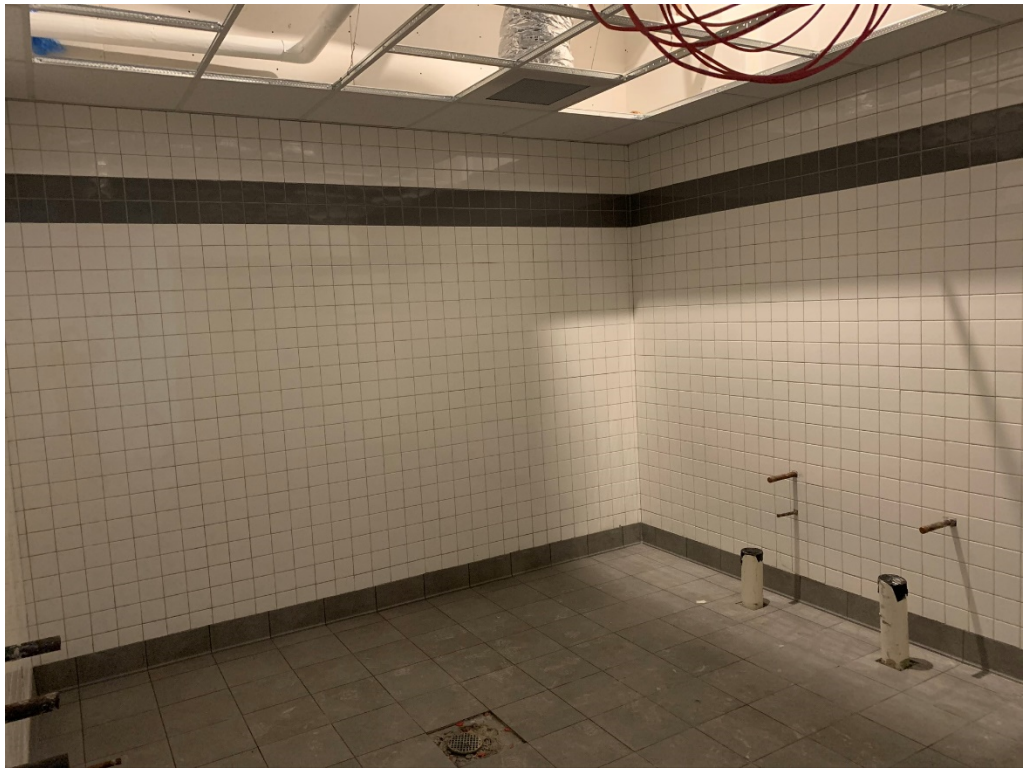
Figure 27 – Upstairs Bathroom Tile is nearing Completion; Ceiling Grid is Installed where Wall Finishes are Complete

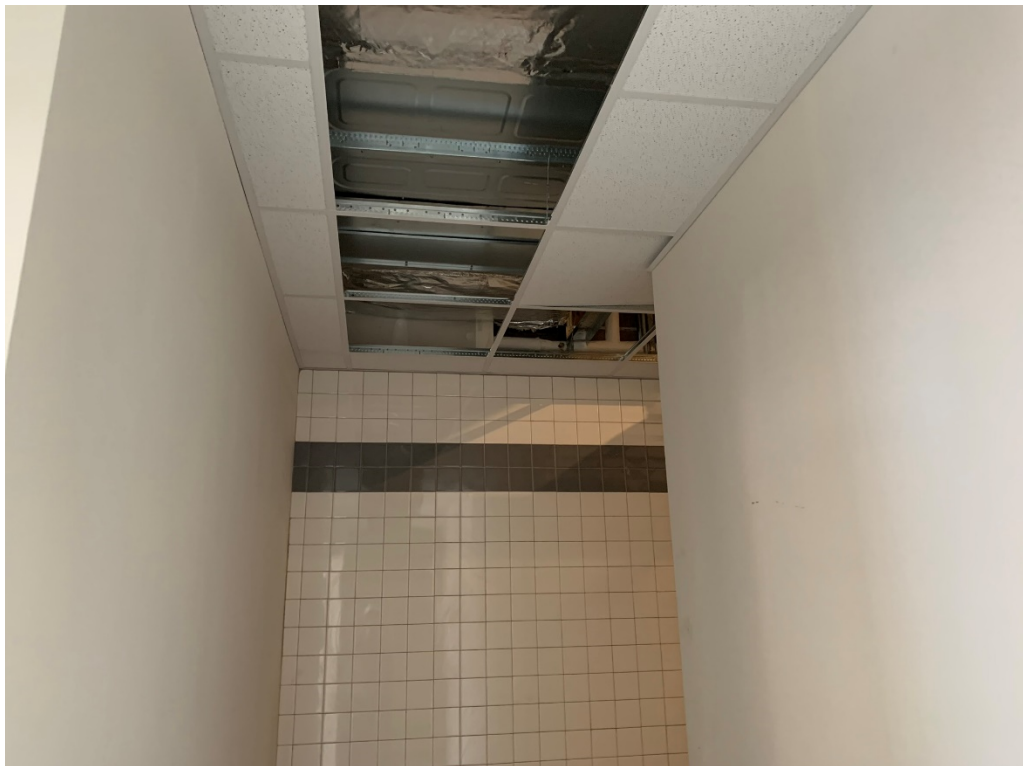
Figure 28 – Ceiling Grid is Installed where Wall Finishes are Complete

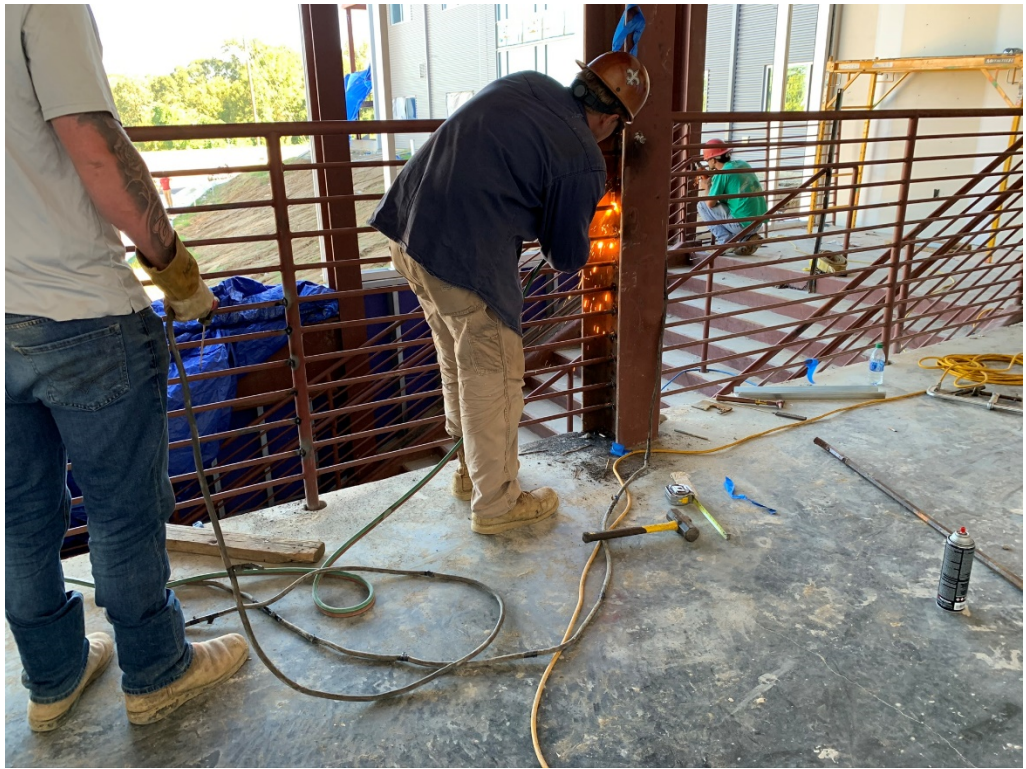
Figure 29 – Steel Handrail Progress

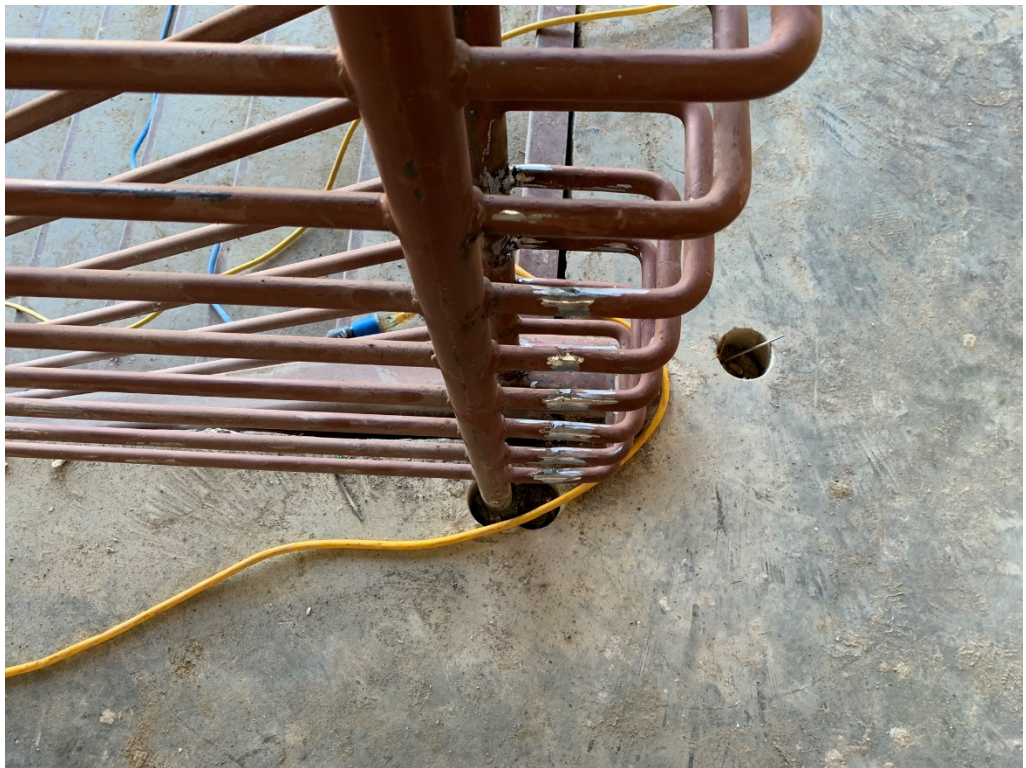
Figure 30 – Grinding Work at Steel Rail

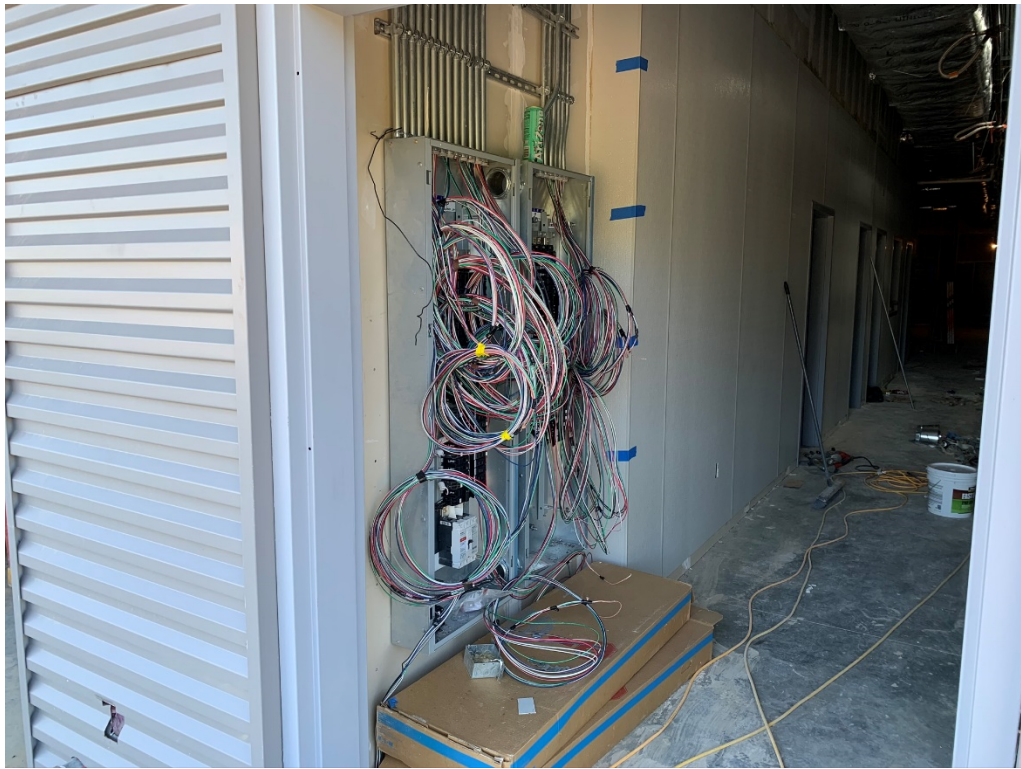
Figure 31 – Electrical Wire Pull

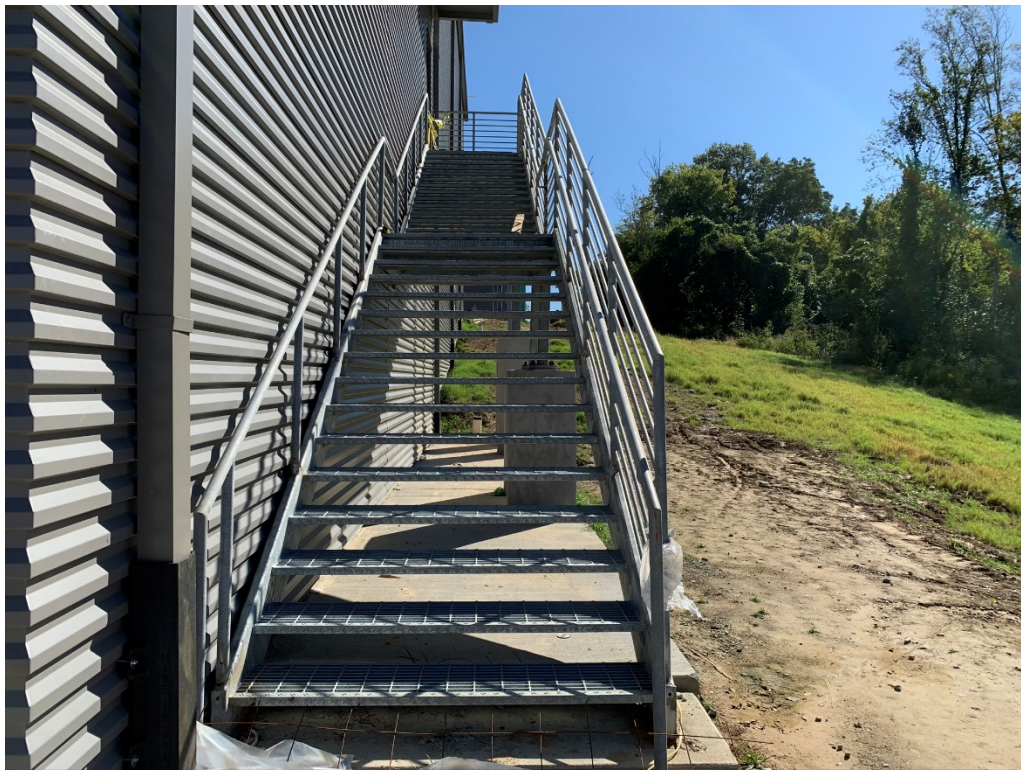
Figure 32 – Exterior Southwest Stair Installed
