Architect's Field Report

31 October 2020

18059-AOI Academy of Innovation / Report Number 049

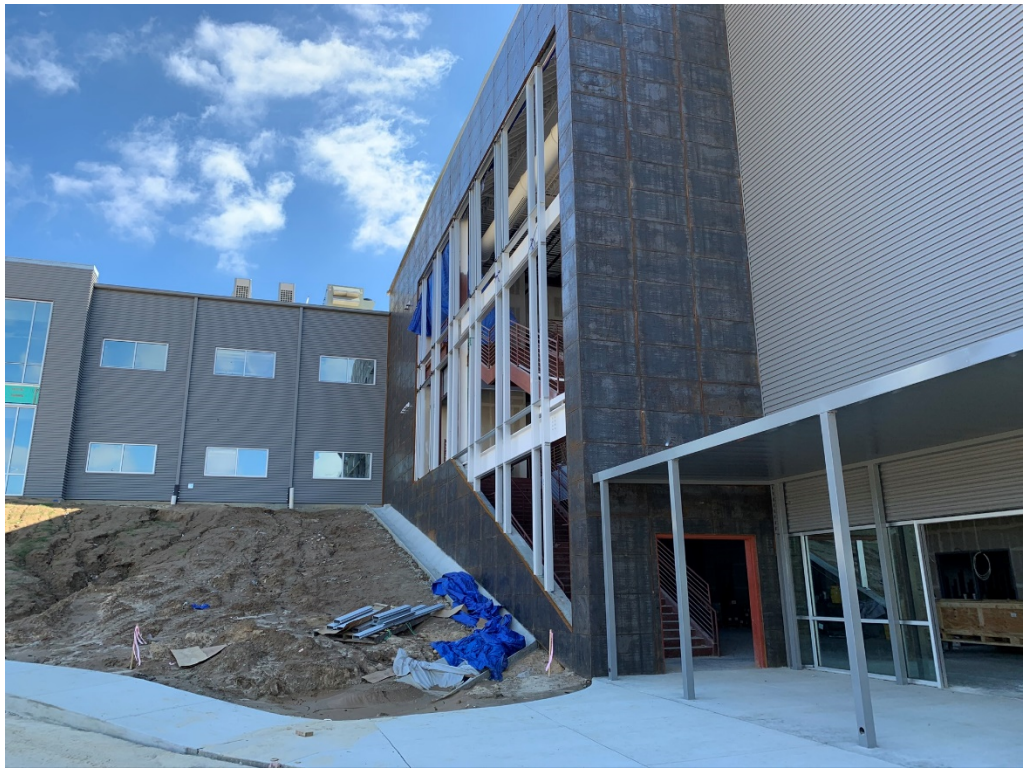
Figure 1 – West Section of Building North Elevation Curtain Wall Install Ongoing

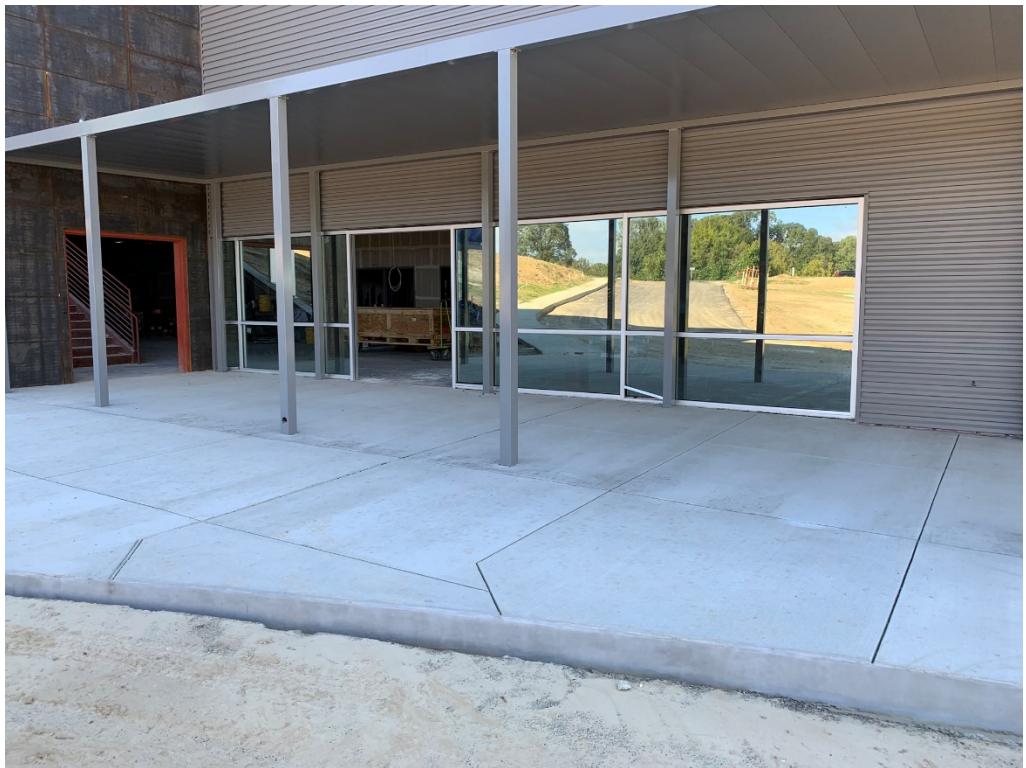
Figure 2 – Cafeteria Entry Glazing Install

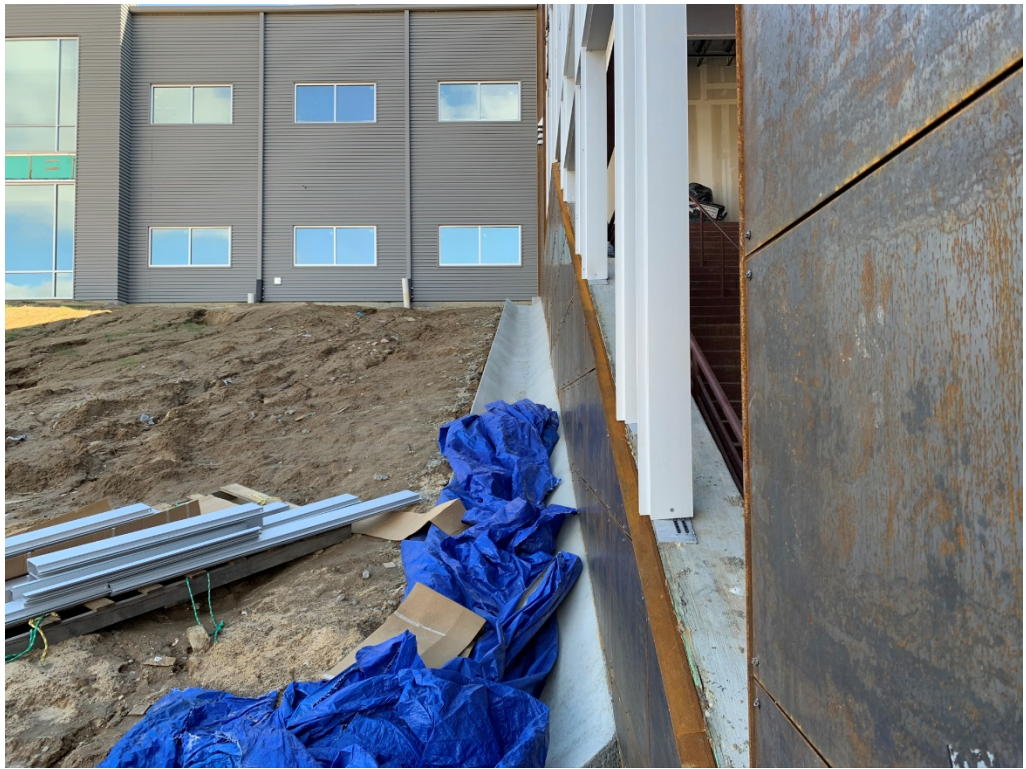
Figure 3 – Concrete Drainage Formed & Poured at Curtain Wall

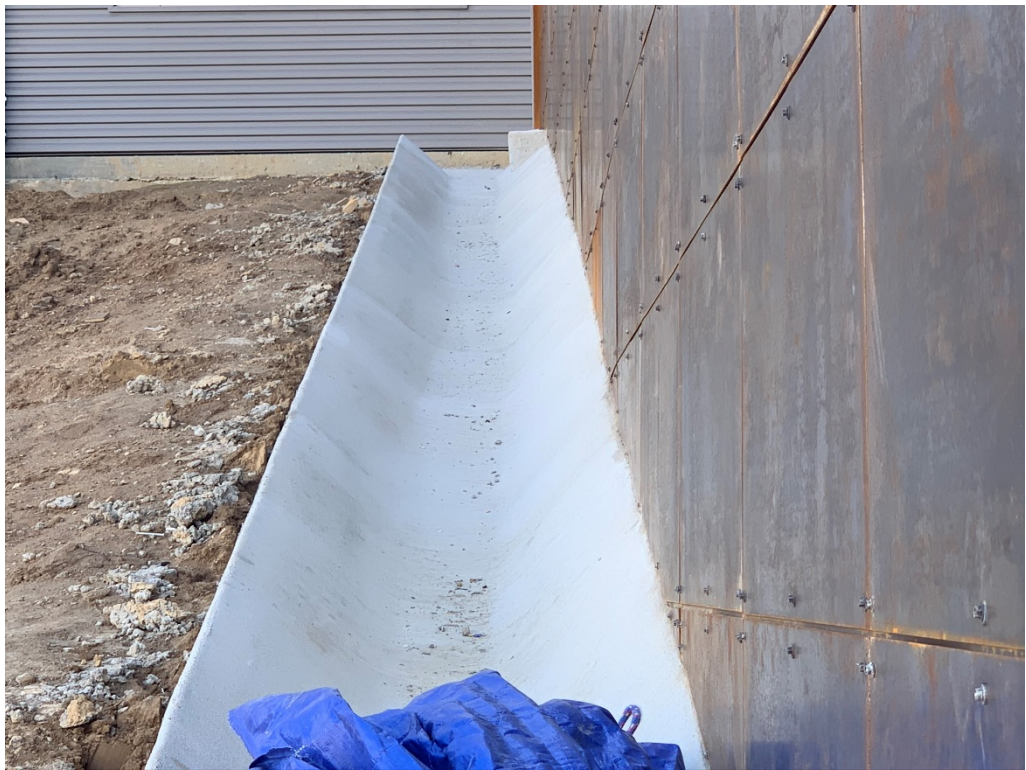
Figure 4 – Concrete Drainage Formed & Poured at Curtain Wall

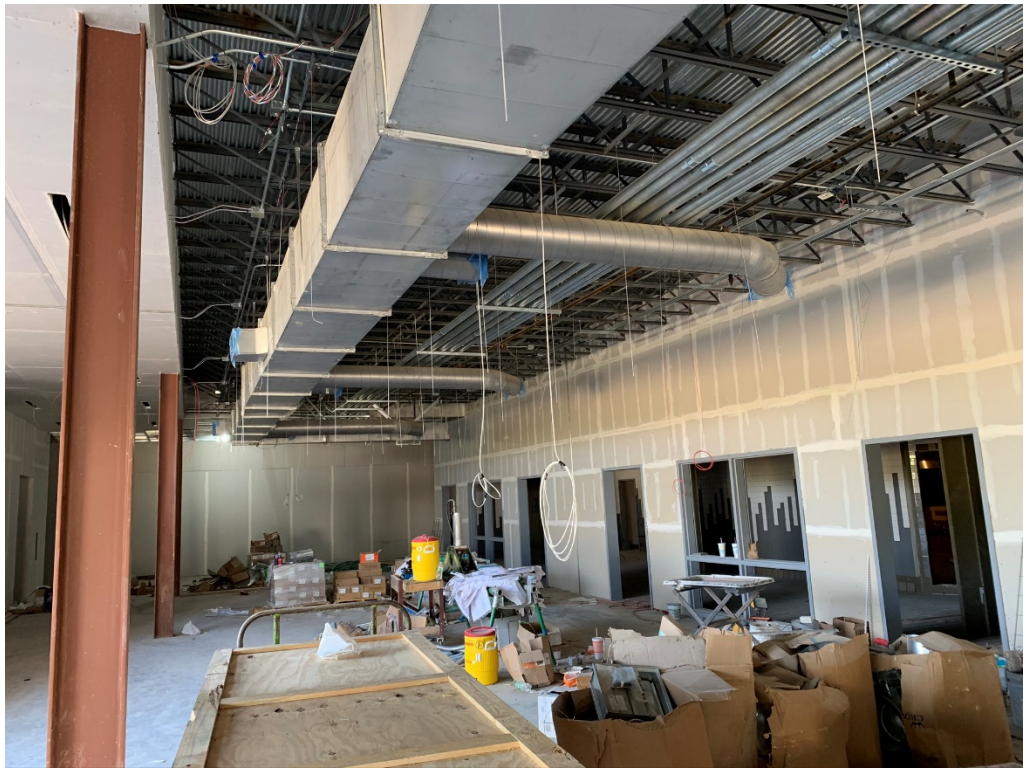
Figure 5 – Cafeteria Mech is Ongoing

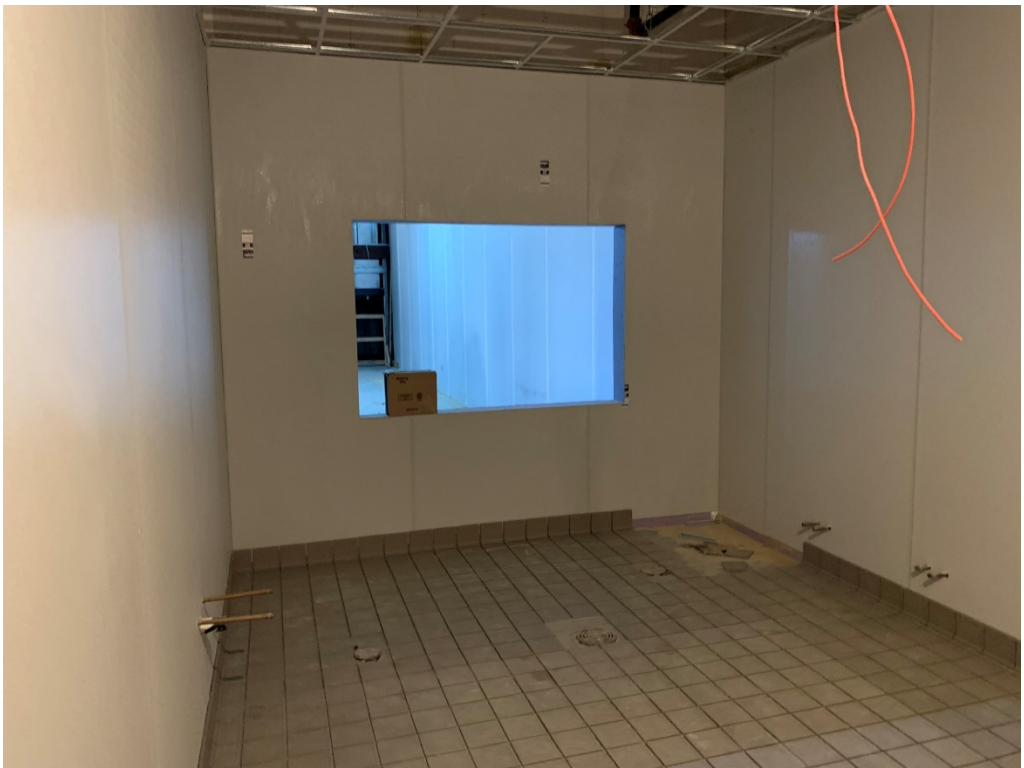
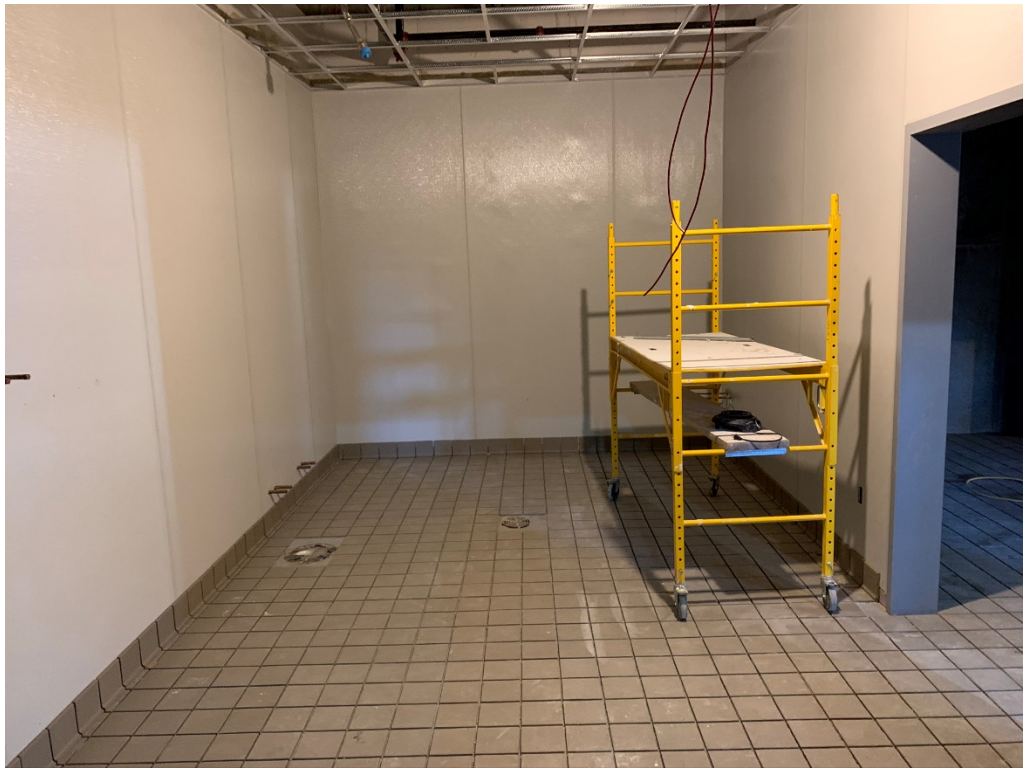
Figure 14 – FRP at Dish Wash

Figure 15 – FRP at Dish Wash

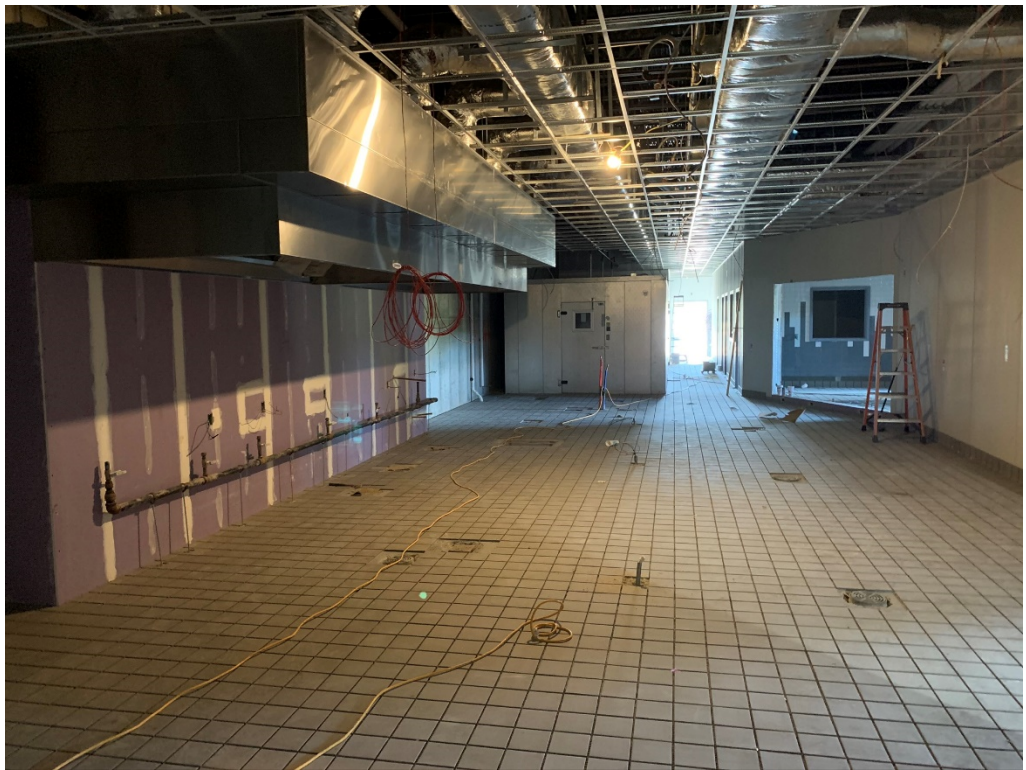
Observations Arriving on site, I entered the building from the west. Tile Progress has been made in the kitchen area at both walls and floors. Ceiling Finishes are also underway. Ceiling grid has been installed at the kitchen areas. Also, hard ceiling in the cafeteria has been installed.

Figure 16 – Ceiling Grid & Tile at Kitchen

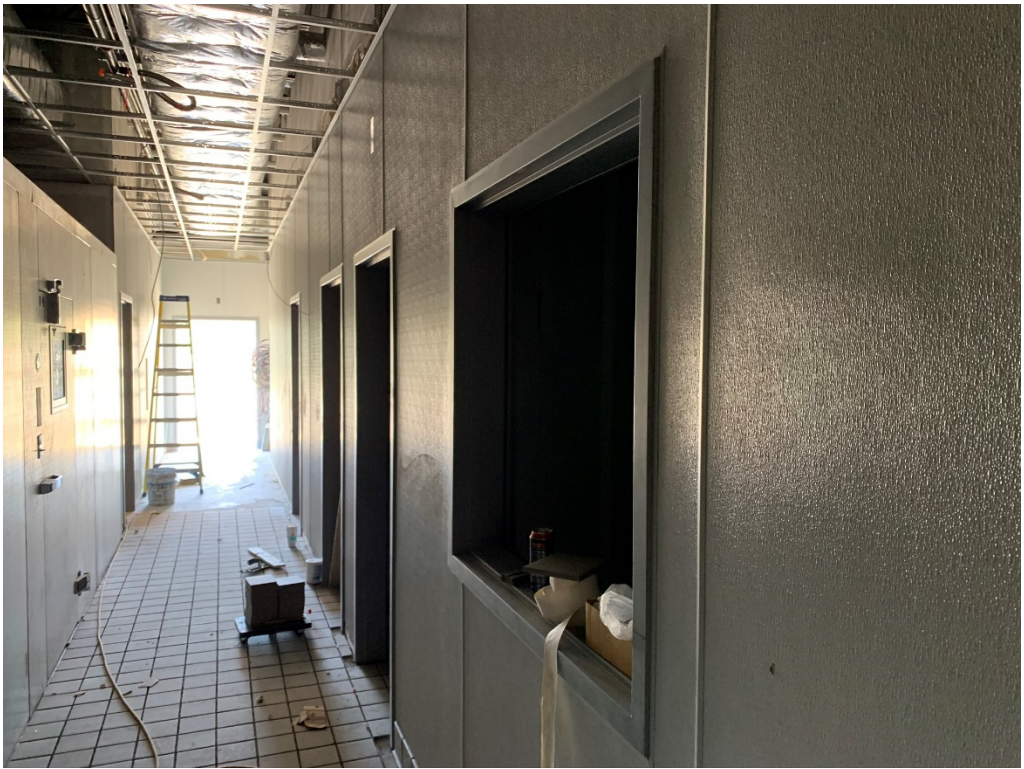
Figure 17 – Tile at Kitchen

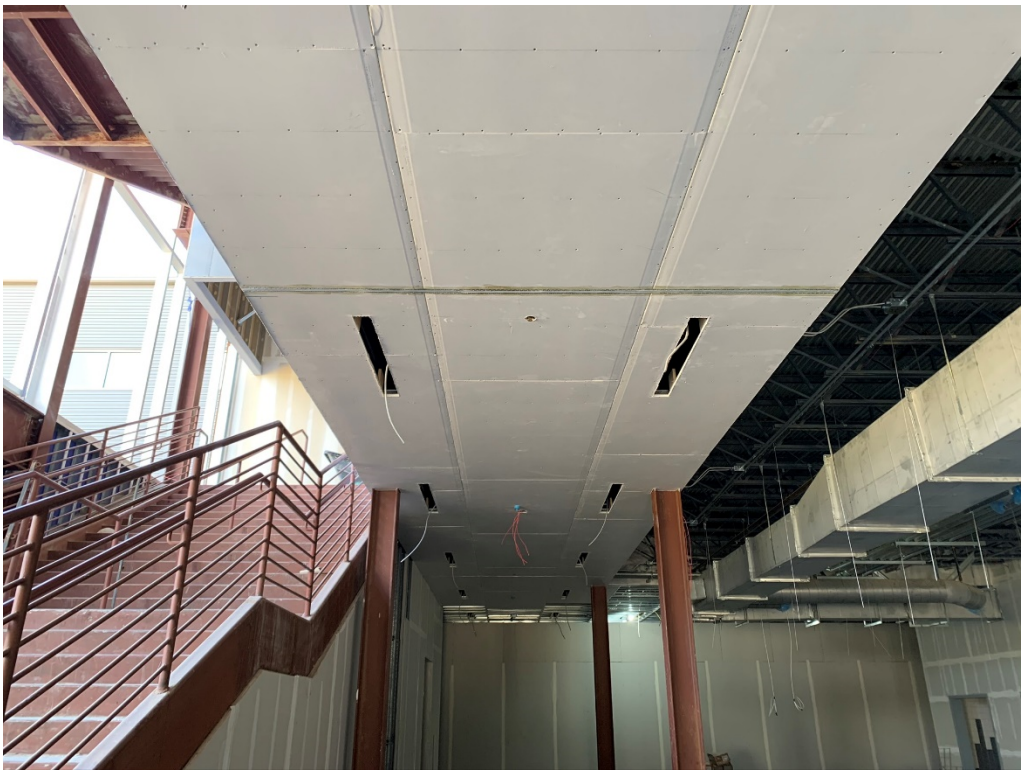
Figure 18 – Hard Ceiling at Cafeteria Stair Connection

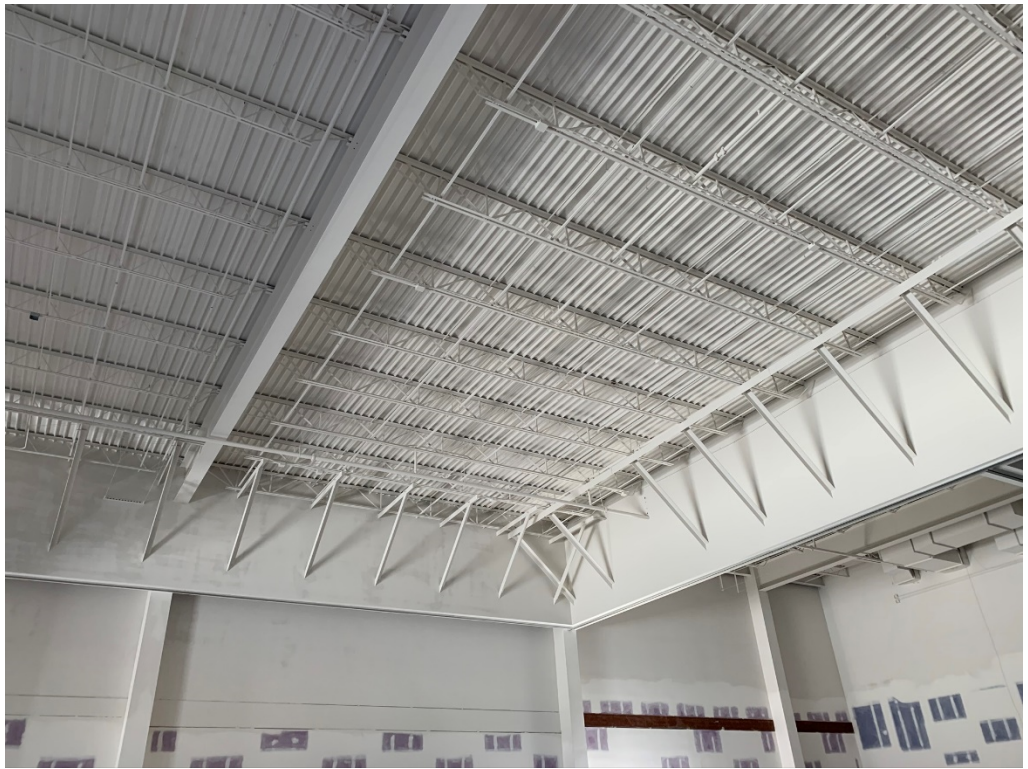
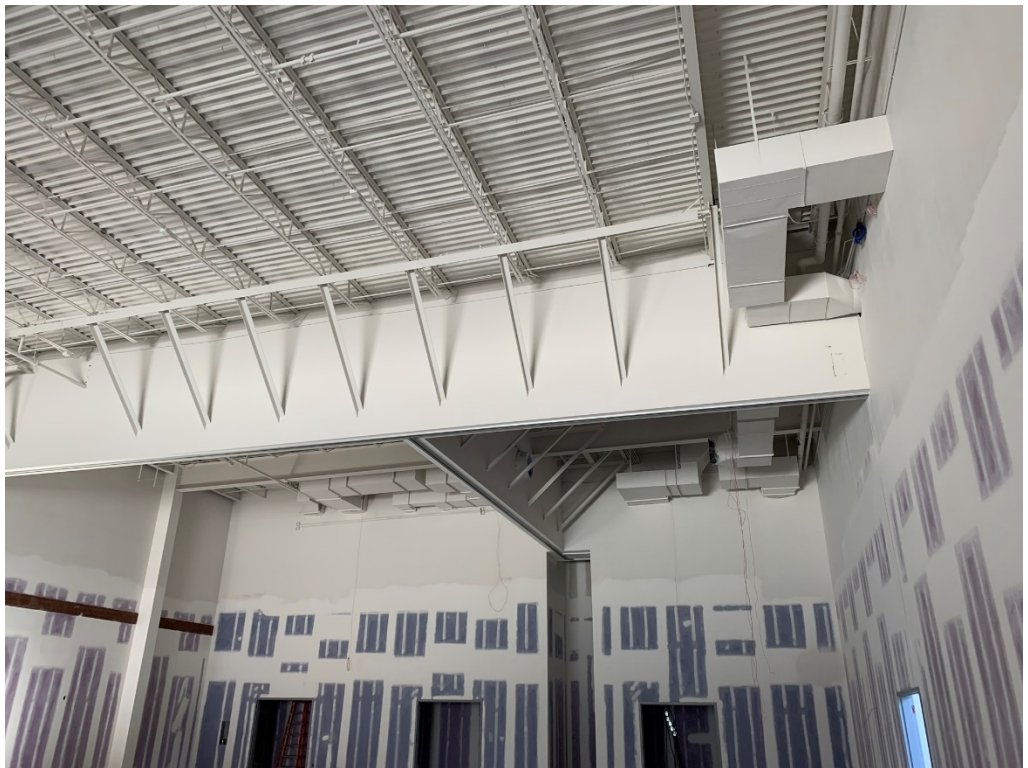
Moving Upstairs, paint has been installed at the gym. Elevators Doors are installed. Ceiling Grid work is also ongoing on the 2nd floor.

Figure 19 – Paint @ Gym Ceilings

Figure 20 – Paint @ Gym Ceilings

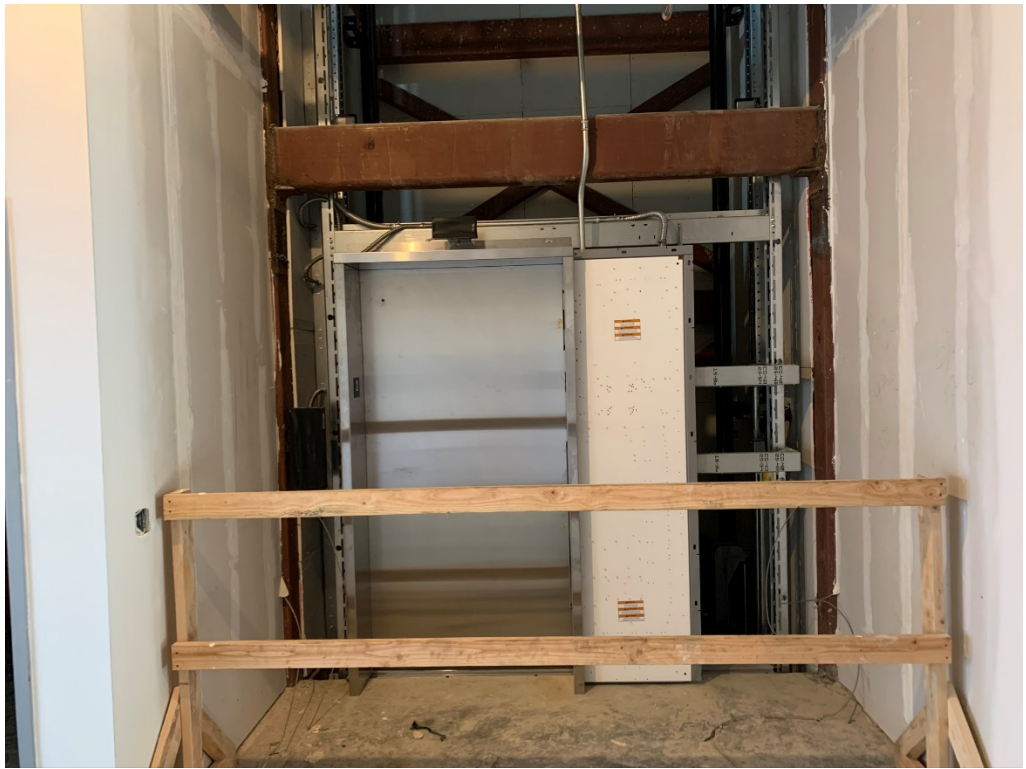
Figure 21 – 2nd Floor Elevator Door Installed

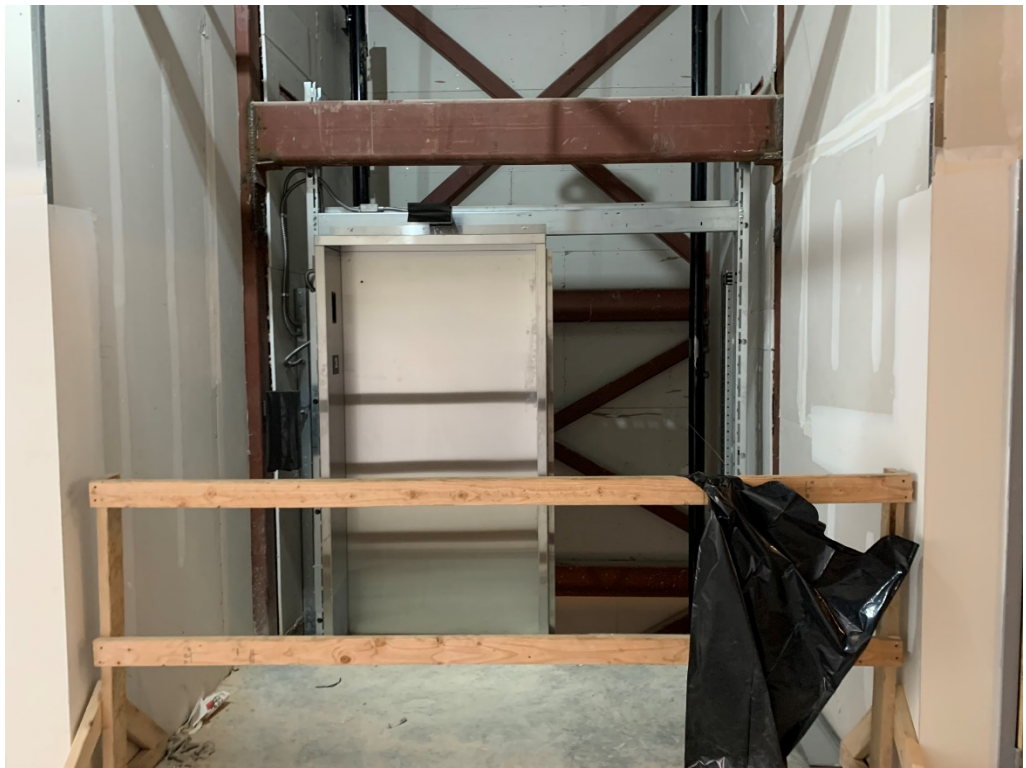
Figure 22 – 3rd Floor Elevator Door Installed

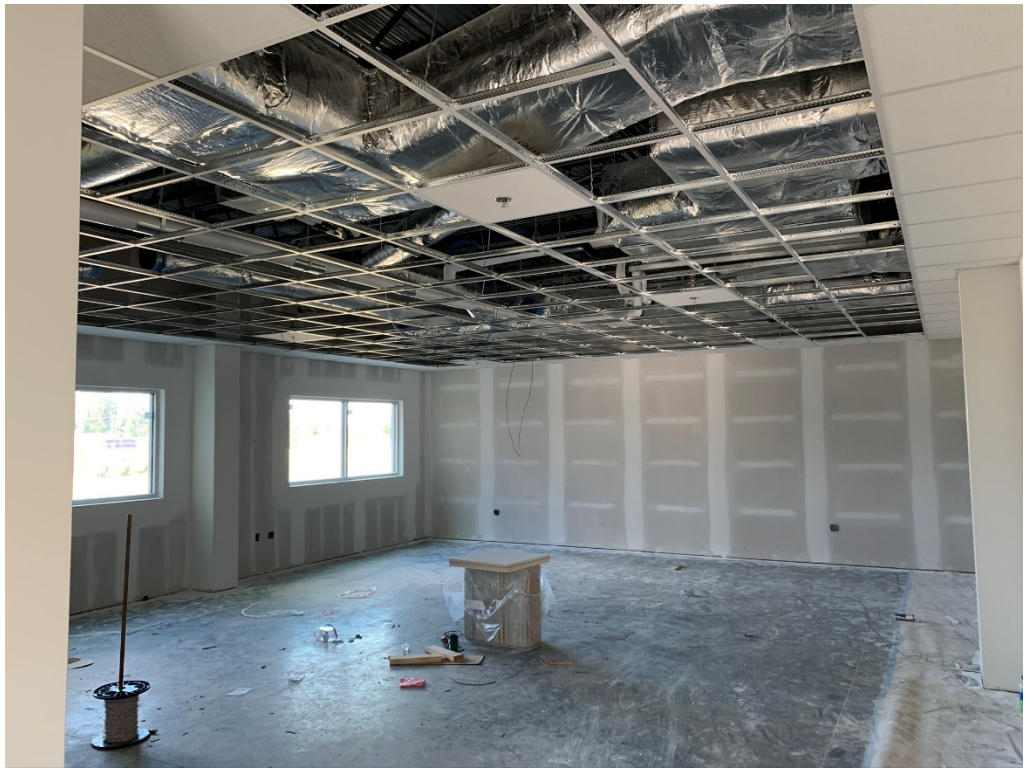
Figure 23 – Ceiling at 2nd Floor Classrooms at North End

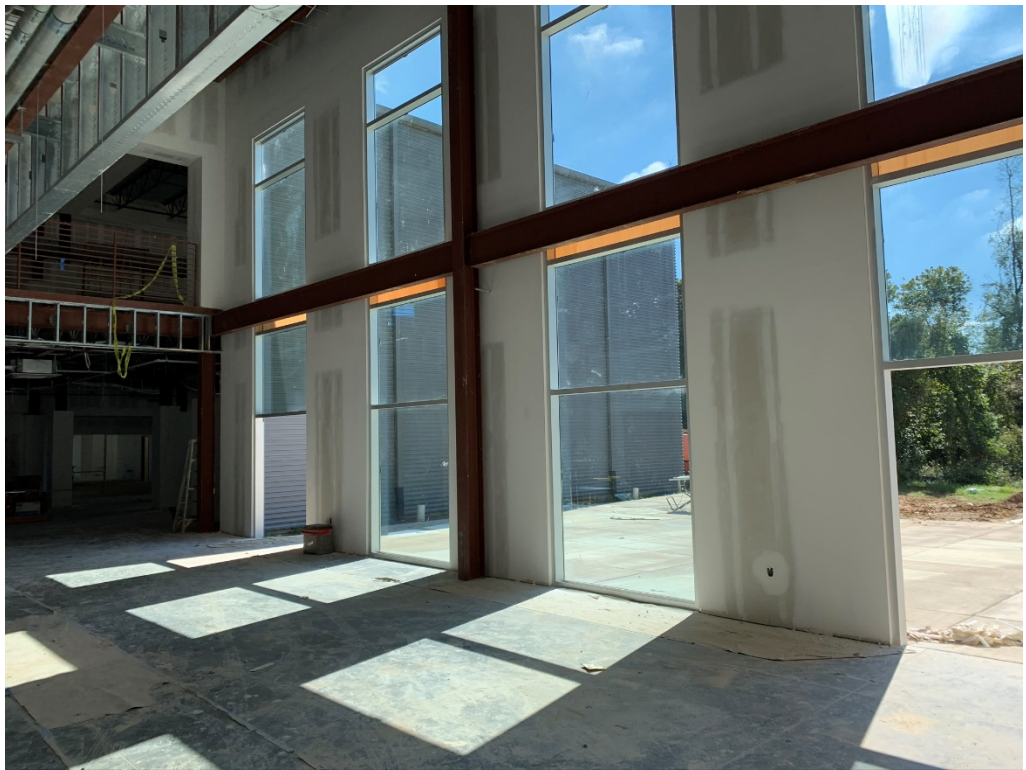
Figure 24 – Lobby Progress

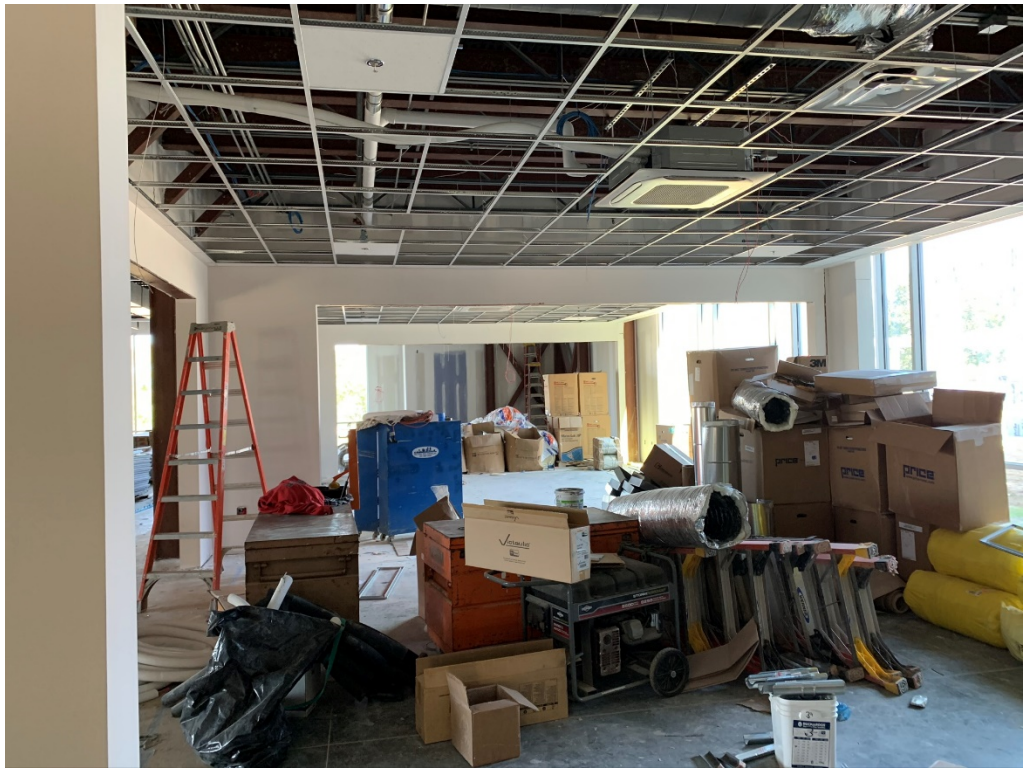
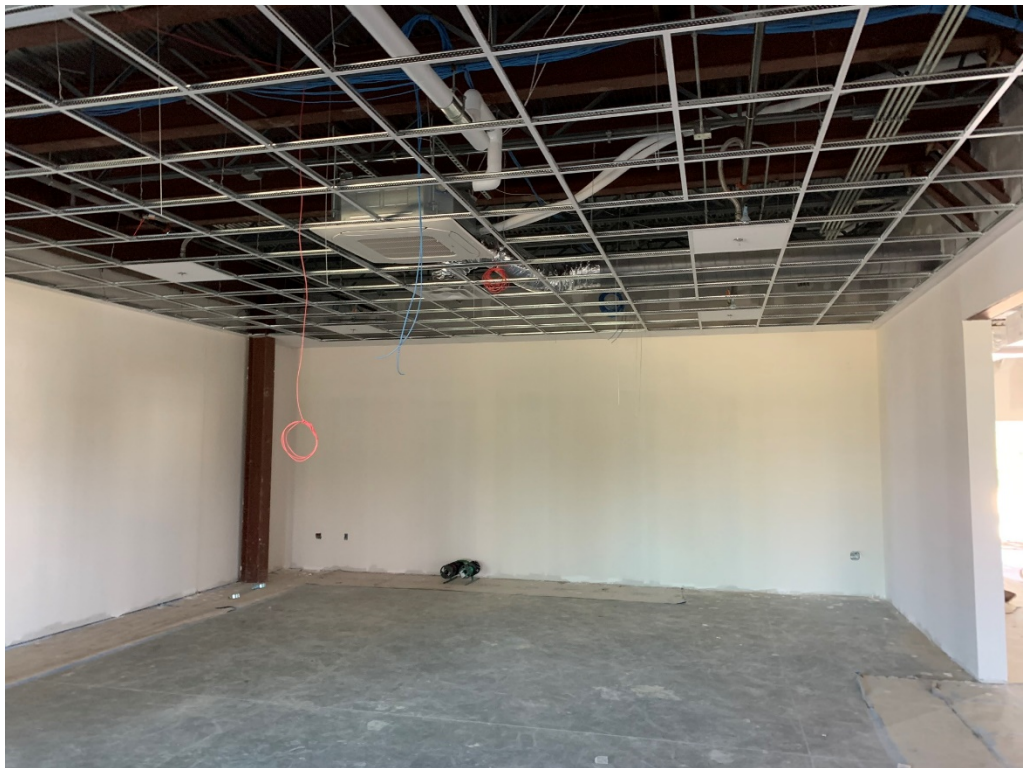
Figure 25 – Ceiling at 2nd Floor Versatile Teaching Space

Figure 26 – Ceiling at 2nd Floor Versatile Teaching Space

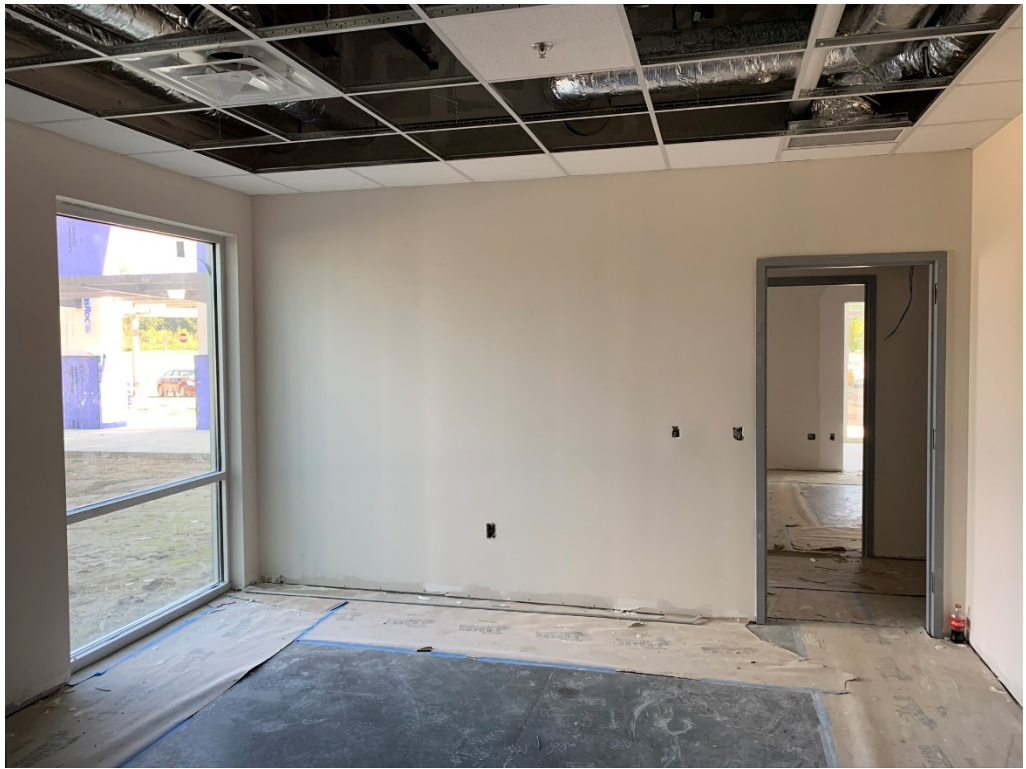
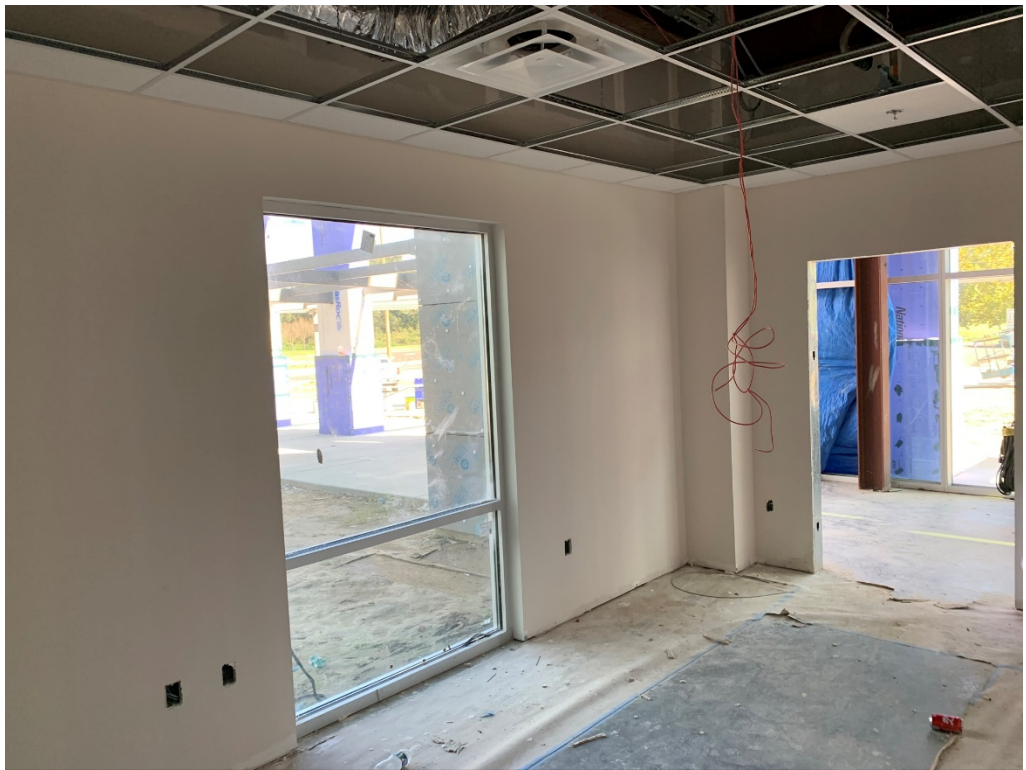
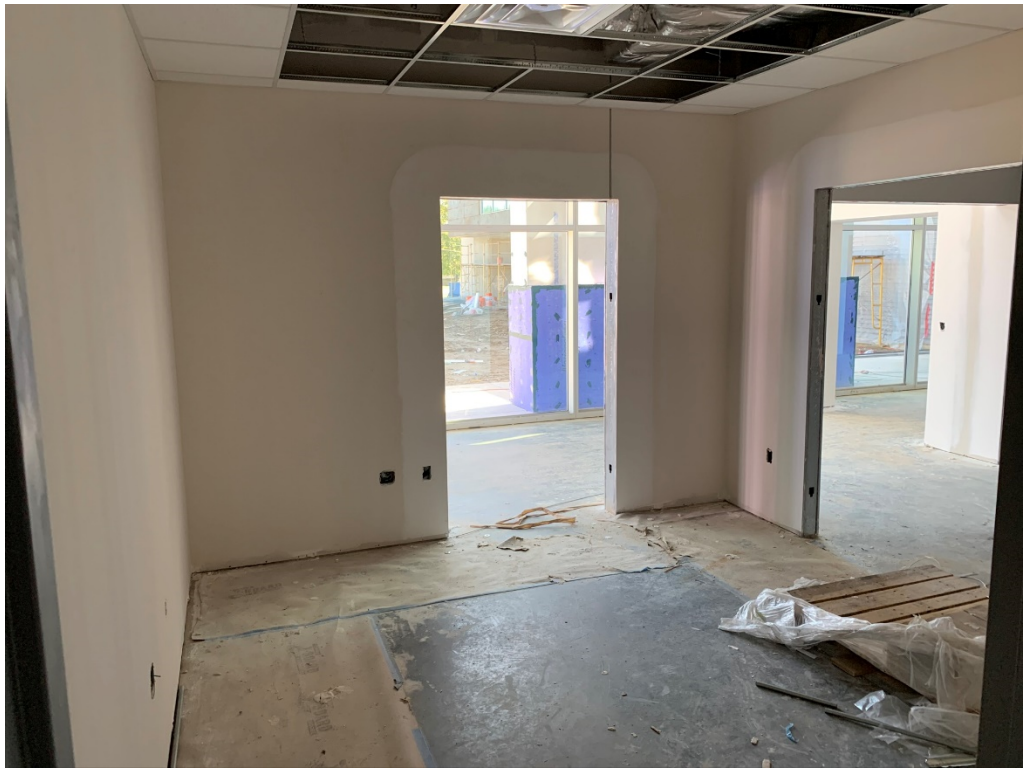
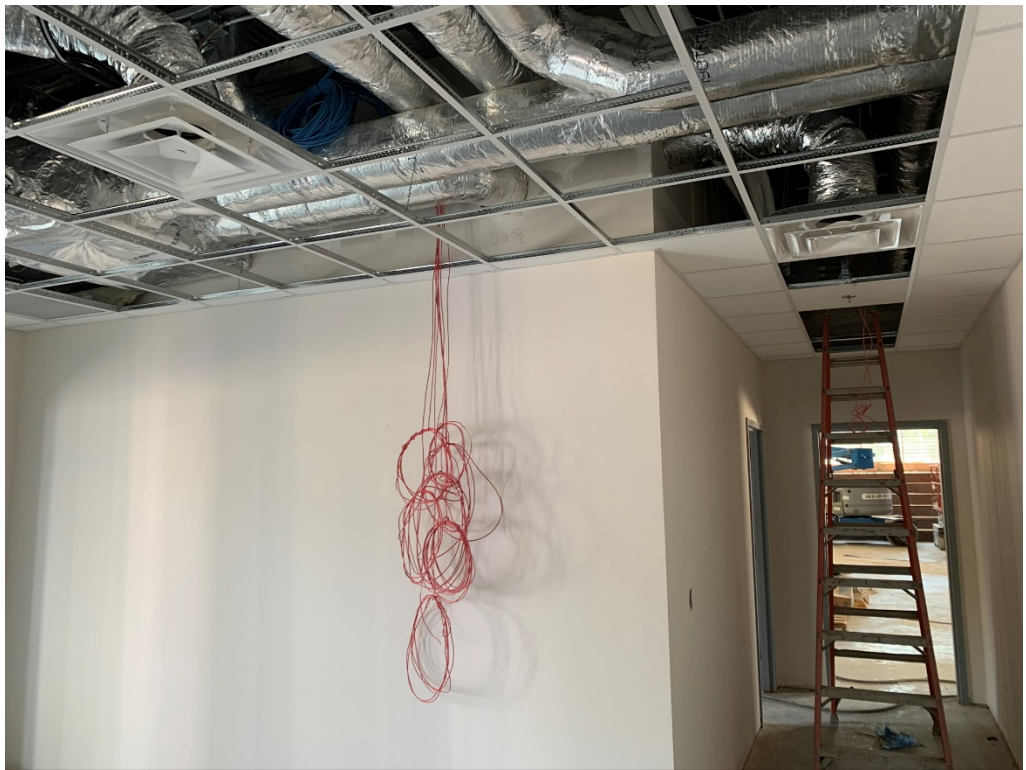
The Administrative area at the second-floor North entry is nearing completion. Wall and ceiling finishes in this area are partially installed.

Figure 27 – Finishing Progress @ 2nd Floor Office Area

Figure 28 – Finishing Progress @ 2nd Floor Office Area

Figure 29 – Finishing Progress @ 2nd Floor Office Area

Figure 30 – Finishing Progress @ 2nd Floor Office Area

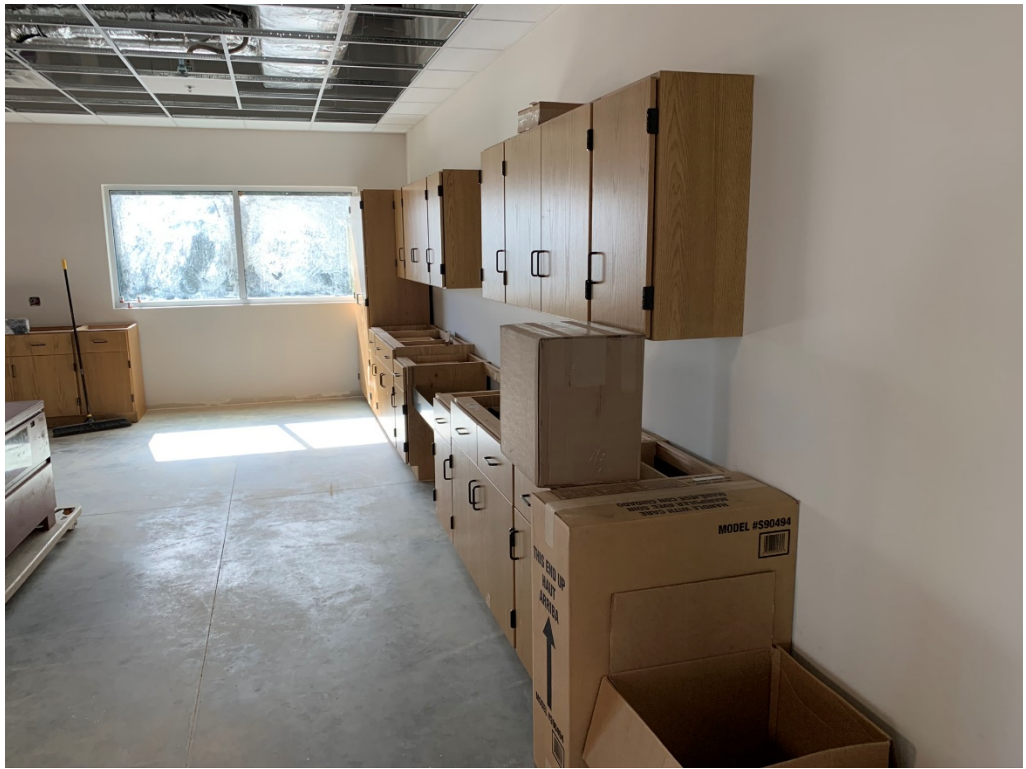
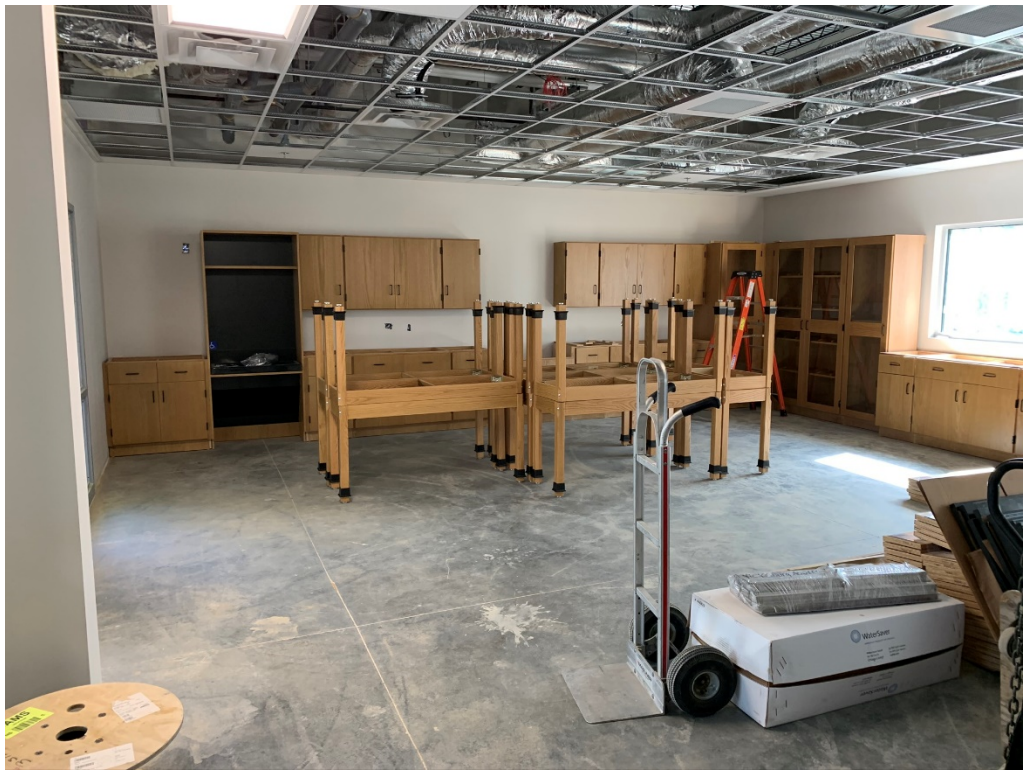
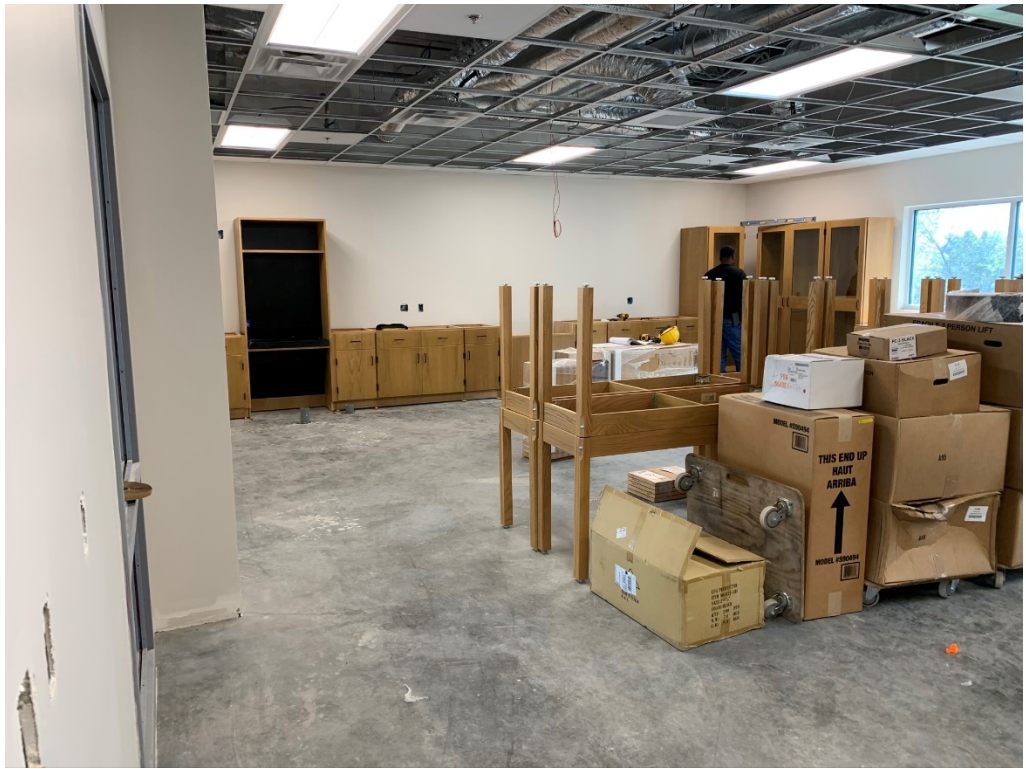
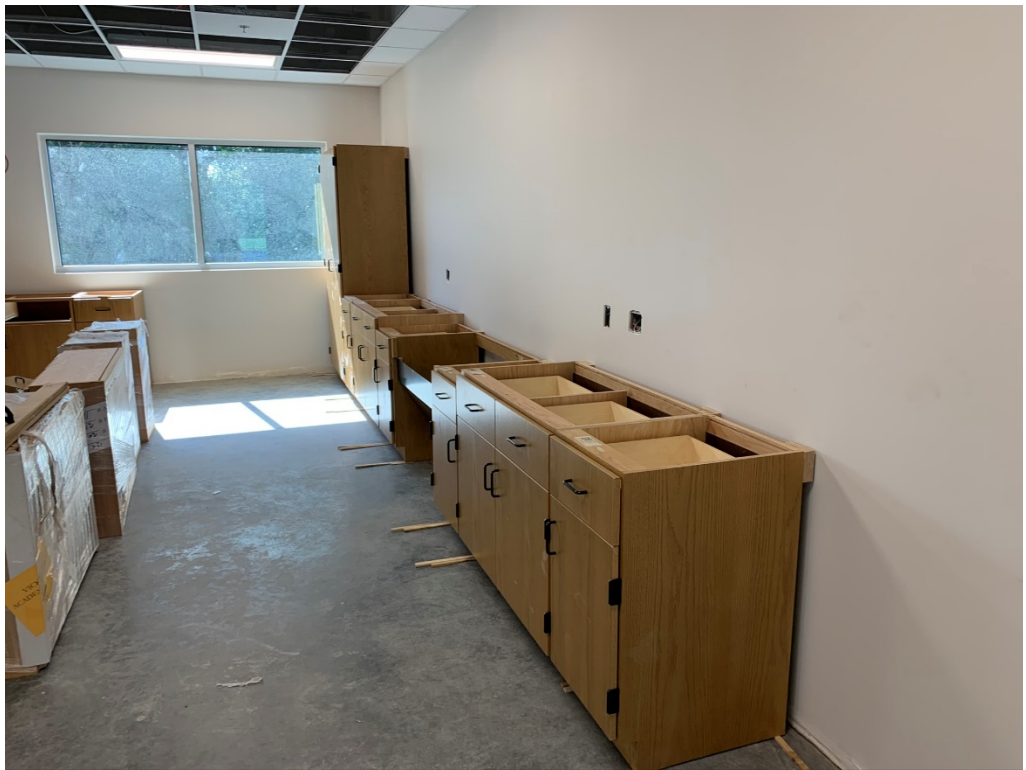
At the east wing, cabinets are being set and leveled. For the most part, cabinets here at the 2nd and 3rd floor labs have mostly been installed.

Figure 31 – Cabinets Installed at East Classrooms

Figure 32 – Cabinets Installed at East Classrooms

Figure 33 – Cabinets Installed at East Classrooms

Figure 34 – Cabinets Installed at East Classrooms

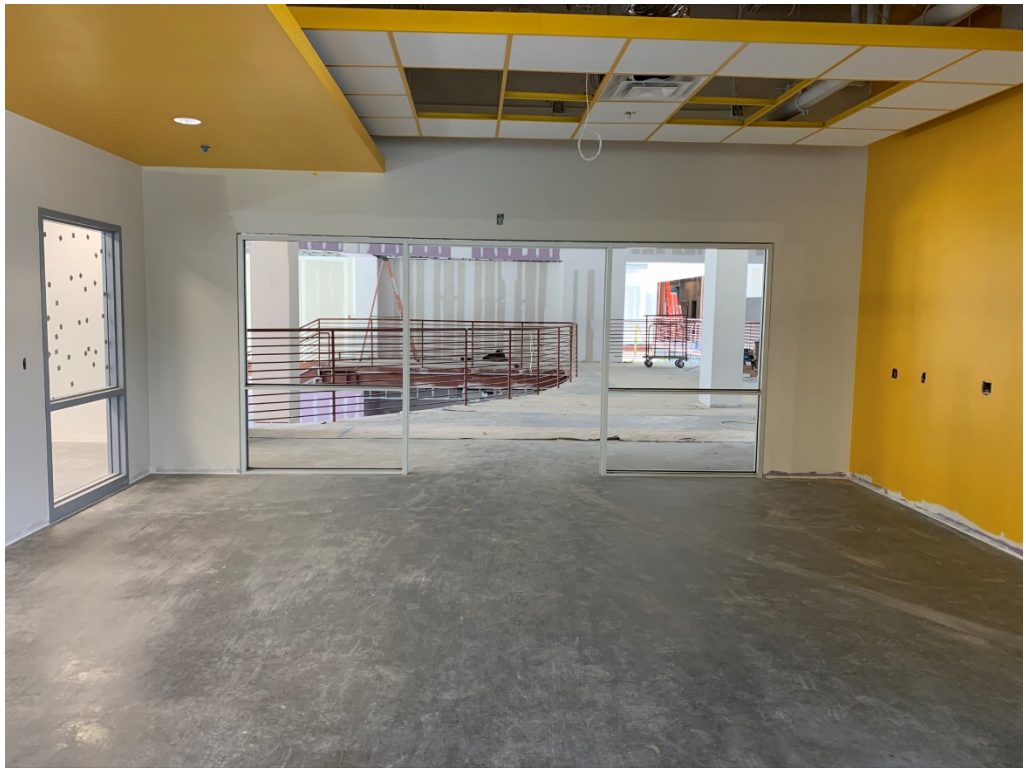
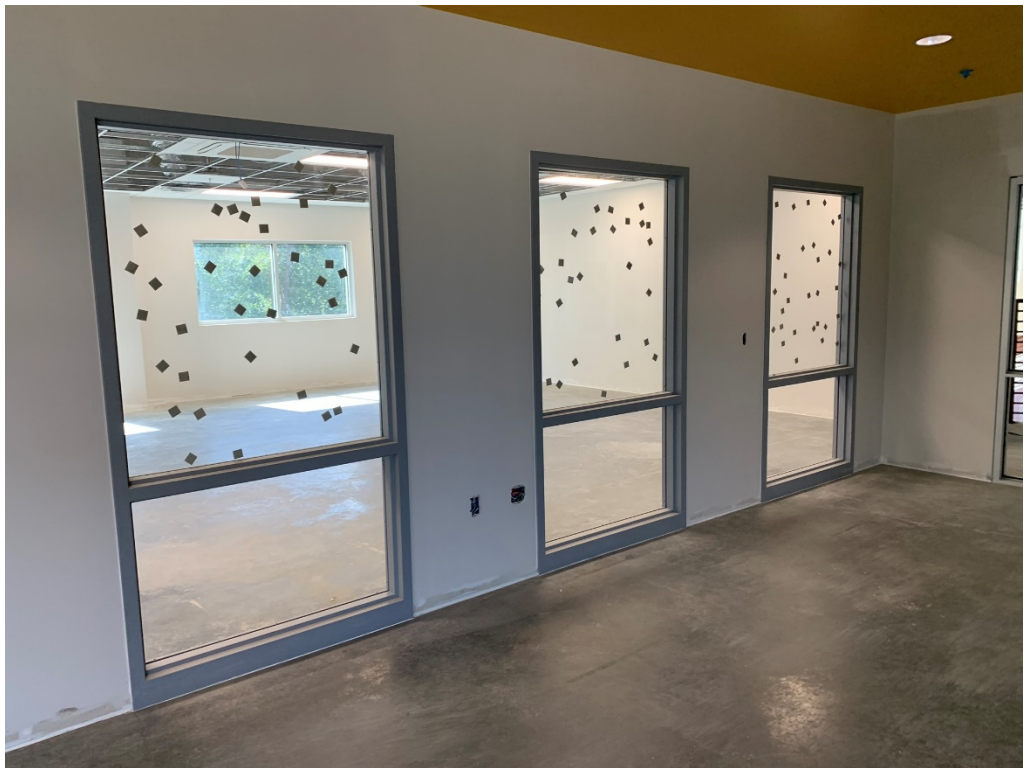
Figure 35 – 3rd Floor Entry Glazing Install Progress

Figure 36 – 3rd Floor Entry Glazing Install Progress
