Architect's Field Report

31 October 2020

18059-AOI Academy of Innovation / Report Number 049

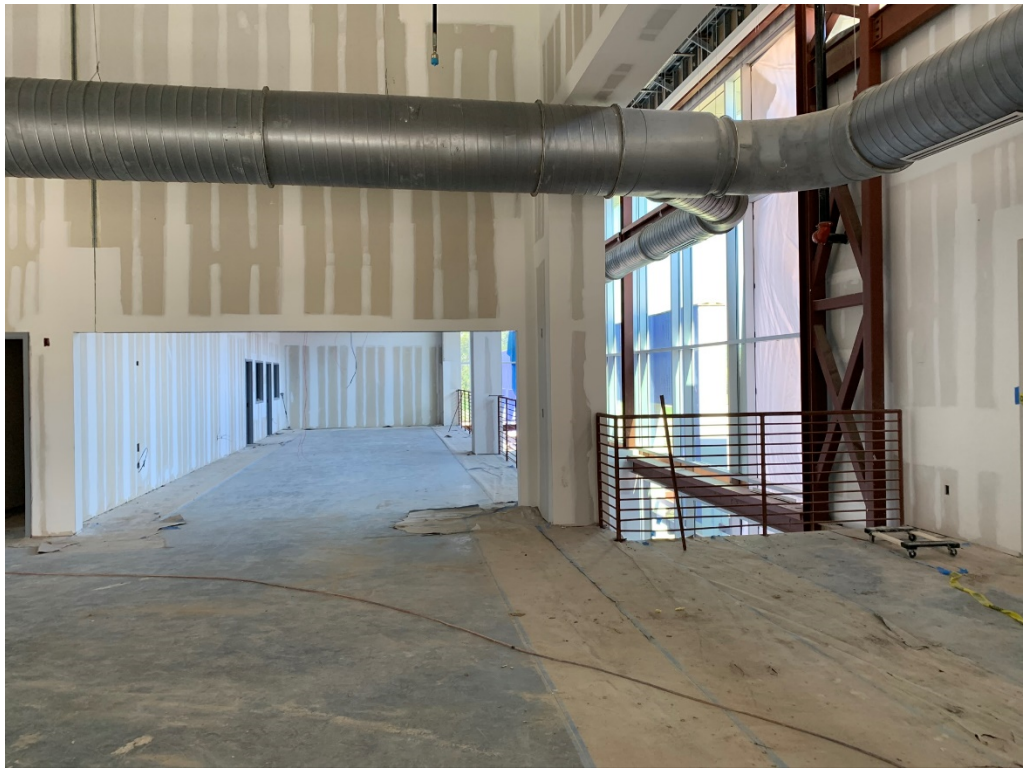
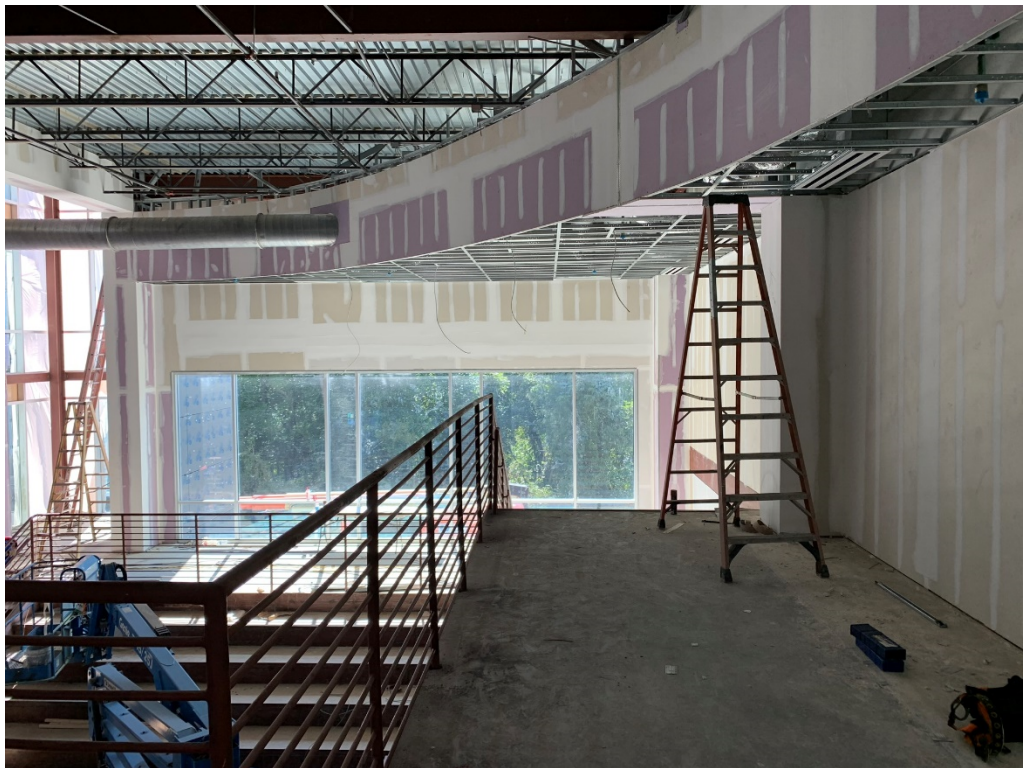
Figure 37 – 3rd Floor Lobby Progress

Figure 38 – 3rd Floor Lobby Progress

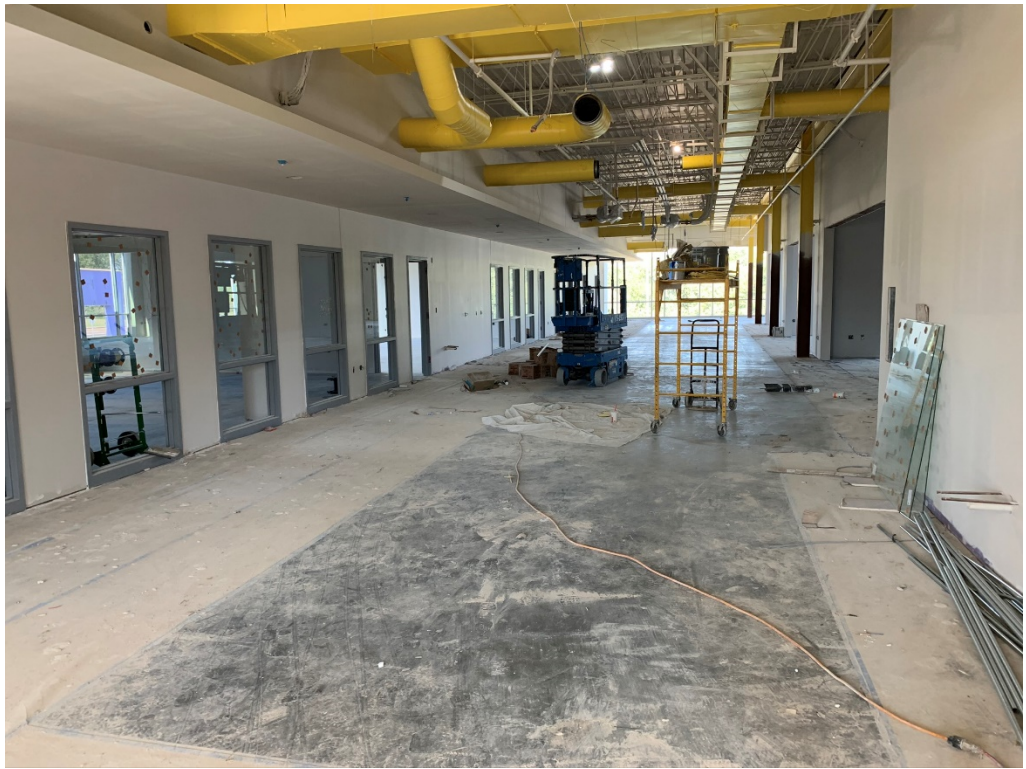
Figure 39 – 3rd Versatile Teaching

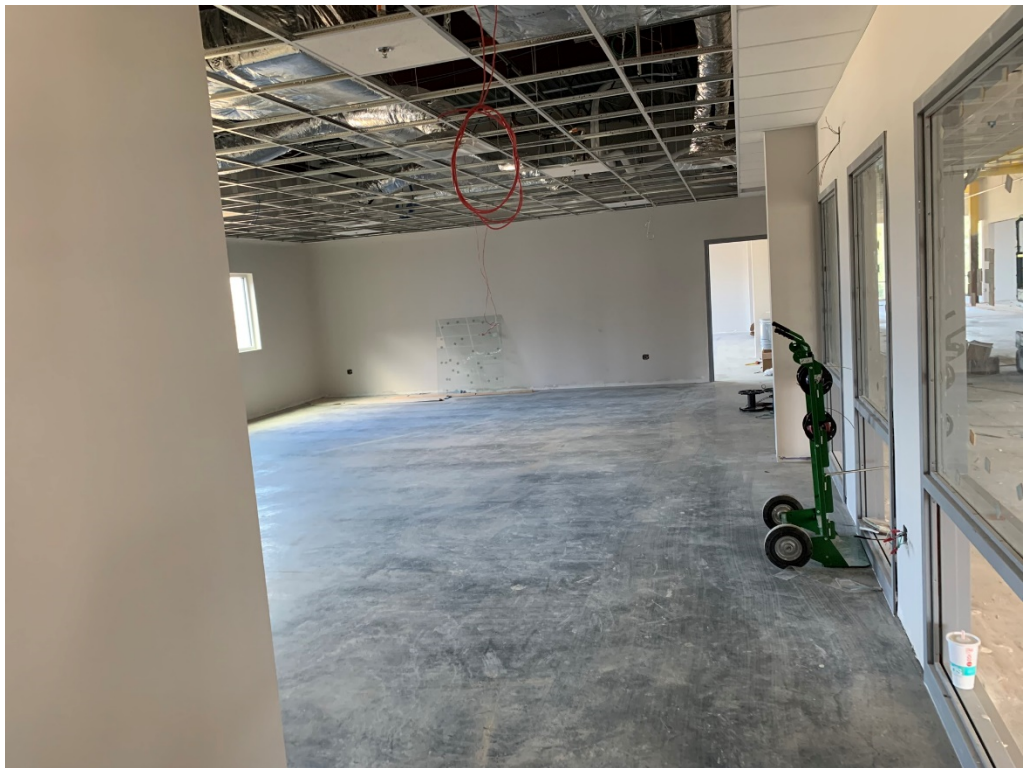
Figure 40 – 3rd Floor Classroom Progress

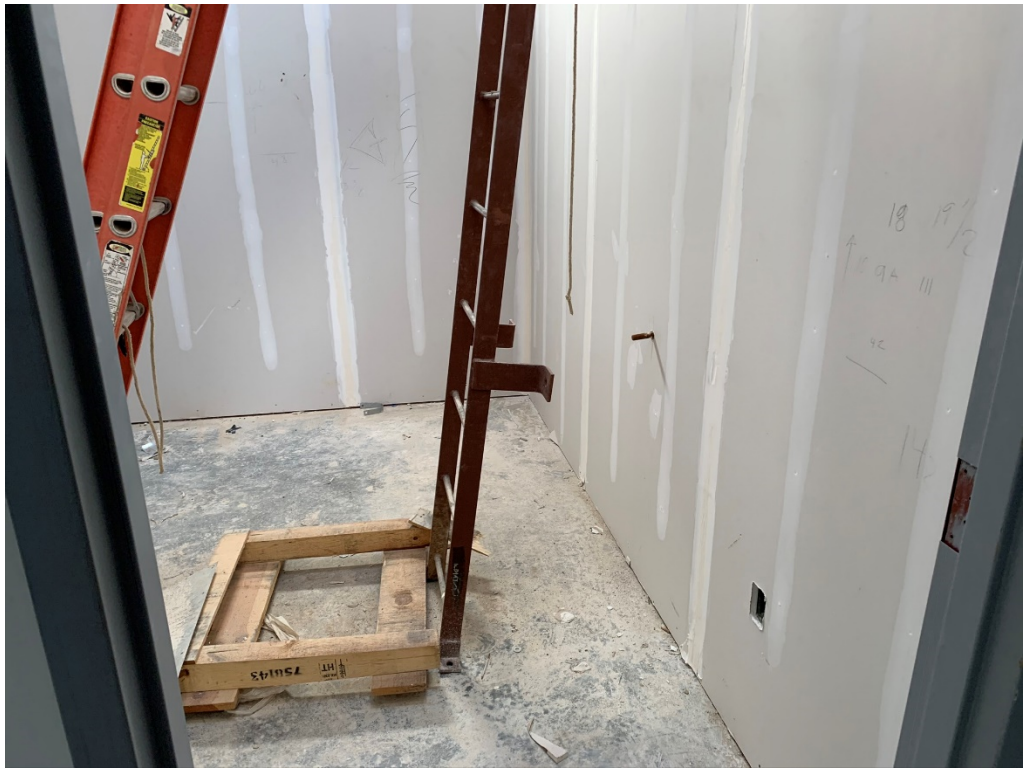
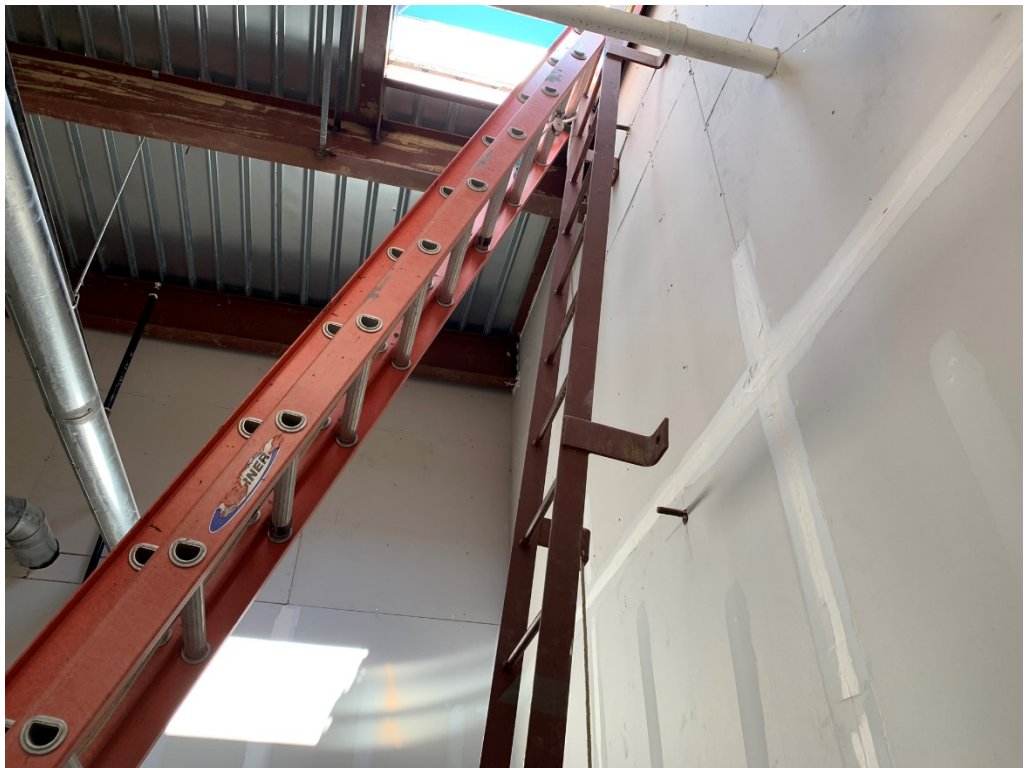
Figure 41 – Ladder Access Install

Figure 42 – Ladder Access Install

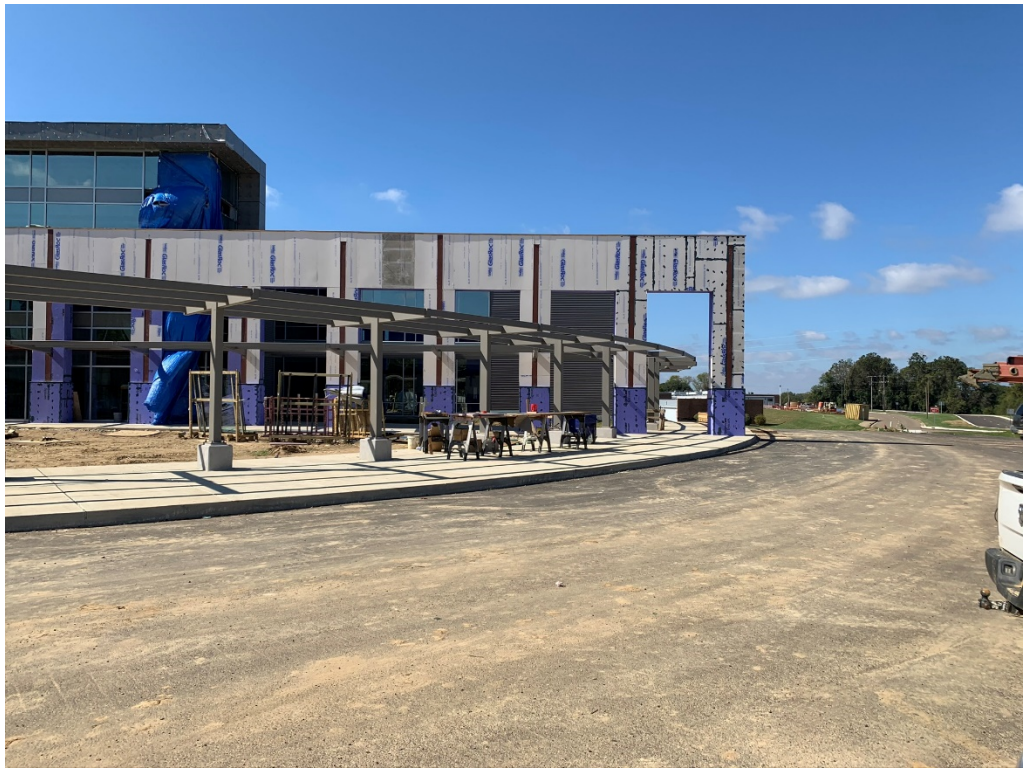
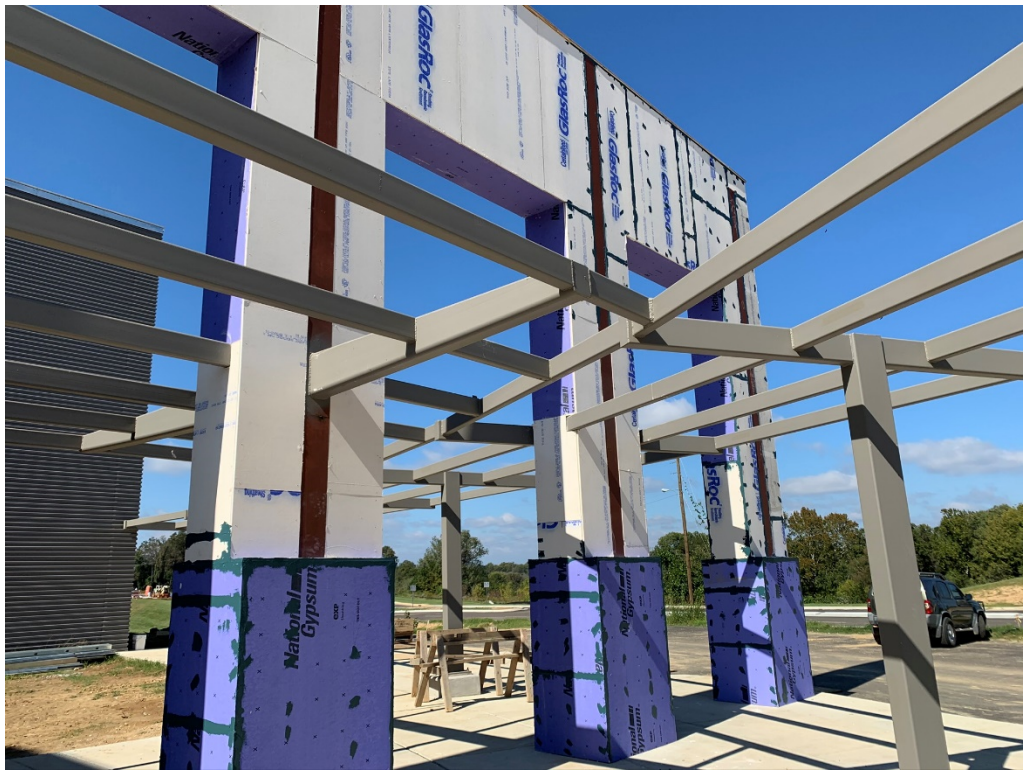
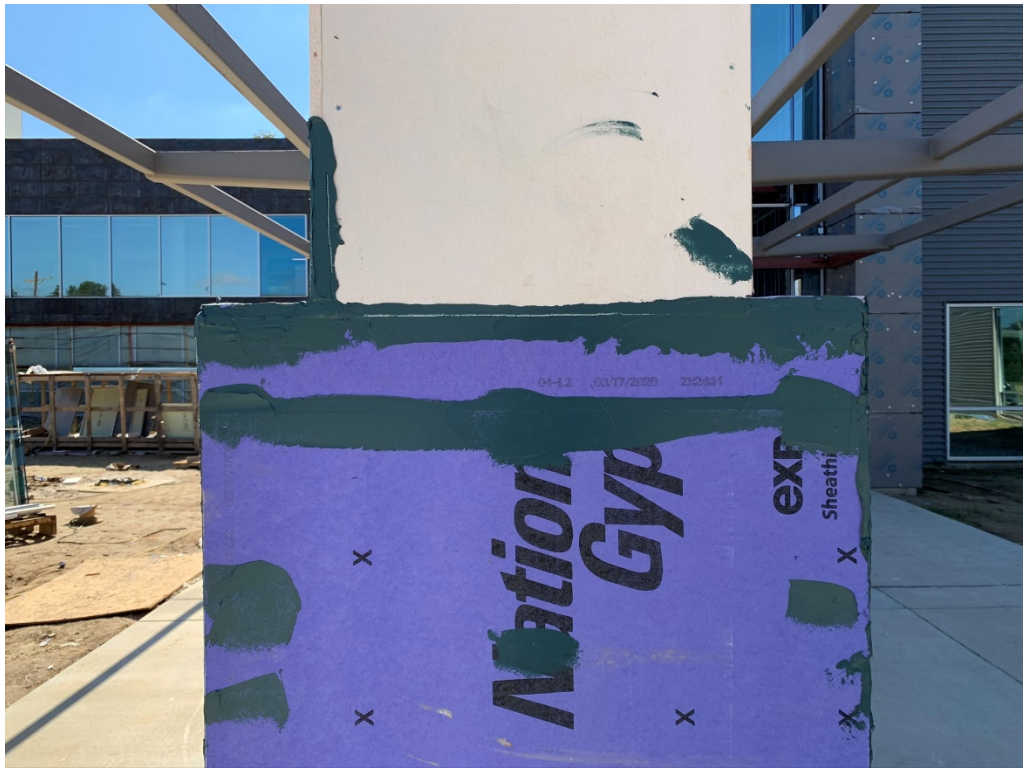
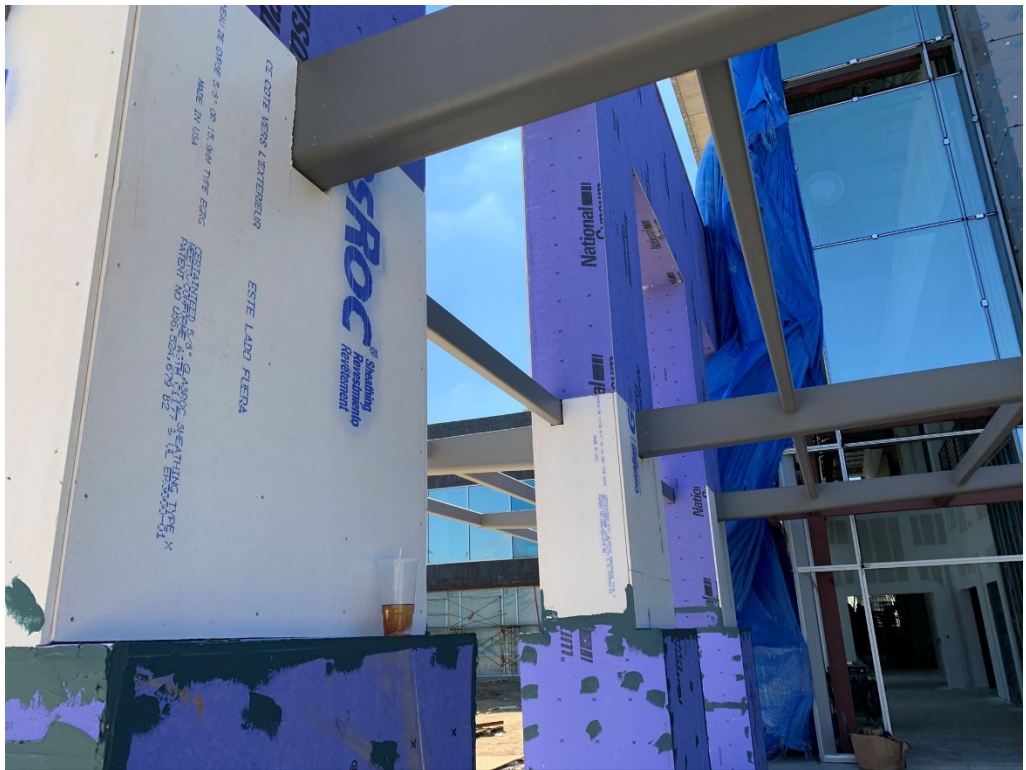
Substrate for stucco has been installed and partially water-proofed at the North "Innovate" Canopy.

Figure 43 – Innovative Canopy Progress

Figure 44 – Innovative Canopy Progress

Figure 45 – Innovative Canopy Progress

Figure 46 – Innovative Canopy Progress
