Architect's Field Report

201 Park Court, Suite B Ridgeland, MS 39157 P 601.790.9432 F 888.281.0547	21 November 2020 18059-AOI Academy of Innovation / Report Number 050
One Jackson Place, Suite 250 188 East Capitol Street Jackson, MS 39201-2100 P 601.352.5411 F 601.352.5362	Contract Century Construction Date / Time 20 November 2020 / 2:30 PM Weather / Temp Clear / 62 ° F Est % Complete 65% Sched Conformance + 68 days Work in Progress Panel Installation Stucco Work Awning Installation
161 Lameuse Street, Suite 201 Biloxi, MS 39530 P 228.374.1409 F 228.374.1414	Present at Site Paul Purser, DBA Observations Installers were putting together the Vitruvian Man at the North Elevation. Also, at the North elevation, awning installers were at work installing the roof covering at the main drop-off's awning. Stucco workers have built scaffolds in this area and have begun installing metal lather in preparation for stucco install. On the inside, Painters were continuing there work throughout.

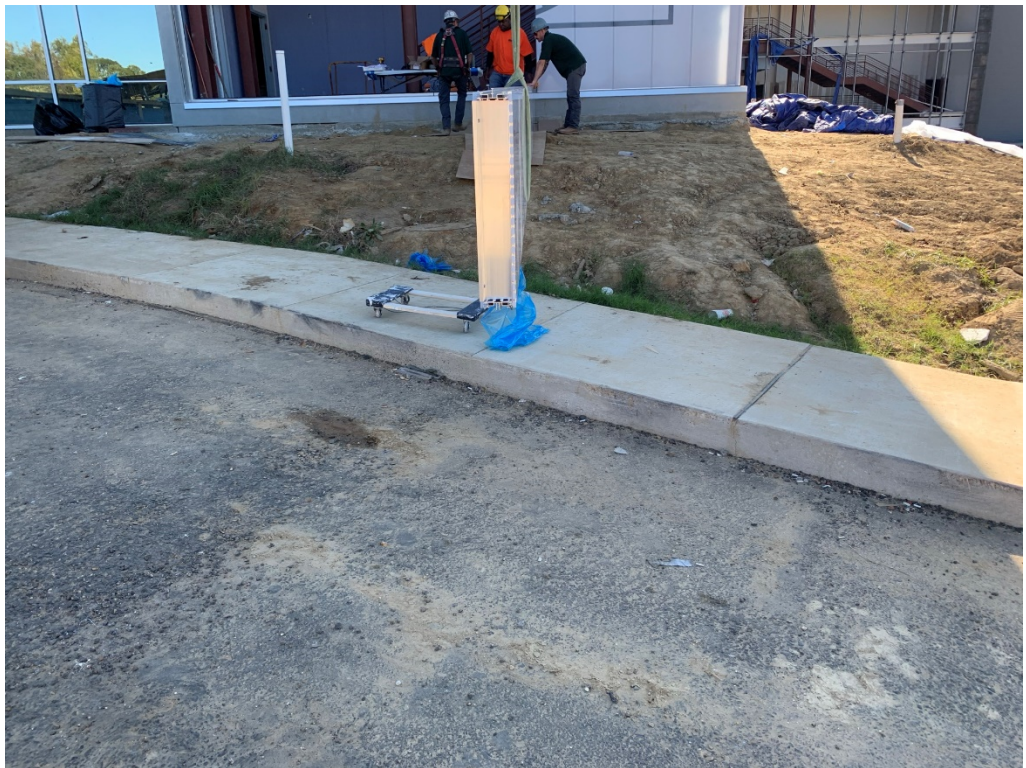
Figure 2 – Panel Installation is Ongoing

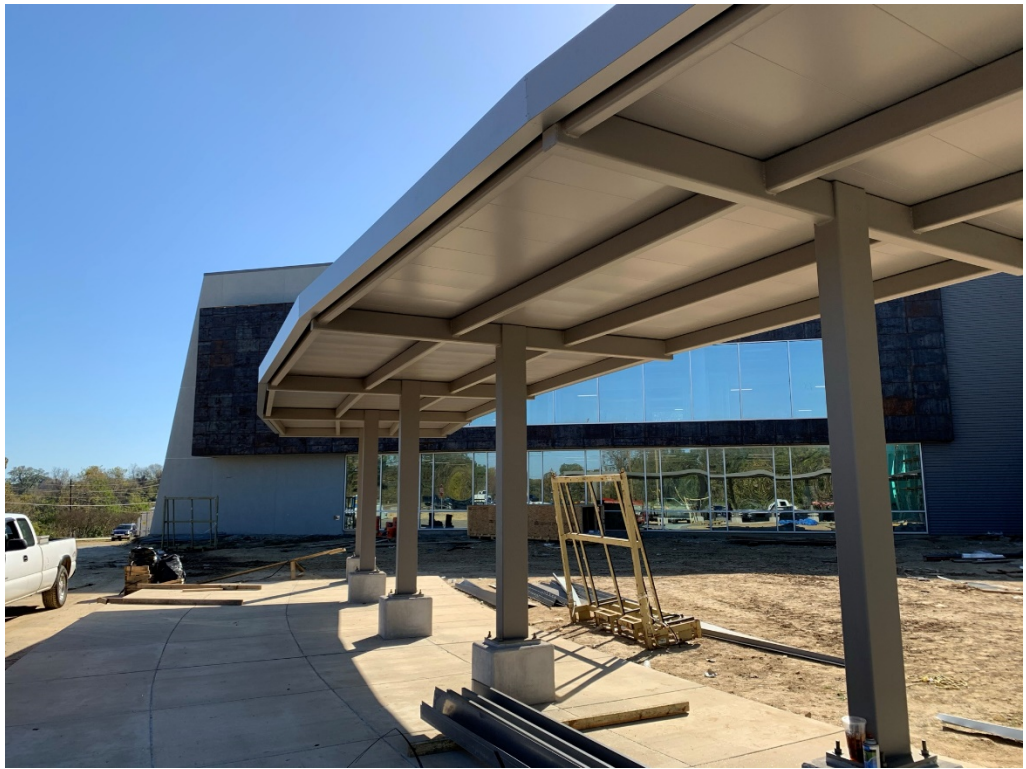
Figure 3 – Awning Covering Installation is Ongoing

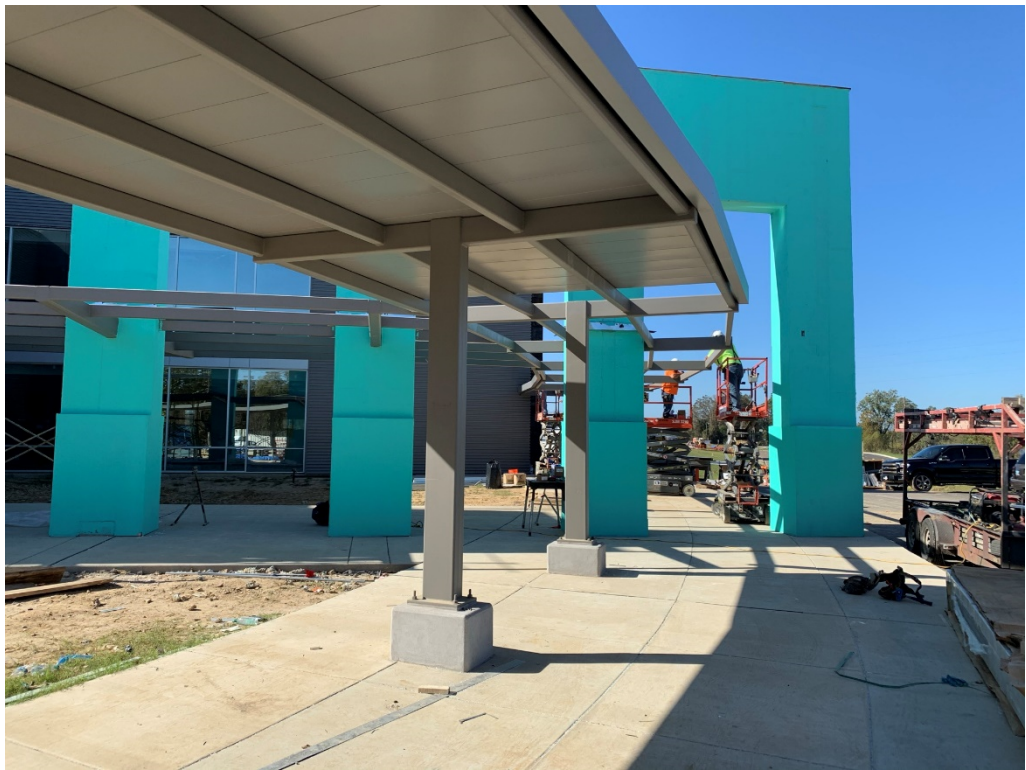
Figure 4 – Awning Covering Installation is Ongoing

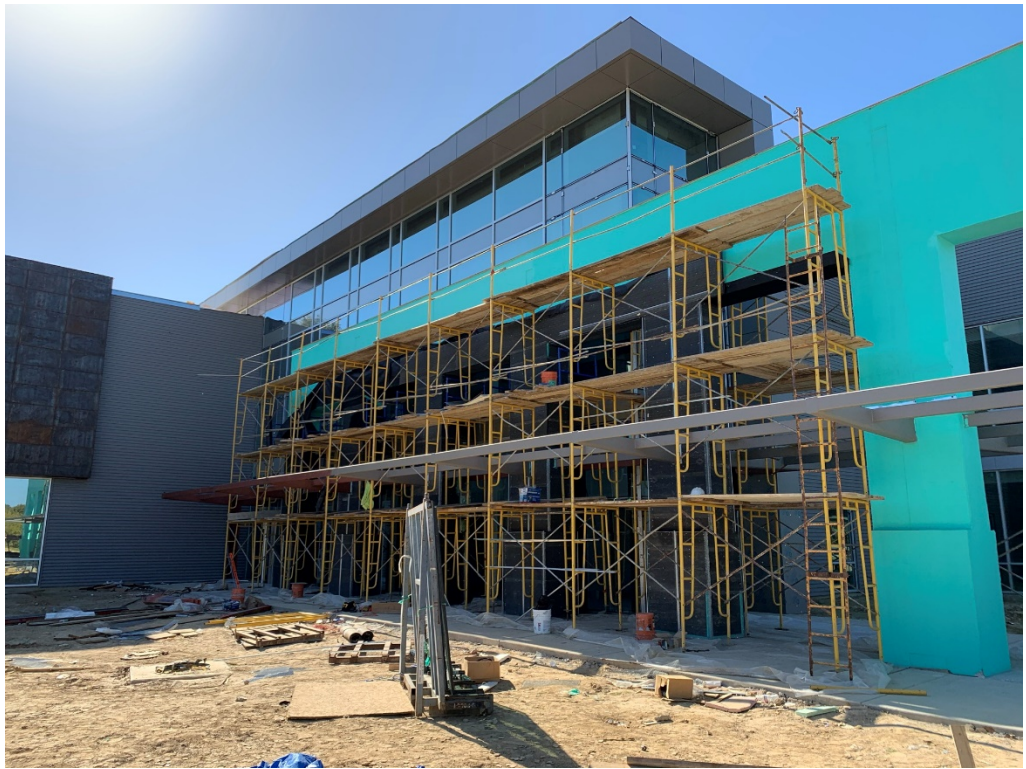
Figure 5 – Stucco work has begun at the main Entrance

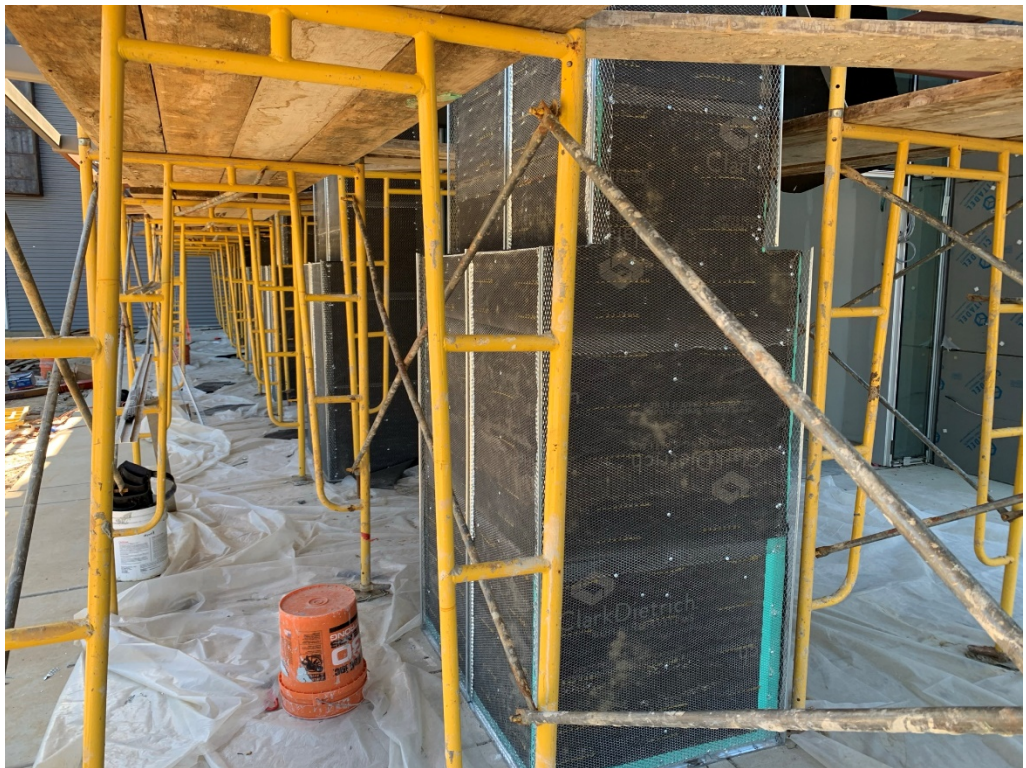
Figure 6 – Stucco work has begun at the main Entrance

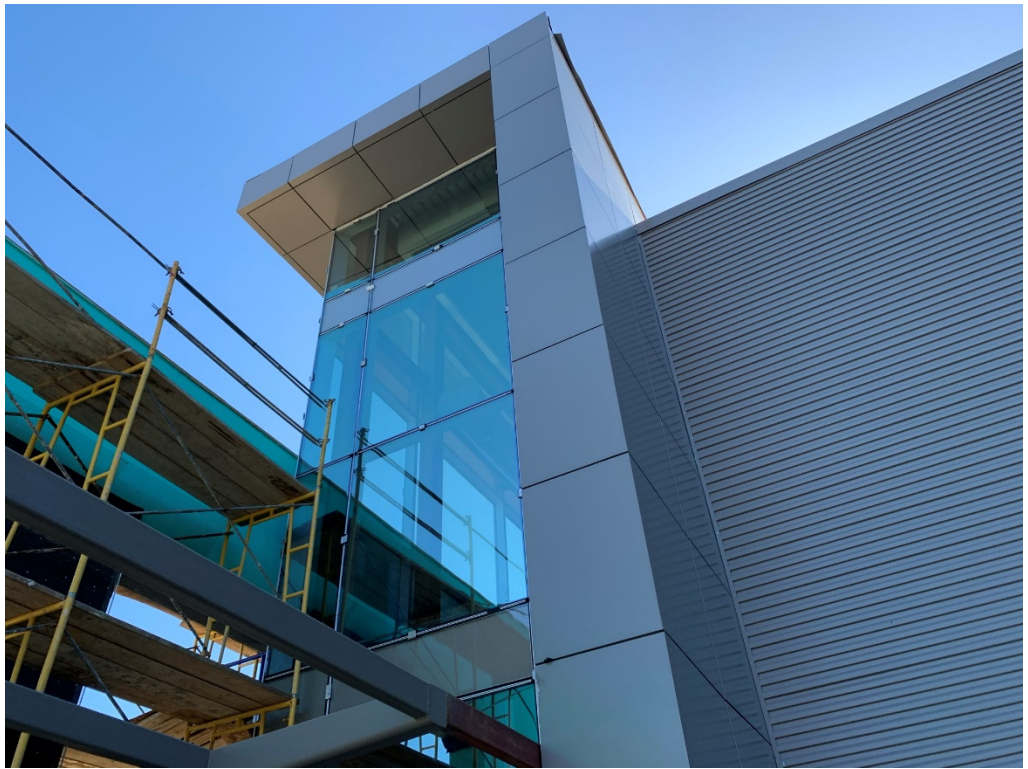
Figure 7 – Metal Paneling and Curtain Wall at the Entrance

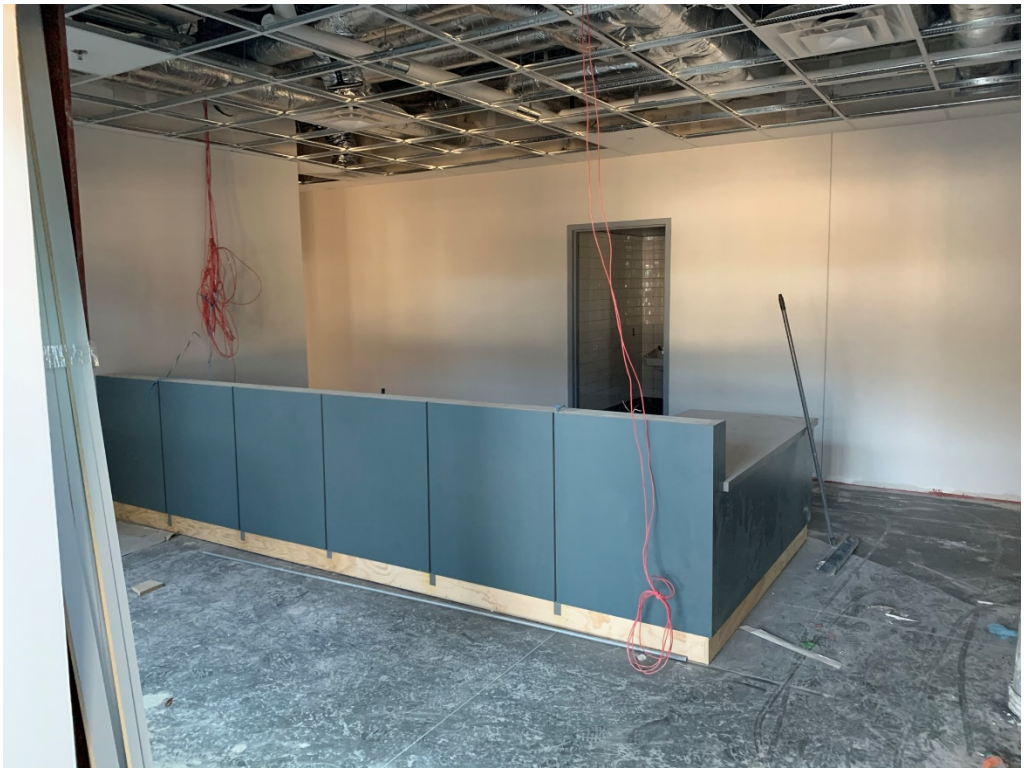
Figure 9 – Millwork at Main Entrance Check In

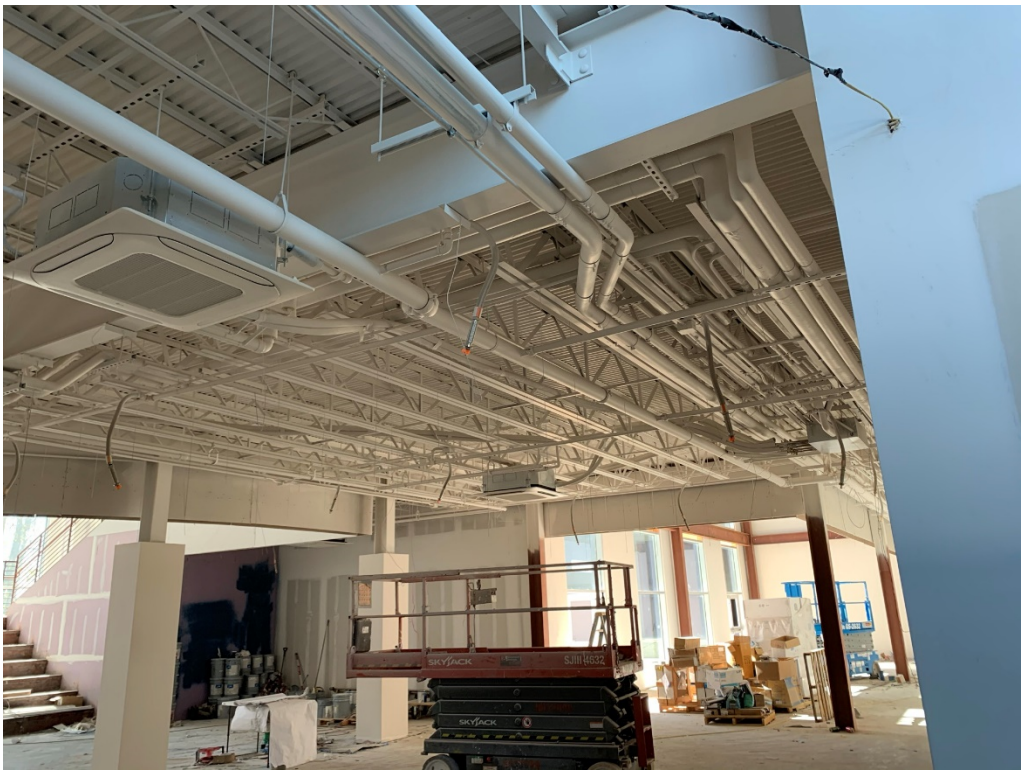
Figure 10 – Ceiling Paint Work

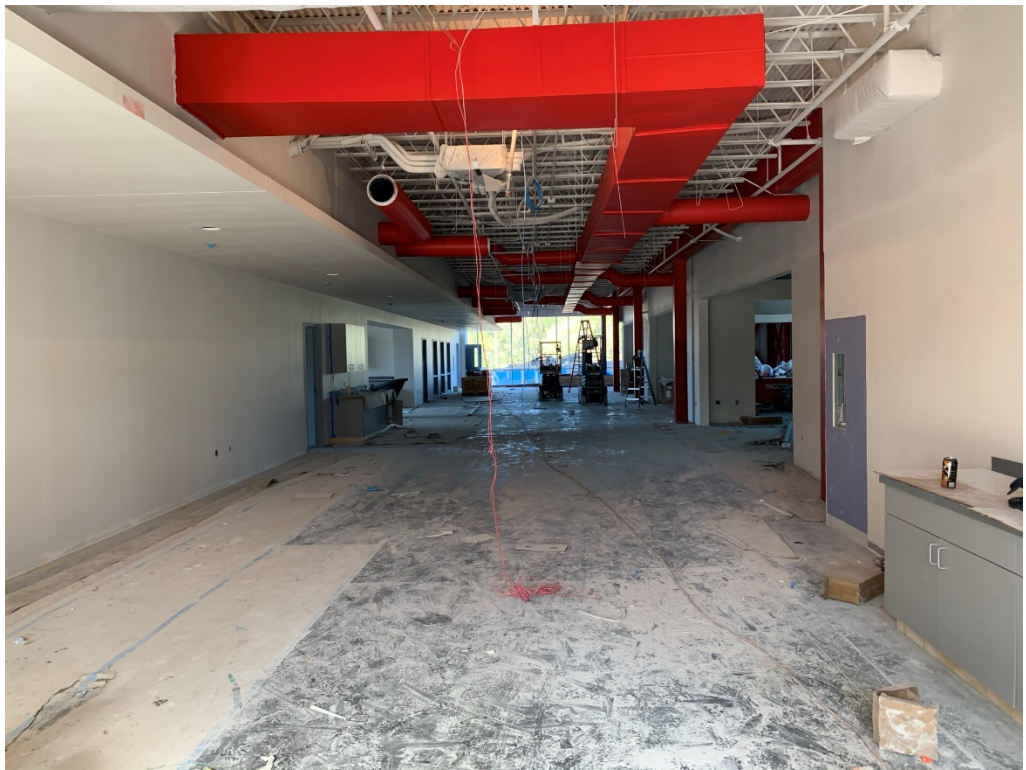
Figure 12 – Paint Work is Ongoing

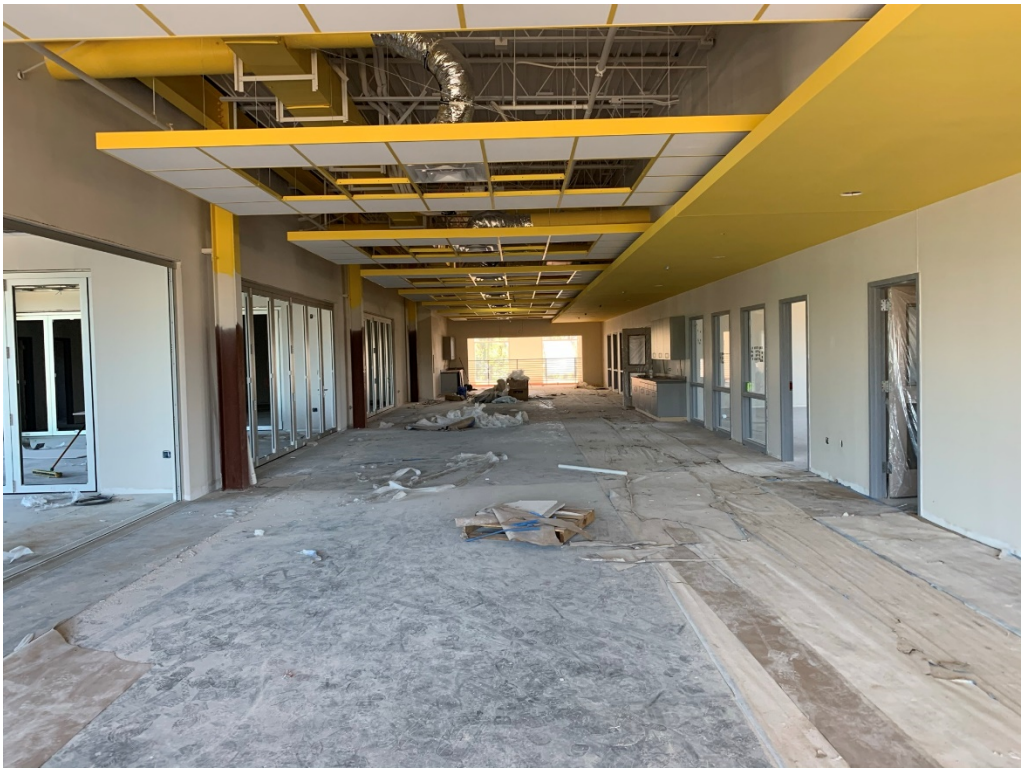
Figure 13 – Paint Work is Ongoing

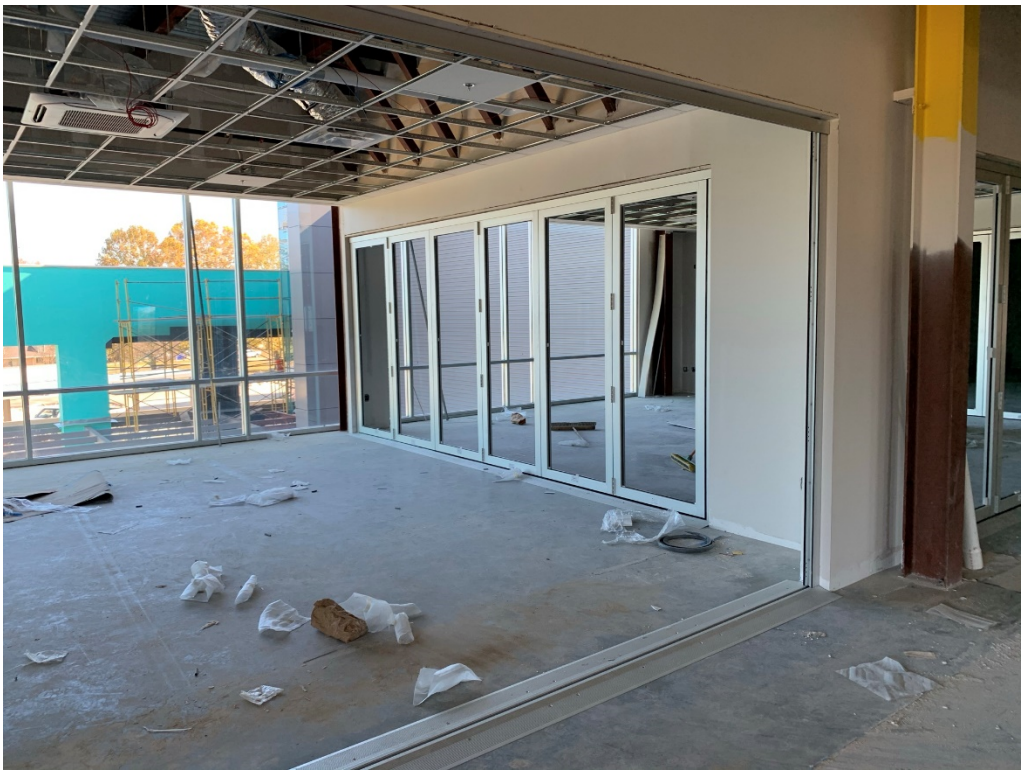
Figure 14 – Partition Wall Installation is Ongoing

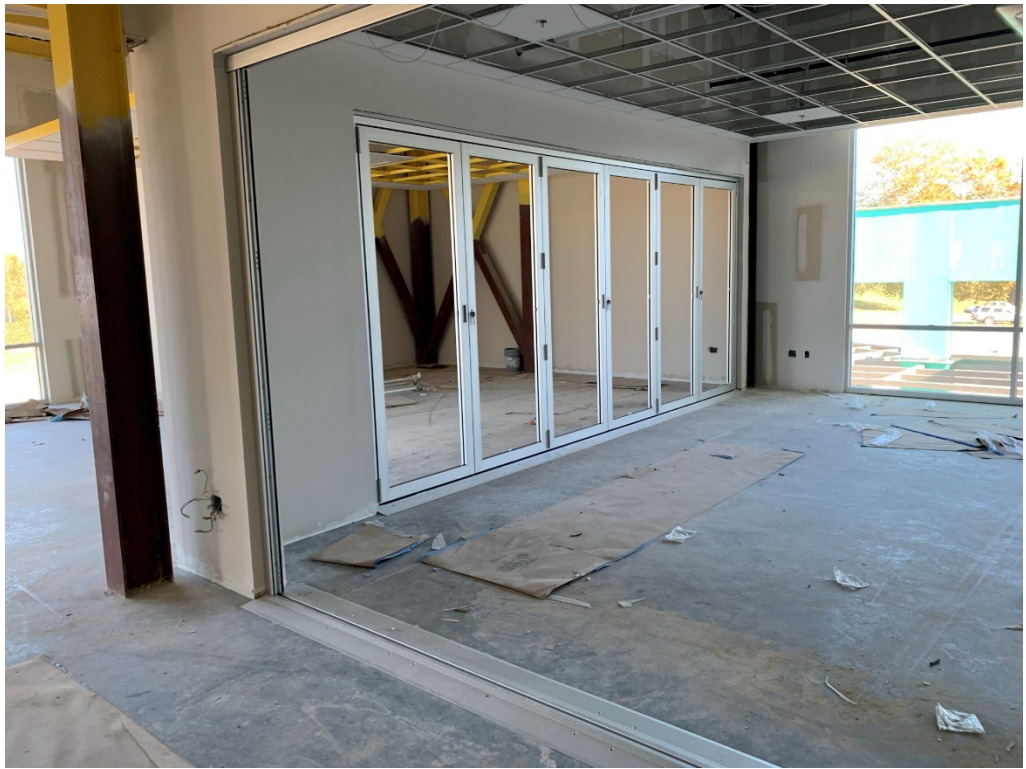
Figure 15 – Partition Wall Installation is Ongoing

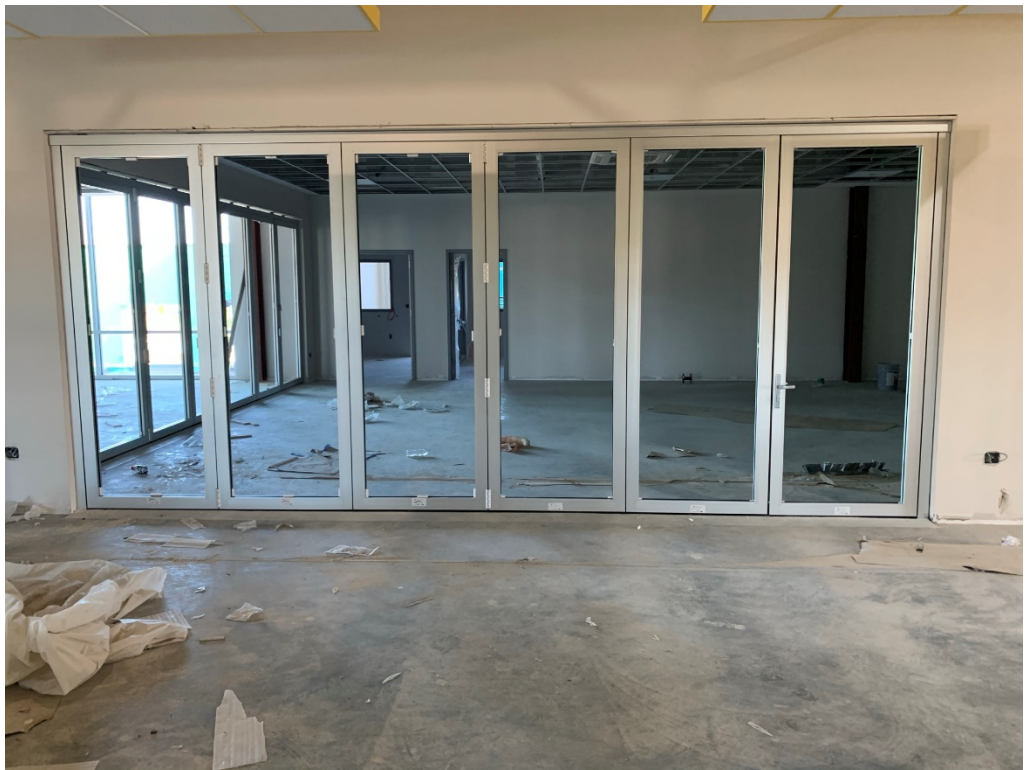
Figure 16 – Partition Wall Installation is Ongoing

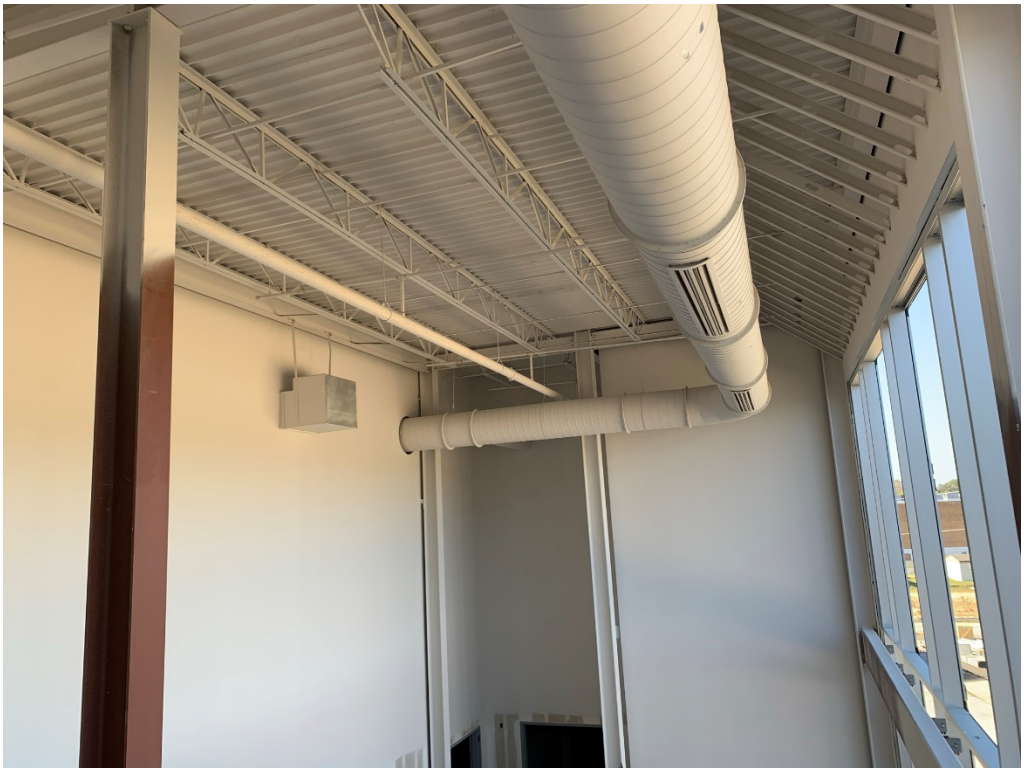
Figure 17 – Painted Ceilings

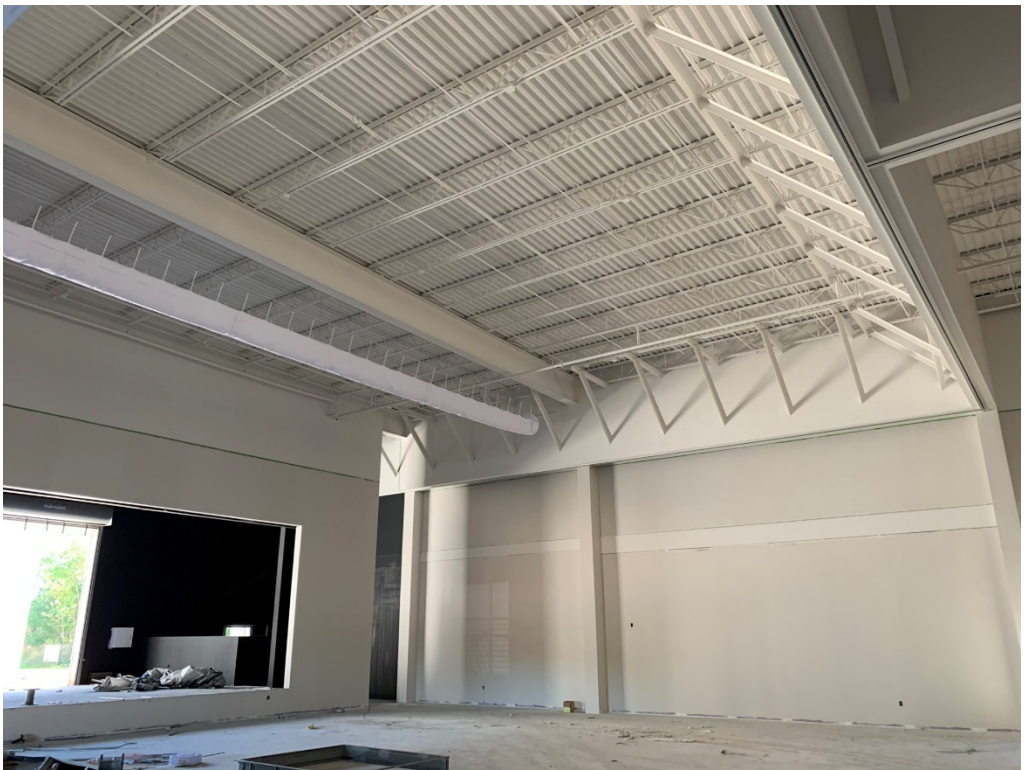
Figure 18 – Paint at Gym
