Architect's Field Report

additional note here that they are many and, in most cases, require the grid to be replaced in their entirety.

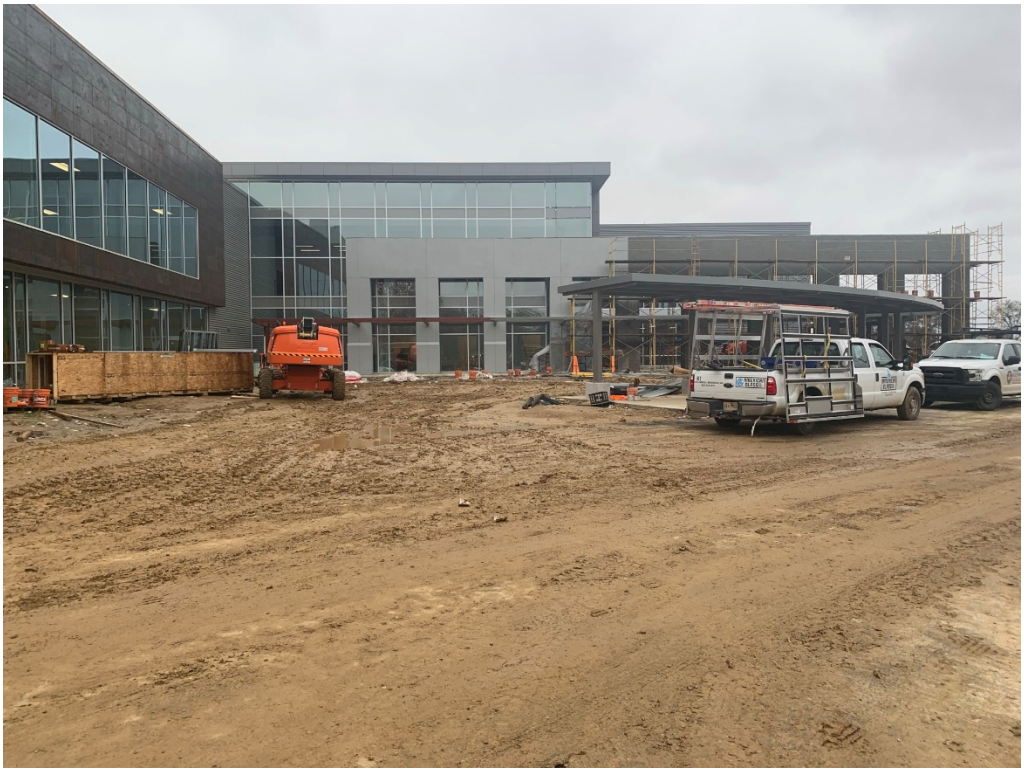
Figure 1 – East Façade at North Central Section of Building

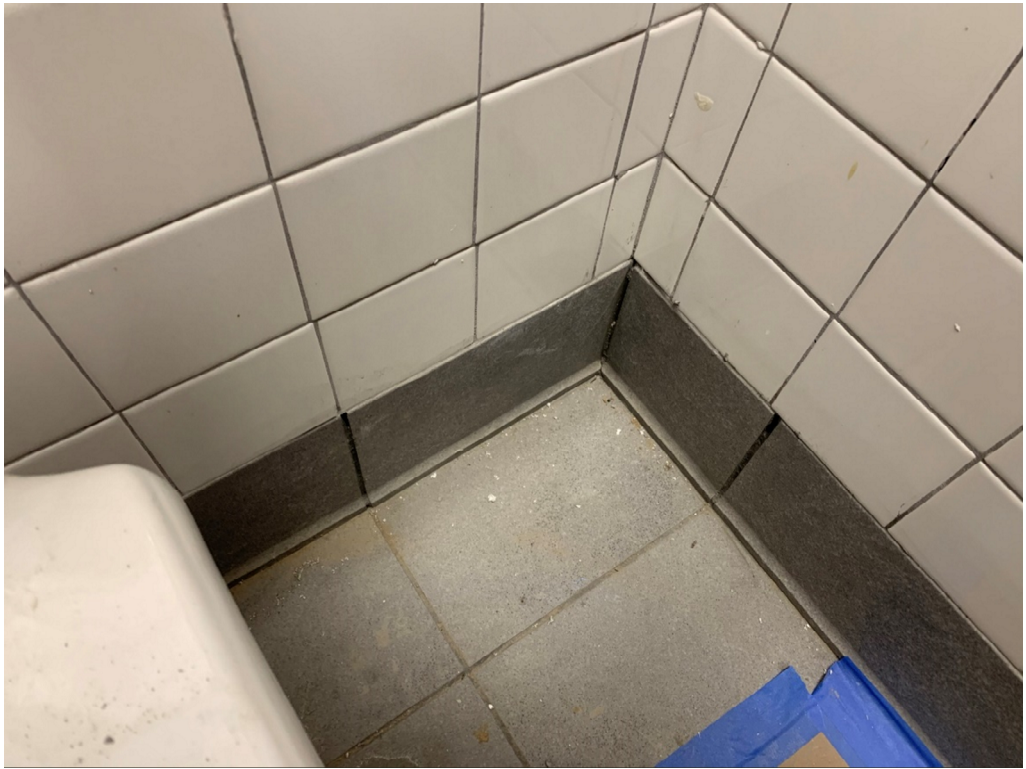
Figure 19 – Corner Tiles at base in several locations need correction (grout missing between base and upper tiles)

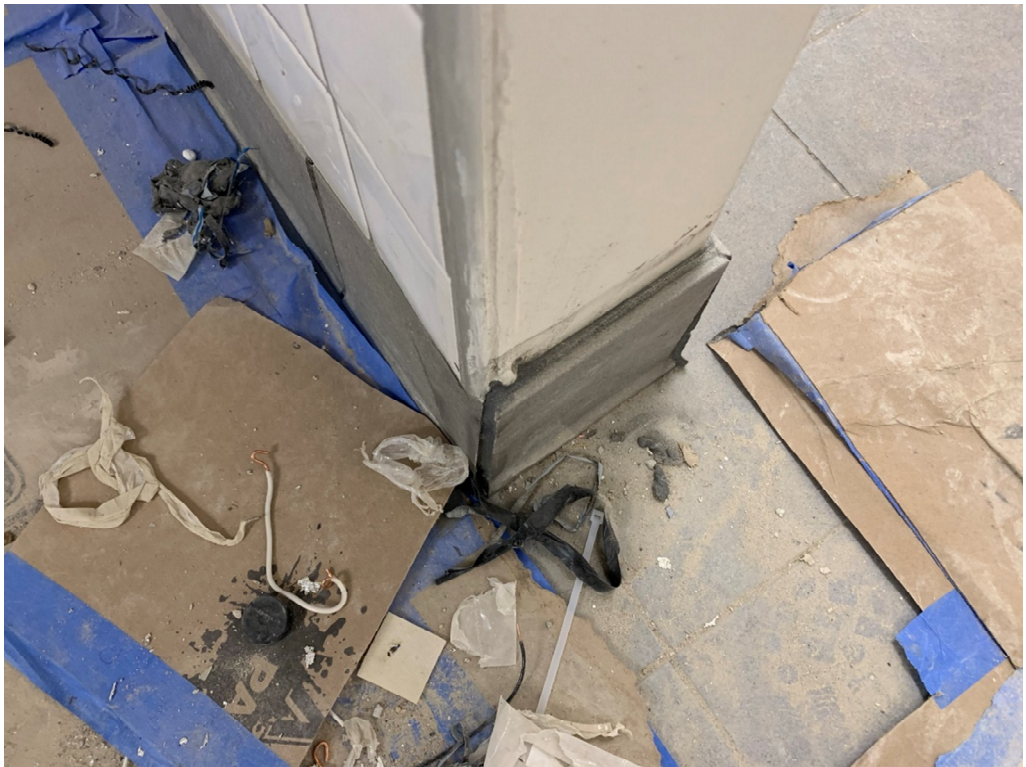
Figure 20 – Corner Tiles at base in several locations need correction (cut back wall tiles so that end tile does not create a larger shelf than is typical)

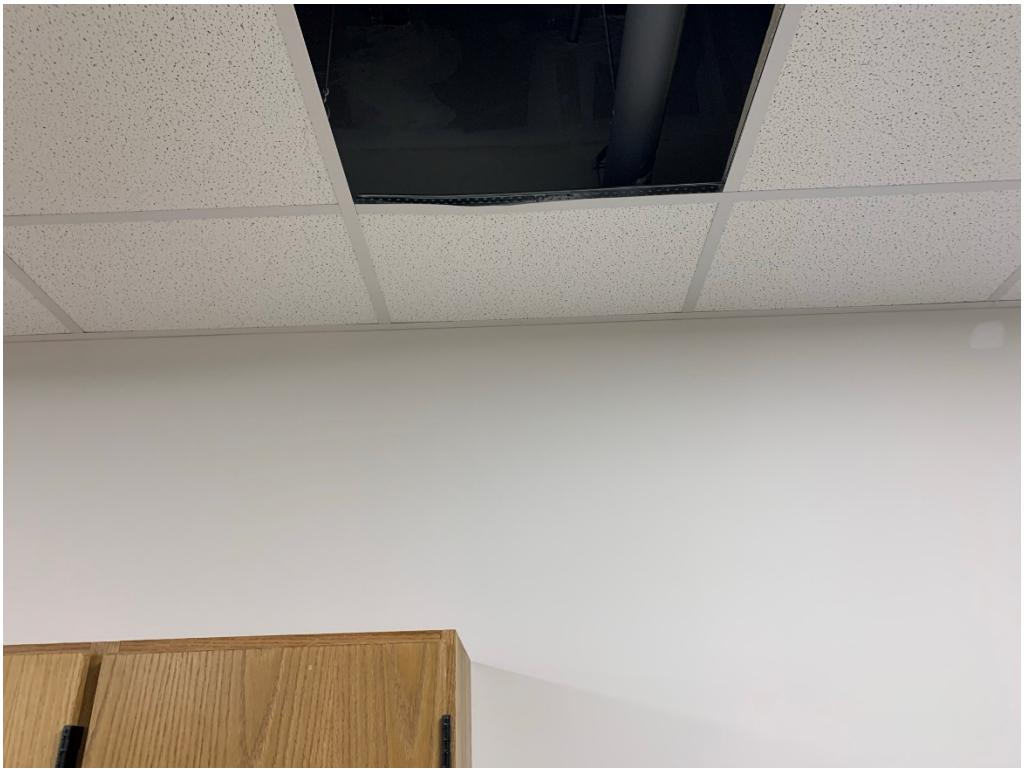
Figure 27 – Ceiling grid throughout has been damaged and will need replacing

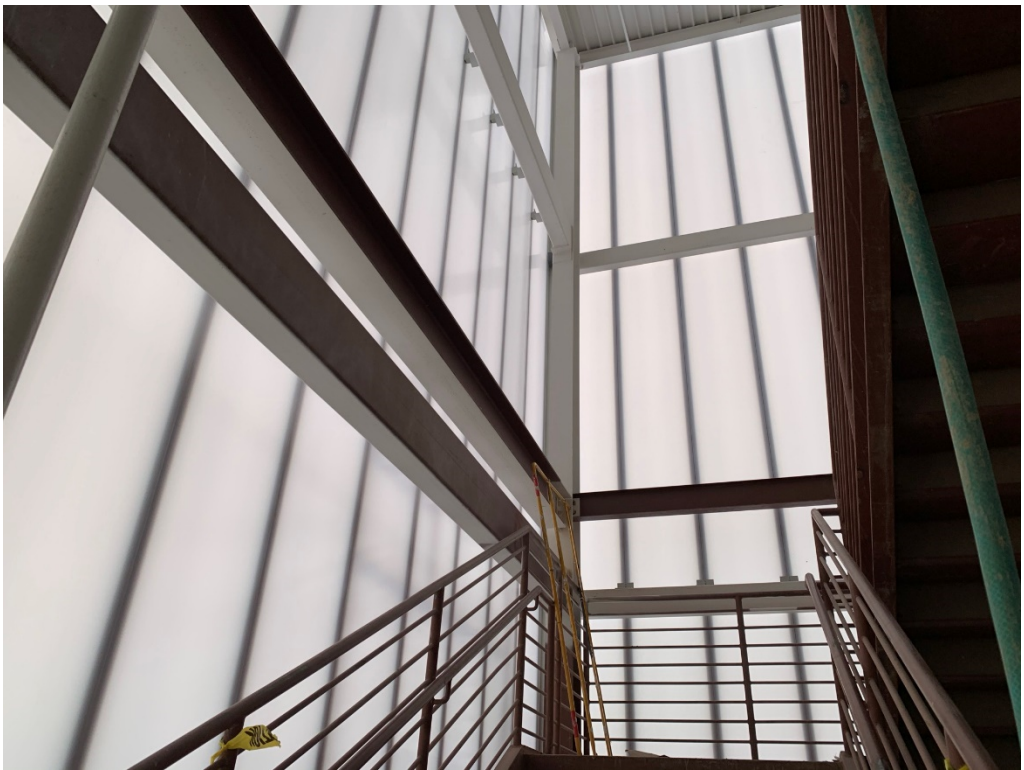
Figure 28 – SE Stair on going

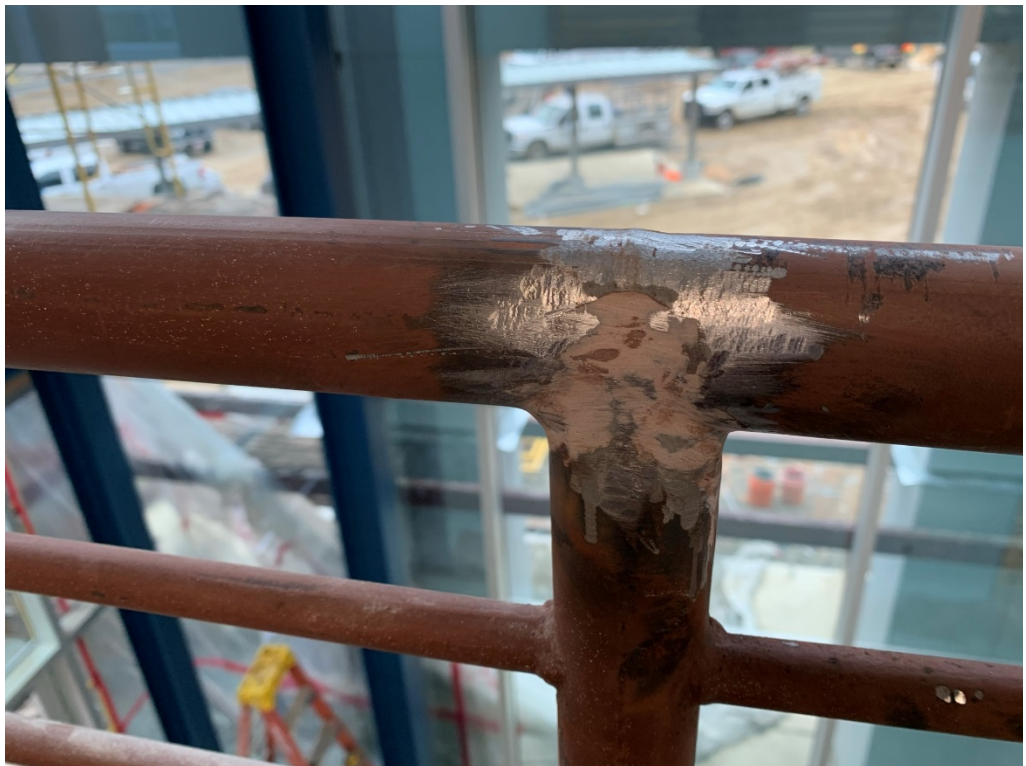
Figure 38 – Example of repair at handrail that should finish out well

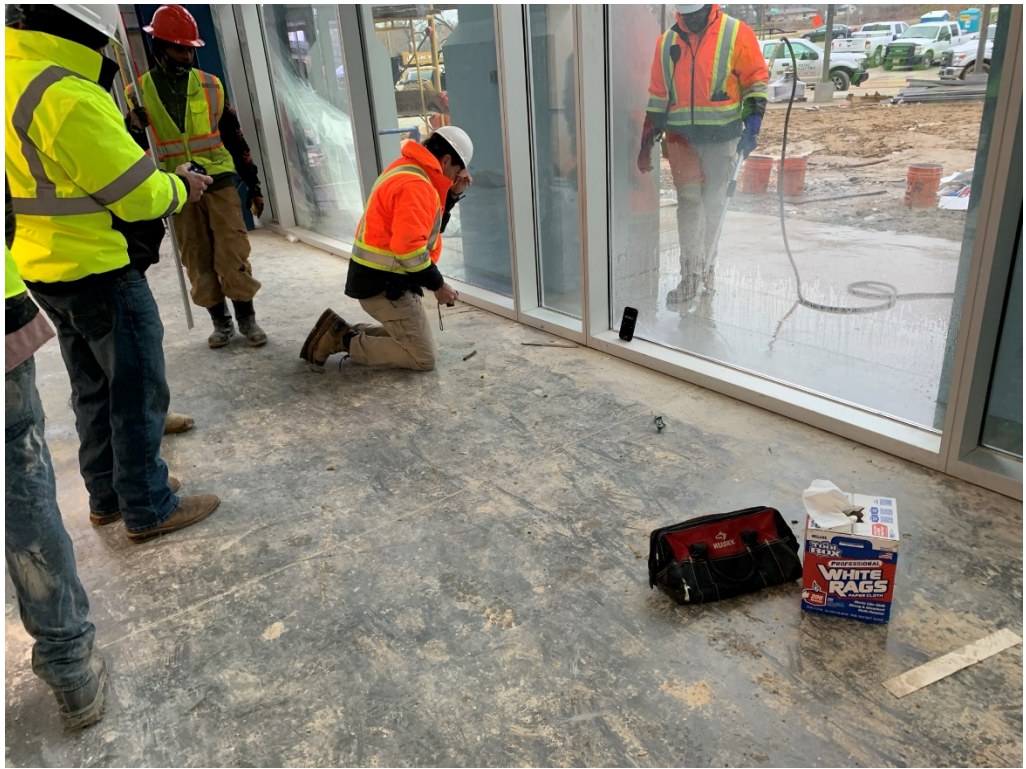
Figure 39 – Storefront Tester BLI&T
