## Architect's Field Report

31 December 2020

18059-AOI Academy of Innovation / Report Number 052

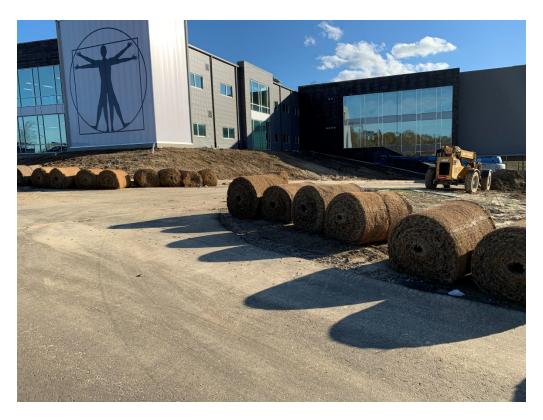
Arriving on site, I noted that sod at the exterior has been delivered and is awaiting installation. Entering the building from the lower west entry,

Figure 1 – Sod is on Site and Ready to Install

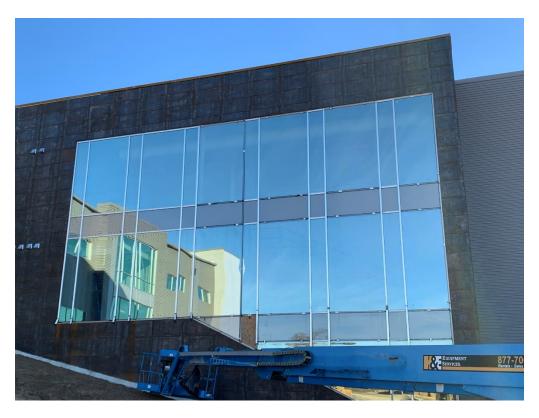
Figure 2 – Curtain Wall Installation is Ongoing

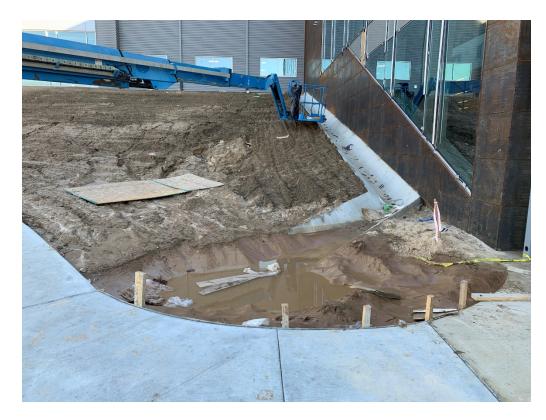
Figure 3 – Concrete Rework at Drop Off Entry

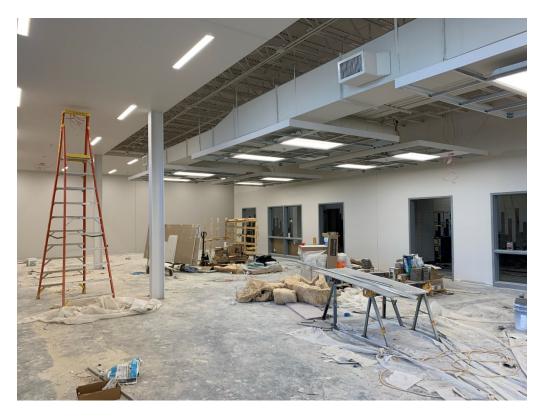
Figure 4 – Cafeteria Paint and Ceiling Install is Ongoing

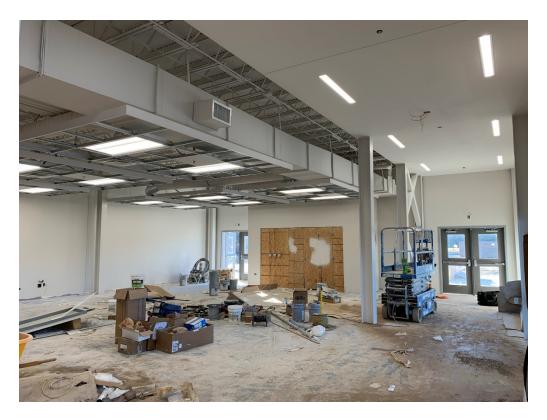
Figure 5 – Cafeteria Paint and Ceiling Install is Ongoing

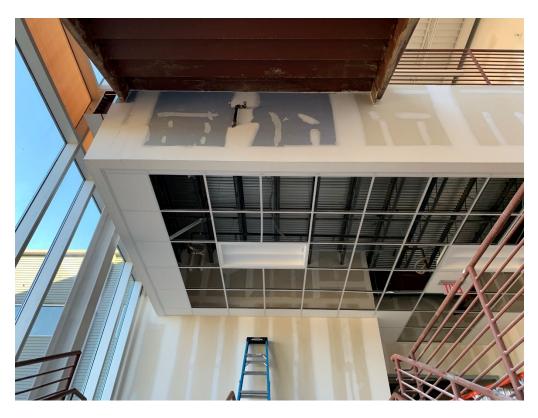
Figure 6 – Paint and Ceiling Install is Ongoing Throughout

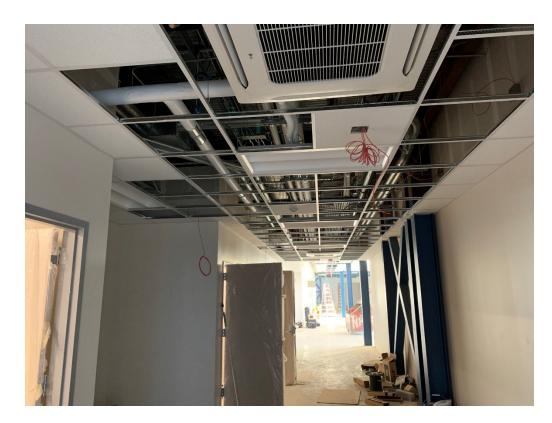
Figure 7 – Ceiling Grid Install is Ongoing Throughout

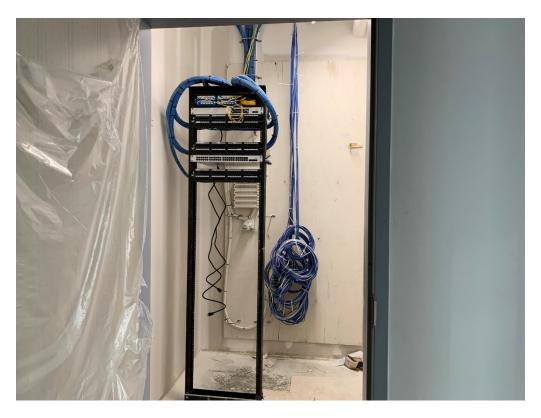
I see that paint and ceiling work is still ongoing. Ethernet cable has been

pulled to closets as well.

Figure 8 – Communication Cabling Installed

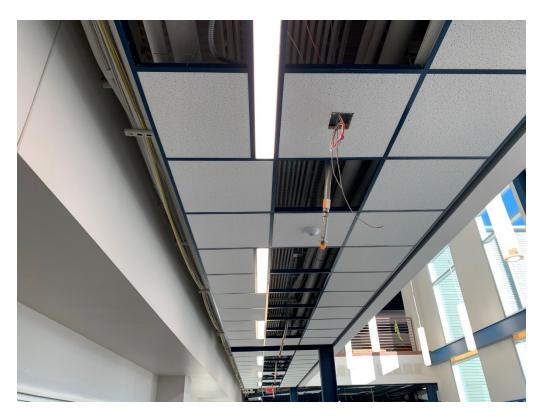
Figure 9 – Ceiling Grid Work Ongoing

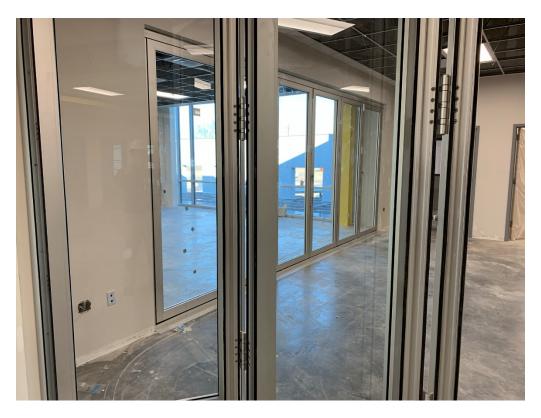
Figure 10 – Glass Installed at Moveable Partitions
