## Architect's Field Report

15 January 2021

18059-AOI Academy of Innovation / Report Number 053

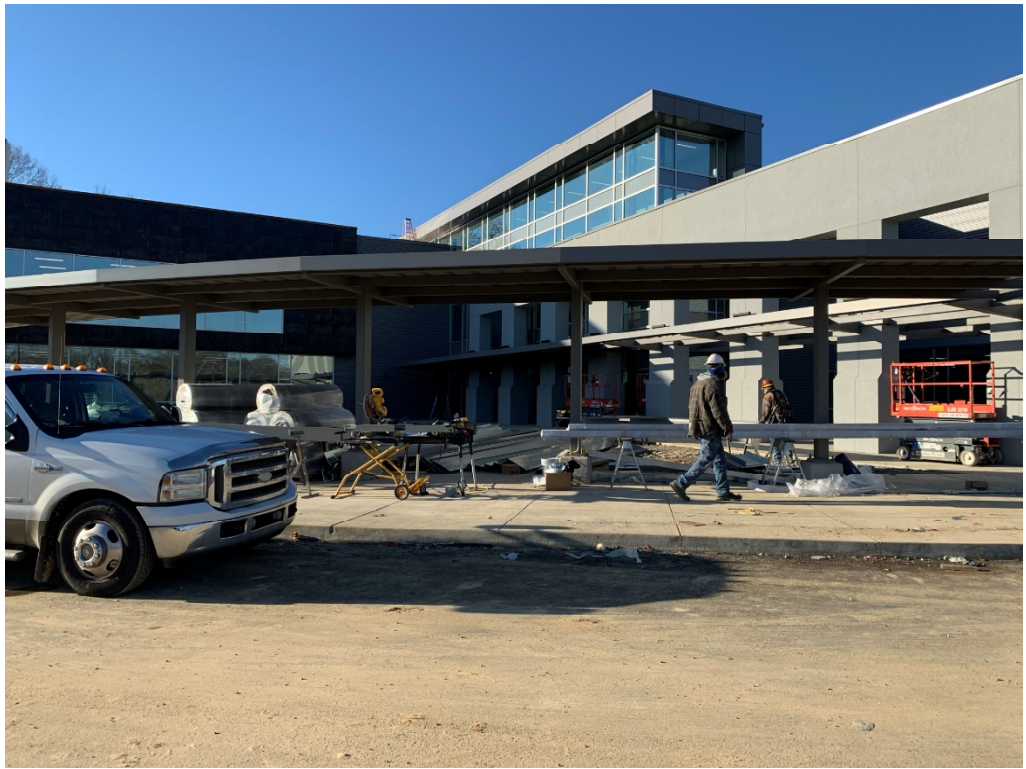
Figure 1 – Metal Trim Install at North Elevation

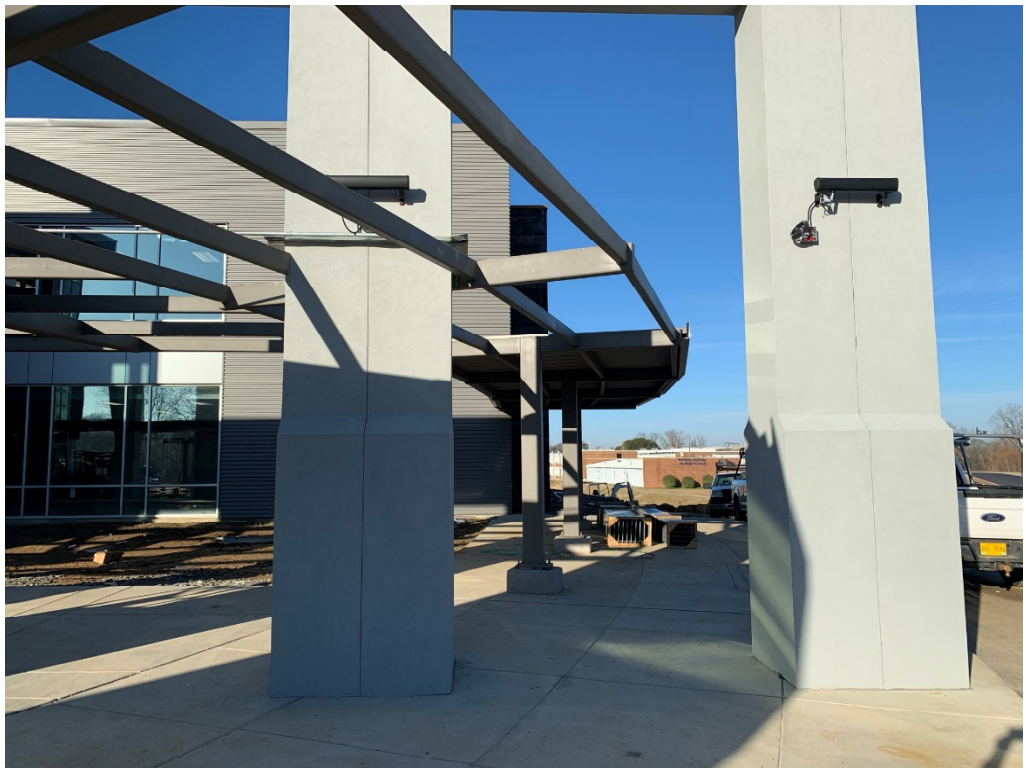
Figure 2 – Canopy Paneling is On-going (Contractor to delete light on right column)

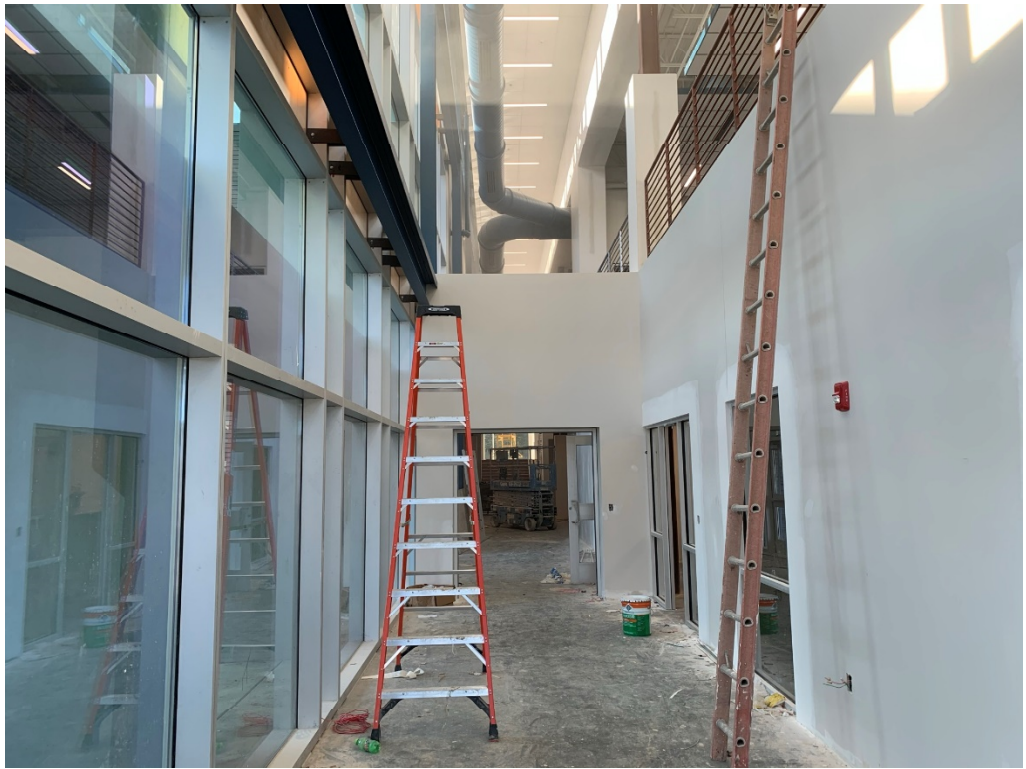
Figure 3 – North Entry

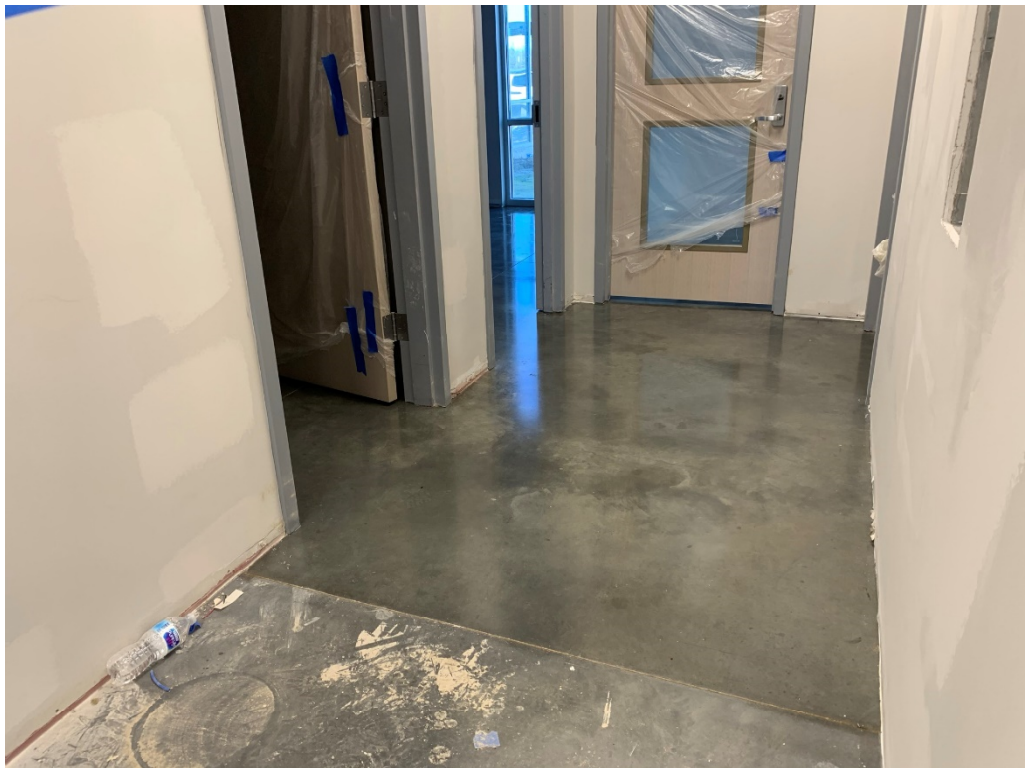
Figure 4 – Admin Area Floor Sealant

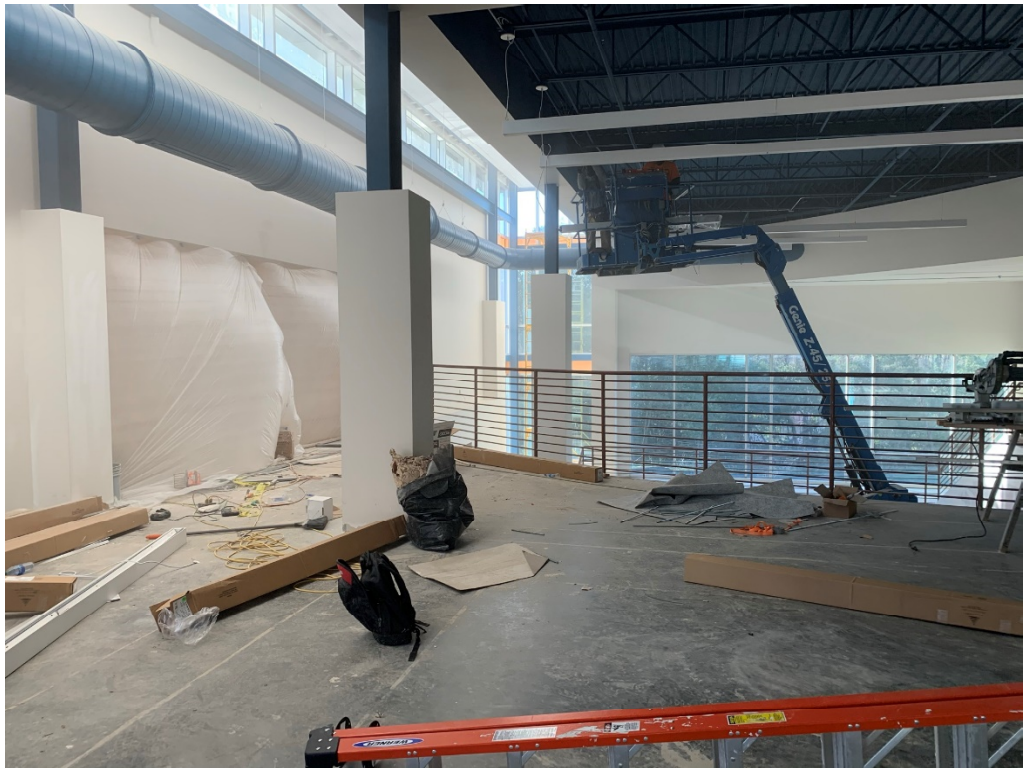
Figure 5 – East Building Work Creating Dust Even with Plastic Barrier

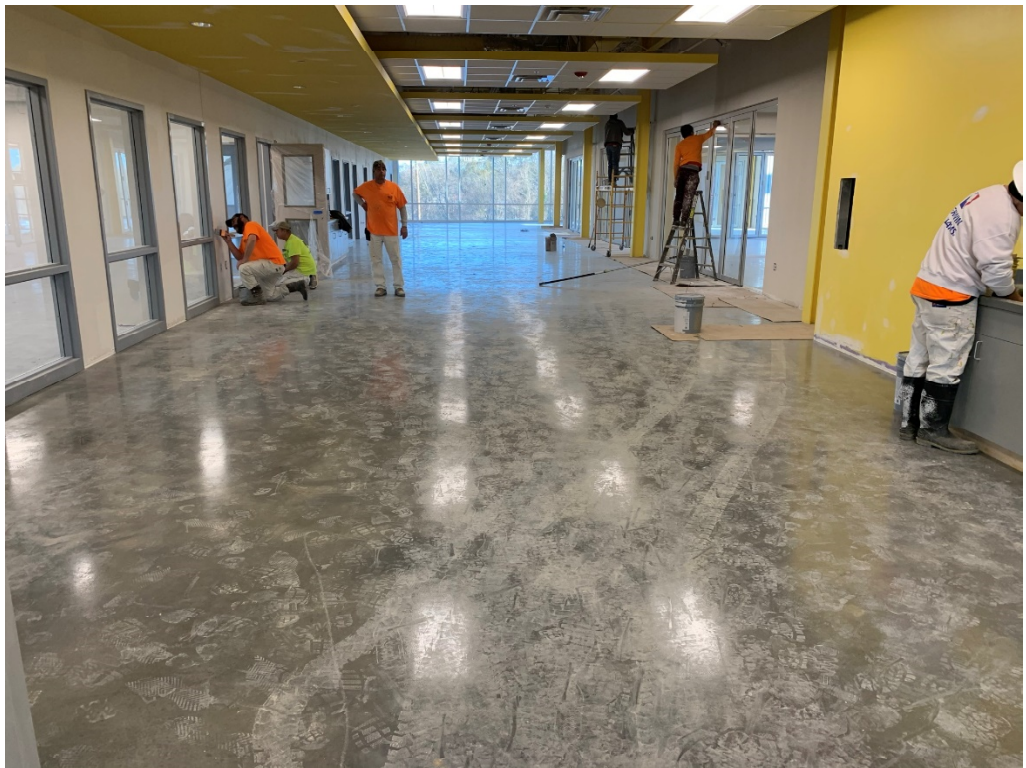
Figure 6 –Paint at Central Upper Floor

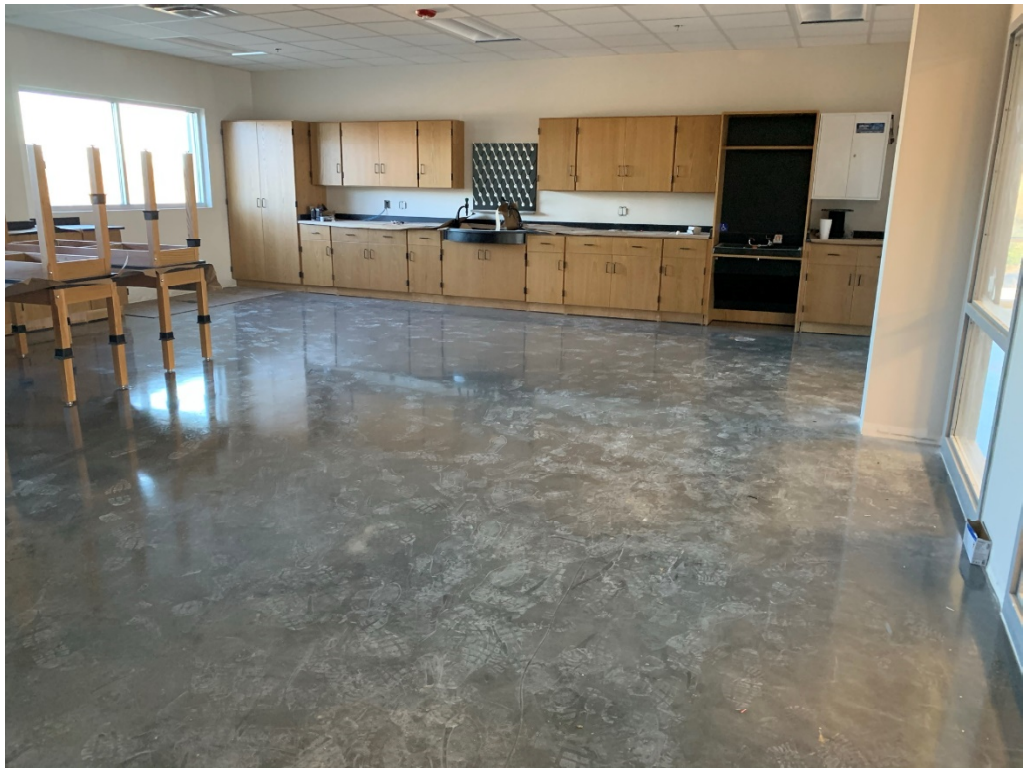
Figure 7 – Complete Lab at Upper Central Floor

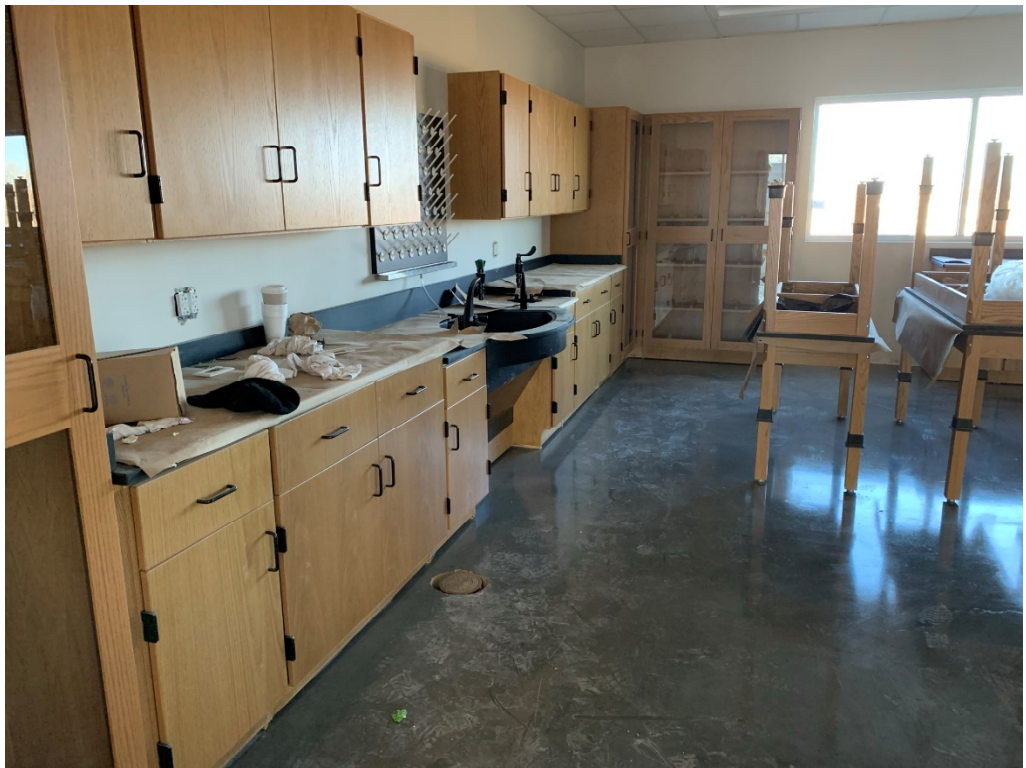
Figure 8 – Complete Lab at Upper Central Floor

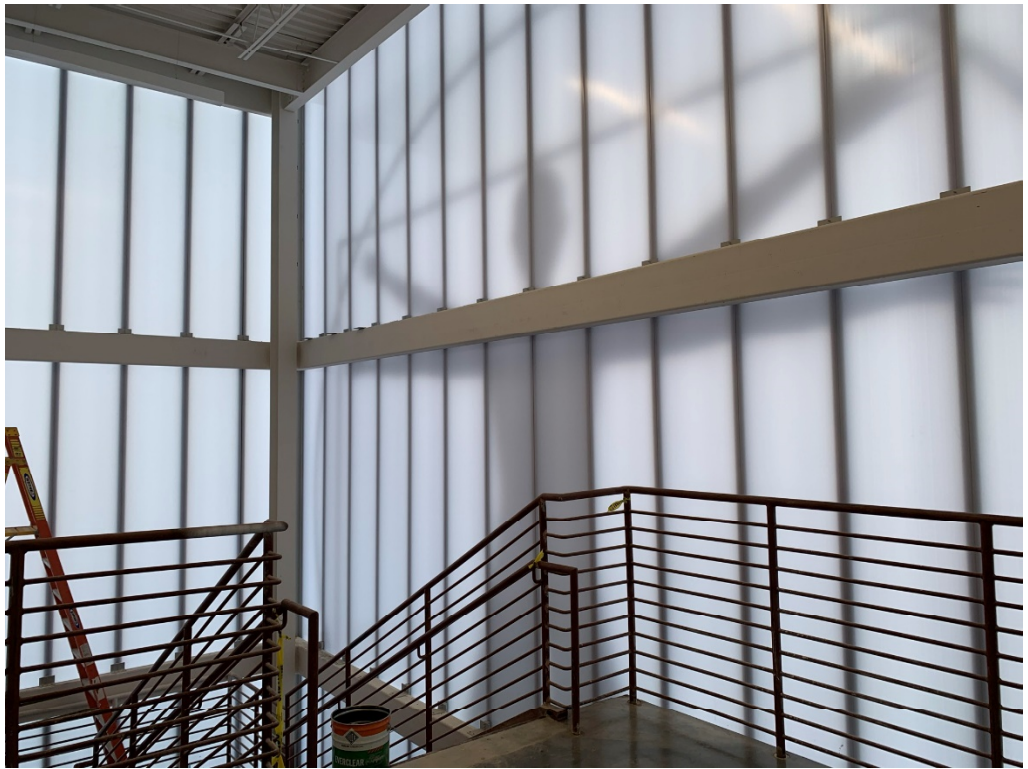
Figure 9 – Egress Stair Progress

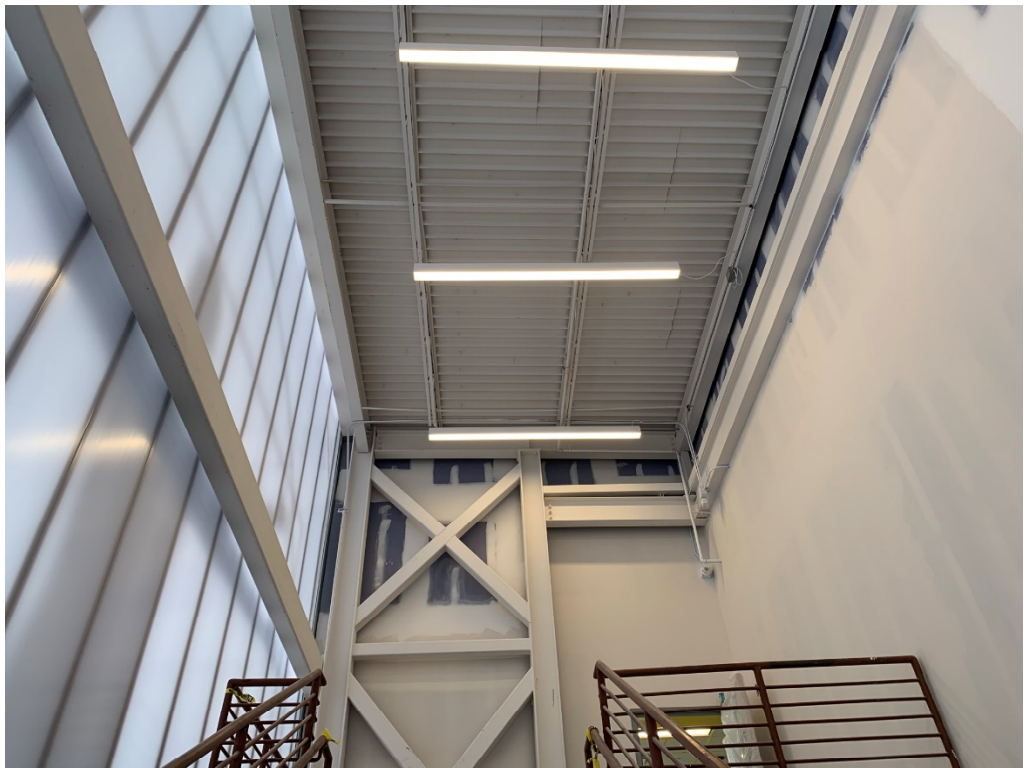
Figure 10 – Egress Stair Progress

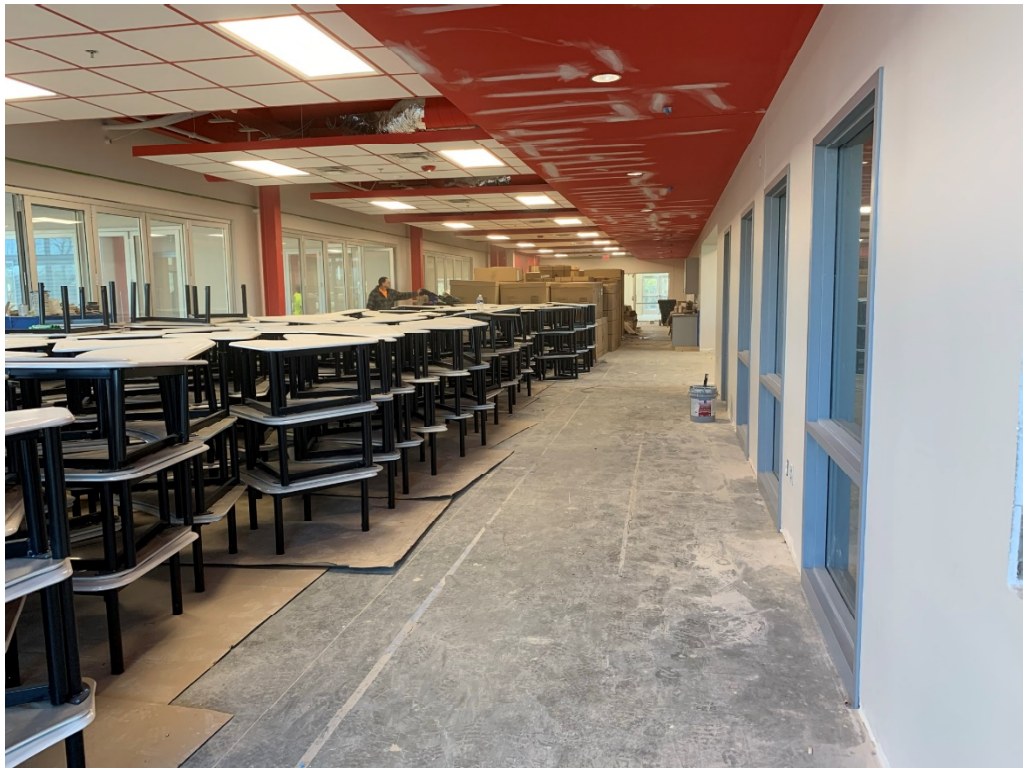
Figure 11 – Central Lower Floor Still Requires Work

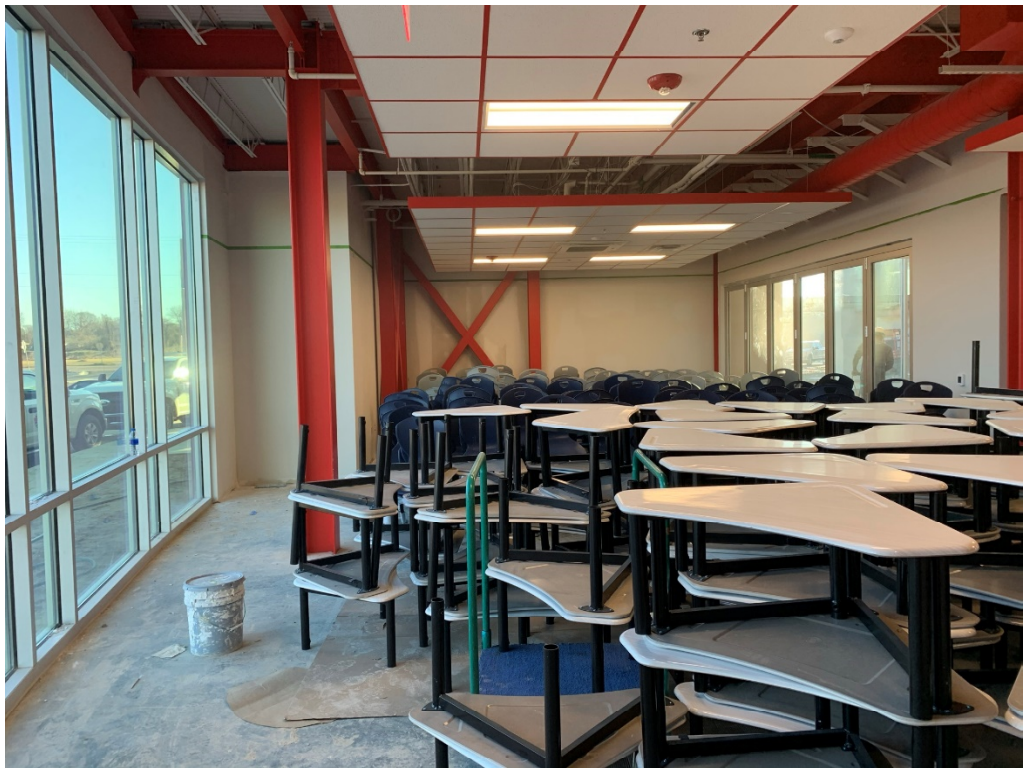
Figure 12 – Central Lower Floor Still Requires Work

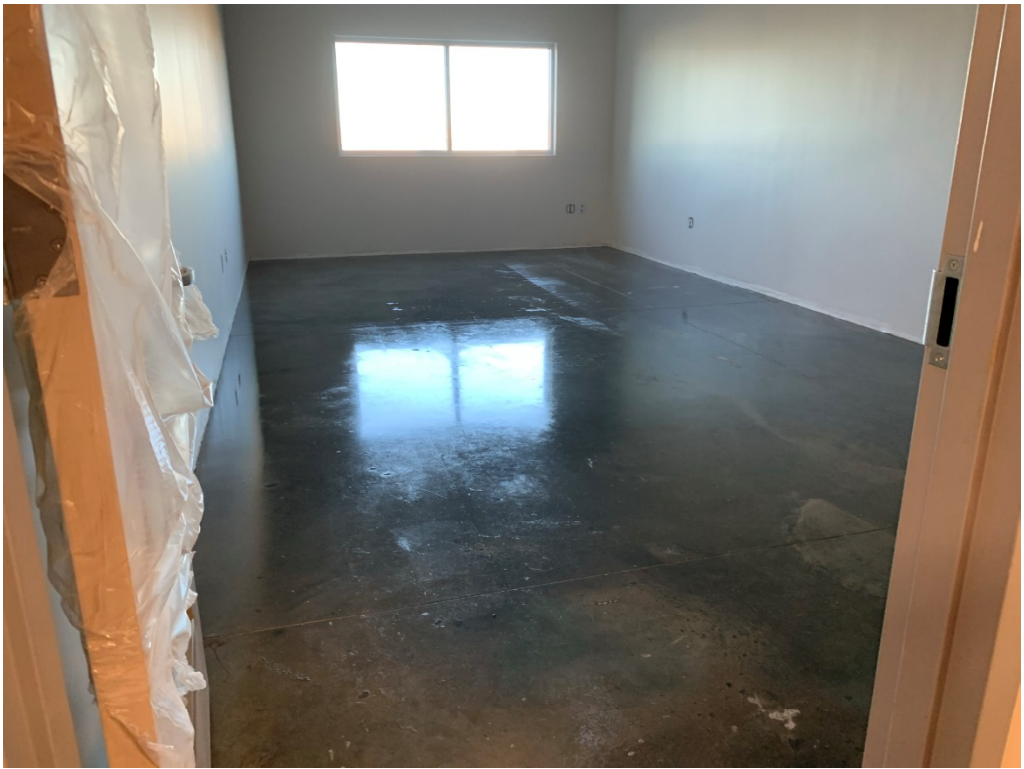
Figure 13 – Floor Sealant is Ongoing; This area has a lot of discoloration and possible debris trapped in sealant and will need further review as to it's acceptability when dry

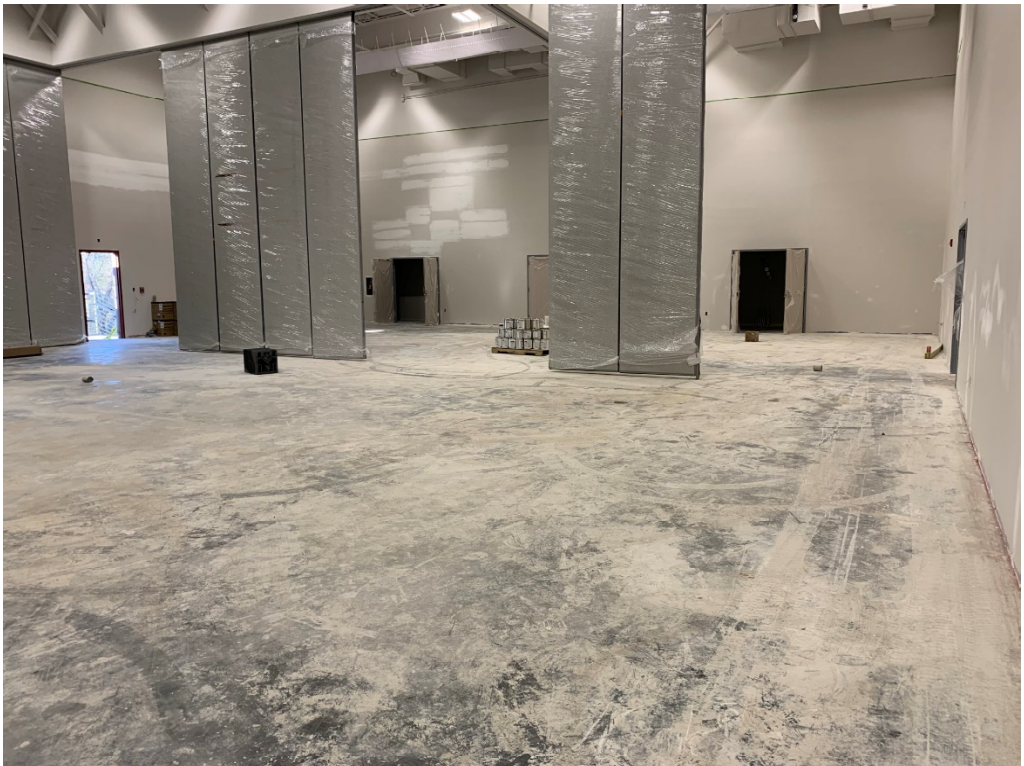
Figure 14 – Gym Progress

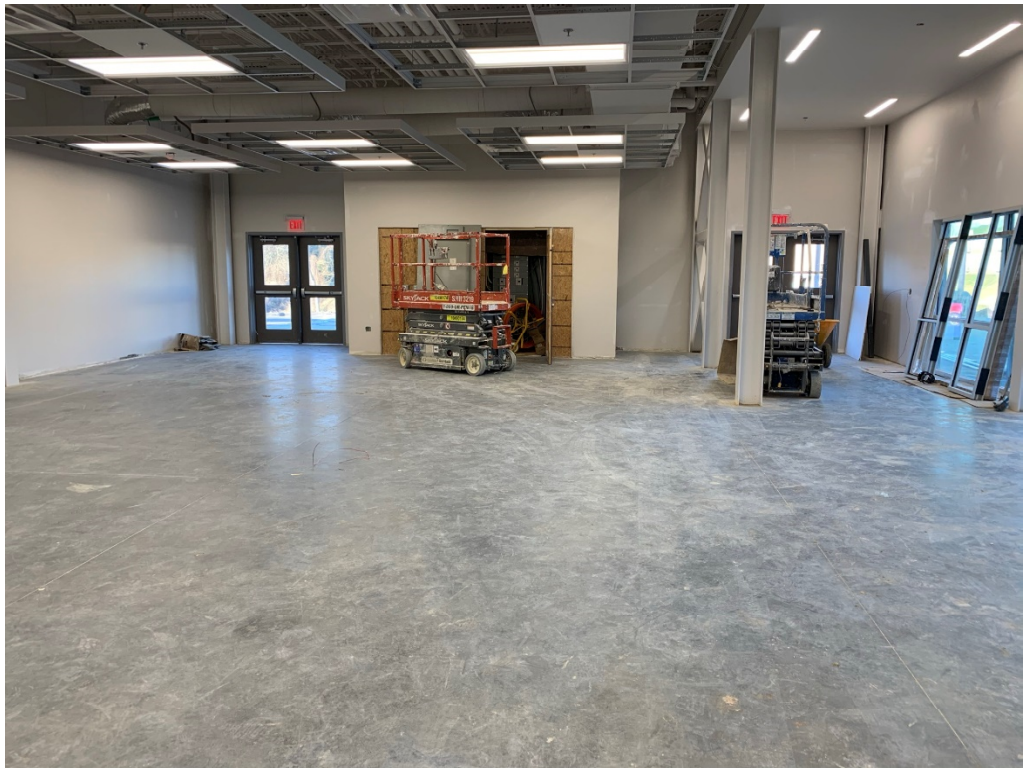
Figure 15 – Cafeteria Progress

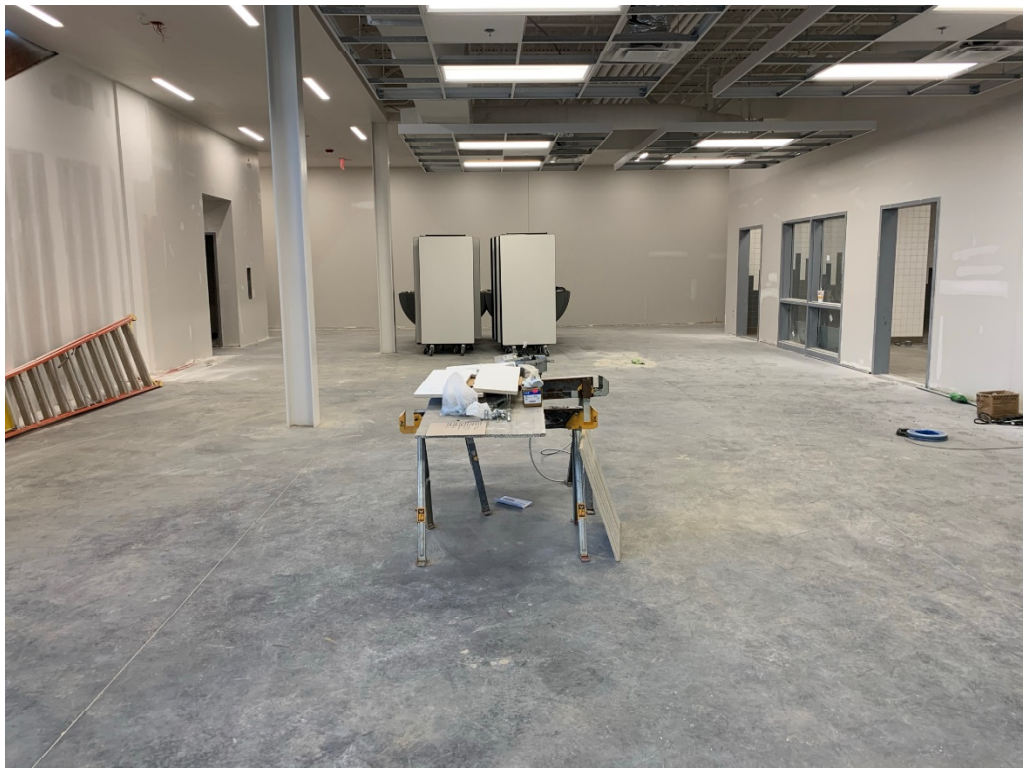
Figure 16 – Cafeteria Progress
