## Architect's Field Report

201 Park Court, Suite B Ridgeland, MS 39157 P 601.790.9432 F 888.281.0547	28 January 2021  18059-AOI Academy of Innovation / Report Number 054
One Jackson Place, Suite 250 188 East Capitol Street Jackson, MS 39201-2100 P 601.352.5411 F 601.352.5362	Contract Century Construction Date / Time 26 January 2021 / 2:30 PM Weather / Temp Overcast / 68 ° F Est % Complete 85% Sched Conformance + 112 days Work in Progress Paint Work Finish Electrical Other Finish Service Work
161 Lameuse Street, Suite 201 Biloxi, MS 39530 P 228.374.1409 F 228.374.1414	Present at Site Joey Moore, CC Paul Purser, DBA  Observations Arriving on site, I entered the site from the east. Grass has been installed throughout the site and appears in good condition.  At the interior, paint and finish work is ongoing.  At the 2 <sup>nd</sup> floor west side of the building, several double door installations appear to be complete, however, these doors require adjustment. Please review and ensure that doors are installed properly and that all carpentry cuts or adjustments are smooth and finished.

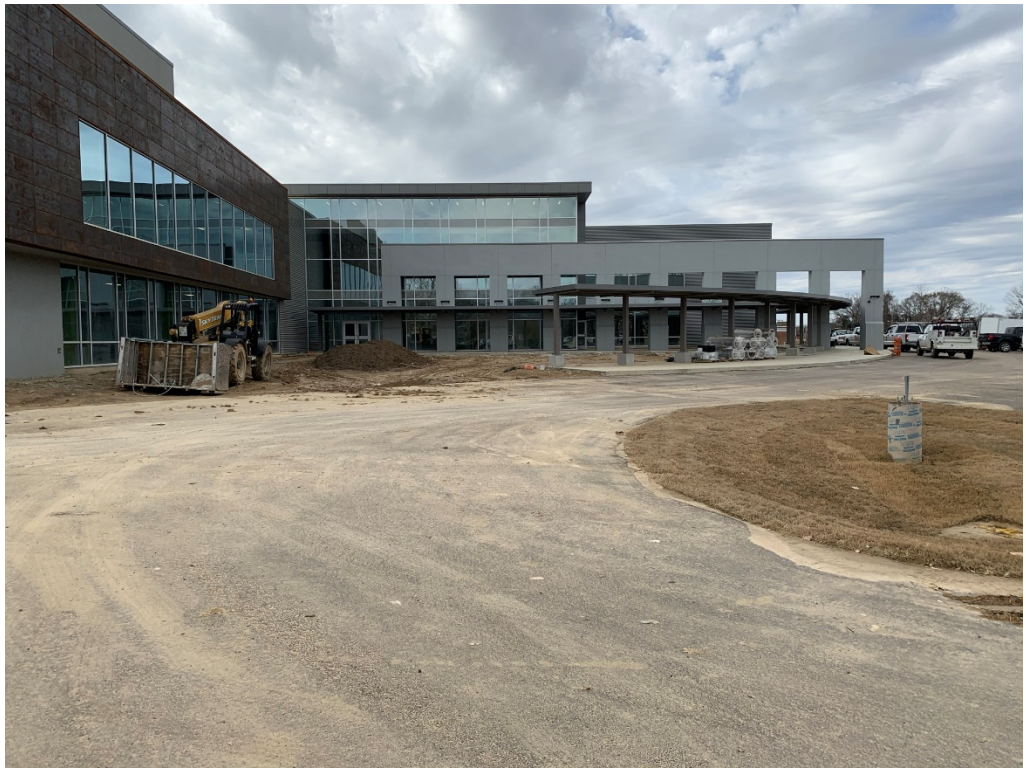
Figure 1 – Grass Installed at Site

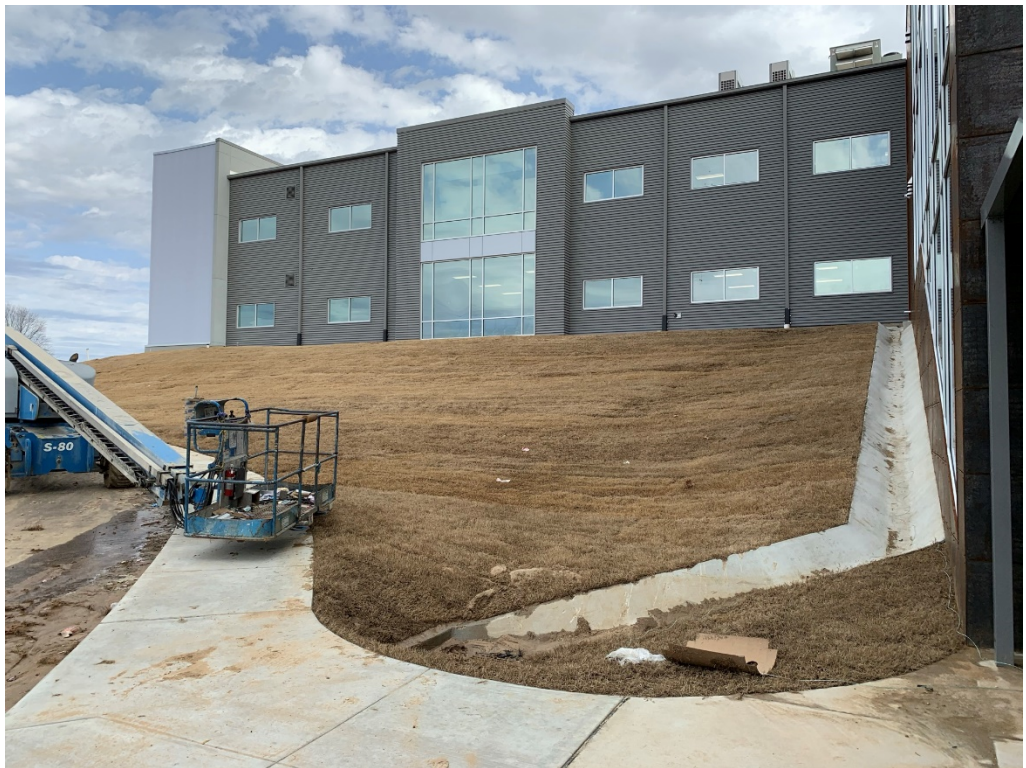
Figure 2 – Grass Installed at Site

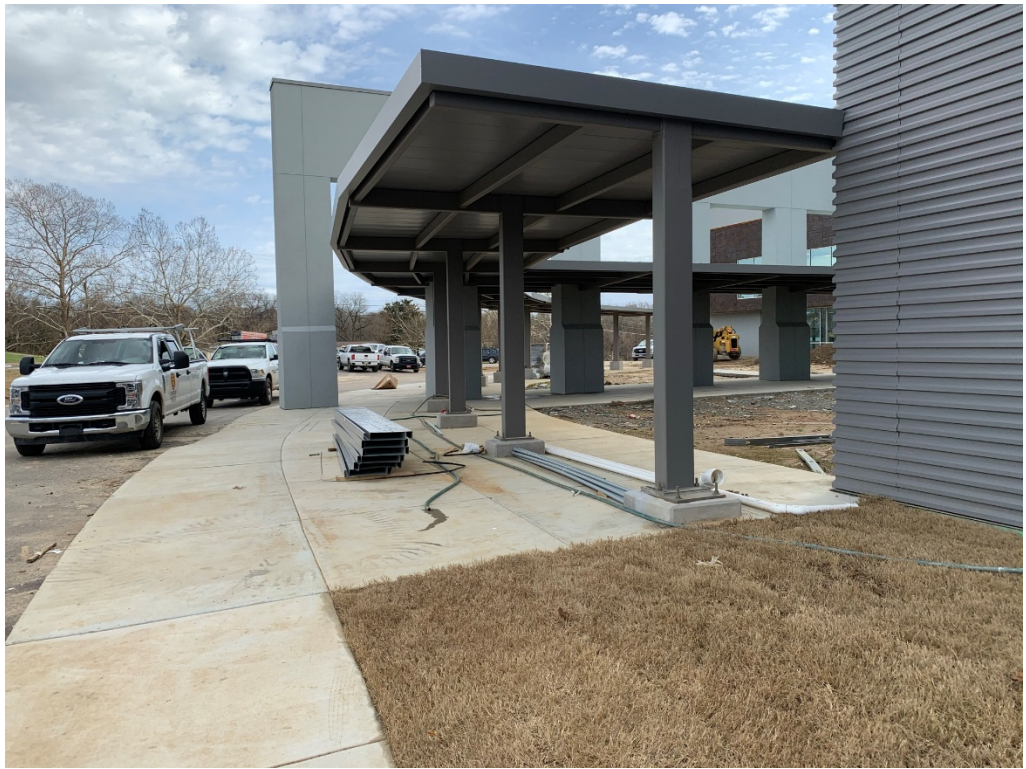
Figure 3 – Grass Installed at Site; Covered Awning Installation Appears Complete

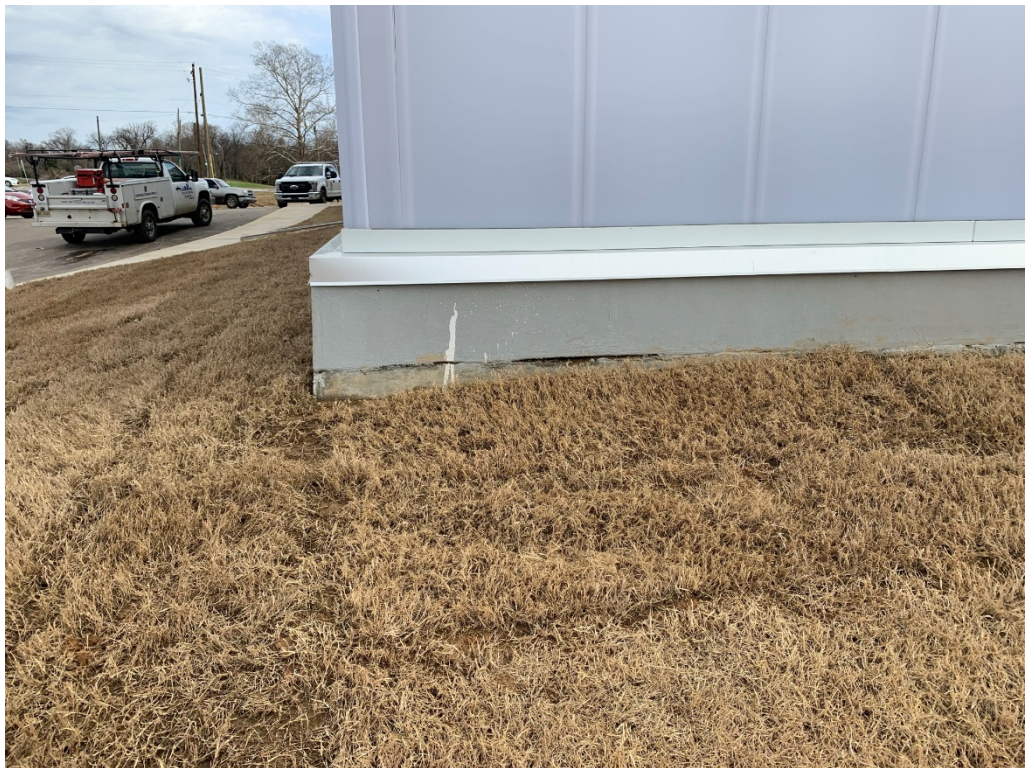
Figure 4 – Clean Up is Ongoing

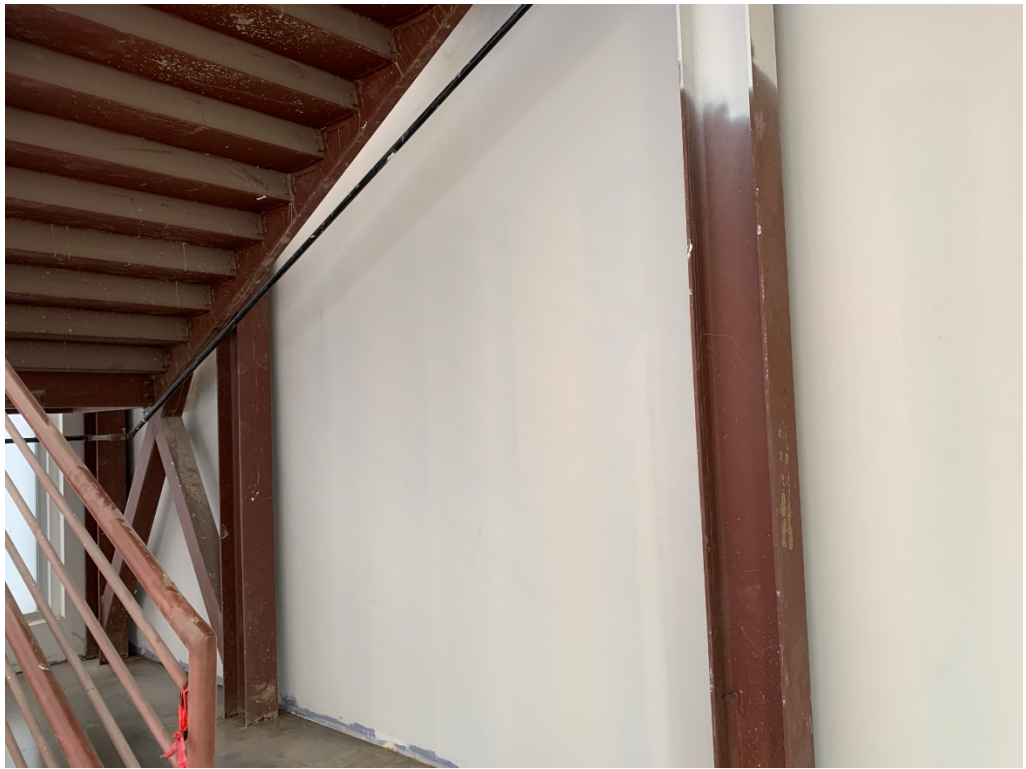
Figure 5 – Paint is Ongoing

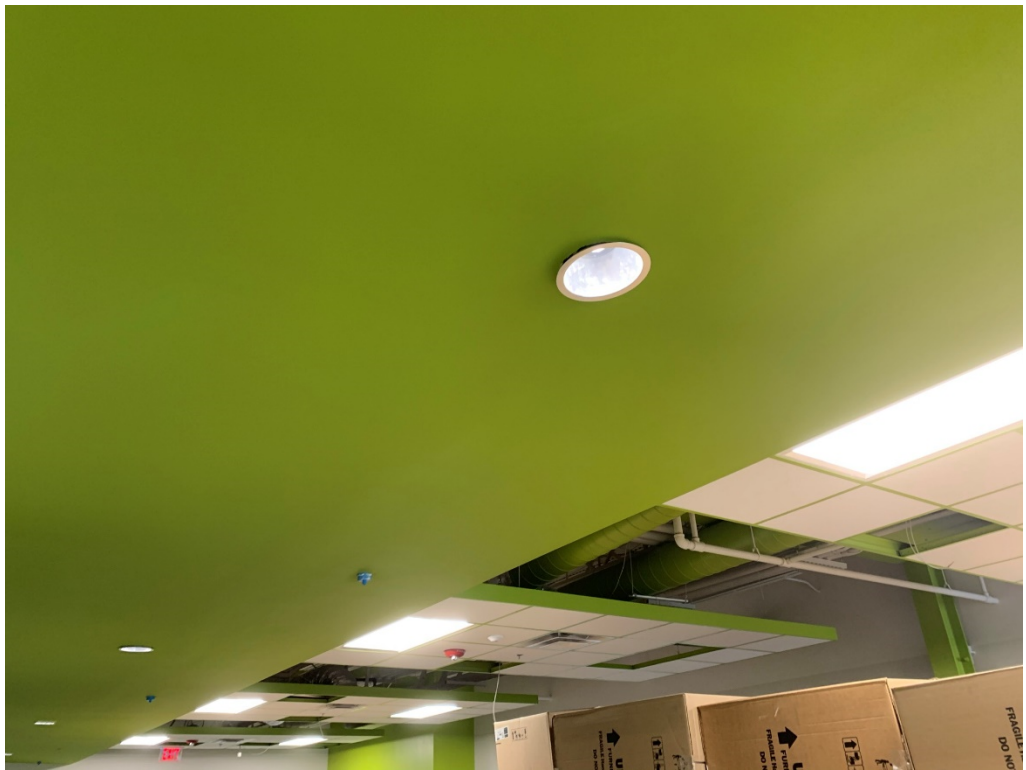
Figure 6 –Finish Electrical is Ongoing (note to check all can lights for flush installation at drywall)

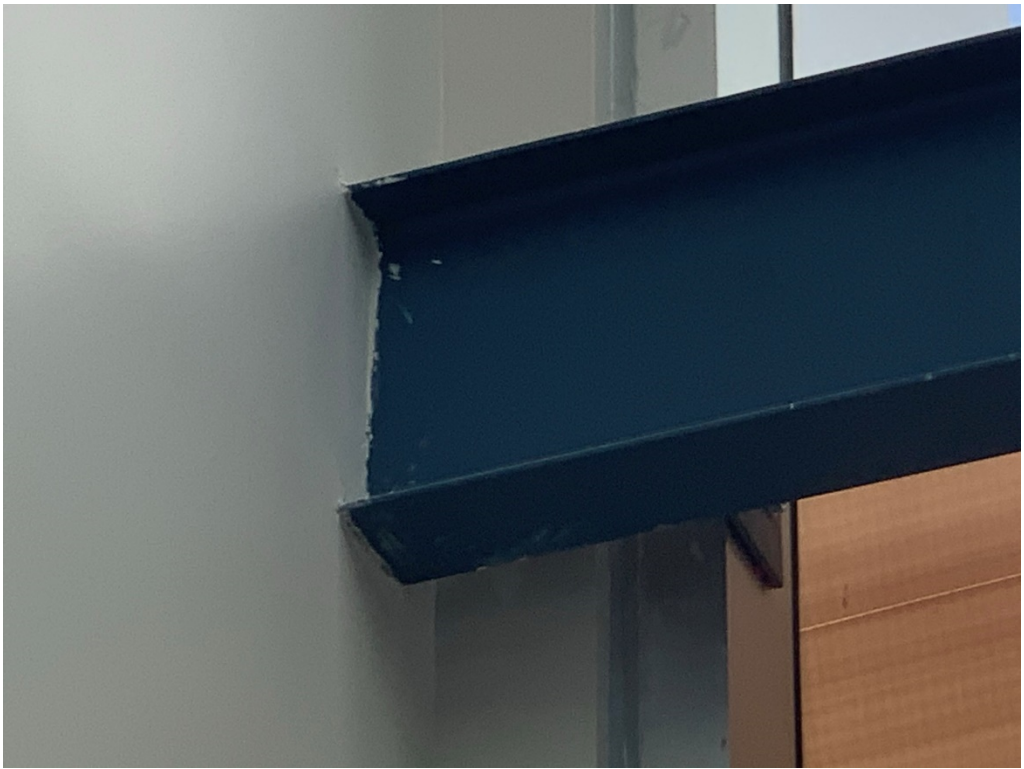
Figure 7 – Paint is Ongoing

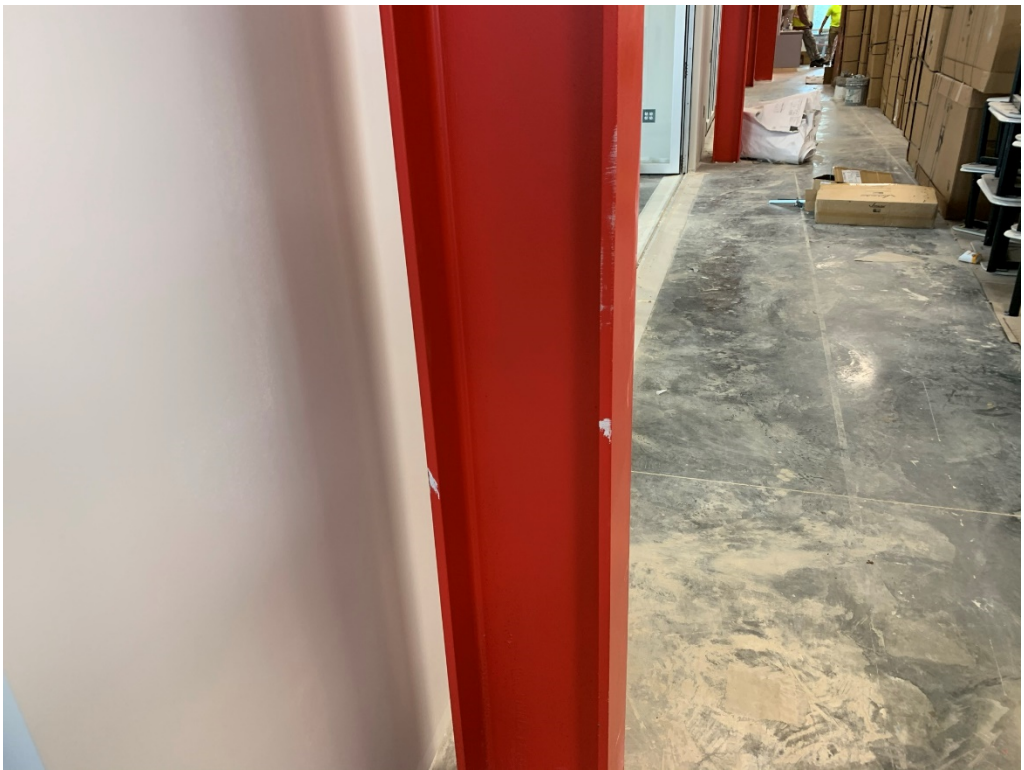
Figure 8 – Paint is Ongoing

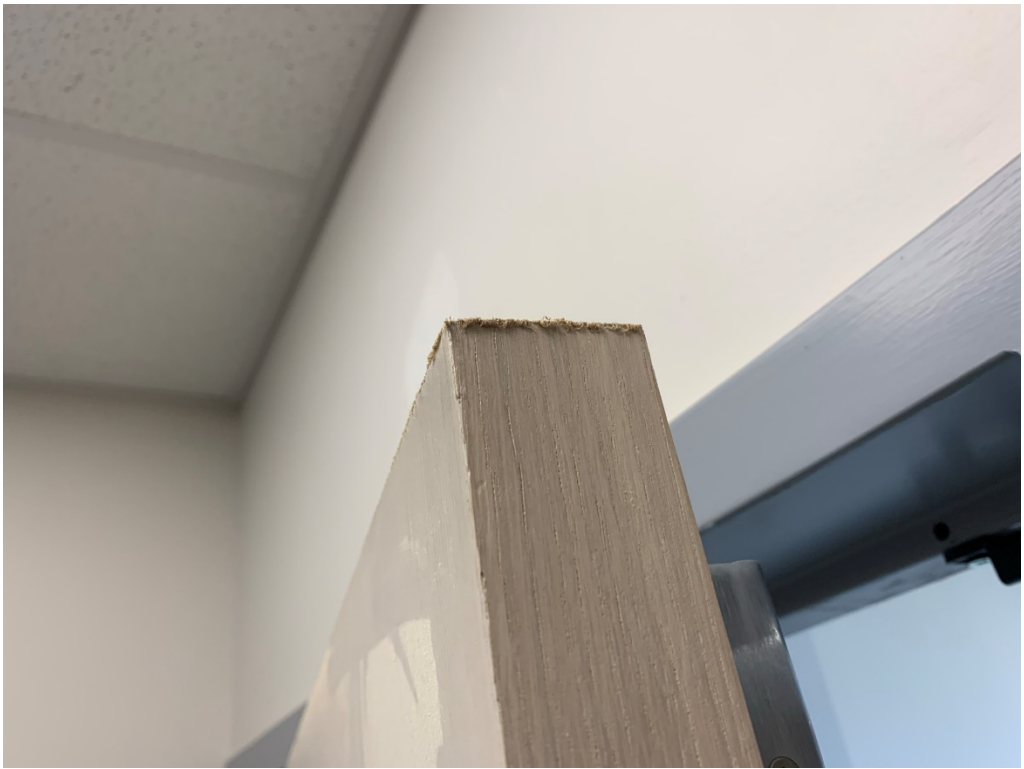
Figure 9 – Poor Carpentry at Door where cut due to Out of Square Installation

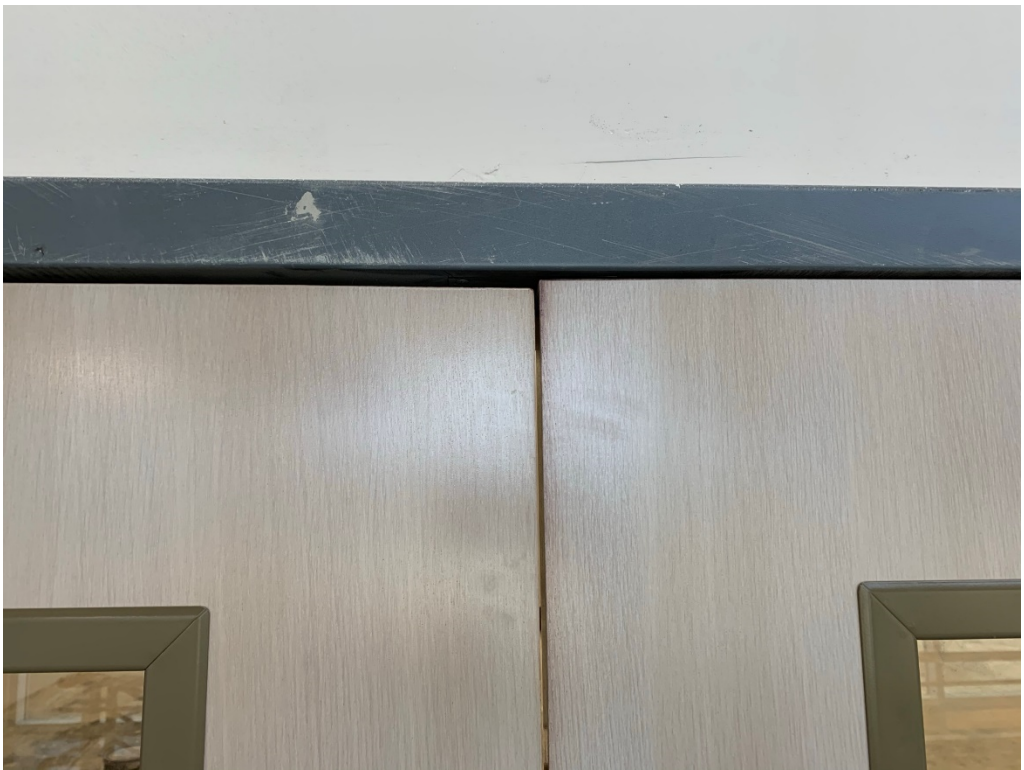
Figure 10 – Installed Double Doors (out of square and need adjustment for proper functionality and aesthetic)

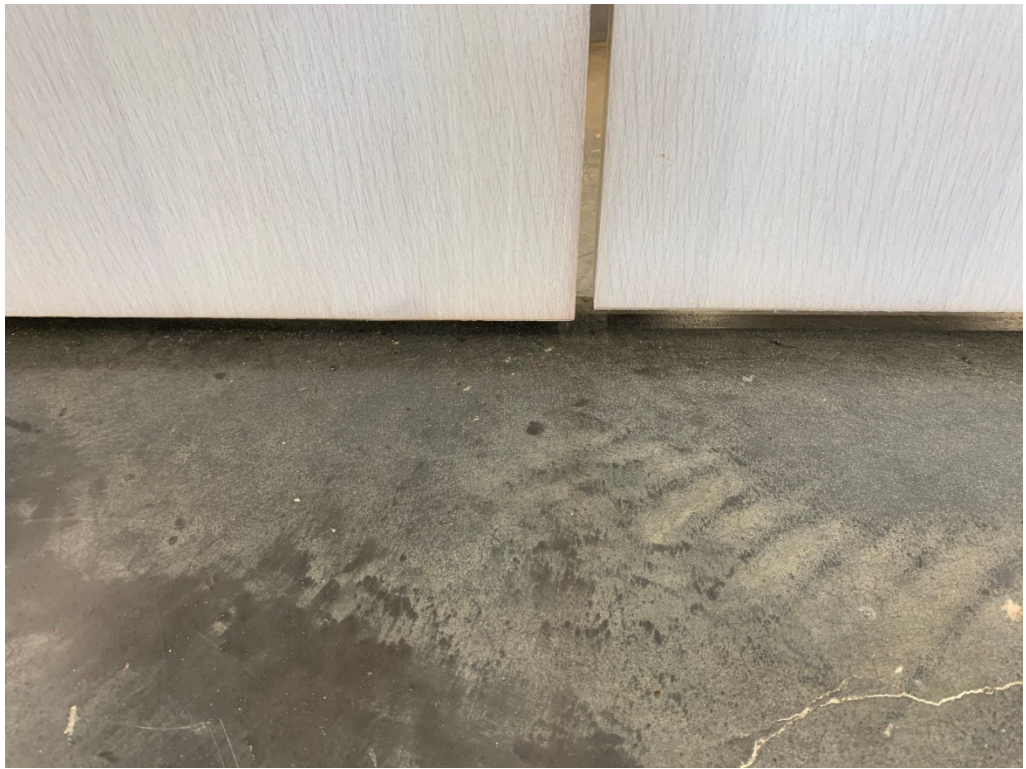
Figure 11 – Installed Double Doors (out of square and need adjustment for proper functionality and aesthetic)

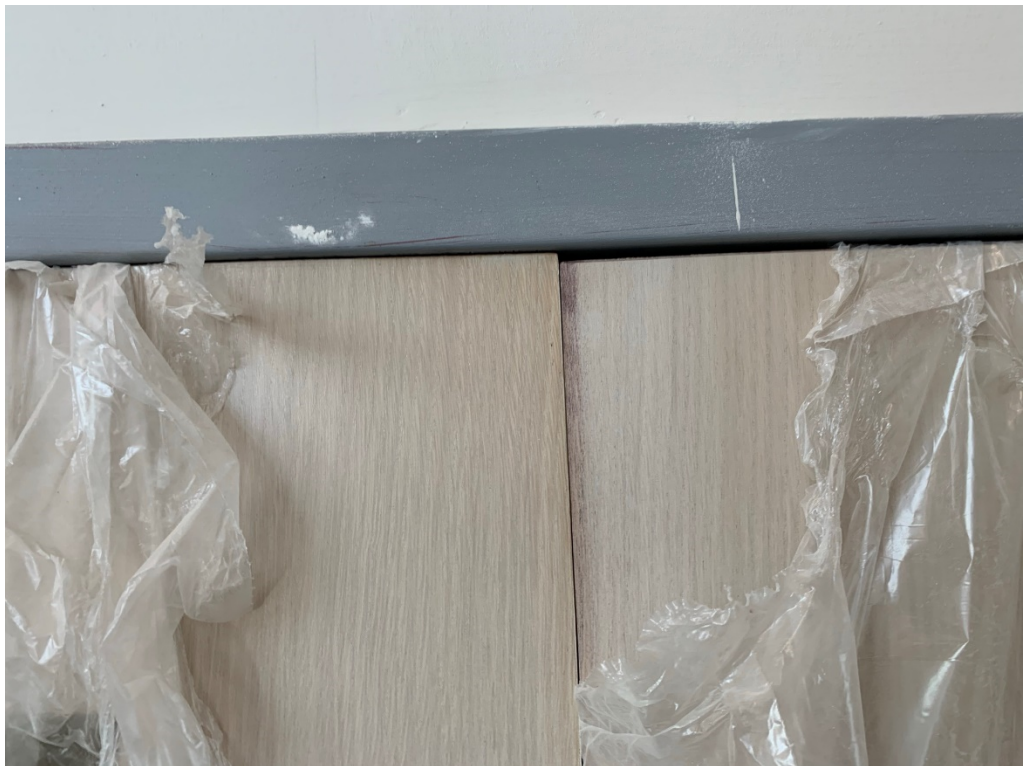
Figure 12 – Installed Double Doors (out of square and need adjustment for proper functionality and aesthetic)

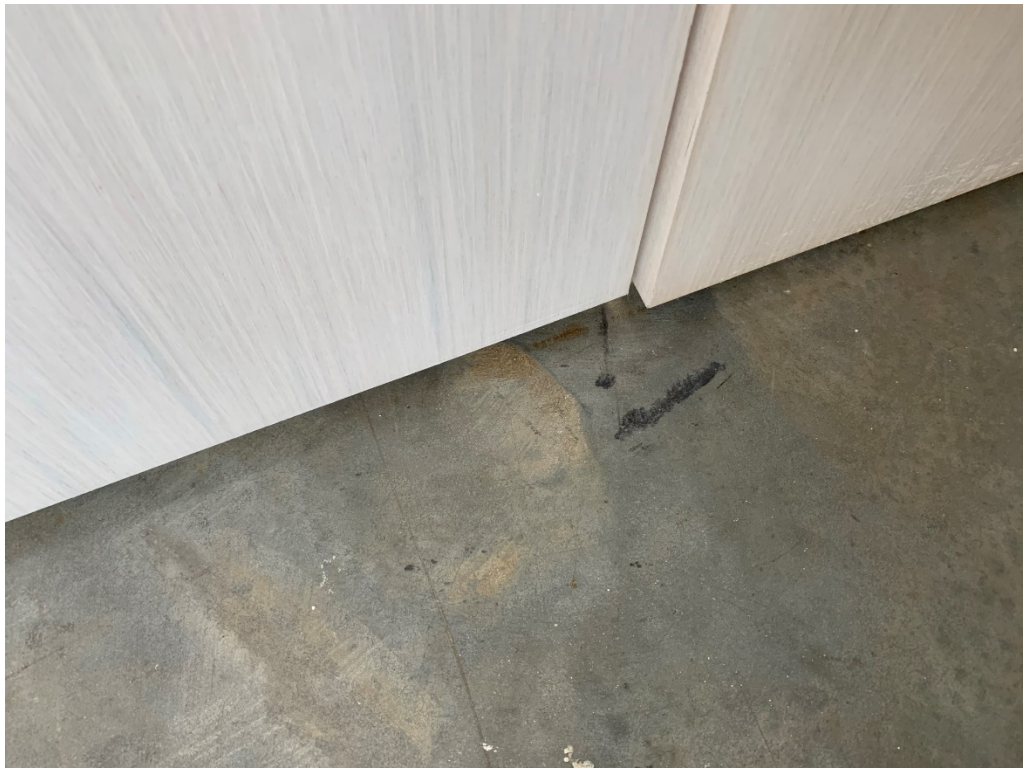
Figure 13 – Installed Double Doors (out of square and need adjustment for proper functionality and aesthetic)

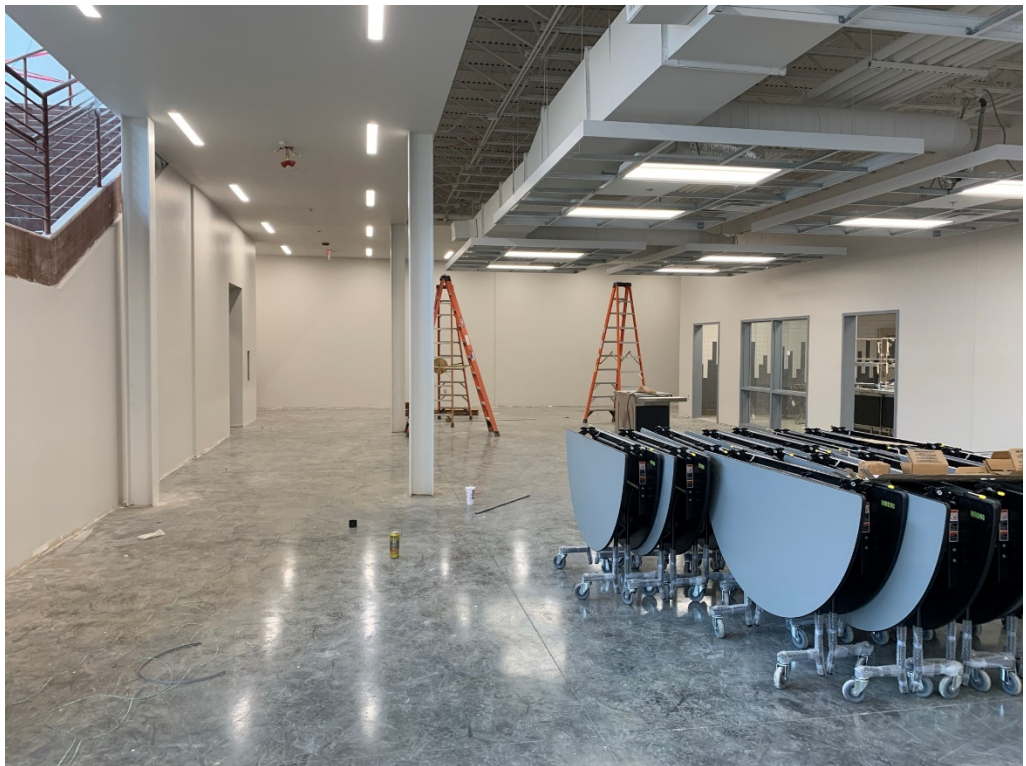
Figure 14 – Progress at Cafeteria
