Architect's Field Report

201 Park Court, Suite B Ridgeland, MS 39157 P 601.790.9432 F 888.281.0547	06 February 2021 18059-AOI Academy of Innovation / Report Number 055
One Jackson Place, Suite 250 188 East Capitol Street Jackson, MS 39201-2100 P 601.352.5411 F 601.352.5362	Contract Century Construction Date / Time 04 February 2021 / 10:30 AM Weather / Temp Overcast / 65 ° F Est % Complete 95% Sched Conformance + 112 days Work in Progress Paint Work Finish Electrical Other Finish Service Work
161 Lameuse Street, Suite 201 Biloxi, MS 39530 P 228.374.1409 F 228.374.1414	Present at Site Joey Moore, CC OAC Meeting Members Paul Purser, DBA
	Observations After our monthly meeting, several of the members of the monthly meeting walked the site. We reviewed cafeteria work at the 1 st floor. This Space is coming together but there are a few issues that need correction, most notably, issues with signage and floor trip hazards. All flooring in the kitchen area needs to be flush and level and free of trip hazards, which means grates and drains need to be brought to the same level. There are still a few finish items in this area that are in progress. Exit signs in the cafeteria are here are also

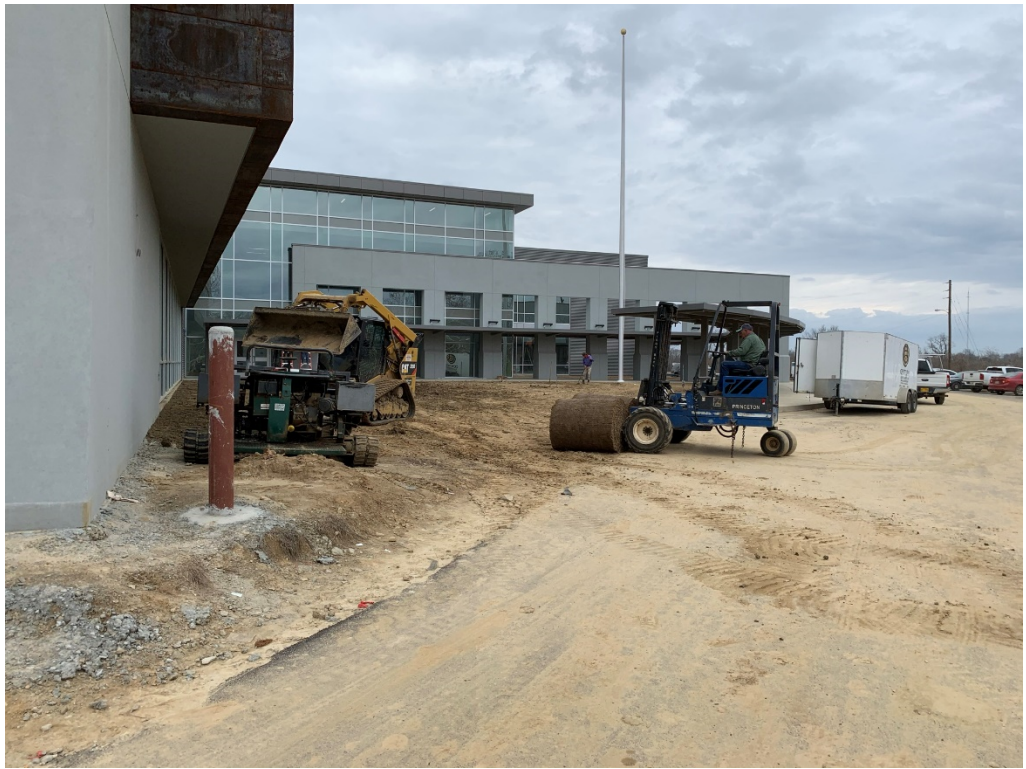
Figure 1 – Sod and grading at front courtyard

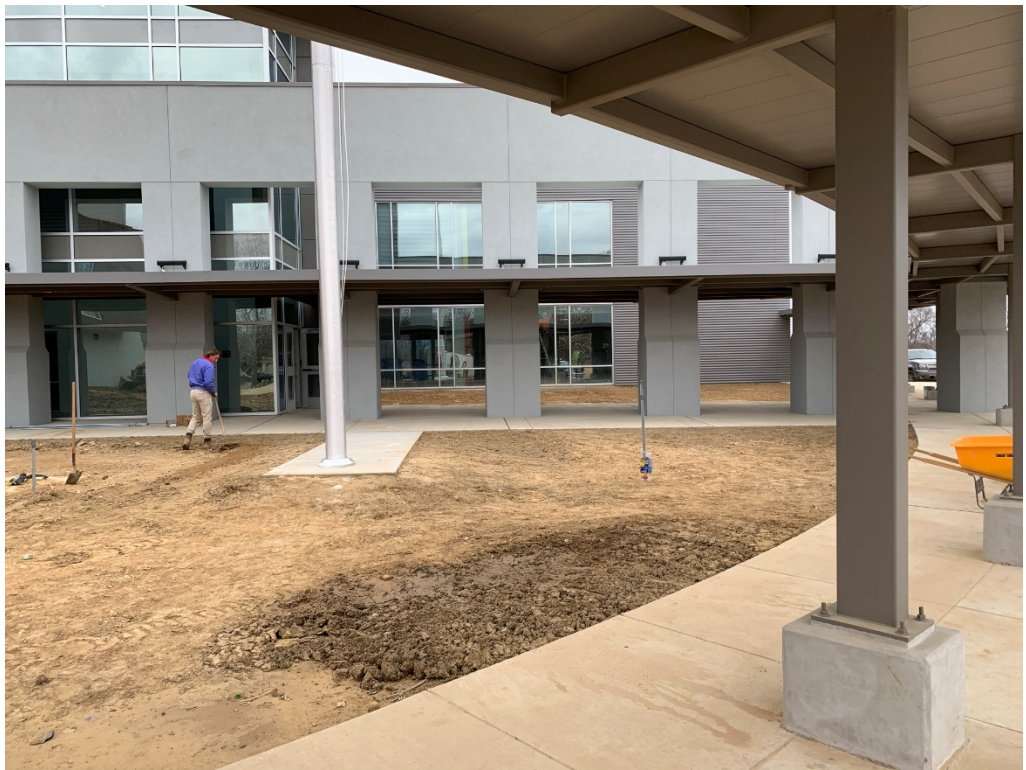
Figure 2 – Flag Pole Installed

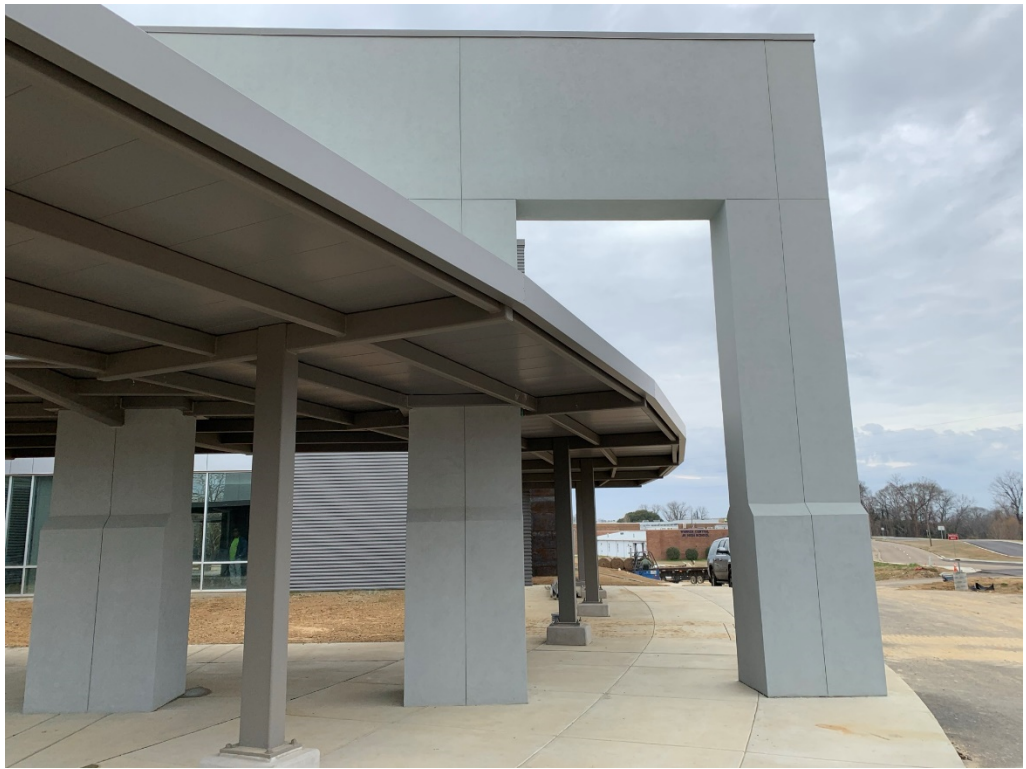
Figure 3 – Fixture Removed and Repair in Good Order

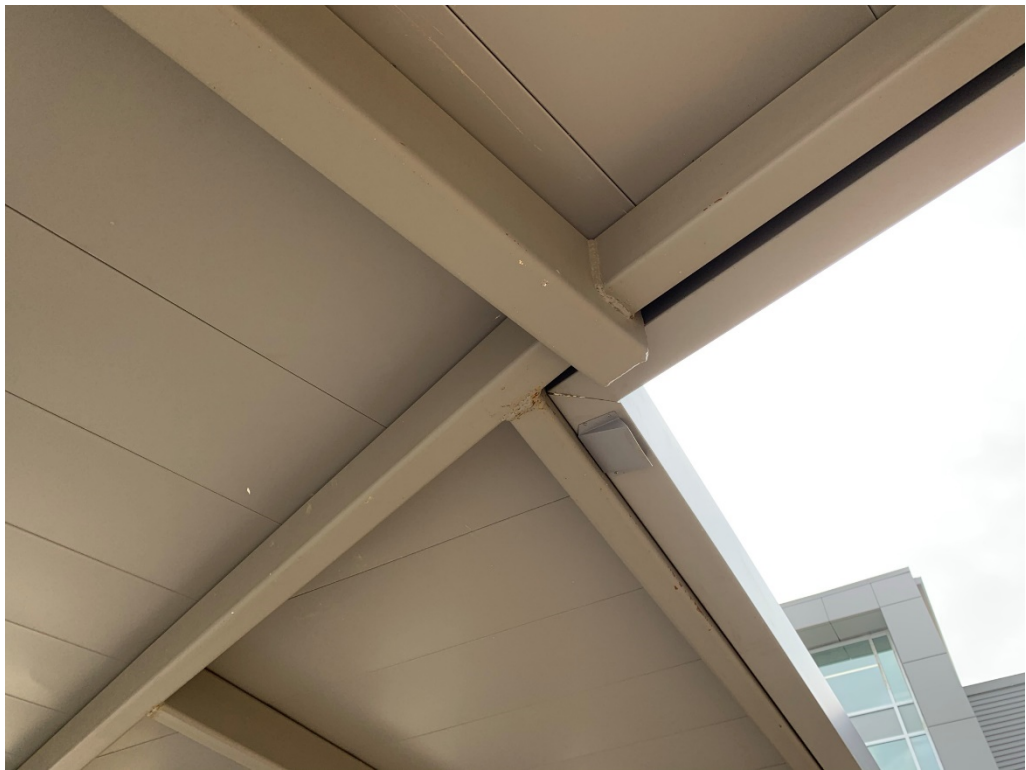
Figure 4 – Divertors at Awning do not Match in color and need to be painted to match

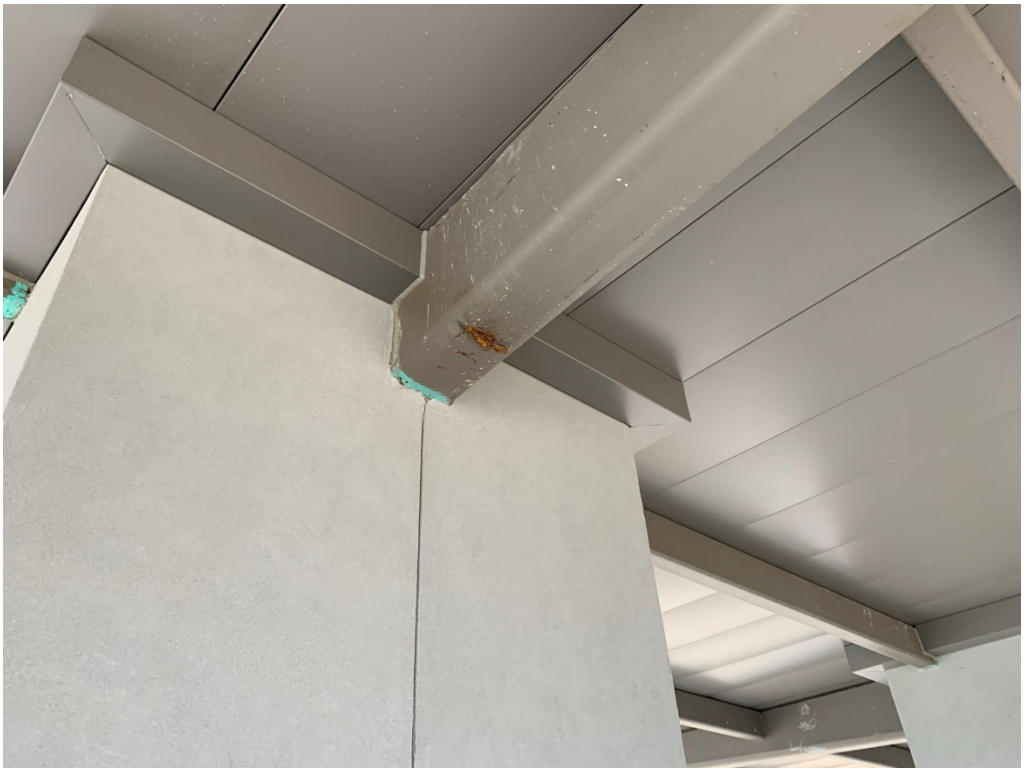
Figure 5 – Awning at drop off leaks and needs to be sealed and repainted where damaged

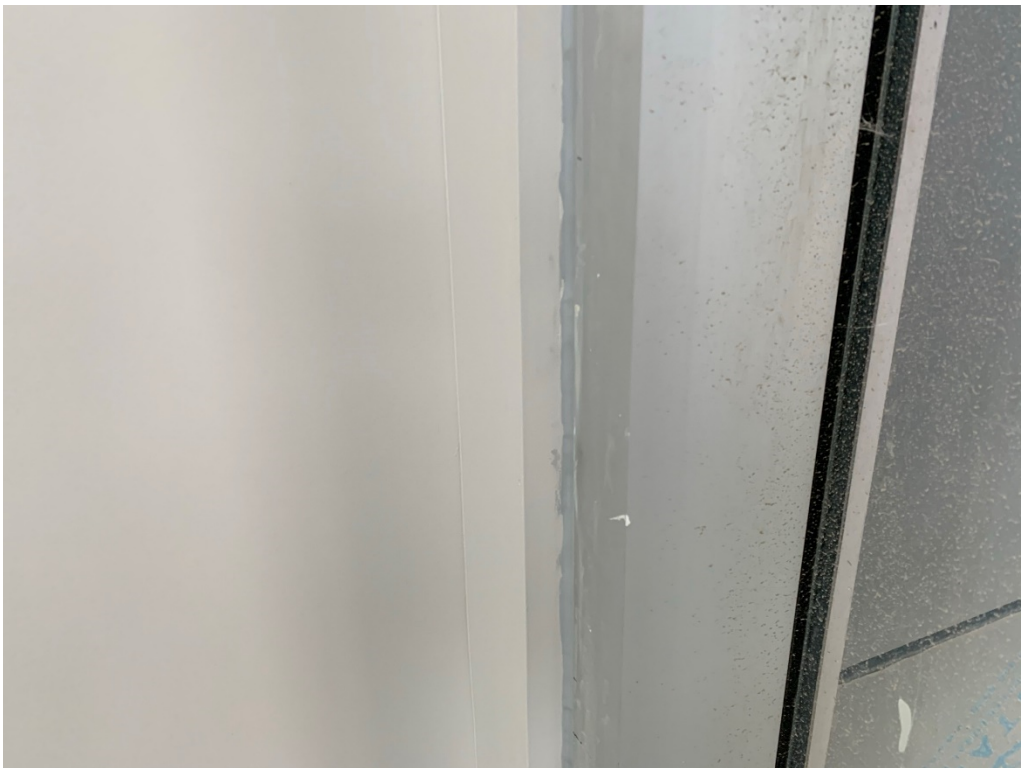
Figure 6 –All Sealant and paint lines need to be straight

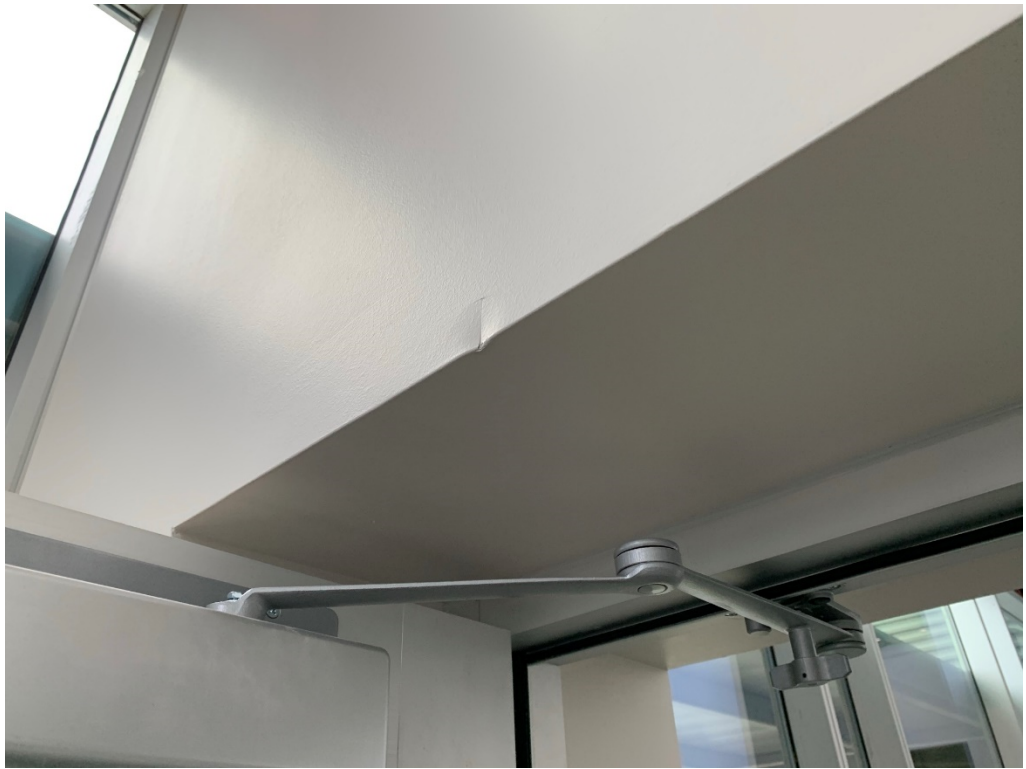
Figure 7 – Damage Noted North Entry

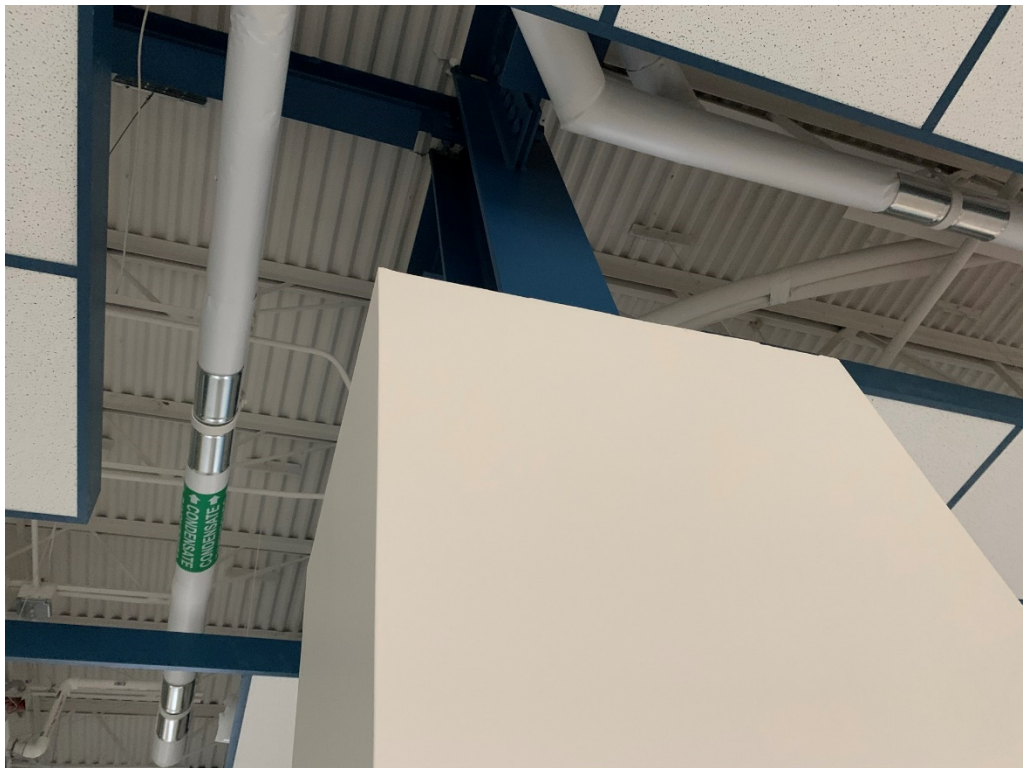
Figure 8 – Tops of all Columns need to be straight and finished smooth

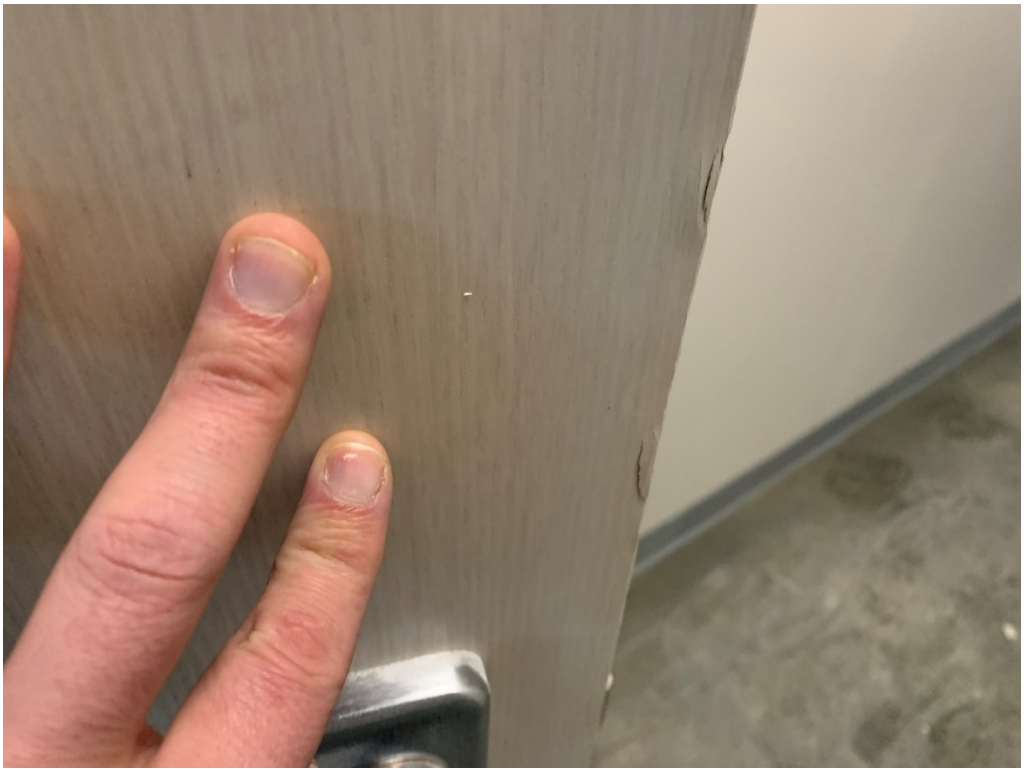
Figure 9 – Damage at New Door Panels in Administration Offices

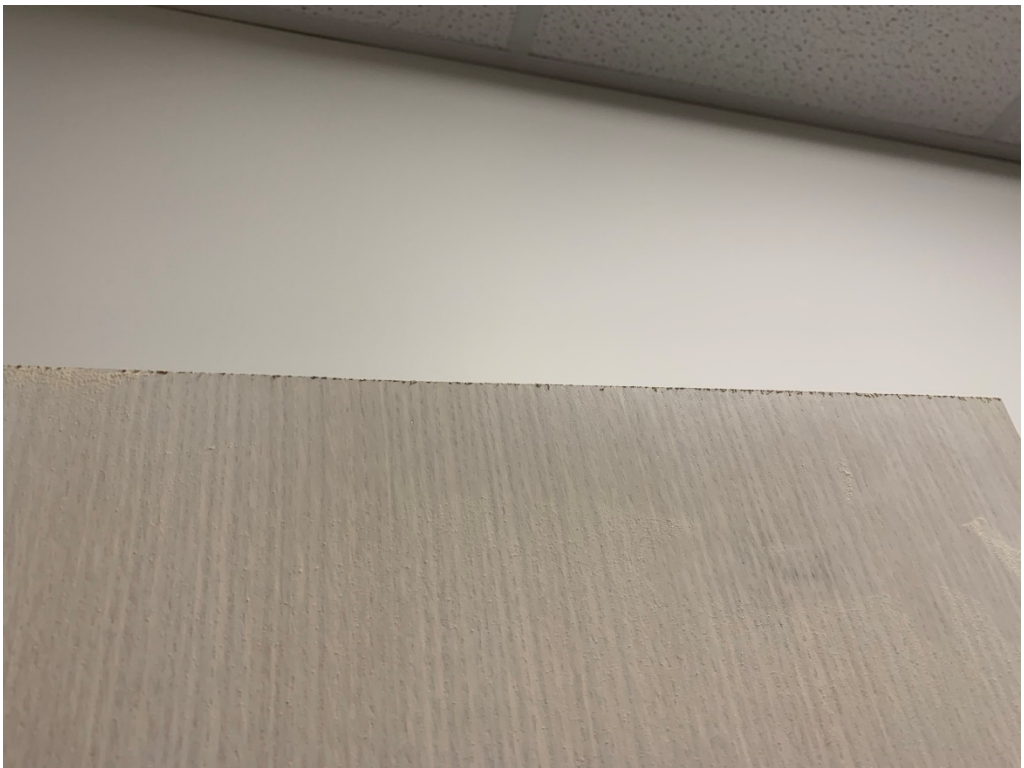
Figure 10 – Field Cuts at doors need to be finished

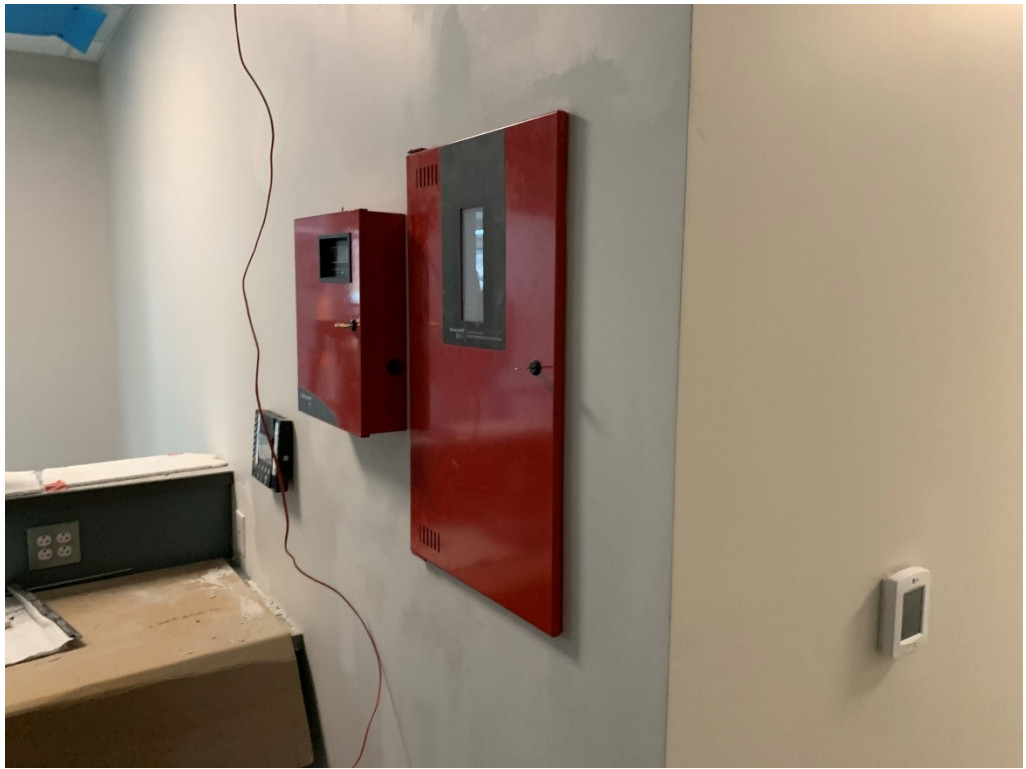
Figure 11 – Install Fire Equipment

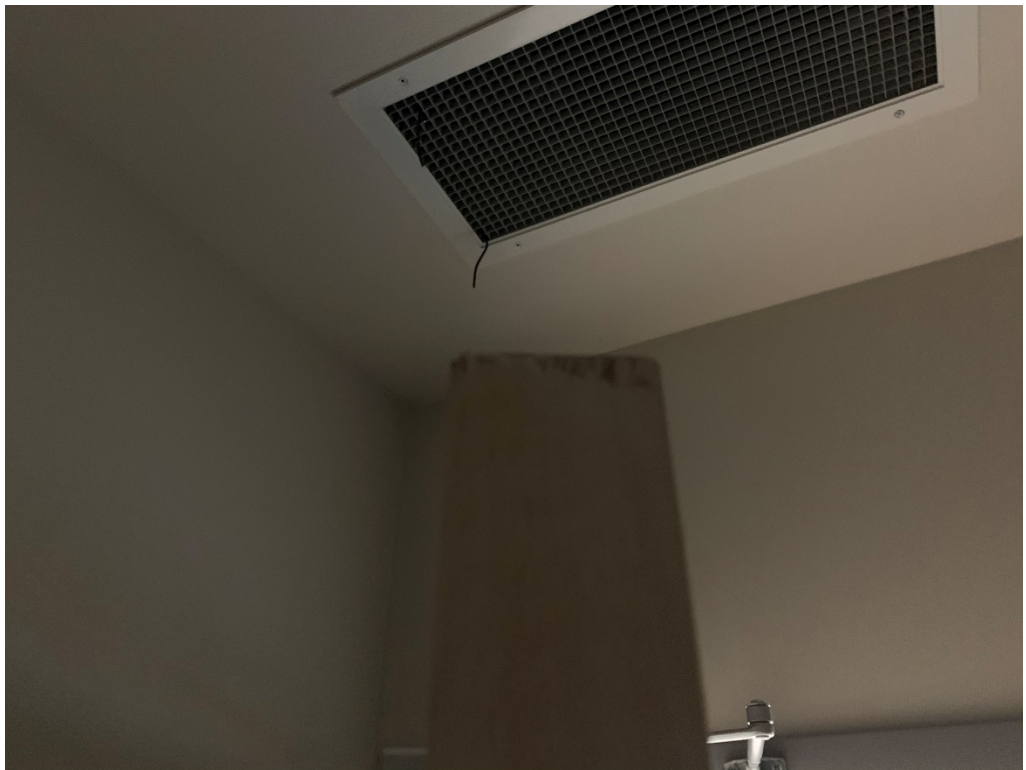
Figure 12 – More Damage Noted at Door Panels

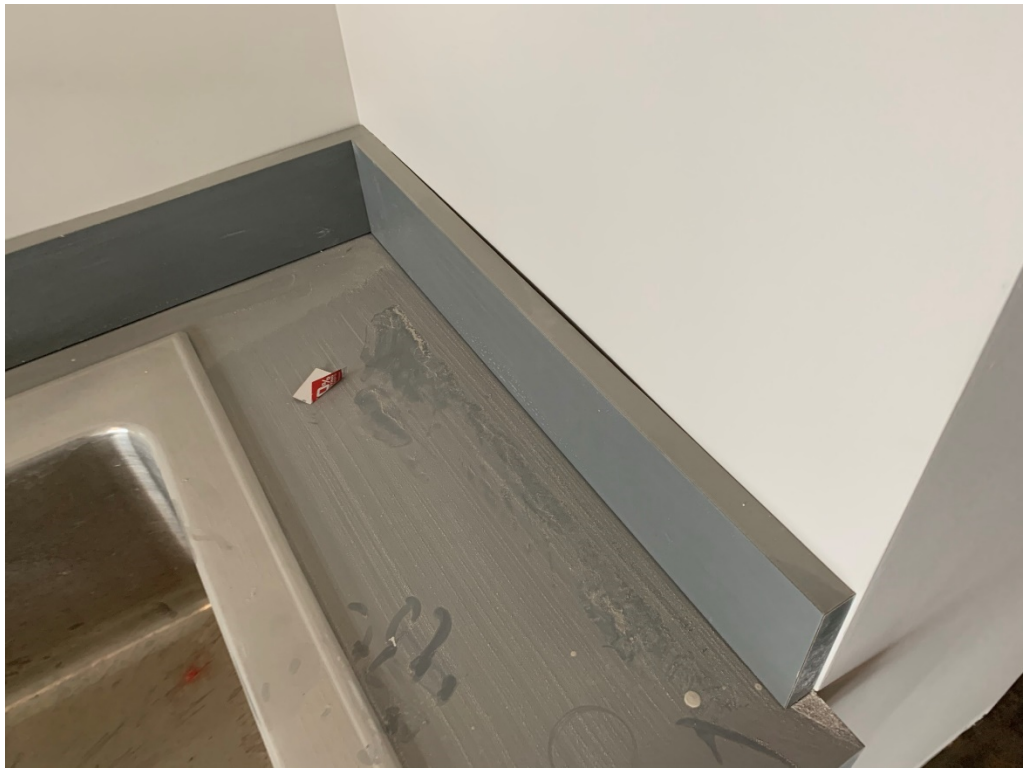
Figure 13 – Sealant is required at all backsplash/wall junctions

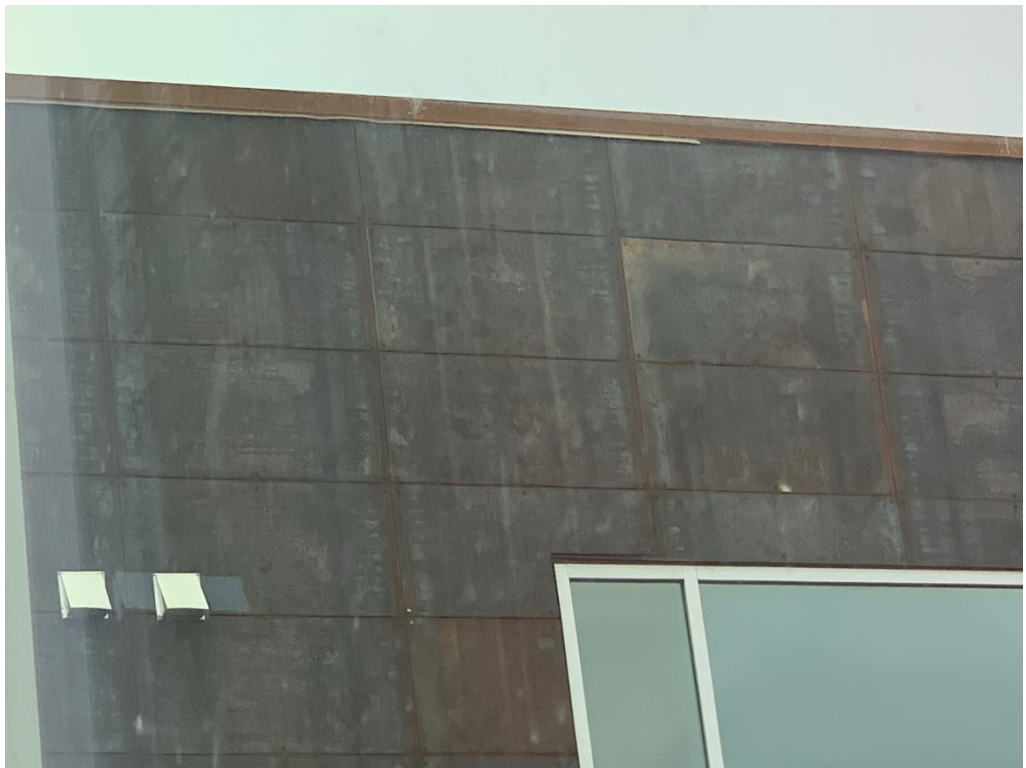
Figure 14 – Roof Membrane is exposed in some sections; This Membrane needs to be trimmed so that it is concealed from view

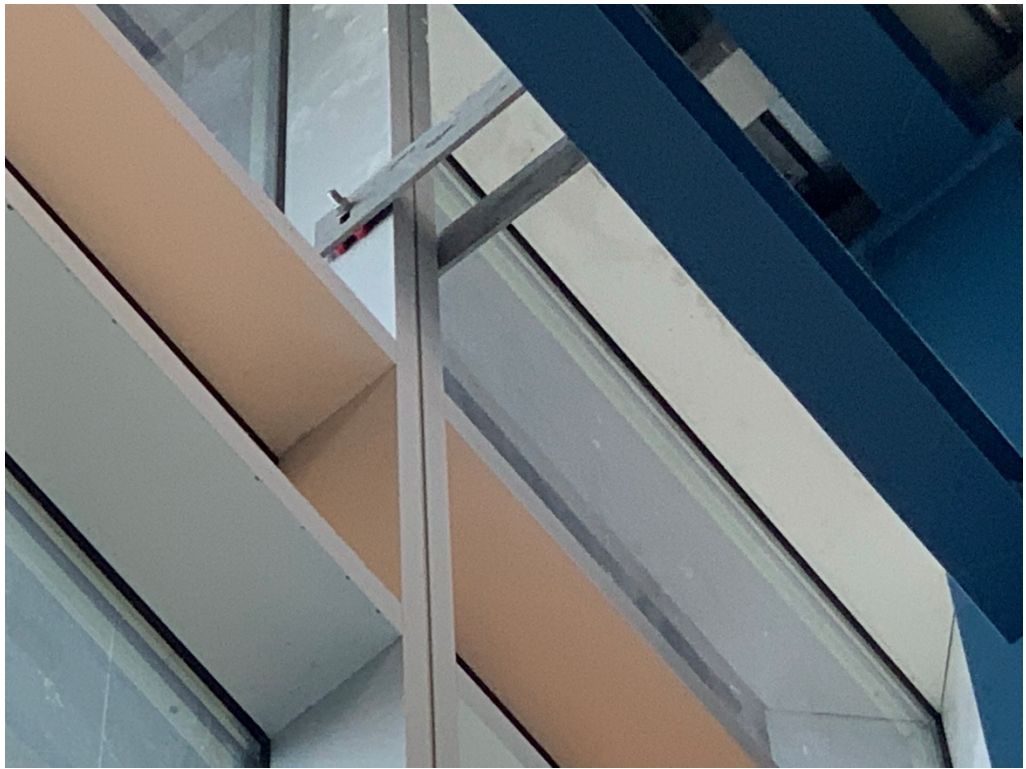
Figure 15 – All Shims need to be concealed Throughout

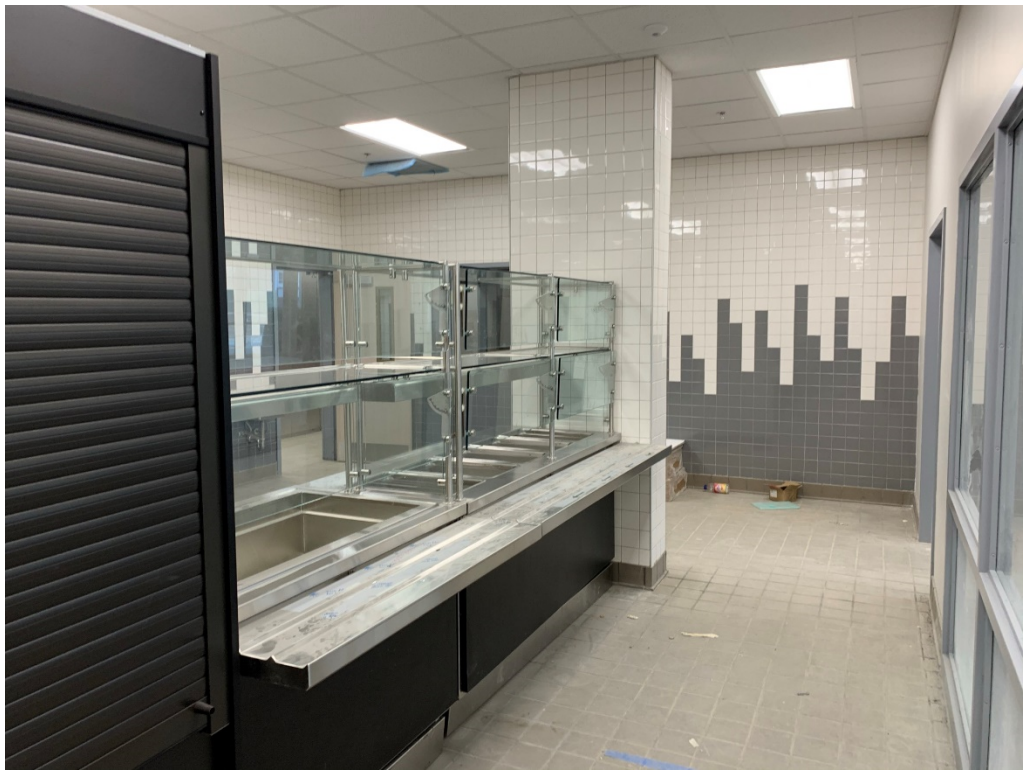
Figure 16 – Kitchen Equipment Installed

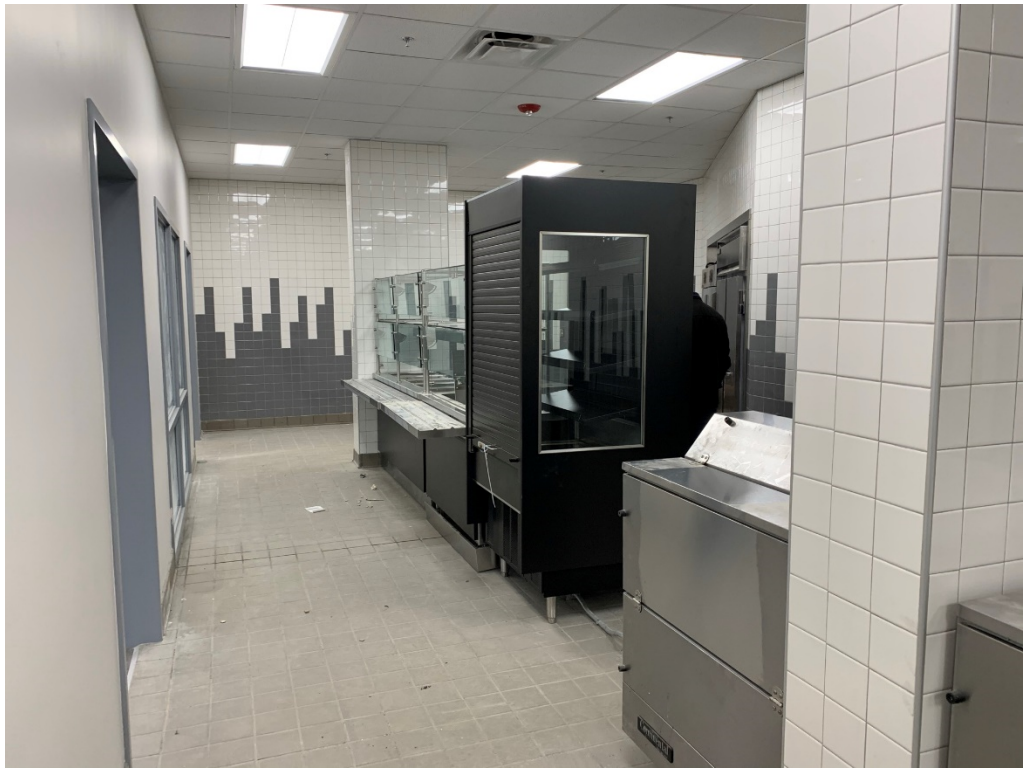
Figure 17 – Kitchen Equipment Installed

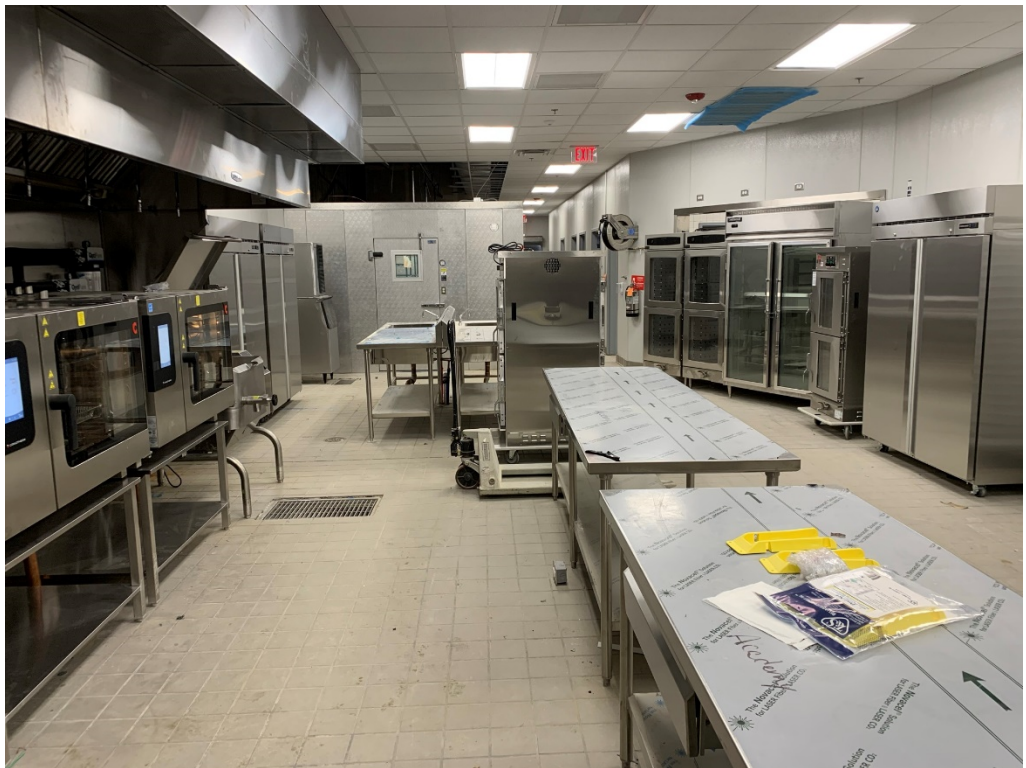
Figure 18 – Kitchen Equipment Installed

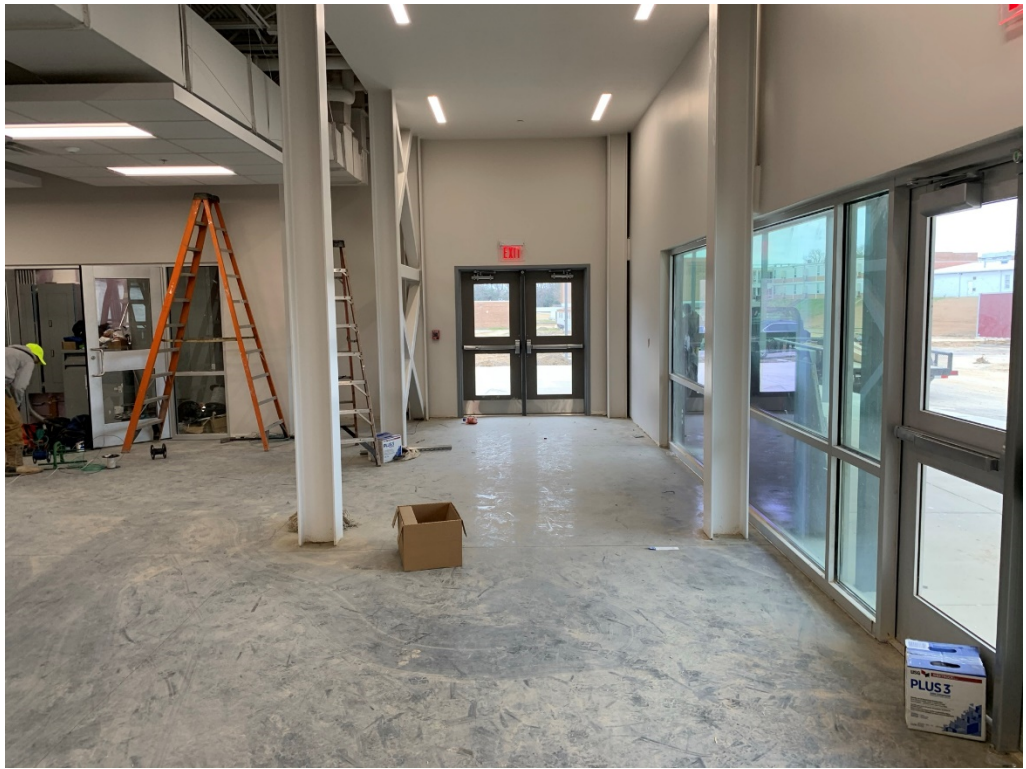
Figure 19 – Exit signs in a similar space need to be at the same height and centered on doors.

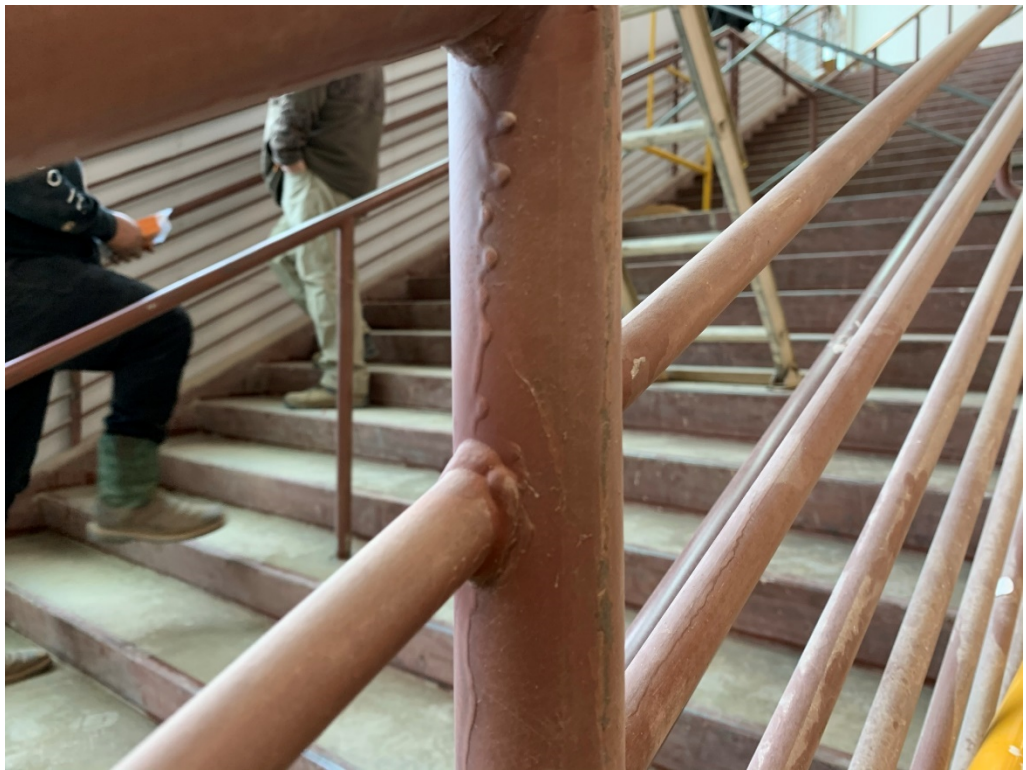
Figure 20 – Ensure that Paint is Sanded Smooth for Final Coat

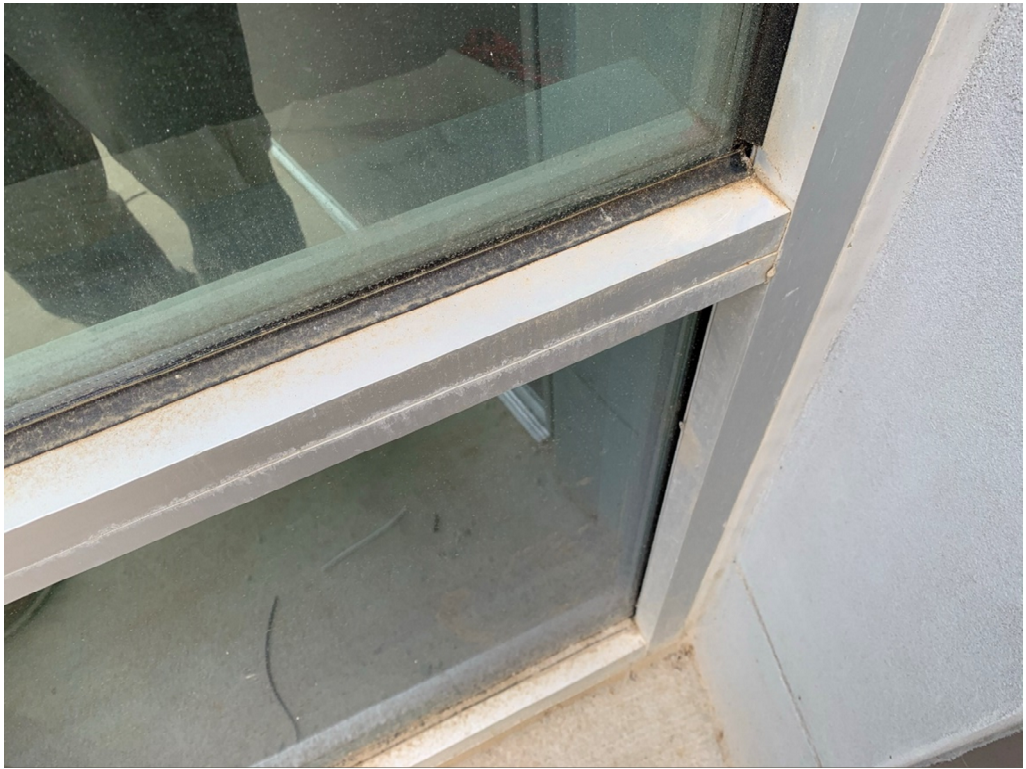
Figure 21 – There are Gaps in Gasketing around windows that need to be filled

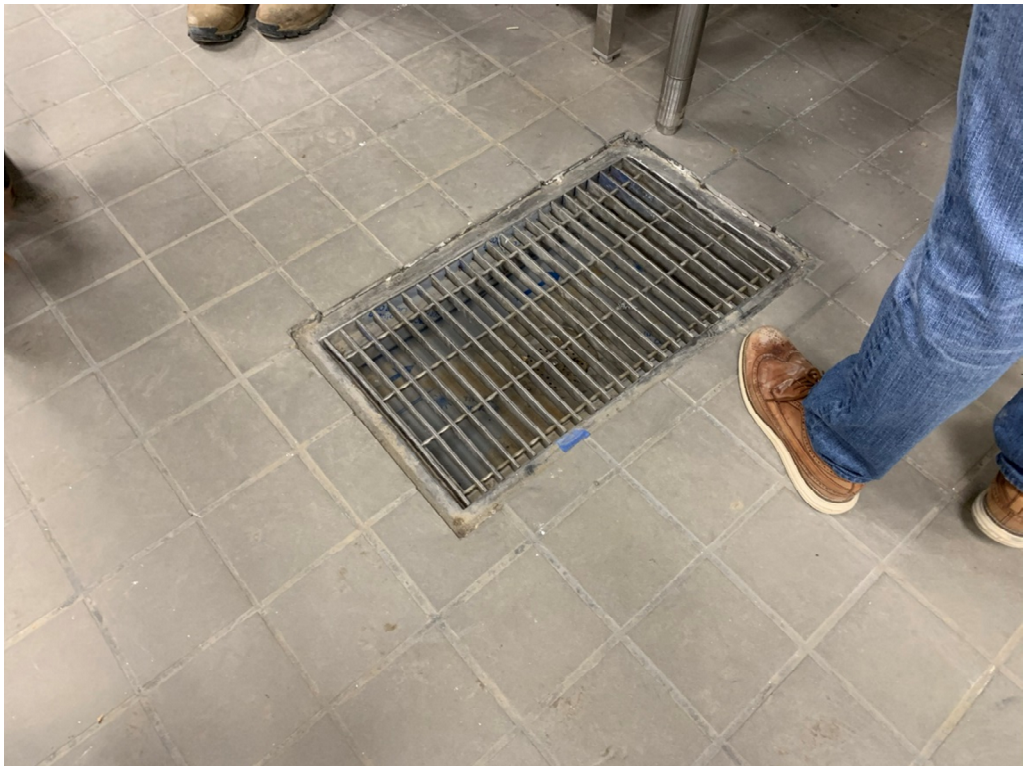
Figure 22 – Grates Need to be Raised in Kitchen flush with the Floor Tile
