Architect's Field Report

T. Doug Dale, AIA

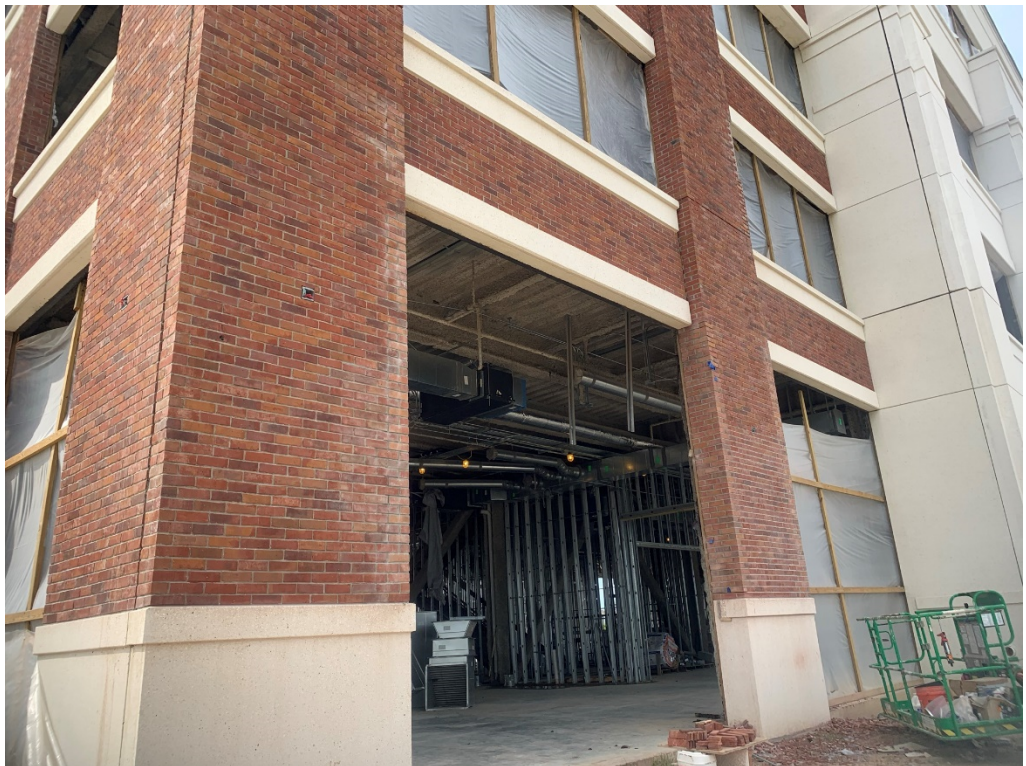
Figure 8 – Repairs to corner brick here (to be cleaned still)

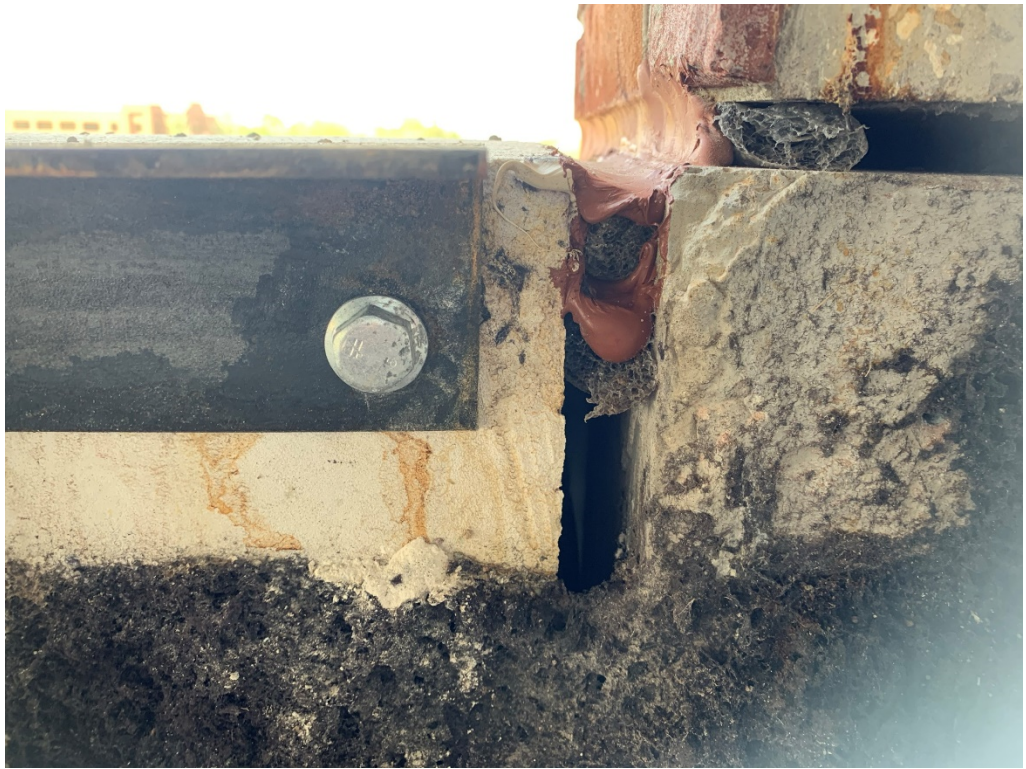
Figure 9 – Example of double Sealant (horizontal joint still needs to be removed and double sealed)

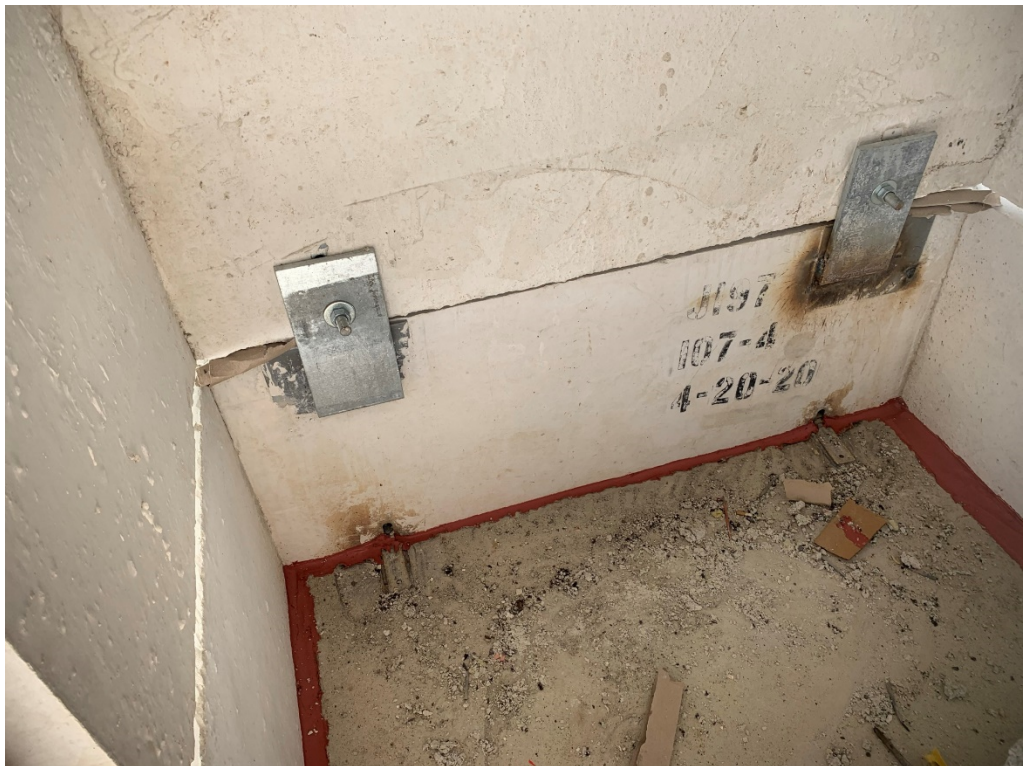
Figure 10 – Plate Missing Weld on left

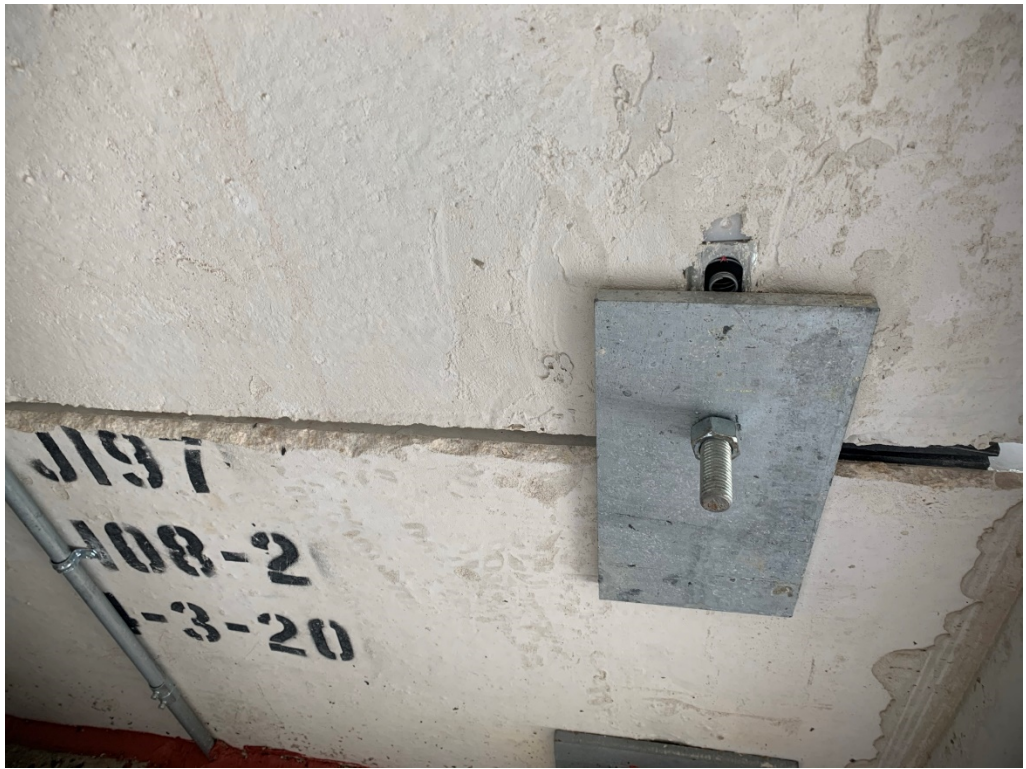
Figure 11 – Plate Missing Weld Plate (solution?)

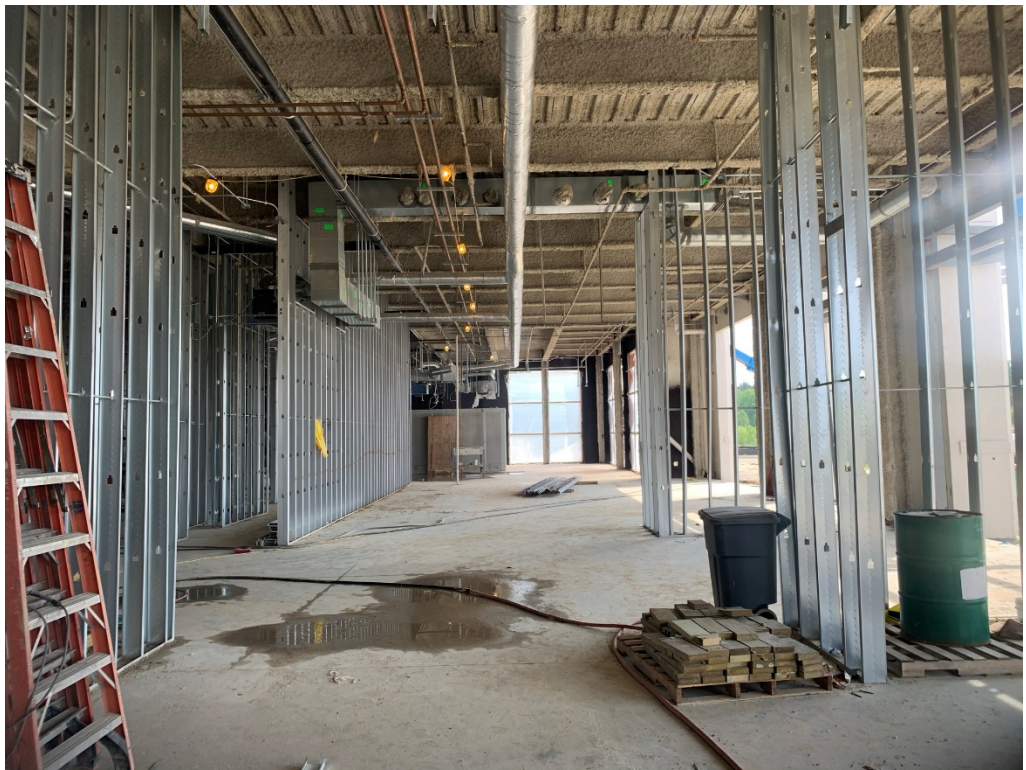
Figure 12 – First Floor at entry Looking South

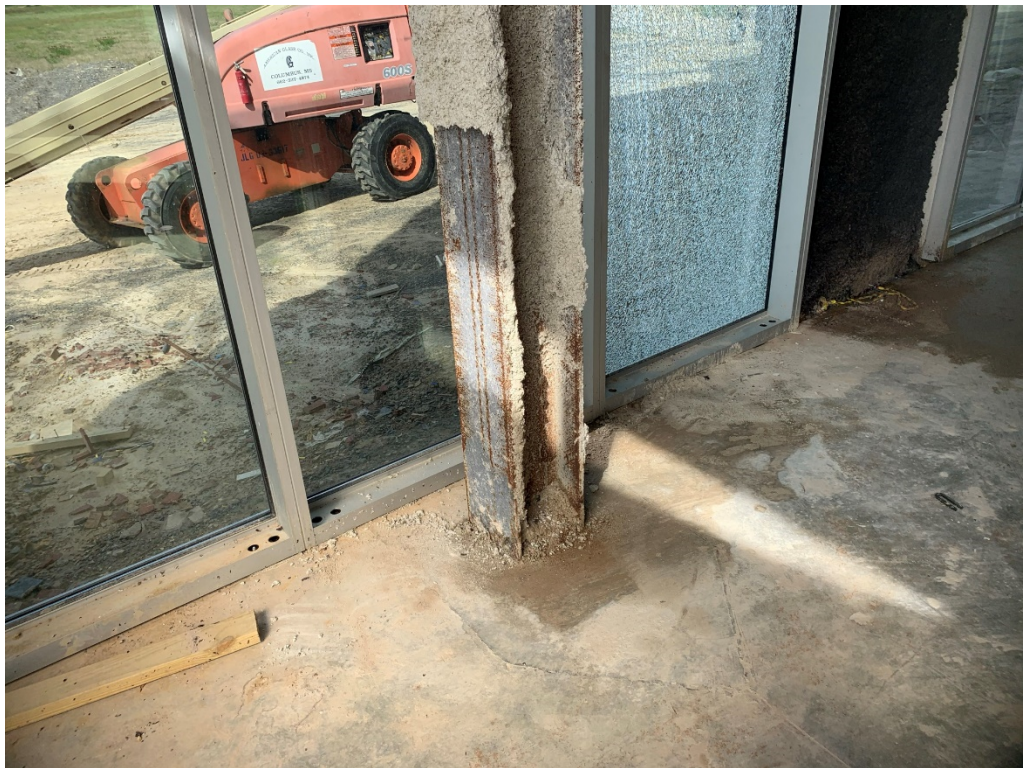
Figure 16 – Example of Degradation of Fire proofing due to weather

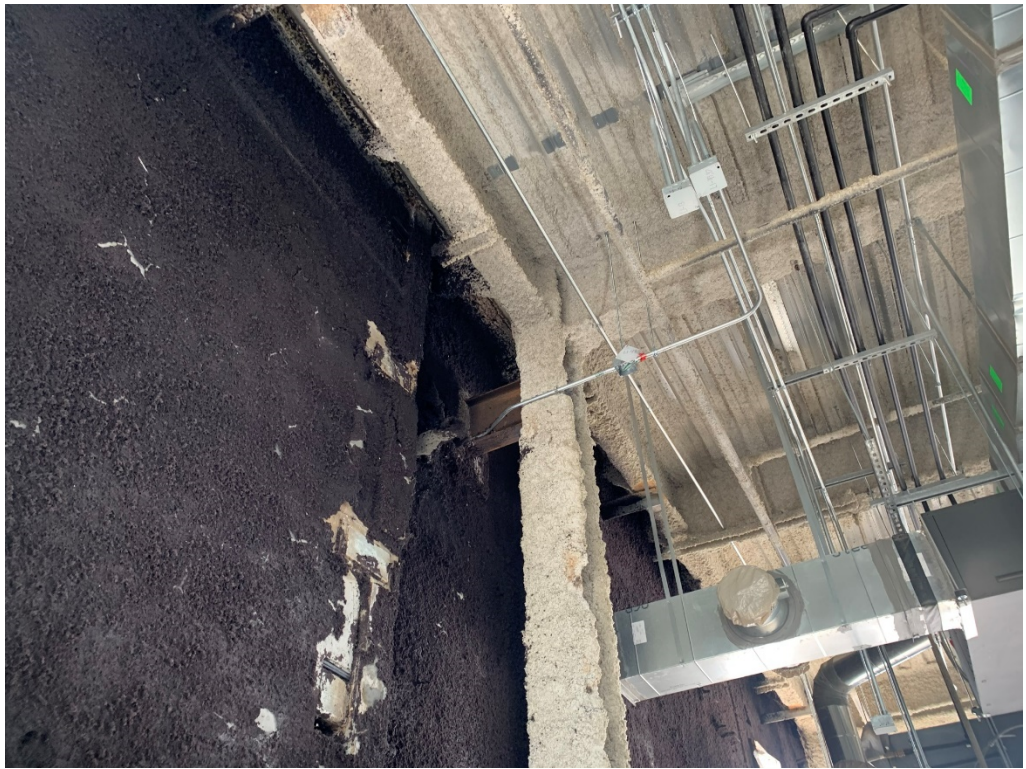
Figure 17 – Structural steel exposed without fire proofing

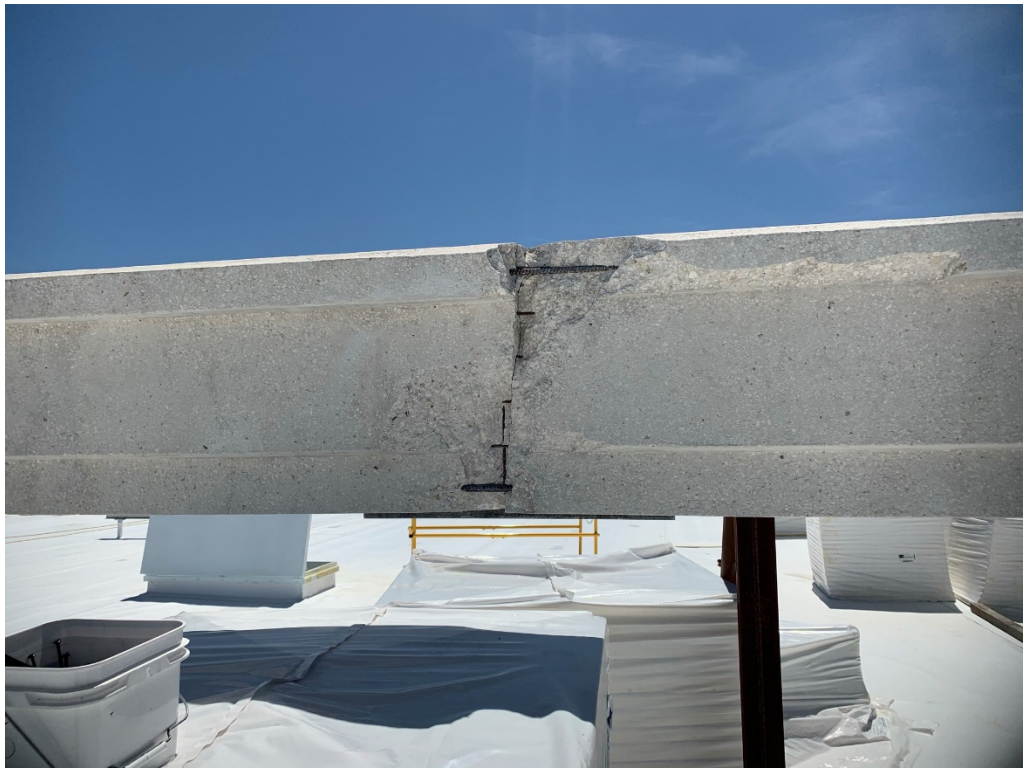
Figure 25 – Damaged Precast at Return over Roof

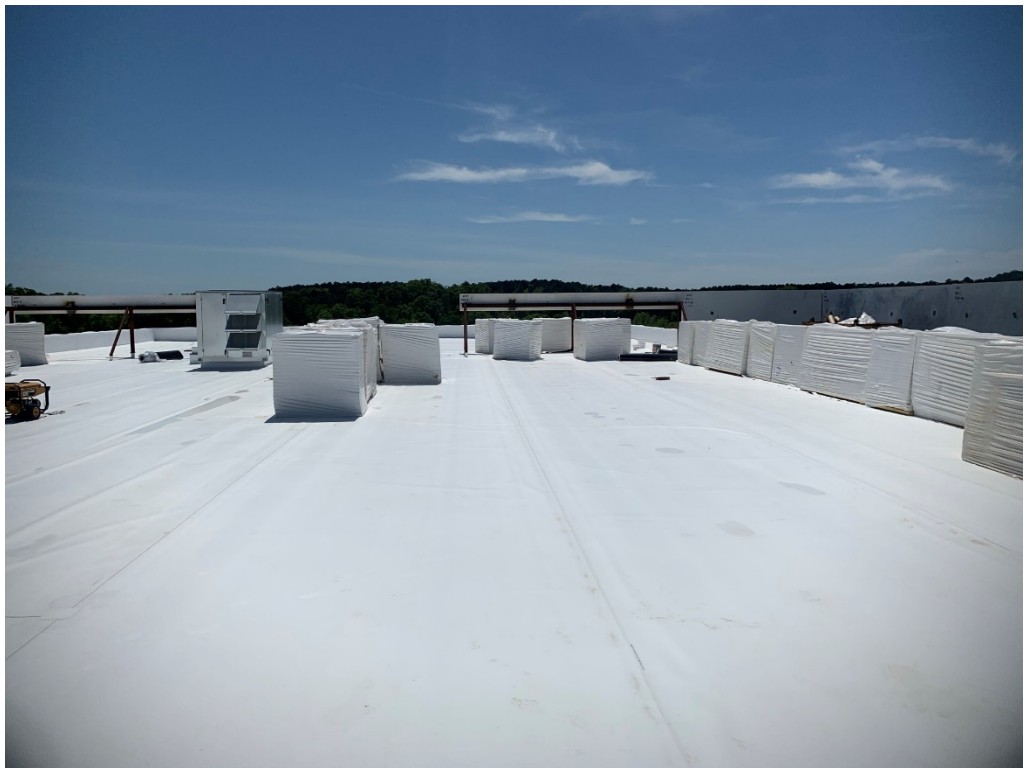
Figure 26 – Bare Decking on other Side of roof insulation stacks
