14 February 2023

21027 Sunflower Consolidated SD Phase I / Report Number 001

Contract UpChurch Services, LLC
Date / Time 08 February 2023 / 11:30 AM
Weather / Temp Drizzle / 65 ° F
Est % Complete 8%

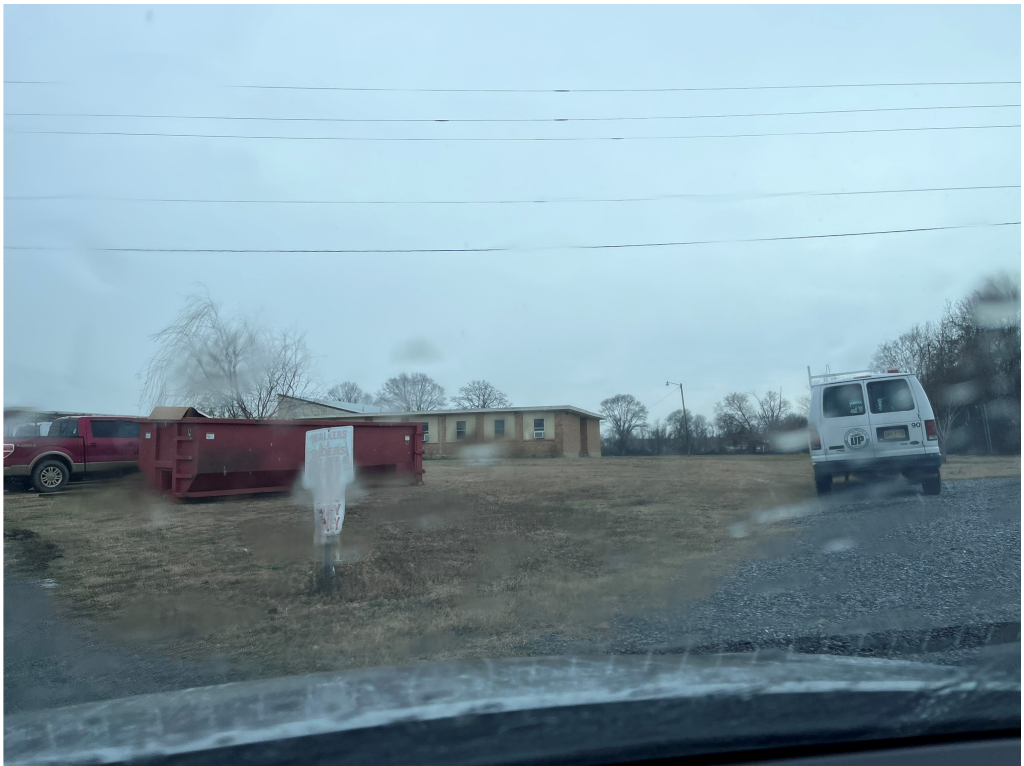
Figure 1 – Upchurch dumpster and vehicles out in front of Drew Hunter

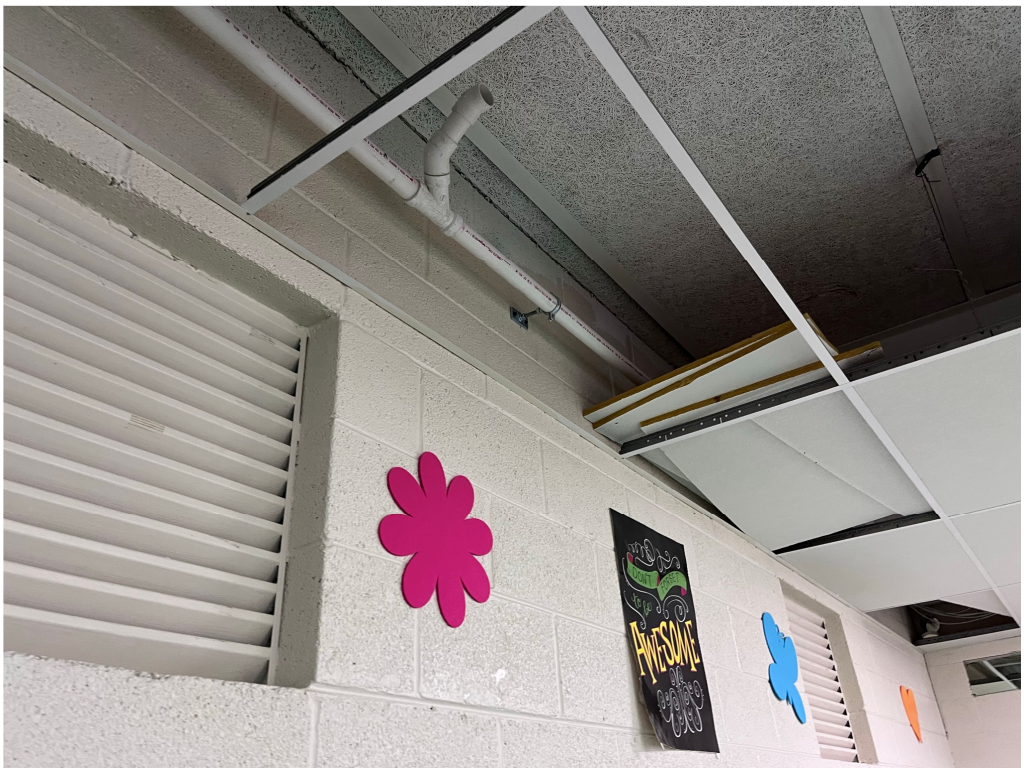
Figure 2 – Condensate Lines for cassettes above ceiling at Drew Hunter

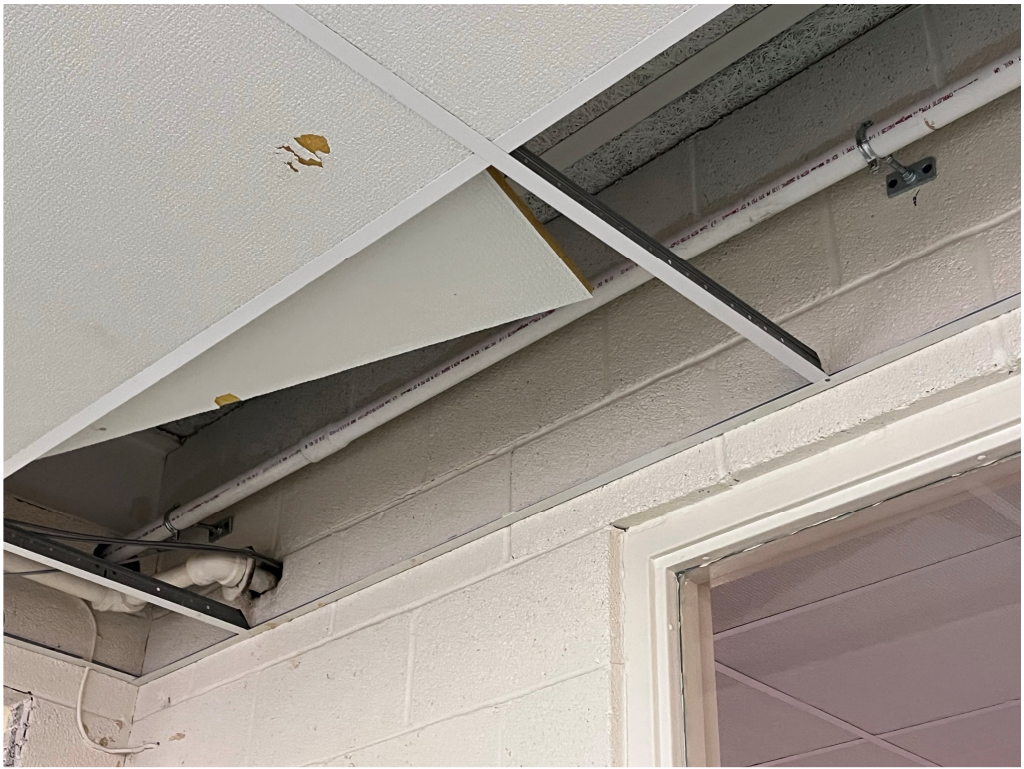
Figure 3 – Condensate Lines for cassettes above ceiling at Drew Hunter

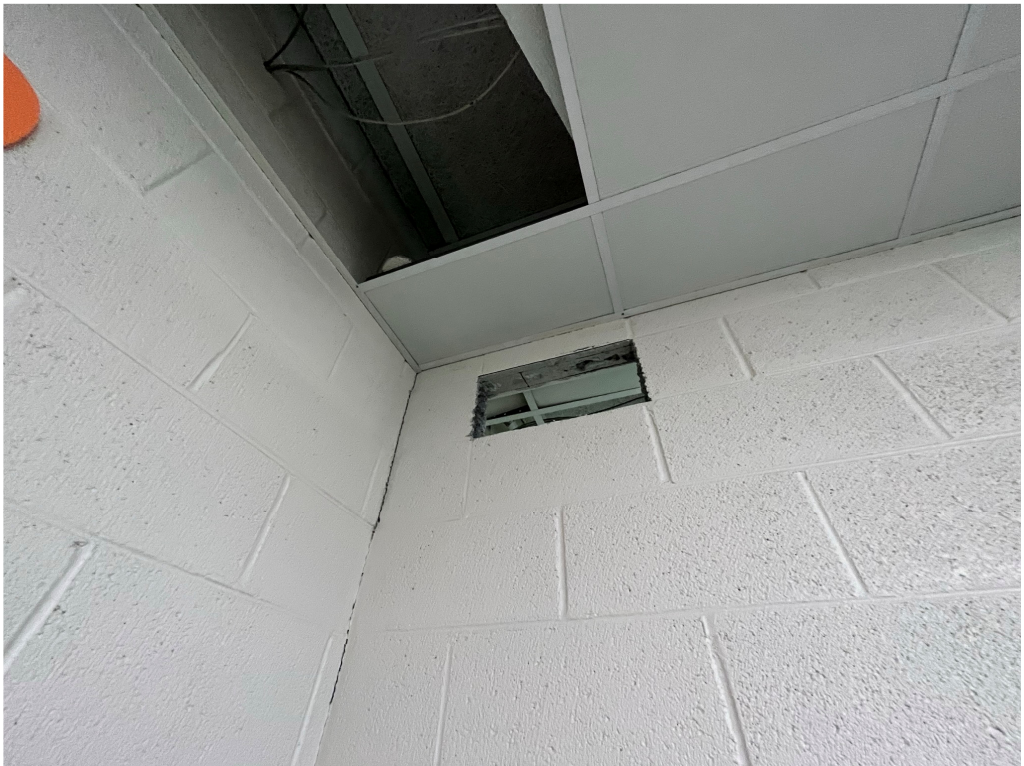
Figure 4 – Fresh air hole cut for ducting at Drew Hunter

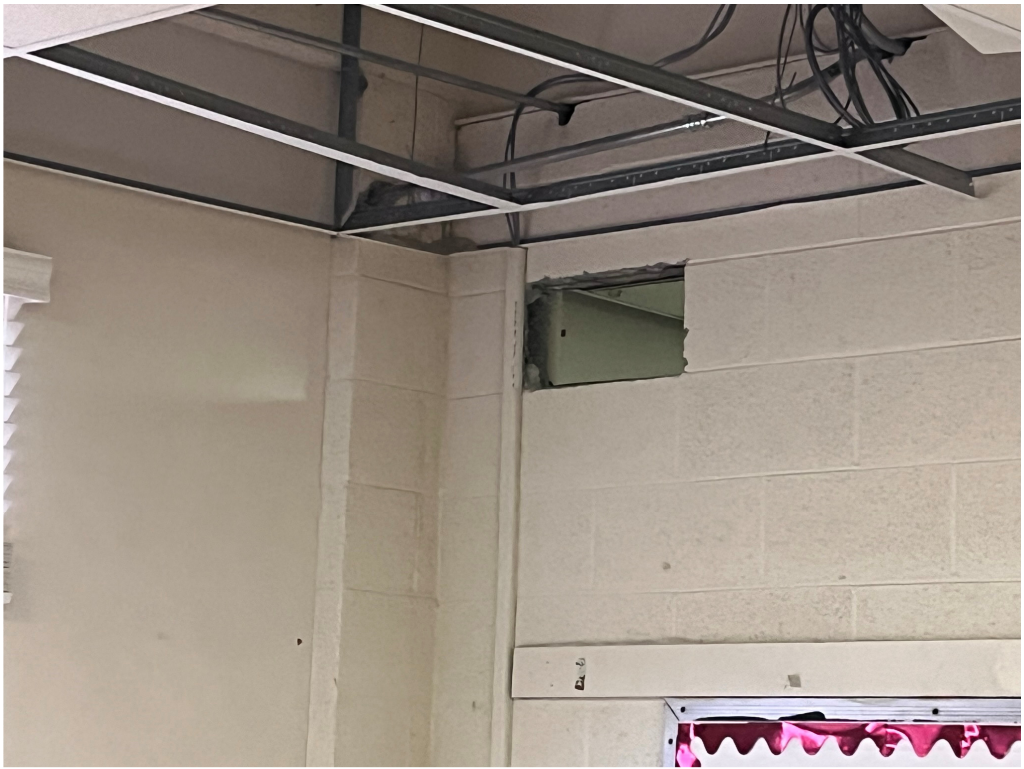
Figure 5 – Fresh air hole cut for ducting at Drew Hunter

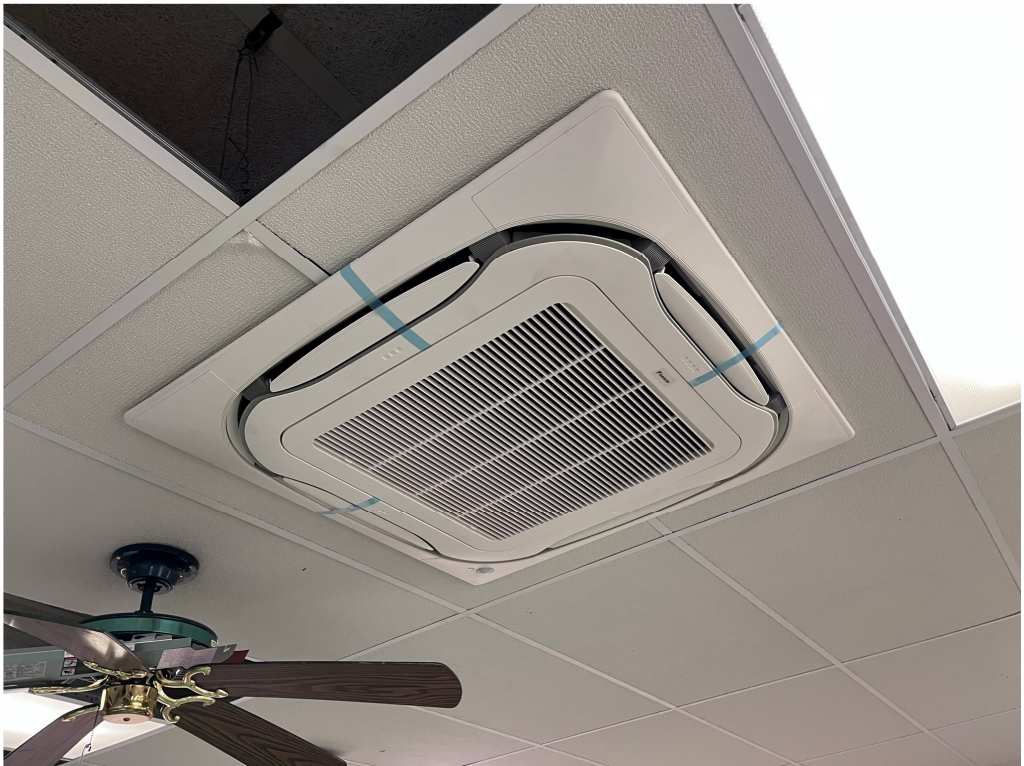
Figure 6 – Cassettes Installed at Drew Hunter

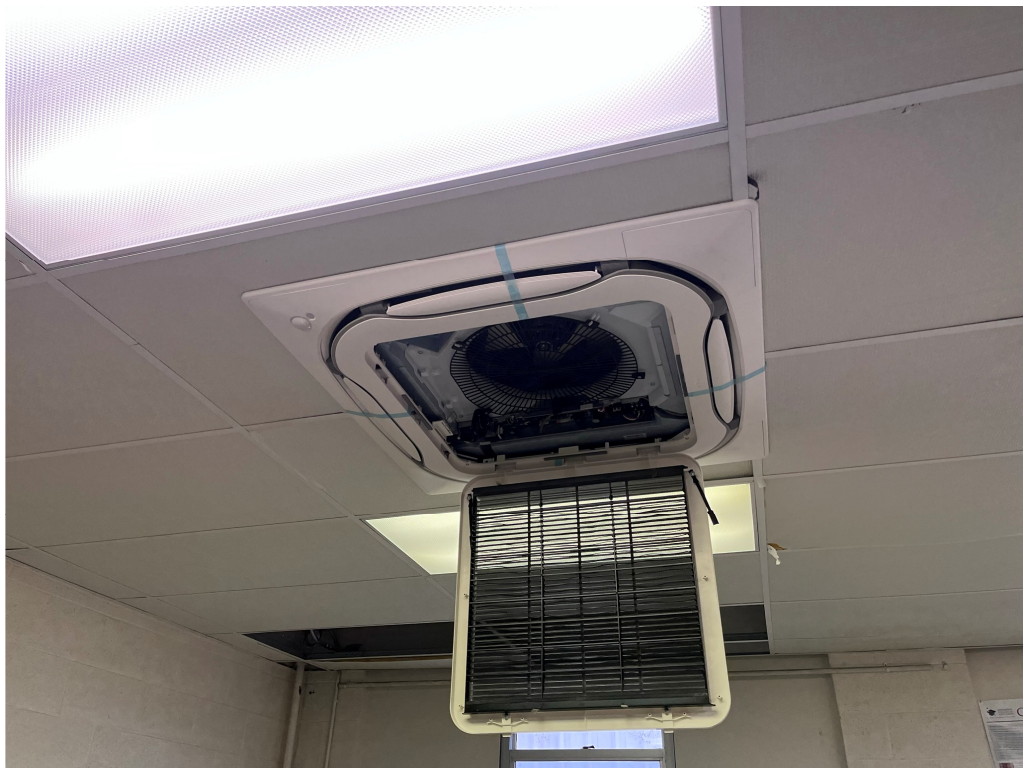
Figure 7 – Cassettes Installed at Drew Hunter

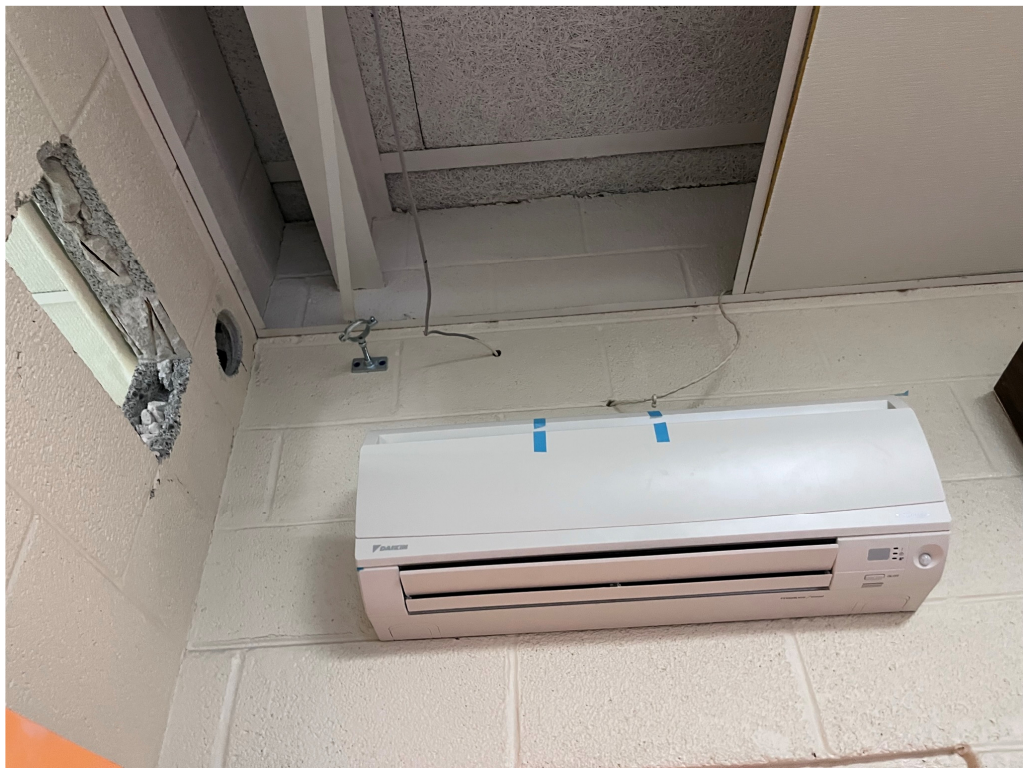
Figure 8 – Fresh air duct may pose servicing hazard at this location in Drew Hunter Teachers Lounge

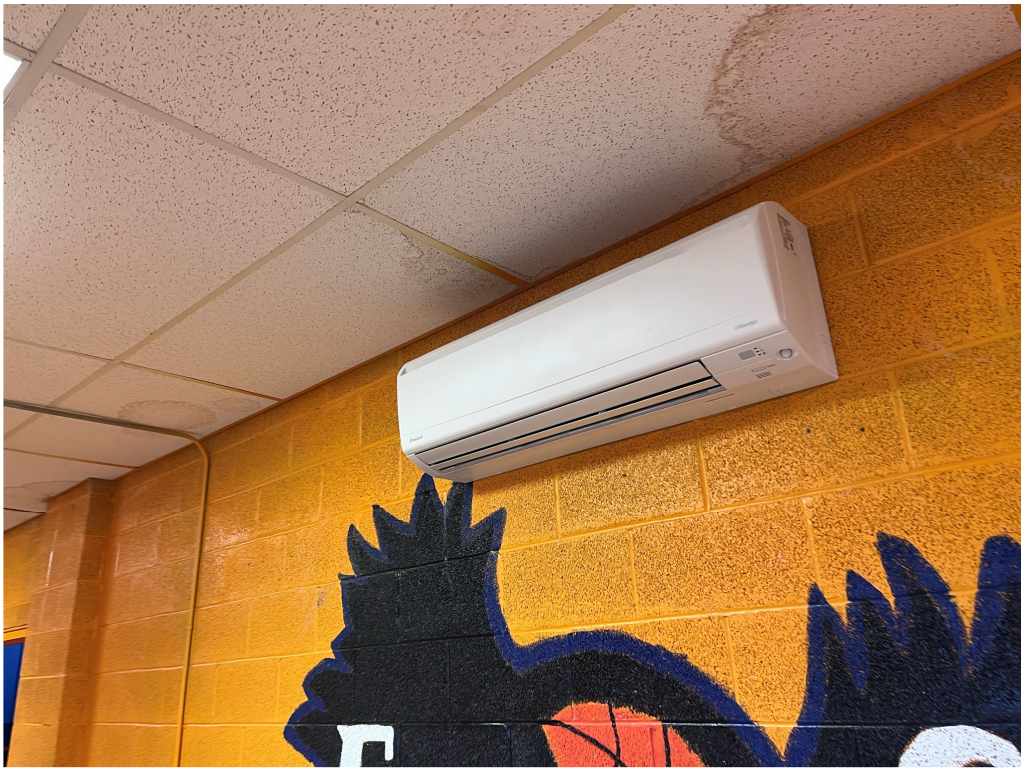
Figure 9 – Typical install at front lobby of Gym at Drew Hunter

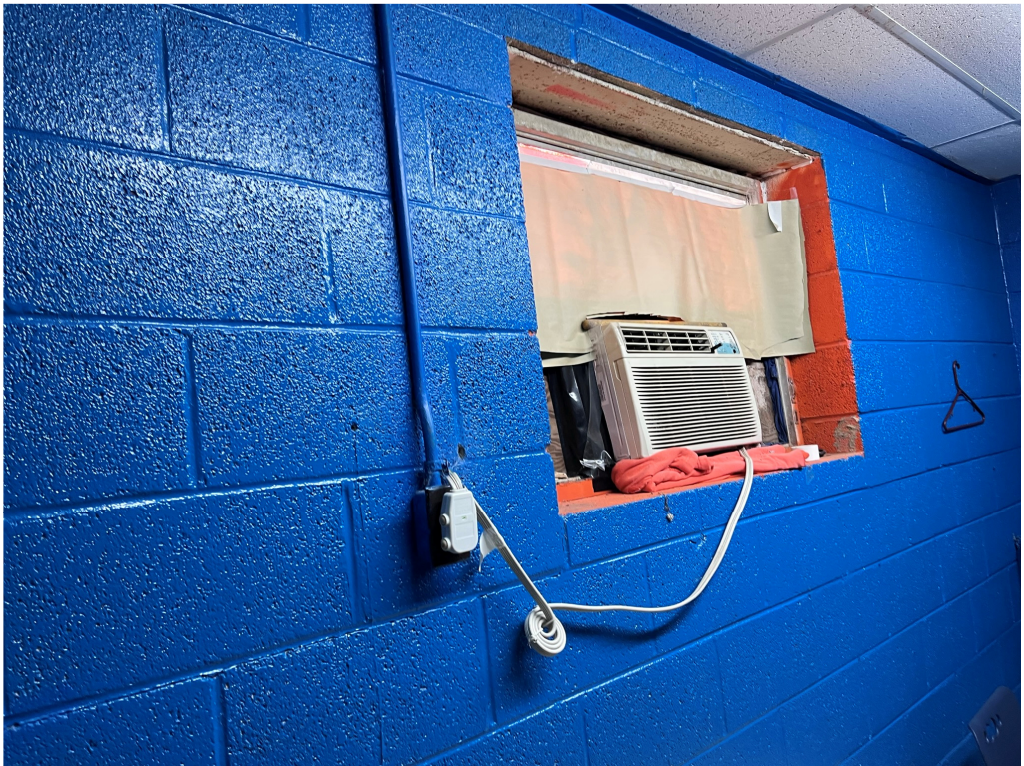
Figure 10 – Drew Hunter Middle Coach's office in room labeled storage on plans

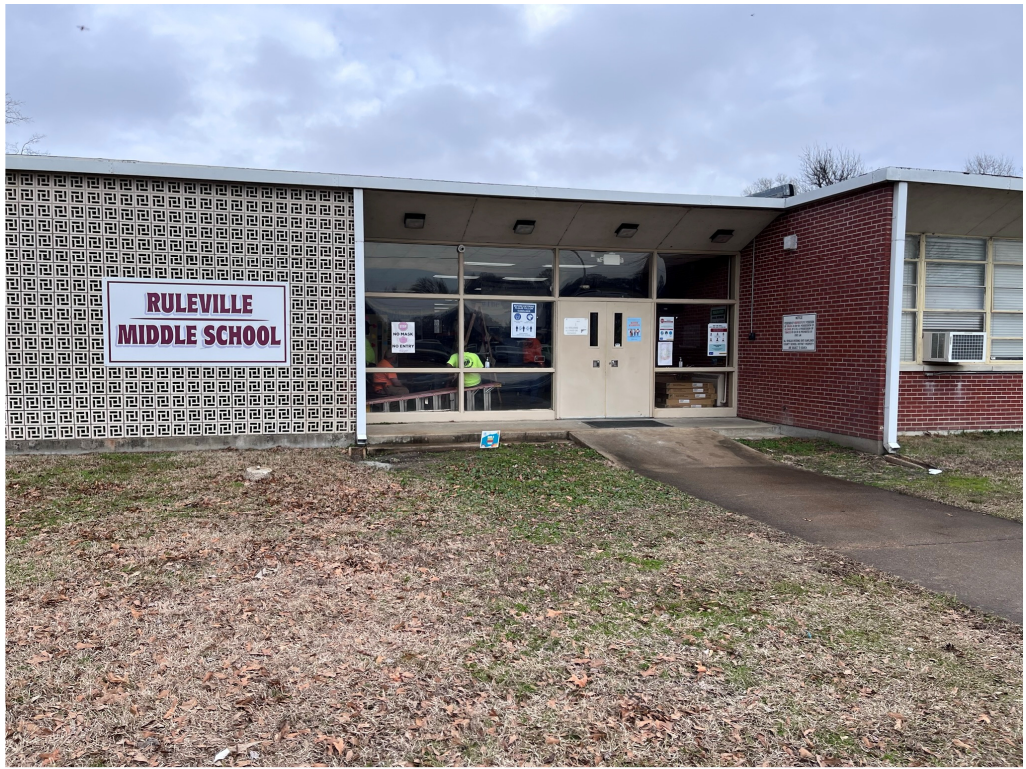
Figure 11 – Ruleville Middle work is ongoing

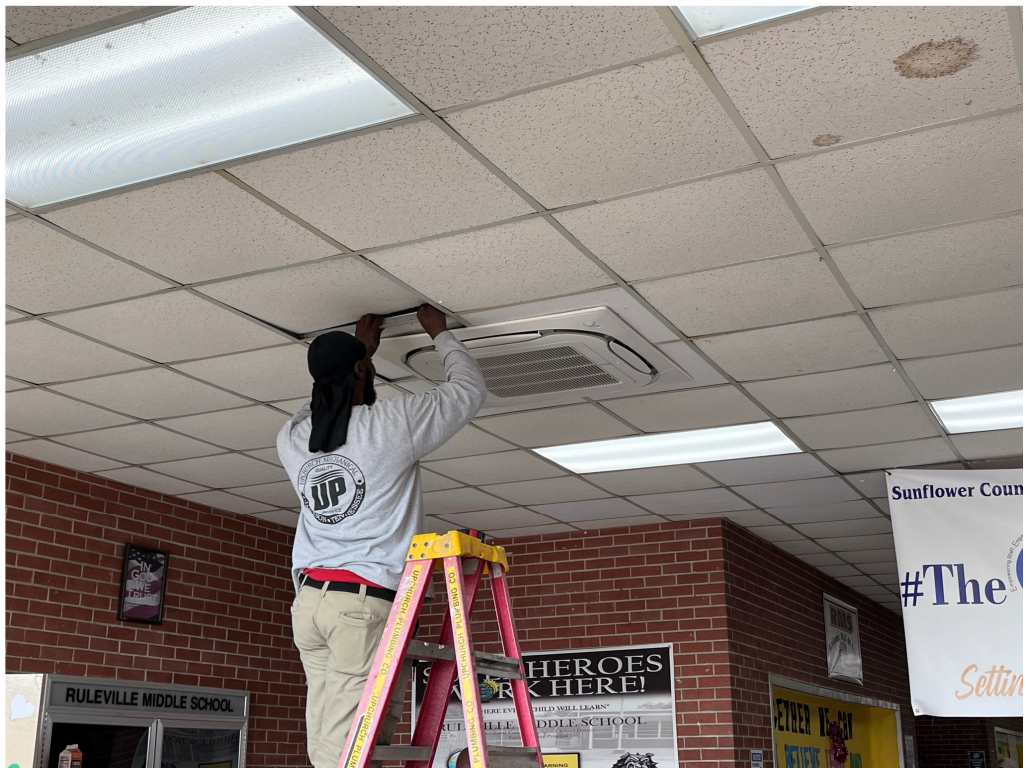
Figure 12 – Cassette location at Ruleville Middle Lobby

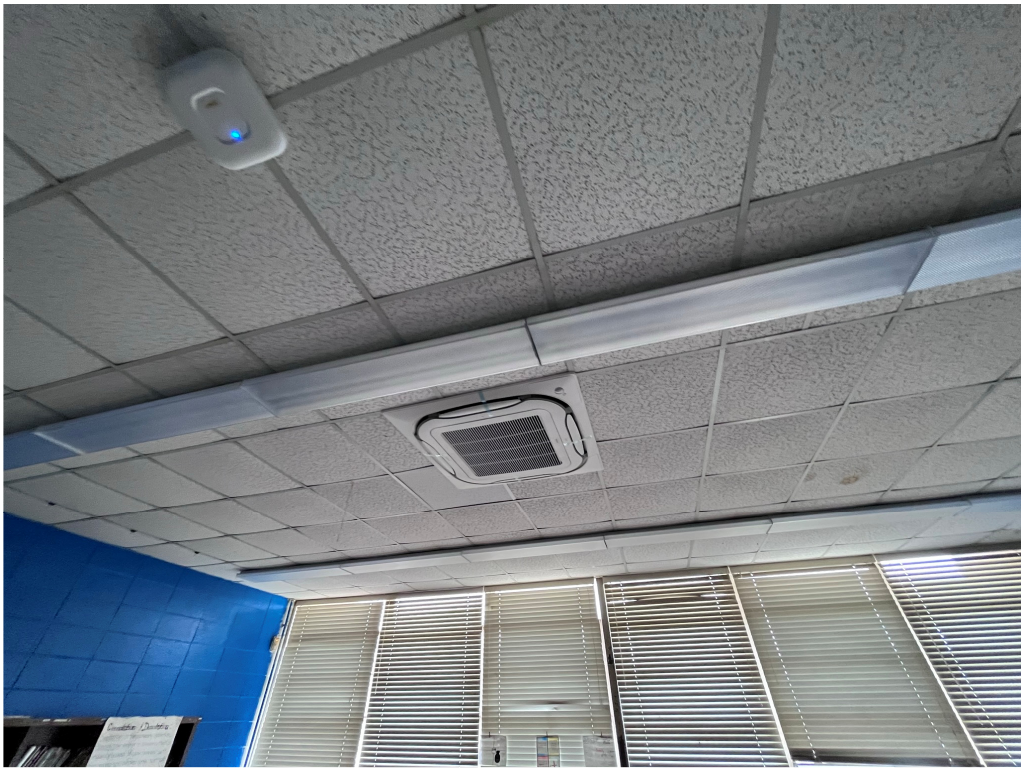
Figure 13 – Cassettes in Ruleville Middle are installed offset to avoid line of lighting

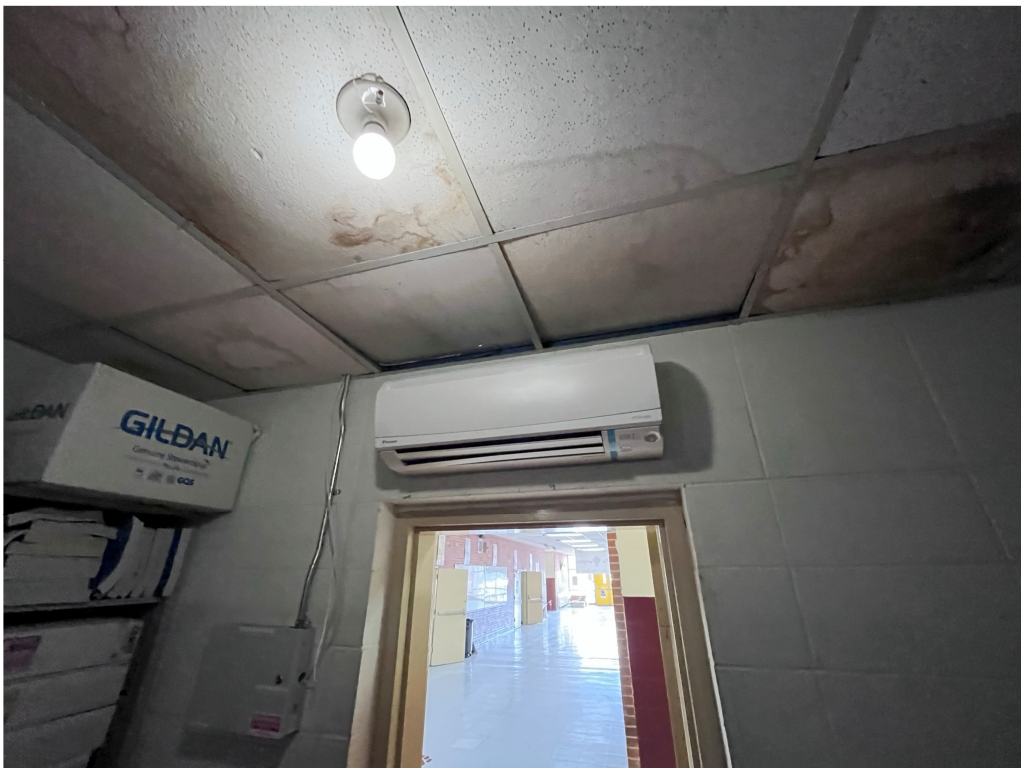
Figure 14 – Mounting height in low ceiling rooms (storage at Ruleville middle)

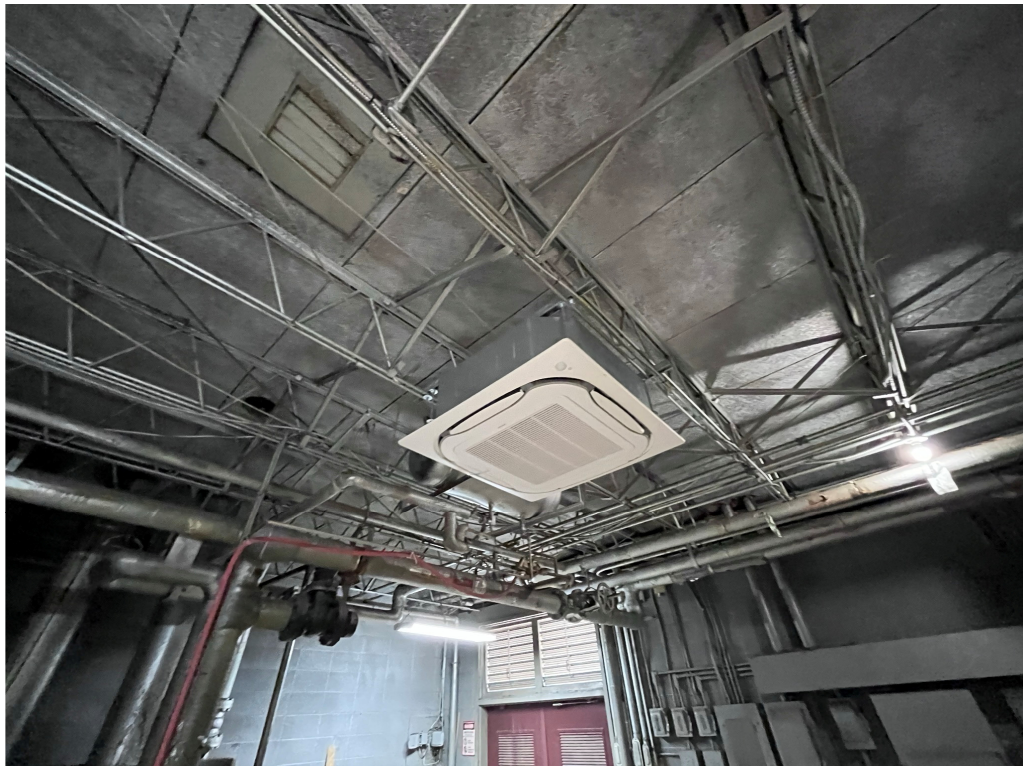
Figure 15 – Utility at Ruleville Middle cassette hung

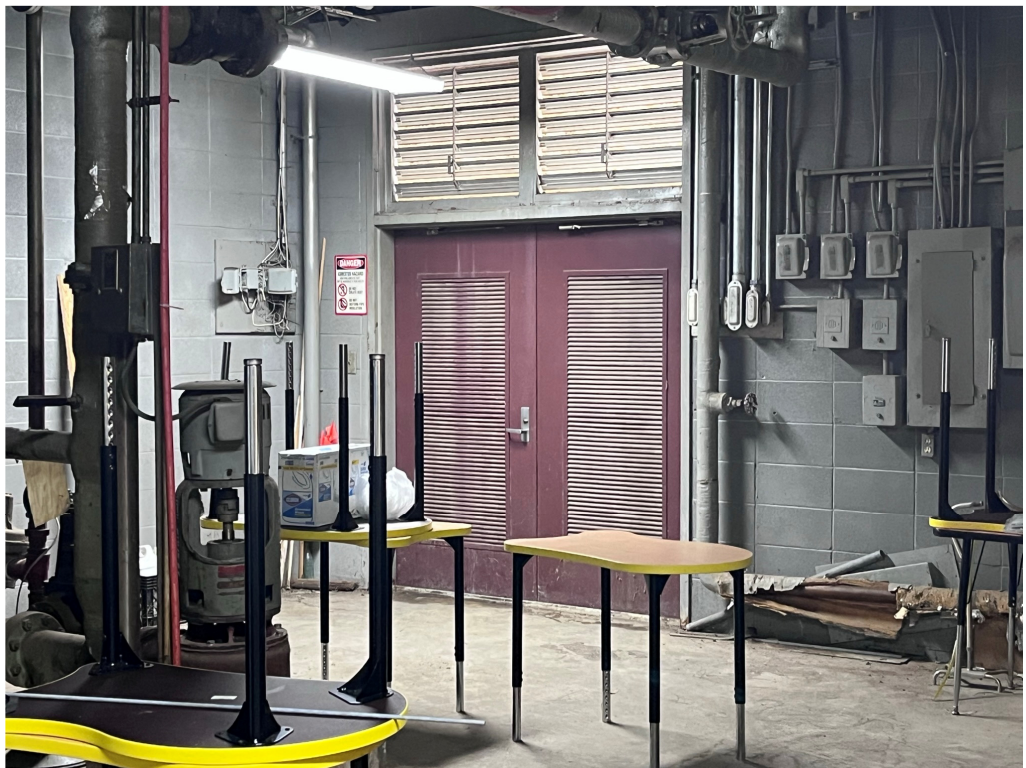
Figure 16 – Ruleville Middle Utility Room needs insulation if boiler no longer in use
