03 March 2023

21027 Sunflower Consolidated SD Phase I / Report Number 002

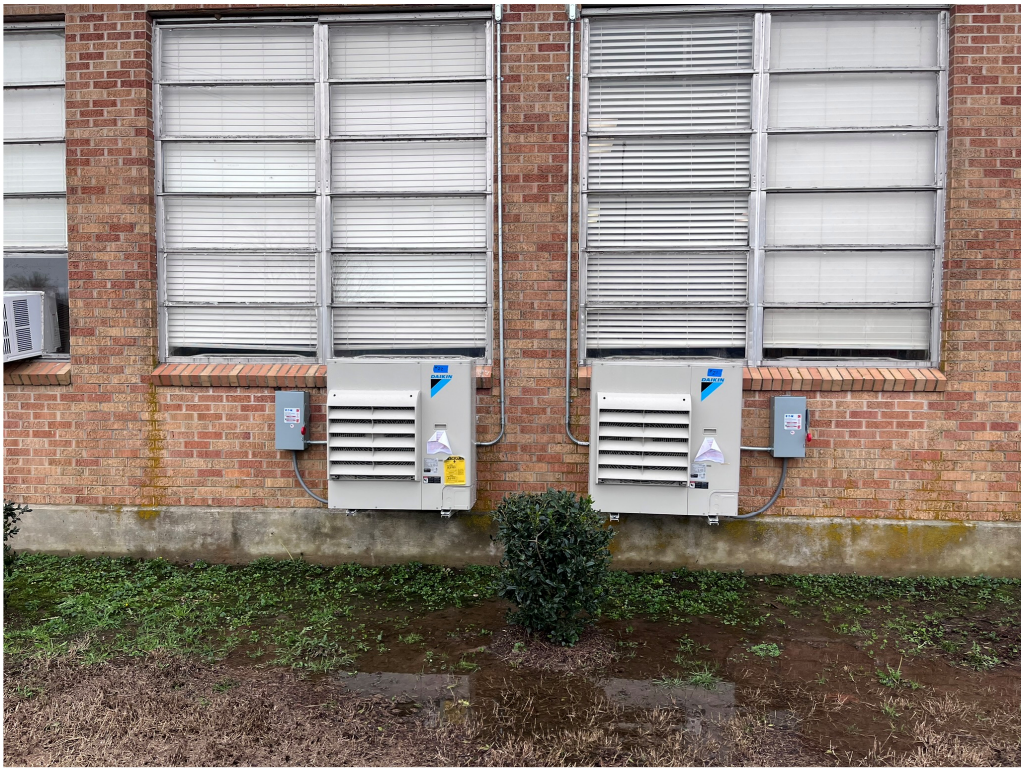
Figure 1 – Good Unit Install

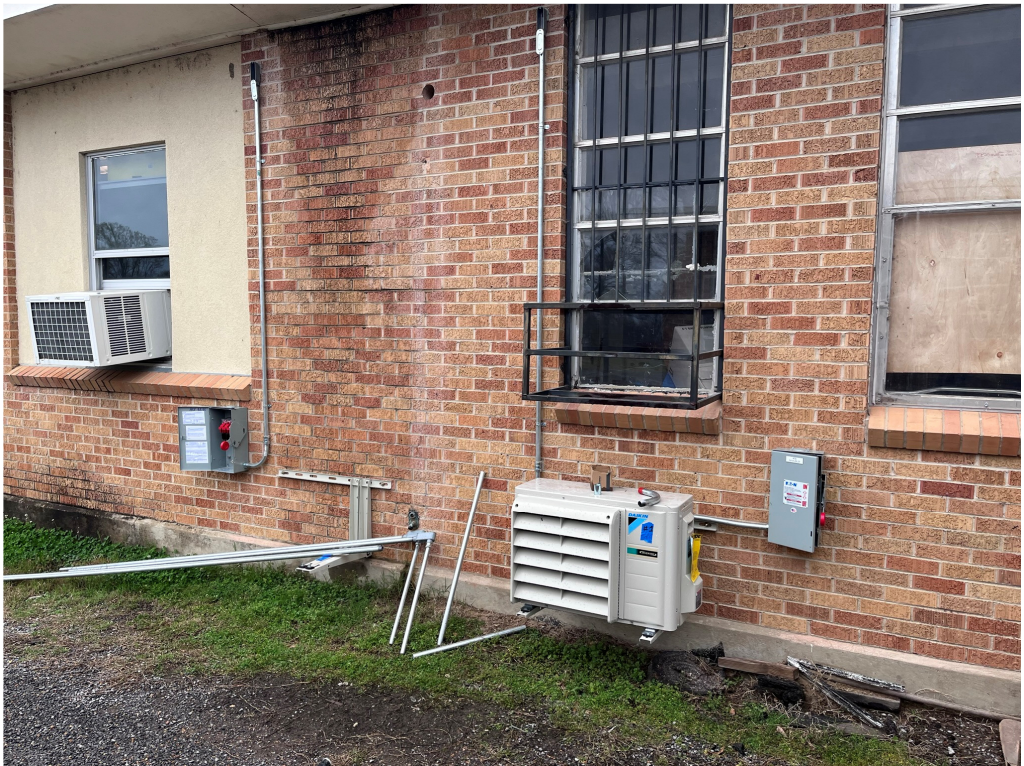
Figure 2 – Electrical Work is ongoing at Drew Hunter Middle

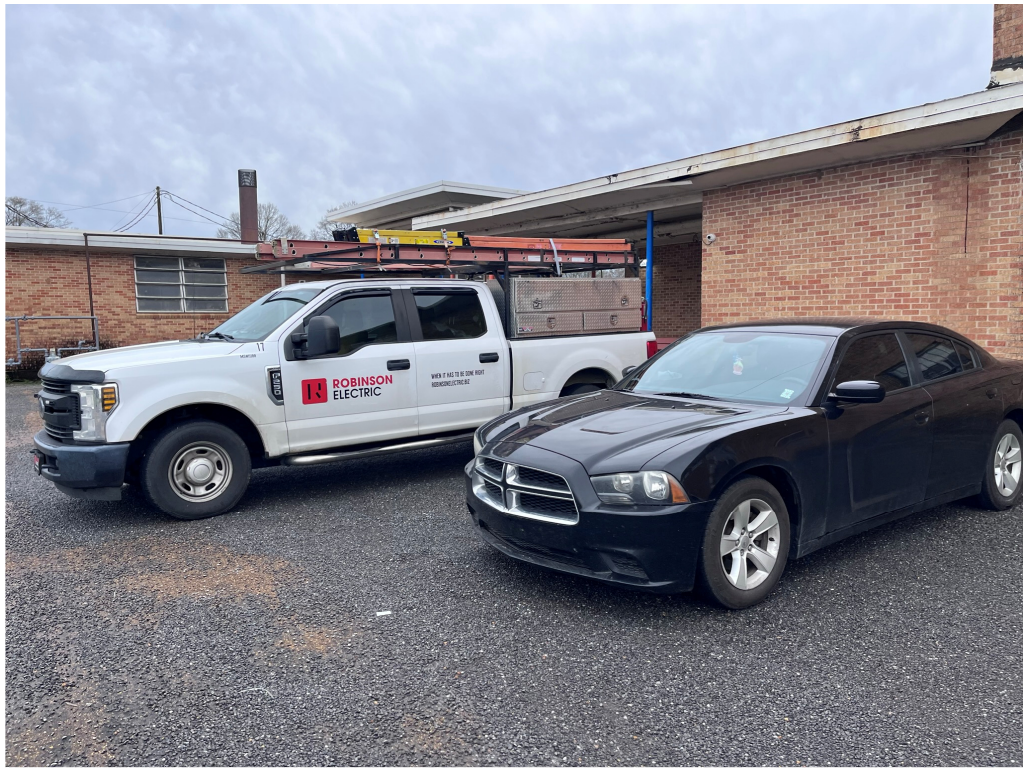
Figure 3 – Robinson Electric On site

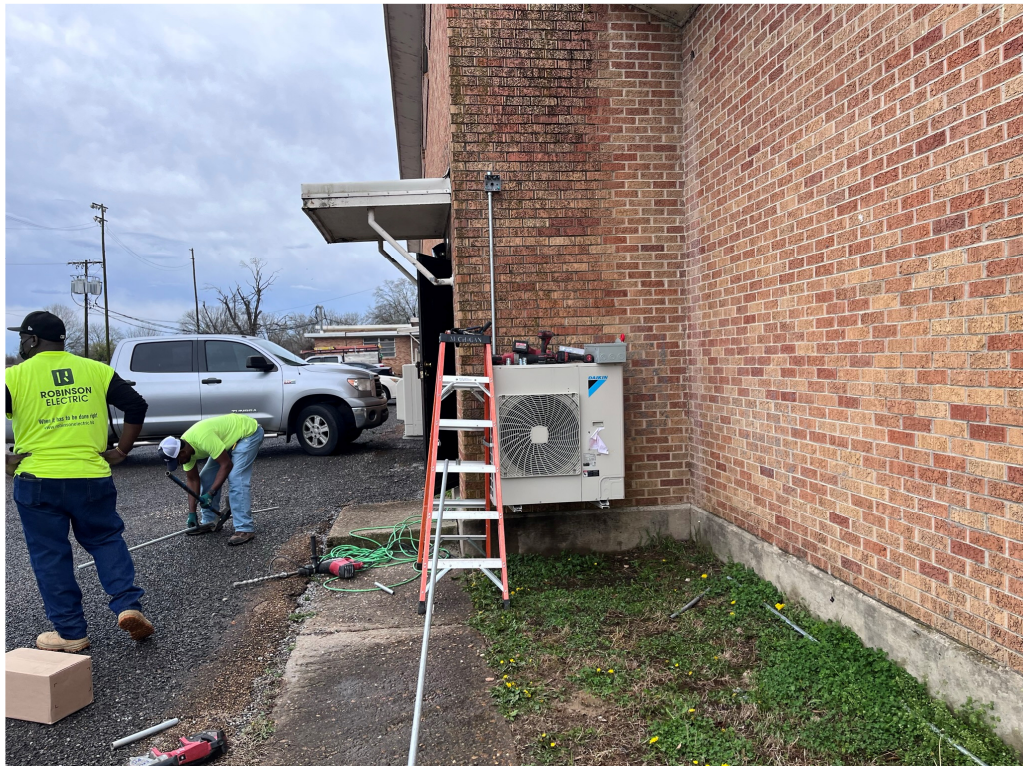
Figure 4 – Workers installing conduit

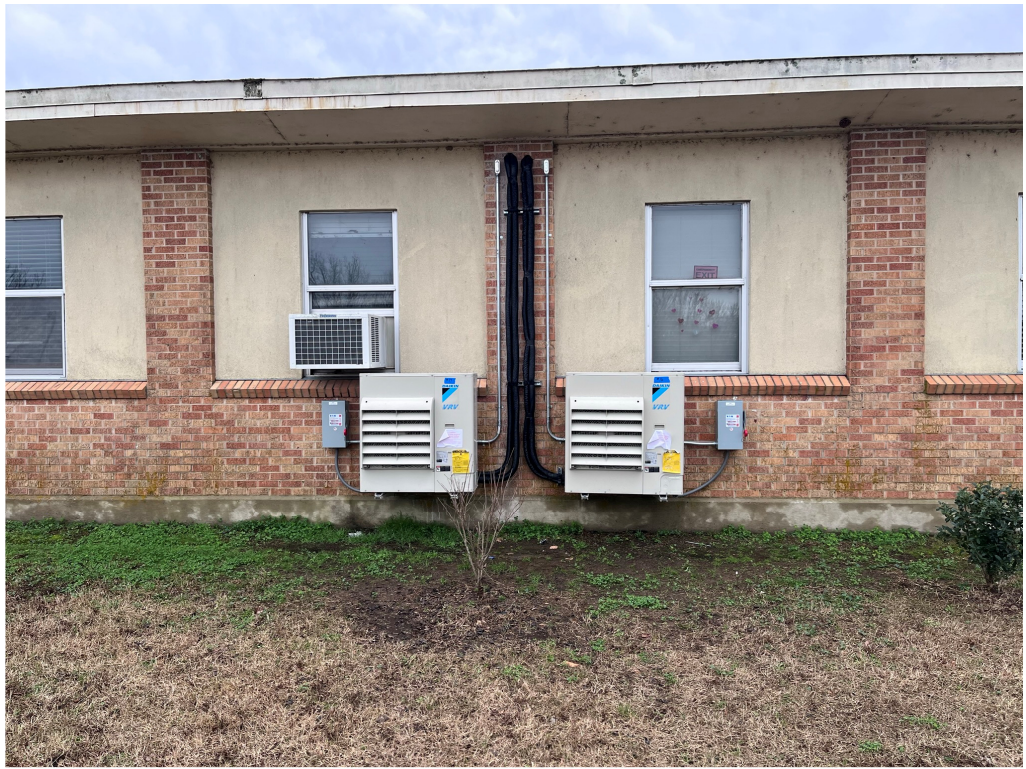
Contract	UpChurch Services, LLC
Date / Time	03 March 2023 / 11:30 AM
Weather / Temp	Drizzle / 70 ° F
Est % Complete	9%
Sched Conformance	+/- 00 days
Work in Progress	None
Present at Site	Robinson Electric Workers Paul Purser, DBA
Observations	On site at Drew Middle School, I reviewed exterior unit installs. There are quite a variety of units installed in good condition. Please pay attention to the levelness of units as they make a big impact on the look of the school. Many appear to be out of level, especially when viewed against the brick. Also, many units are installed per the reviewed diagram for this site, but several are set haphazardly and need to be adjusted. Units should be aligned with brick jamb edges on windows per the reviewed submittal. If singular, they can be centered or aligned (see figure 7). If units cannot be aligned with brick jamb edges, they should be set equal distance on either side of brick jambs at windows (see figures 5&6).

Figure 5 – Unit ARE lined up equal distance from brick edges and this is acceptable

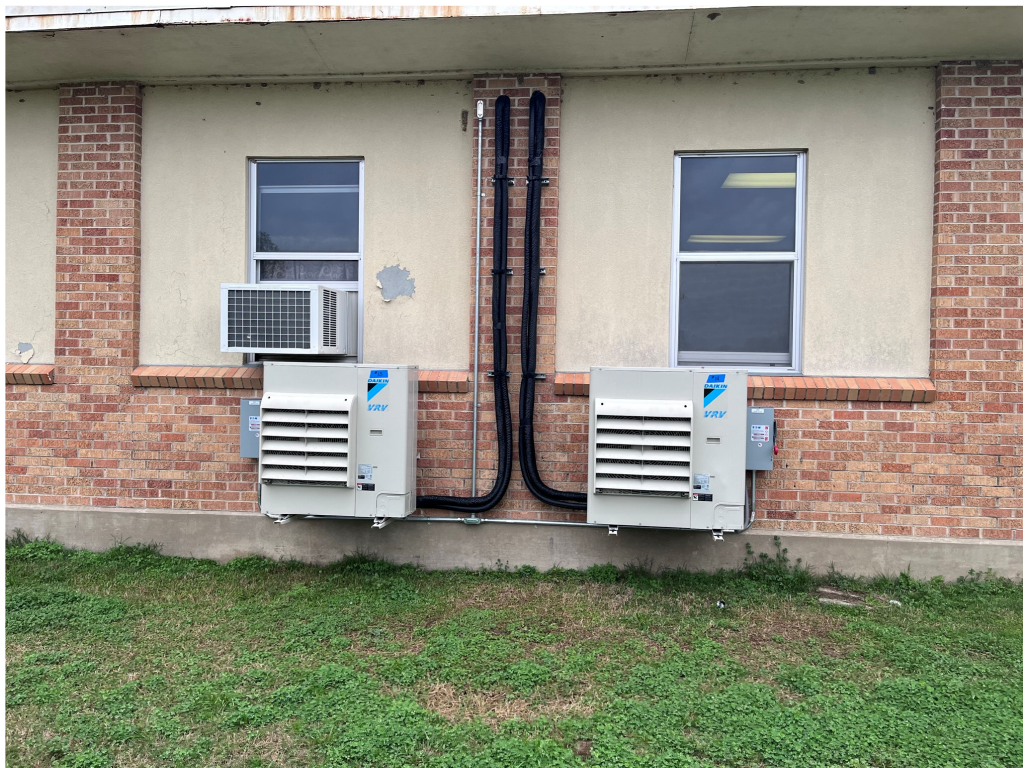
Figure 6 – Units ARE NOT lined up as in submitted diagram; this is not acceptable

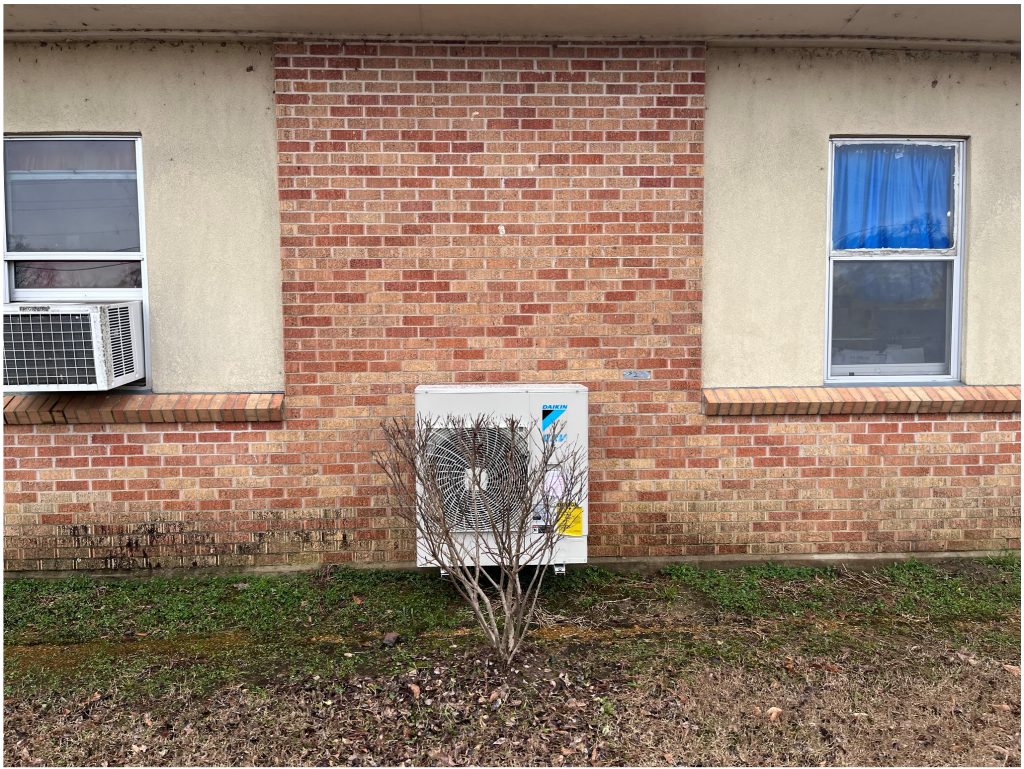
Figure 7 – Unit Centered is good install

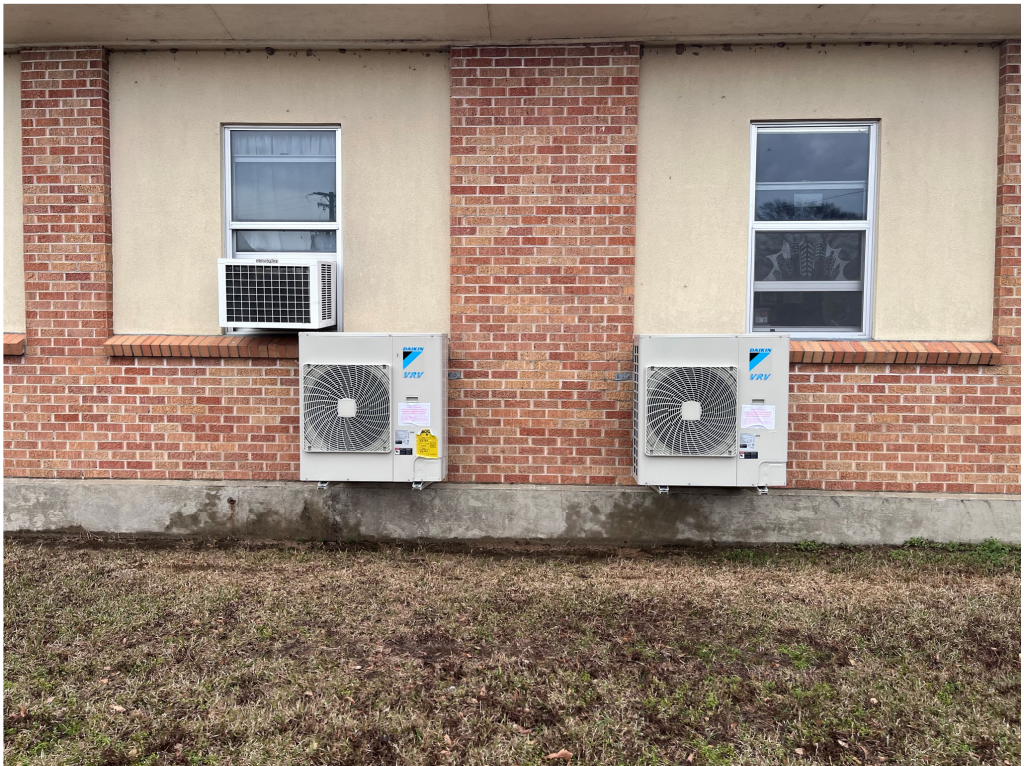
Figure 8 – Units lined up with brick edges are good installs

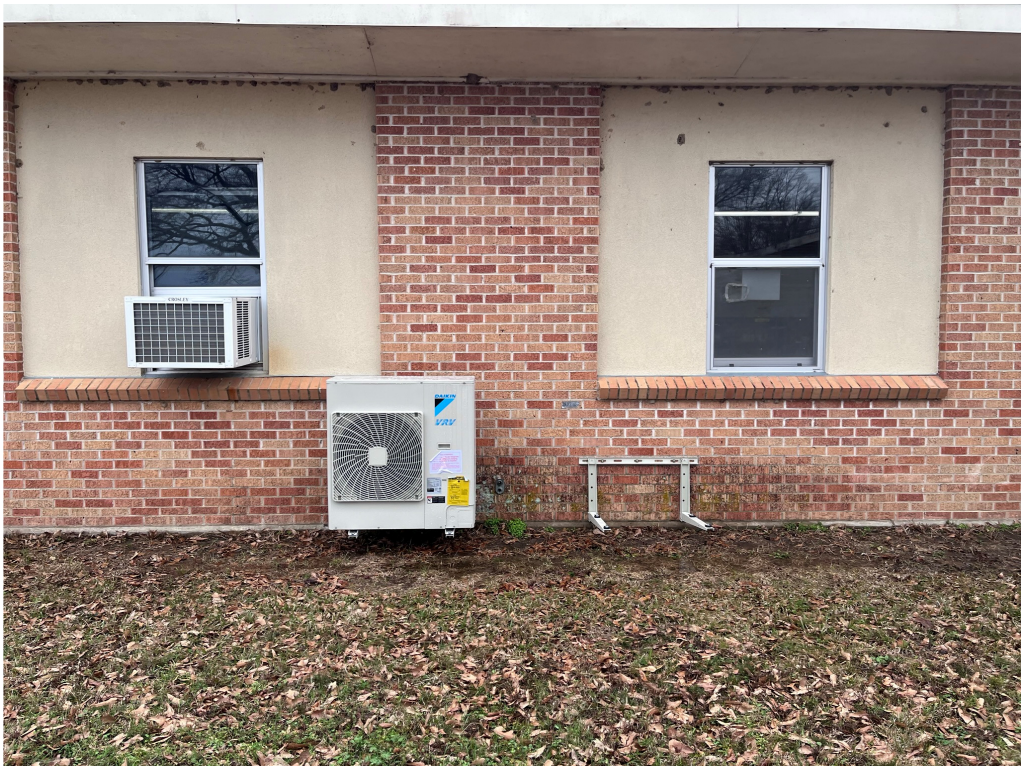
Figure 9 – Unit mis-aligned are not acceptable

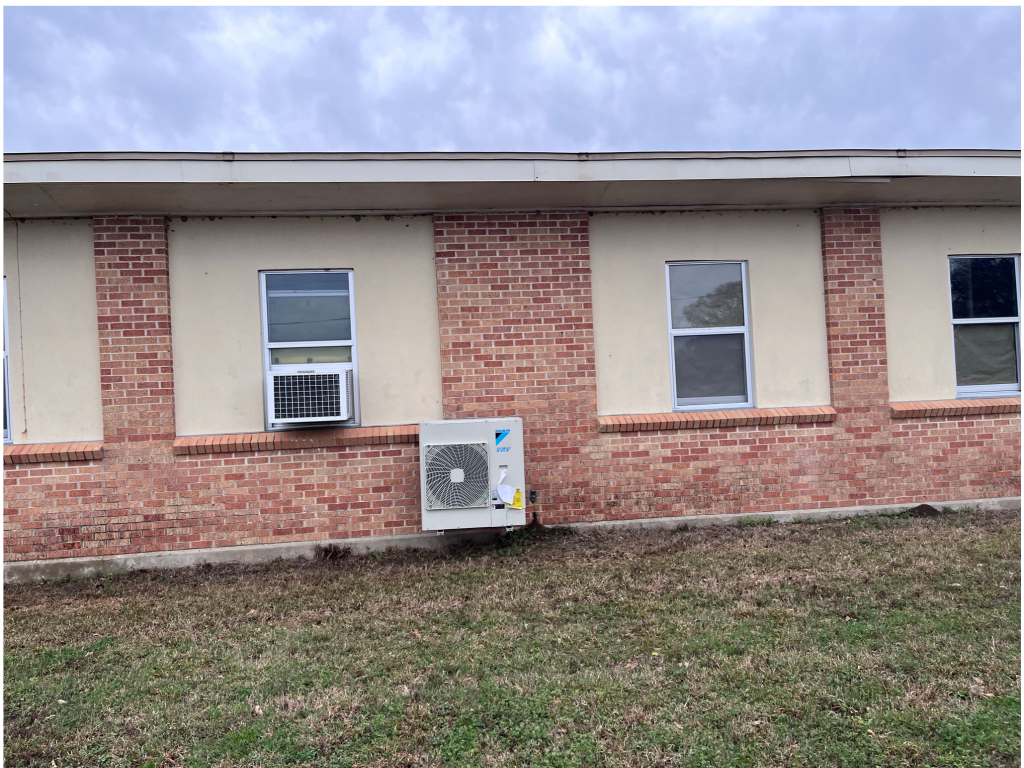
Figure 10 – Unit not centered or aligned on brick is not acceptable
