11 October 2023

21027 Sunflower County Consolidated SD Phase I / Report Number 007

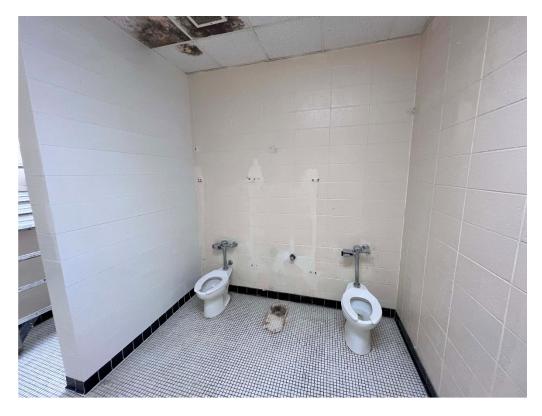
Figure 1 – grout lines should be aligned with horizontal cmu mortar lines

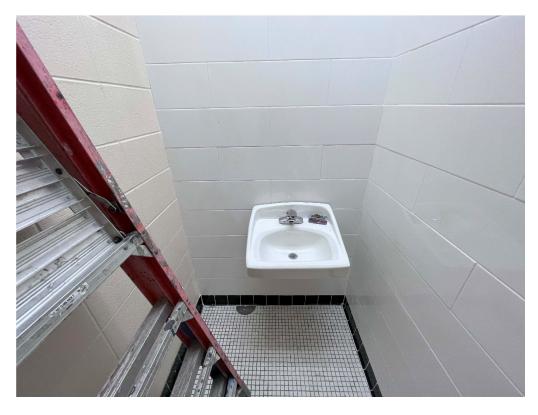
Figure 2 – remove and center fixture in space

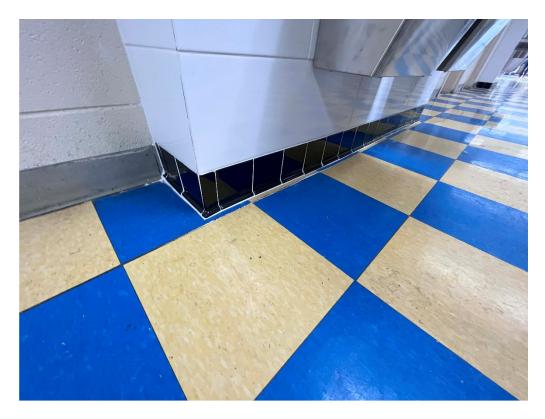
Figure 3 – specified grout is to be midnight black; replace

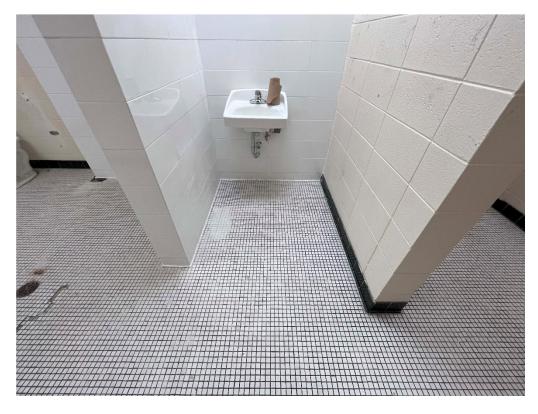
Figure 4 – lavatories should be centered in space; remove and install centered

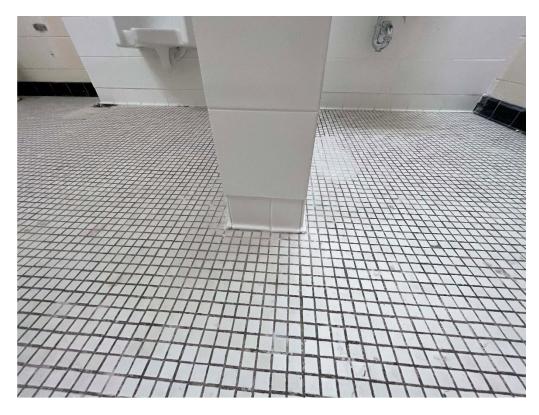
Figure 5 – Base Cove tile should be black and installed flush with wall tile

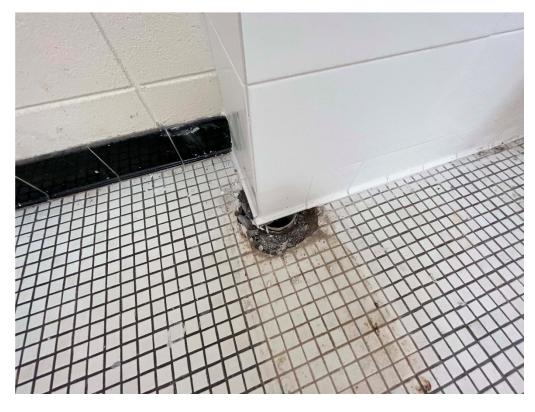
Figure 6 – Open sewer pipe should be capped below floor and sealed

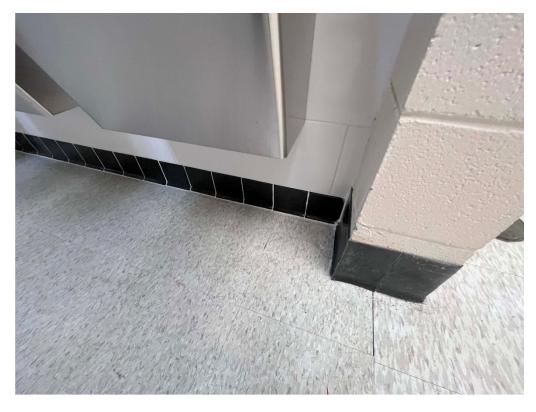
Figure 7 – specified grout for black tile is midnight black

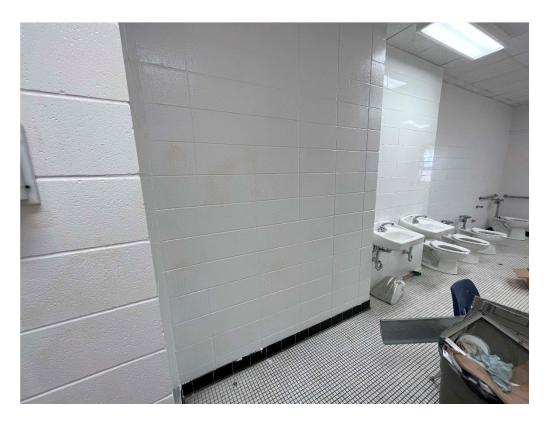
Figure 8 – 1 coat of paint

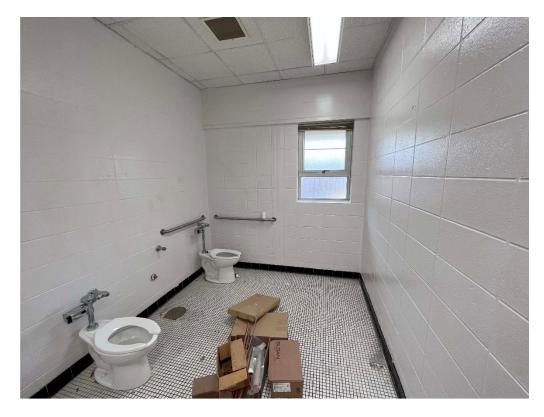
Figure 9 – Painted 1 coat only

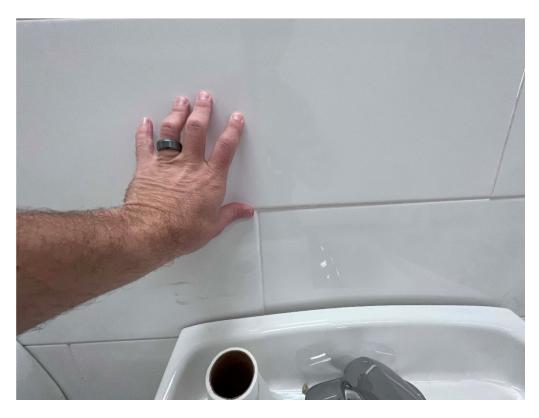
Figure 10 – Tiles throughout are not acceptable. They should be flush

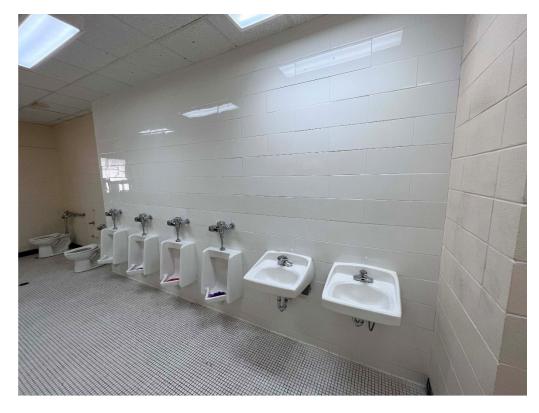
Figure 11 – This tile wall is not acceptable. Tiles should be flush and flat

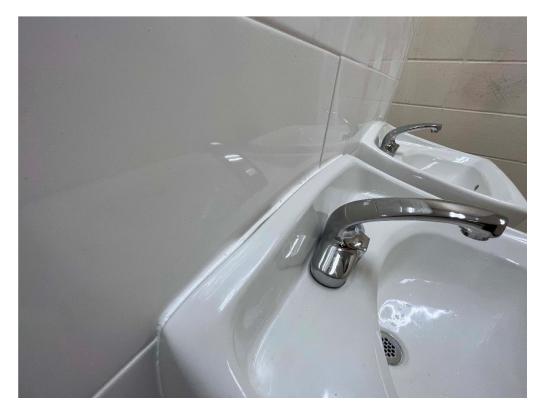
Figure 12 – Completely Fill gaps so that sealants has no recess
