02 November 2022

21081 Sunflower Consolidated SD Phase II / Report Number 002

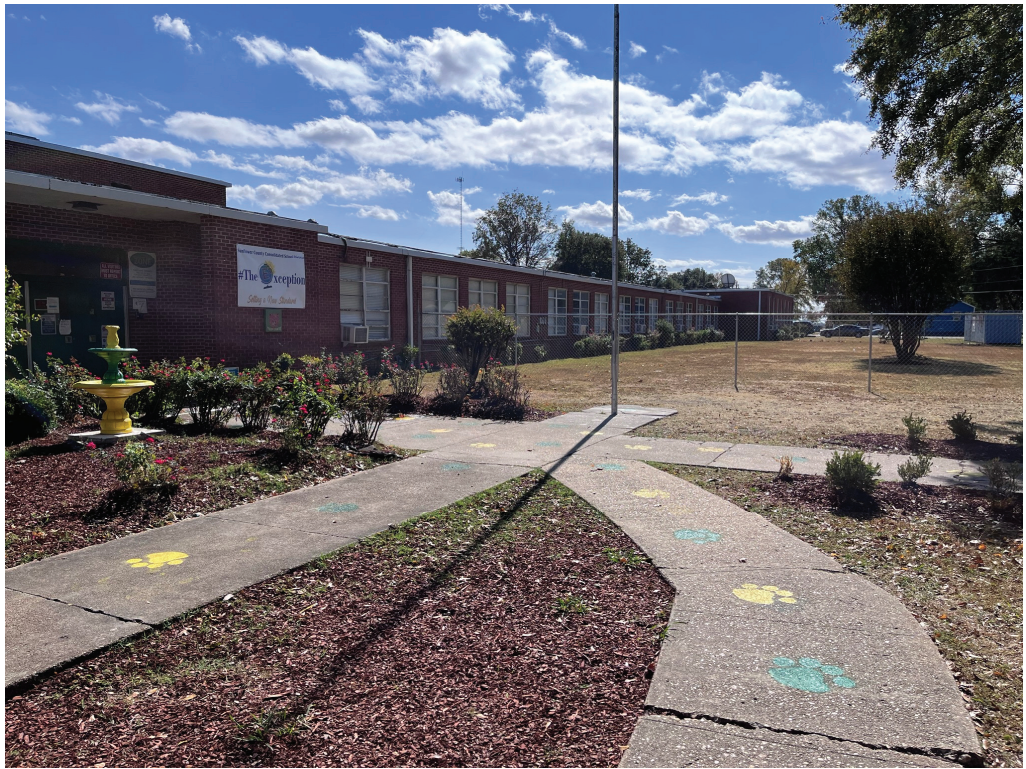
Observations On site at Thomas Edwards, I noted temporary construction fence has been erected. A storage container has been located near the project signage. This fencing is not secured but also construction has not begun. When demo begins, this fencing should be maintained and secured, always.

Figure 1 – Construction Fencing

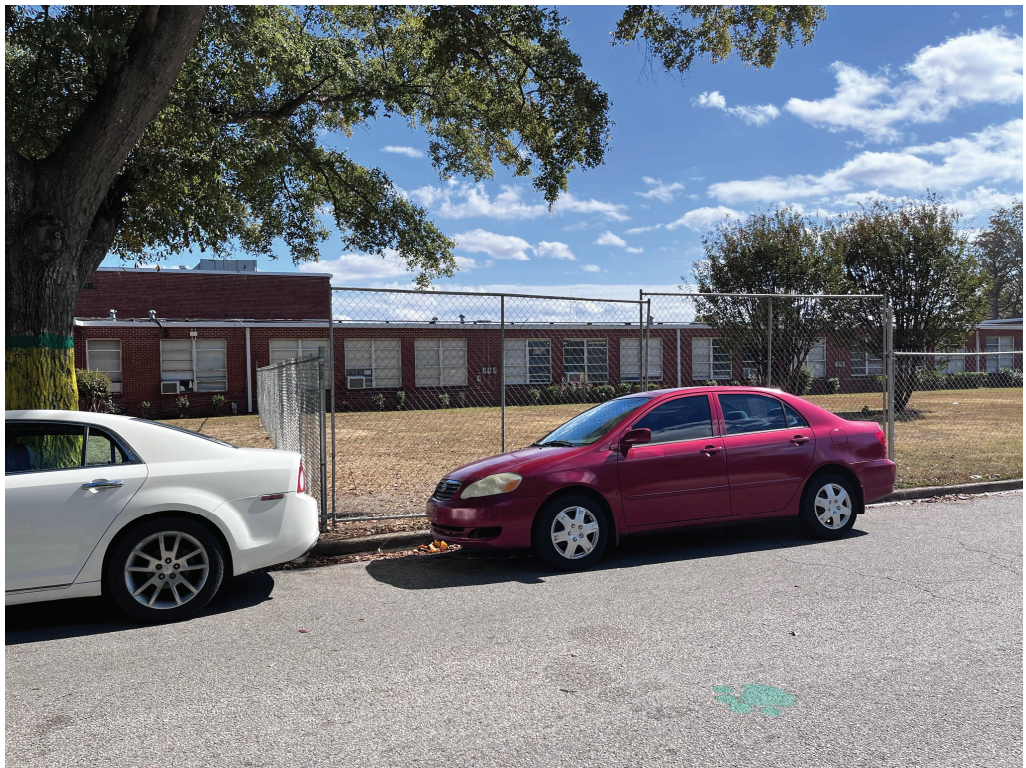
Figure 2 – Construction Fencing

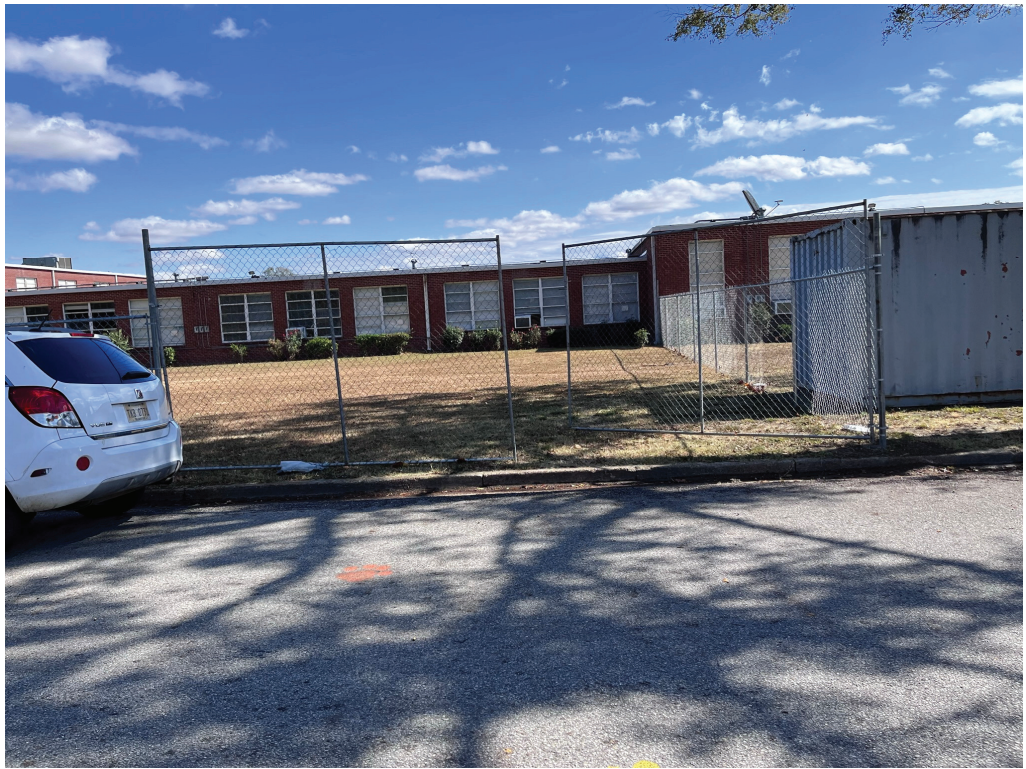
Figure 3 – Construction Fencing not Secured

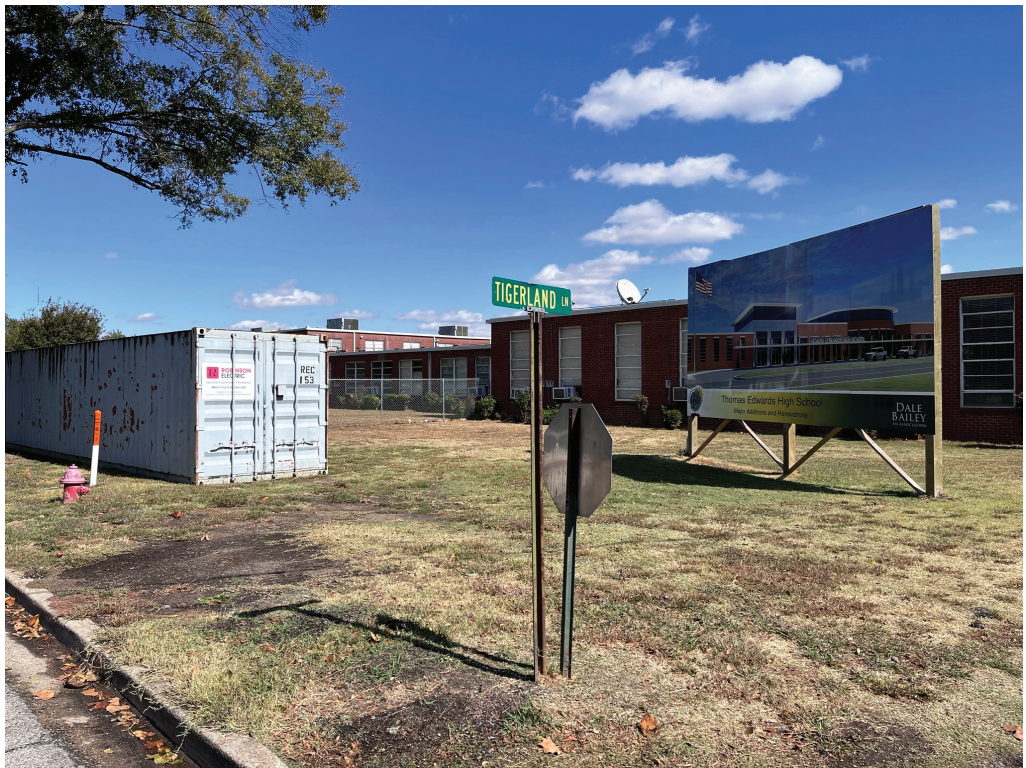
Figure 4 – Storage Container on Site at Edwards

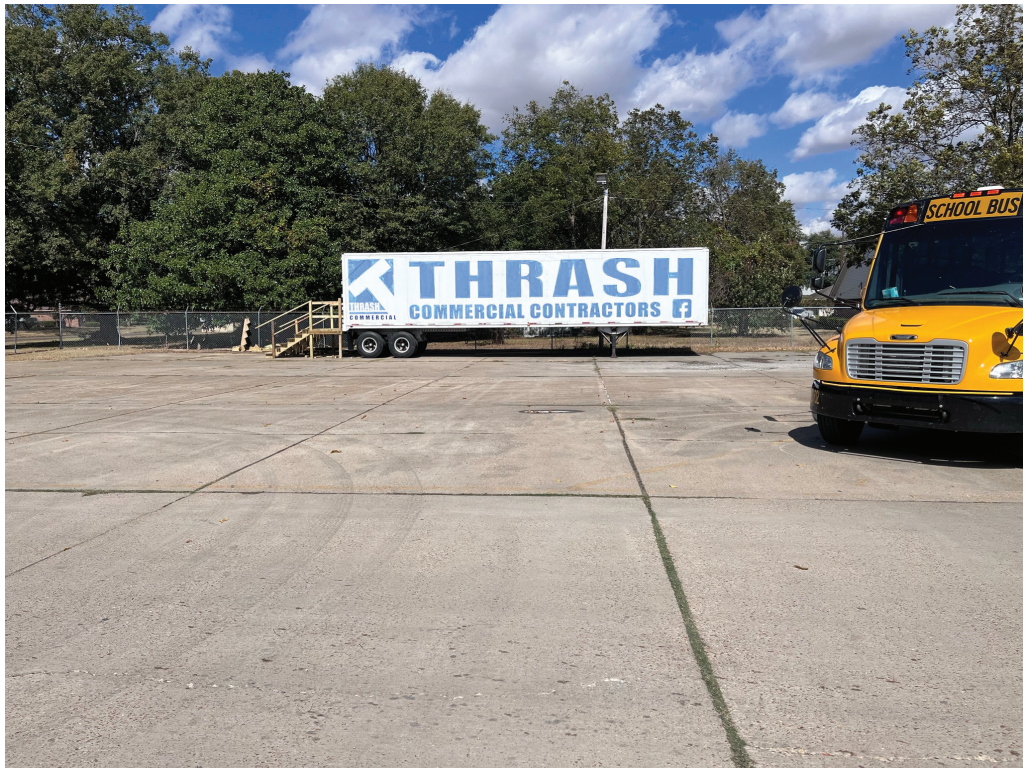
Figure 5 – Contractor Signage

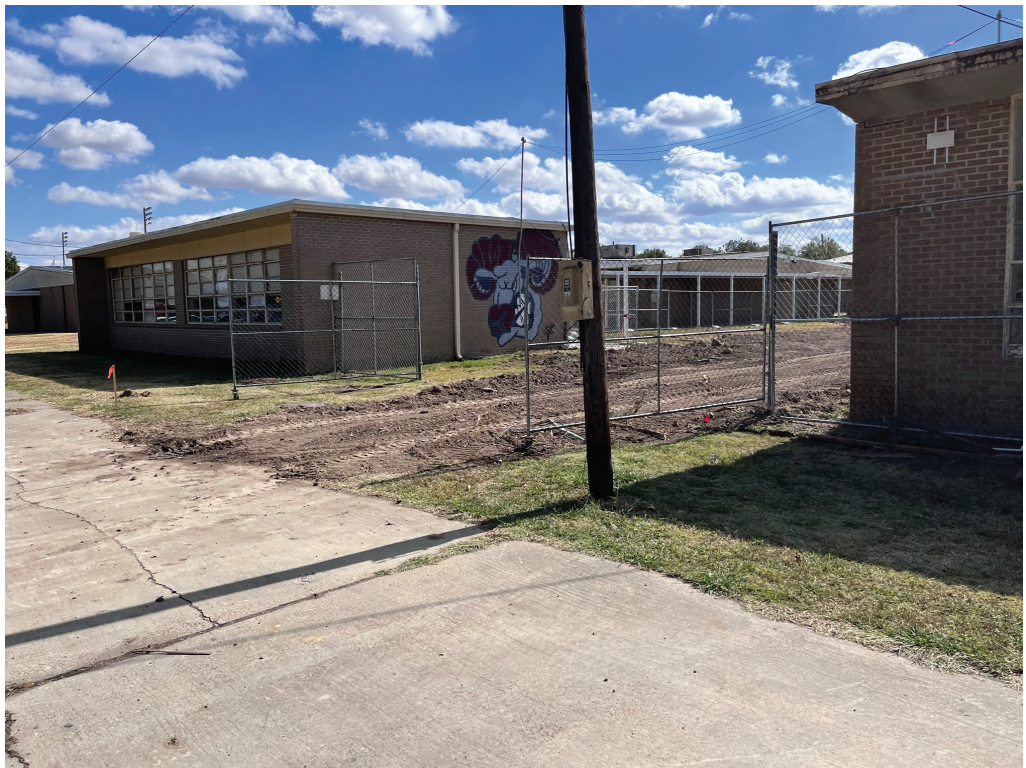
Figure 6 – Main Construction Entry to Yard

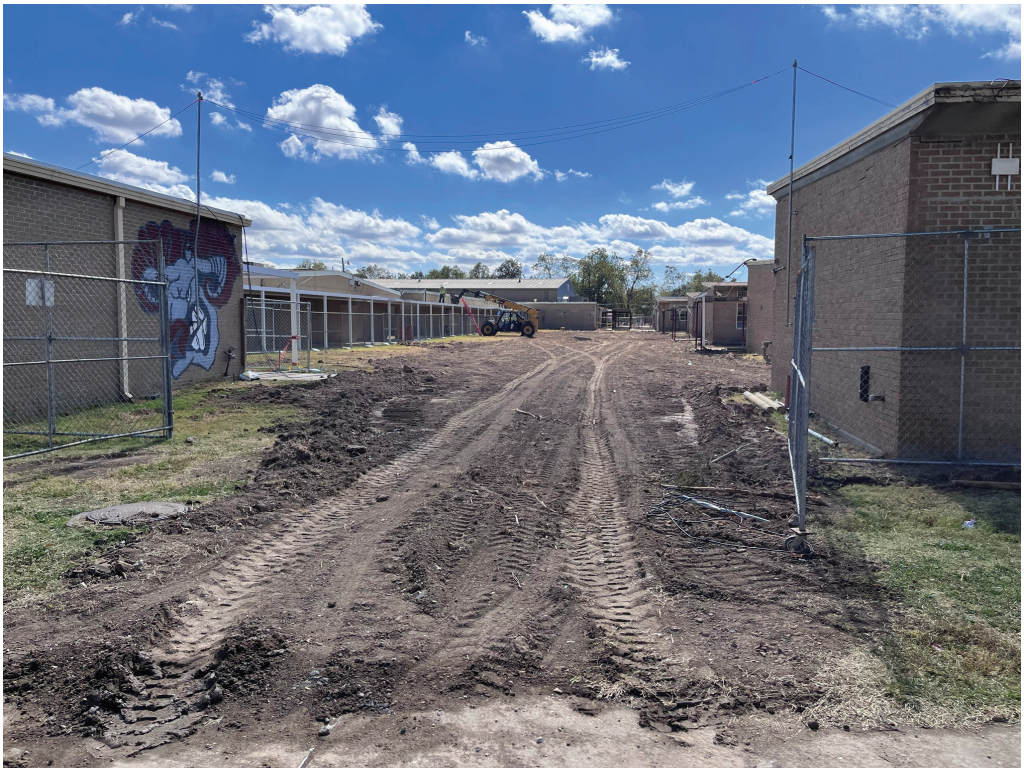
Figure 7 – Main Construction Entry to Yard

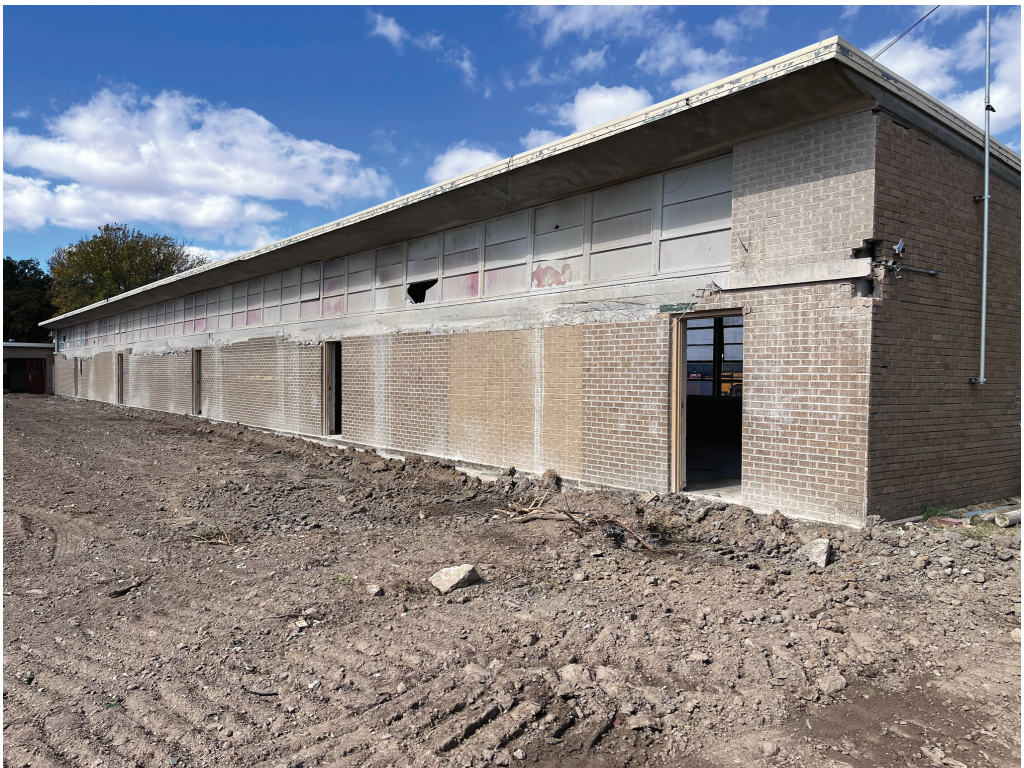
At Gentry, I entered the main courtyard. New work has been performed at the existing north building to remain. The concrete awning has been removed by a clean saw cut.

Figure 8 – Saw Cut Work at Building to remain

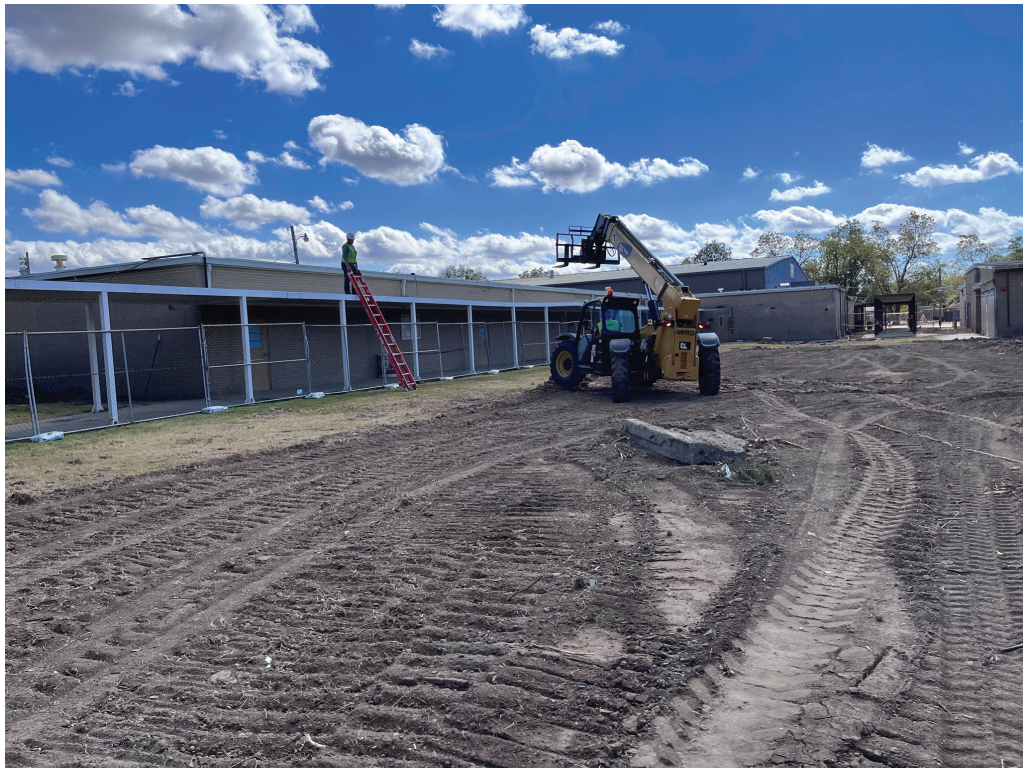
Figure 9 – Workers at Middle Yard

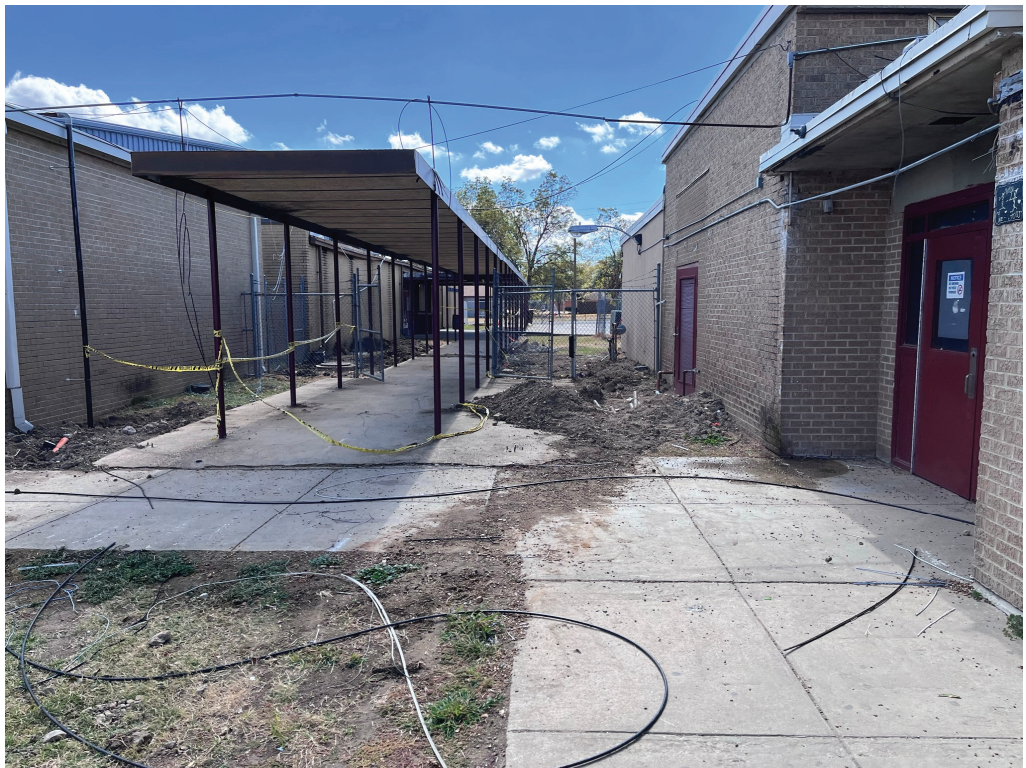
Figure 10 – Ongoing Service Work

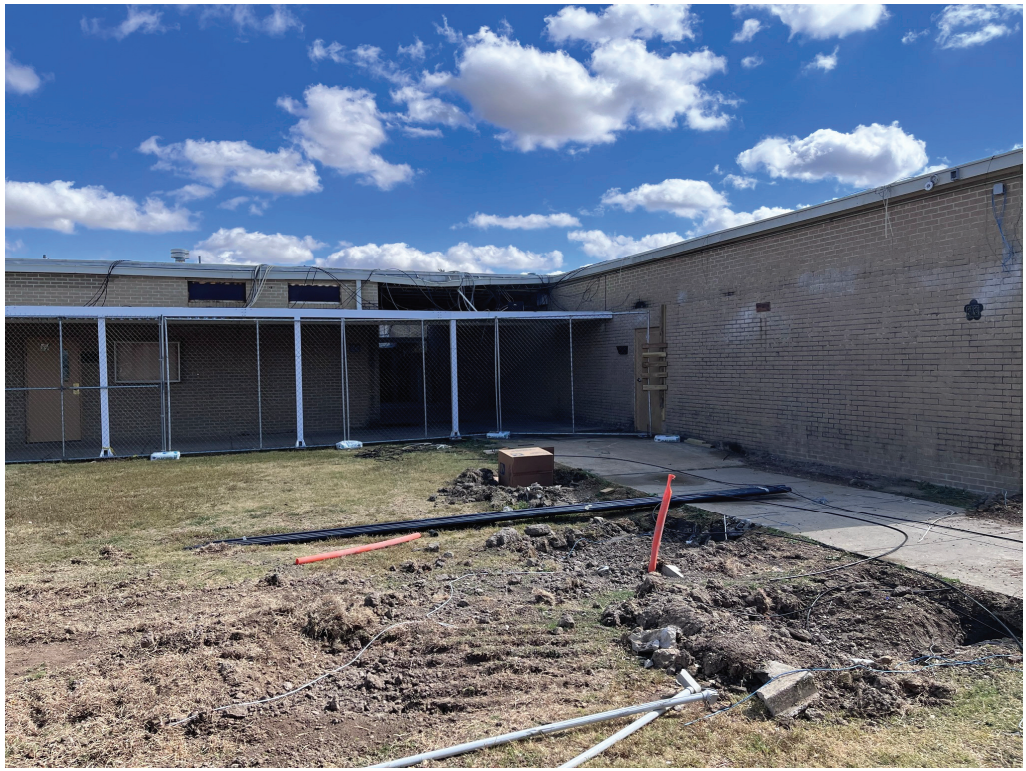
Figure 11 – Ongoing Service Work

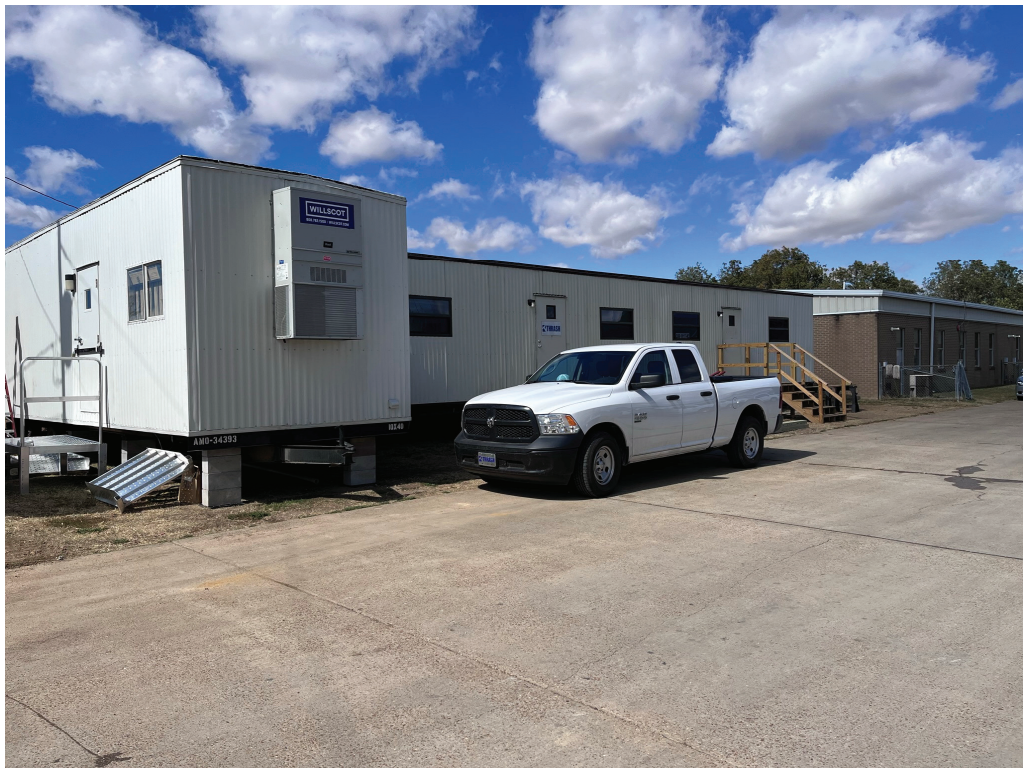
Figure 12 – Job Trailers

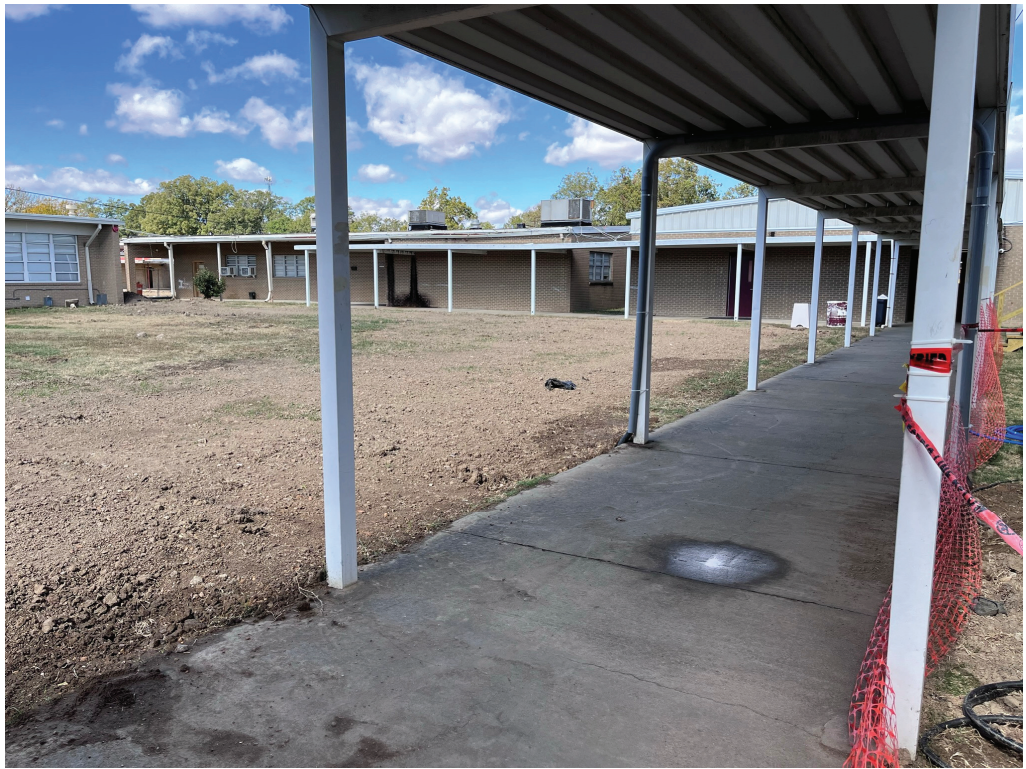
Figure 13 – East courtyard by Job Trailer

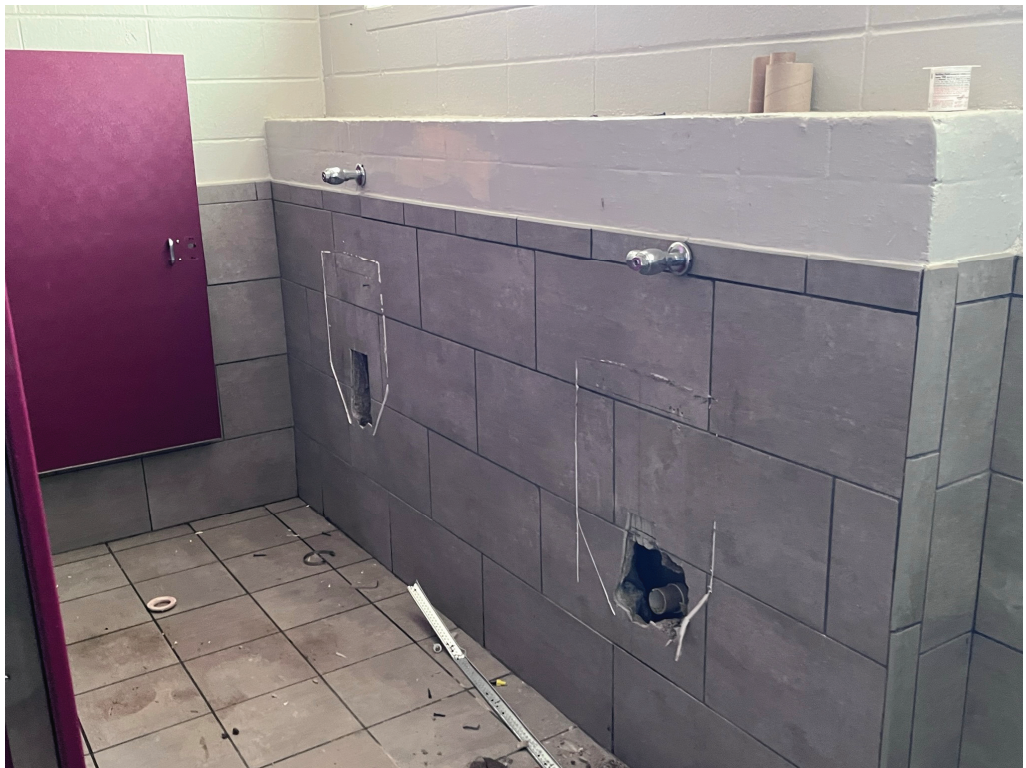
Figure 14 – Fixtures removed per Alternate 8

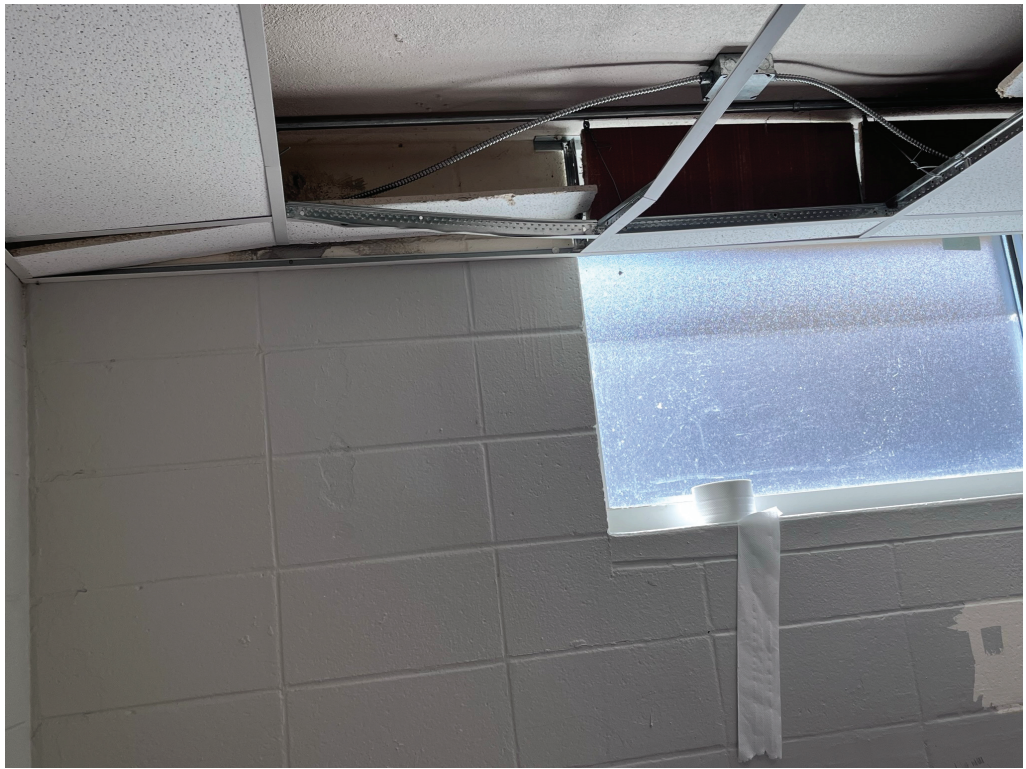
Figure 15 – Ceiling Grid Damage at Grid to remain

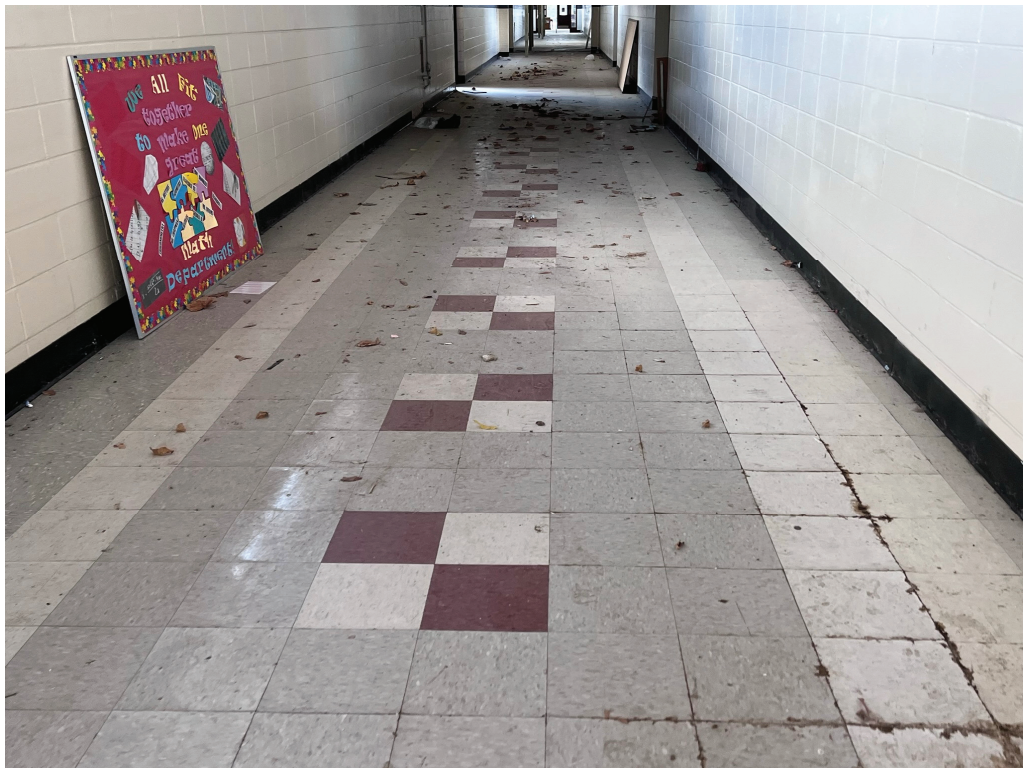
Figure 16 – Hall to remain

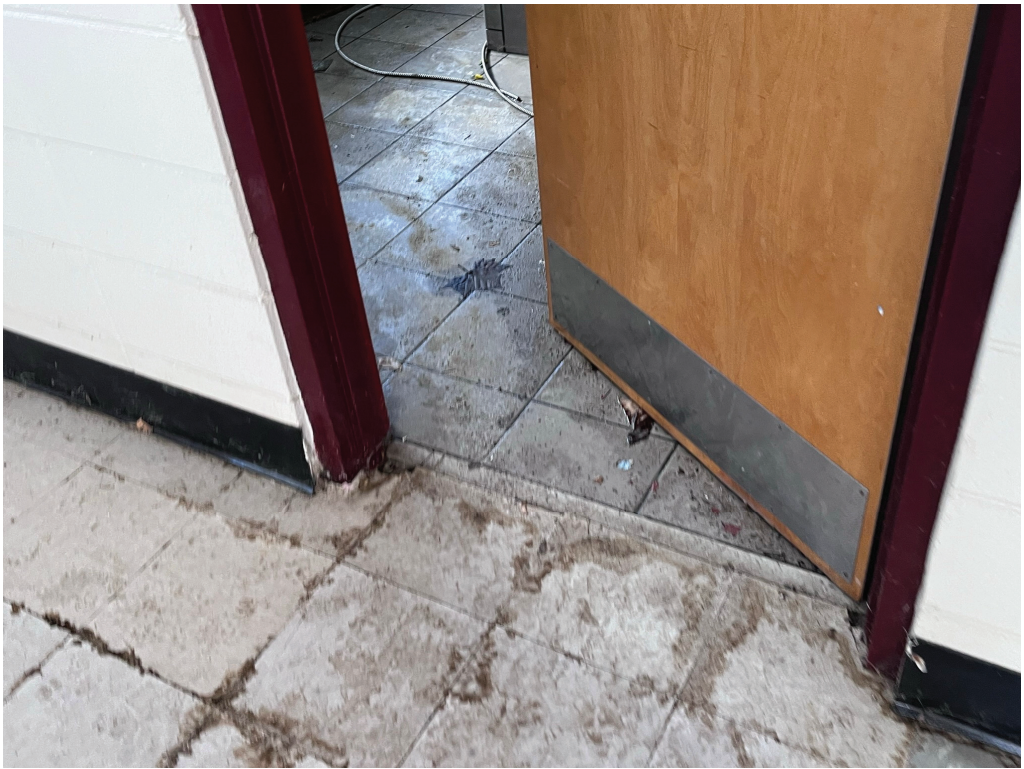
I walked the west hall to remain. Some demo work has been performed in the toilet rooms connected to this hall. There is some damage to finished in these rooms that are to remain and will need to be repaired by the contractor.

Figure 17 – Damage to unprotected Finishes to remain shall be repaired by contractor

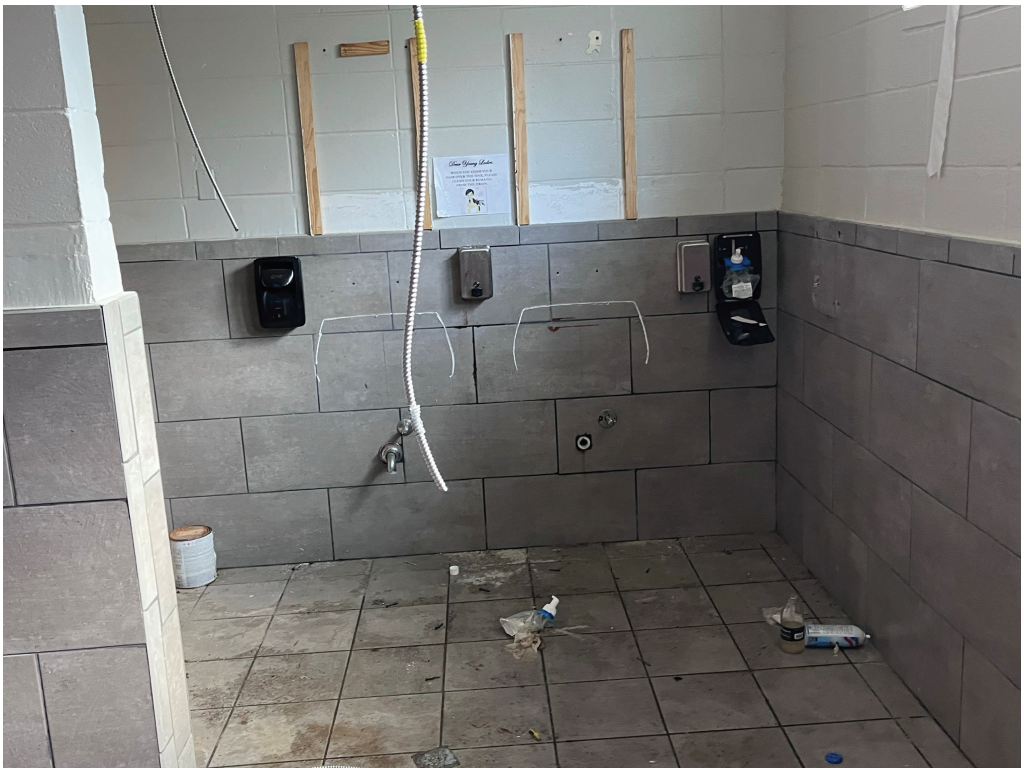
Figure 18 – Damage to unprotected Finishes to remain shall be repaired by contractor

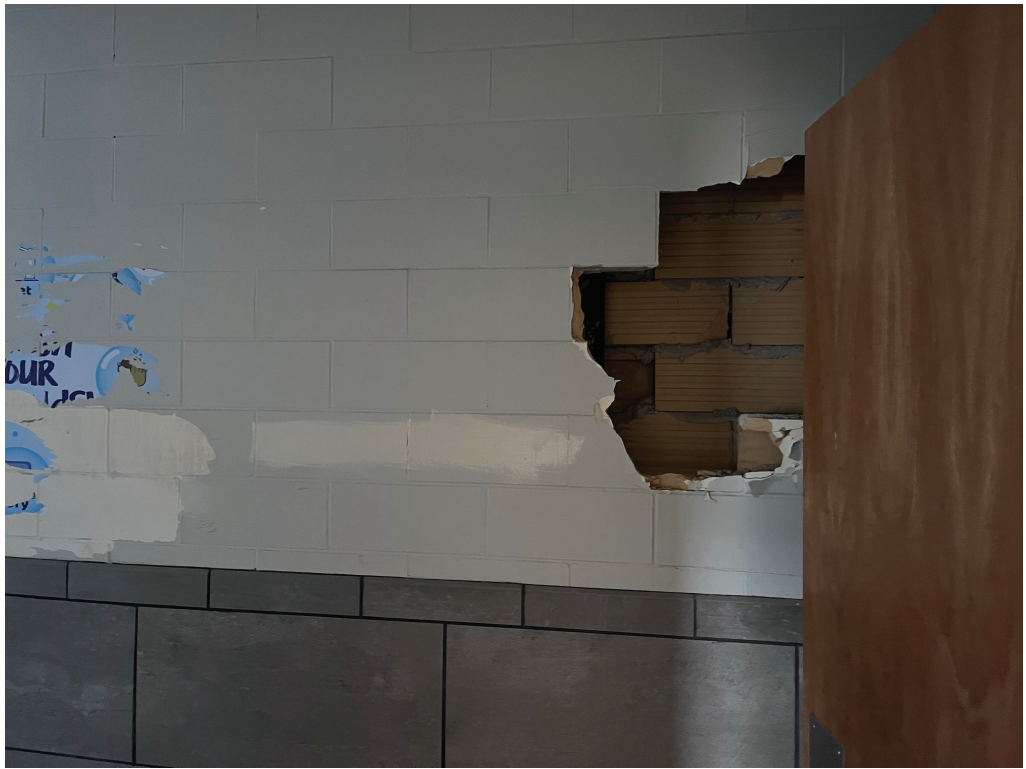
Figure 19 – Damage to unprotected Finishes to remain shall be repaired by contractor

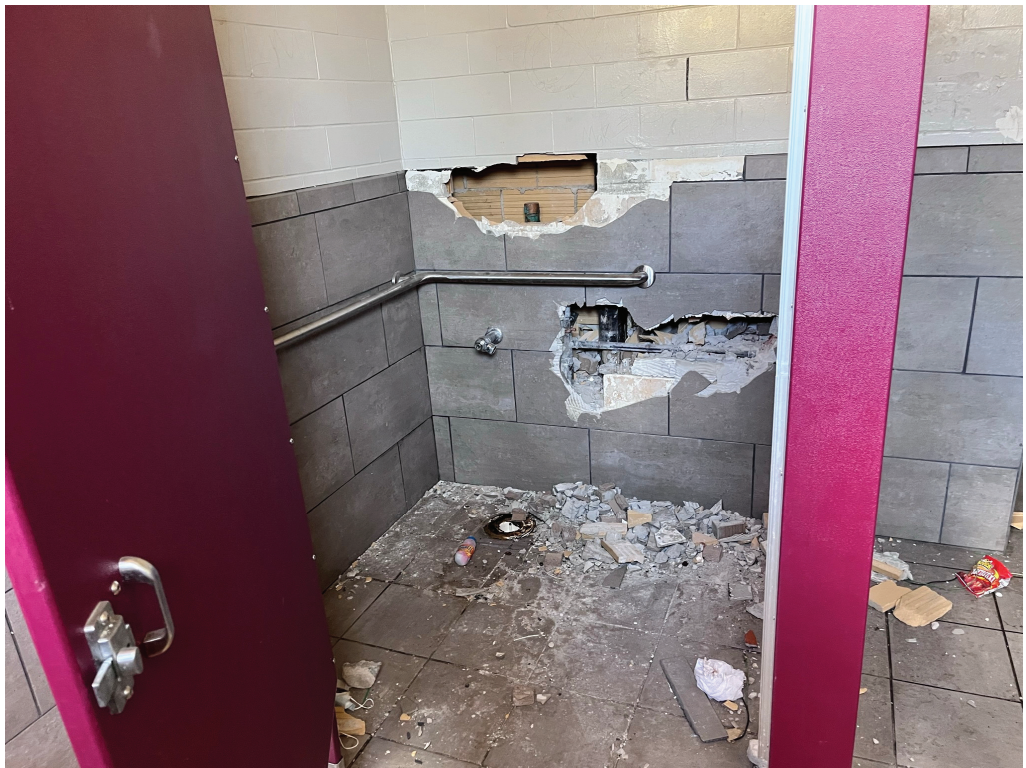
Figure 20 – Damage to unprotected Finishes to remain shall be repaired by contractor

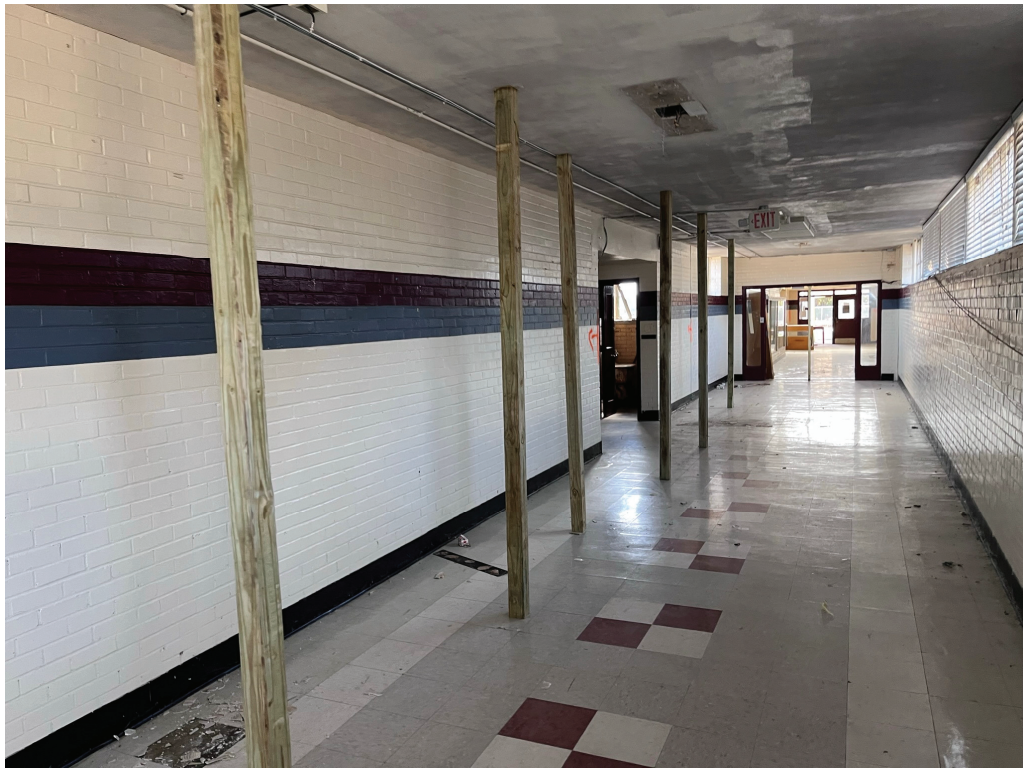
Figure 21 – Temporary posts Installed

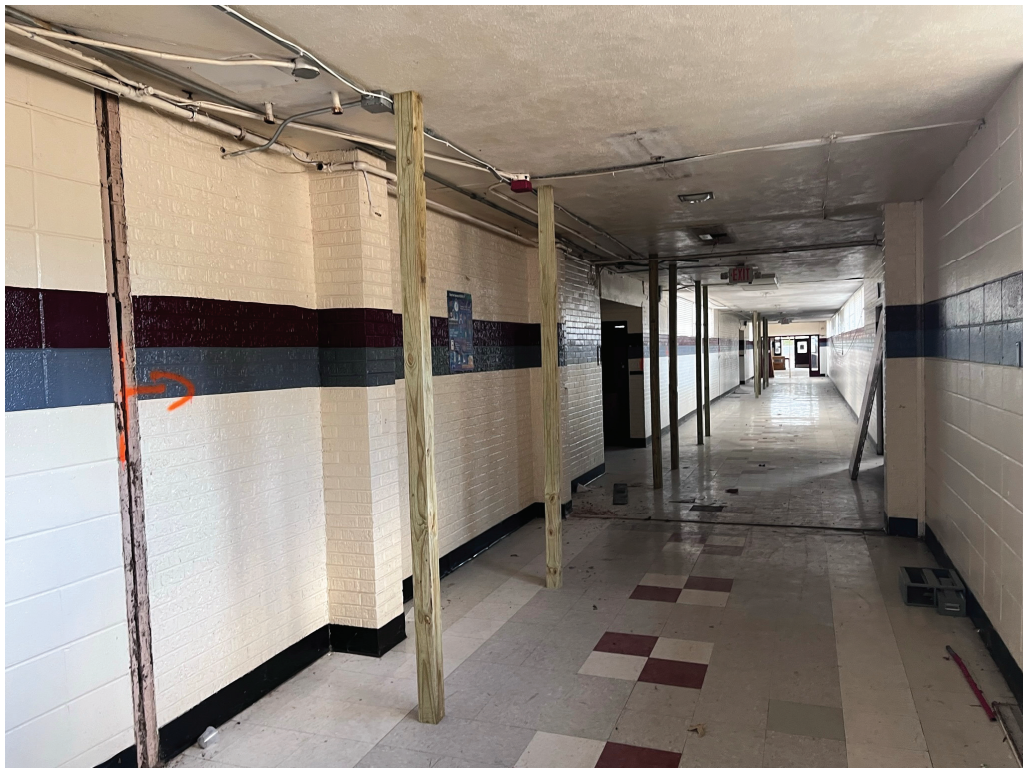
Figure 22 – Temporary posts Installed
