04 January 2023

21081 Sunflower Consolidated SD Phase II / Report Number 003

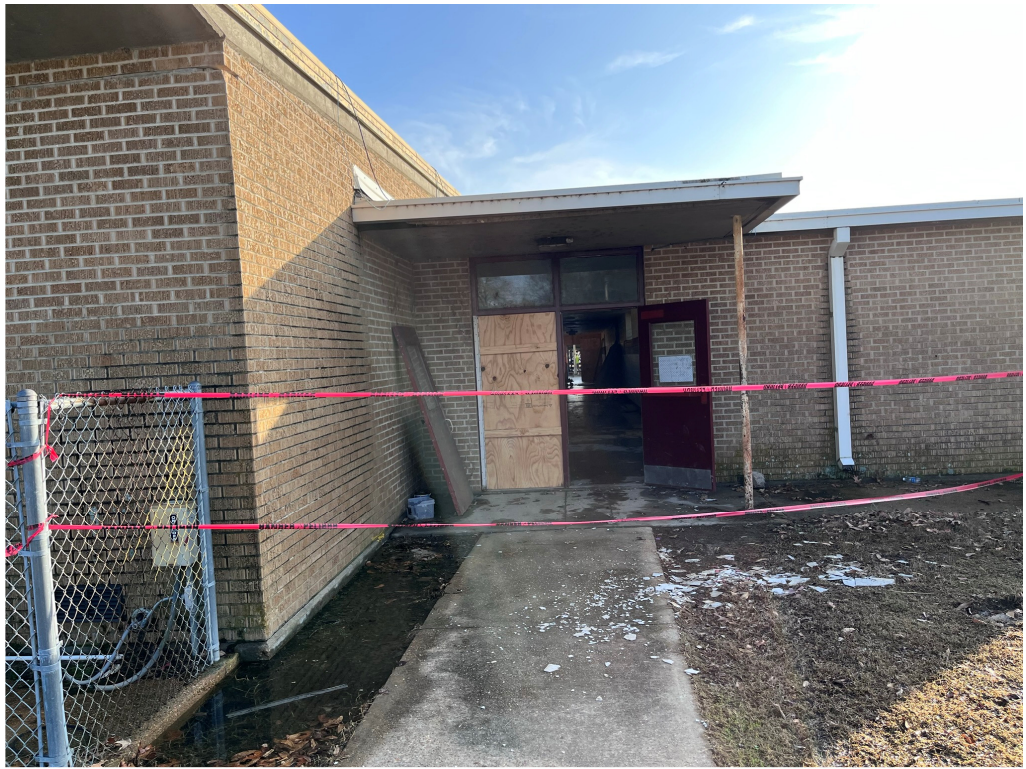
Figure 1 – North Entry to West Hall

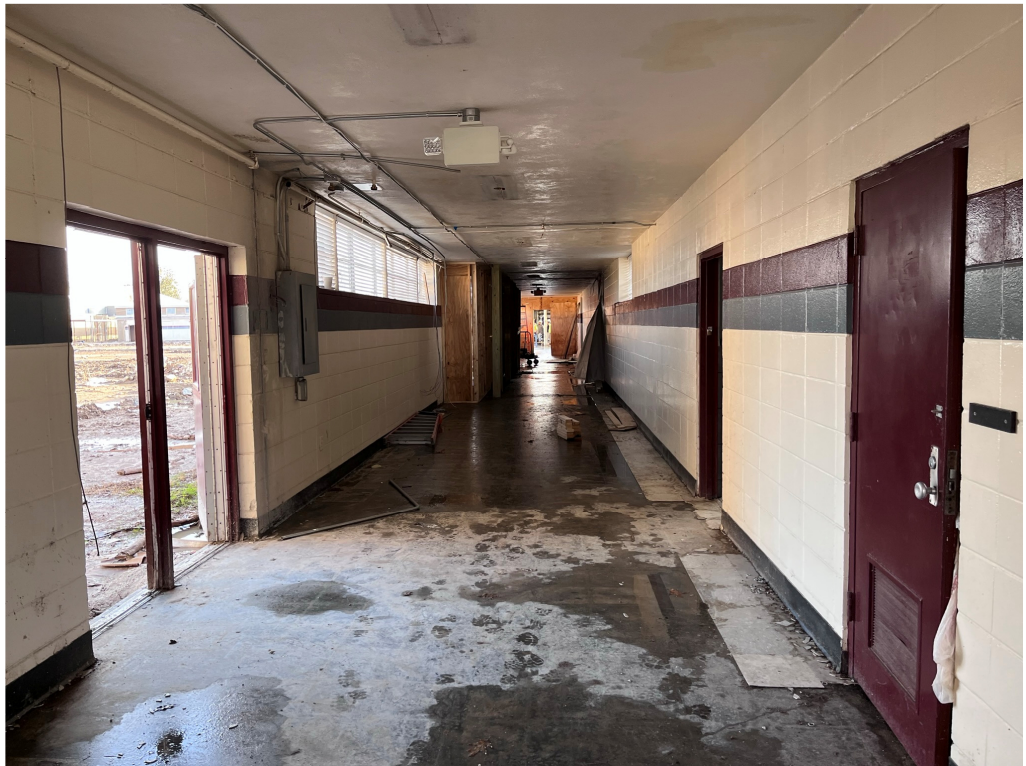
Figure 2 – Temporary construction @ West Hall looking south

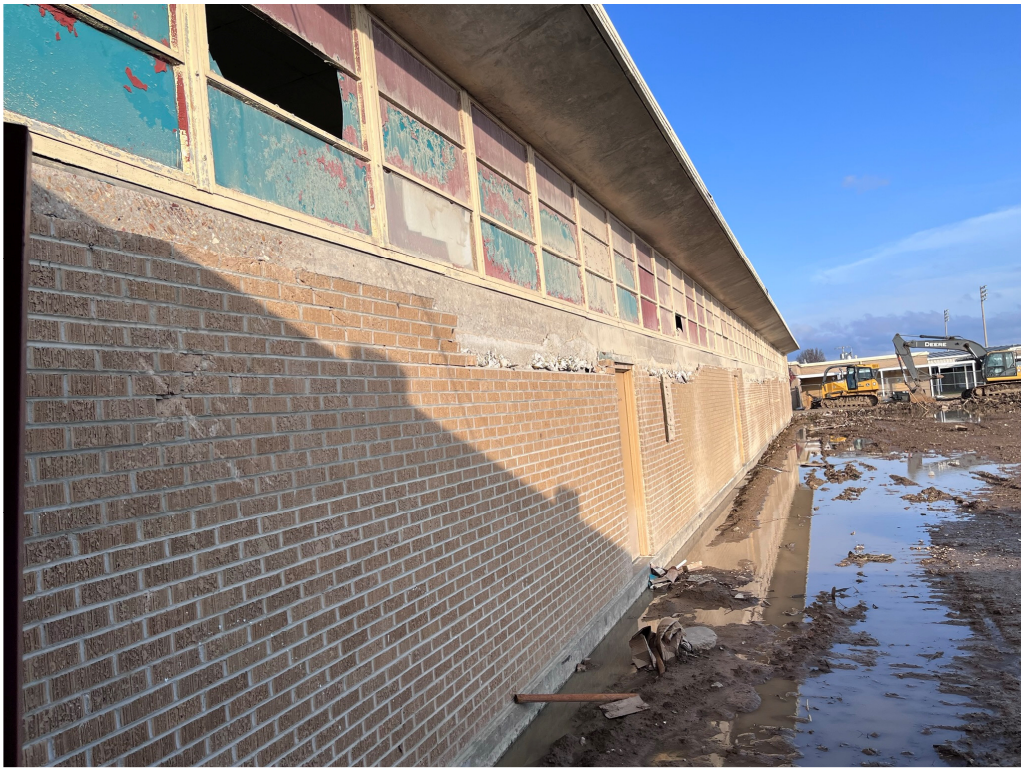
Figure 3 – Demolition @ Interior Yard with remaining buildings in foreground & background

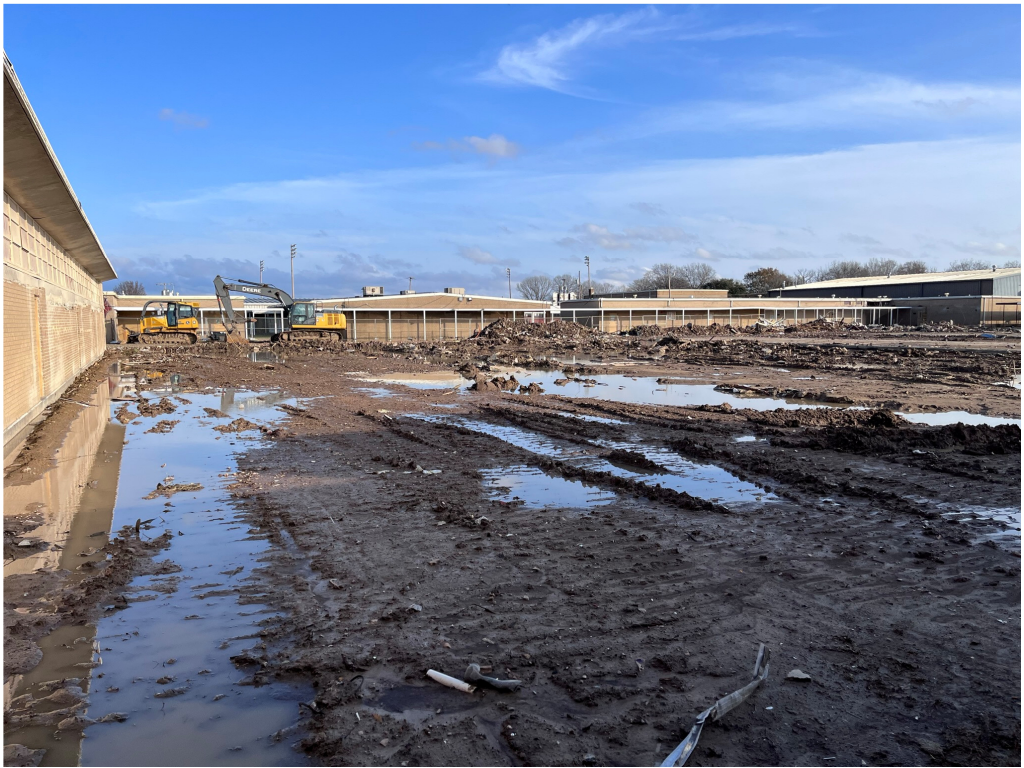
Figure 4 – Demolition @ Interior Yard with remaining buildings in background

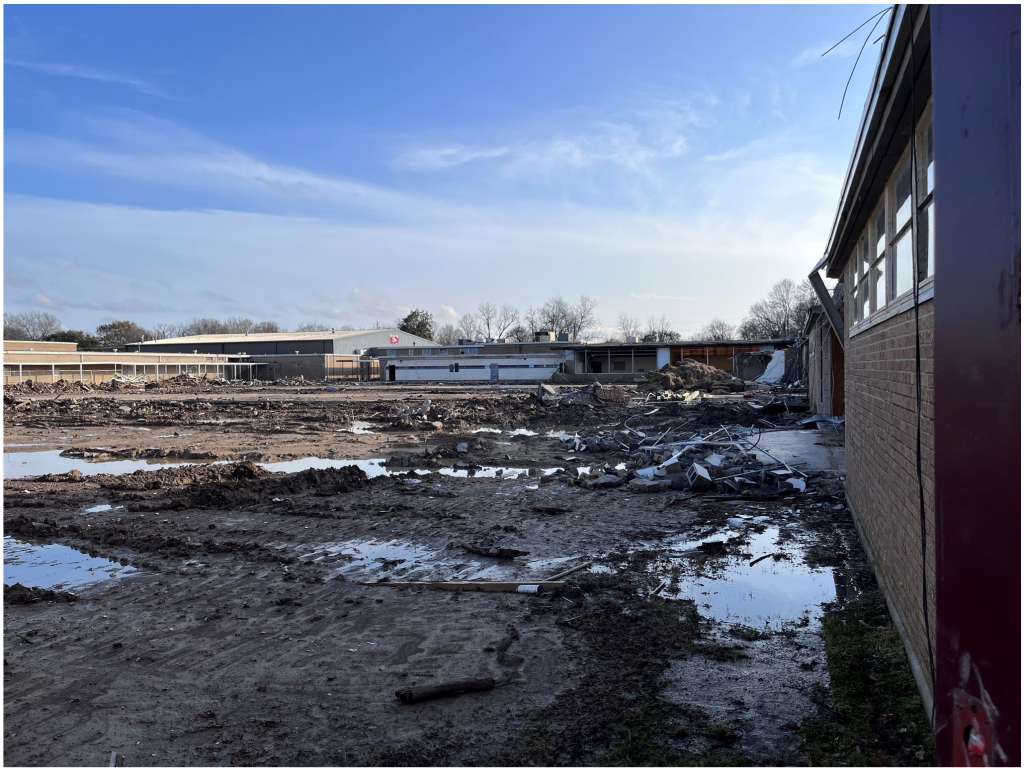
Figure 5 – Demolition @ Interior Yard with remaining buildings in foreground

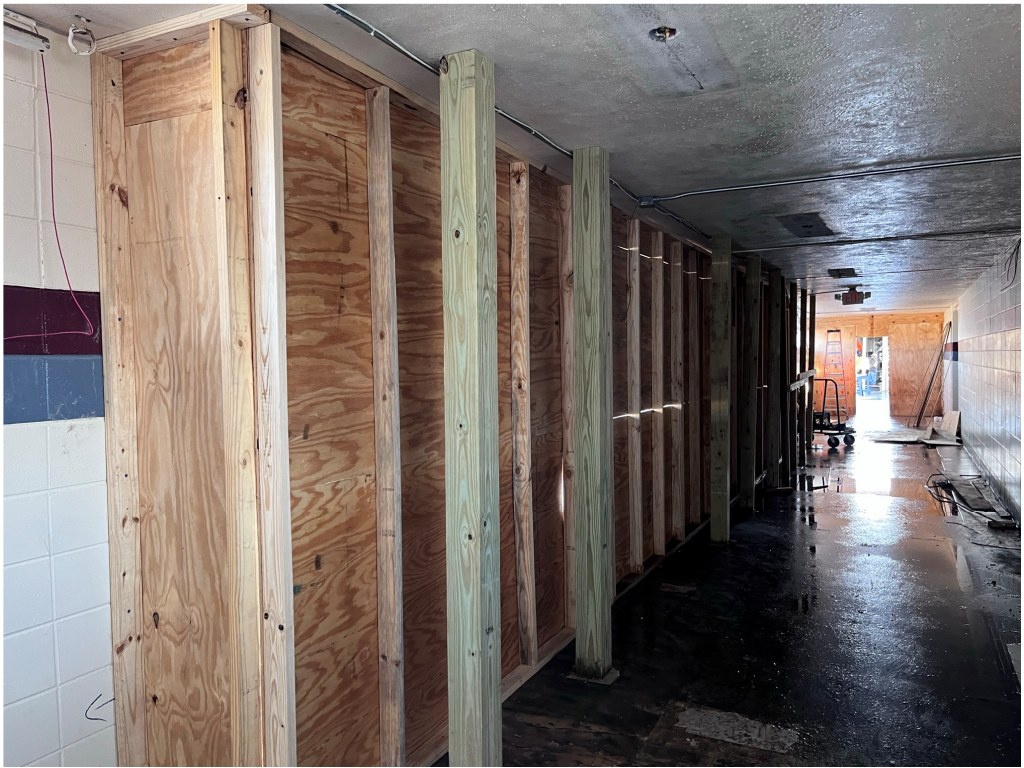
Figure 6 – Temporary construction @ West Hall

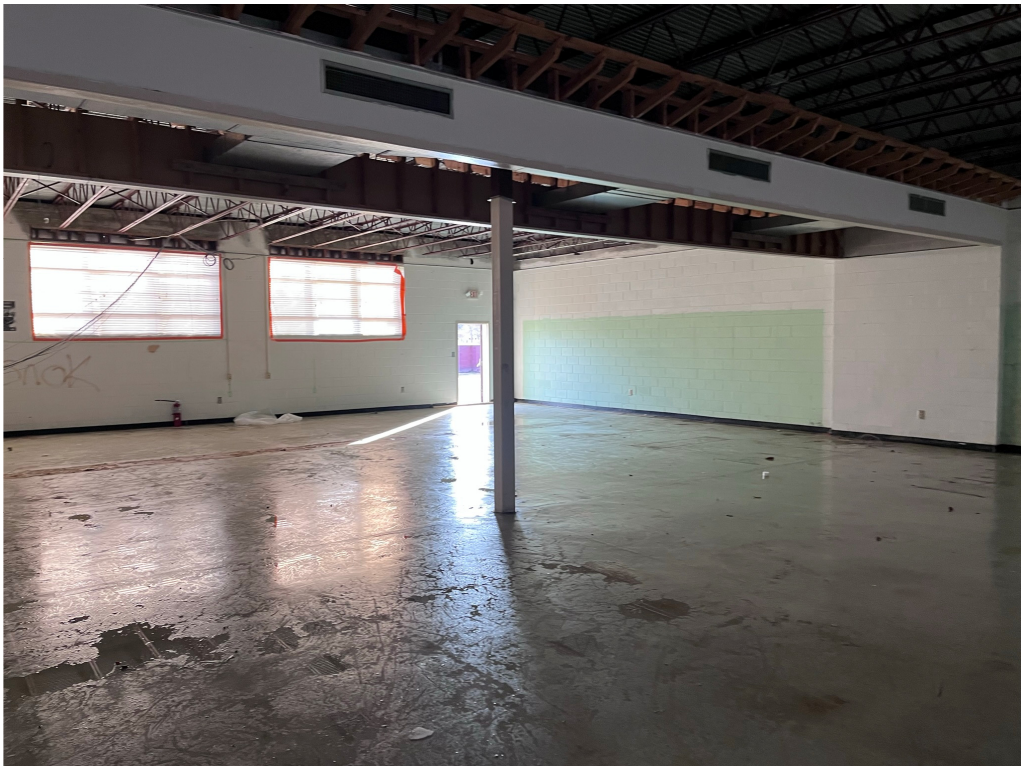
Figure 7 – Media Center Demolition; Sweating is an issue and needs to be addressed to prevent degradation of existing materials to remain

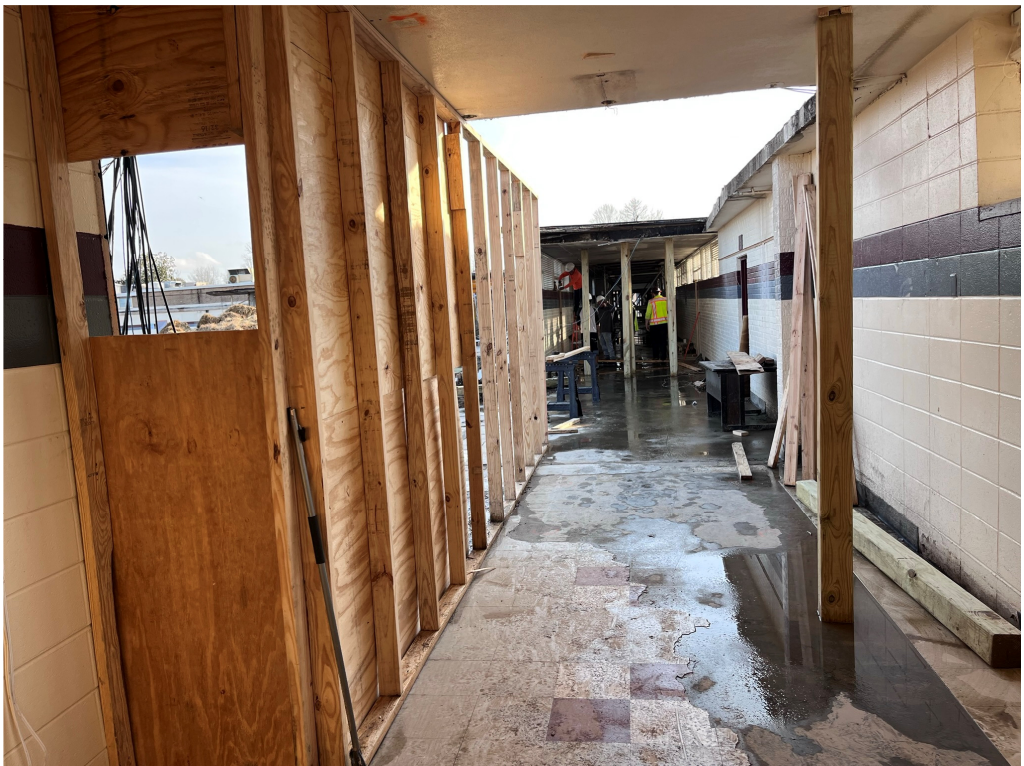
Figure 8 – Temporary construction @ West Hall

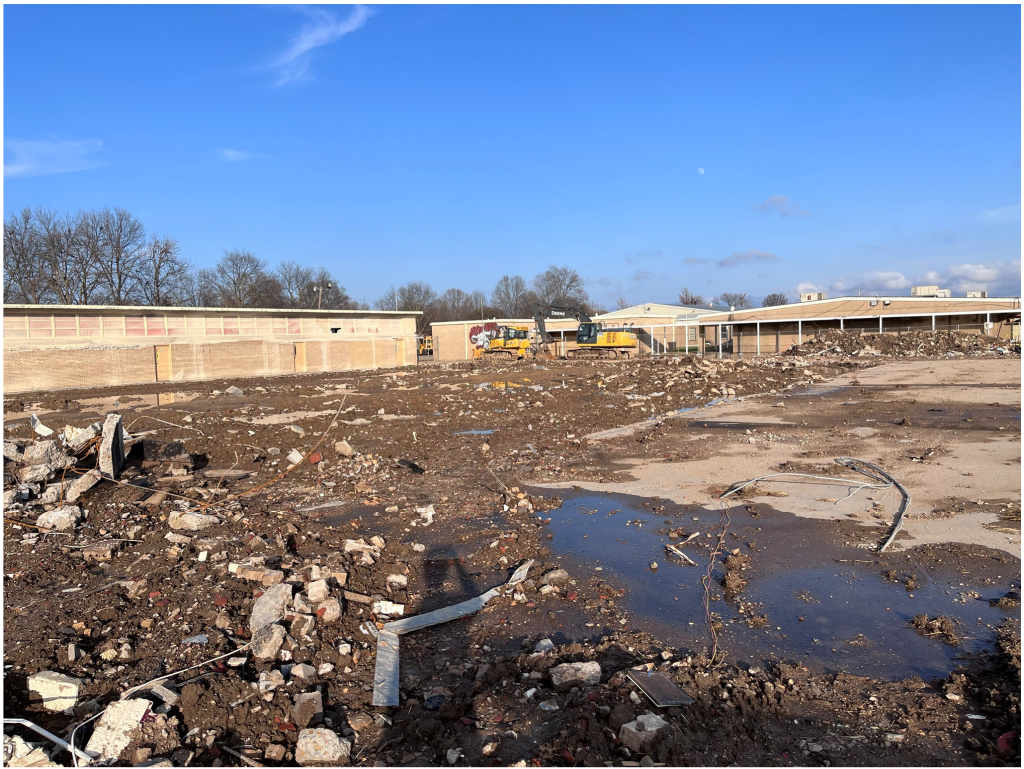
Figure 9 – Demolition @ Interior Yard with remaining buildings in background

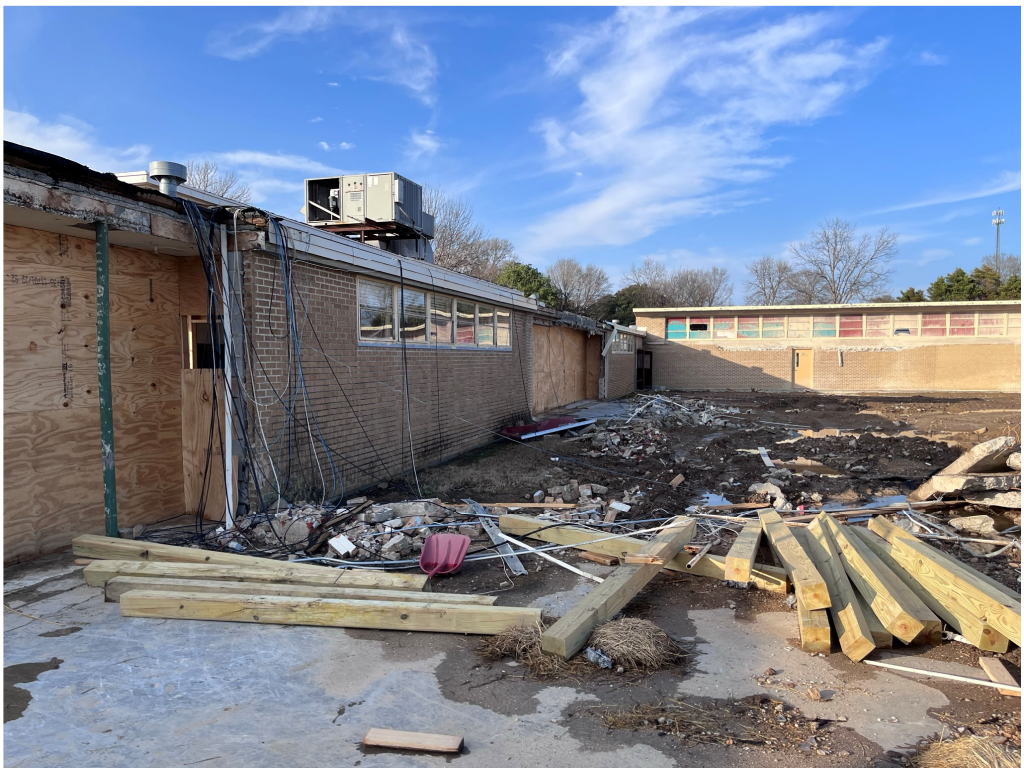
Figure 10 – Demolition @ Interior Yard with remaining buildings in background & foreground

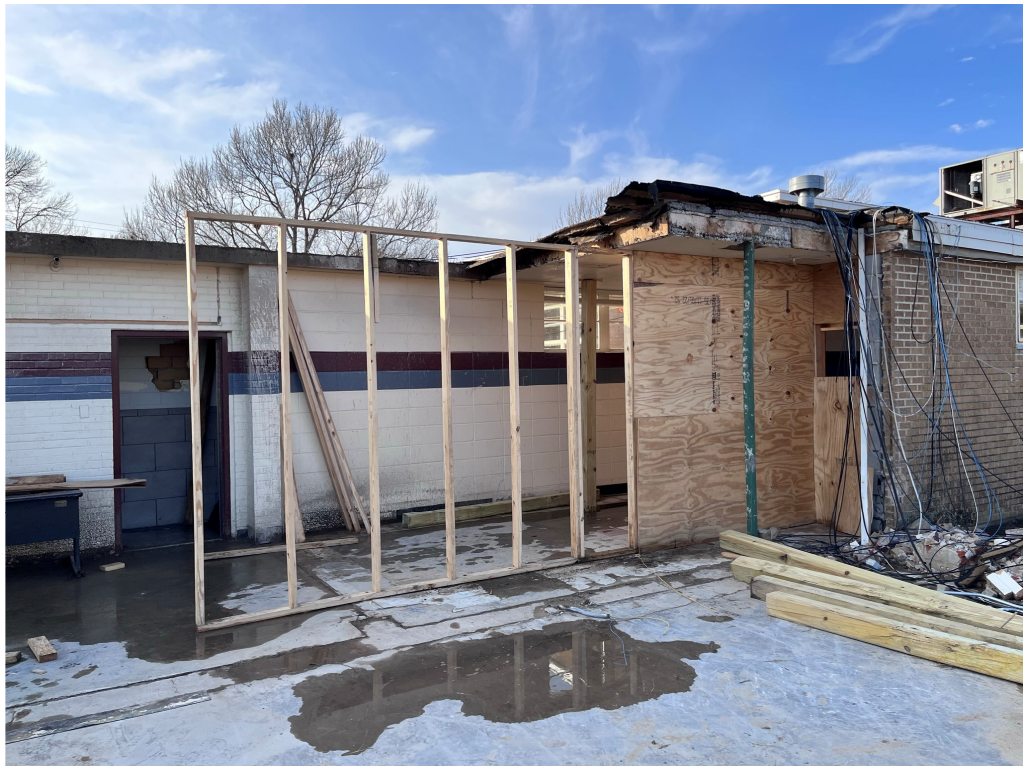
Figure 11 – Demolition @ West Hall

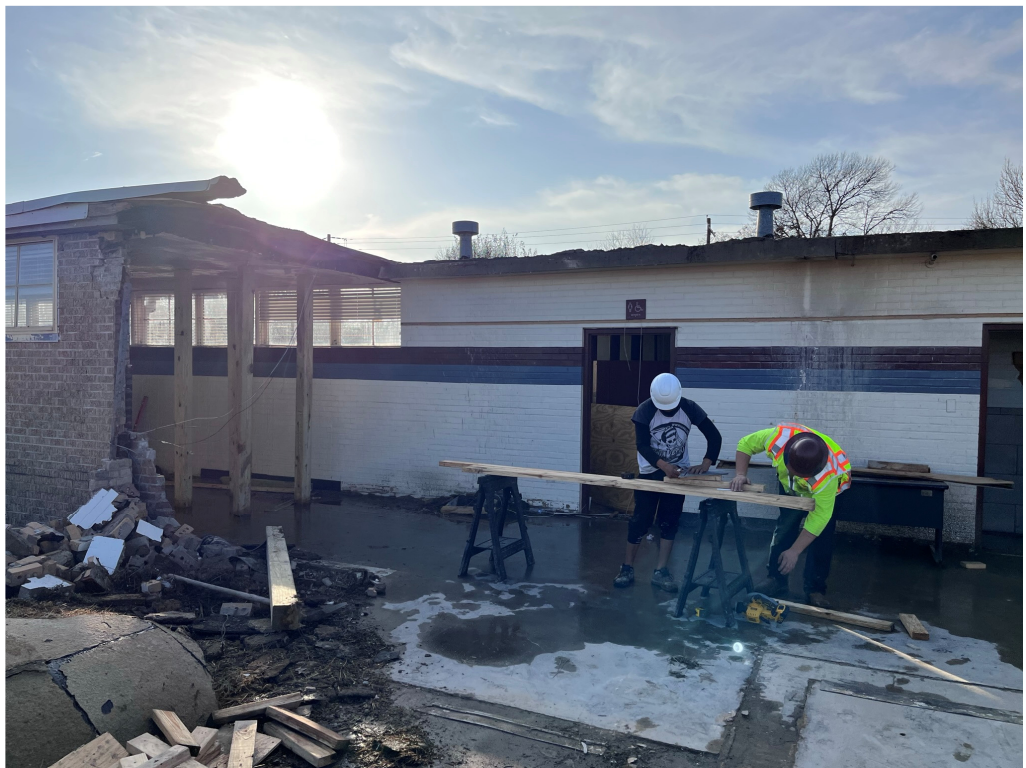
Figure 12 – Demolition @ West Hall

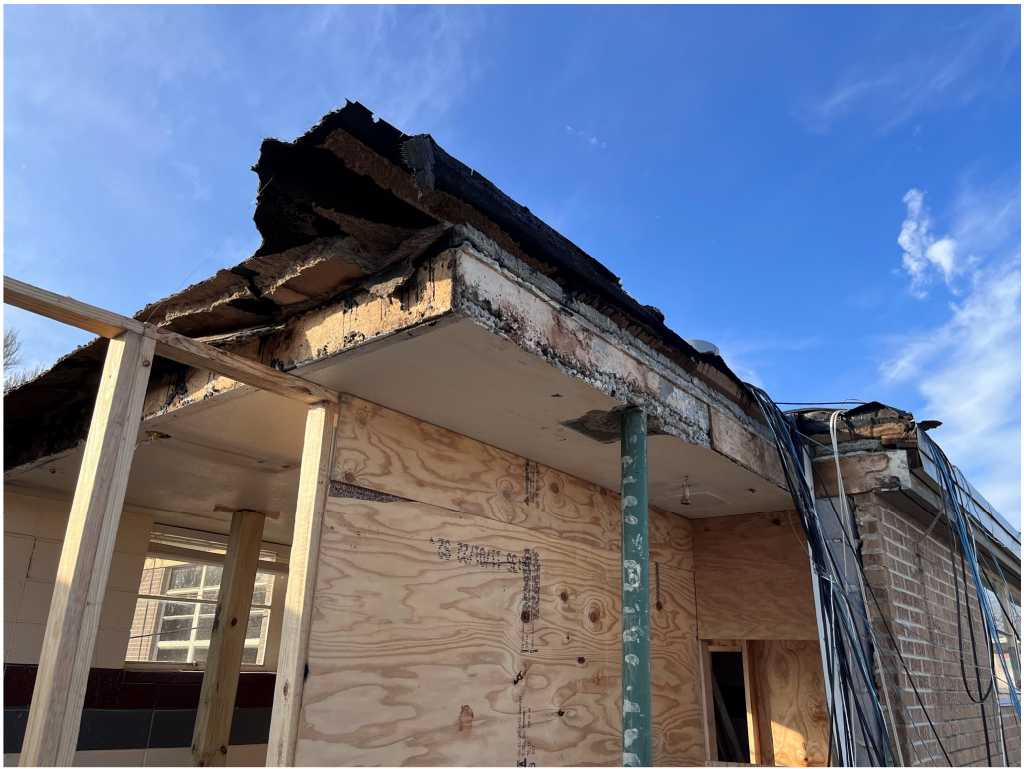
Figure 13 – Existing West Hall Construction

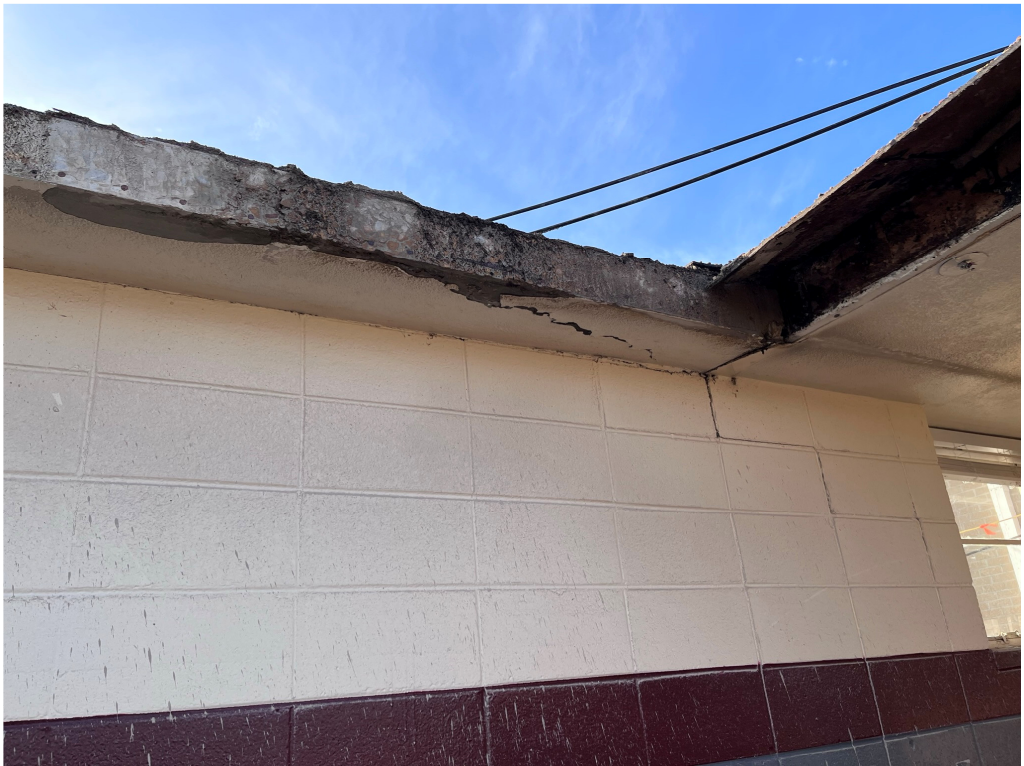
Figure 14 – Concrete Deck Cut back during demolition @ West Hall

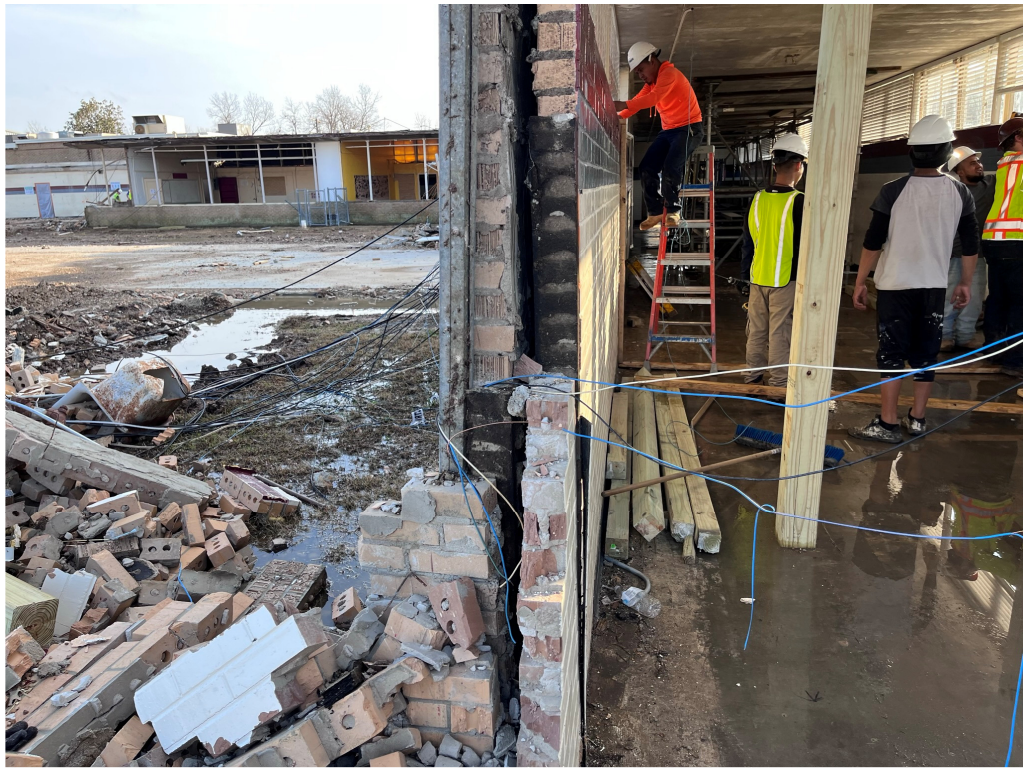
Figure 15 – Existing Wall Construction @ West Hall

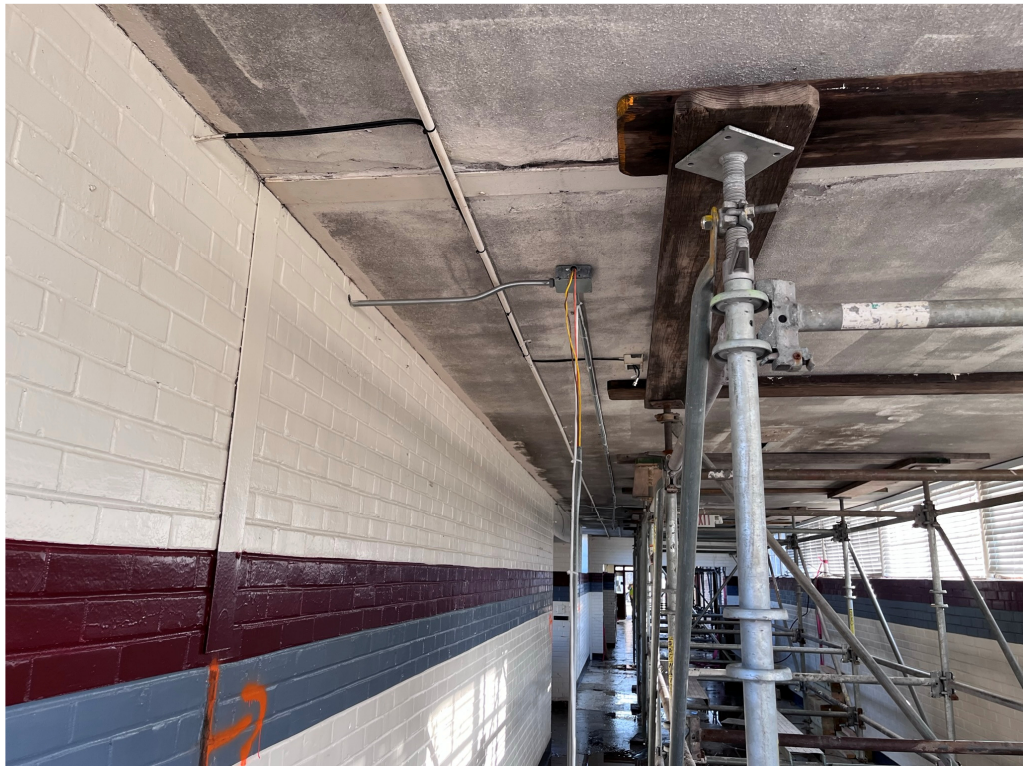
Figure 16 – Temporary Shoring at west building/hall to remain

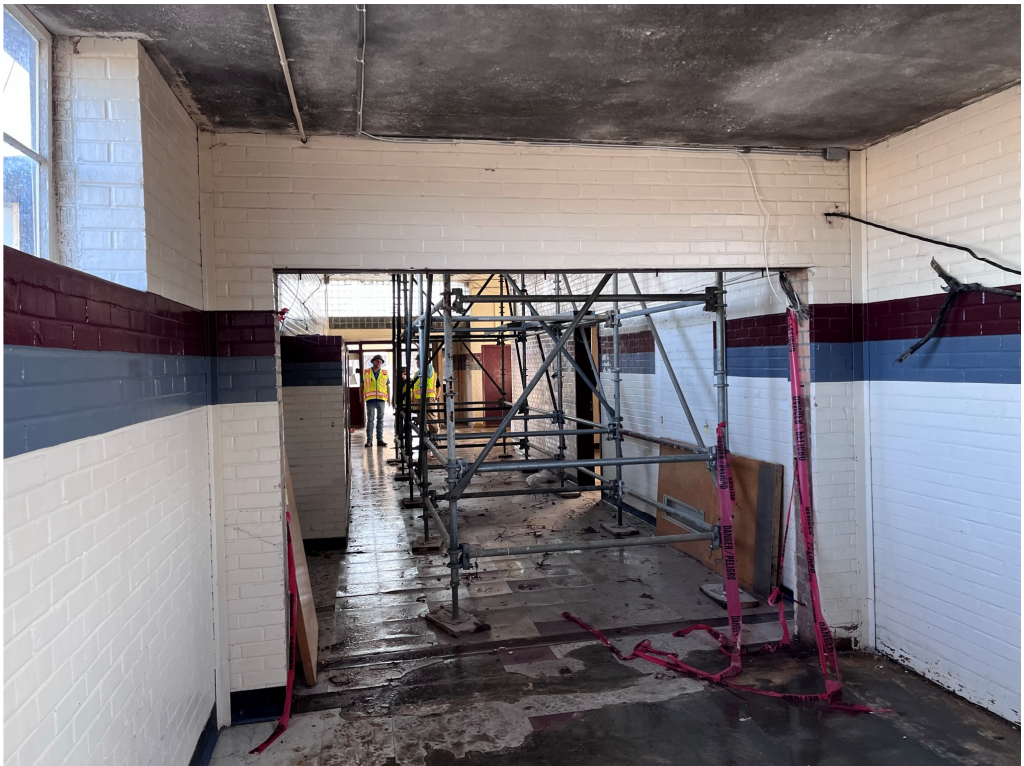
Figure 17 – Opening to remain

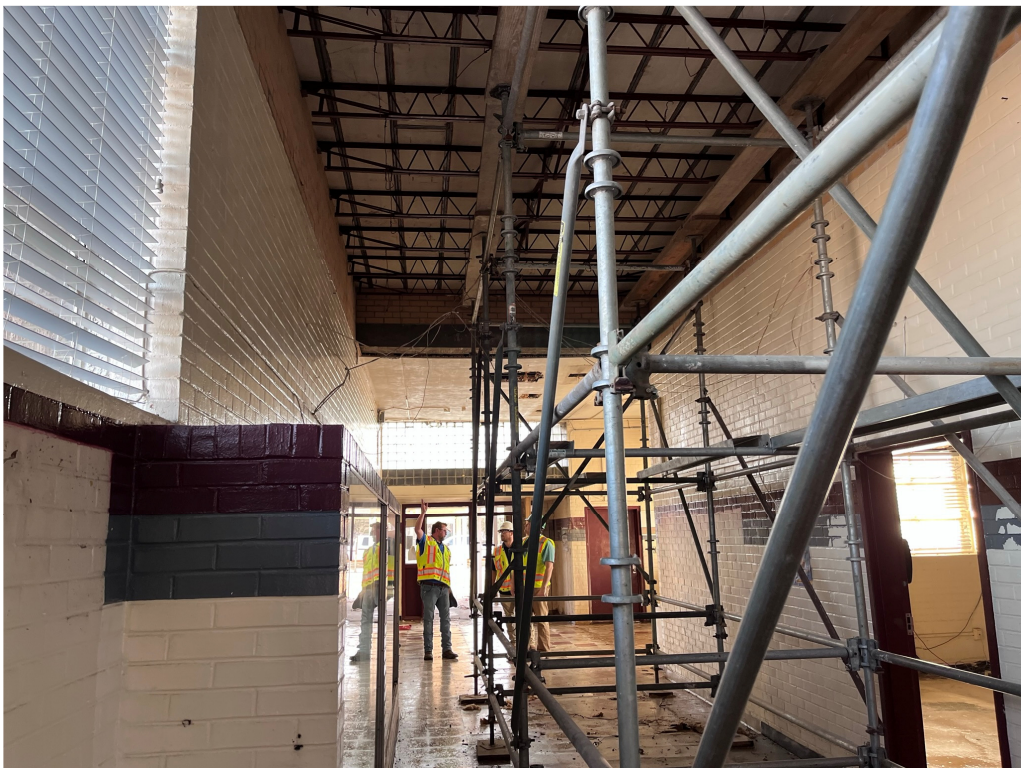
Figure 18 – Entry lobby (ceiling to remain [wall on left to be restructured])

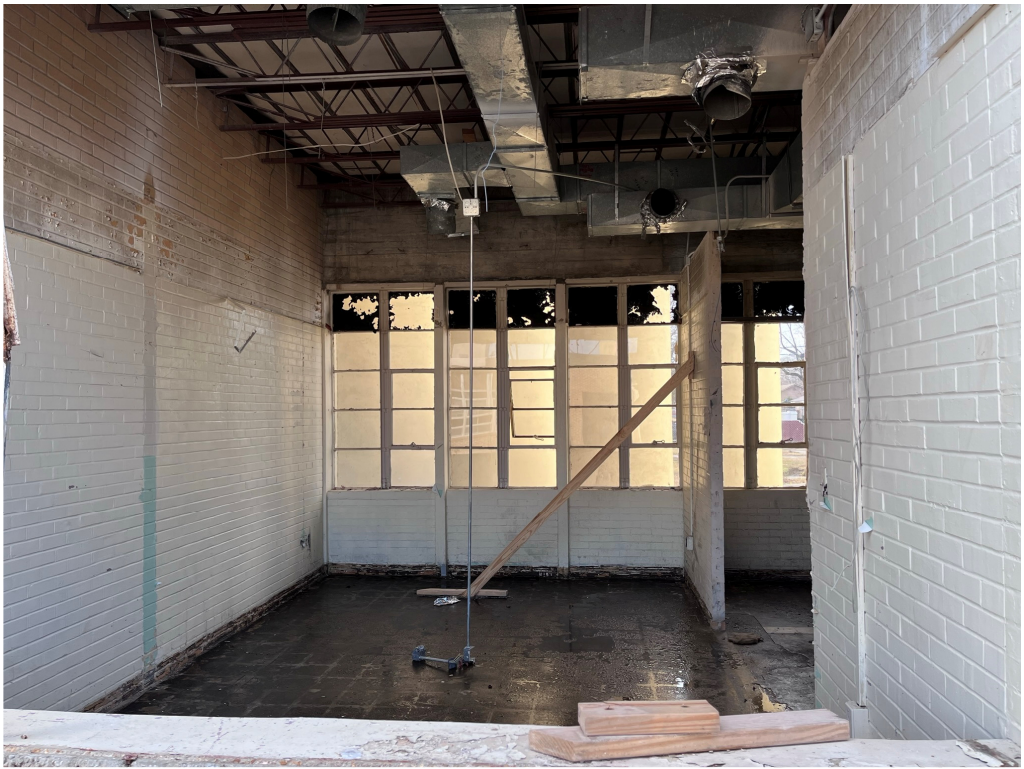
Figure 19 – Southwest corner building to remain

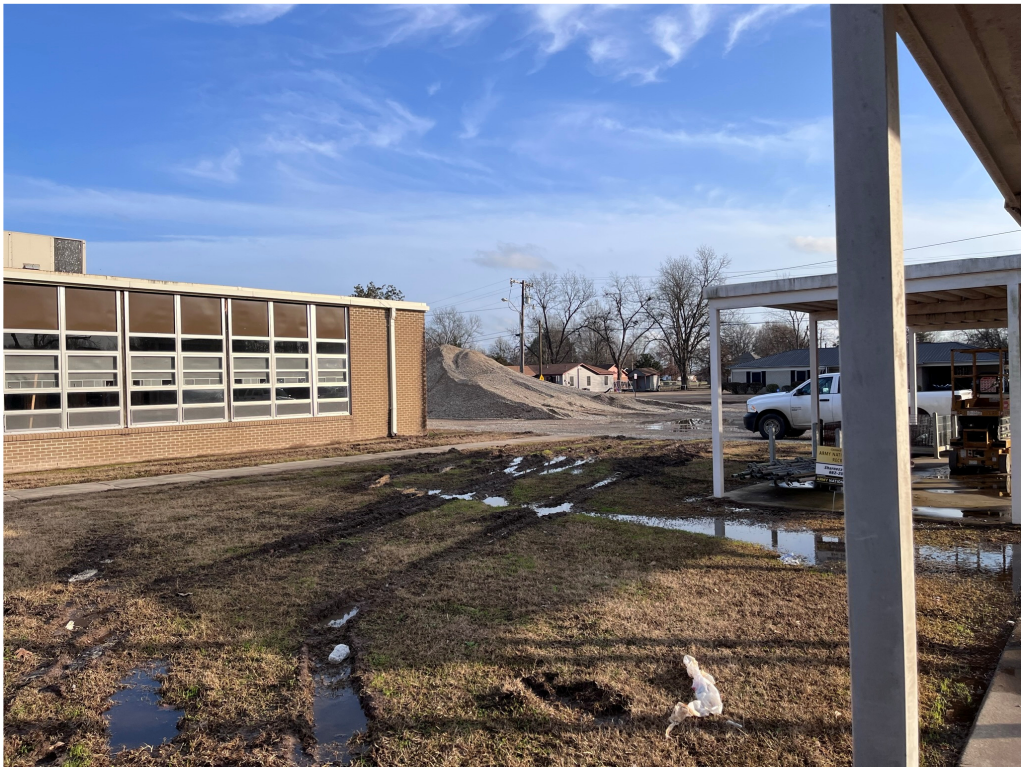
Figure 20 – Site work at Parking is Ongoing

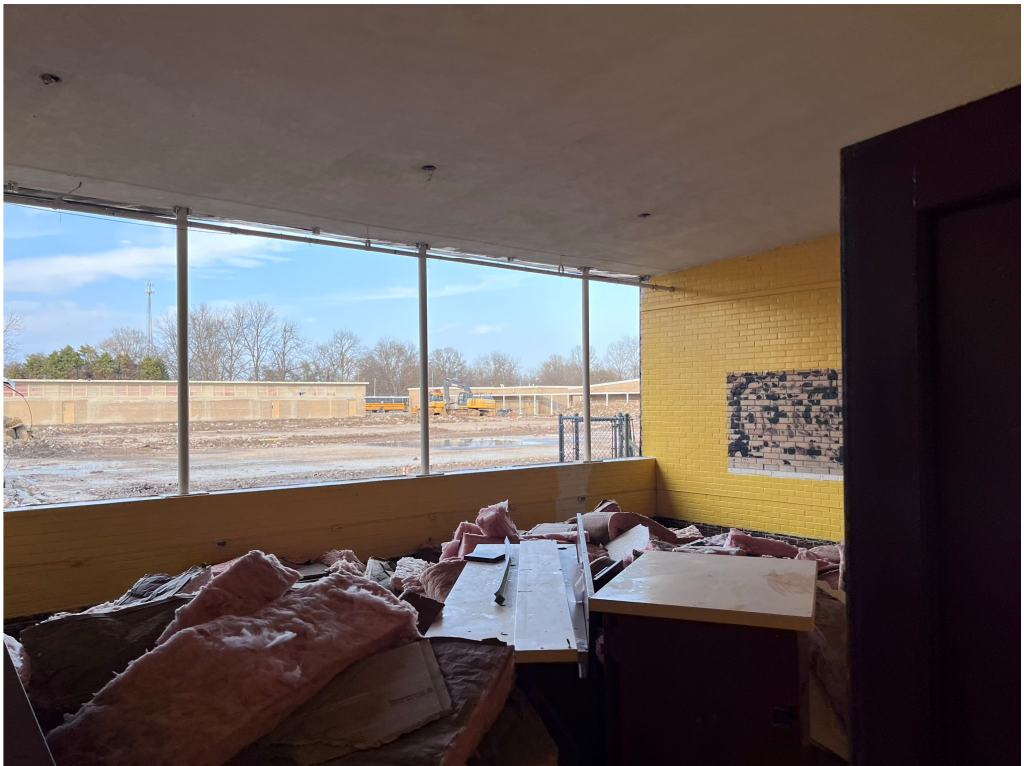
Figure 21 – South Building still to be Demolished

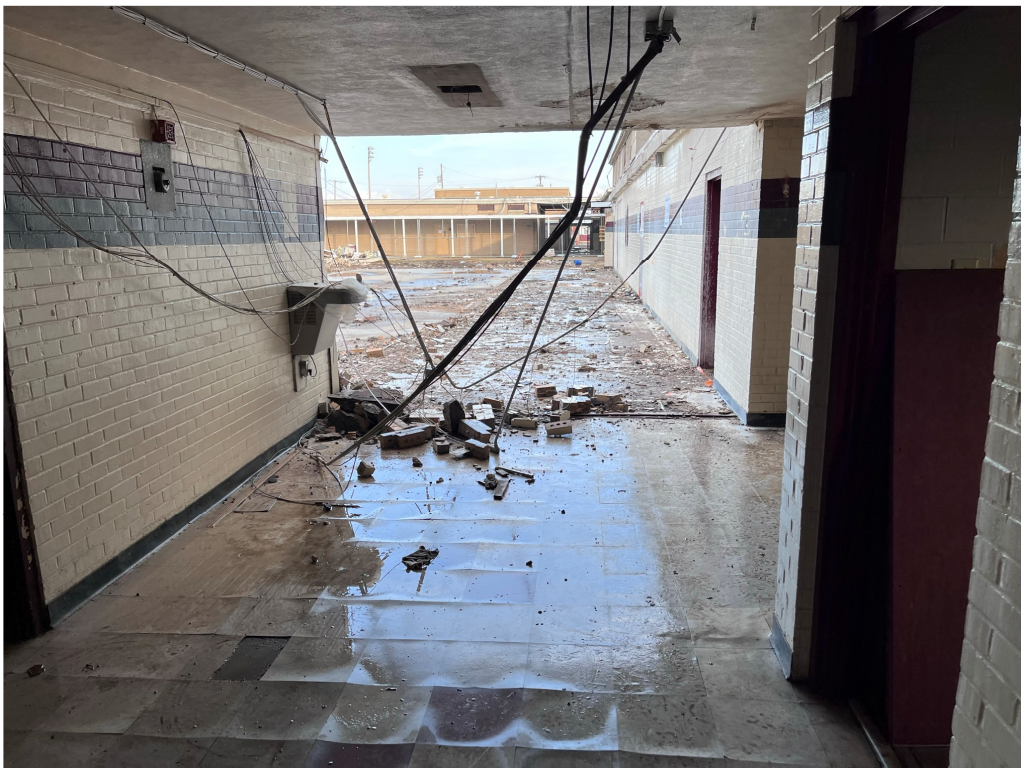
Figure 22 – South Building still to be Demolished

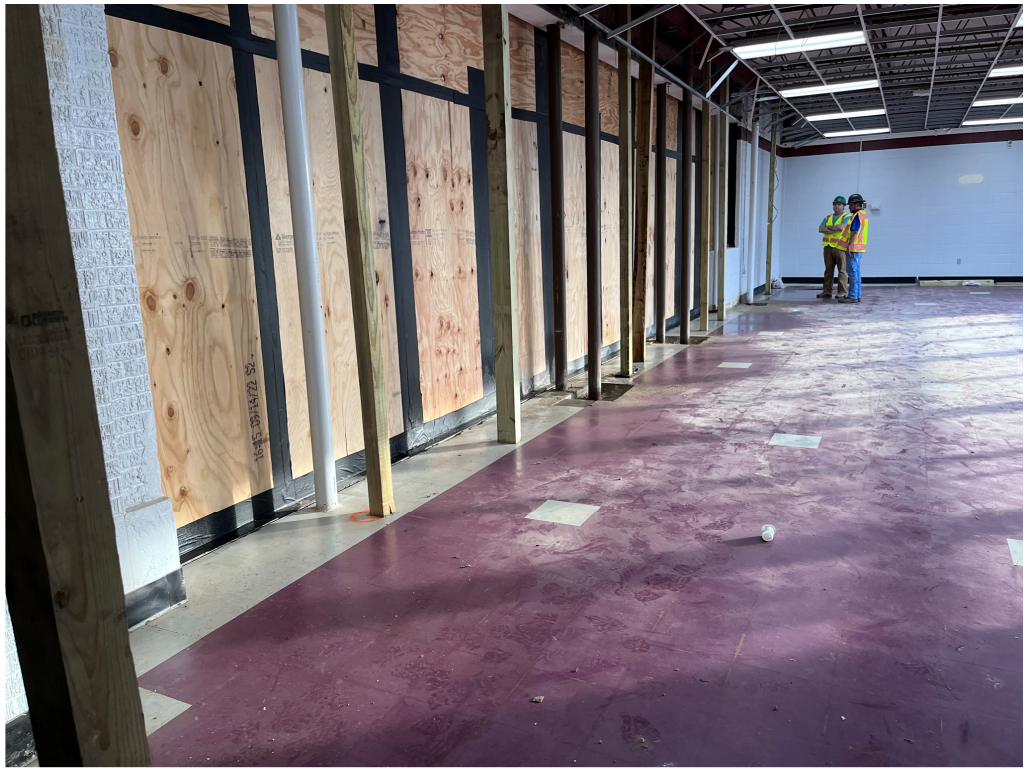
Figure 23 – Temporary Construction @ Cafeteria

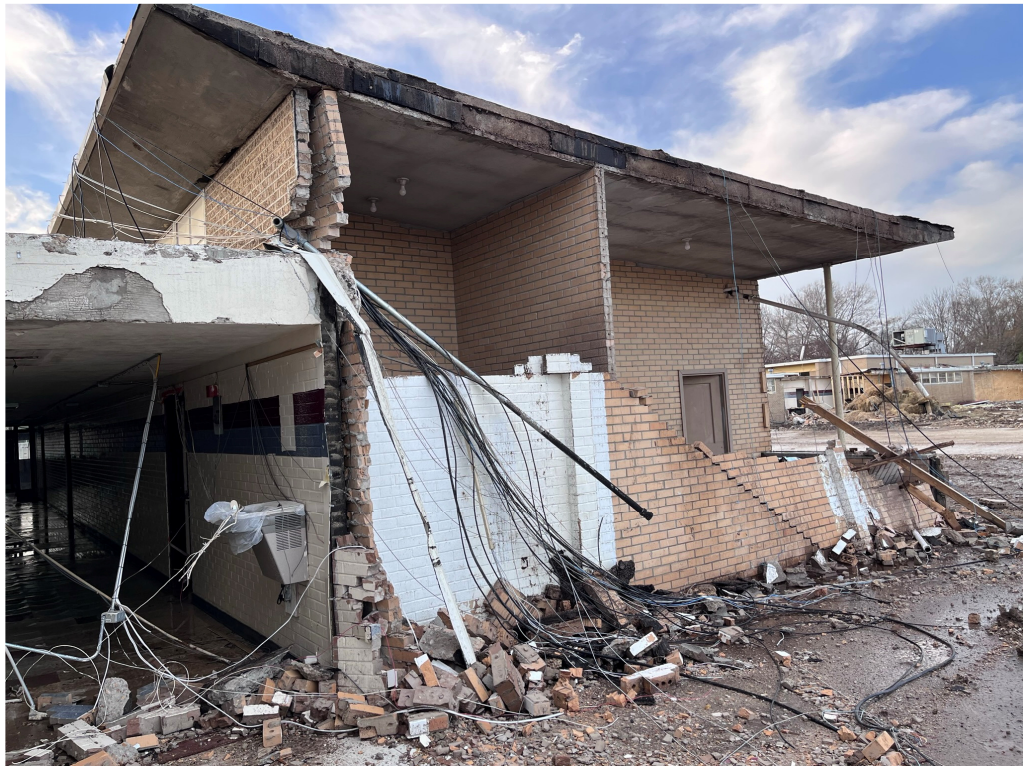
Figure 24 – South Building still to be demolished

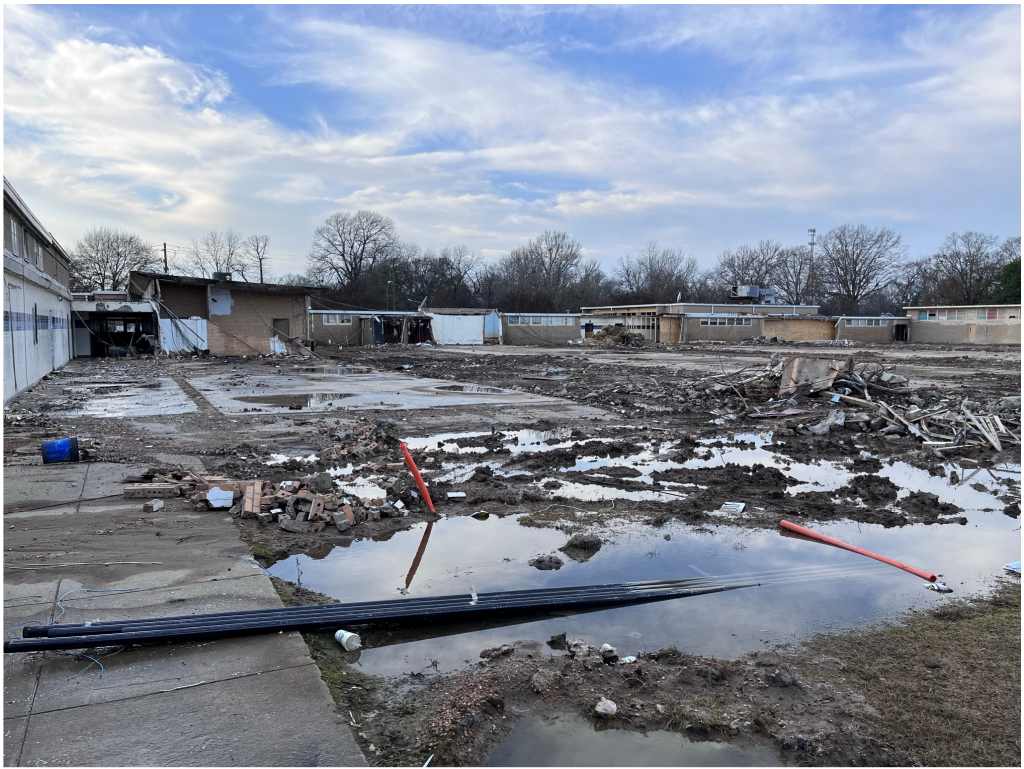
Figure 25 – Gentry Interior Courtyard Demolition/Site Work is Ongoing

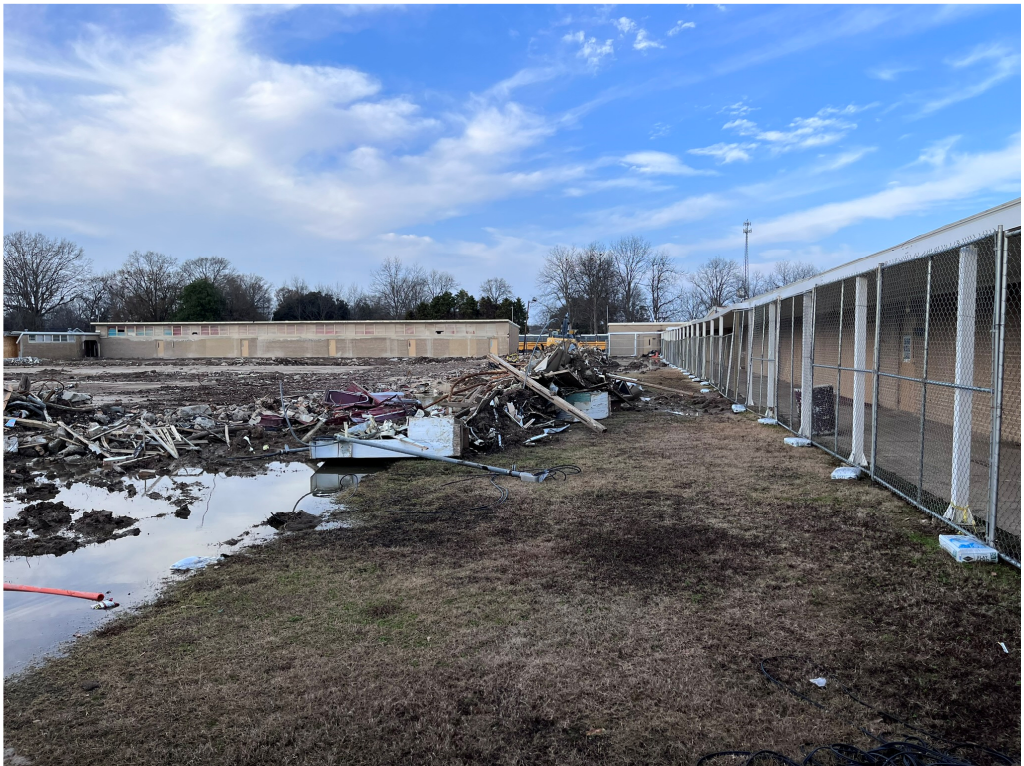
Figure 26 – Gentry Interior Courtyard Demolition/Site Work is Ongoing

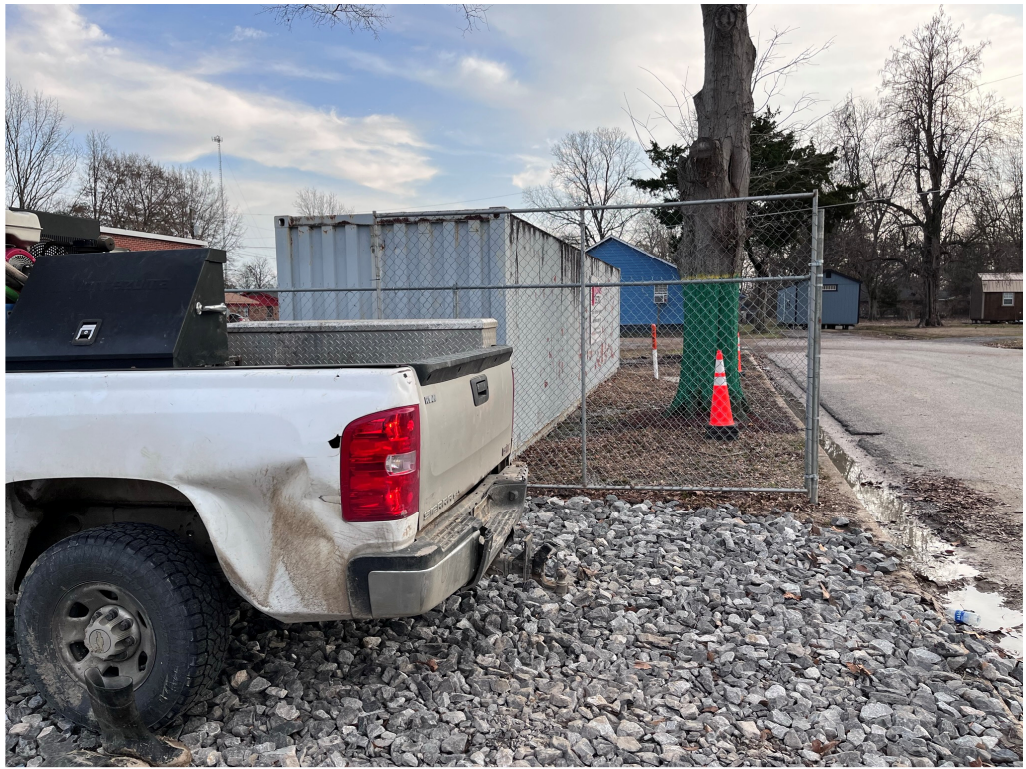
Figure 27 – Temporary Entry @ Thomas Edwards

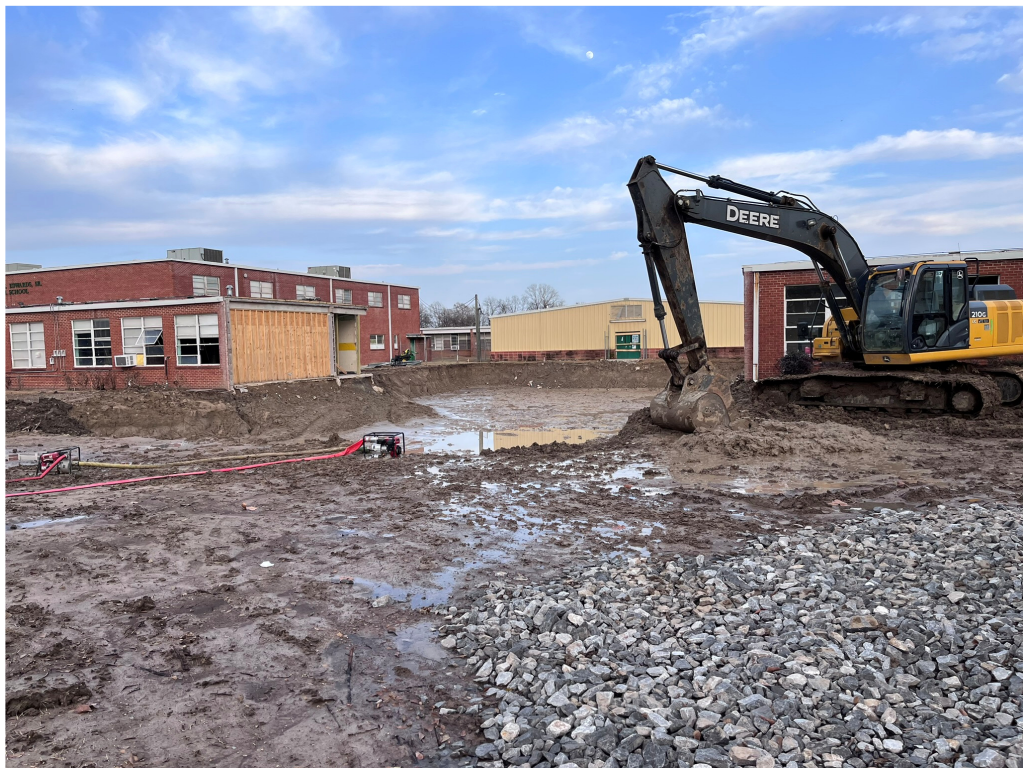
Figure 28 – Site Work is ongoing; pumping currently in progress

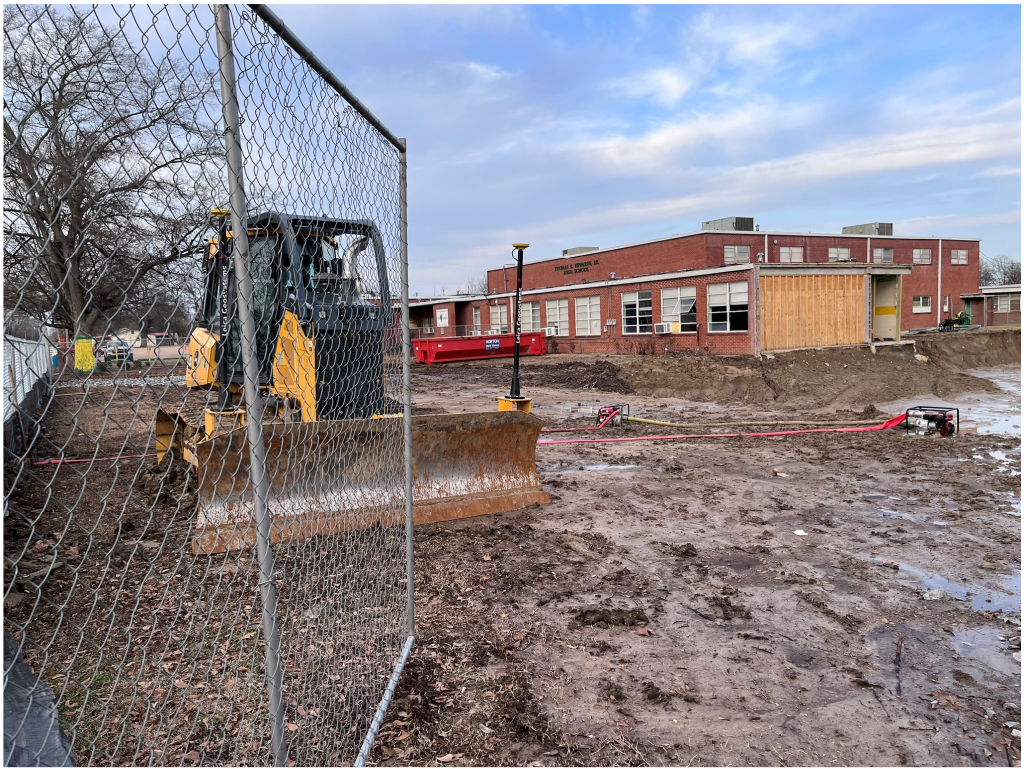
Figure 29 – Site Work is ongoing; pumping currently in progress
