04 January 2023

21081 Sunflower Consolidated SD Phase II / Report Number 003

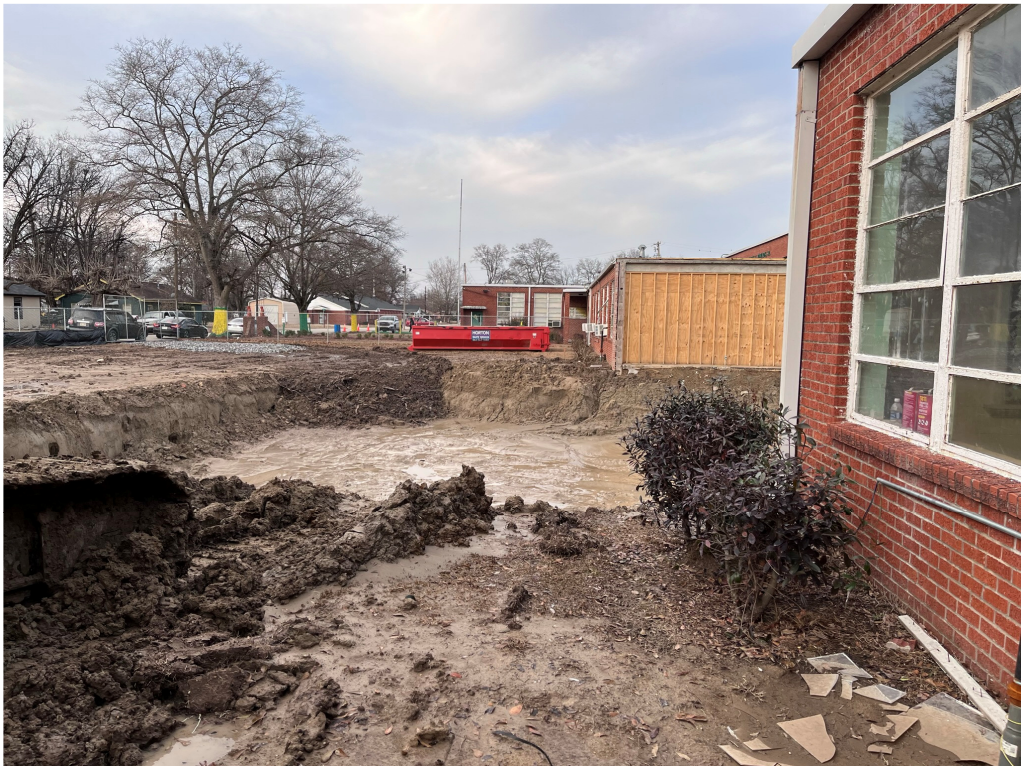
Figure 30 – Continued Excavation at Thomas Edwards New Construction

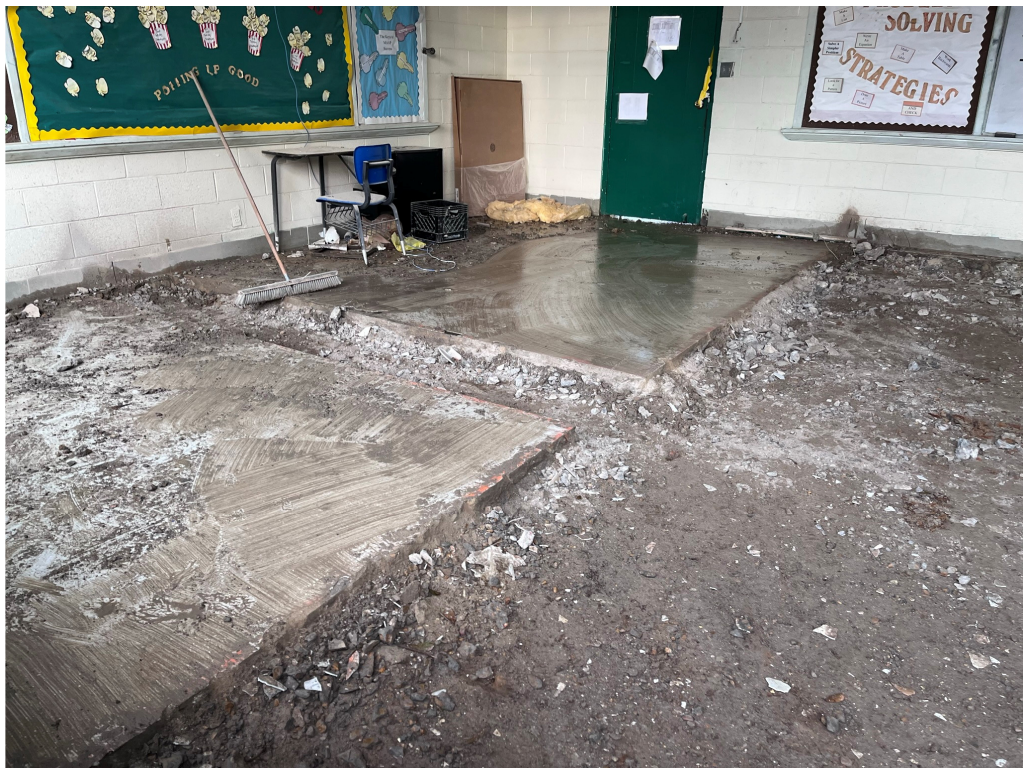
Figure 31 – Concrete demo at south building wing to remain @ Thomas Edwards

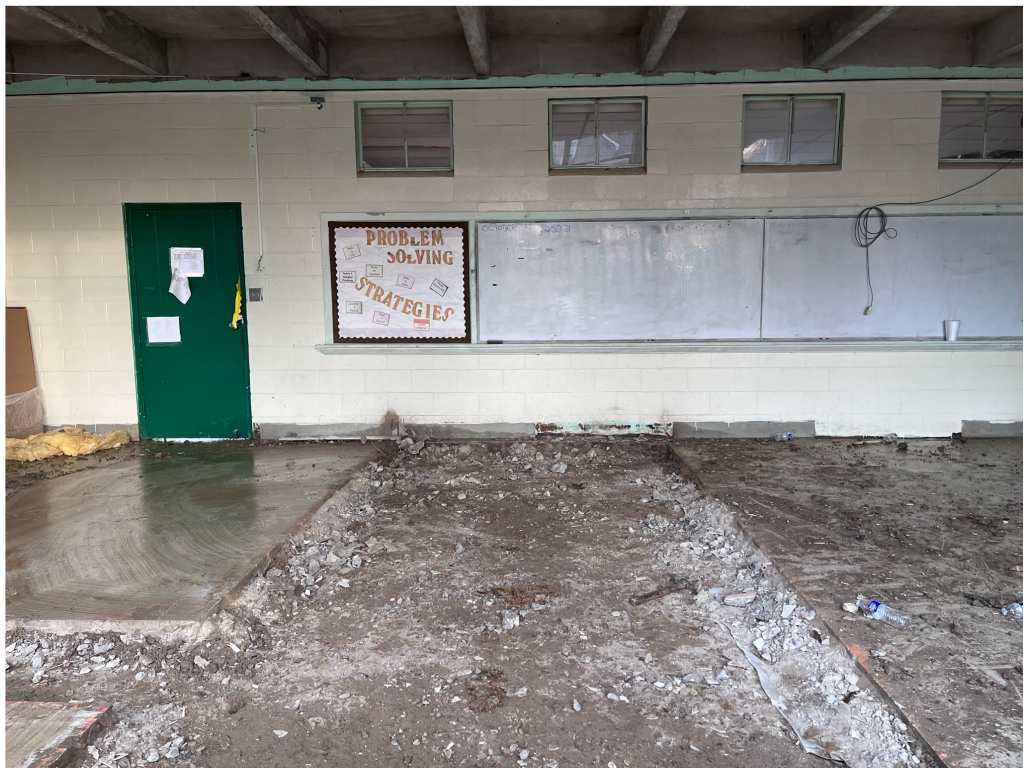
Figure 32 – Concrete demo at south building wing to remain @ Thomas Edwards

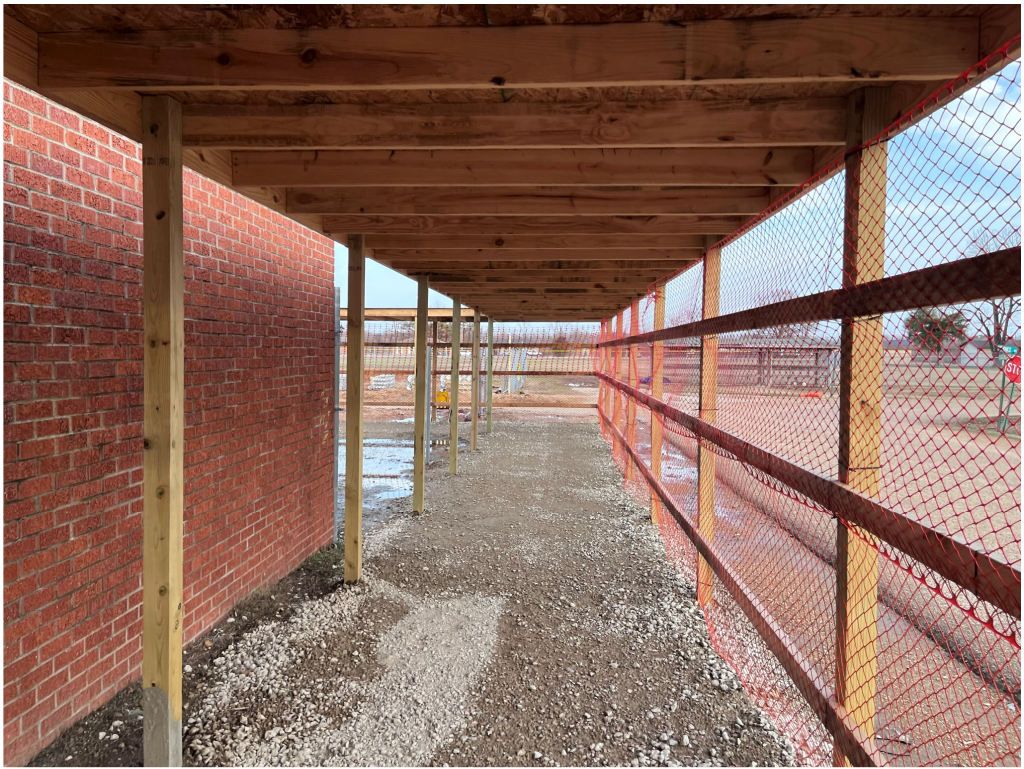
Figure 33 – Temporary Awning Appears in Good Shape; continue to maintain

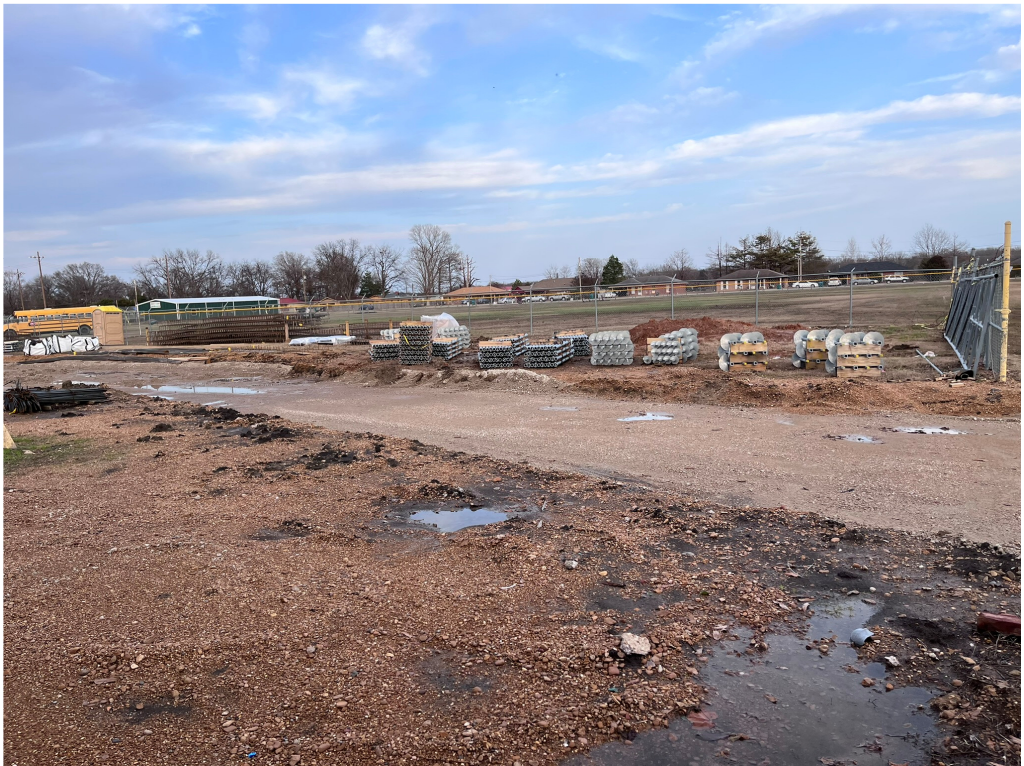
Figure 34 – Site work at Back of School

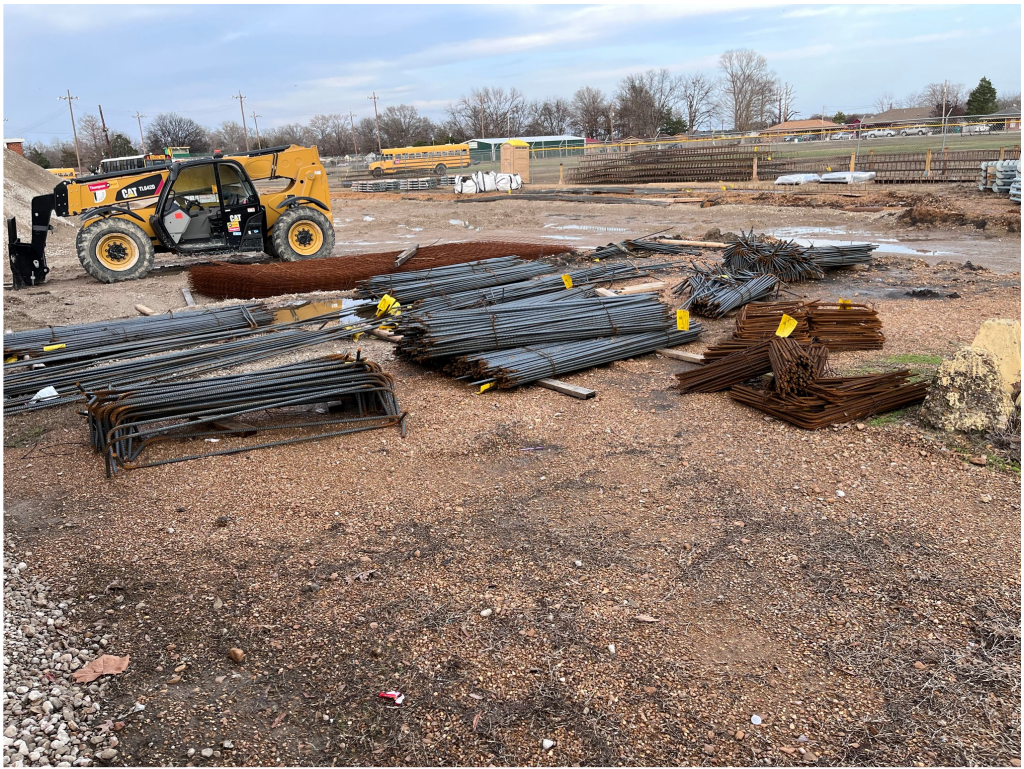
Figure 35 – Rebar Stored on Site

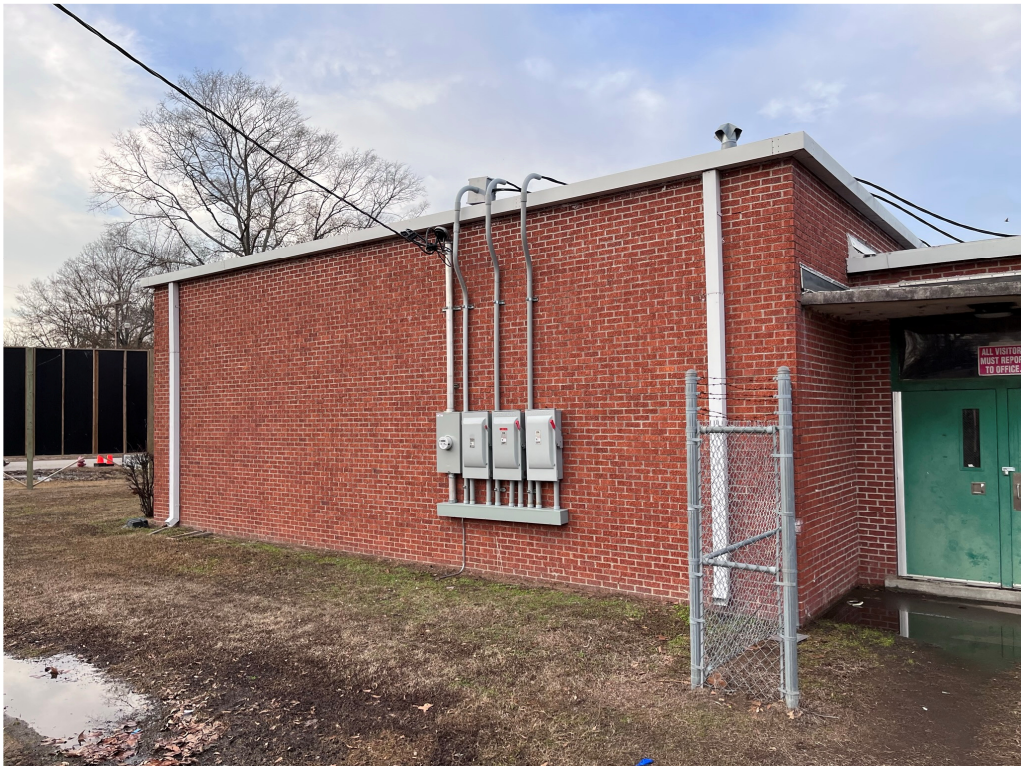
Figure 36 – New Service @ Thomas Edwards
