21081 Sunflower Consolidated SD Phase II, Report Number 013

Date, Time 10 October 2023, 8:00 AM

Paul Purser, AIA
Dale | Bailey, an Association

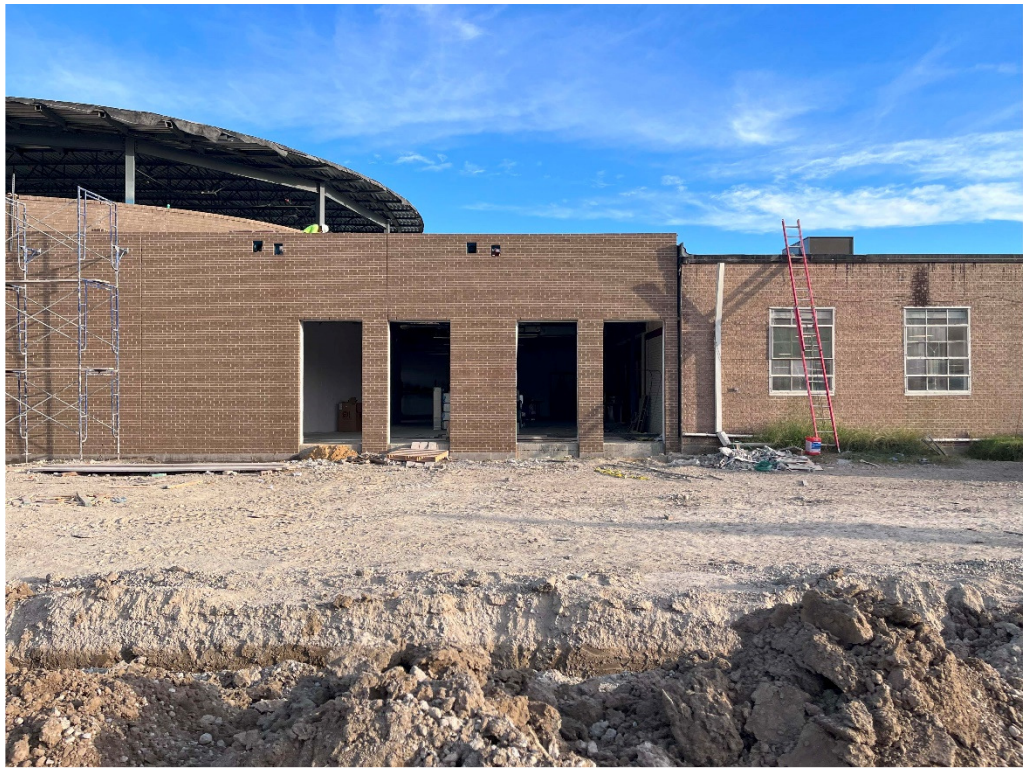
Figure 1 – GHS: new brick installation

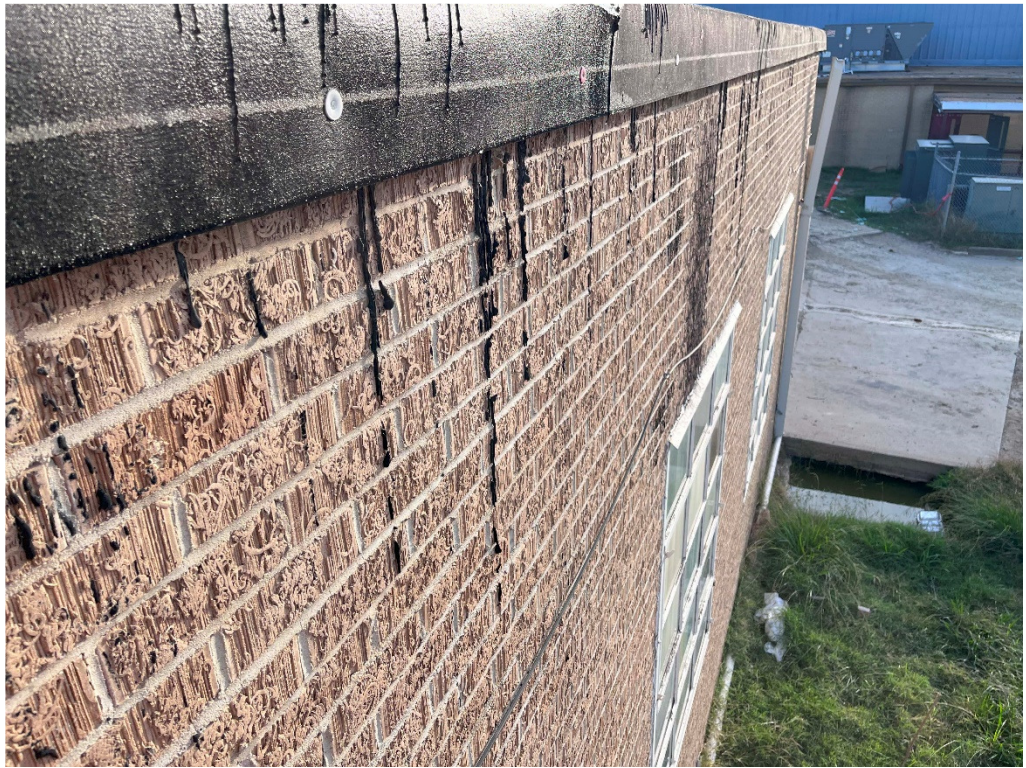
Figure 2 – GHS: contractor reminded to clean all asphalt from face of brick

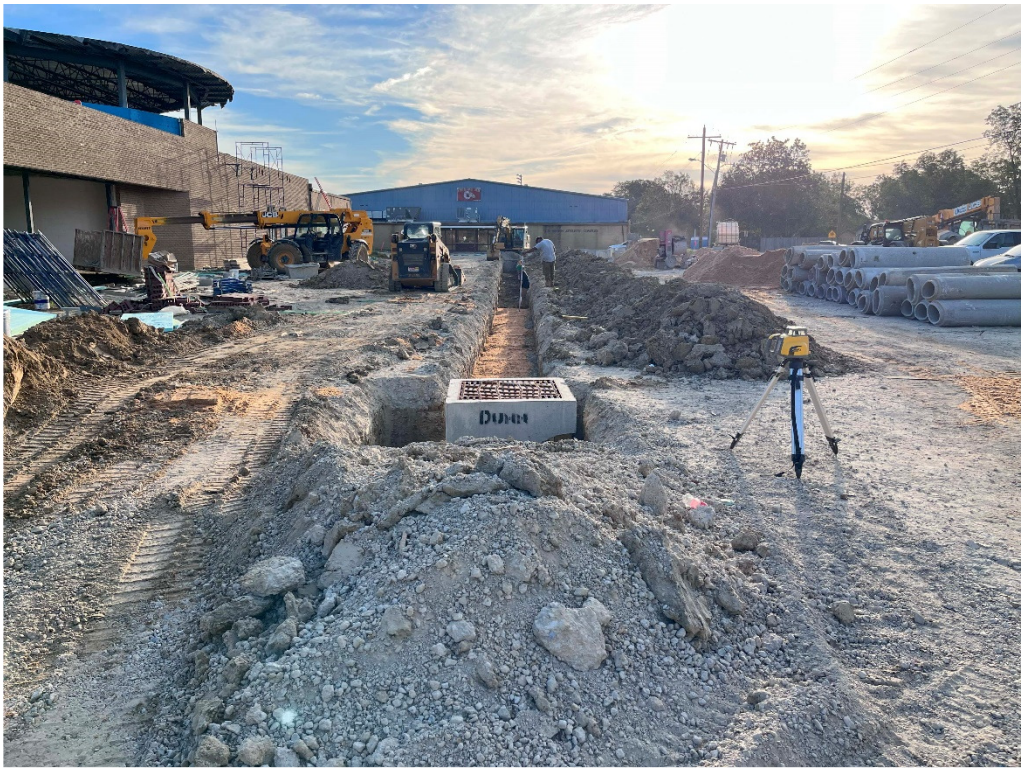
Figure 3 – GHS: subdrainage work at parking

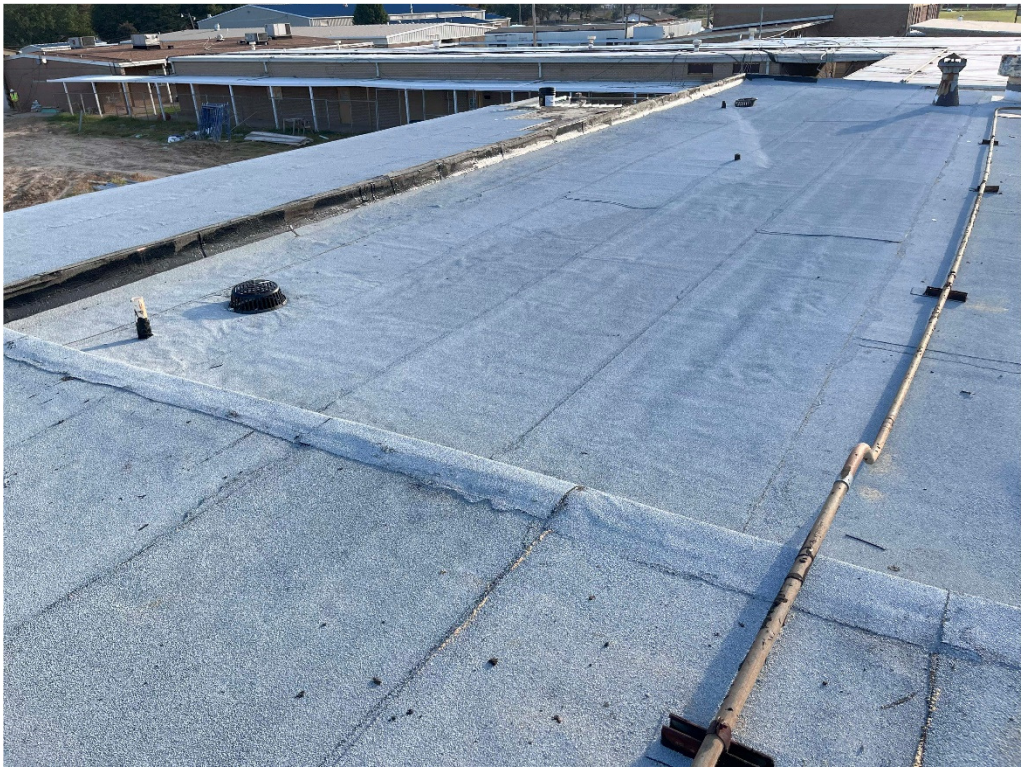
Figure 4 – GHS: progress at cafeteria roof

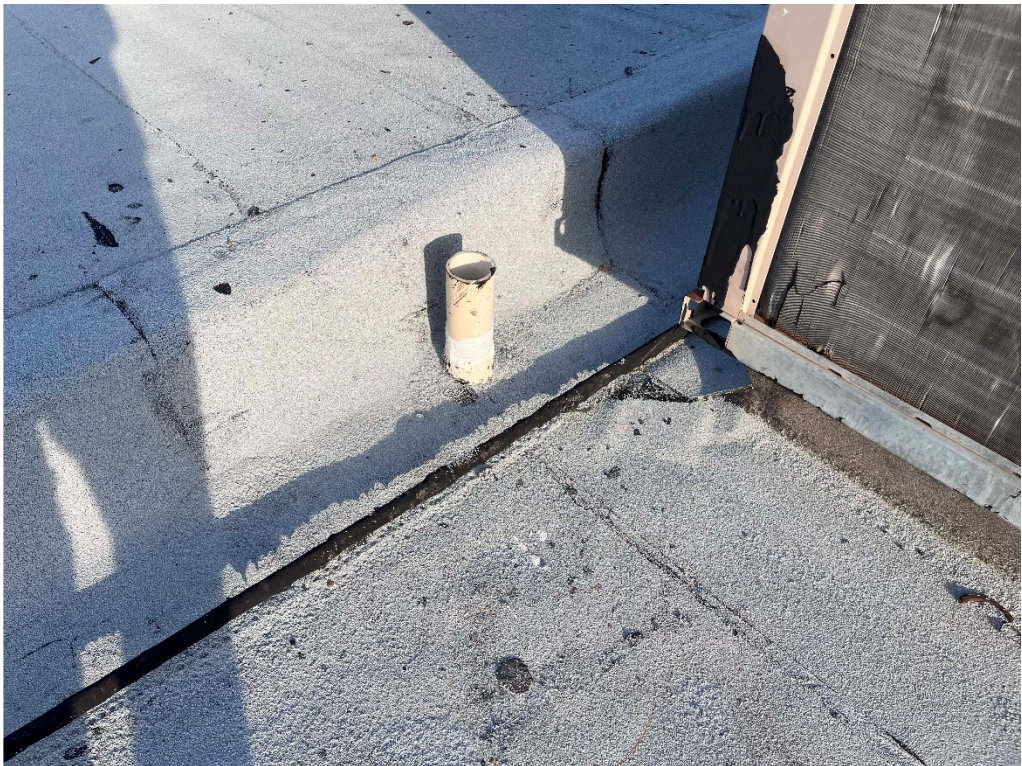
Figure 5 – GHS: this pipe does not appear to meet 12 MIN clearance requirements

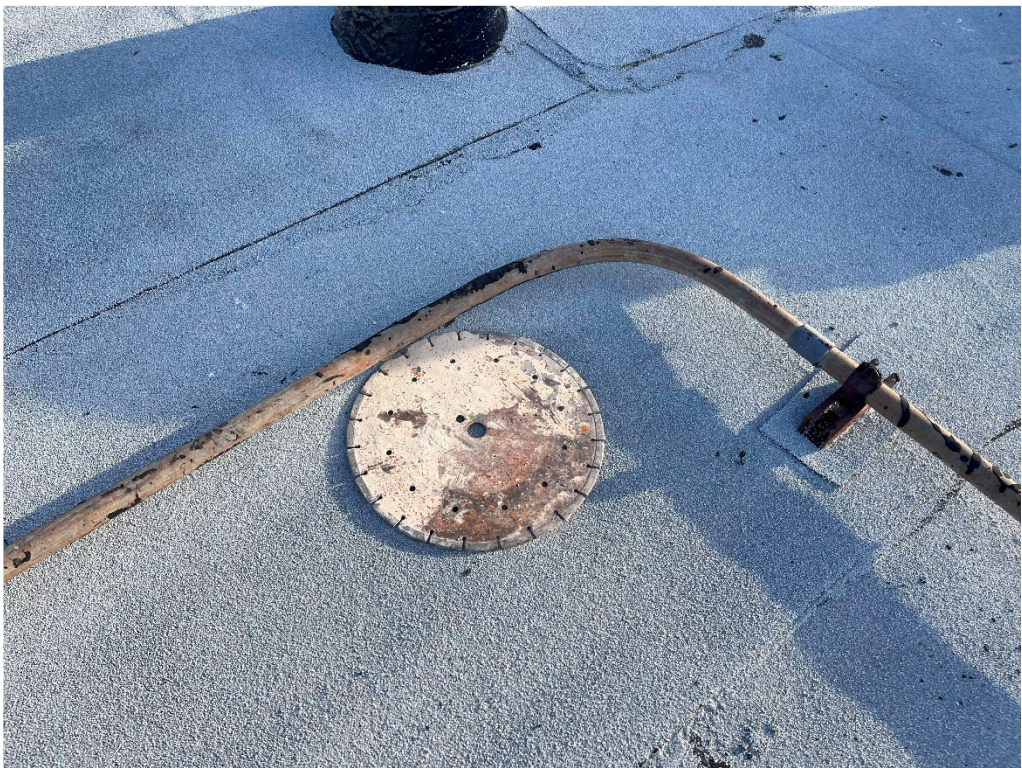
Figure 6 – GHS: contractor is reminded to clean up and the end of each; hazards like the type shown could cause damage to property or injury to person if left on the roof, unsecured over night

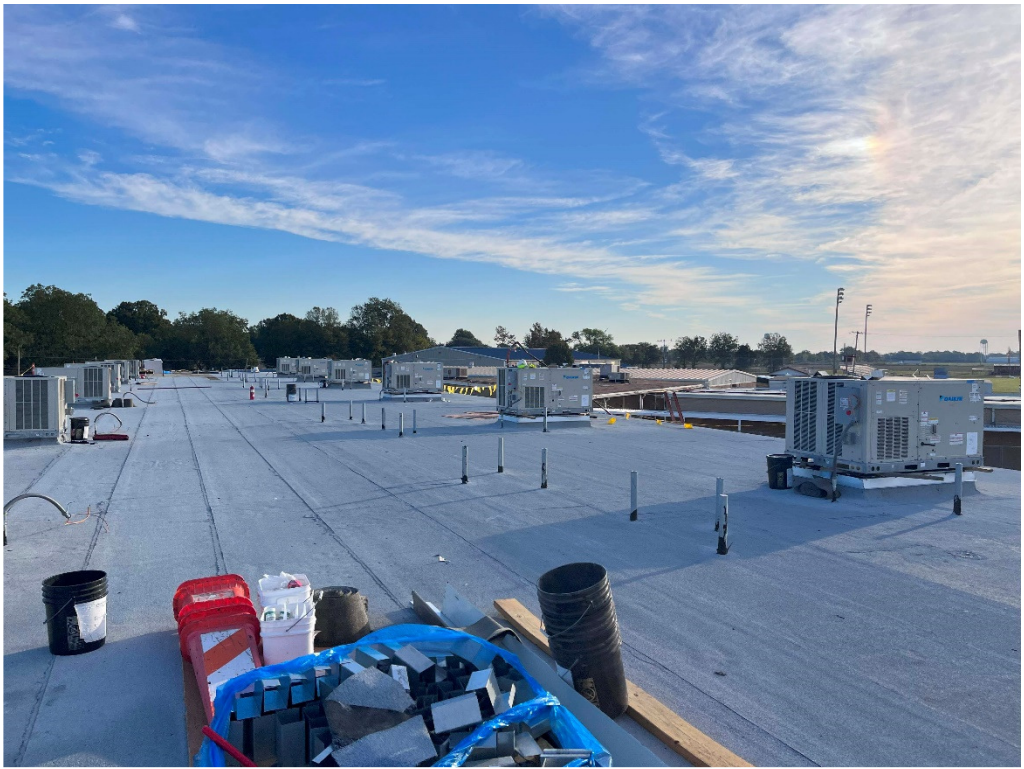
Figure 7 – GHS: diagonal hall roof progress

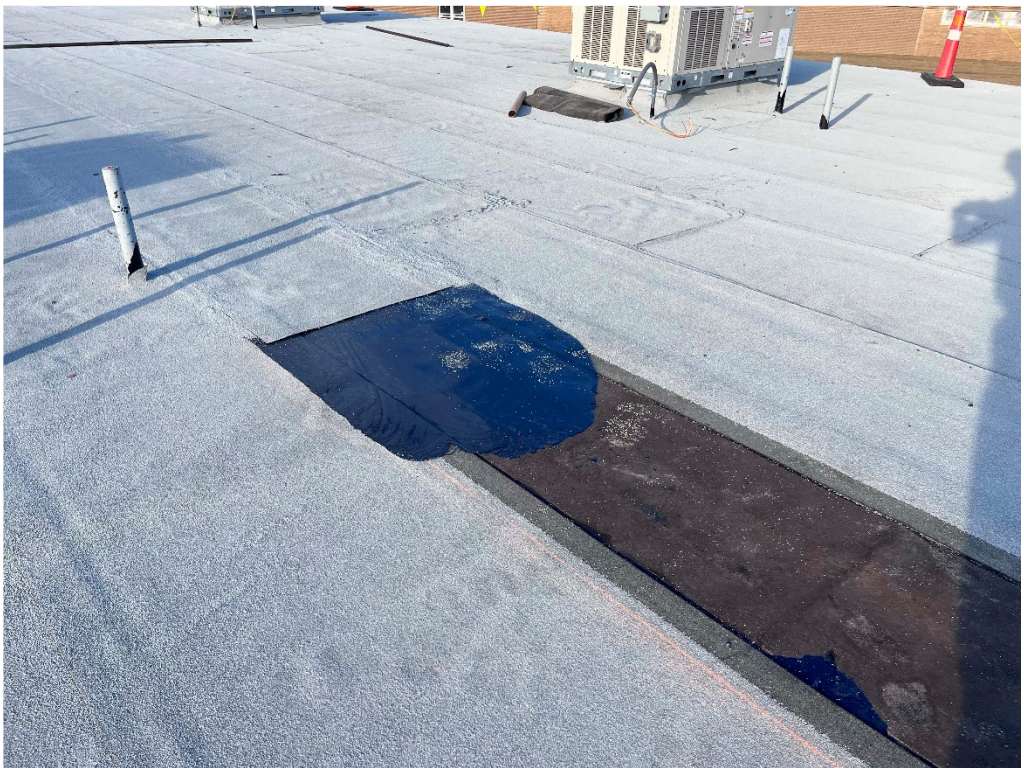
Figure 8 – GHS: roof progress to NE campus corner

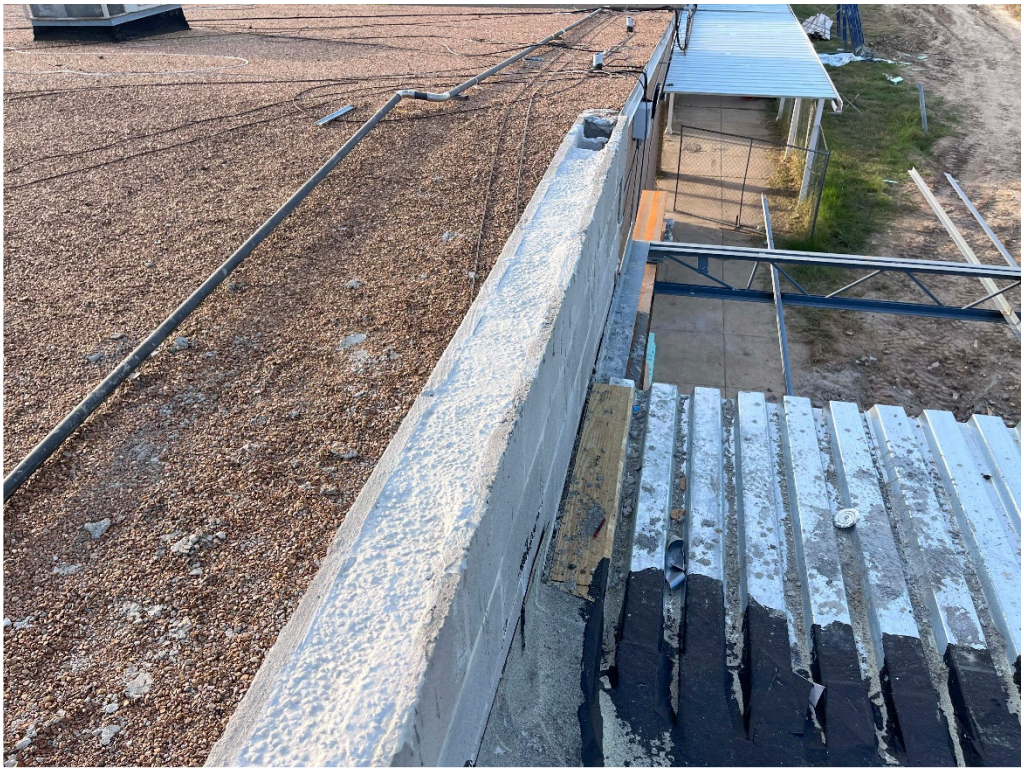
Figure 9 – GHS: firewall detail above existing.

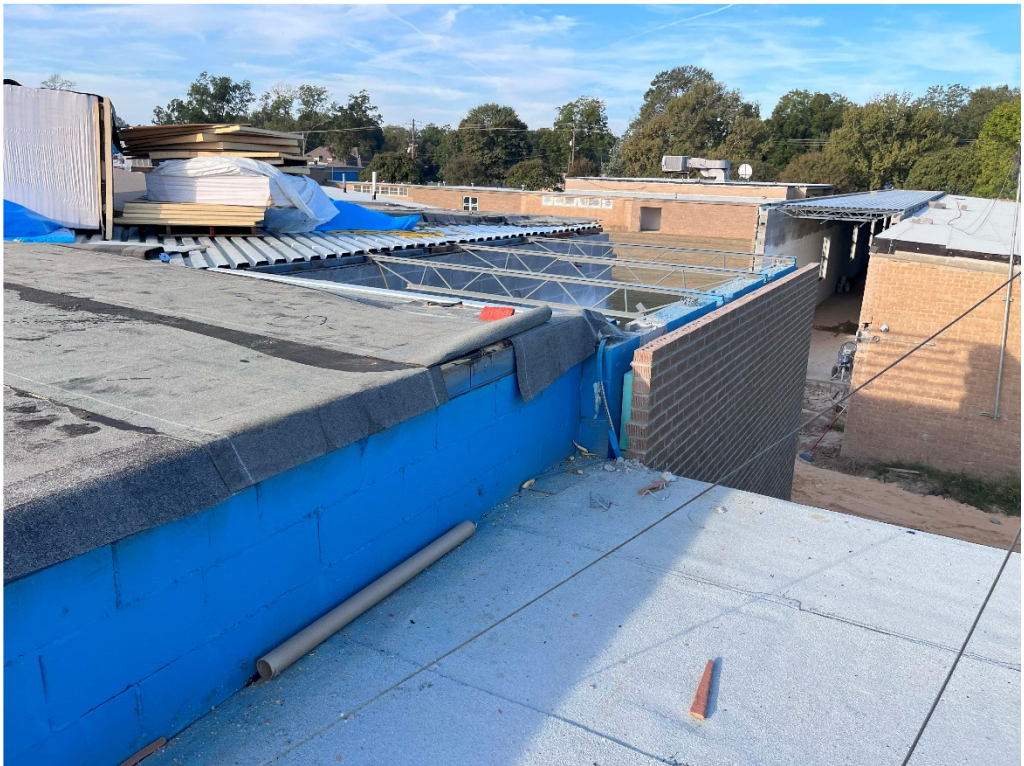
Figure 10 – GHS: roof progress at NE campus corner

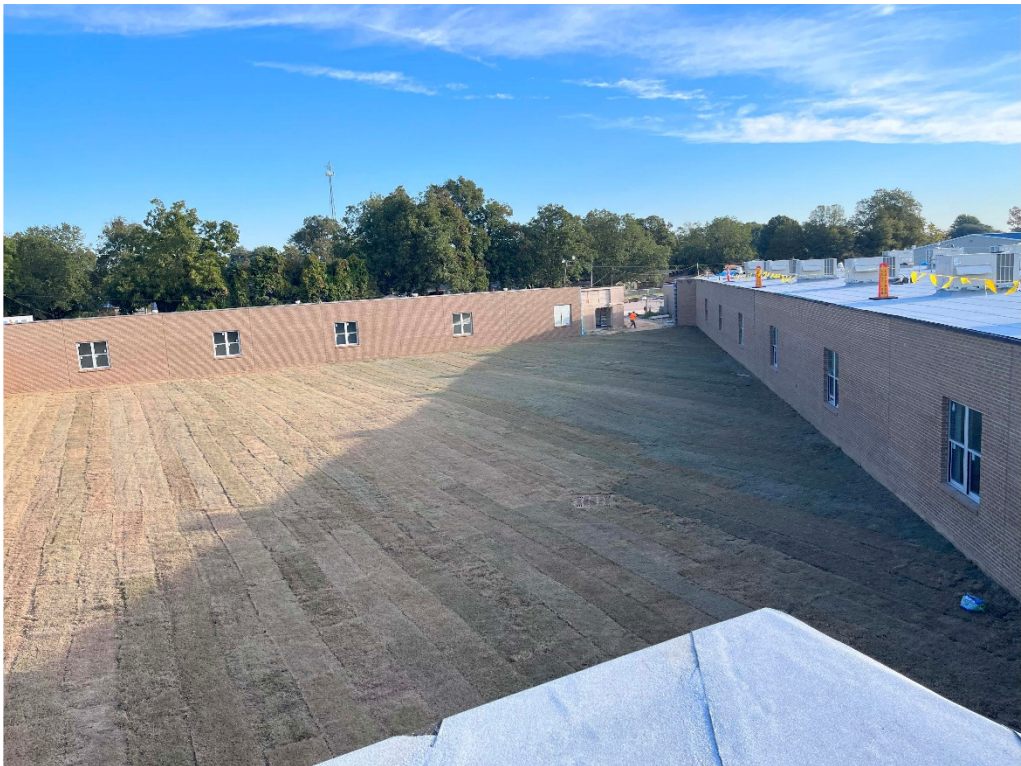
I walked the new roofing which seems to be in good order and is ongoing. I could tell from the roof top that the NW exterior courtyard appeared complete.

Figure 11 – GHS: NW exterior courtyard progress

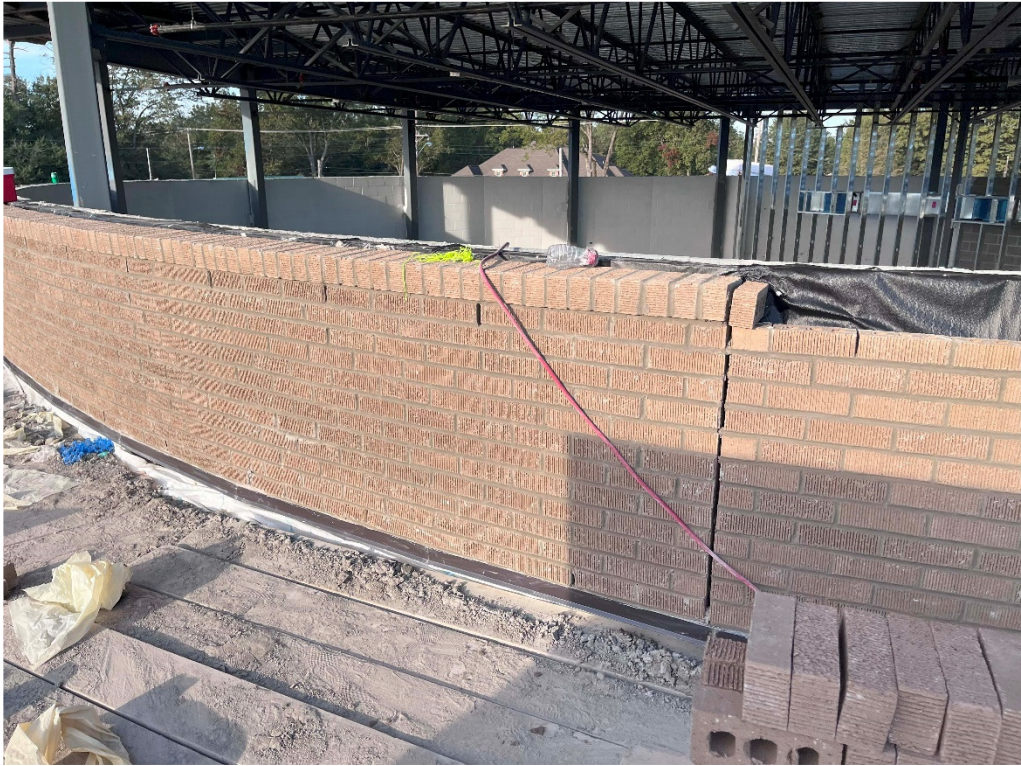
Observations GHS: on site, workers were busy installing ceiling grid. Masons were at roof installing brick around rotunda. I met Collin Chandler on the roof and ask him to make sure rigid foam board was installed correctly behind masonry wall. Product has been loose laid in the space and gaps exist at the end of the wall cavity of which I had viewership. He said that he would review and ensure cavities were filled vertically without gaps with rigid foam board.

Figure 12 – GHS: Brick work at roof top

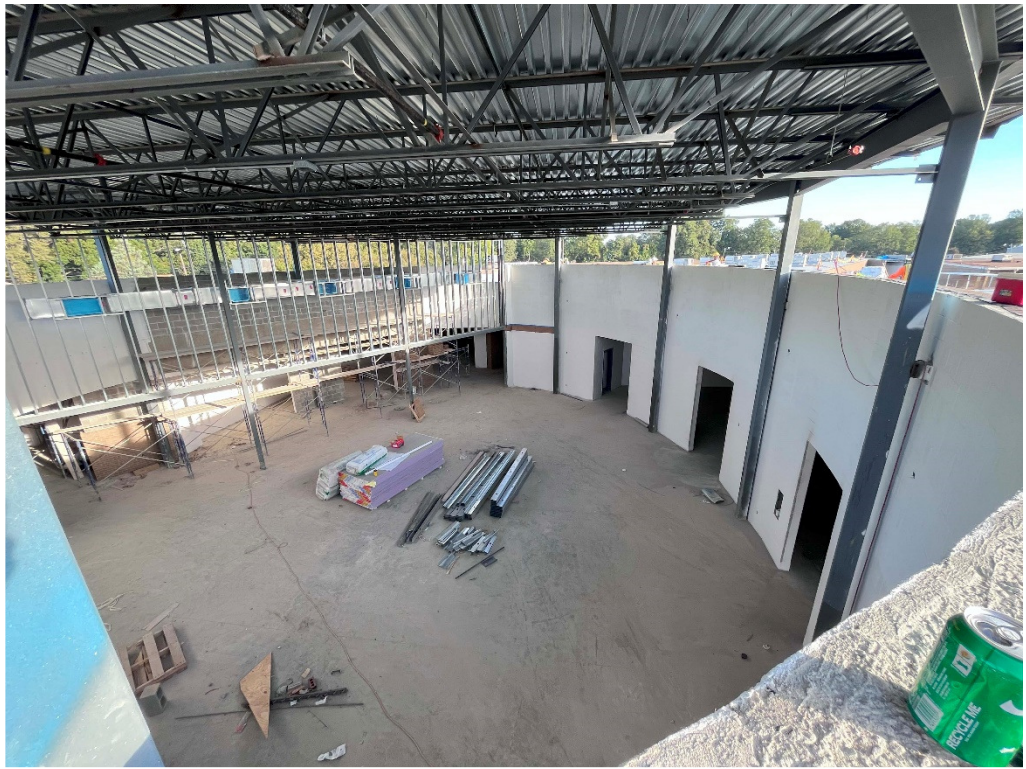
Figure 13 – GHS: cafeteria from above

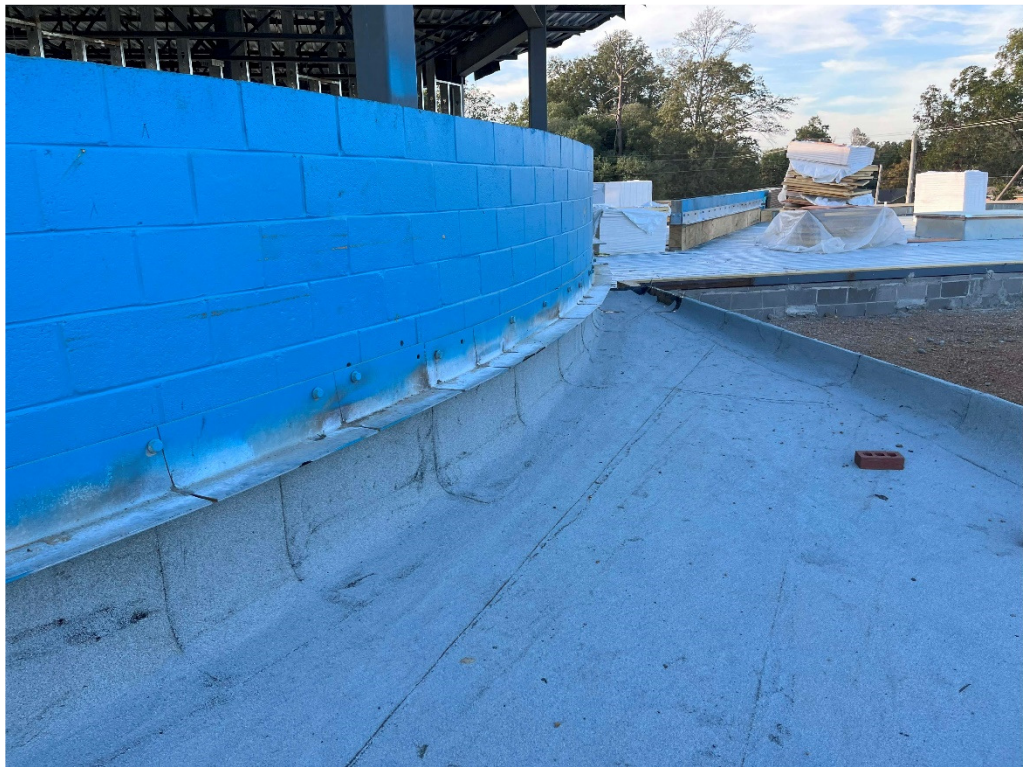
Figure 14 – GHS: brick lintel in place

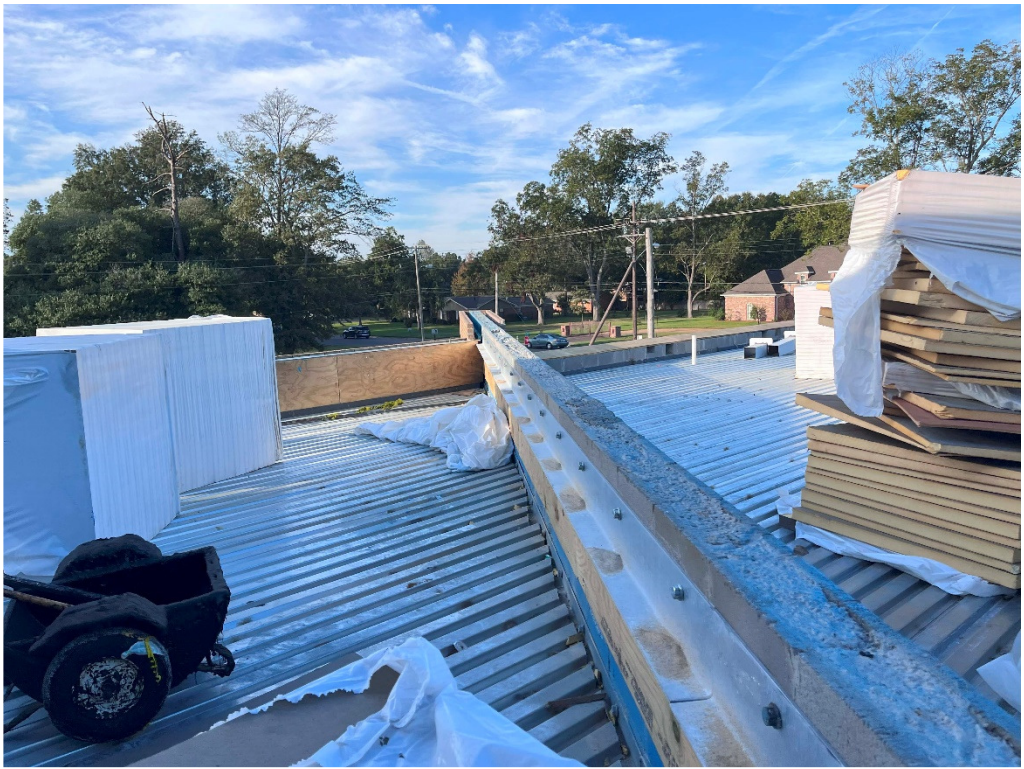
Figure 15 – GHS: roof top progress

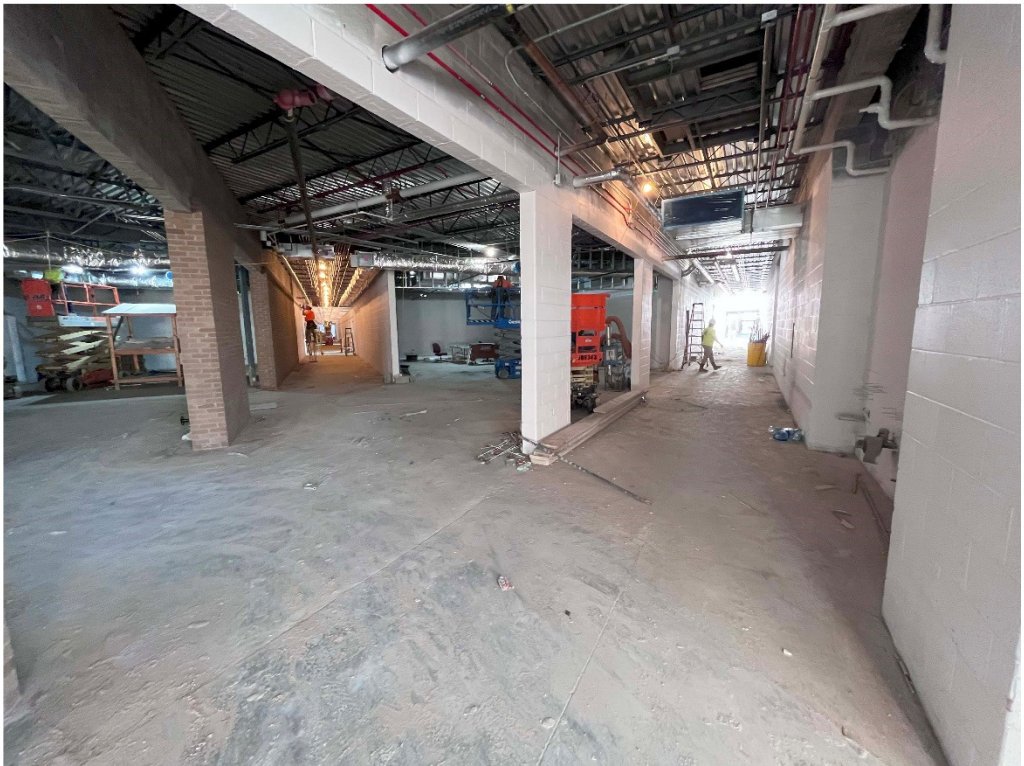
Figure 16 – GHS: 5 points hall

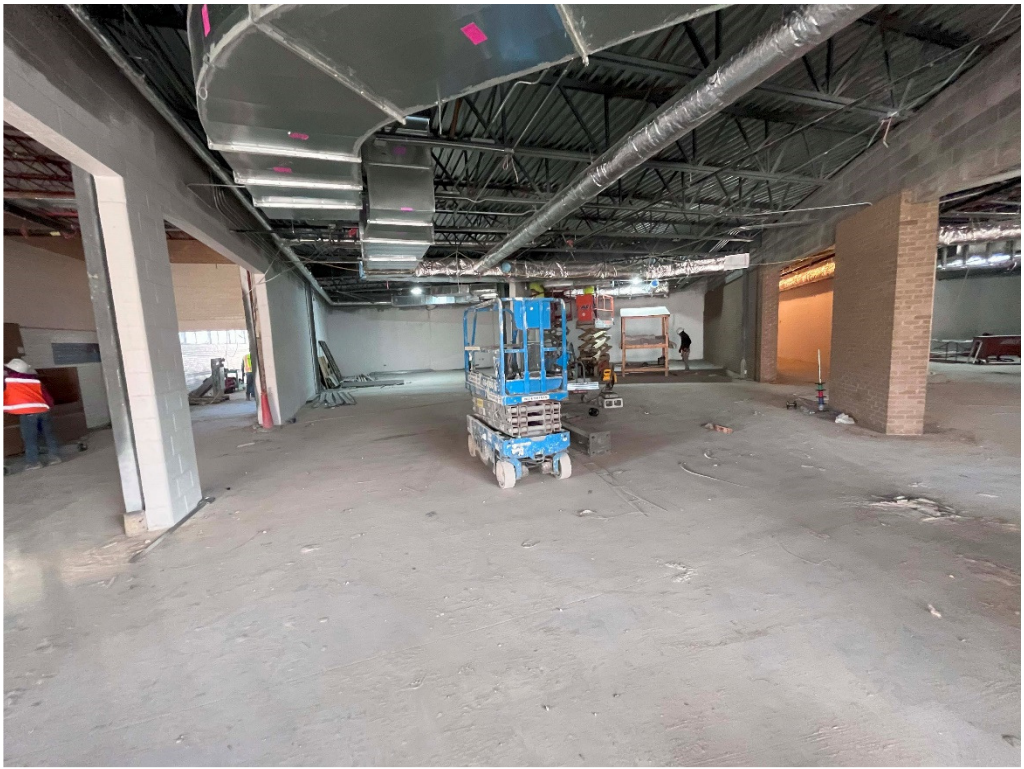
Figure 17 – GHS: front lobby, where discussed lowered ceiling may be required

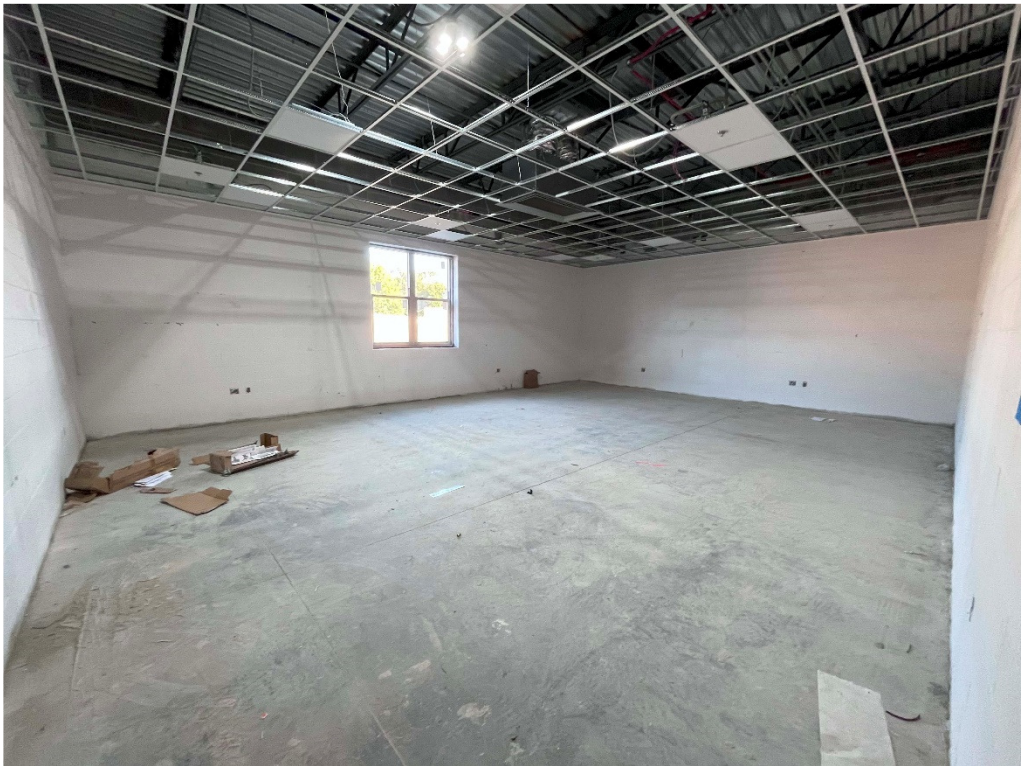
Figure 18 – GHS: typical classroom at diagonal hall progress

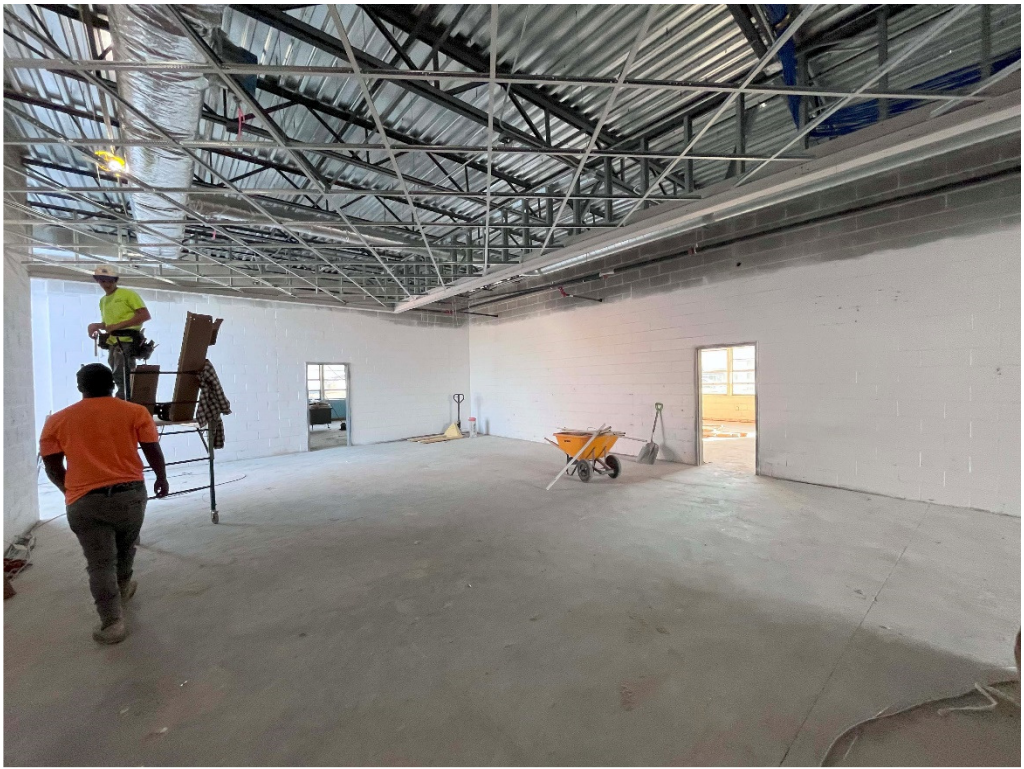
Figure 19 – GHS: NE end of diagonal hall

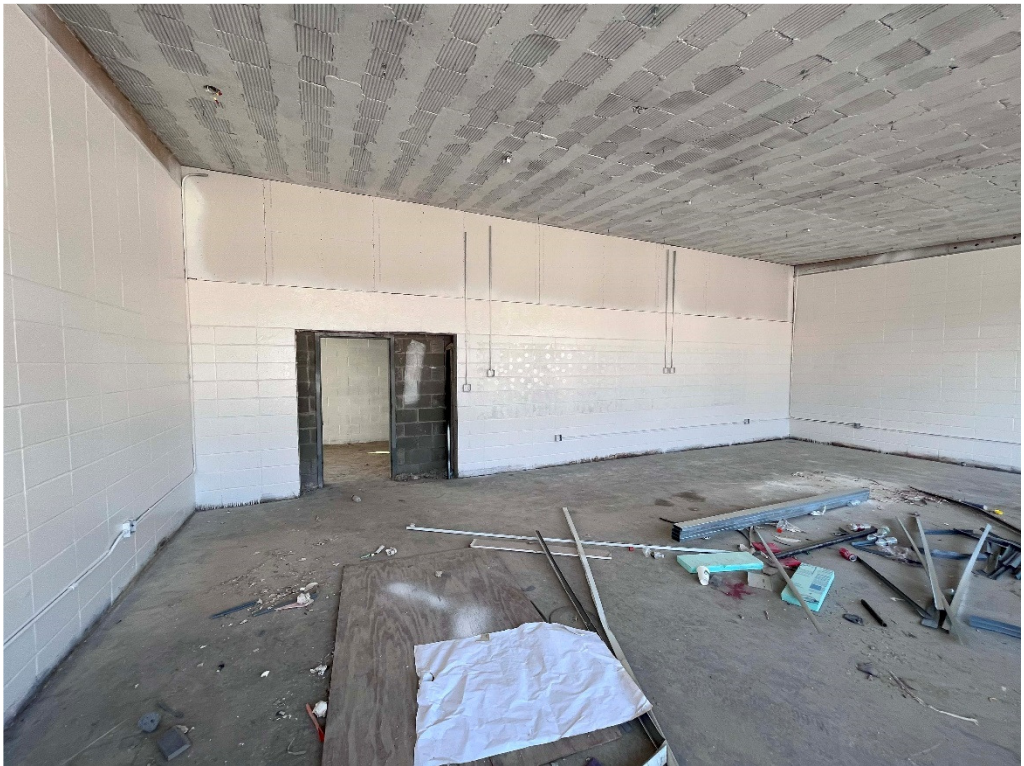
Figure 20 – GHS: Typical north classroom progress

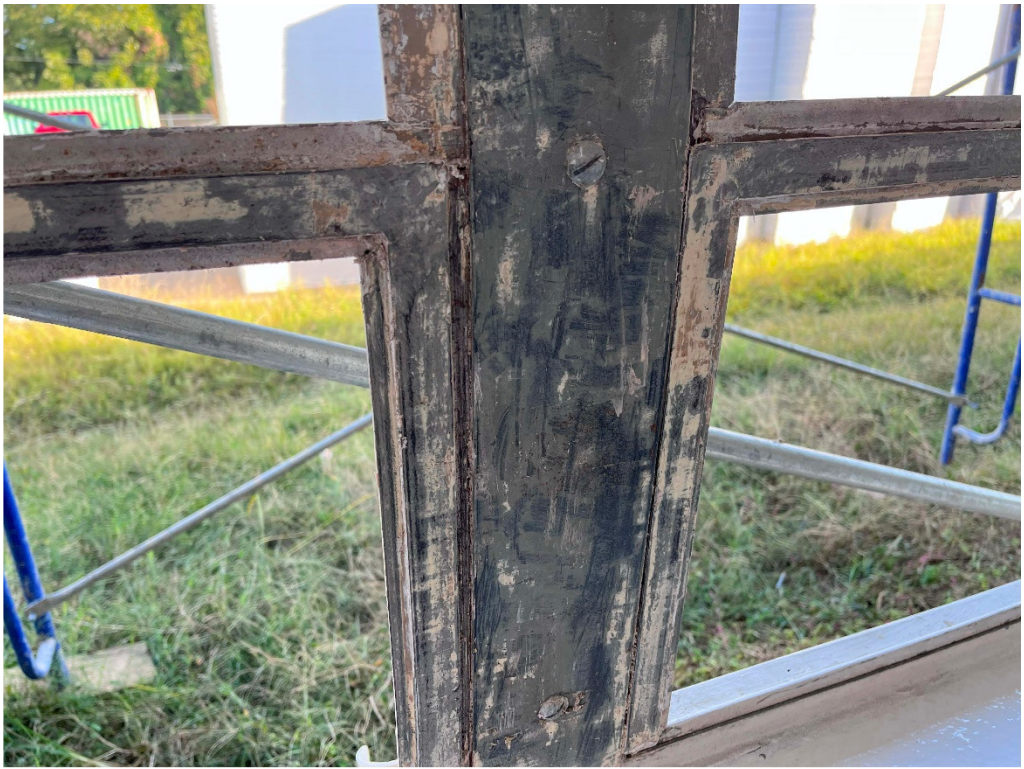
Figure 21 – GHS: progress at window restoration at north hall

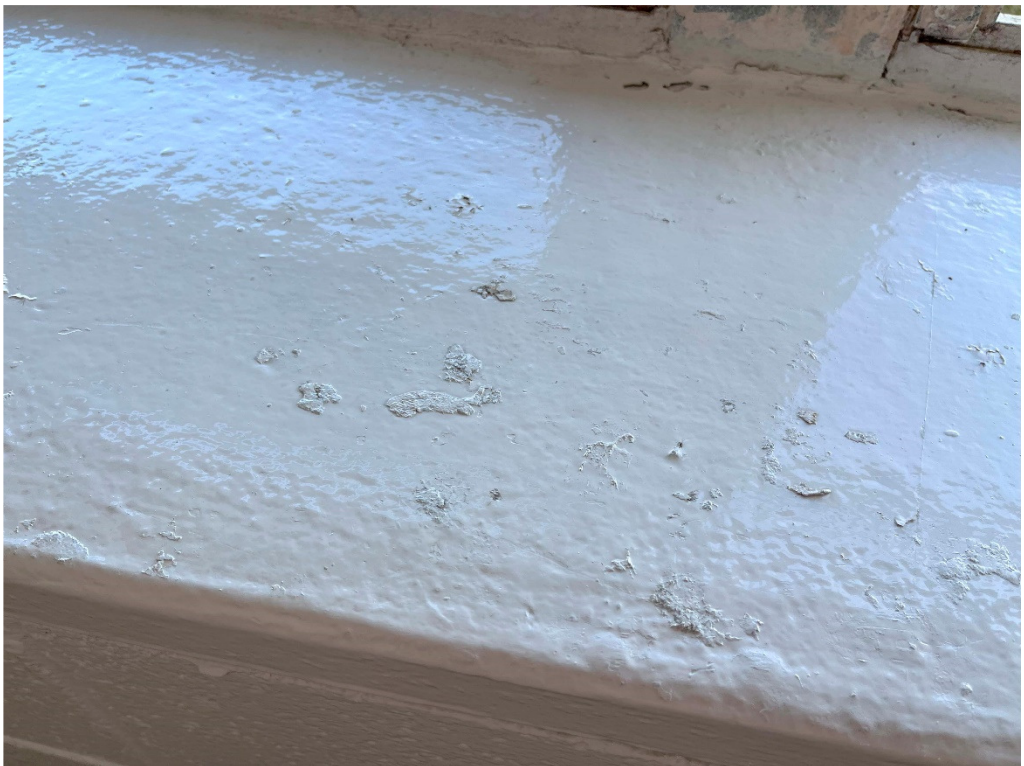
Figure 22 – GHS: debris noted beneath paint at existing seal shall be removed prior to paint

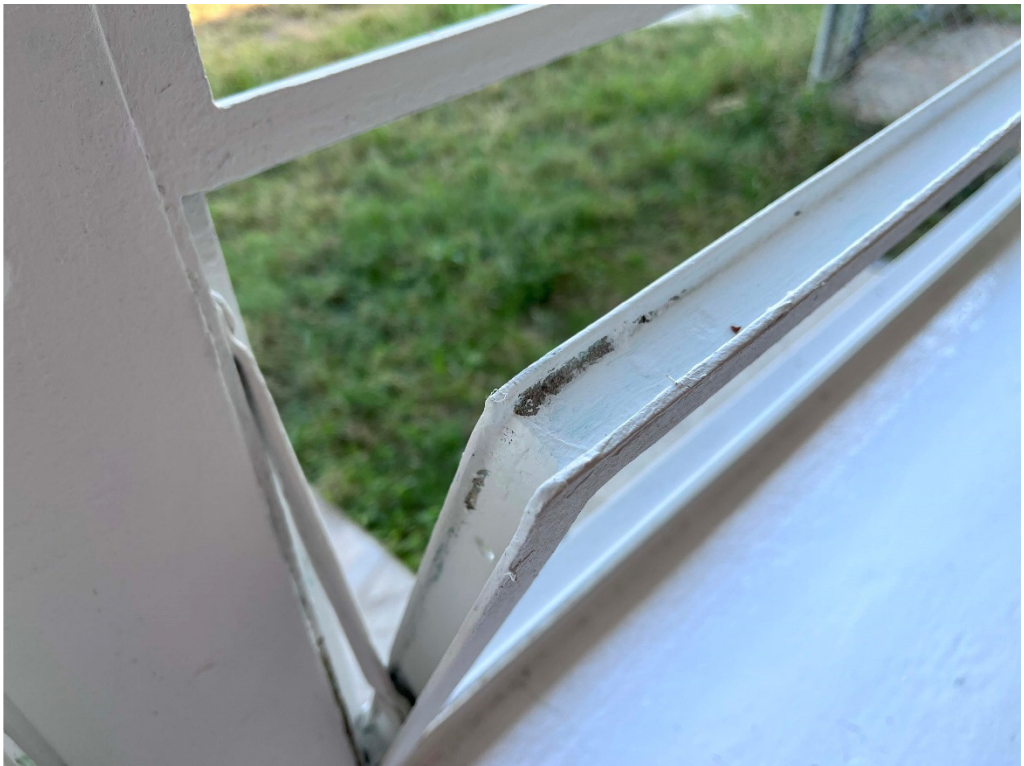
Figure 23 – GHS: full coverage at all new window restorations is required

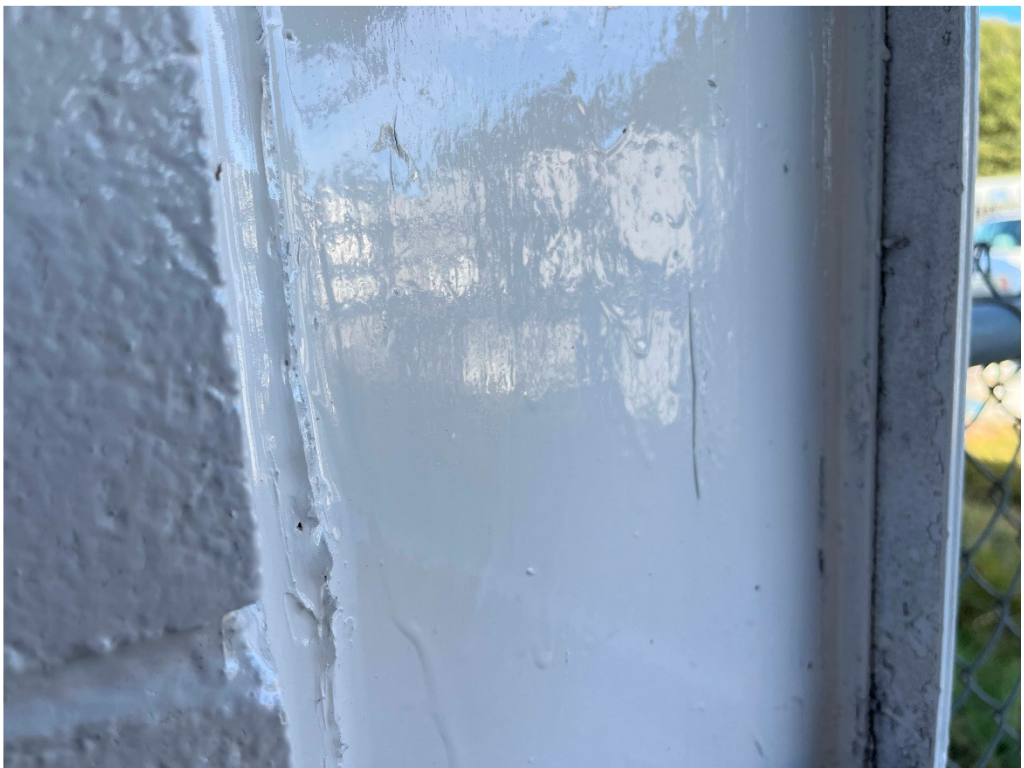
Figure 24 – GHS: drips and runs in paint shall be sanded, removed, and repainted

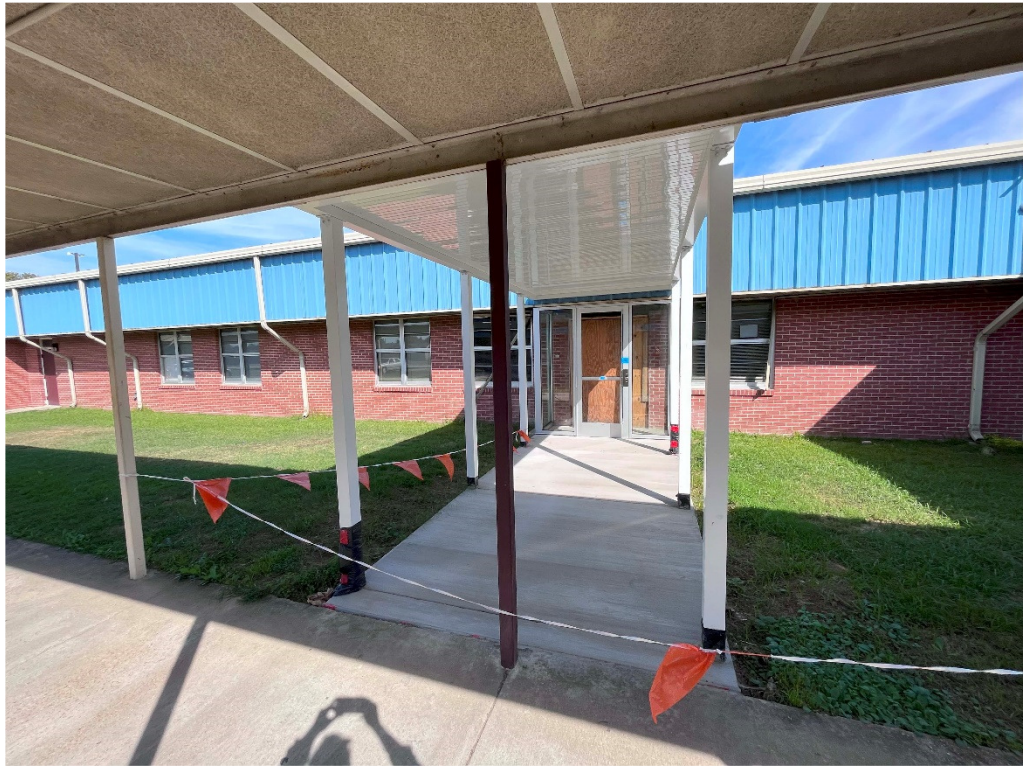
Figure 25 – Merrit Middle: provide pricing to restructure existing awning as described above

Action Required At Merrit Middle, provide cost to add 2 columns aligned with 2 new column lines from new storefront entry with mounting flanges at bottom and bolted directly to existing concrete and fastened to upper structure in compression. Remove existing column in center of new sidewalk.

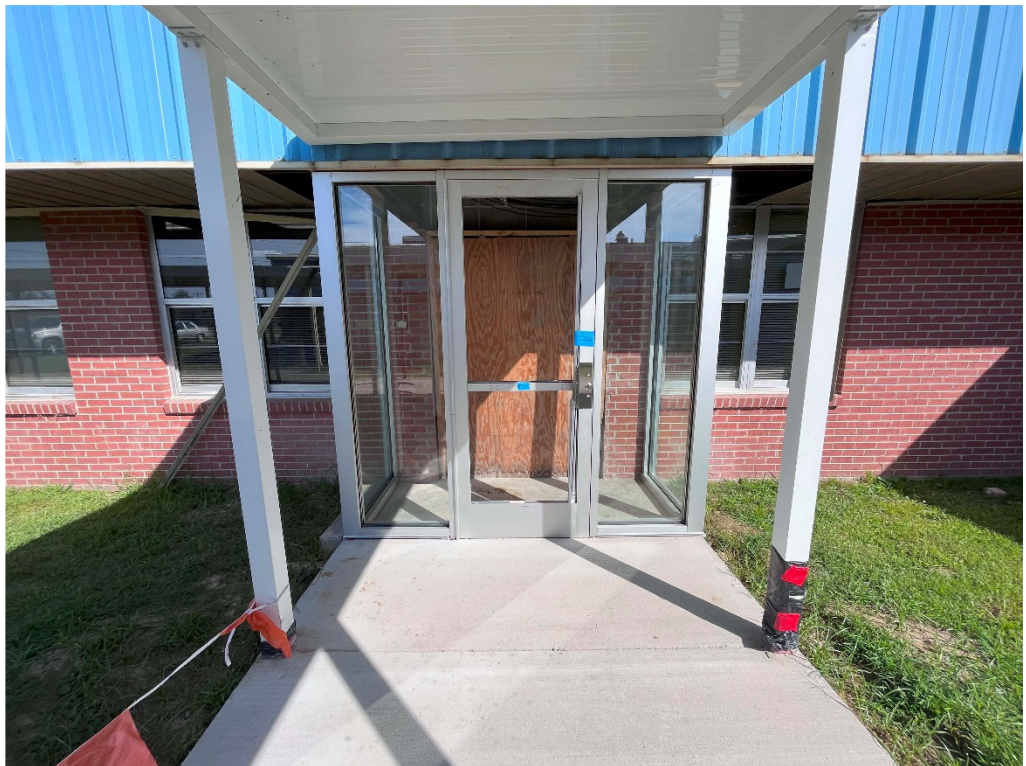
Figure 26 – Merrit Middle: progress at Merrit Middle Entry

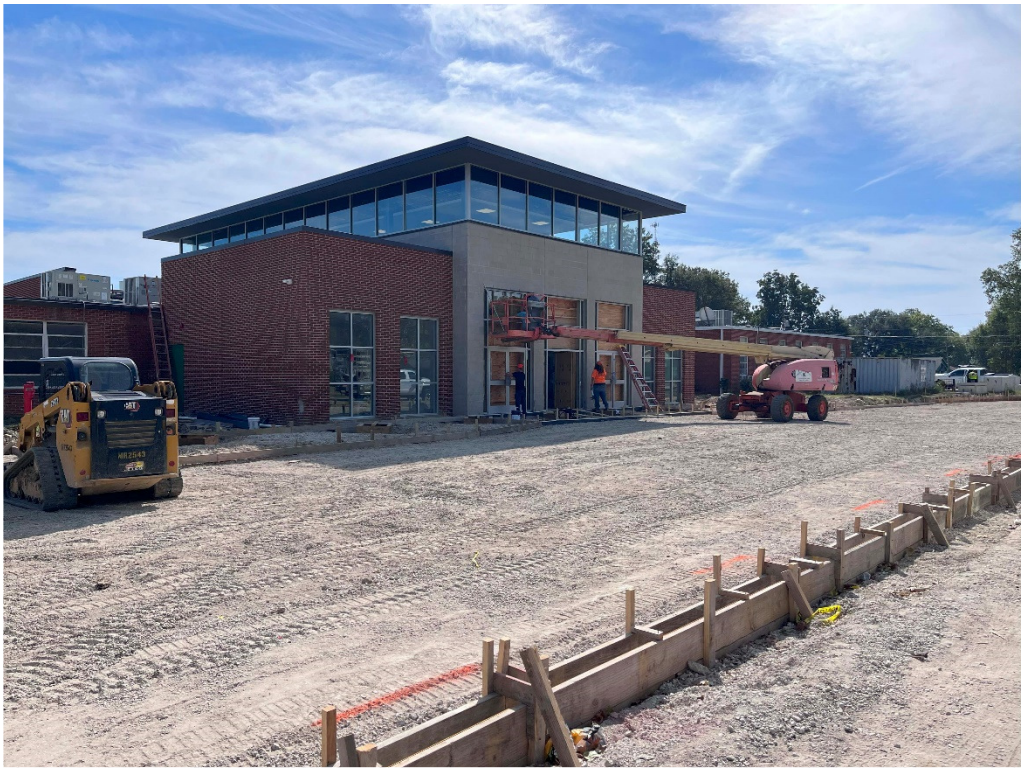
Figure 27 – TEHS: progress at front entry; glass install in progress

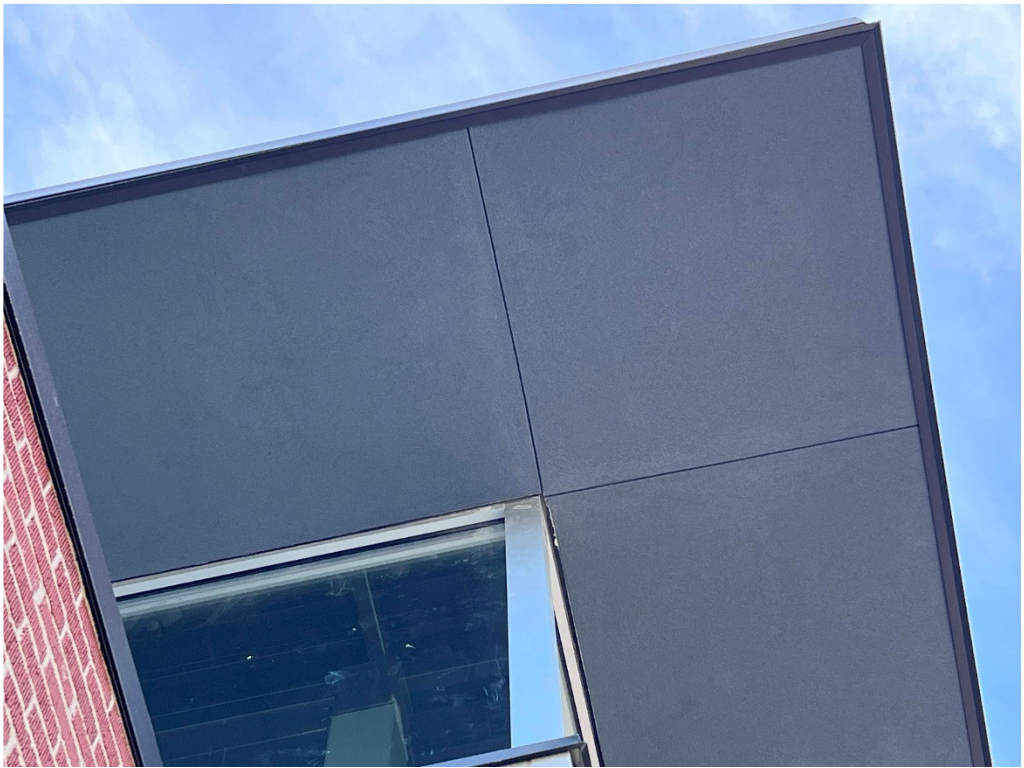
Figure 28 – TEHS: stucco installed
