21081 Sunflower Consolidated SD Phase II, Report Number 013

Date, Time 10 October 2023, 8:00 AM

Paul Purser, AIA
Dale | Bailey, an Association

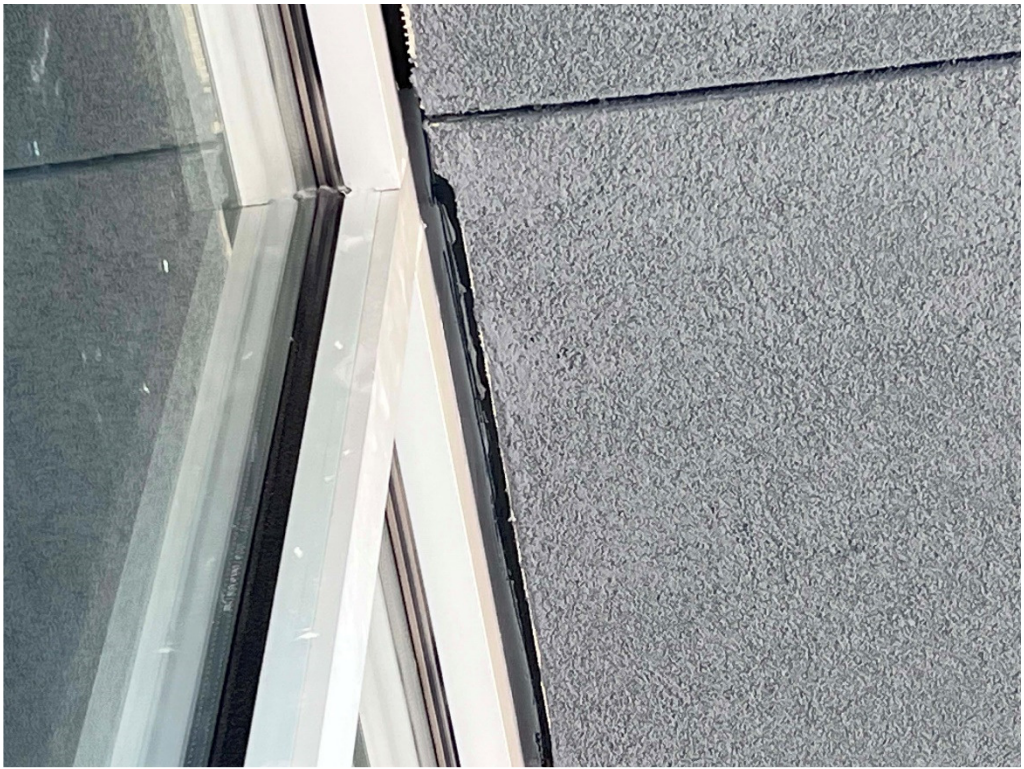
Figure 29 – TEHS: Joints Awaiting Sealant Installation

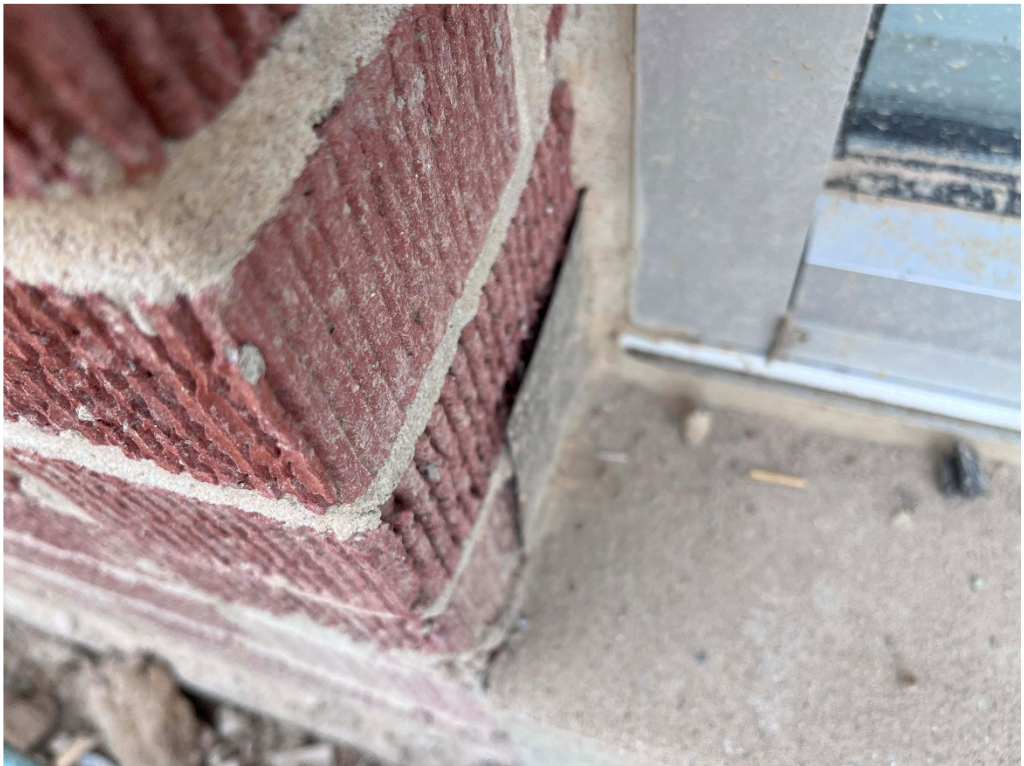
Figure 30 – TEHS: cut back exposed flashing to flush with concrete and storefront

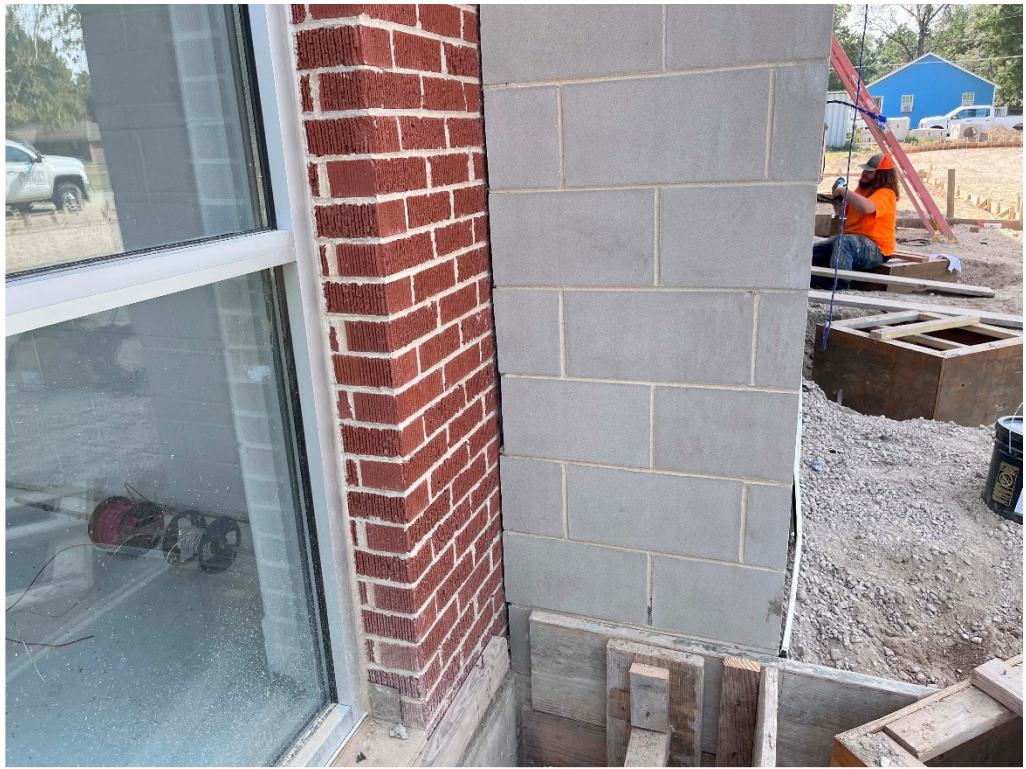
Figure 31 – TEHS: Joints Awaiting Sealant Installation

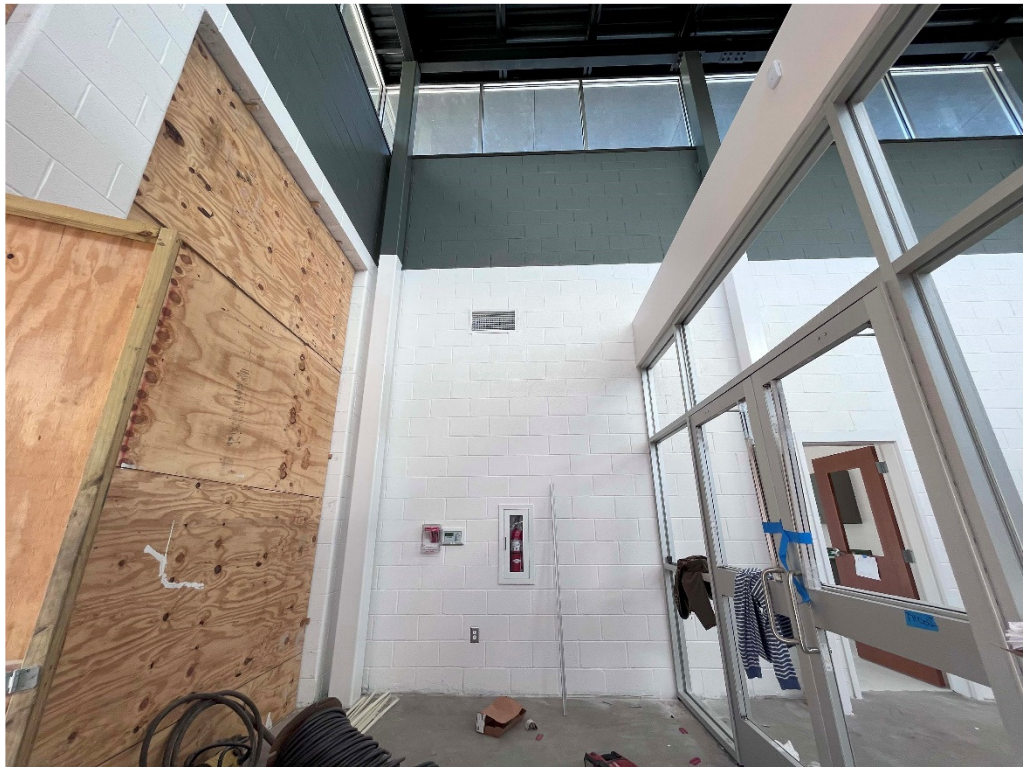
Figure 32 – TEHS: secure vestibule progress

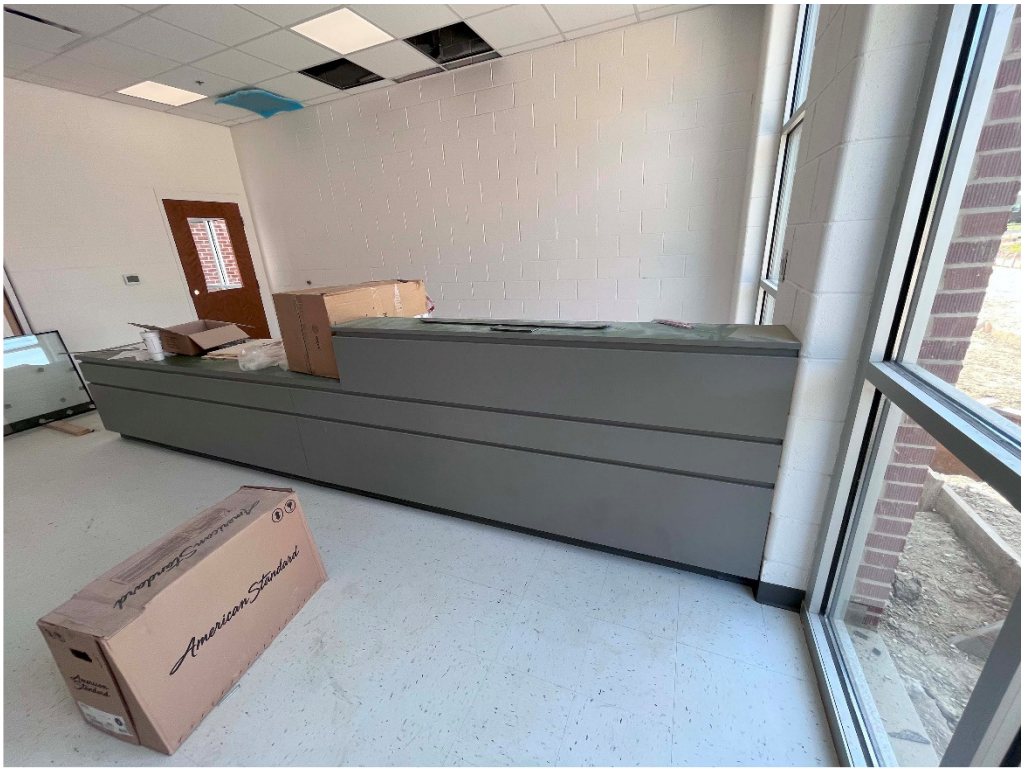
Figure 33 – TEHS: millwork installed

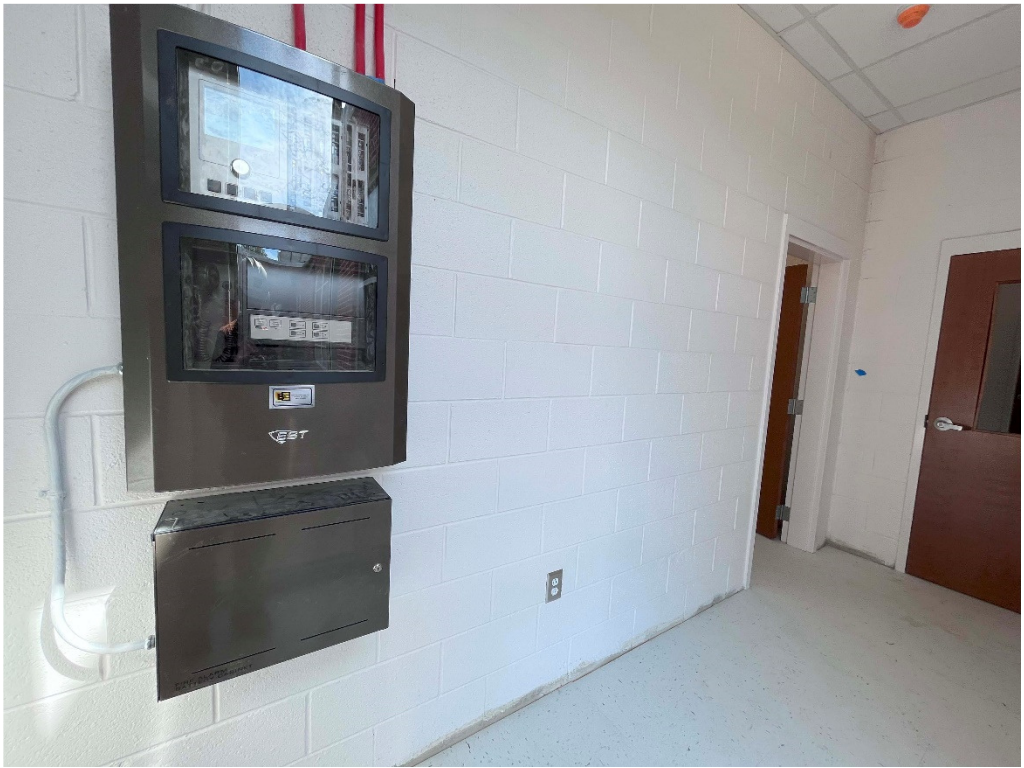
Figure 34 – TEHS: fire alarm equipment installed

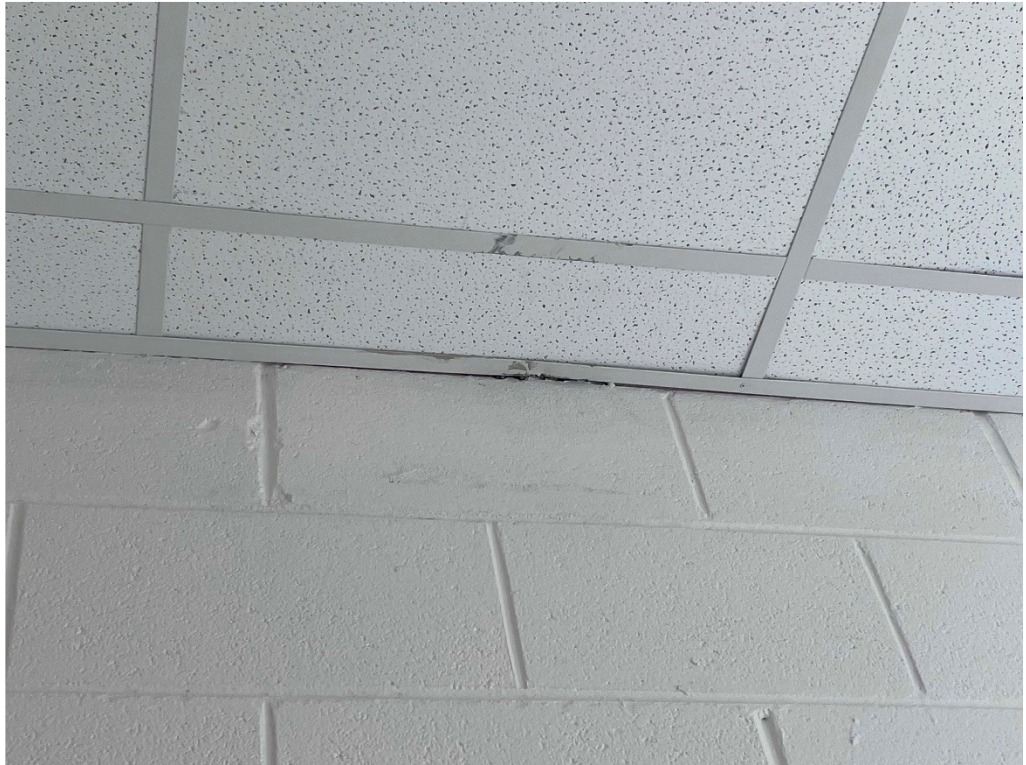
Figure 35 – TEHS: contractor is reminded to that all new ceiling installation shall be new and without deformation or discoloring

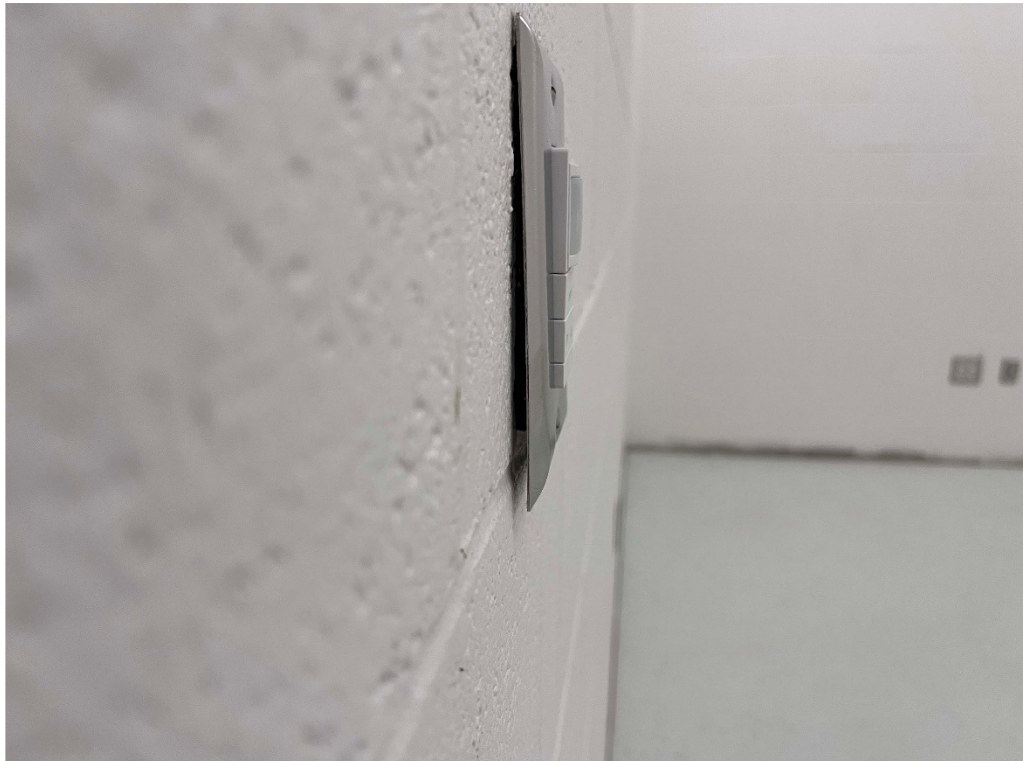
Figure 36 – TEHS: contractor is reminded to install all electrical plates flush with wall surface

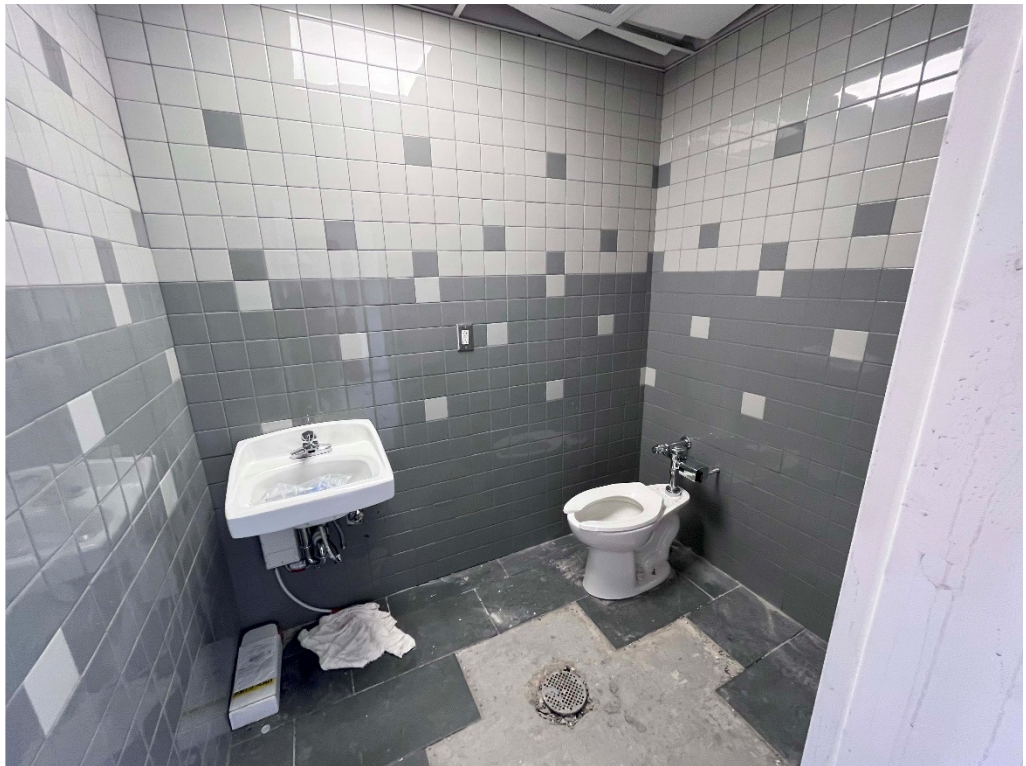
Figure 37 – TEHS: progress at toilets rooms noted

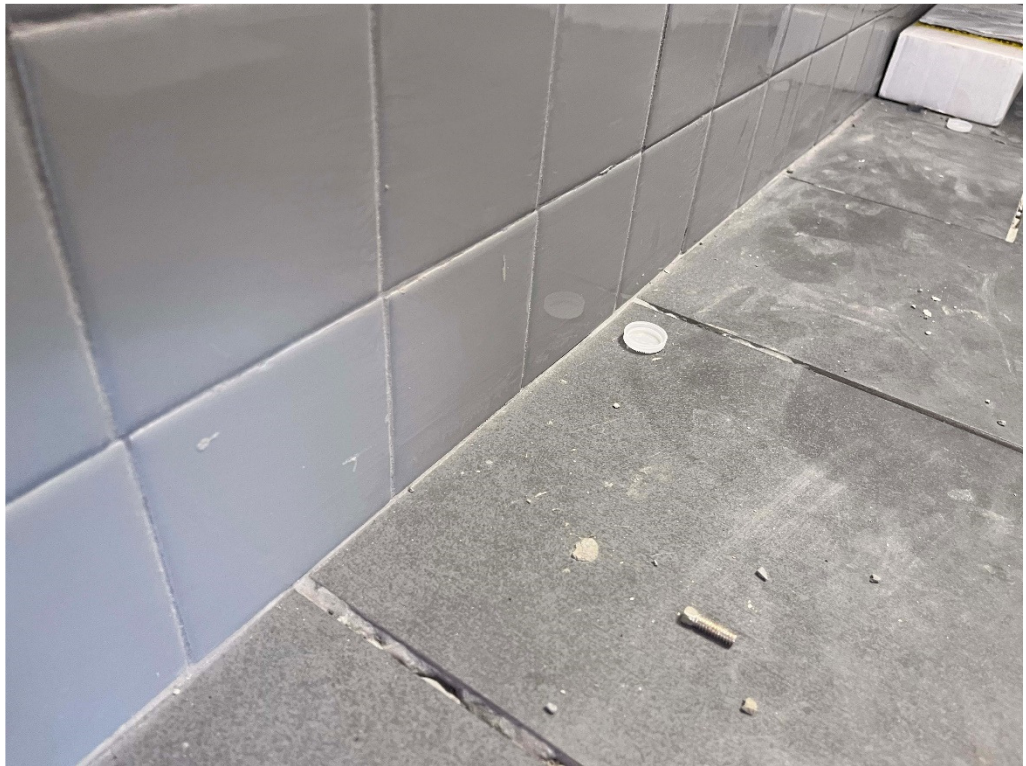
TEHS: missing cove tile at bottom of tile walls as specified in Spec section 093013 2.3 A

Figure 38 – TEHS: cove tile missing from toilet rooms; a credit in lieu of replacement could be considered; make proposal

At TEHS, propose replacement or credit for missed cove tile in toilet rooms

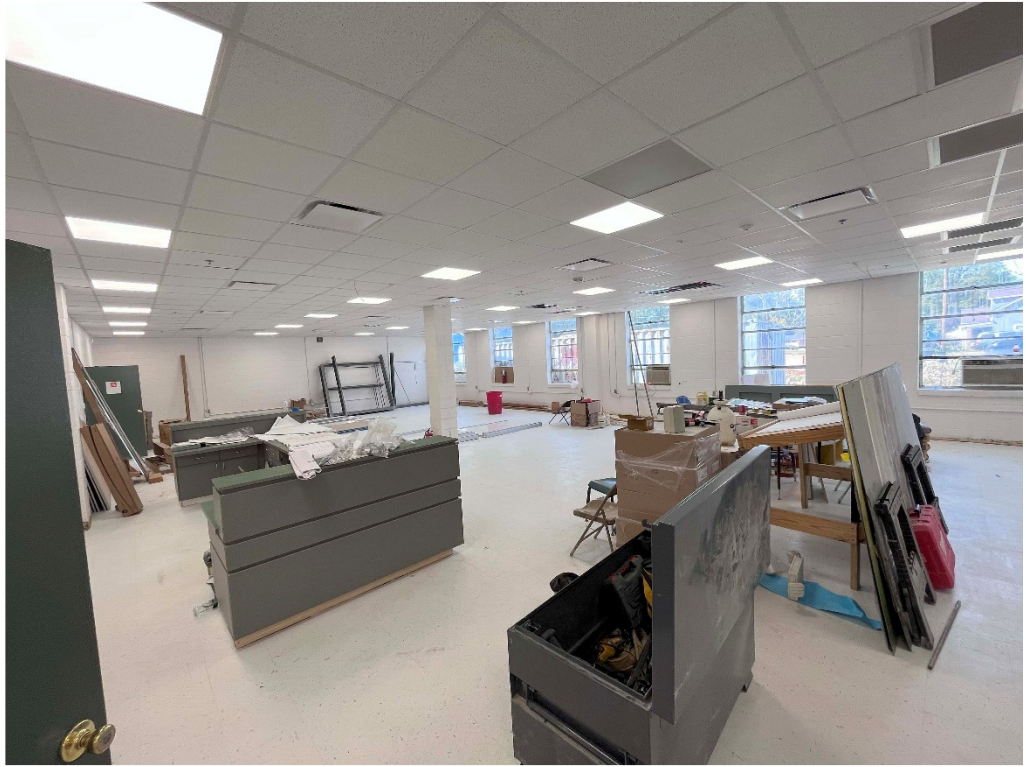
Figure 39 – TEHS: Media library progress

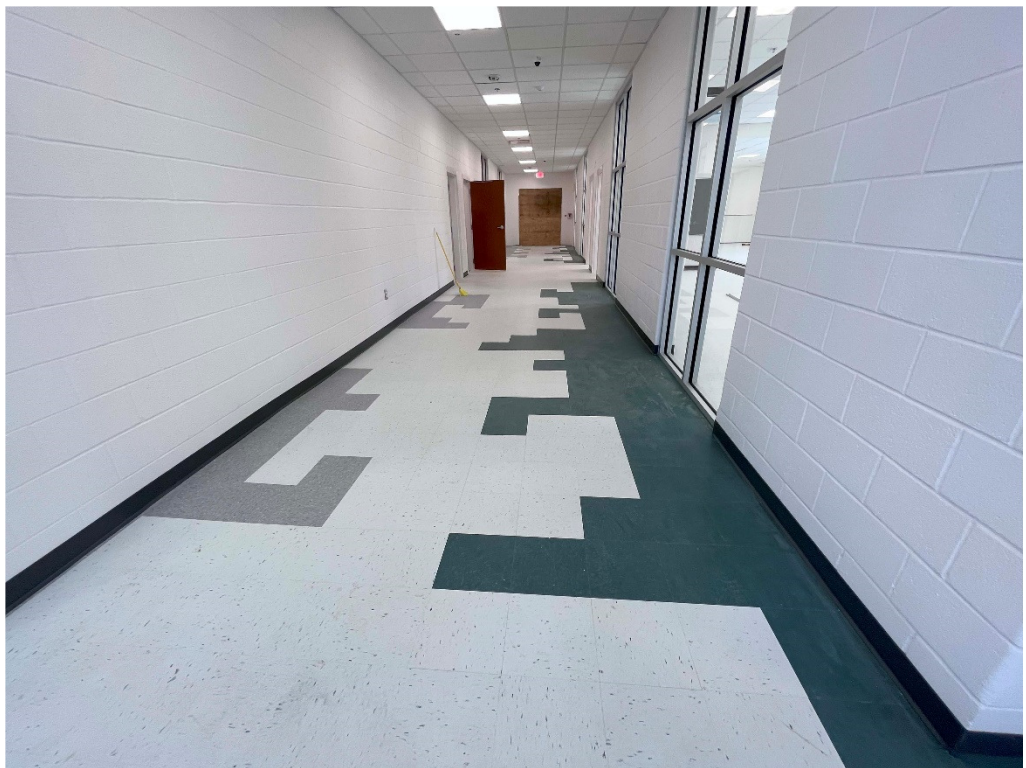
Figure 40 – TEHS: VCT progress noted at corridors

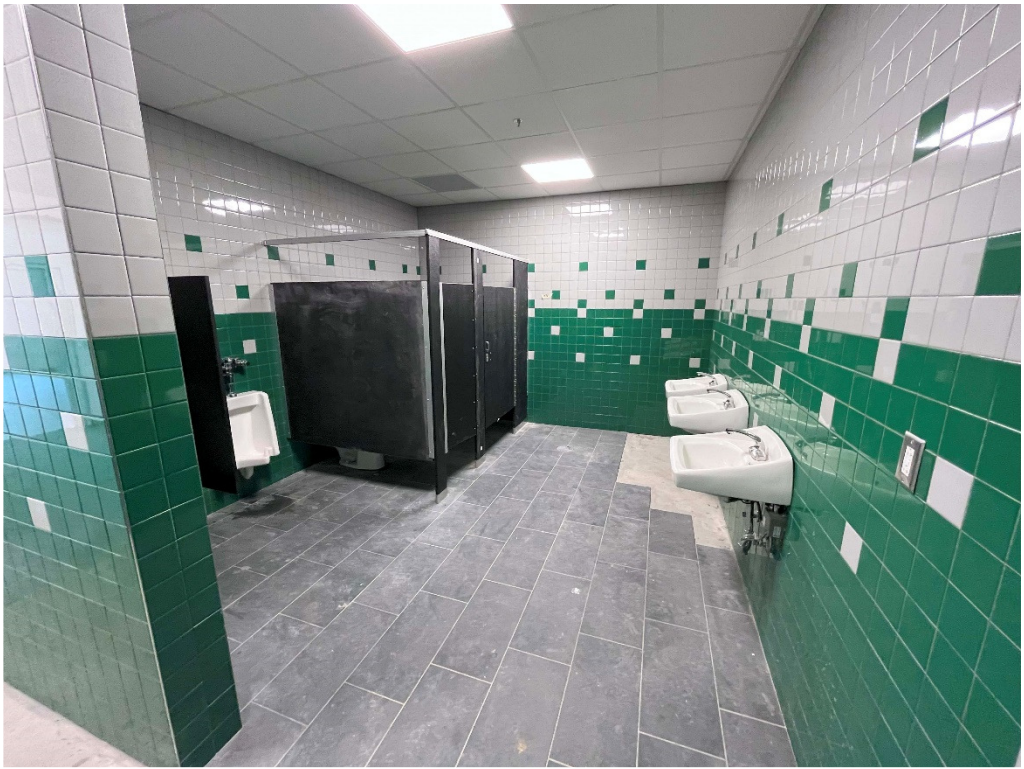
Figure 41 – TEHS: progress noted at toilet rooms; NOTE cove tile missing here also

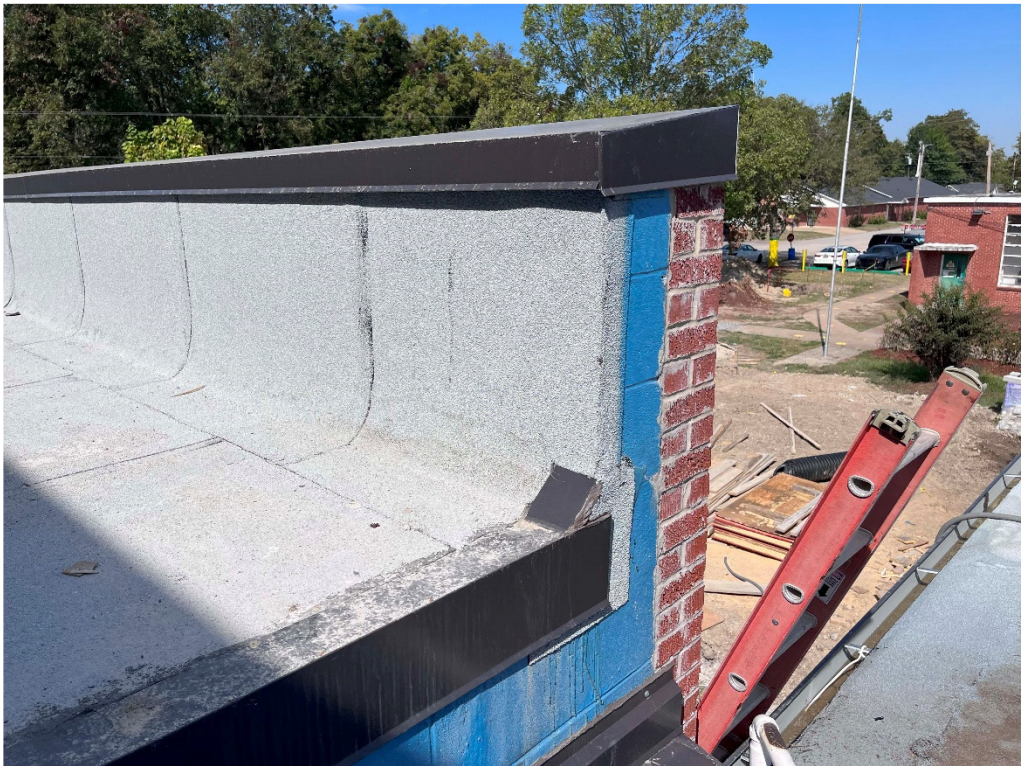
Figure 42 – TEHS: minimum dampproofing required over liquid vapor barrier

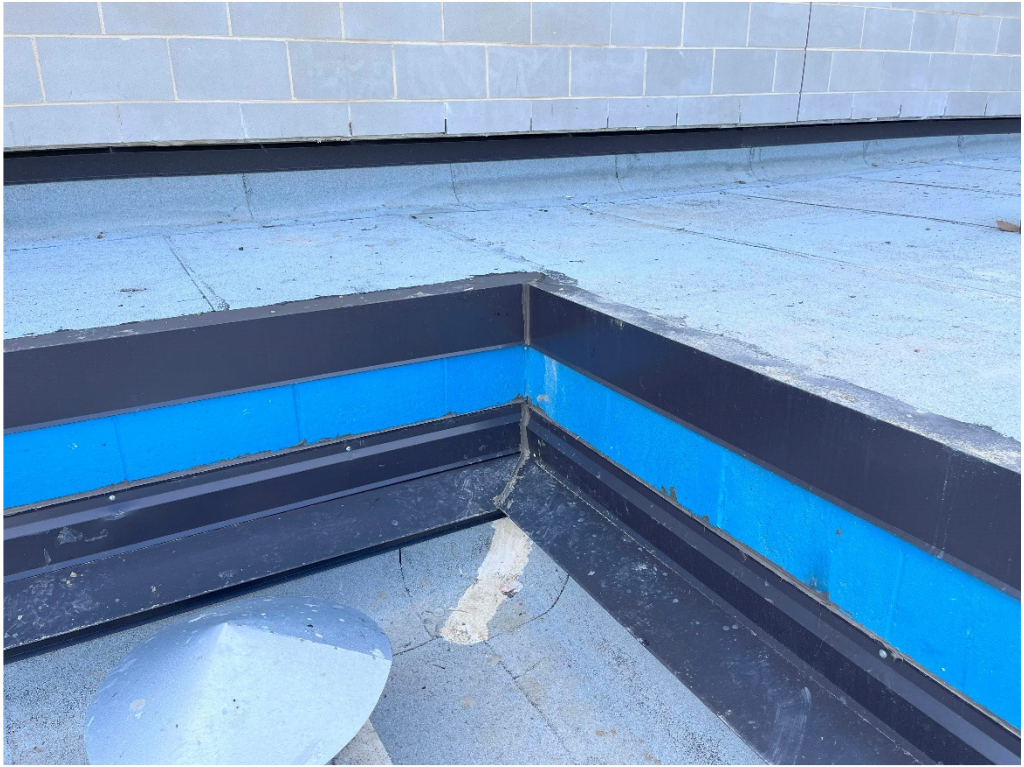
Figure 43 – TEHS: minimum dampproofing required over liquid vapor barrier

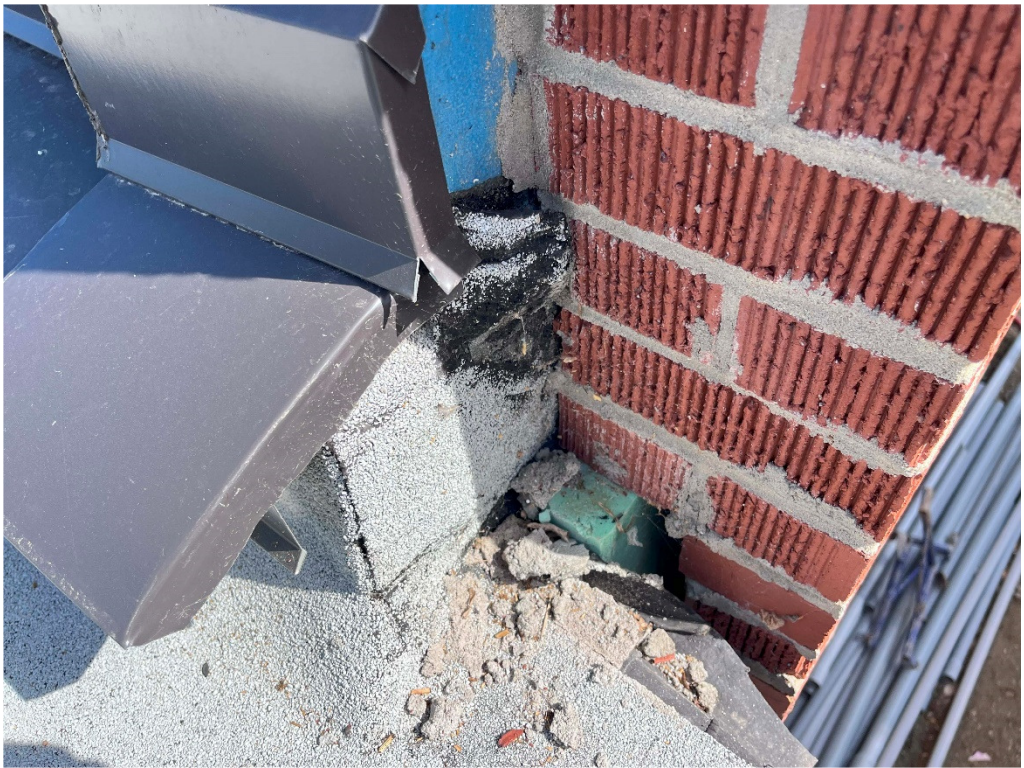
Figure 44 – TEHS: provide flashing and sealants over open wall cavity

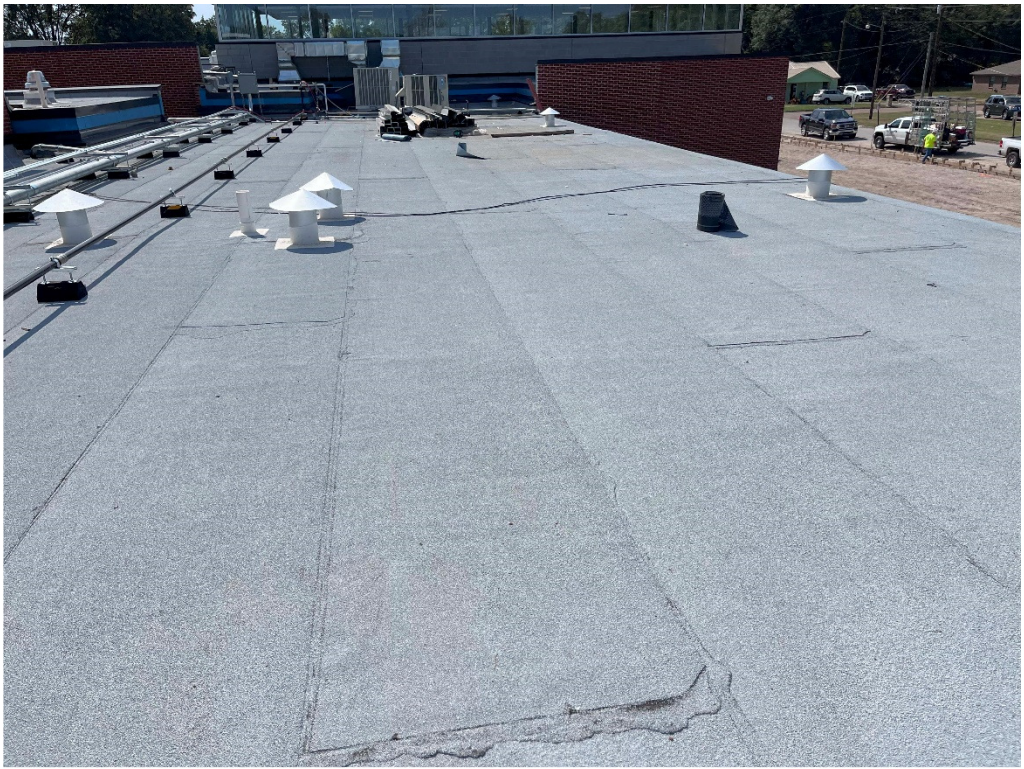
Figure 45 – TEHS: roof progress noted

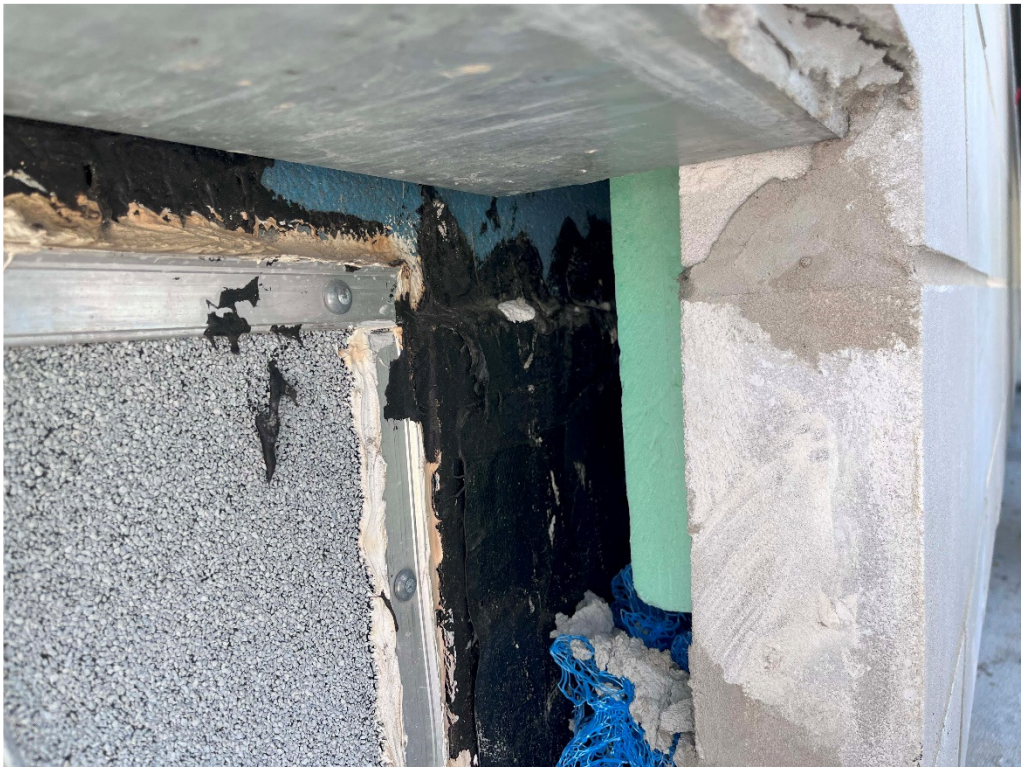
Figure 46 – TEHS: NE Roof Connection at Lobby: foam in gap; cover with metal flashing

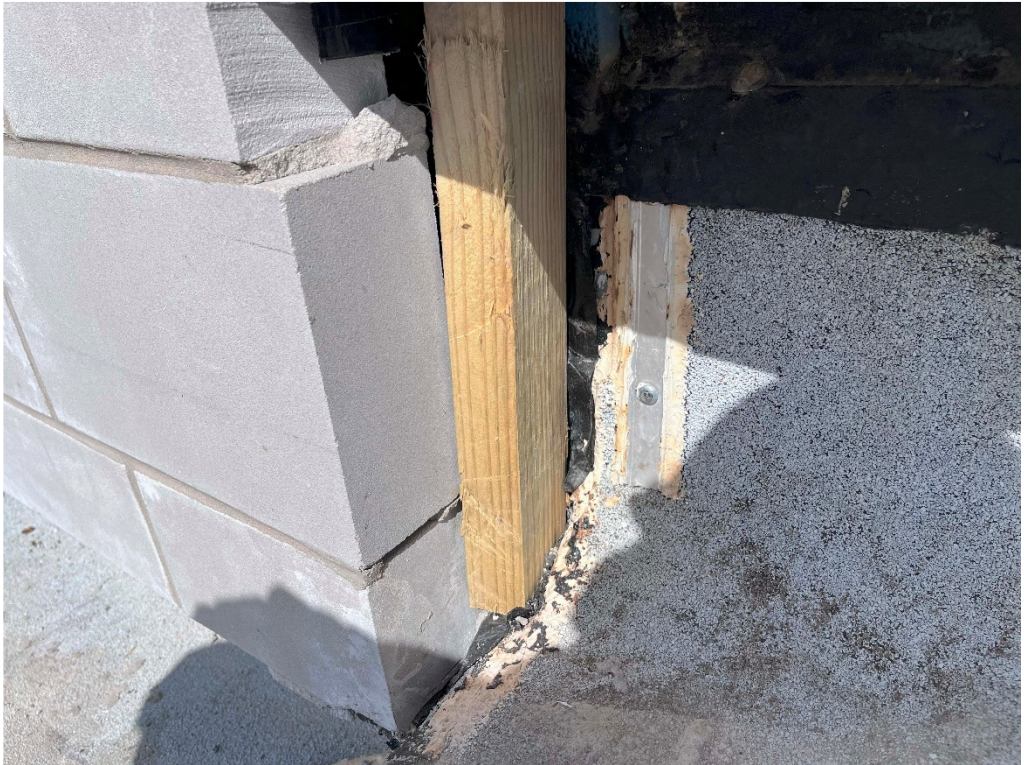
Figure 47 – TEHS: SE Roof Connection to Lobby: remove deadwood; foam in gap and install metal flashing in place

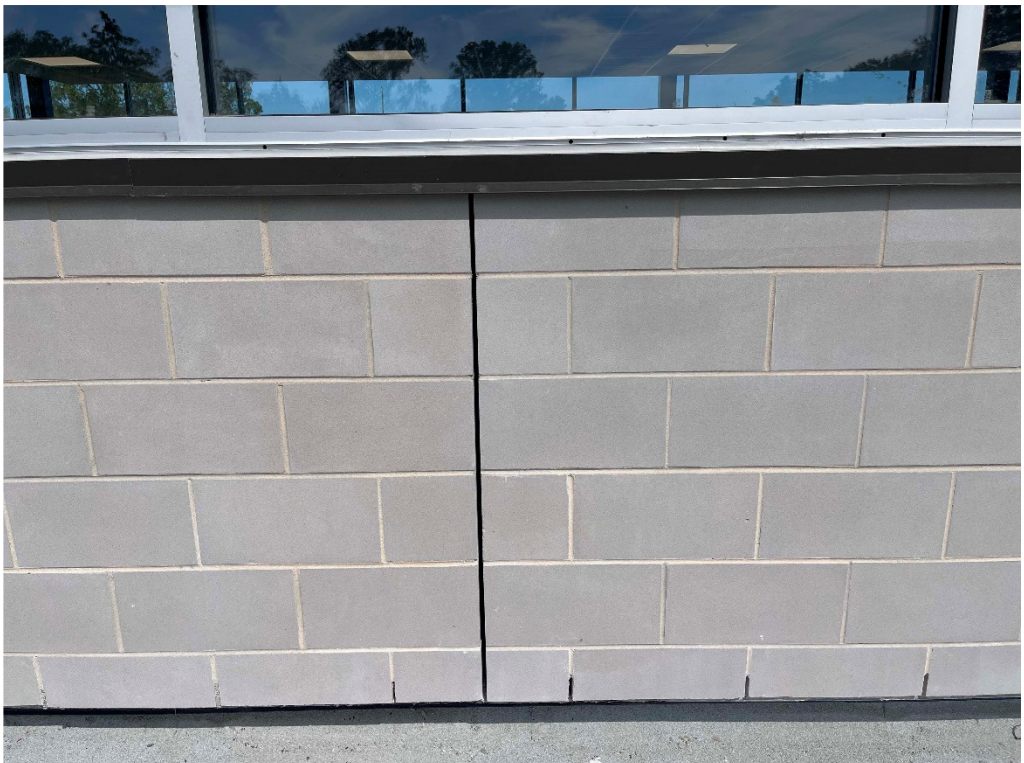
Figure 48 – TEHS: Joints Awaiting Sealant Installation
