12 January 2023

21097 Greenwood Leflore Consolidated SD ESSER / Report Number 001

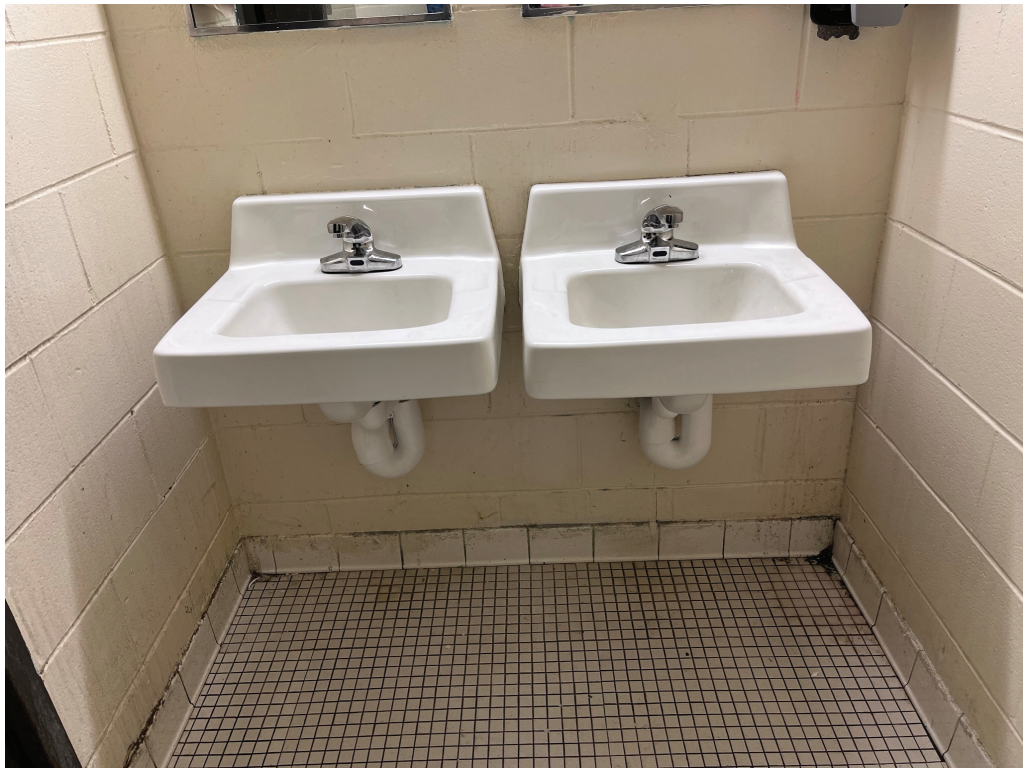
Figure 1 - Typical Finished Installation at Claudine Brown

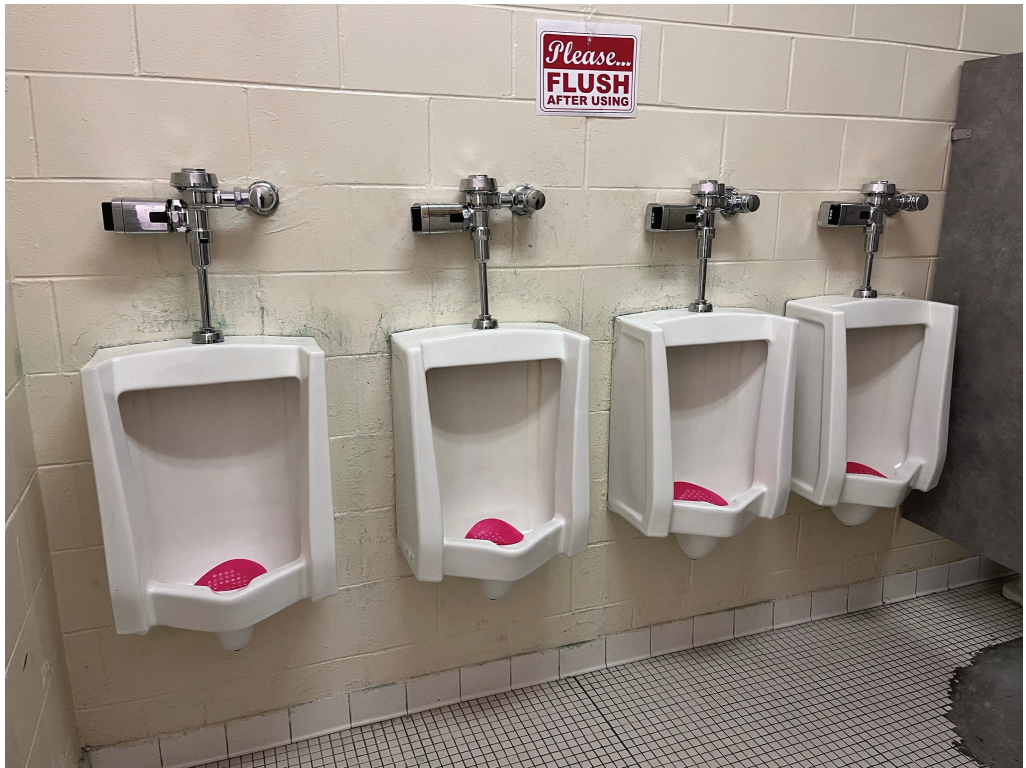
Figure 2 – Typical Urinal Valves

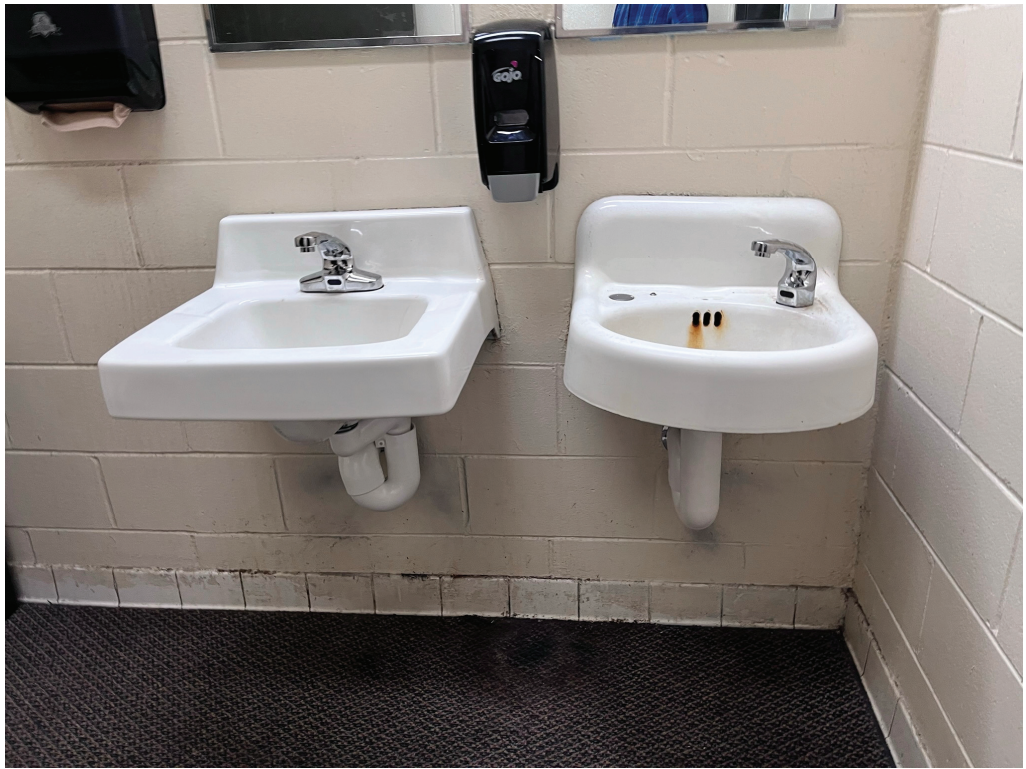
Figure 3 – Please Provide Price to replace sink on right with like sink as on left

Items to Verify	None.
	Action Required	Provide pricing per Figures 3 & 8. Coordinate with Claudine Brown Admin on Repairs. Provide clarification on Figure 9.

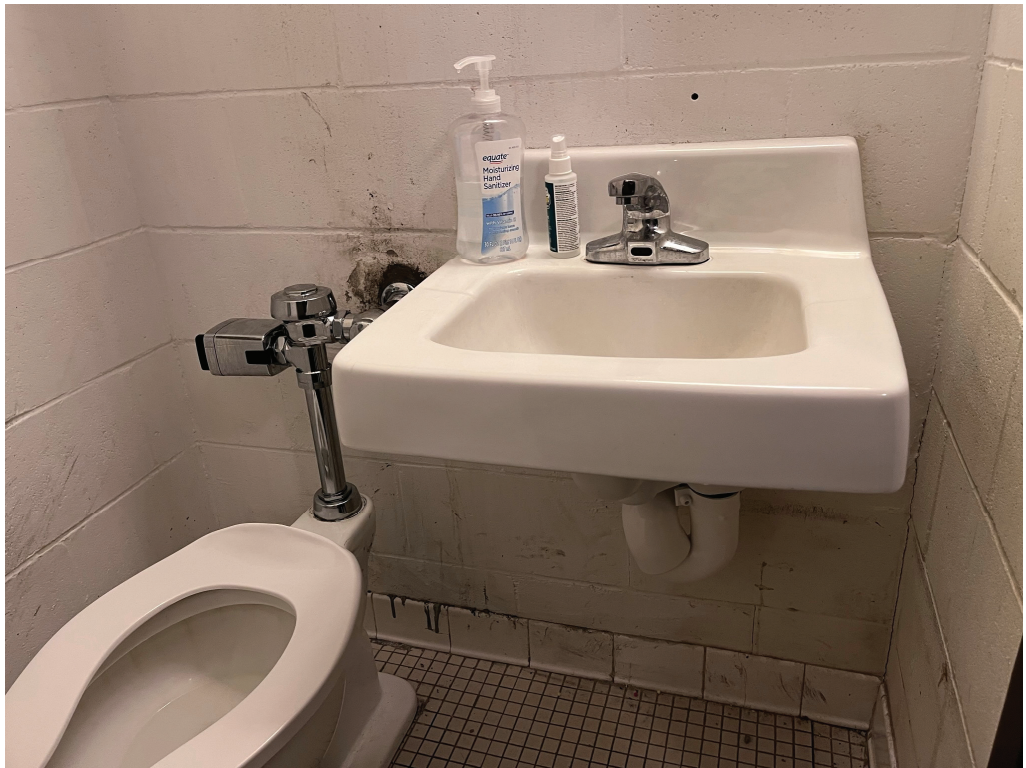
Figure 4 – Typical New Faucet @ Claudine Brown

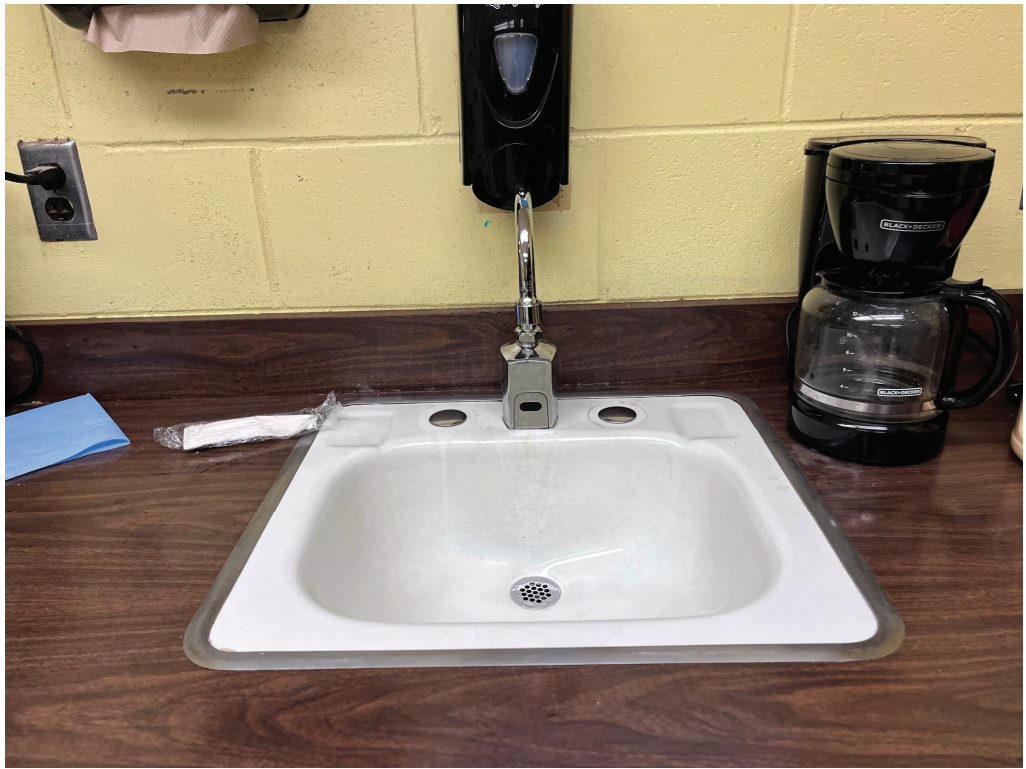
Figure 5 – Typical New Faucet @ Claudine Brown

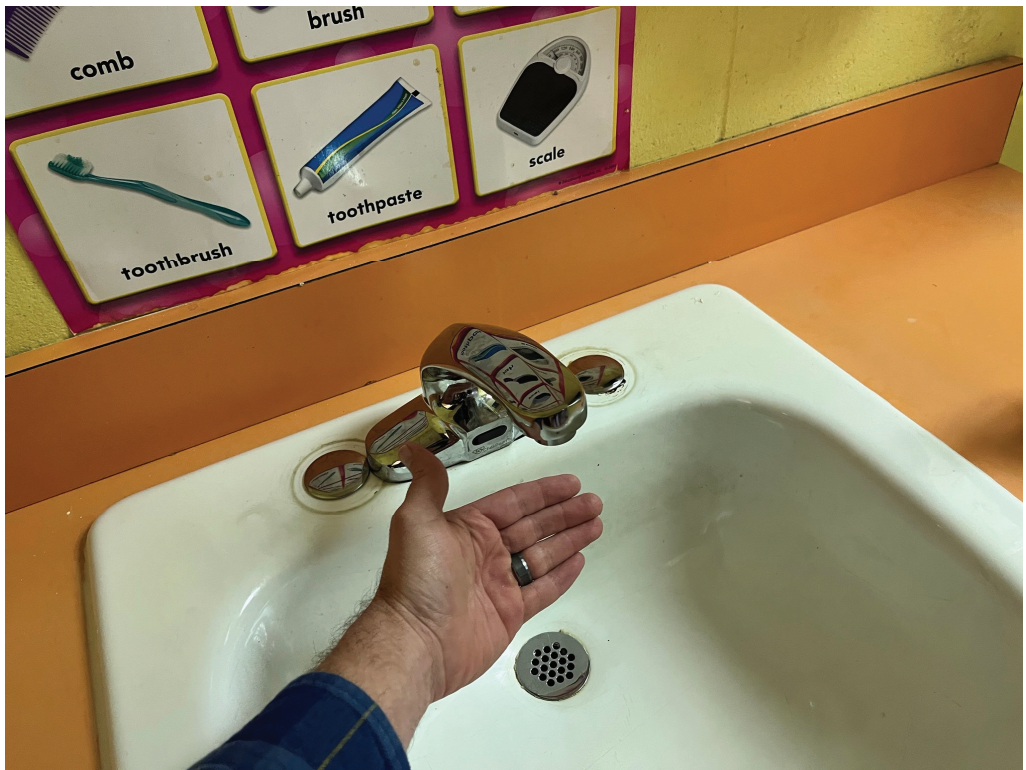
Figure 6 – This Faucet Does not Appear to respond at Claudine Brown

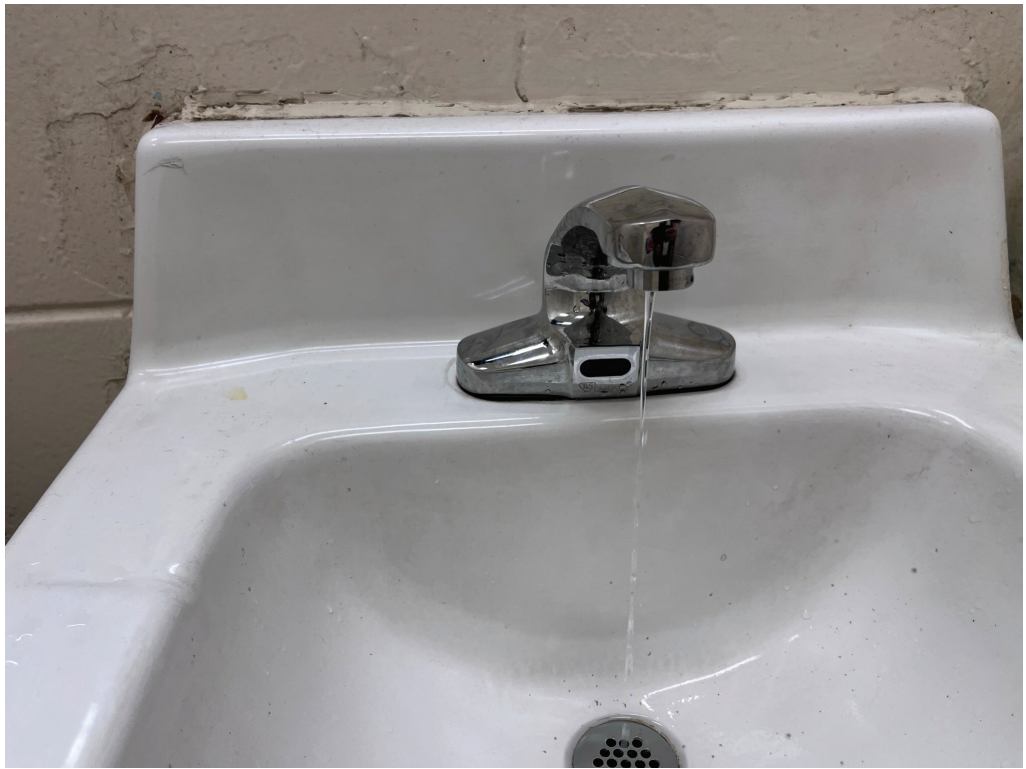
Figure 7 – Some Faucets Dripping @ Claudine Brown

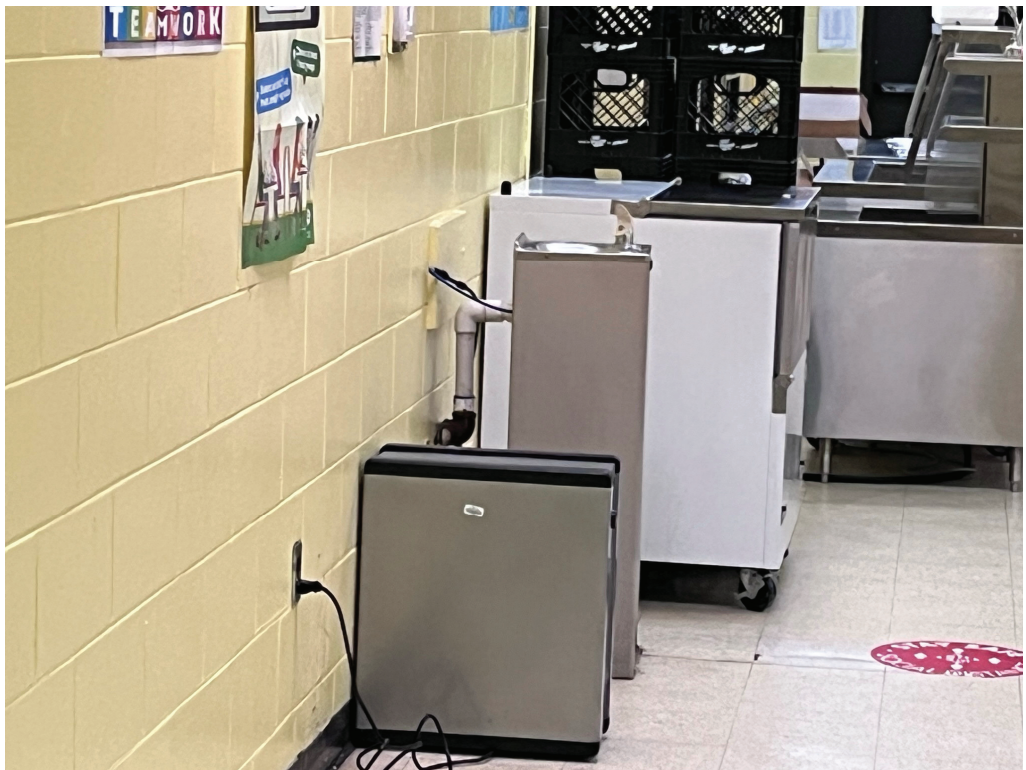
Figure 8 – Please Provide Price to Install Partial Height Wall and Bottle Filler Here in Cafeteria at Claudine Brown

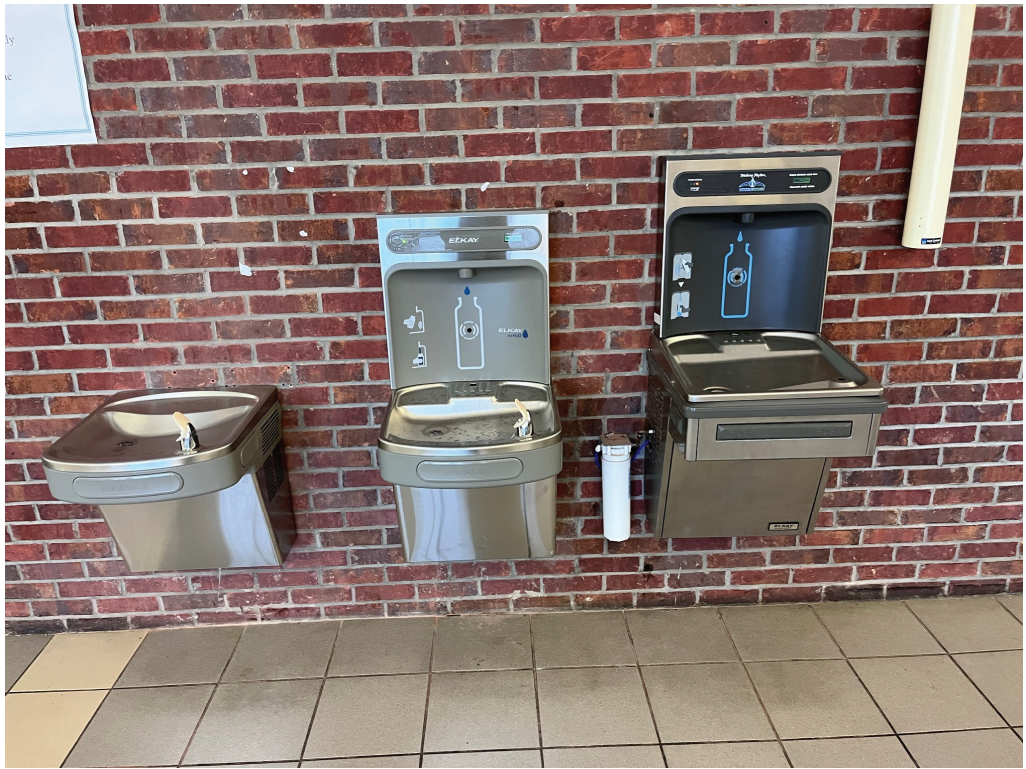
Figure 9 – 2 New Bottle Fillers in Plans for here; is the other still to come?

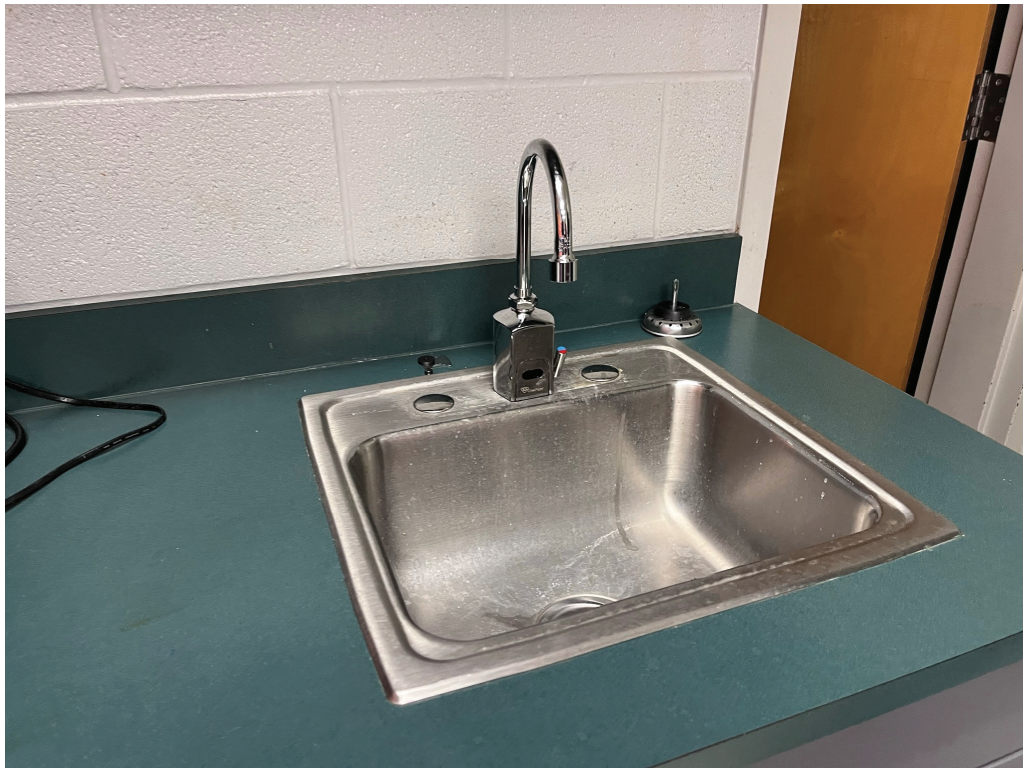
Figure 10 – Typical New Faucet @ Greenwood Middle

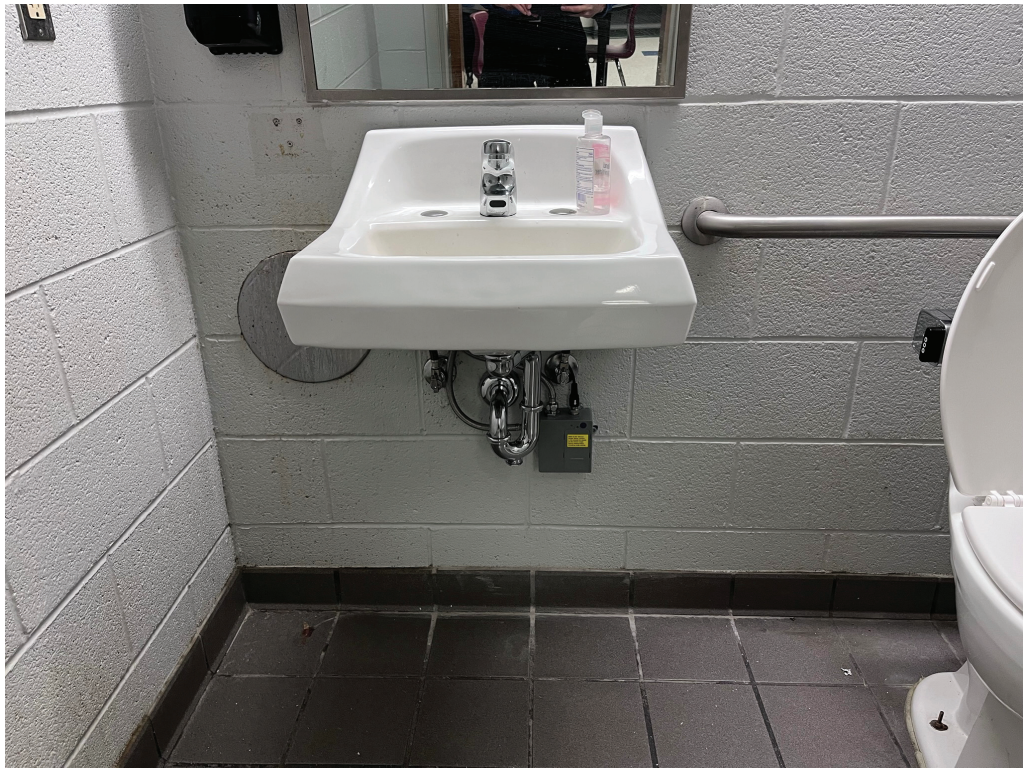
Figure 11 – Typical New Faucet @ Greenwood Middle

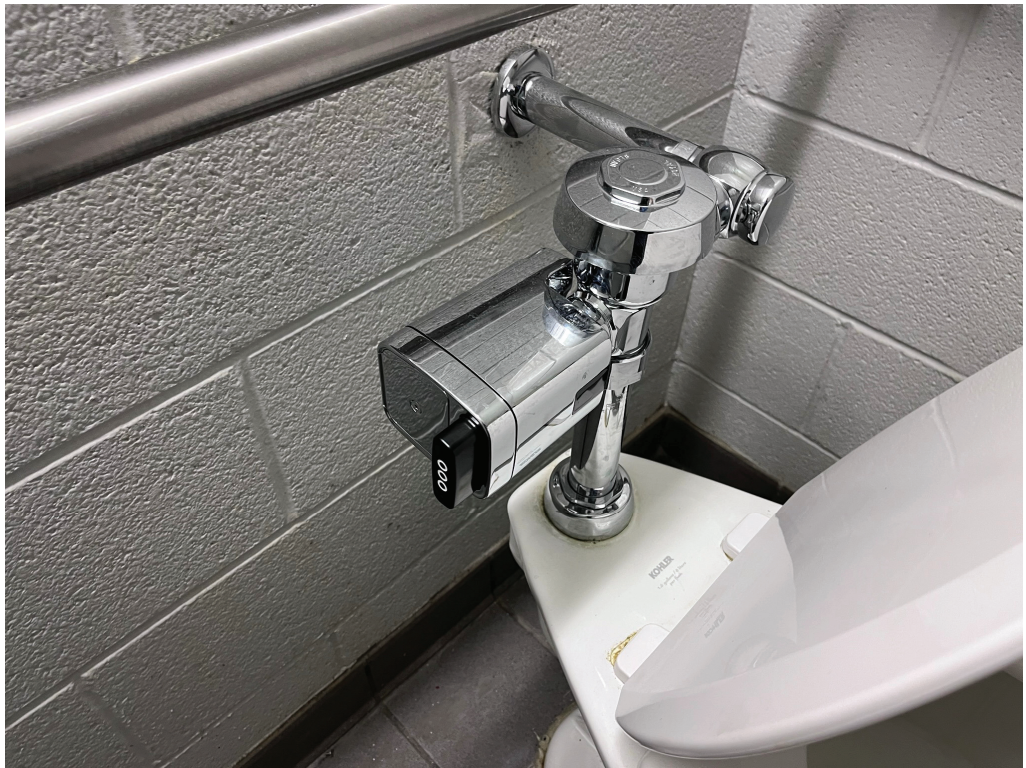
Figure 12 – Typical New Flush Valve @ Greenwood Middle

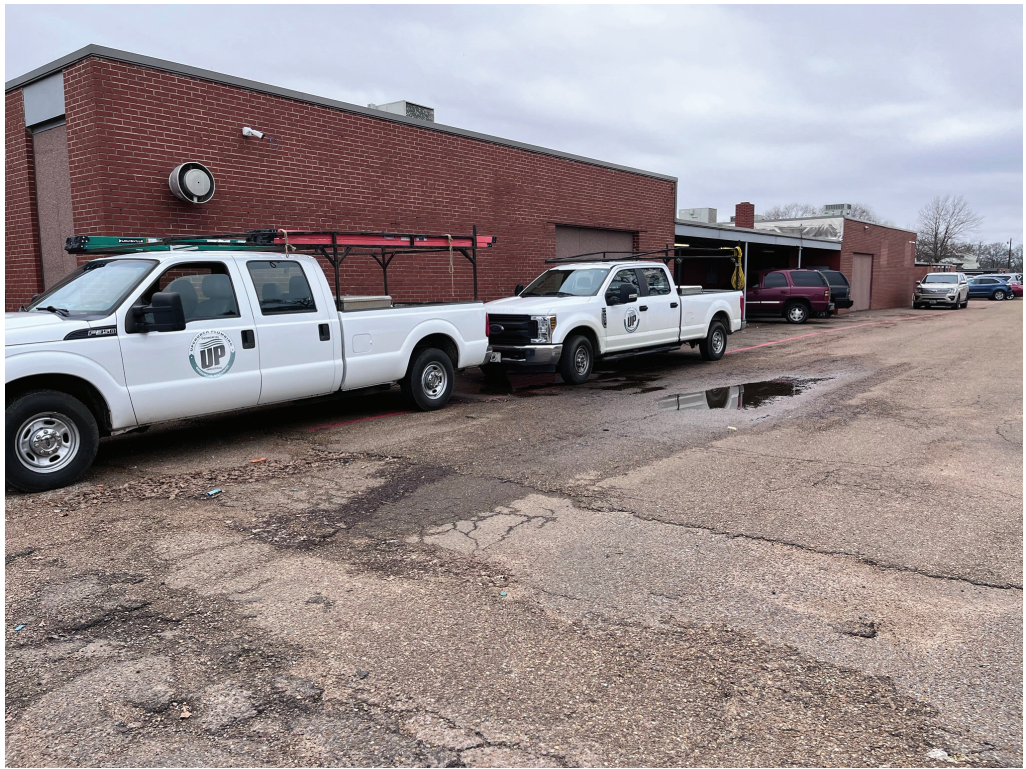
Figure 13 – Upchurch On Site at Amanda Elzy

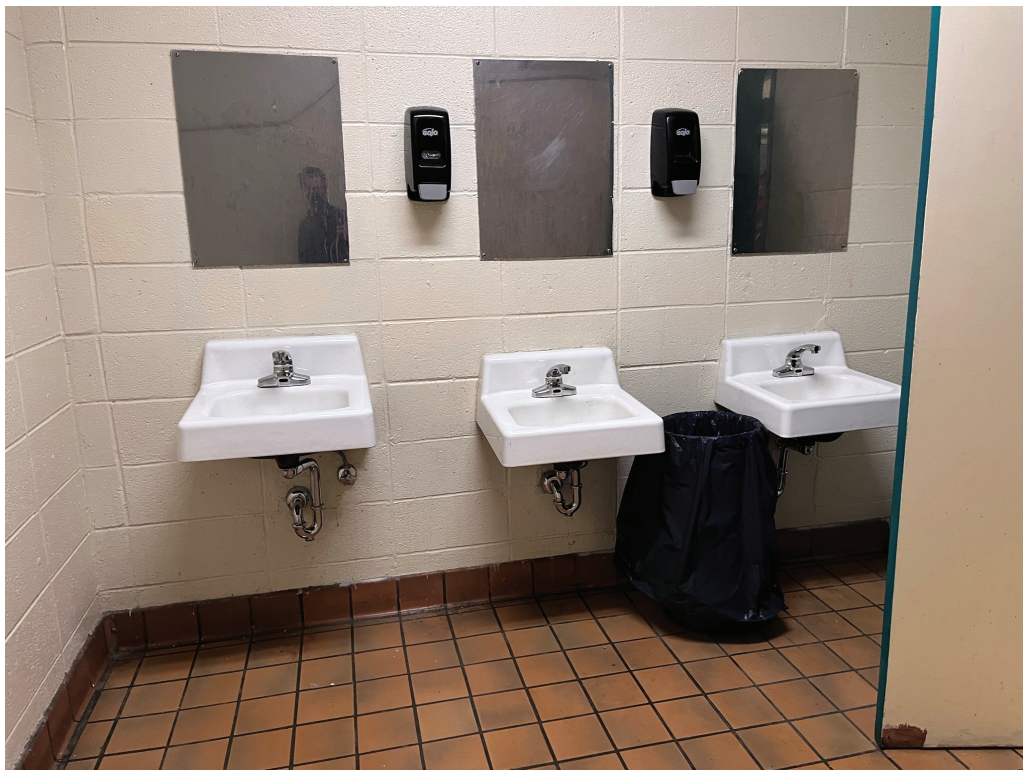
Figure 14 – New Faucets at Amanda Elzy
