15094 Community bank Headquarters – Precast review

COMMUNITY BANK HDQTRS.
 FLOWOOD, MISSISSIPPI

FIELD MODIFICATION

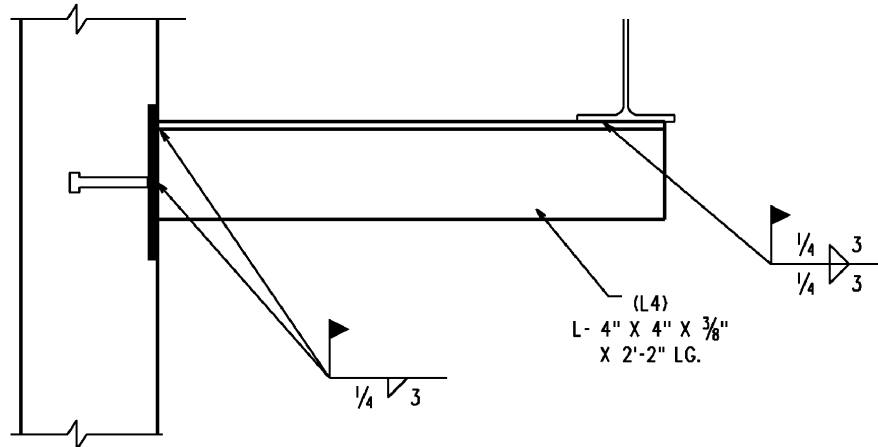
DETAIL (21)

DESCRIPTION OF PROBLEM

NOT WELDED PER DETAIL
WELDED SOLID @ PANEL W/OUT
BOLTED SLIP PLATE

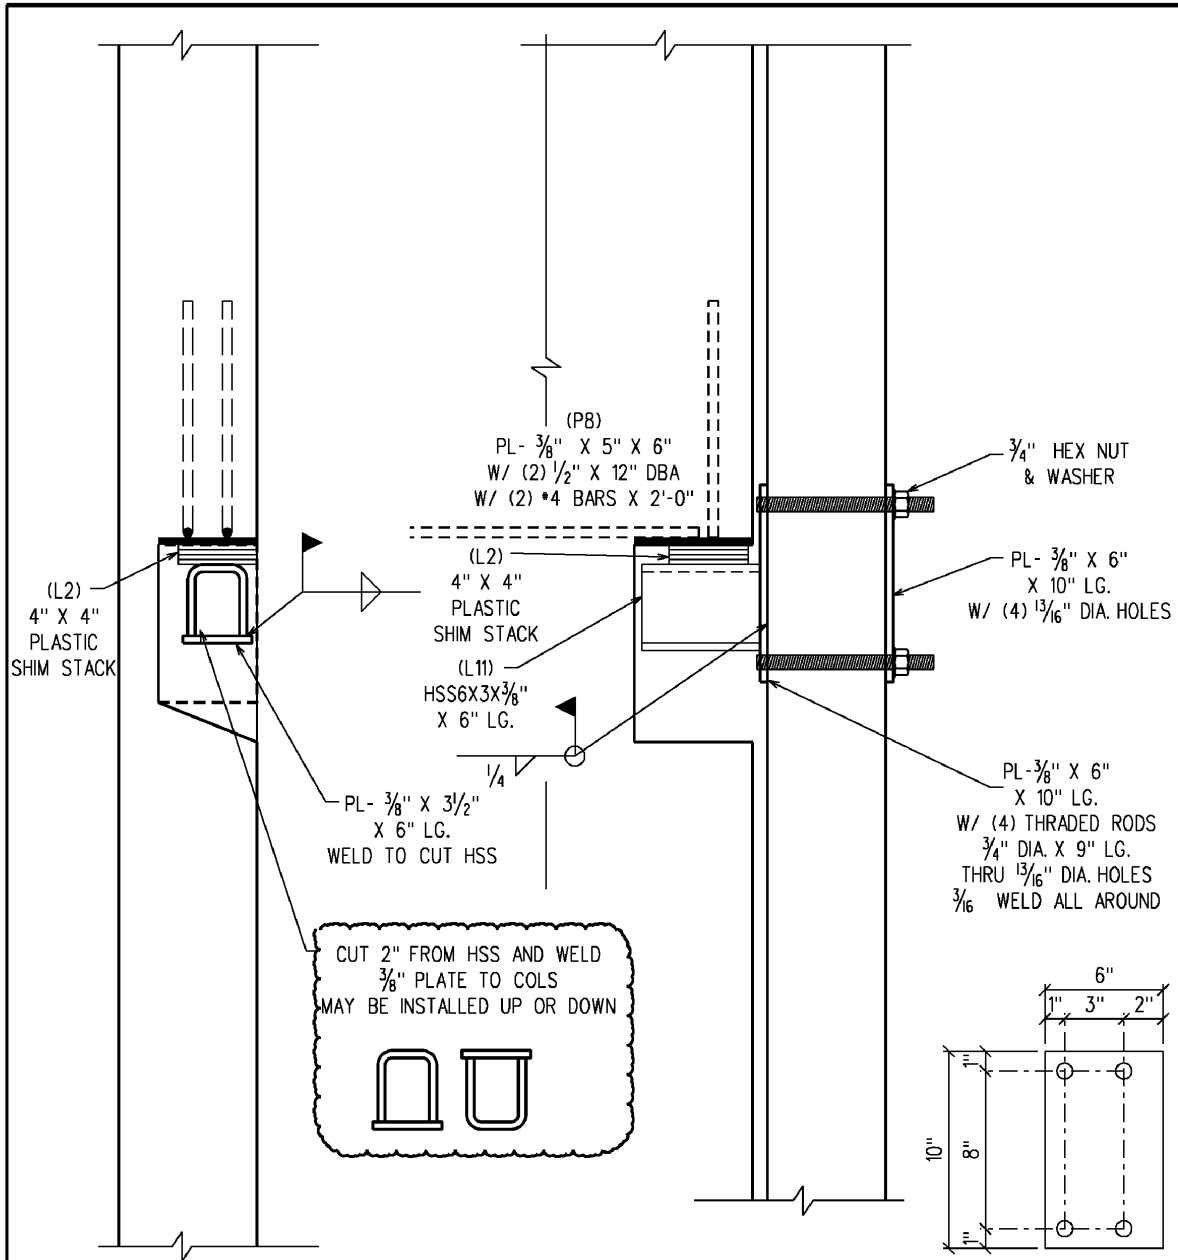
DESCRIPTION OF PROBLEM

POCKET IS 2" TOO LOW
 & P7 MISSING ADJACENT PANEL

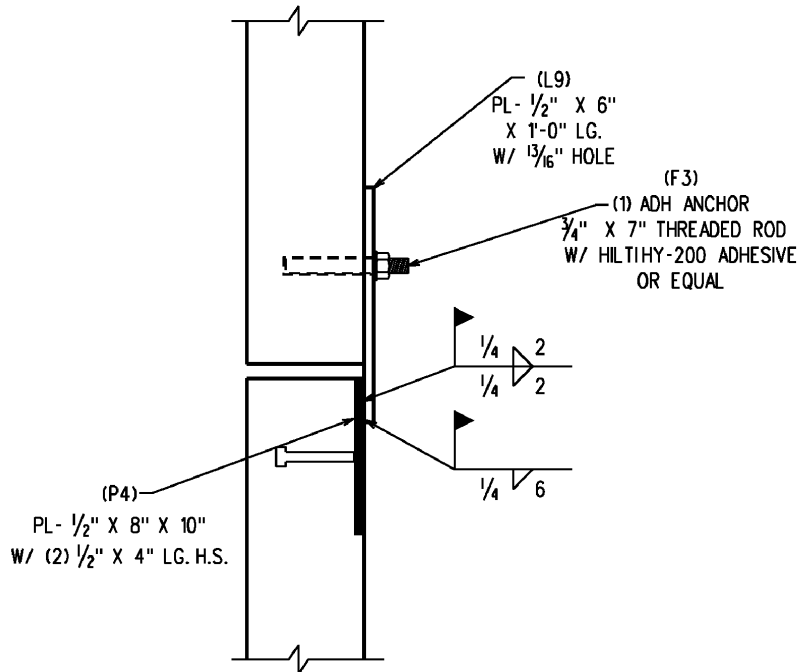
DETAIL (16)

DESCRIPTION OF PROBLEM

PSA INSERT MISSING FROM PANEL

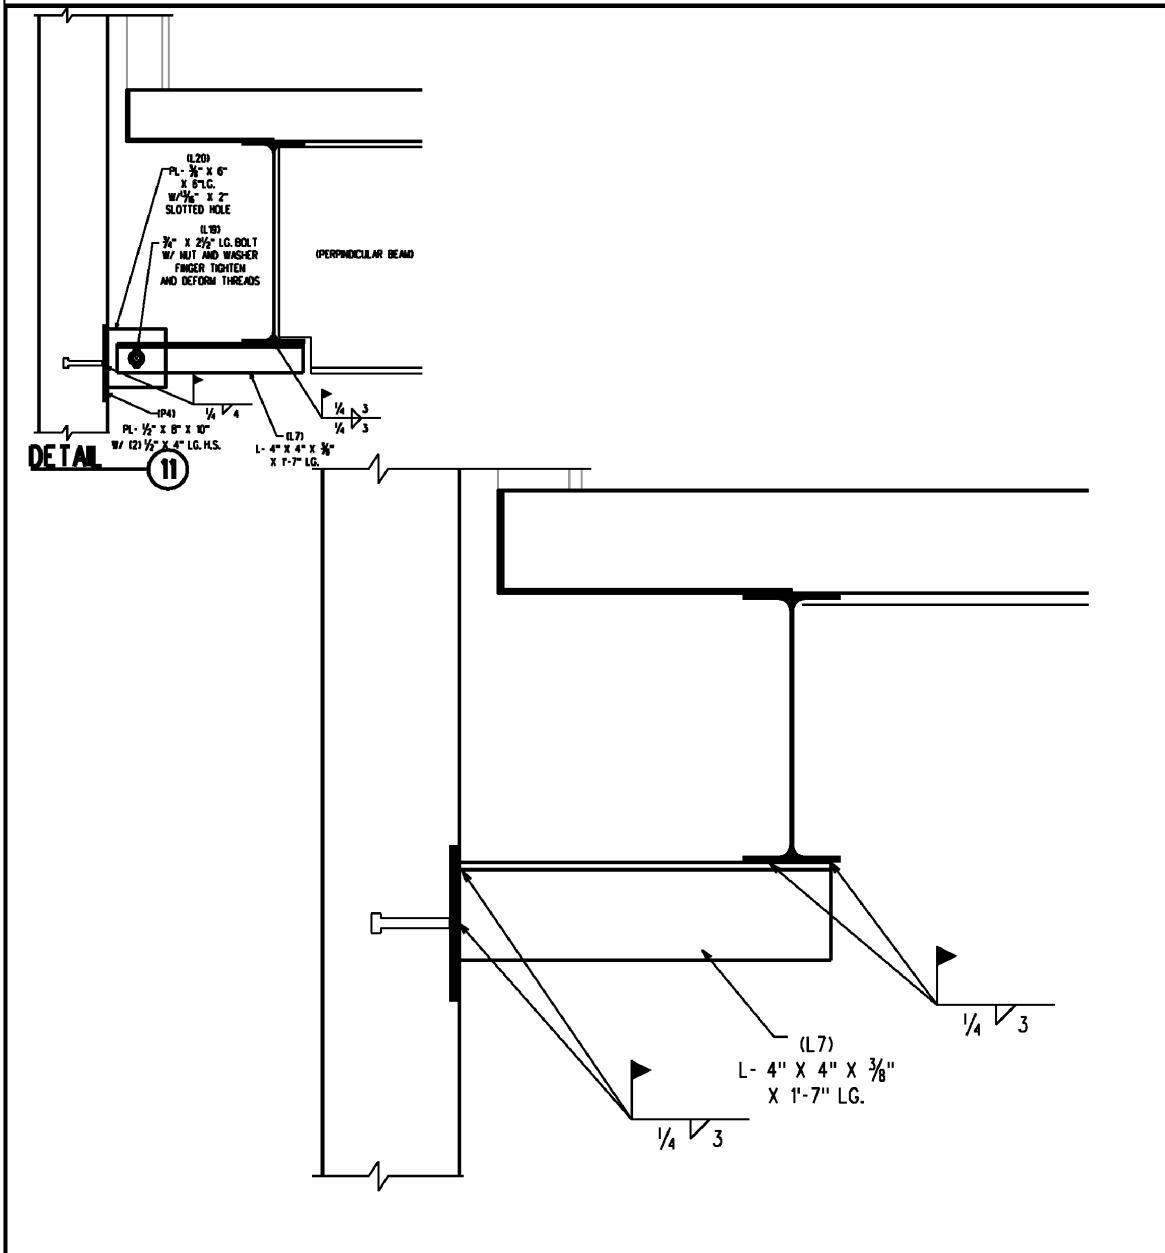
REF: **11**
FM. NO.: **11-4**

DESCRIPTION OF PROBLEM
NOT WELDED PER DETAIL
WELDED SOLID @ PANEL W/OUT
BOLTED SLIP PLATE

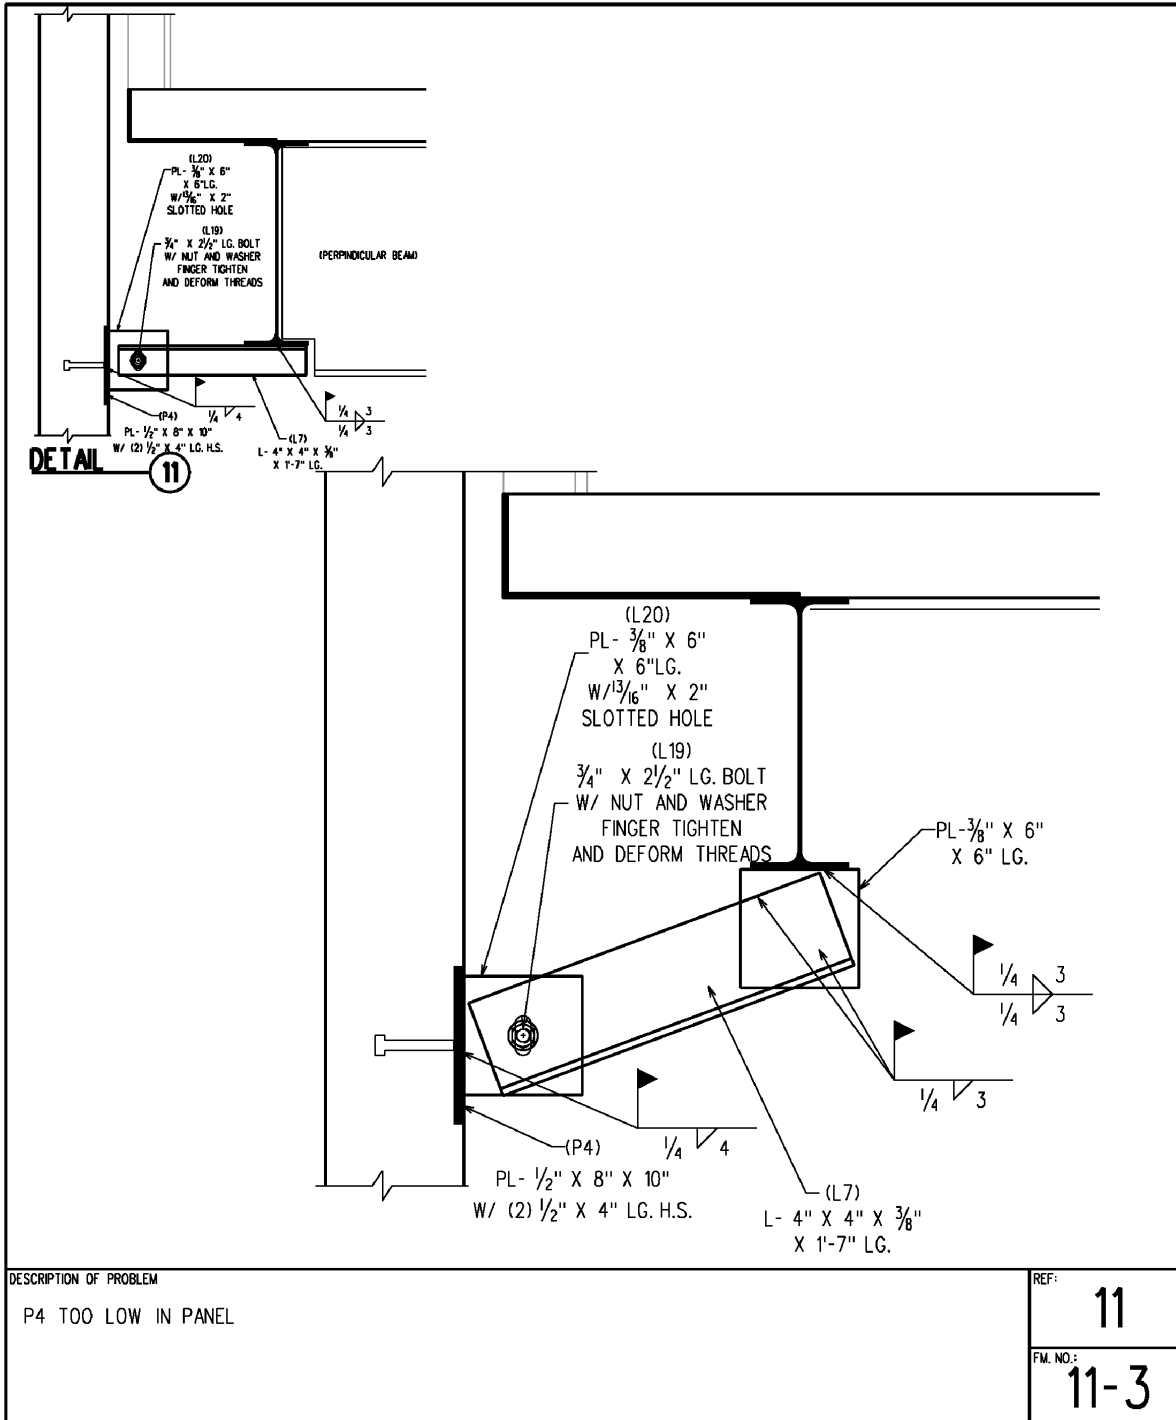
DESCRIPTION OF PROBLEM P4 TOO LOW IN PANEL	REF: 11
	FM. NO.: 11-3

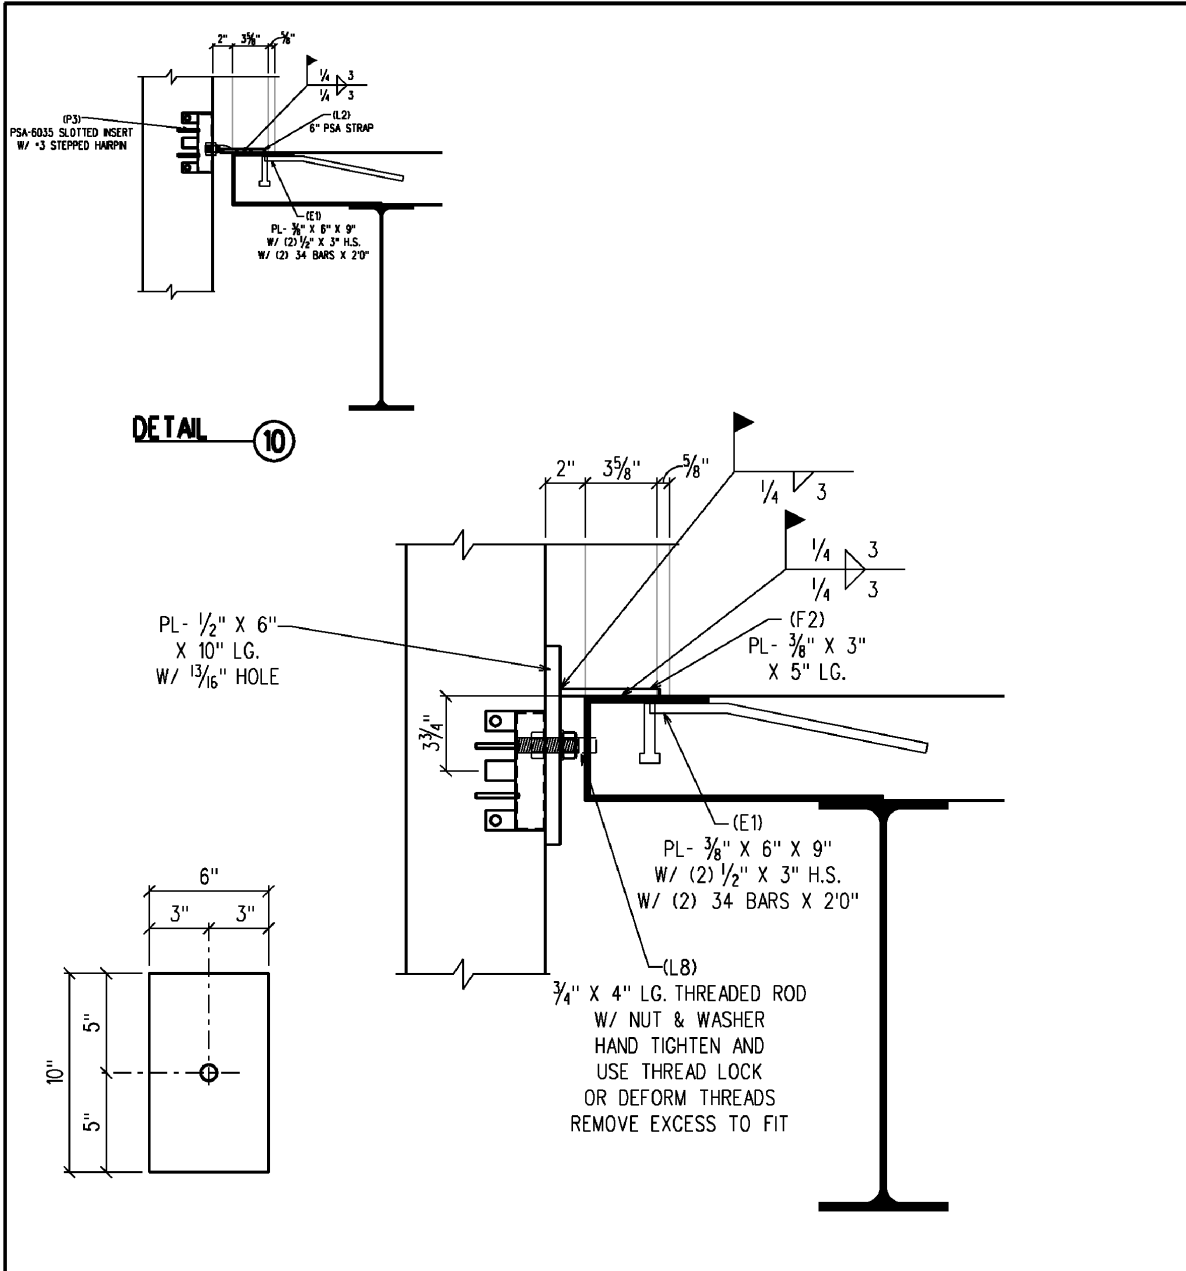
DESCRIPTION OF PROBLEM

PSA INSERT IS TOO LOW
 FM10-2 CALLS FOR $\frac{3}{4}$ " THICK PLATE
 $\frac{1}{2}$ " THICK PLATE WAS USED

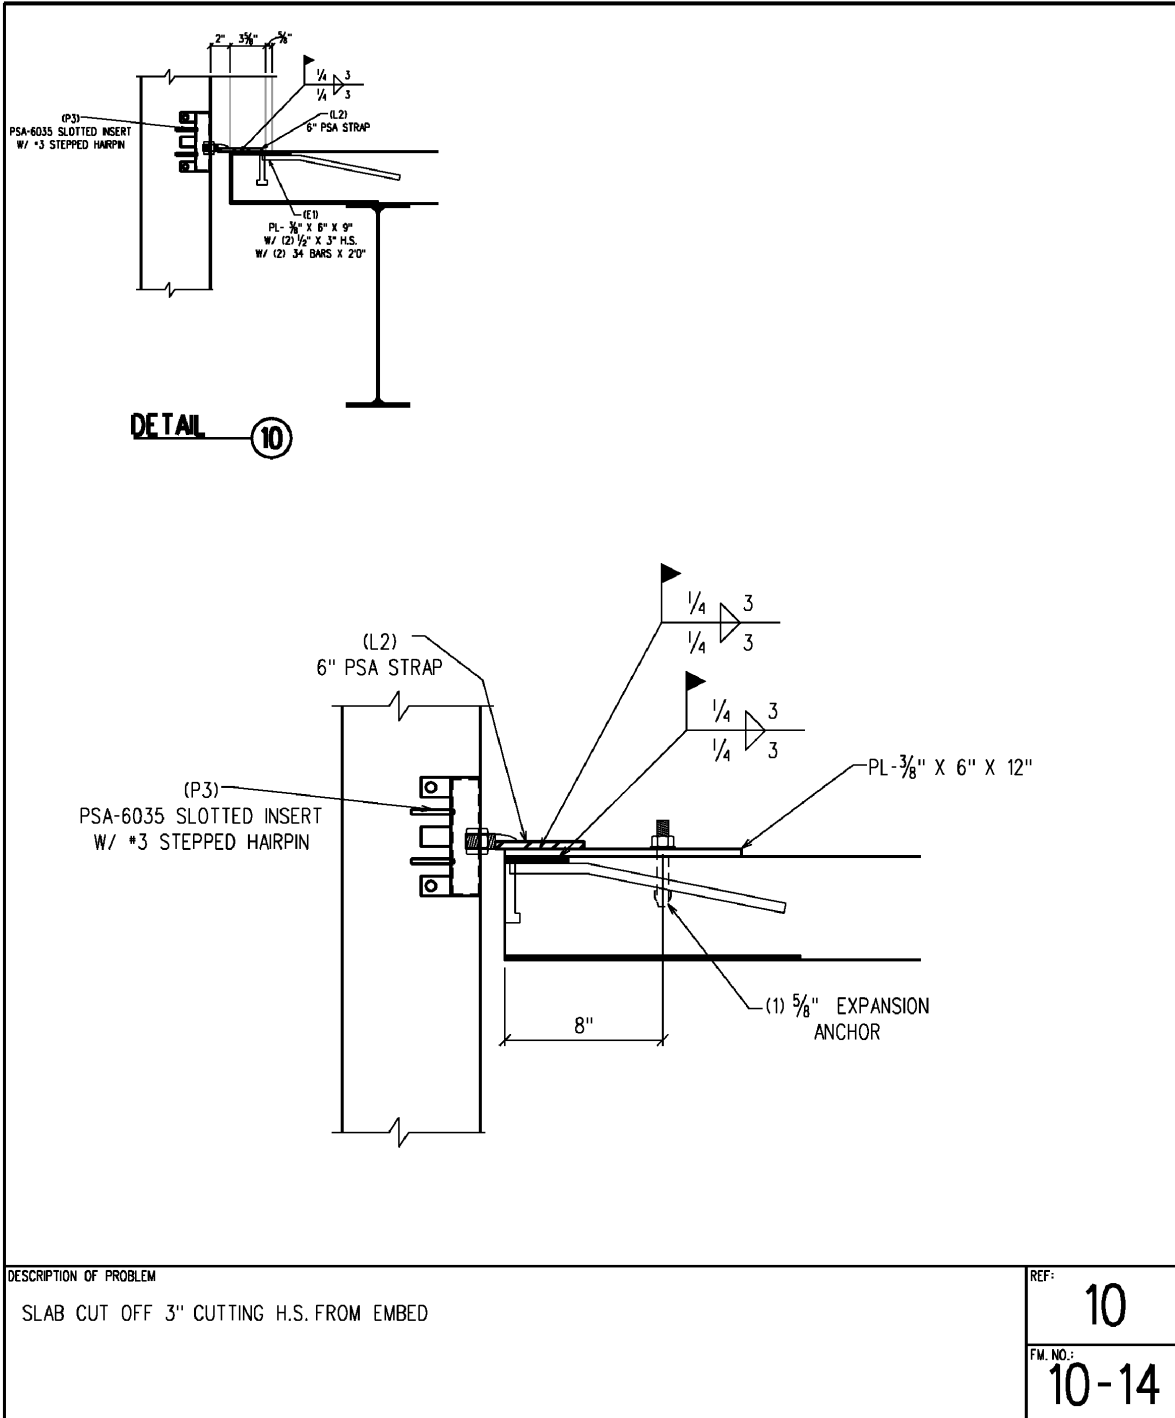
REF: **10**
 FM. NO.: **10-14**

DESCRIPTION OF PROBLEM
 SLAB CUT OFF 3" CUTTING H.S. FROM EMBED

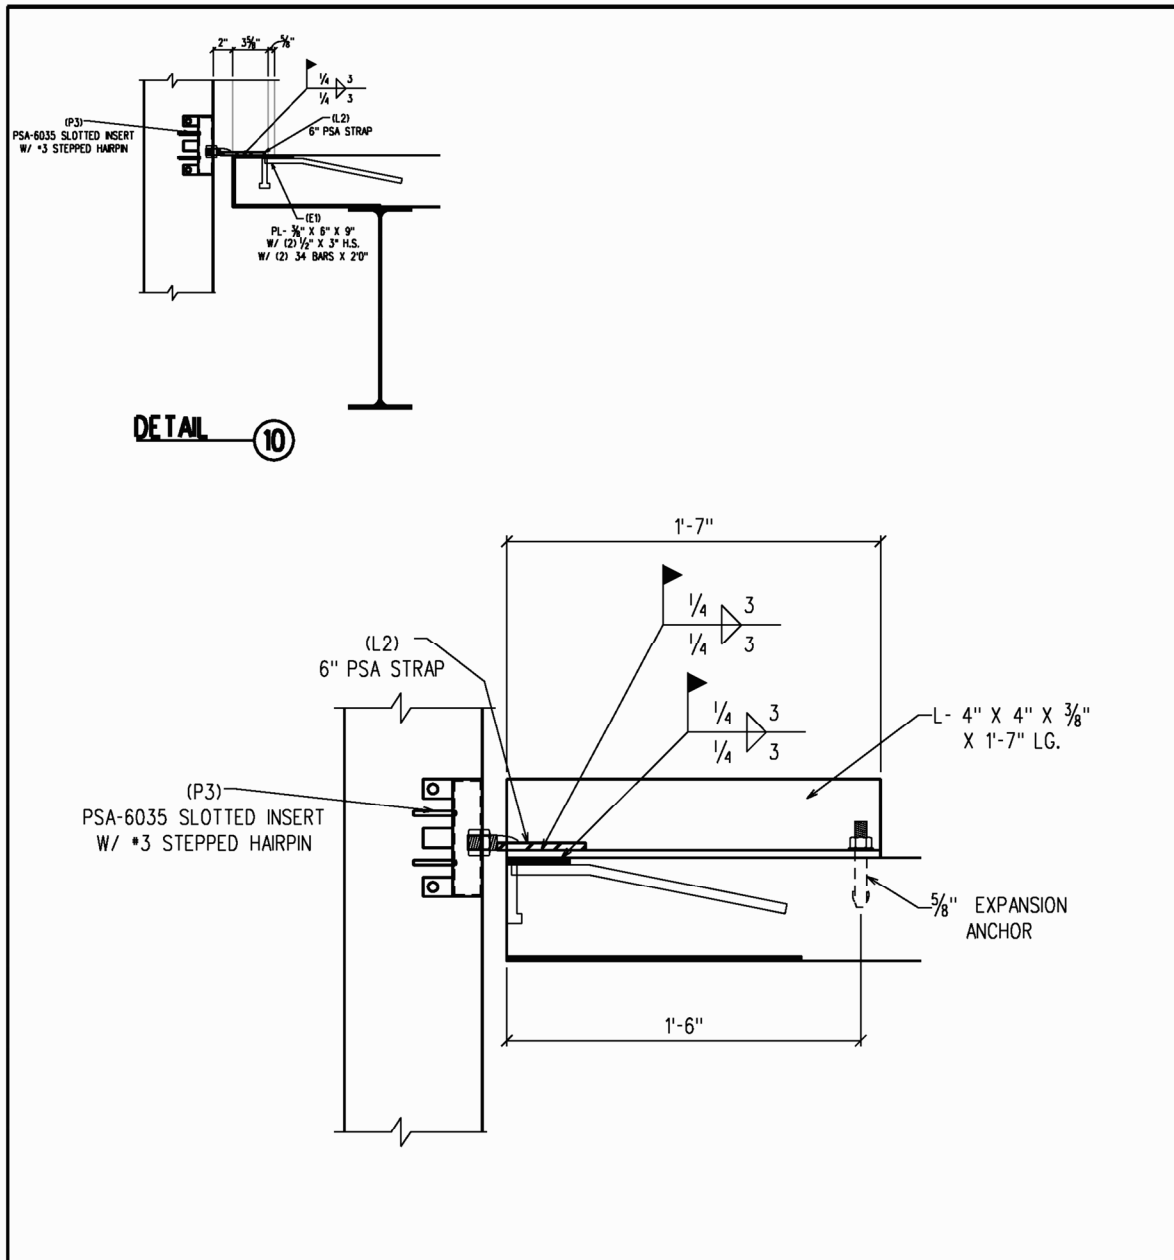
DESCRIPTION OF PROBLEM SLAB CUT OFF 3" CUTTING H.S. FROM EMBED	REF: 10
	FM. NO.: 10-11

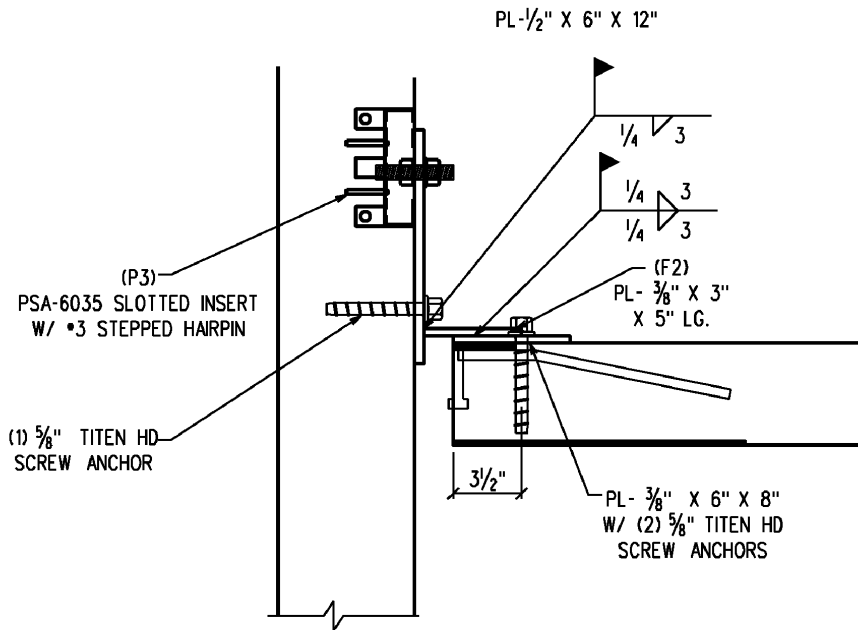
DESCRIPTION OF PROBLEM

PSA TO HIGH
SLAB CUT OFF 3" CUTTING H.S. FROM EMBED

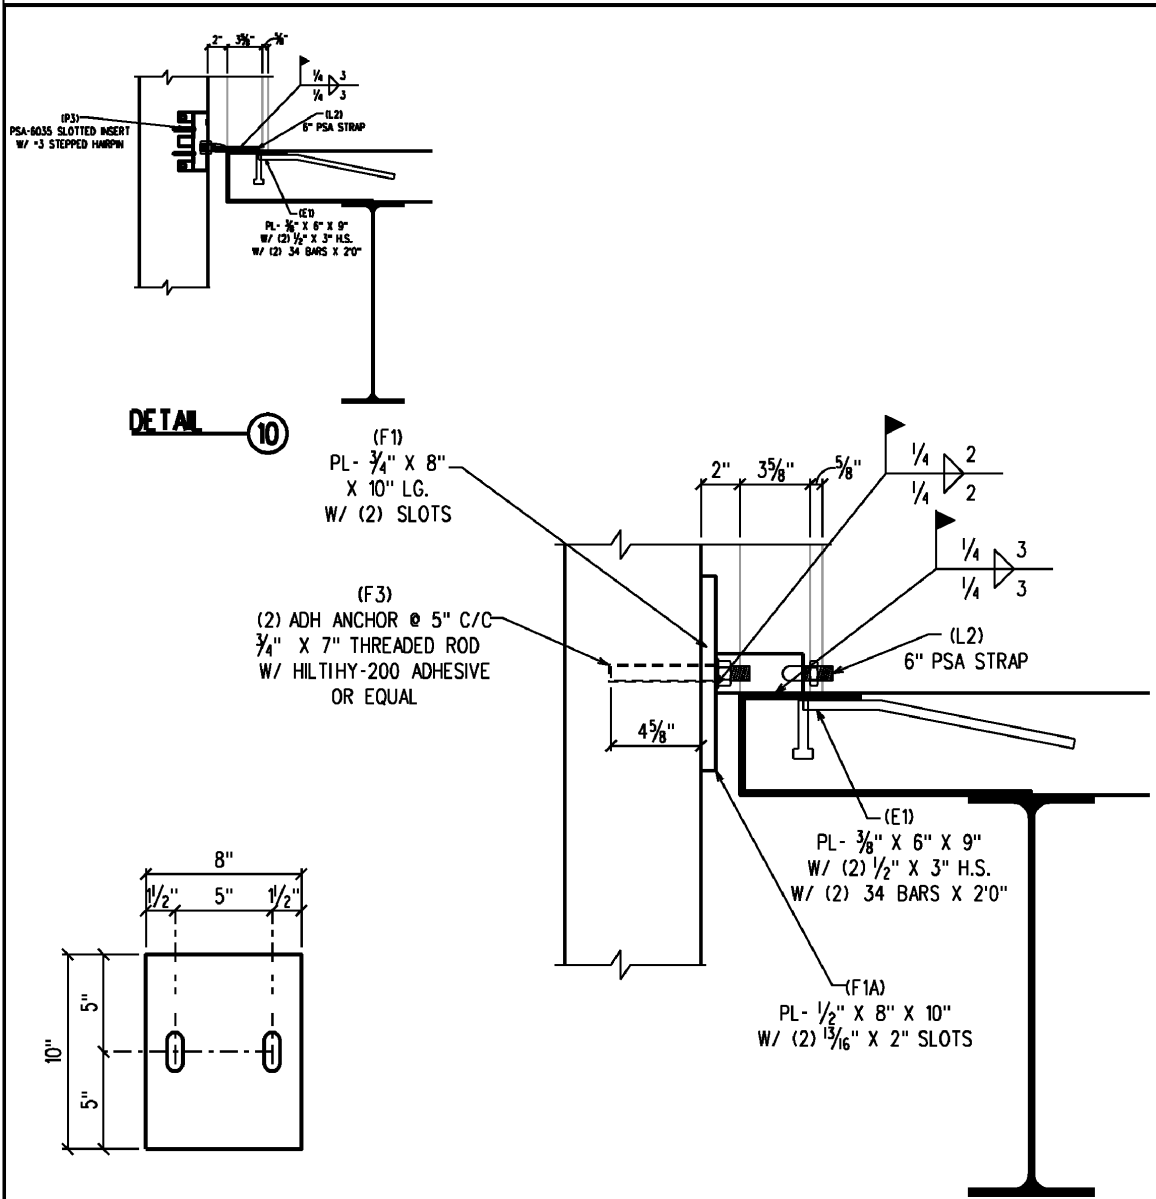
REF: 10

DESCRIPTION OF PROBLEM
PSA INSERT MISSING FROM PANEL

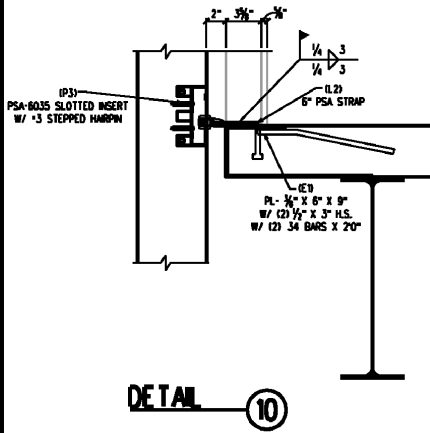
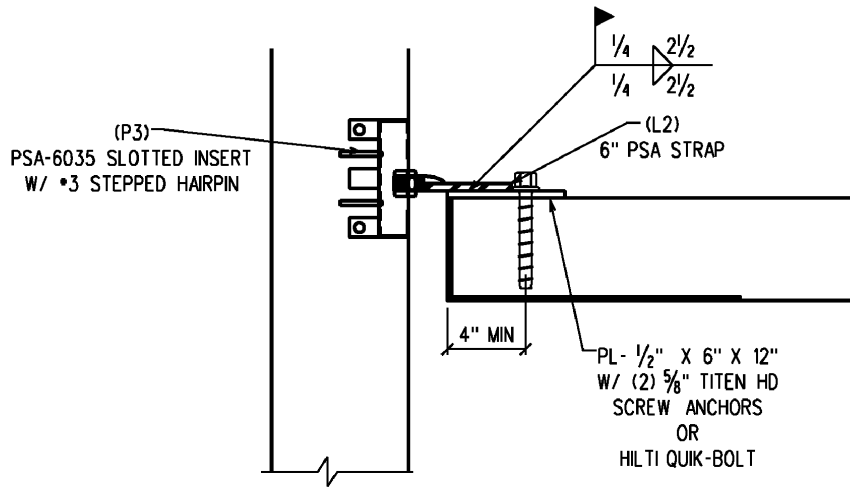
DESCRIPTION OF PROBLEM

EMBED MISSING FROM SLAB

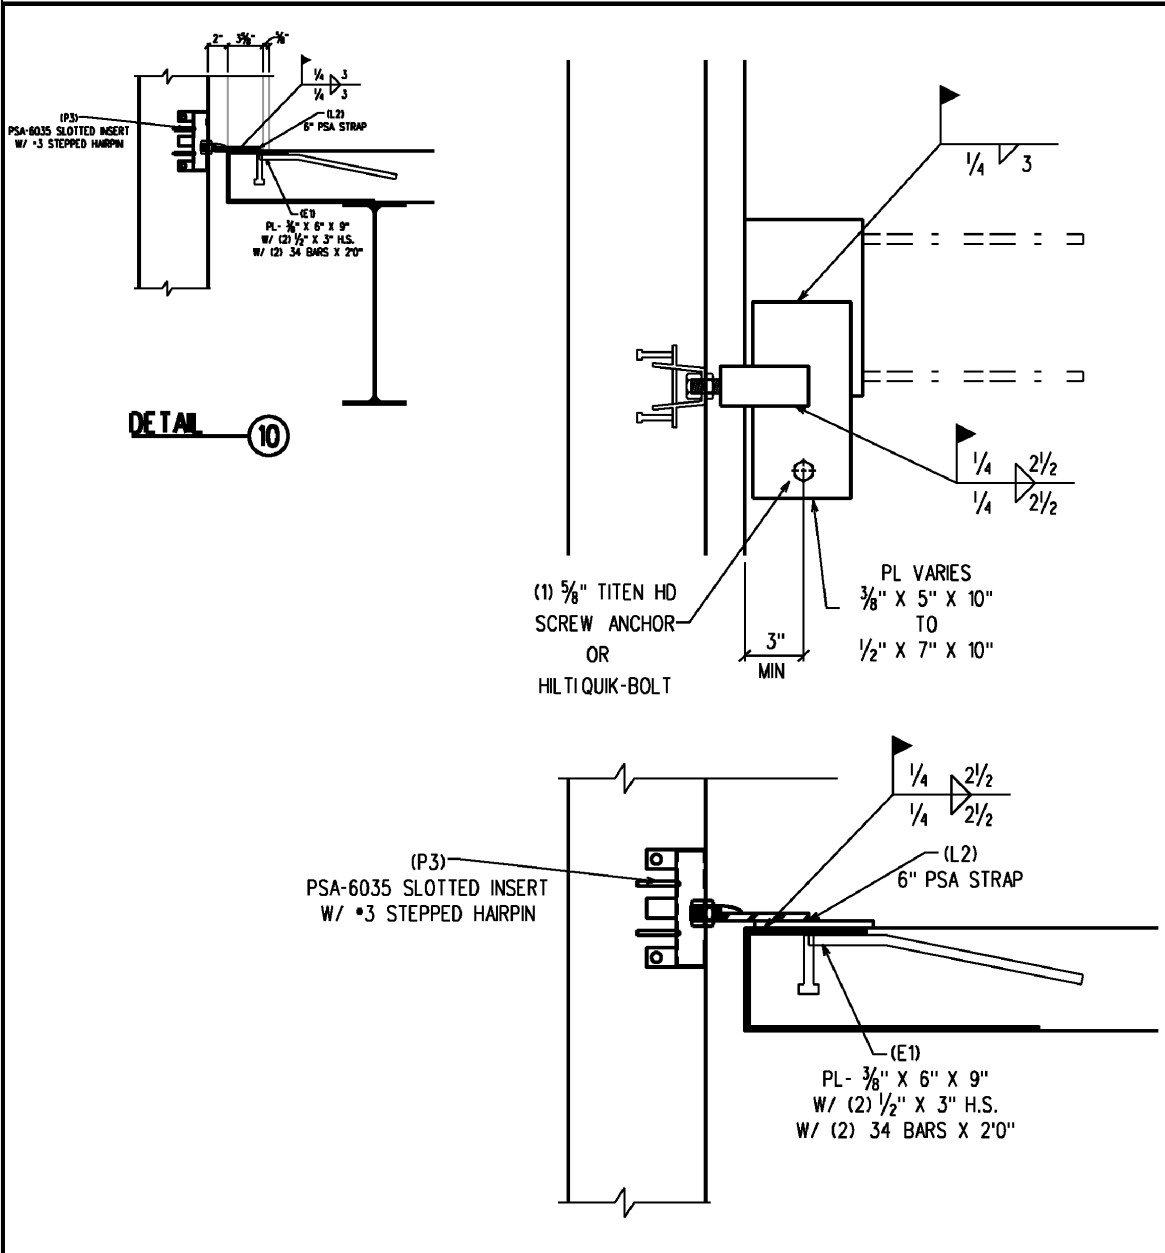
DESCRIPTION OF PROBLEM PSA INSERT AND EMBED DO NOT ALIGN	REF: 10
	FM. NO.: 10-7

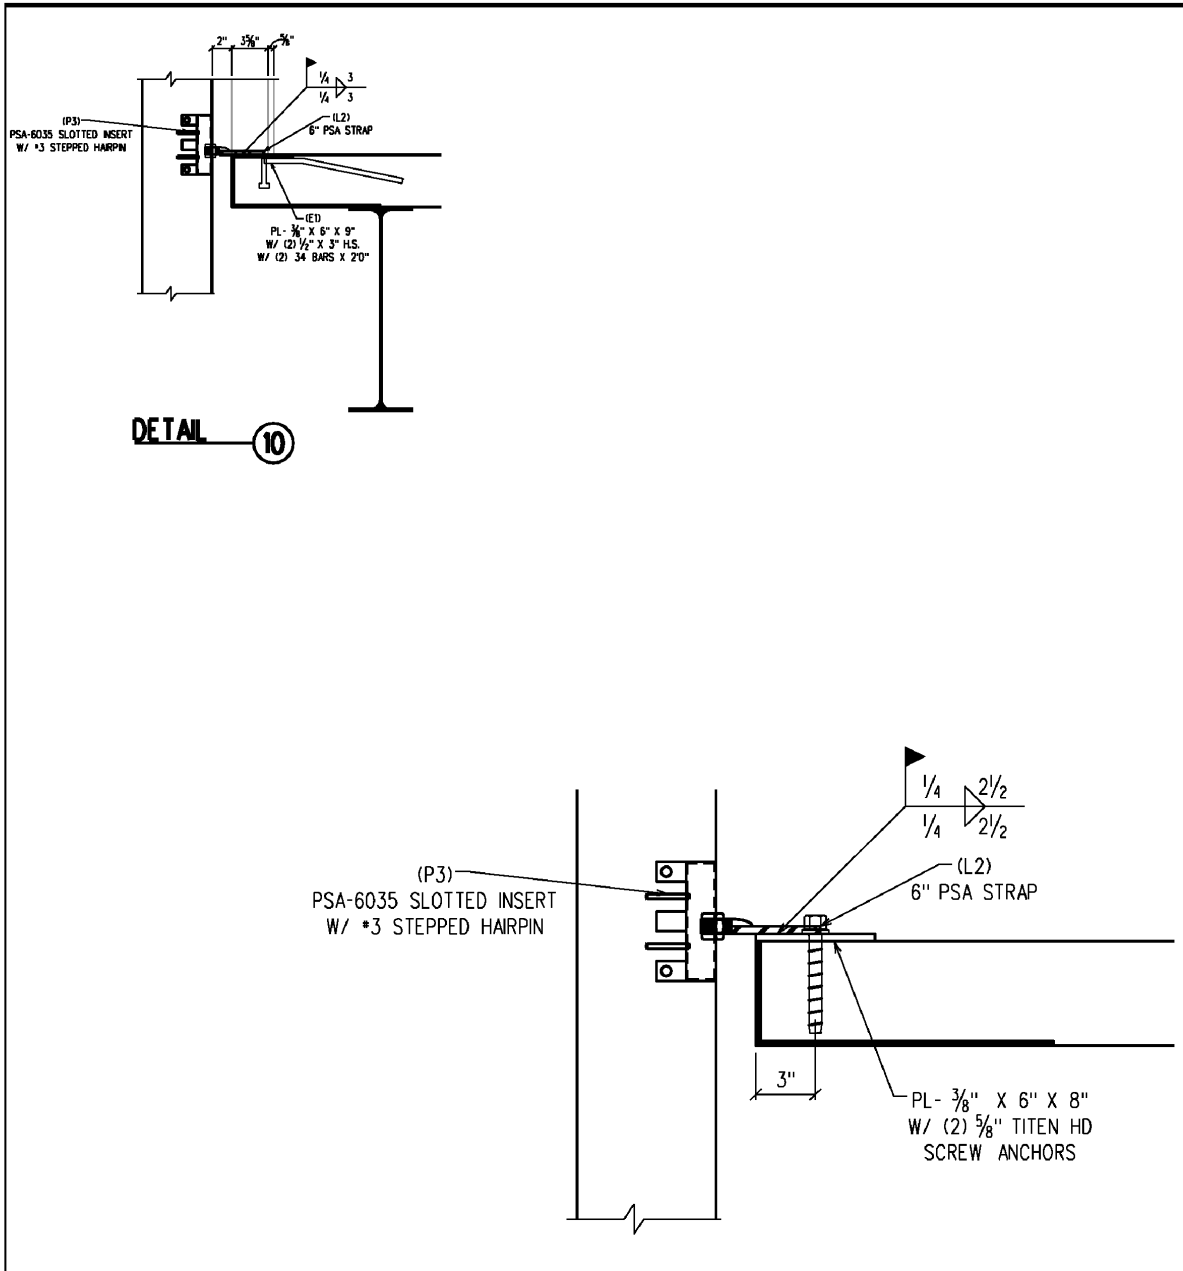
DETAIL 10

DESCRIPTION OF PROBLEM
 EMBED MISSING FROM SLAB

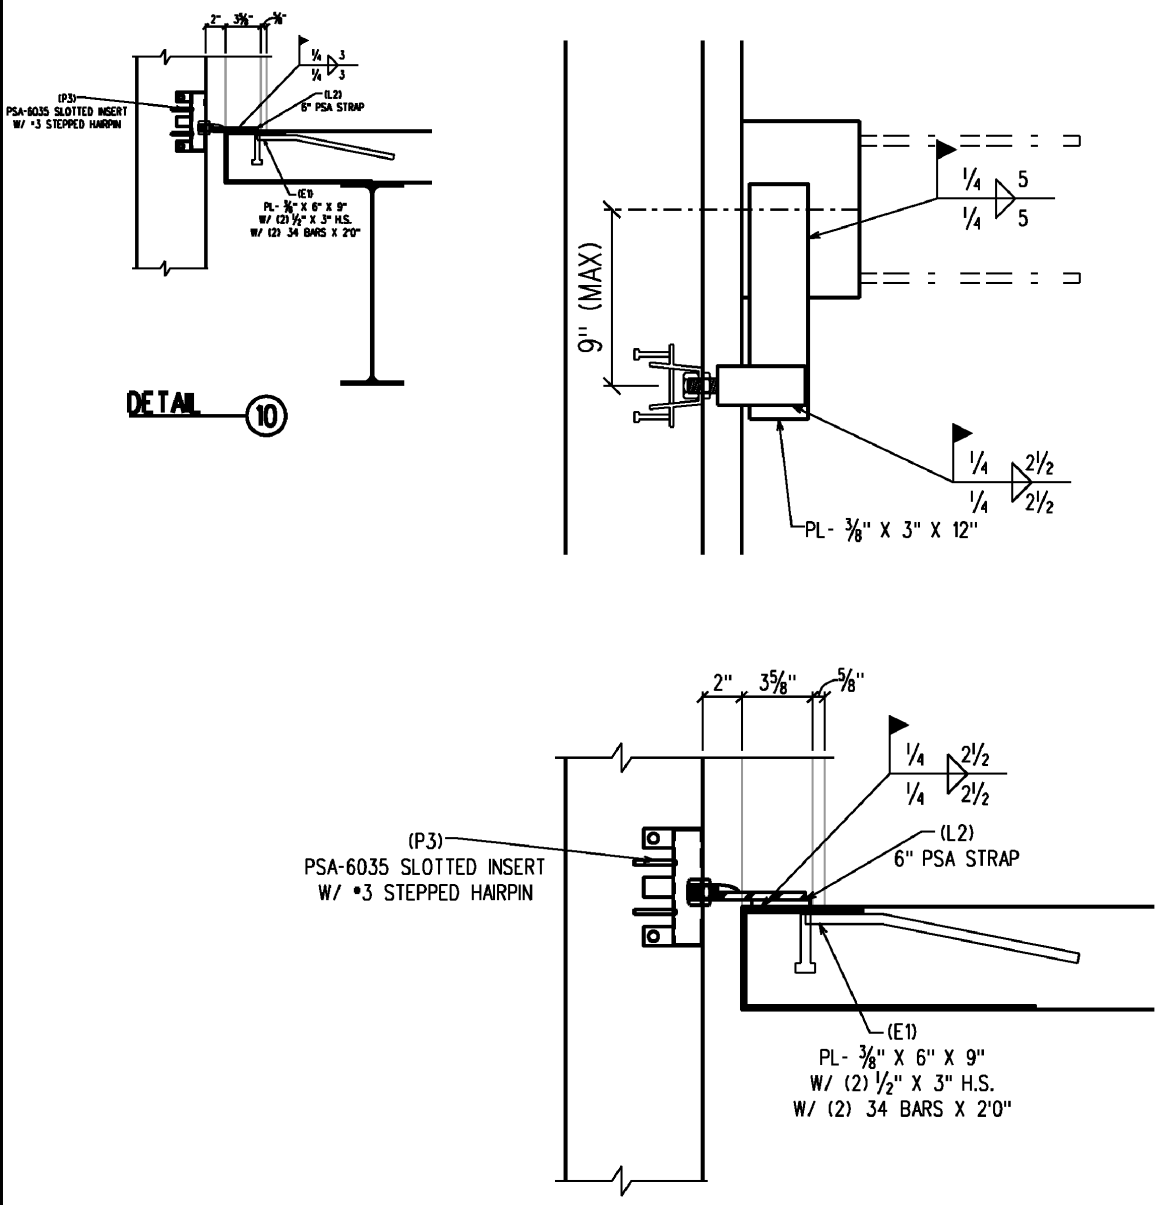
DESCRIPTION OF PROBLEM PSA INSERT LOCATED 8" OFF	REF: 10
	FM. NO.: 10-4

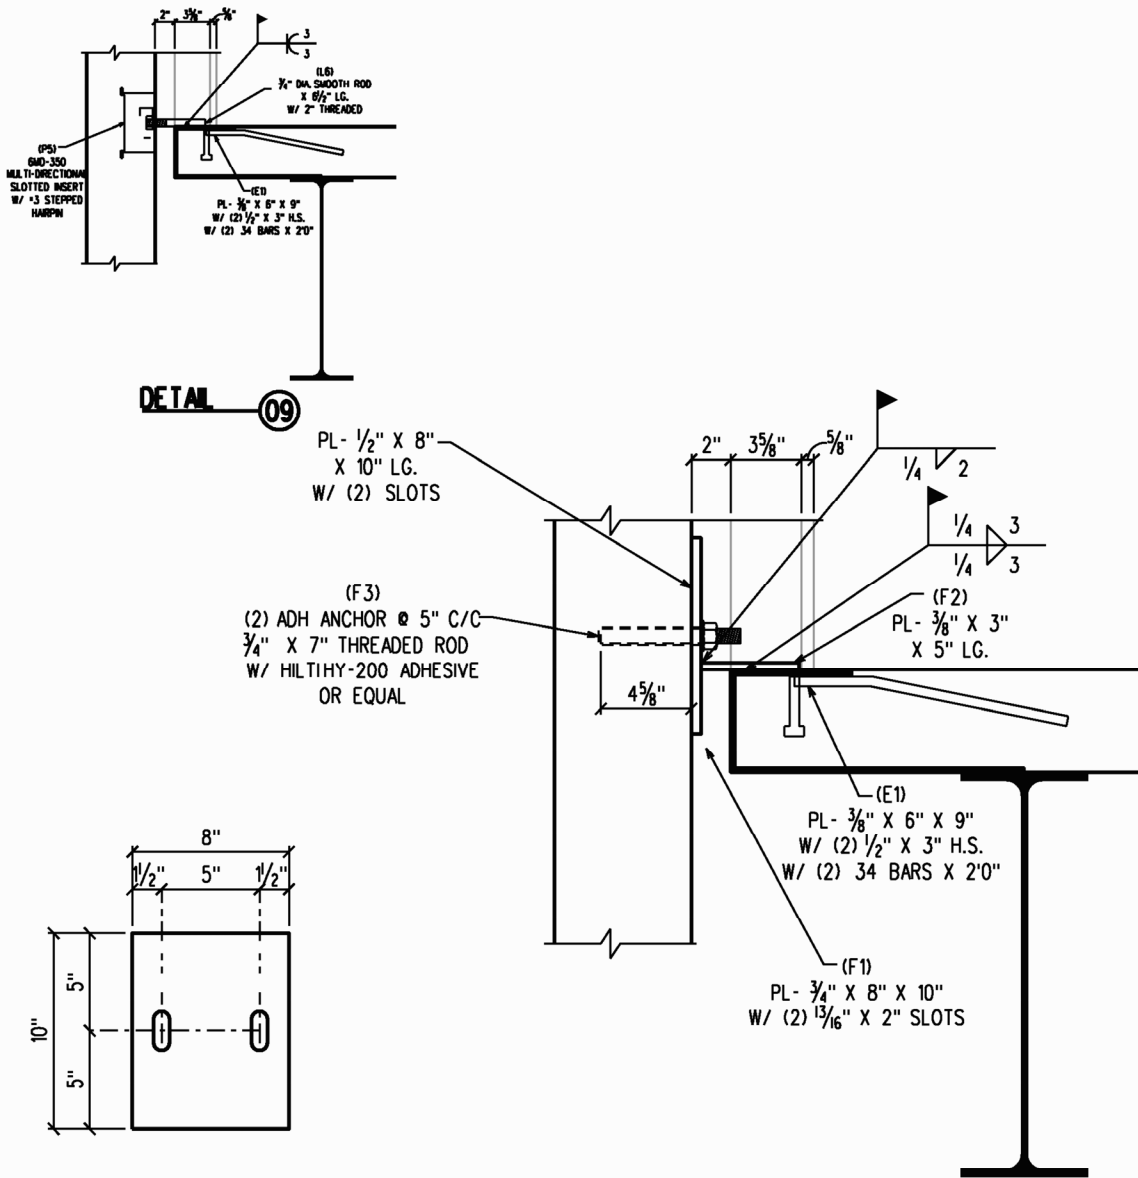
REF: **09**
 FM. NO.: **09-06**

DESCRIPTION OF PROBLEM
 PSA INSERT MISSING FROM PANEL

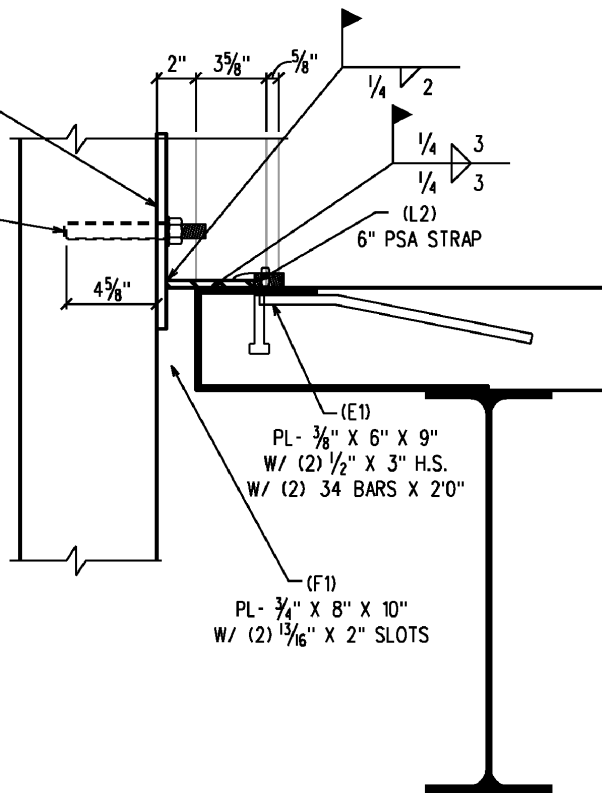
DESCRIPTION OF PROBLEM

PSA INSERT MISSING FROM PANEL

(F3) (2) ADH ANCHOR @ 5" C/C 3/4" X 7" THREADED ROD W/ HILTIHY-200 ADHESIVE OR EQUAL

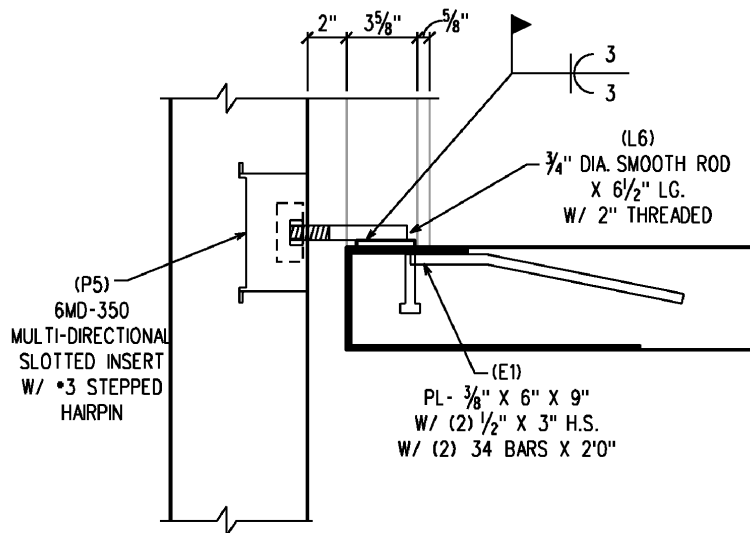
DESCRIPTION OF PROBLEM

6MD-350 INSERT NOT ALIGNED W/ EMBED

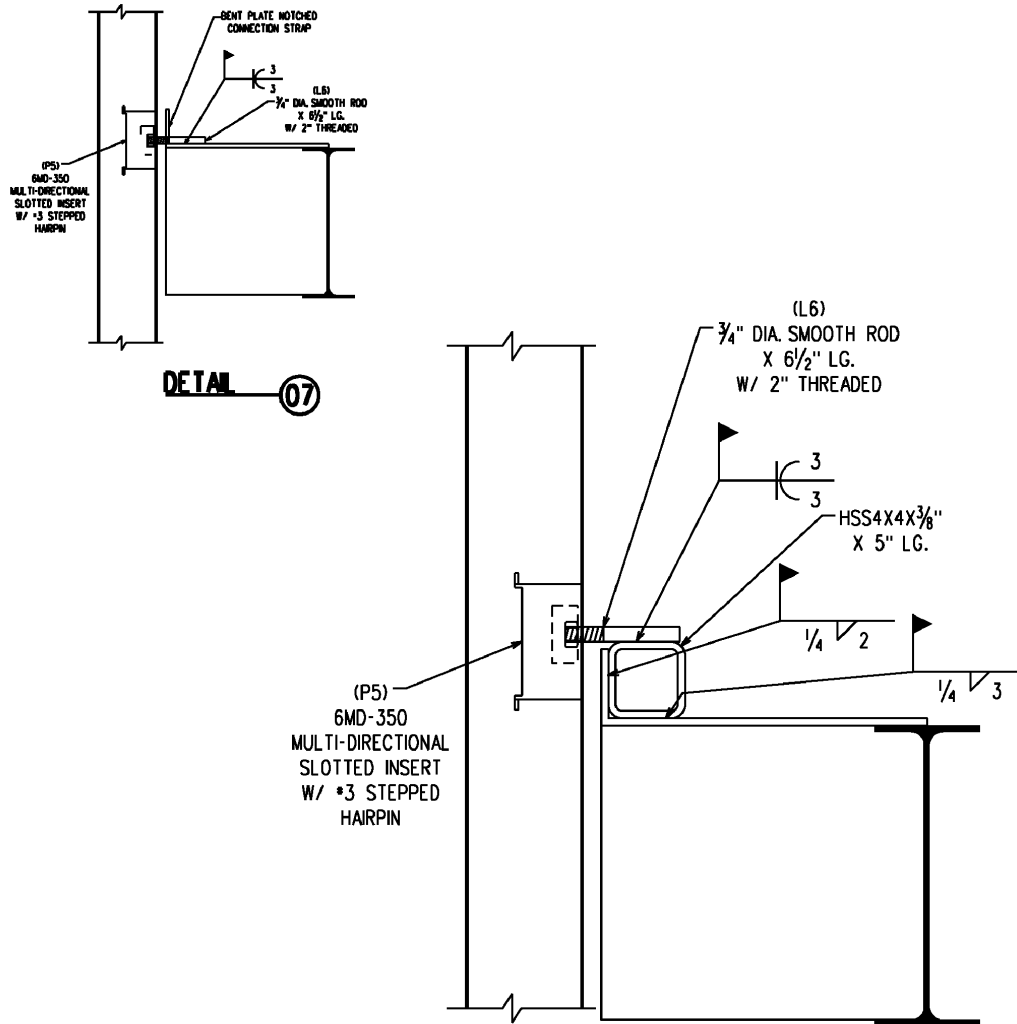
DESCRIPTION OF PROBLEM

6MD-350 IS TOO HIGH

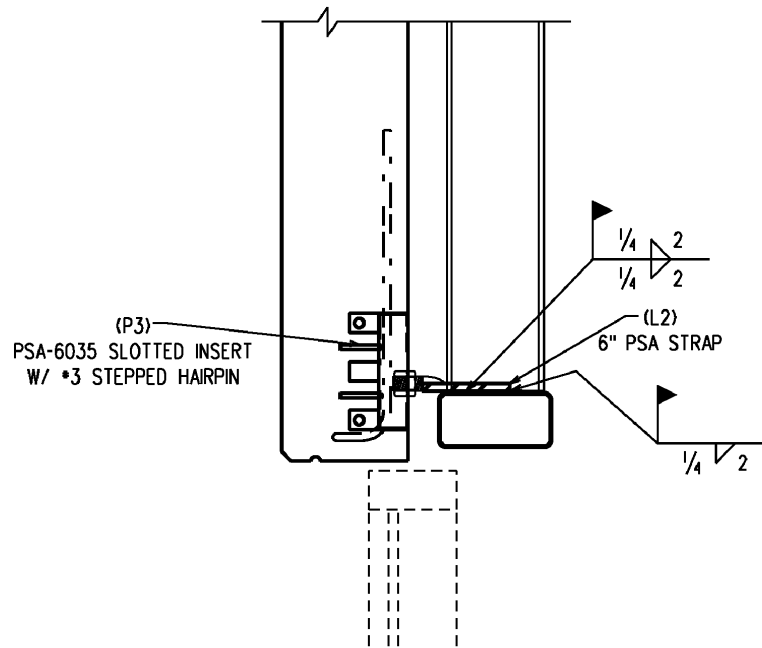
DESCRIPTION OF PROBLEM

WELD VARIED FROM DETAIL

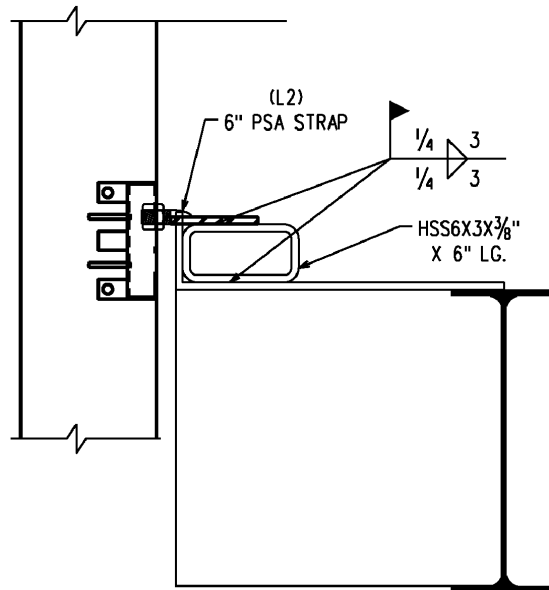
DETAIL 02

DESCRIPTION OF PROBLEM

HSS SPACER ADDED

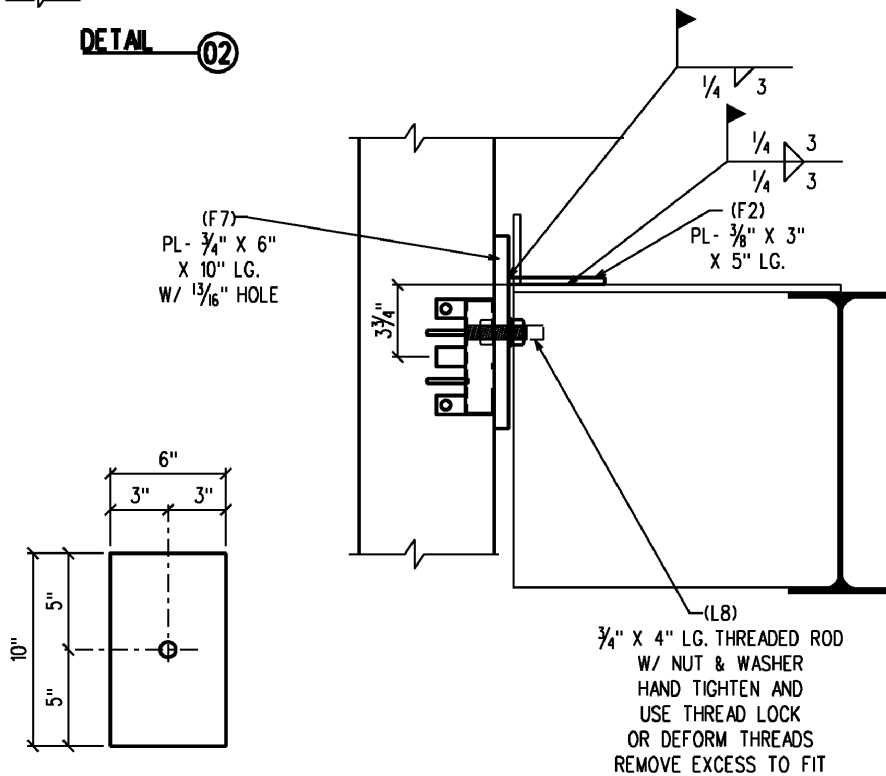
DETAIL 02

DESCRIPTION OF PROBLEM

(L8)
 $\frac{3}{4}$ " X 4" LG. THREADED ROD
W/ NUT & WASHER
HAND TIGHTEN AND
USE THREAD LOCK
OR DEFORM THREADS
REMOVE EXCESS TO FIT
