15094 Community bank Headquarters – Precast review

COMMUNITY BANK HDQTRS.
 FLOWOOD, MISSISSIPPI

FIELD MODIFICATION

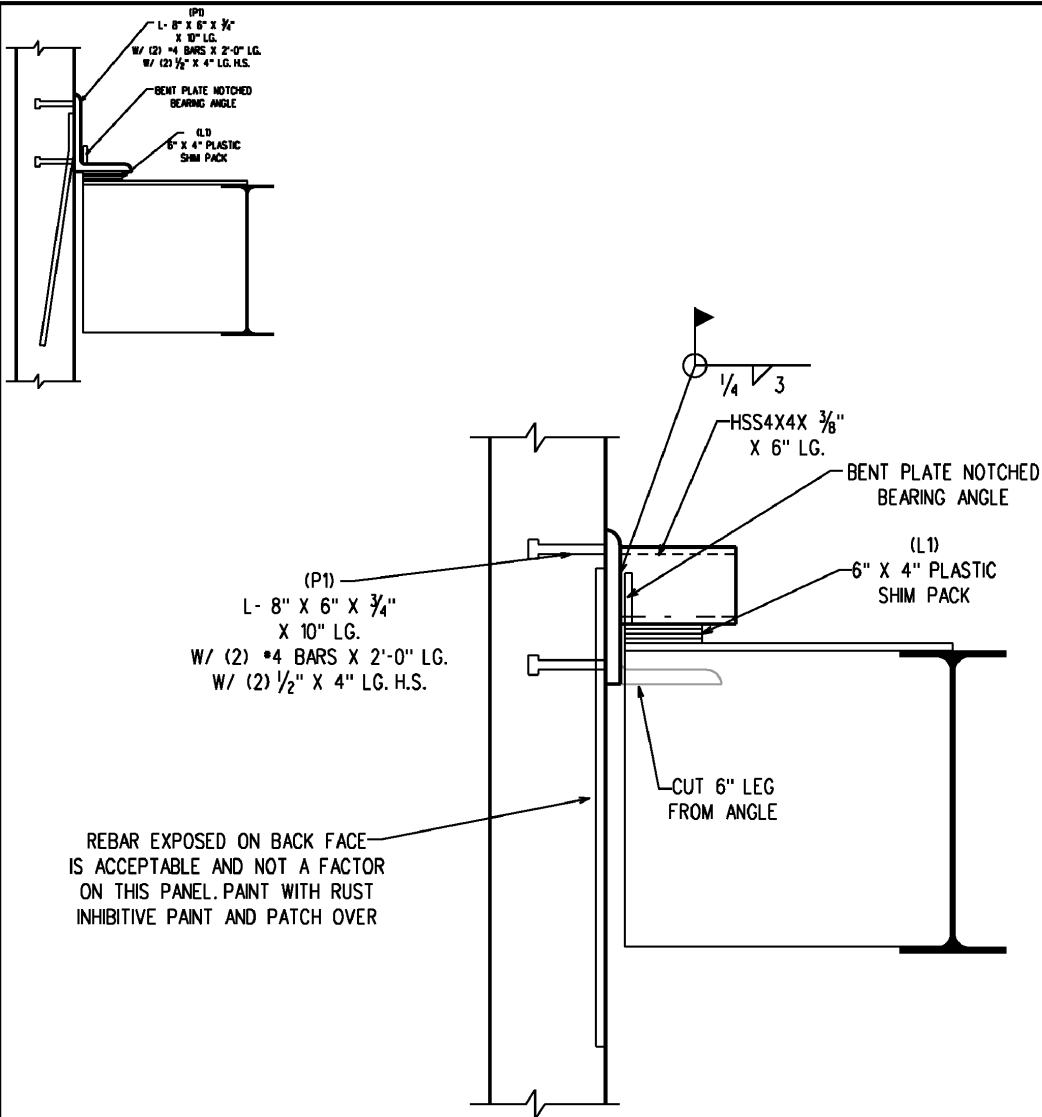
DESCRIPTION OF PROBLEM

P1 CAST $\frac{1}{8}$ " TOO LOW IN PANEL AND TAIL BARS ARE EXPOSED ON REAR FACE (PANEL 104)

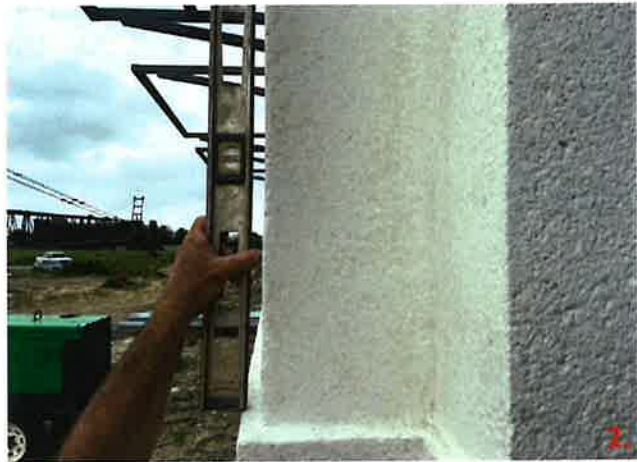
Panel 107 at grid line D is approximately 1" out of plumb over a span of 6'. It appears that adjusting panel 107 at the top will produce proper alignment of the panels.

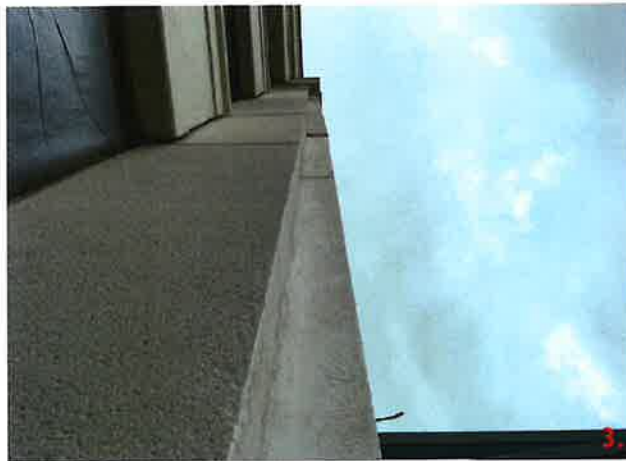
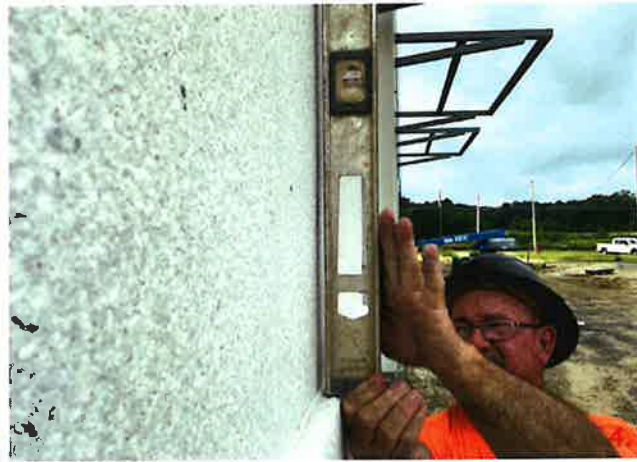
Panel 107 at grid line G is approximately 1/4" out of plumb over a span of 6'. This indicates that panel 107 is installed too far away from the building to achieve proper alignment with the panel above.

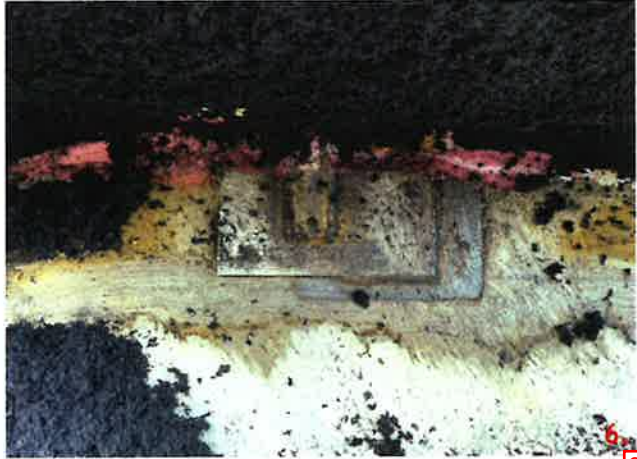
Panels 109B and 109A have connecting points detailed 11 that were field modified using FM 11-1. Instead of using a L4x4x3/8" a PL8x6x3/8" was used at these connections.

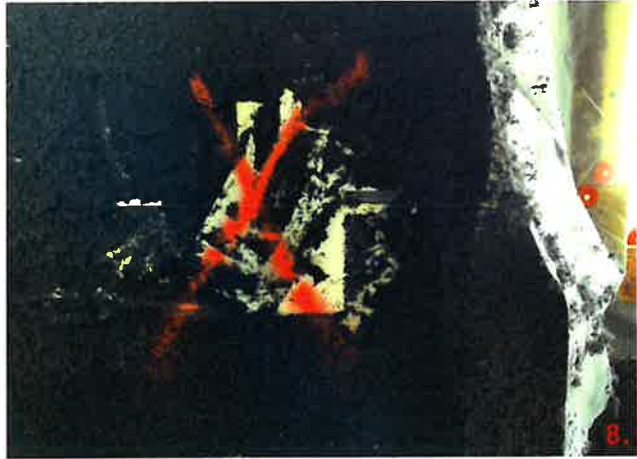
Connection points of panel 107 to 112 at grid line F has one connection detailed 16 that is not complete. The 1/2" plate is not welded to the embed plate in panel 107.

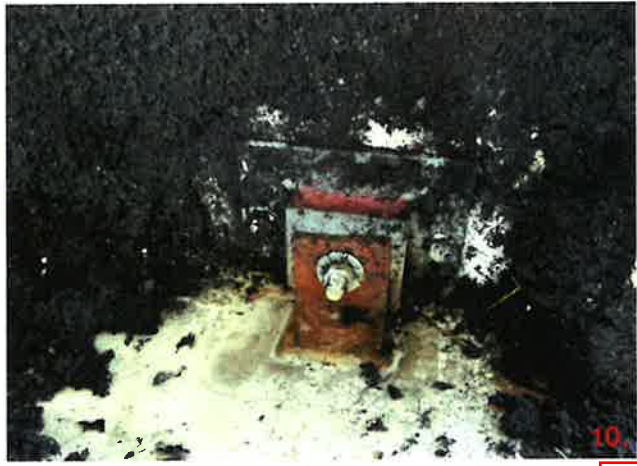
Panel 108 at grid line C has two connection points detailed 10 that have been modified using FM 10-5. These connections meet the requirements of this FM.

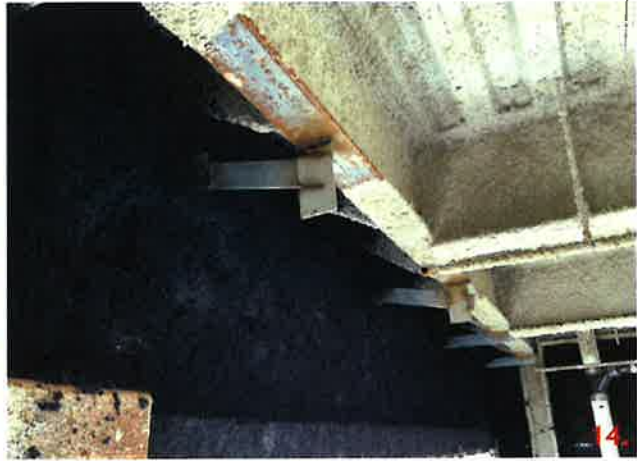
3- Panel 114 has two connections detailed 11 that have been modified similar to FM 11-1. Instead of using a L4x4x3/8x1'-7" a PL3/8x6x8" was used. EOR, is this condition structurally acceptable? (photo 14)

Panel 114 has two connections detailed 11 that have been modified similar to FM 11-1. Instead of using a L4x4x3/8x1'-7" a PL3/8x6x8" was used.

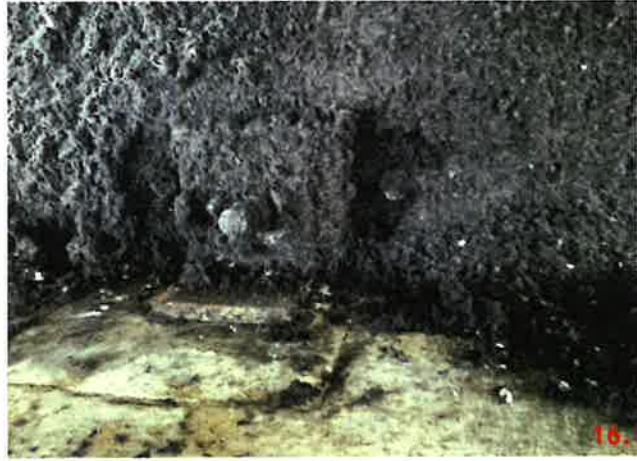
Panels 115, 116 and 117 have connection points detailed 10 and 09 that have been modified using FM 10-5 and FM 9-3.

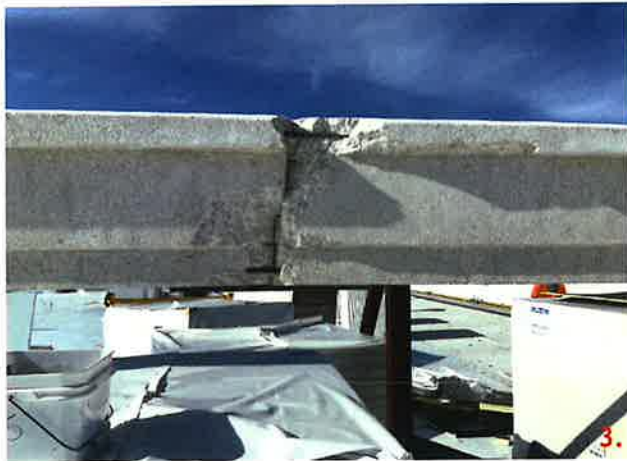
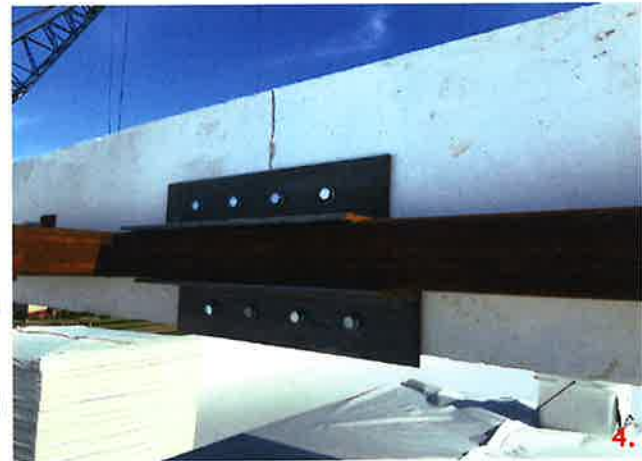
- ~~Panel 105-1 is cracked in two locations. One of the locations has been reinforced with L6x6 angle and 3/4x4" HD screw anchors. The other location is not reinforced. It appears that this panel is in the process of repair.~~ **Removing all 105 Panels.**

Panel 105-1 is cracked in two locations. One of the locations has been reinforced with L6x6 angle and 3/4x4" HD screw anchors.

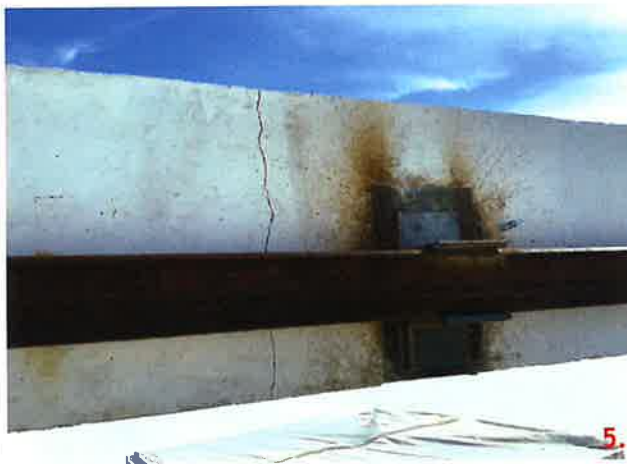
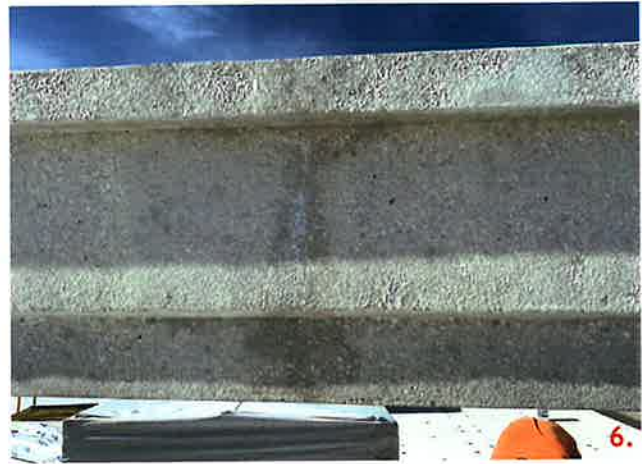
Panel 105-1 has another location that is not reinforced.

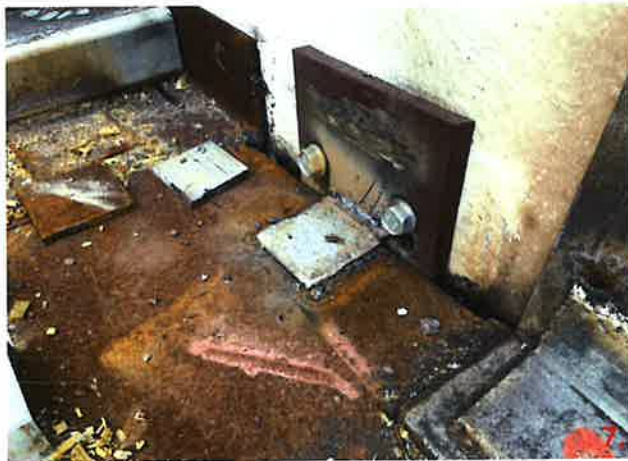
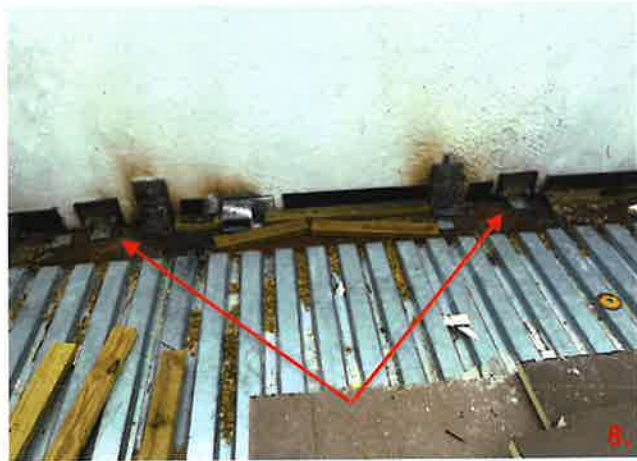
Panel 104-1 has been modified with FM 02-1. HD screw-in anchors were installed instead of epoxy threaded rods at these two connections.

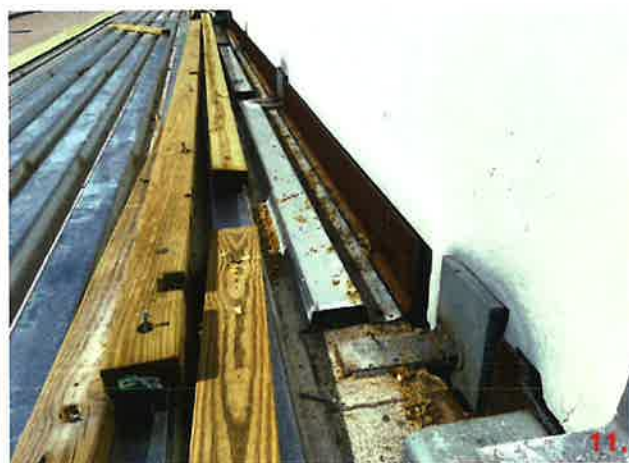
Panel 122-1, at connection point 22 the embedded angle was installed too high but not 4" high. The bottom leg of the angle was cut off and a new L6x6 angle with gussets was welded to the embedded angle all around. A field modification was not provided for this connection.

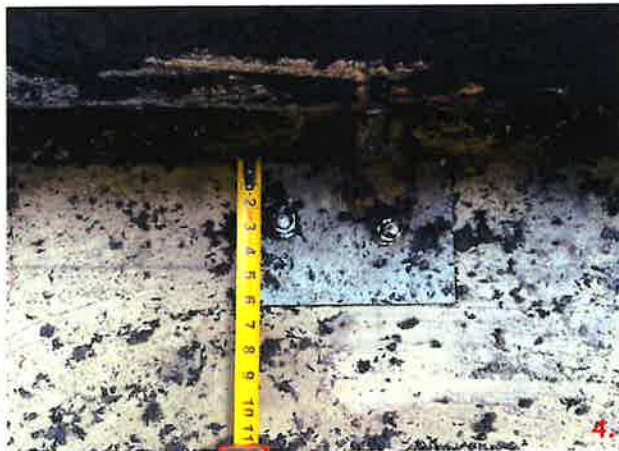
Panel 109A has been modified with FM-11.1. This detail requires the use of a L4x4x3/8 to be welded to the structural steel. This connection has a 6x6x3/8 plate instead.

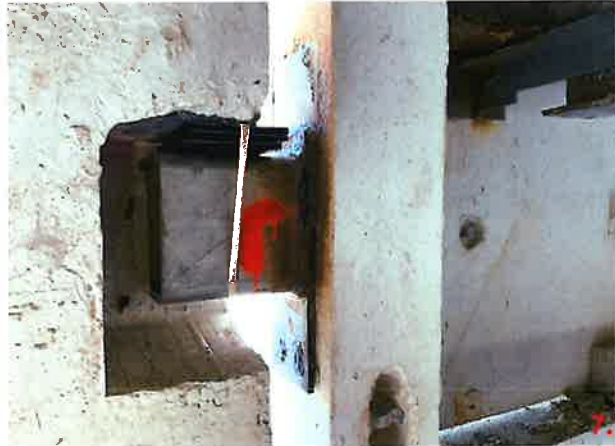
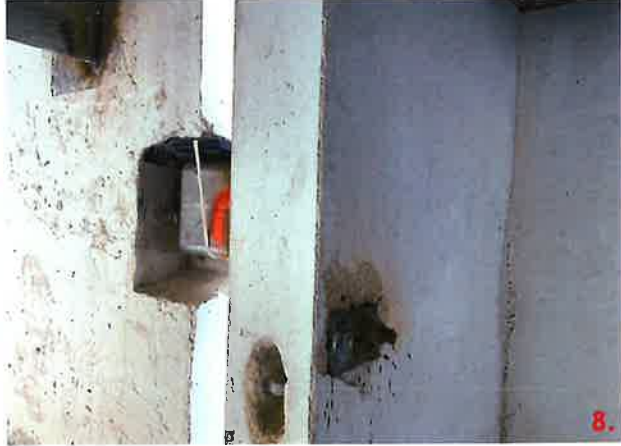
Panels 107-6 and 112 have connection points detailed 16 where PSA insets and embed plates that do not align. The plates are only welded on one side to the embed plate.

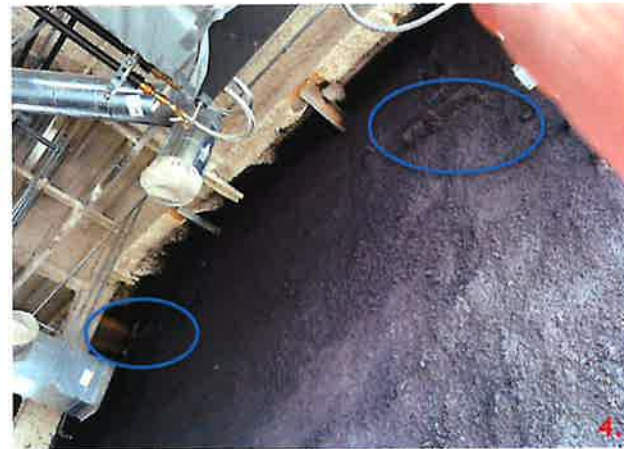
Panel 217-2 & 217-1 have been modified with FM-11.1. This detail requires the use of a L4x4x3/8 to be welded to the structural steel. This connection has a 6x8x3/8 plate instead.

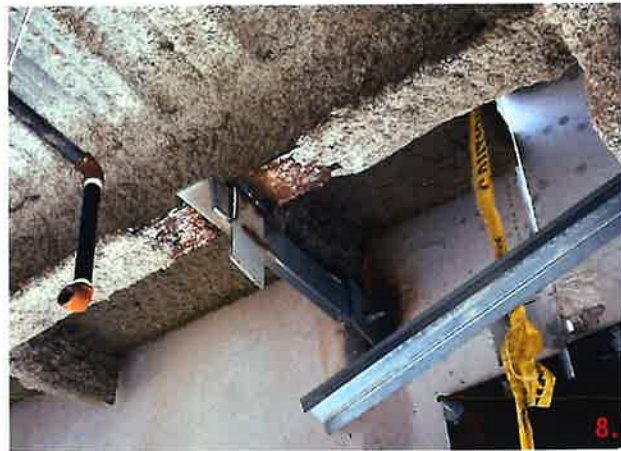
Panel 225-1, 226-1, 227-2, 228-2, connection points detailed 11 do not have 3/8x6x6 plates with slotted holes welded to the embedded plate. These connections are welded directly to the embedded plate and Structural steel.

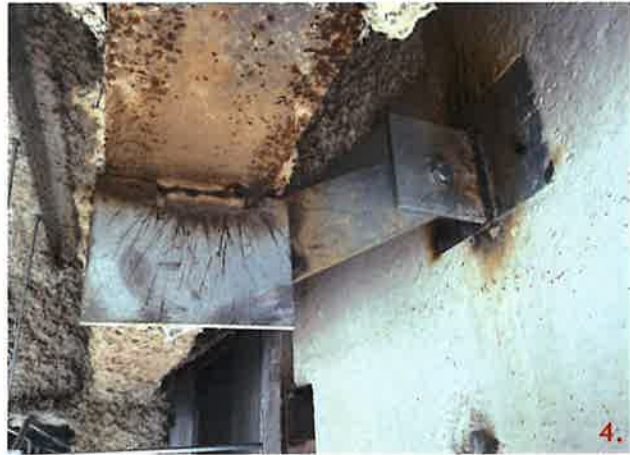
Panel 217A-2, connection points detailed 11 do not have 3/8x6x6 plates with slotted holes welded to the embedded plate. These connections are welded directly to the embedded plate and structural steel.

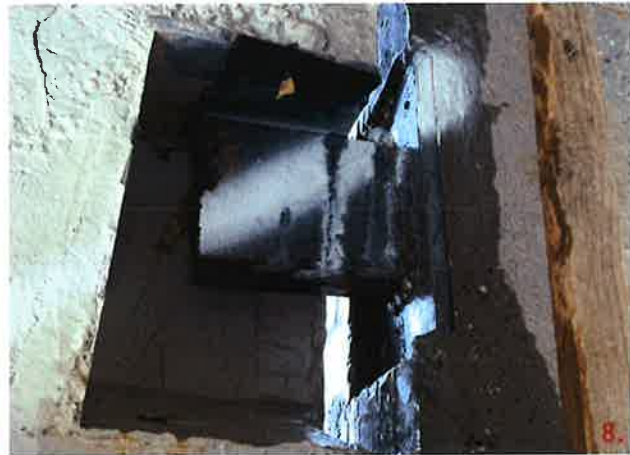
FM-18.10 modification of panel 215-1.

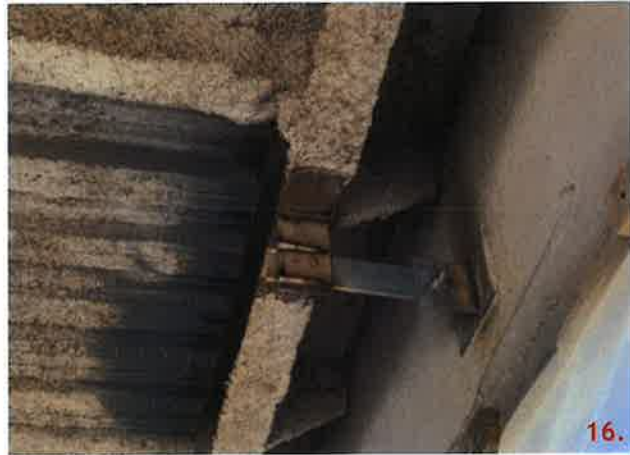
Panel 217B-1 and 203B-2 have been modified with FM-11.1. This detail requires the use of a L4x4x3/8 to be welded to the structural steel. This connection has a 6x8x3/8 plate instead.

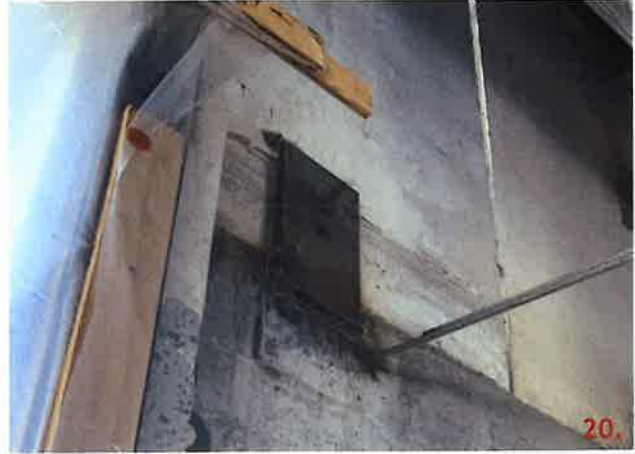
Panel 225-2 is not connected to panel 219-1 as detailed on 16.

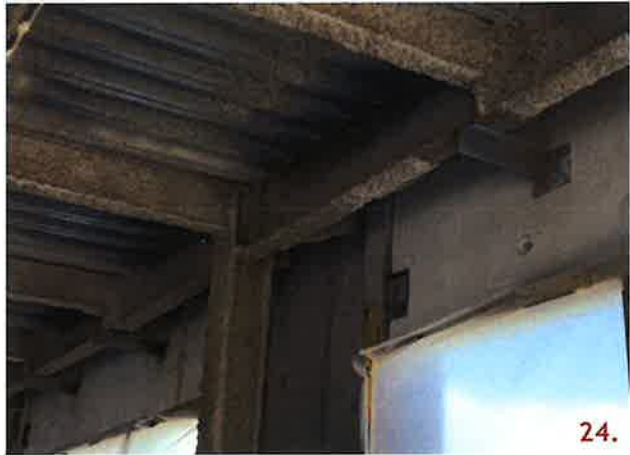
Panel 103-2 is not connected to the structural steel as detailed on 28.

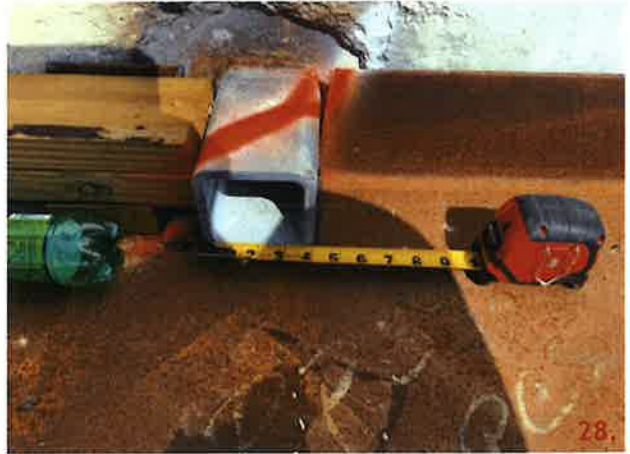
Panel 207-2 & 235-2 have connection points that has been field modified similar to FM-9.2. A 6" PSA strap was used at this connection instead of a 3/8x3x5 plate. The plates attached to the panel are 1/2" thick. FM9.2 requires 3/4" plates.

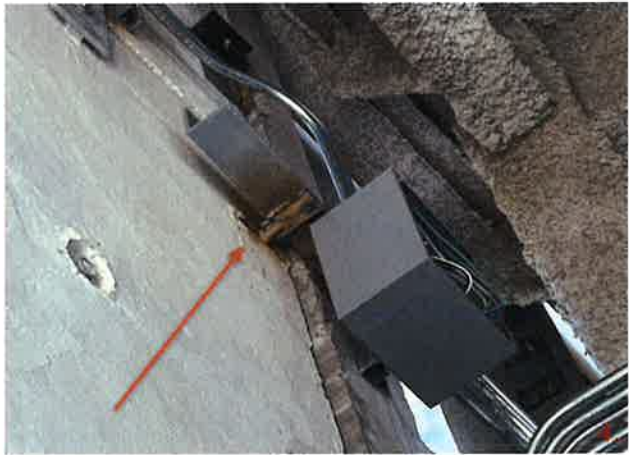
Panel 211B has a plate anchored to the panel and an angle welded to the plate and the 6" PSA strap.

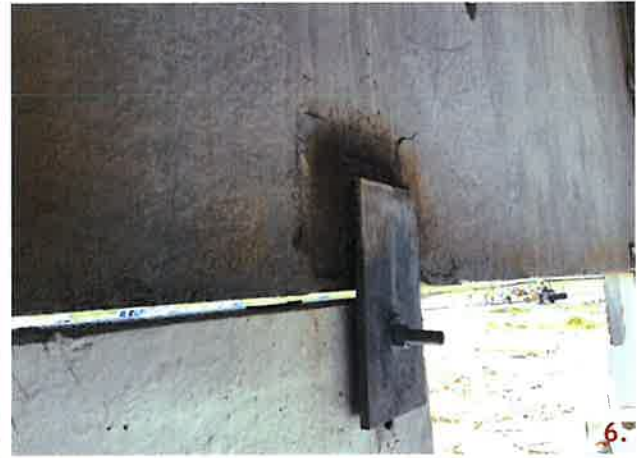
On panels 239 and 240 below elevation 20'-0" between grid lines 4 and 5, plates and angles were used as spacers to achieve the desired placement of the panels.

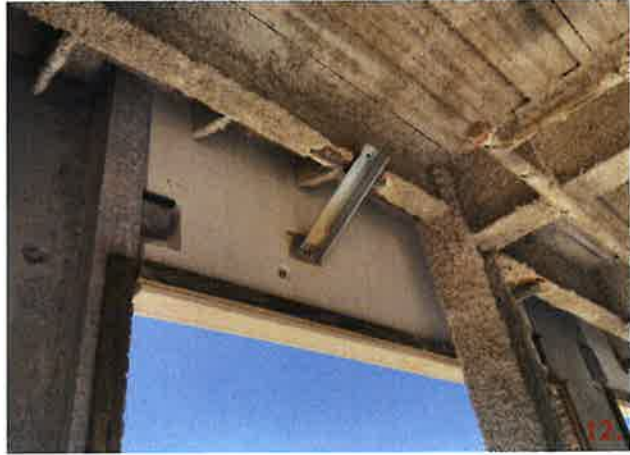
Panel connections of 247 and 223 at elevation 34'-0" at grid line 4 are not aligned with the embed plate. The plates are only welded on one side.

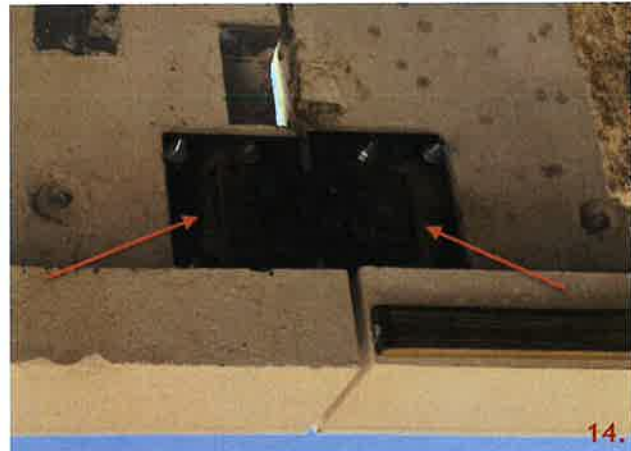
L4x4x3/8 angels at elevation 49'-4" are welded with 6" of 1/4" fillet weld to the beam but not in the detailed locations.

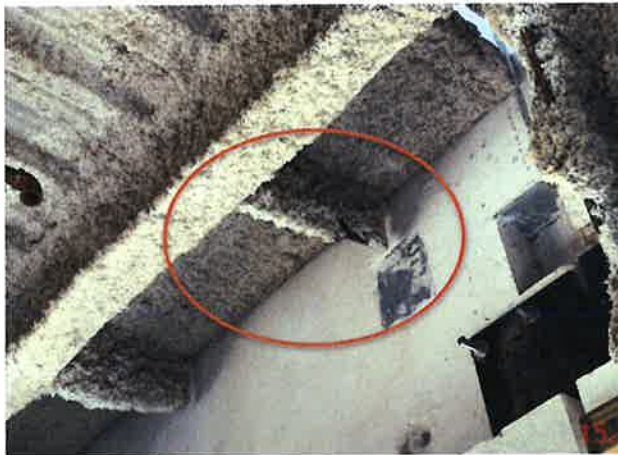
The P7 plate is missing from panel 228 at grid line 3 at elevation 49'-4". Field modification FM18-7 was used at this location. The welds of the connection are on the vertical leg of the 3/4x8"x1'-4" plate and do not have a 1" return.

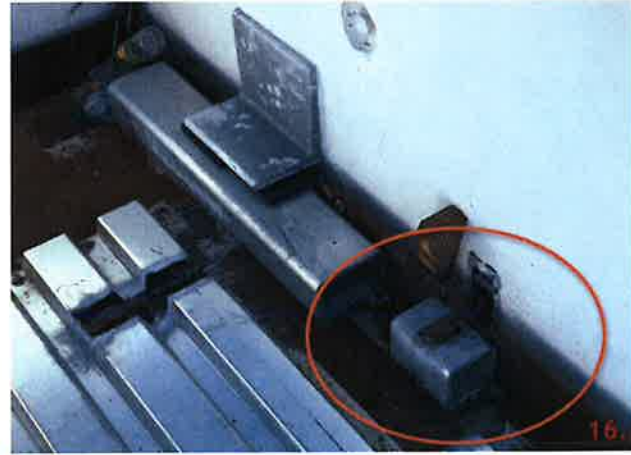
One L4x4x3/8 angles is not installed on panel 229 at grid line 2 at elevation 49'-4".

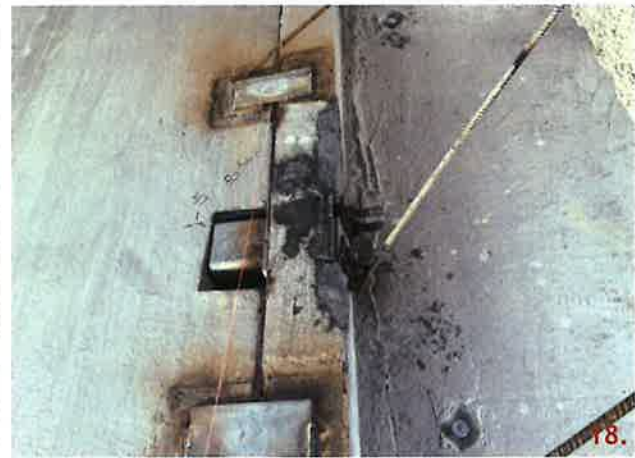
Panel 247 at grid line 4 has two HSS6x3x3/8 and p7 plate bolted through the panel edge. The lower connection at approximately elevation of 6" only has two (2) 3/4 threaded rods at this connection.

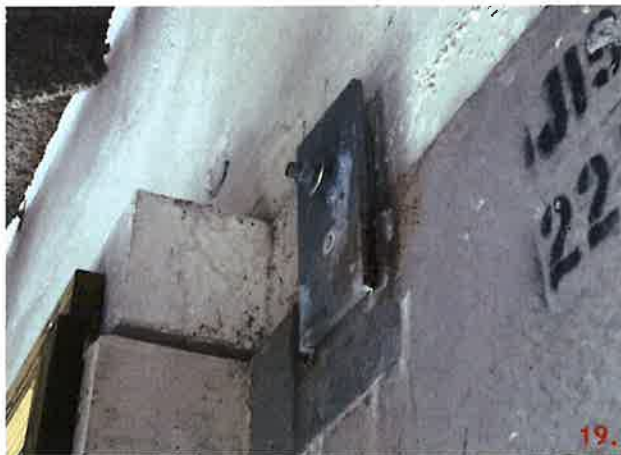
Panel 246 at grid line 5 has one HSS6x3x3/8 and p7 plate bolted through the panel edge. This connection meets the requirements of the approved field modification FM18-3.
