Architect's Field Report

16 January 2020

Tunica Schools

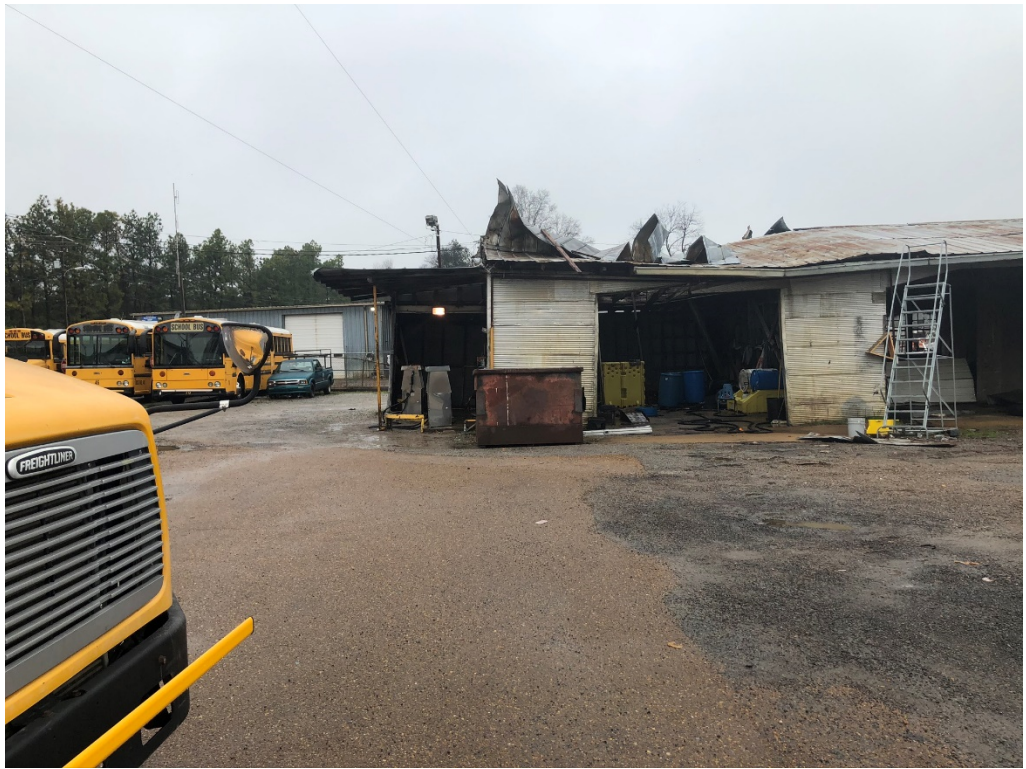
Figure 1 – South Elevation

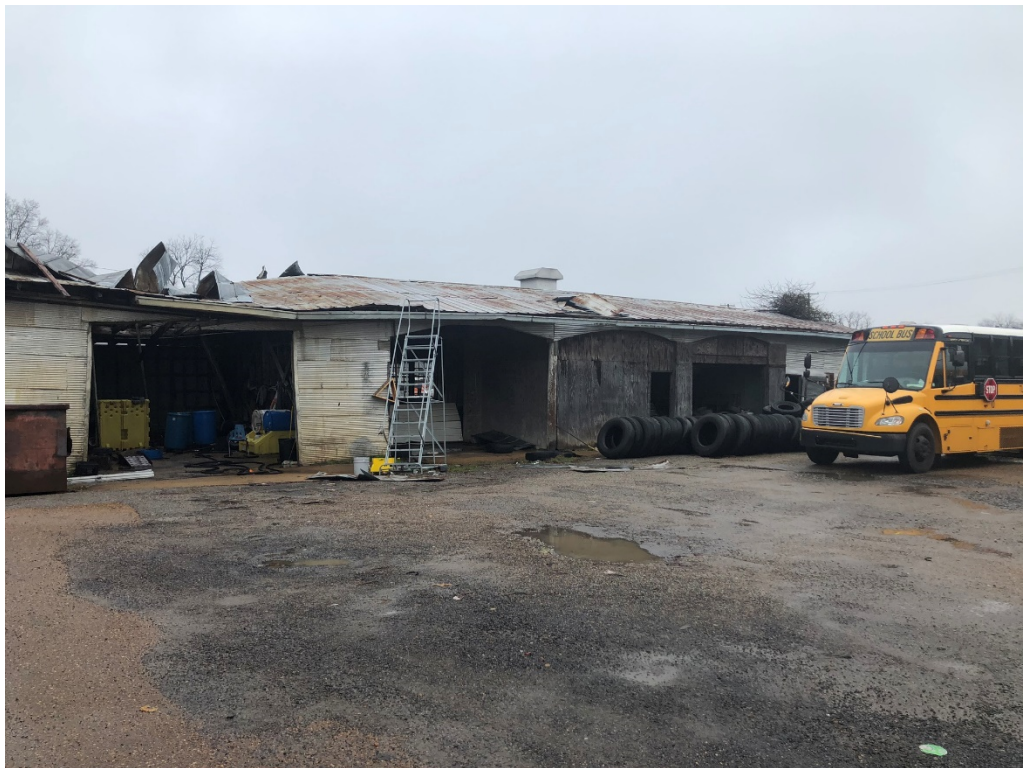
Figure 2 - South Elevation

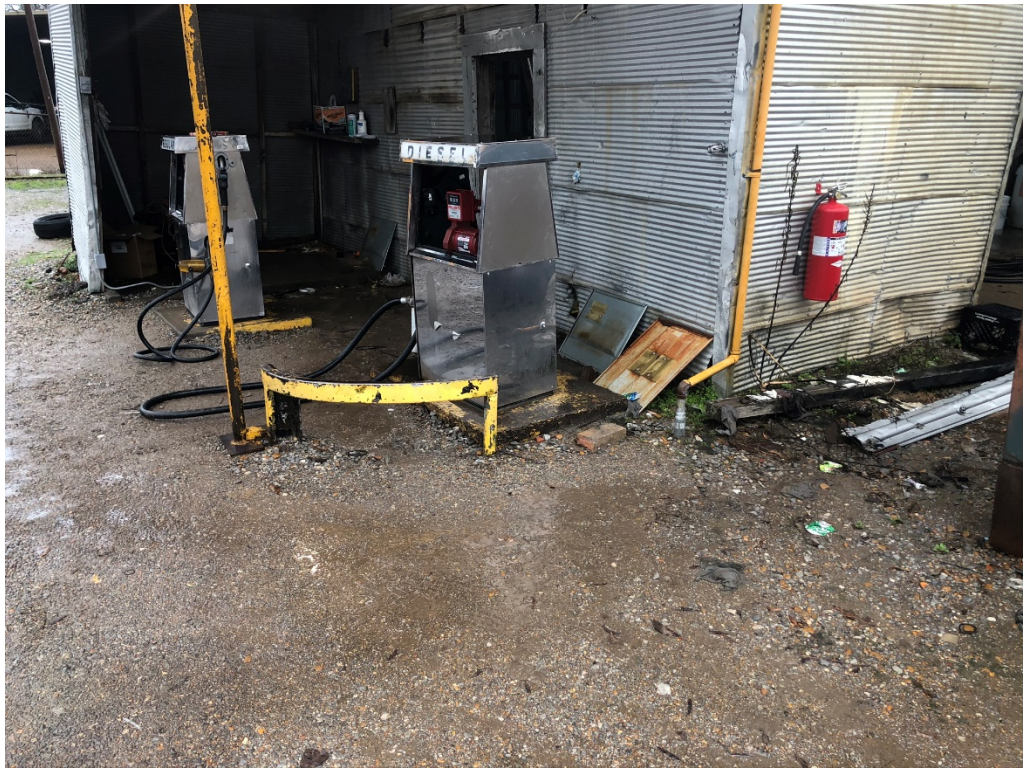
Figure 3 - South Elevation; pump area (to remain)

They mentioned issues with people driving into and hitting the southwest corner at the gas pump area and I suggested needing a couple of bollards to which they were receptive.

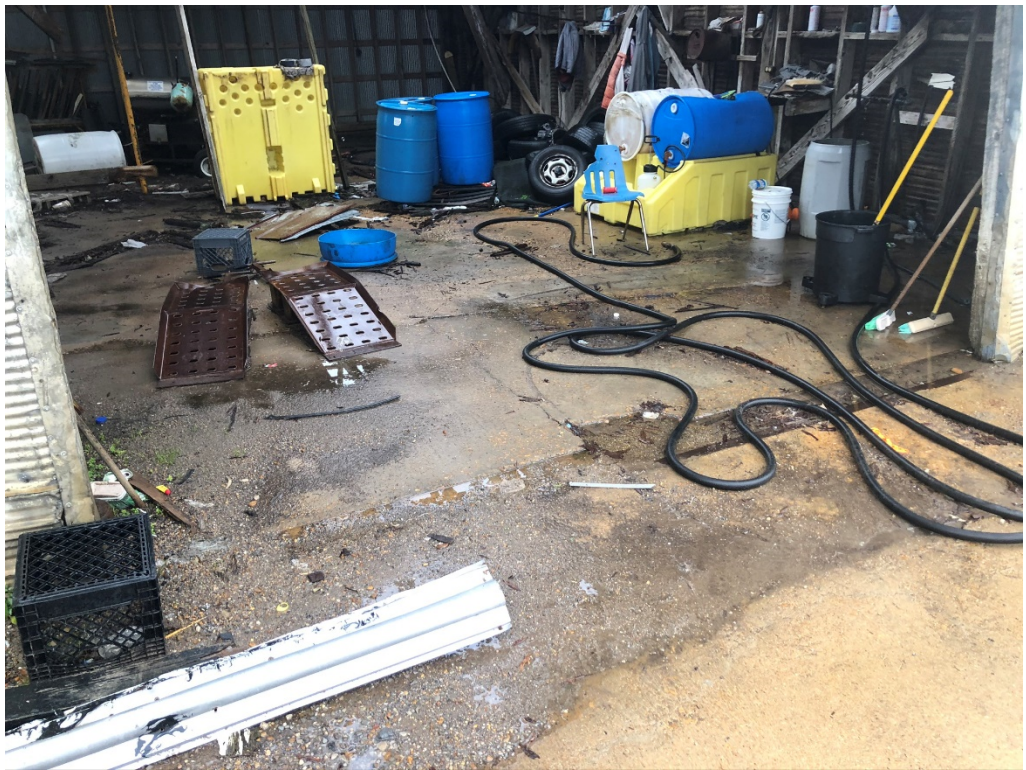
They need the bay to be high enough to fit buses for washing. The tallest bus they currently own is 11'6". Mr Richard mentioned needing something 3-4 feet higher. He pointed to a building nearby whose eave was close to 16'.

Figure 4 - Wash Bay

Mr Richard requested that the roof be insulated at the bus washing area.

They mentioned that they would like to reuse the current foundation, but they also mentioned needing positive drainage at the bus washing area.

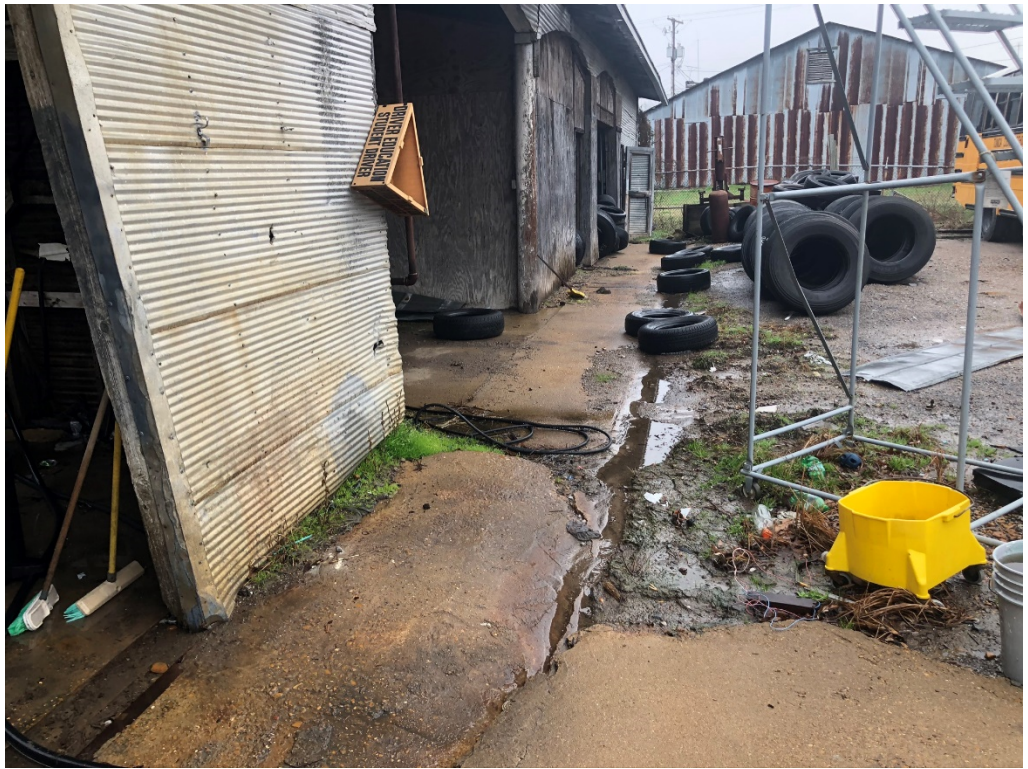
Figure 5 - South Elevation

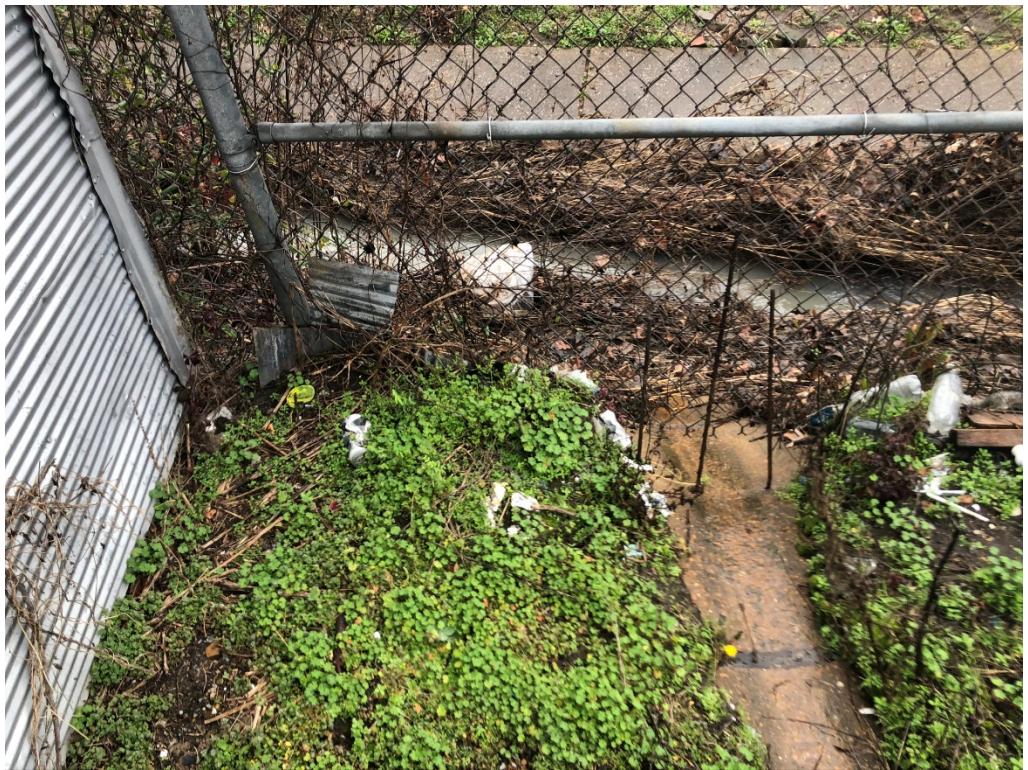
Figure 6 – Drainage Ditch @ East (no issues with overflow)

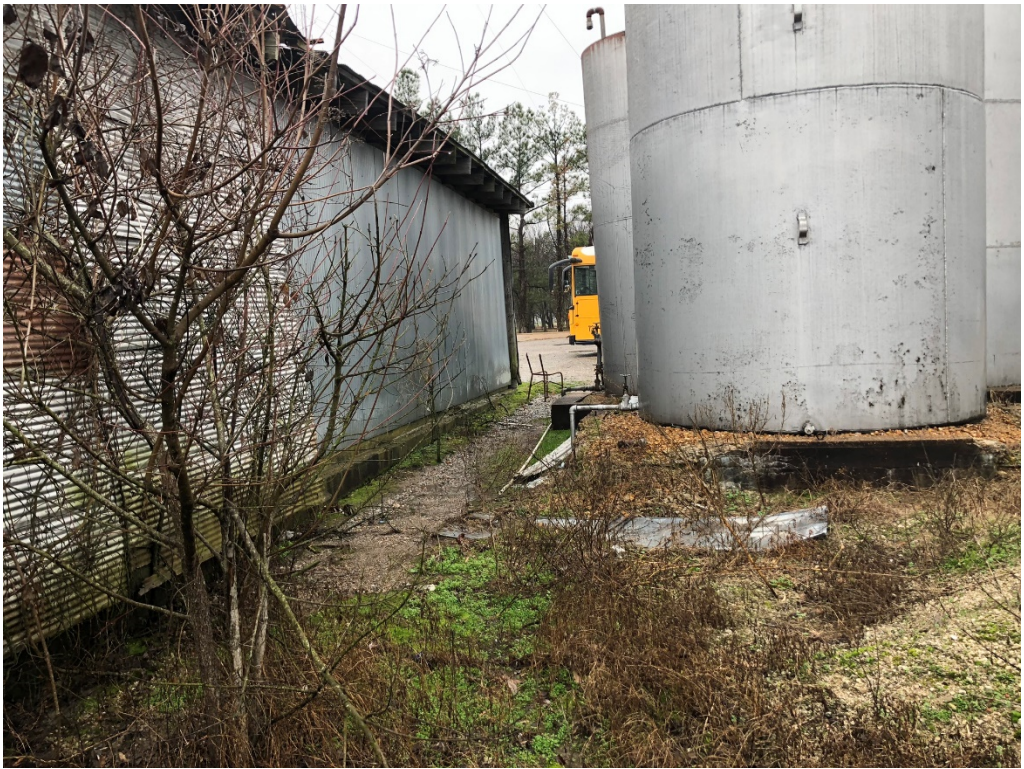
Figure 7 – North side & Fuel Tanks

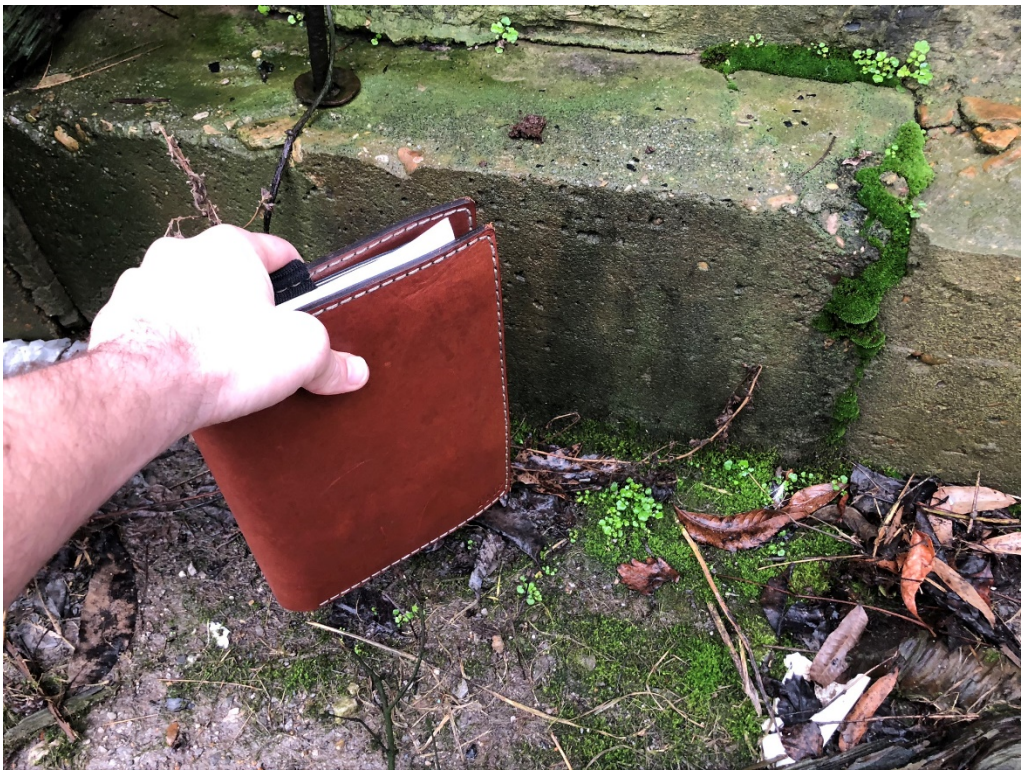
Figure 8 – 8" Existing Slab shown at North @ Wash Bay Slab

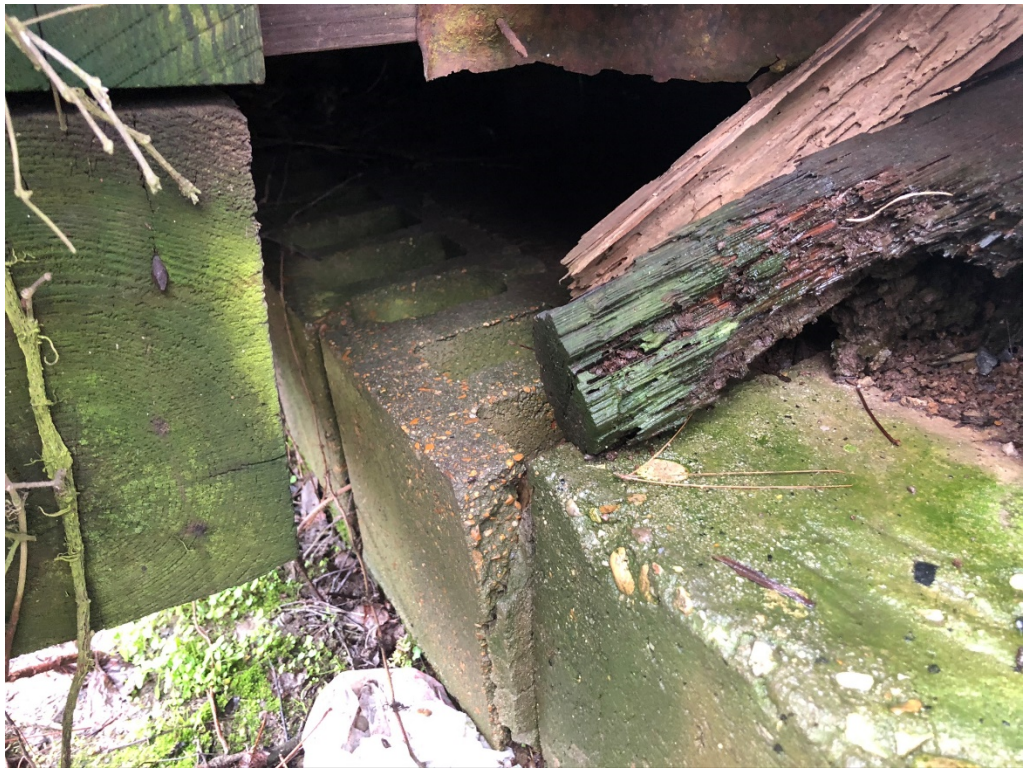
Figure 9 – Un-mortared blocks at slab to east of wash bay (concrete floor on interior)

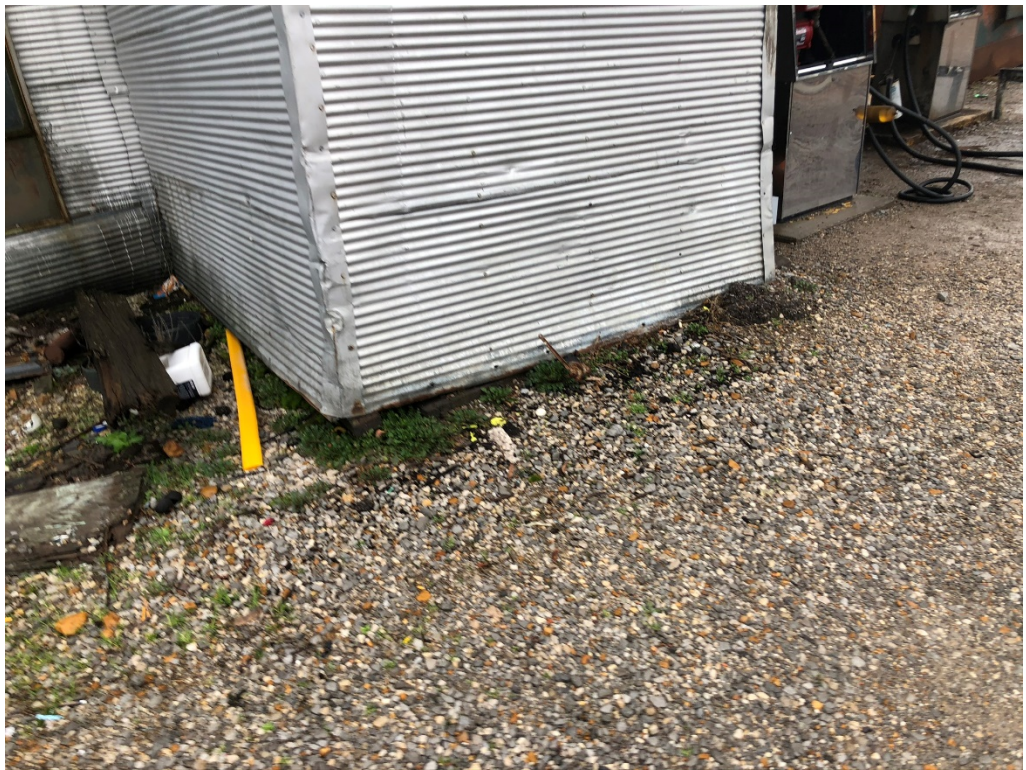
Figure 10 – Gas Pump Storage room (2 sides walled and open on pump side)

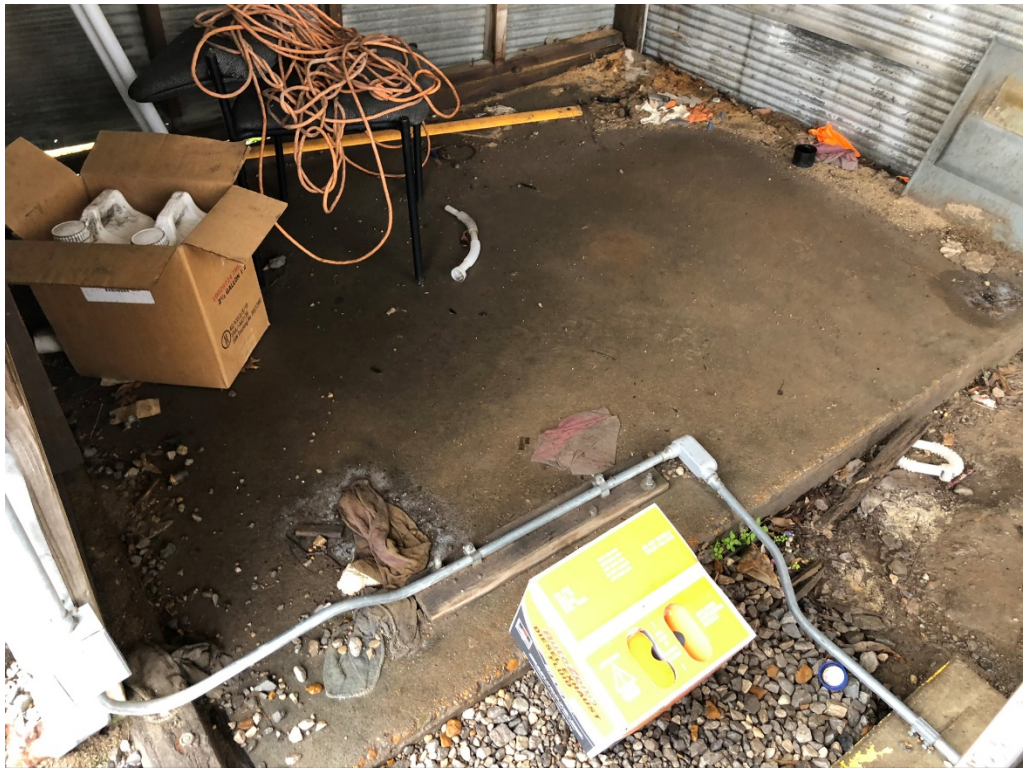
Figure 11 – Pump Storage Slab

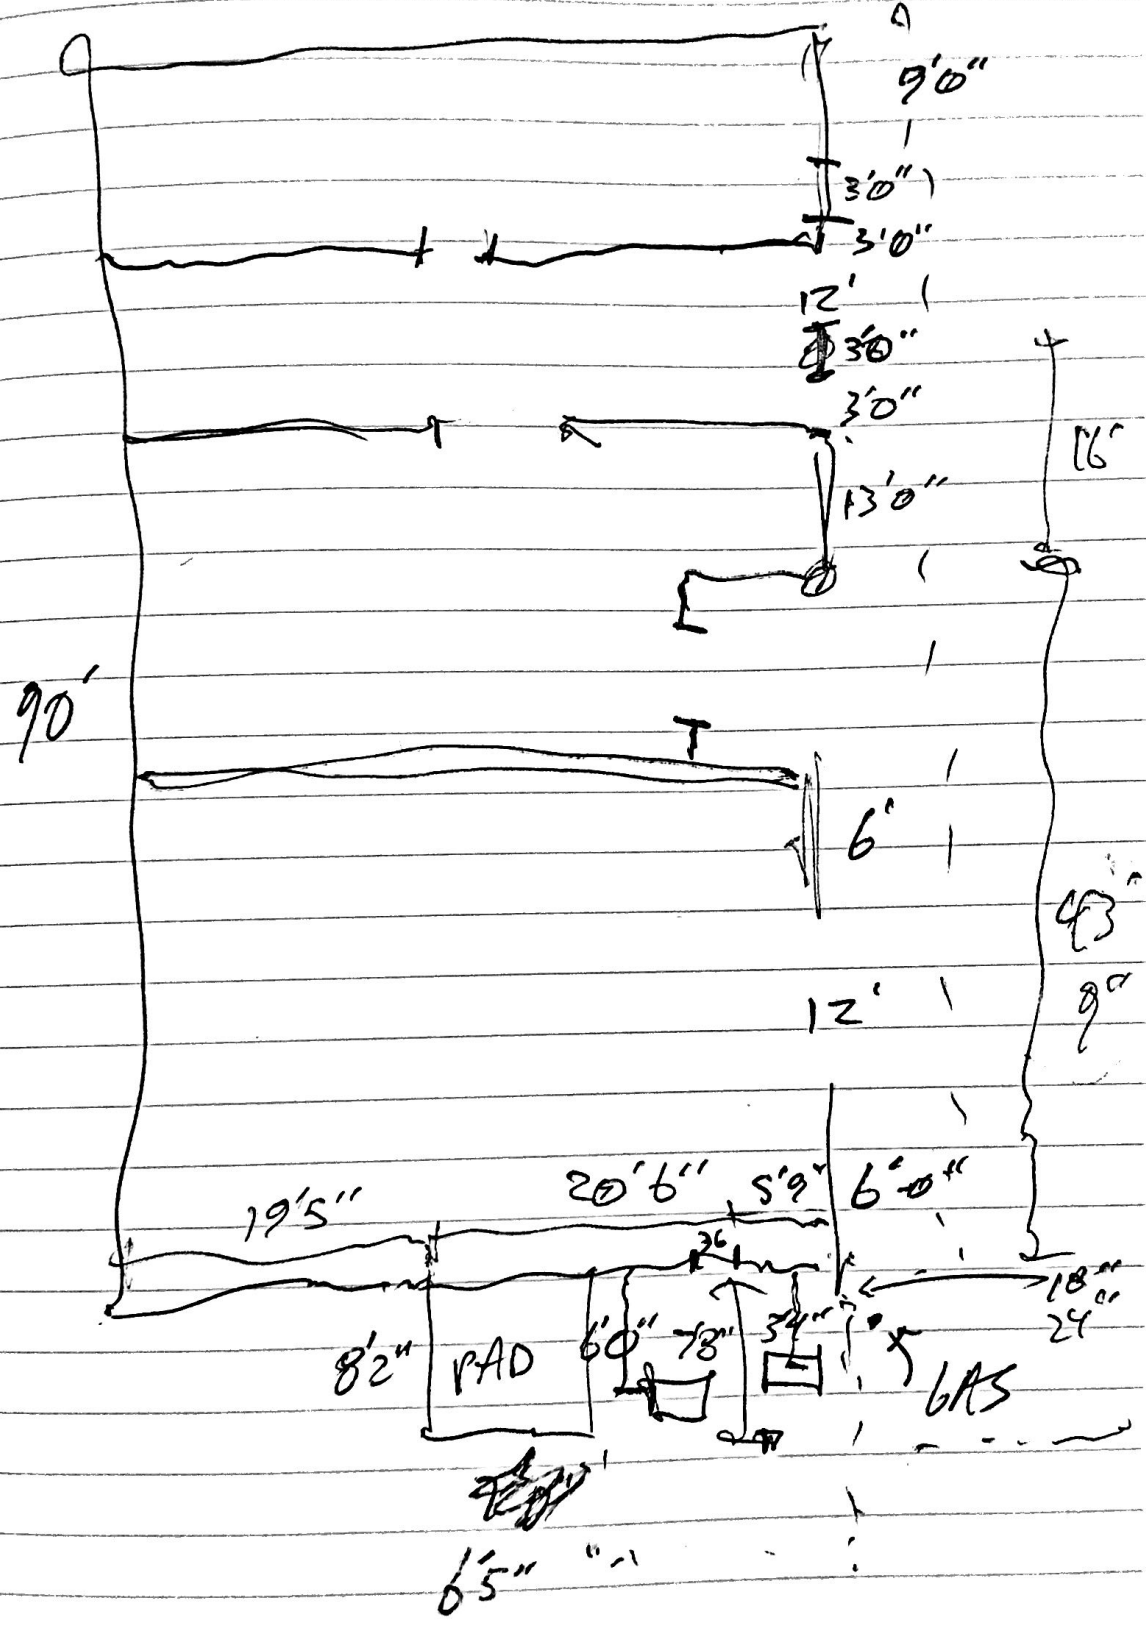
Notes I met with Mr Alexander and Mr. Richard (I believe his name is ricky herring, but all I got was Richard from him). We discussed what they needed and what they've used in the past. Attached is my rough building plan sketch.

Current building measures 40x90; They mentioned that they would prefer it to be 40x80. They also had some specific eave requirements: South eave should have at least 10-14 feet of overhang; West eave at gas pumps should have at least 6' of overhang.
