Architect's Field Report – Warranty Walk

18 October 2022

18056-Warren Central Junior High School / Warranty Walk

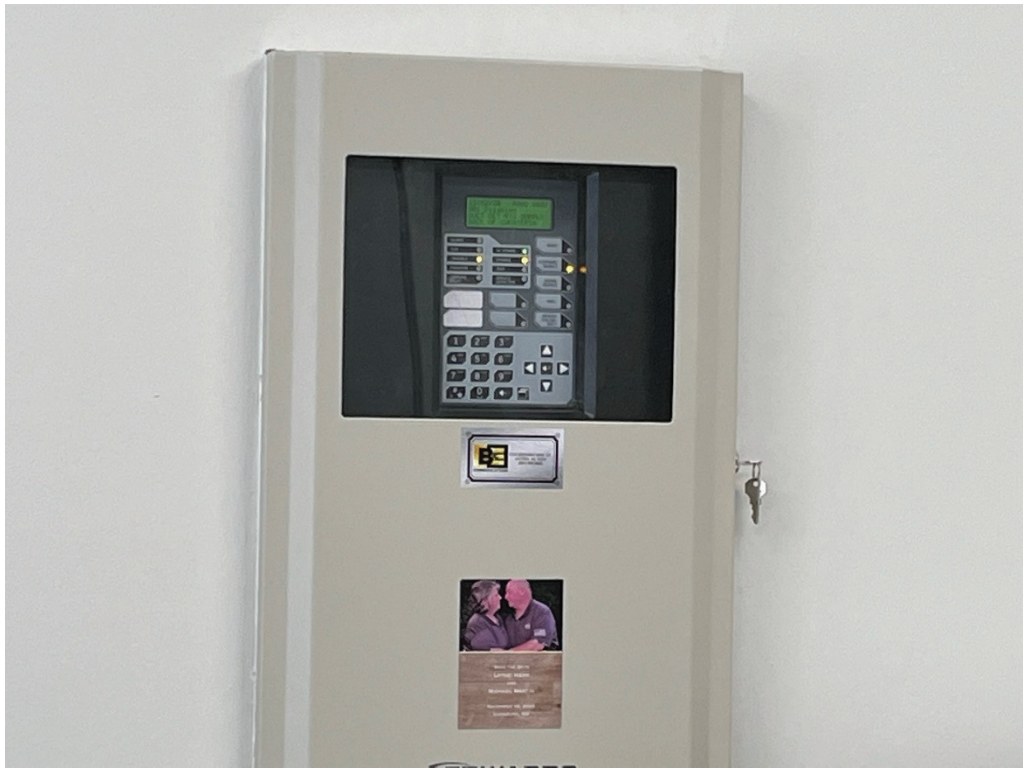
At the reception area in administration, I was notified that 2 sensors in the cafeteria were abandoned by the alarm installer recently because they coded constantly; this situation should be explored further to determine if this puts the public in danger by the contractor and the local fire Marshall.

Figure 1 – 2 Sectors in Cafeteria Abandoned because they constantly “Coded”

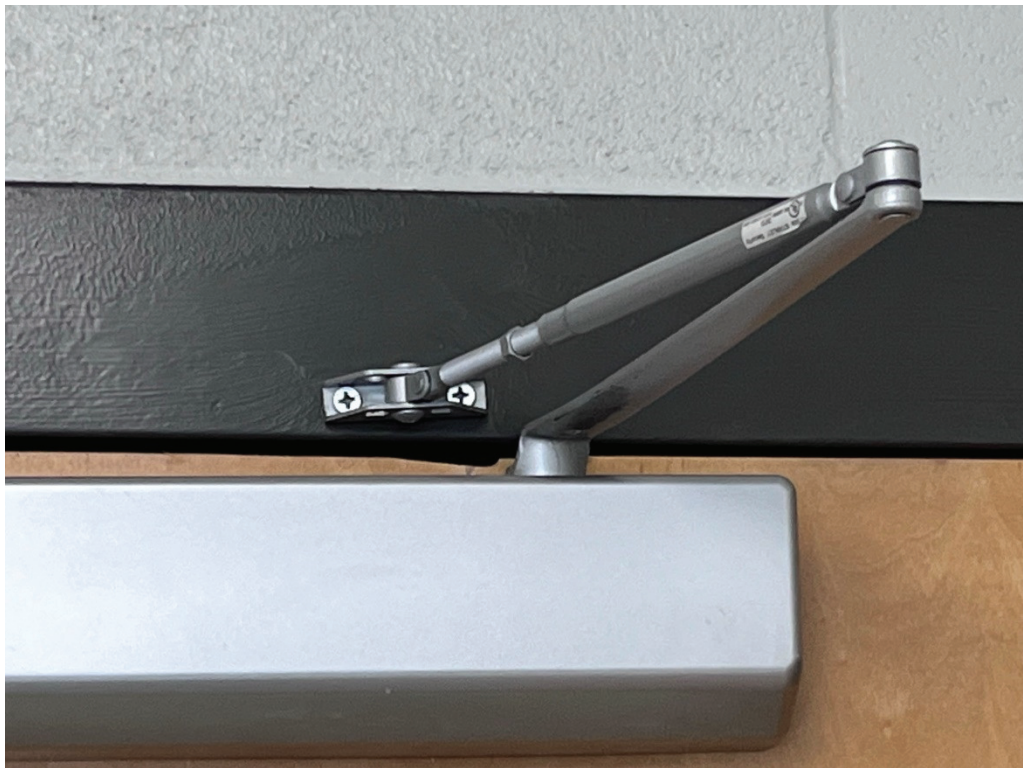
In this same area, a door closers arm was supposed to be raised so that it did not obstruct the door panel from closing smoothly; this was never done and the door has been damaged due to the issue.

Figure 2 – Closer Rubs Top of Door

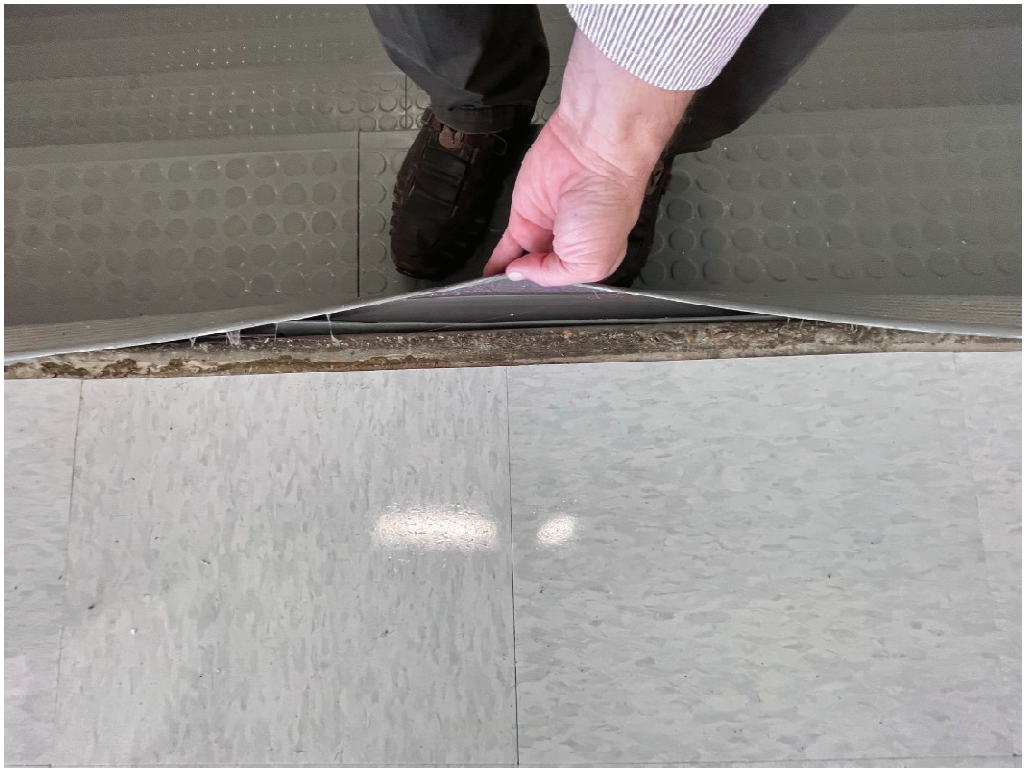
Nosings throughout newly remodeled staircases are coming off due to glue that has been used.

Figure 3 – Rubber Nosing poorly adhered

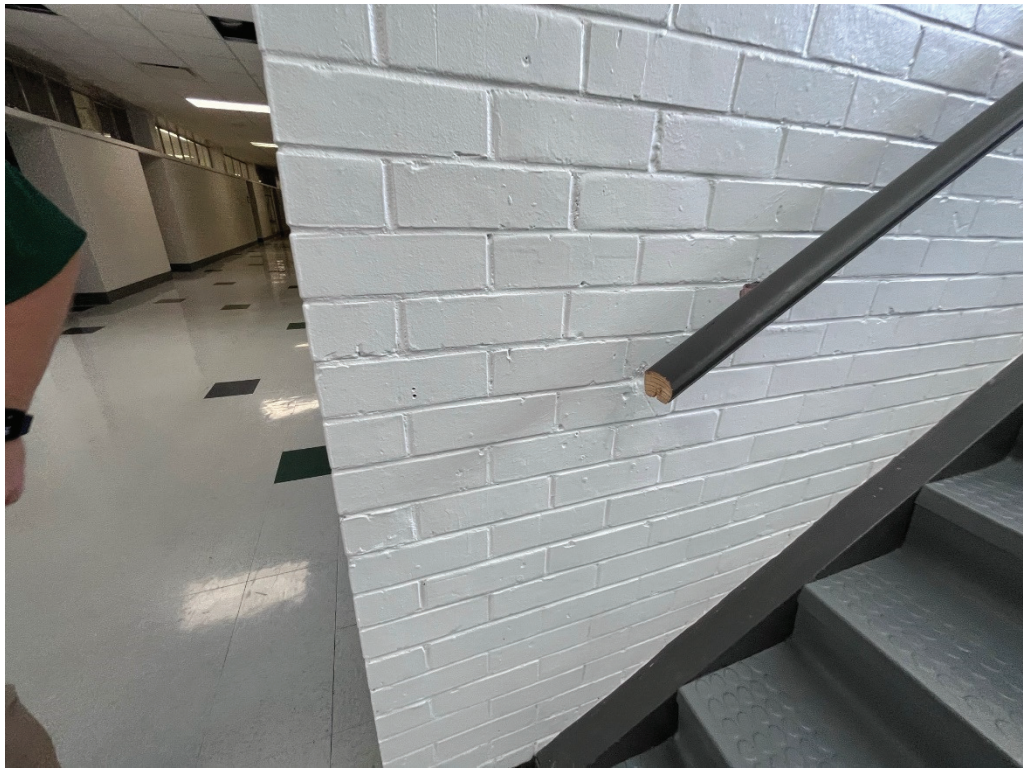
Handrails that were noted not complete, have never been fully so. Some that were installed were poorly fastened and unfinished. In other areas, they were never installed.

Figure 5 – Handrail Extension not Substantial; needs to be replaced

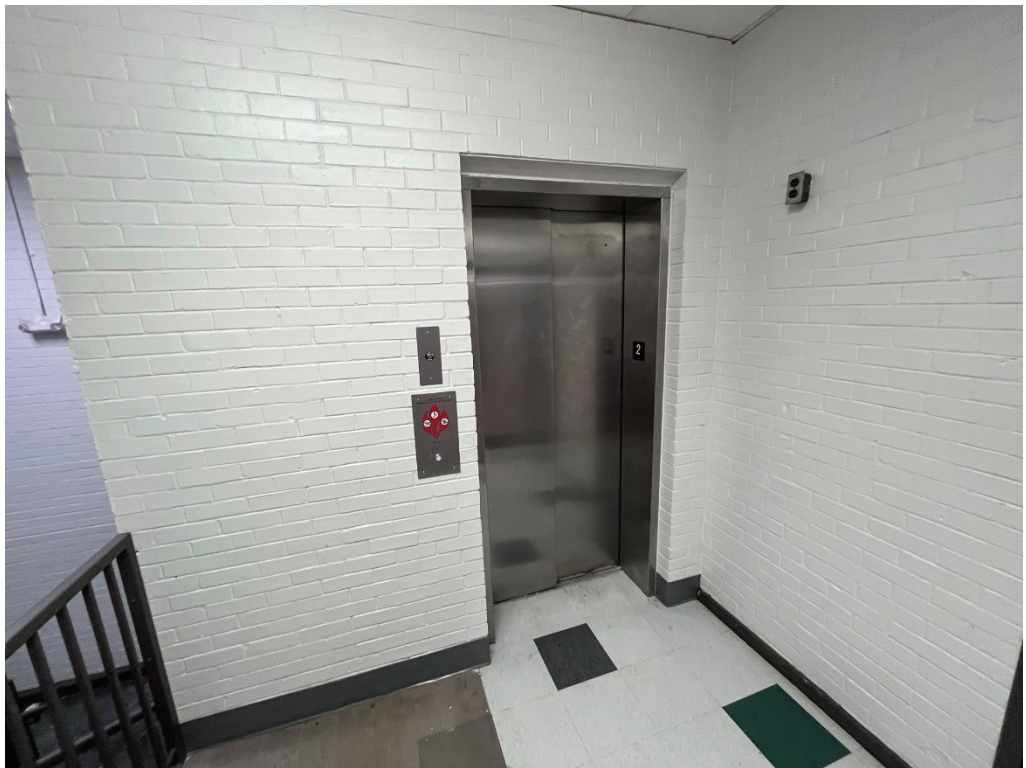
The elevator has not been working for a while. The school has been in touch with the manufacturer who has provided an \$8k bill for repair. This should be covered under the contractor's warranty.

Figure 8 – Elevator has Not worked for Months

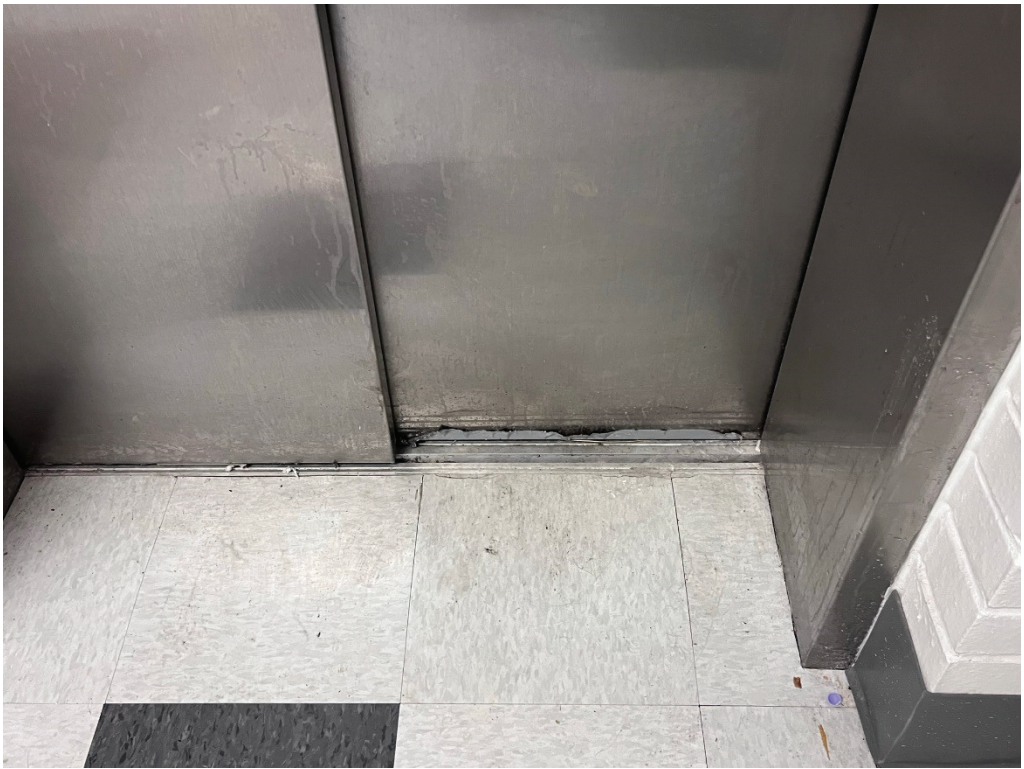
Figure 9 – Protective Film Never Removed

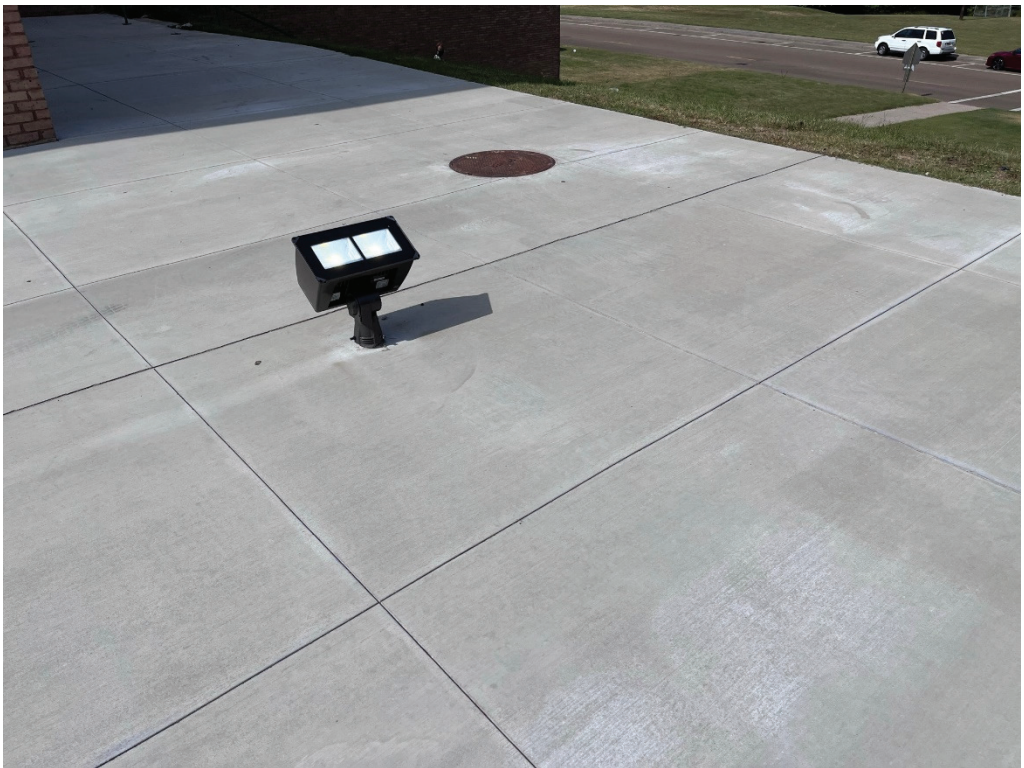
Finally, lights at the flag pole appear to be lit during day time hours. Please review and replace any lighting sensors that are not operating properly.

Figure 10 – Flagpole Lights Always On
