Architect's Field Report

12 December 2021

15094 Community Bank Headquarters / Report Number 032

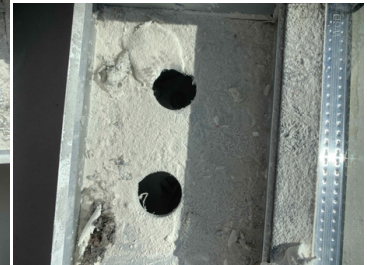
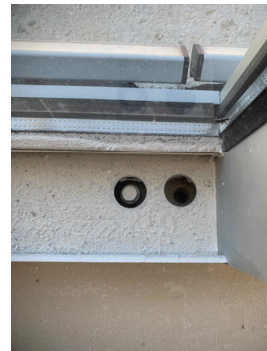
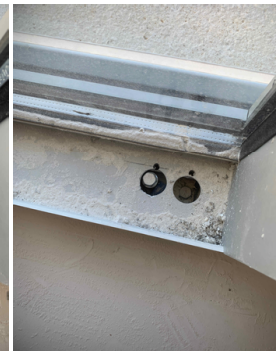
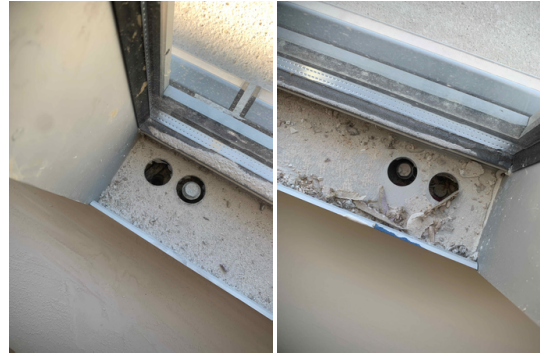
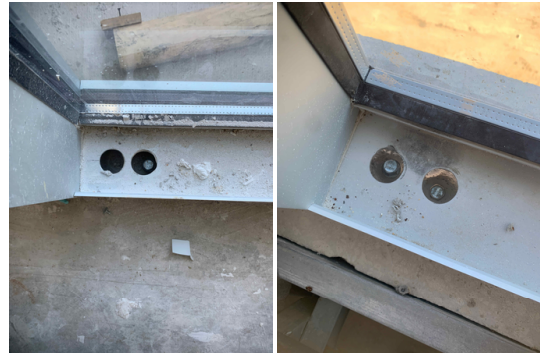
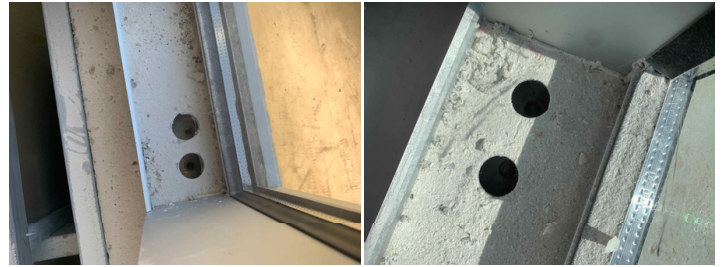
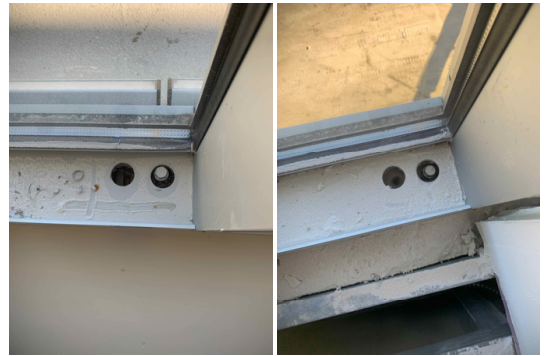
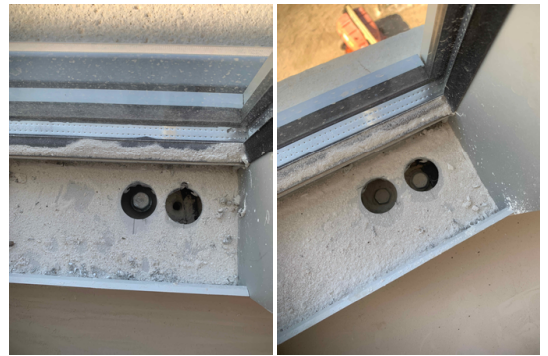
#154: Missing or incomplete bolt install at aluminum frames

Description:
Missing screws or screws not fully set
