Architect's Field Report

02 October 2019

18043-BW Beechwood Elementary / Report Number 002

Work in Progress Parking Lot Compaction & Sewer Line Rework / Ceiling Grid Demo

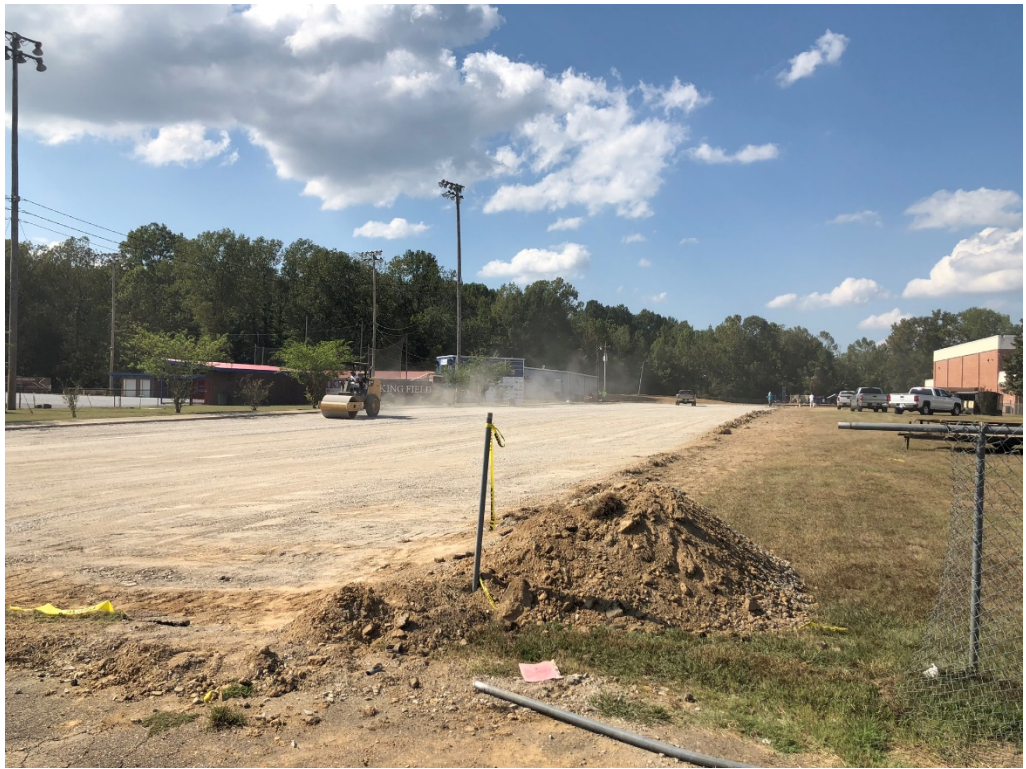
Figure 1 – Parking Area East Corner Looking W

Observations When I arrived, I noted substrate was being compacted. Some Caution tape lay scattered about.

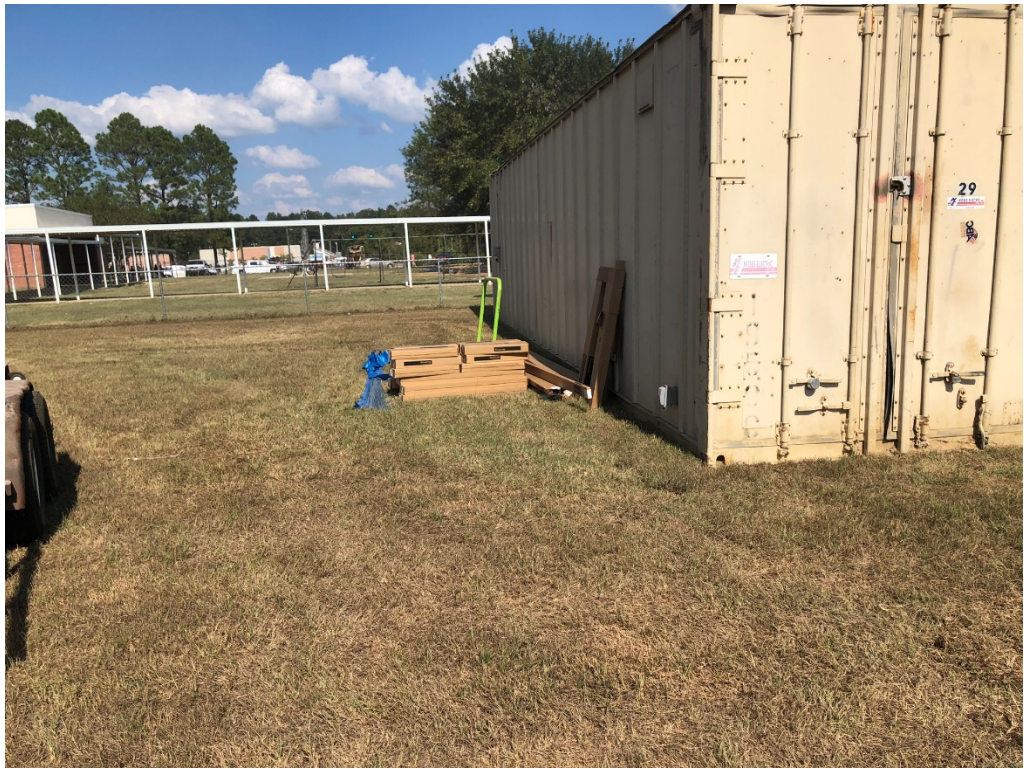
Figure 3 – Limited Ceiling Grid on Site

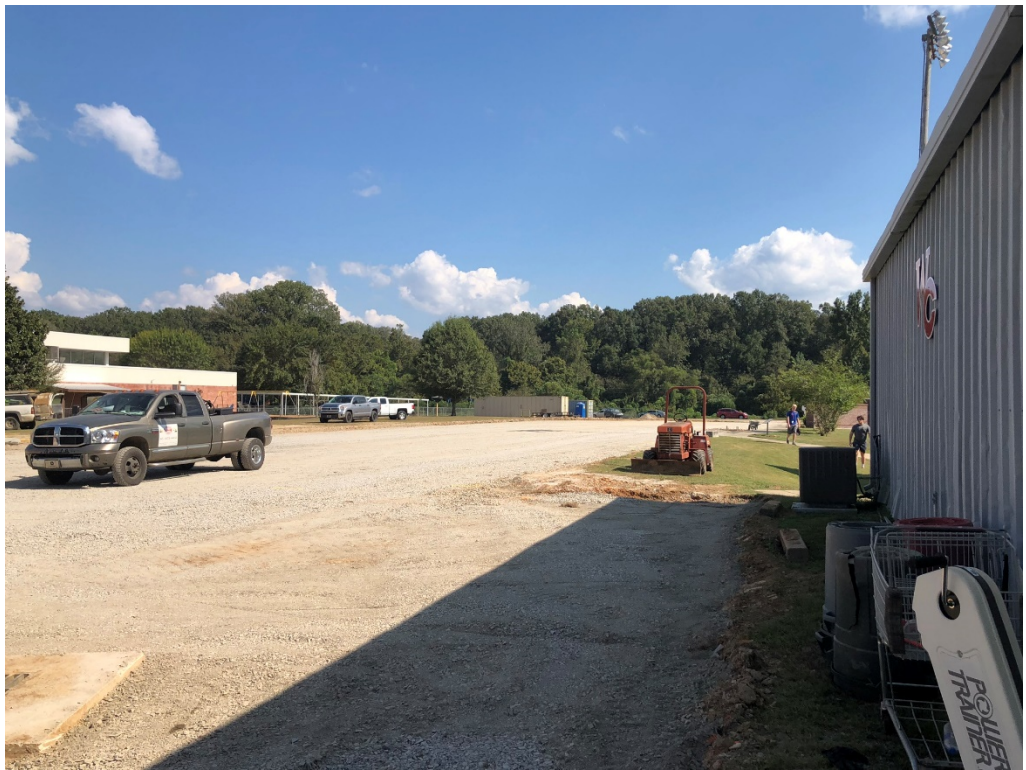
Figure 6 – West side of Parking Looking East

Substrate compaction was being performed in parking area; concrete finishers were completing work on the dumpster slab.

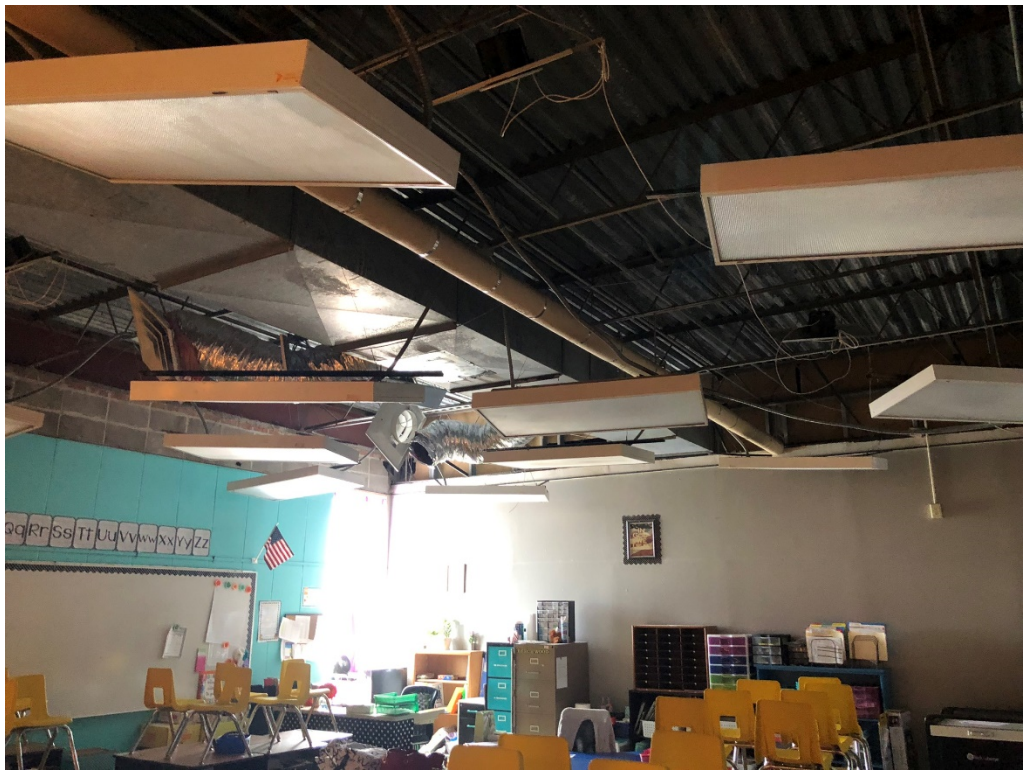
Interior ceiling demolition continued in building 1. Ceiling tile has been removed as well as grid in 35% of classrooms.

Figure 10 – Example of Demoad Ceiling

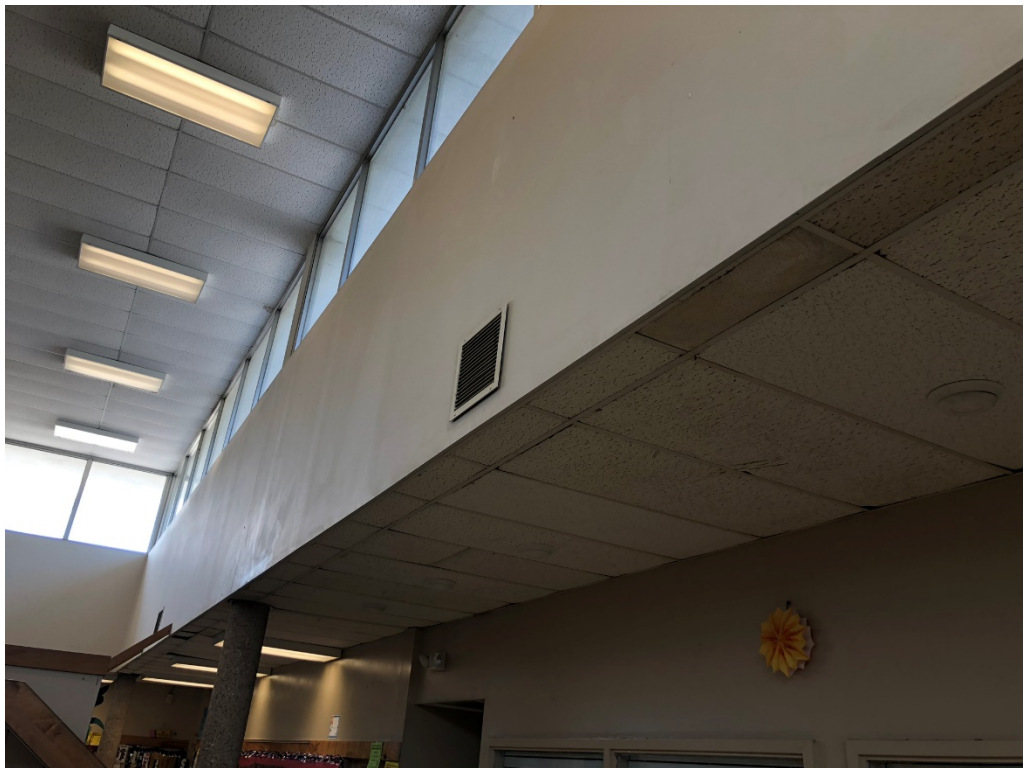
Figure 22 – Side Wall Vents for Open Air Return Plenum
