## Architect's Field Report

16 October 2019

18059-AOI Academy of Innovation / Report Number 004

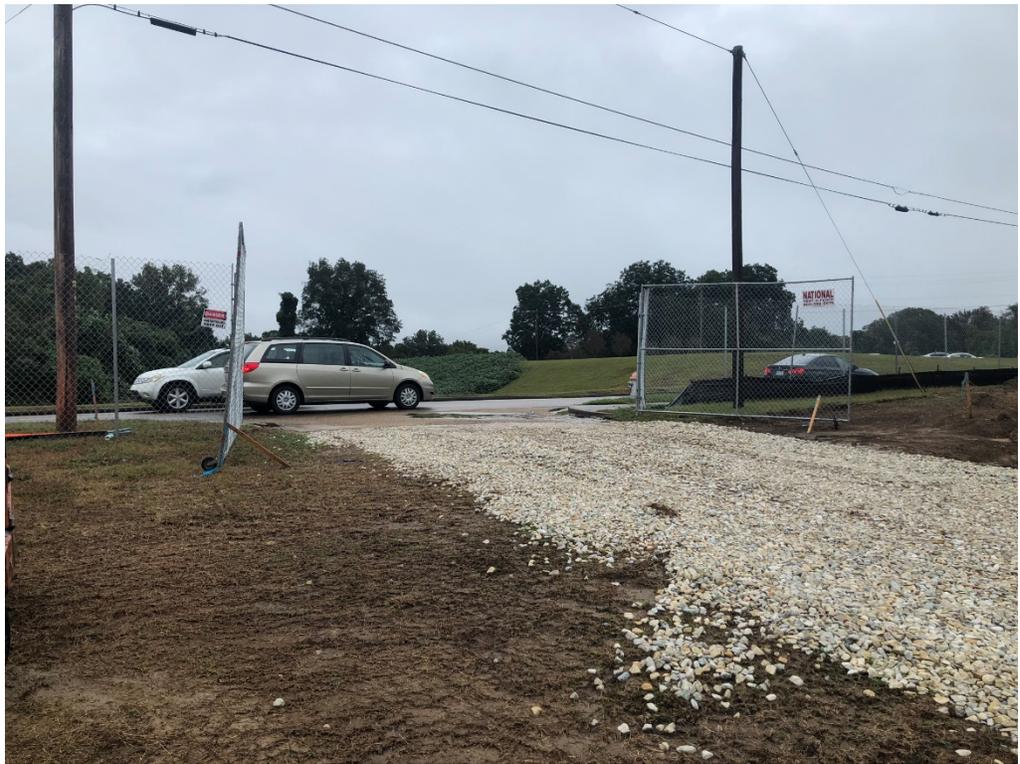
Figure 18 – Entry Gate at North Side of Project

Observations I arrived and it had just cleared up from a hard rain. No one was on site. Entry Gates were open. Some wash out has occurred at the job site trailer entry.
