Architect's Field Report

19 March 2020

18059-AOI Academy of Innovation / Report Number 026

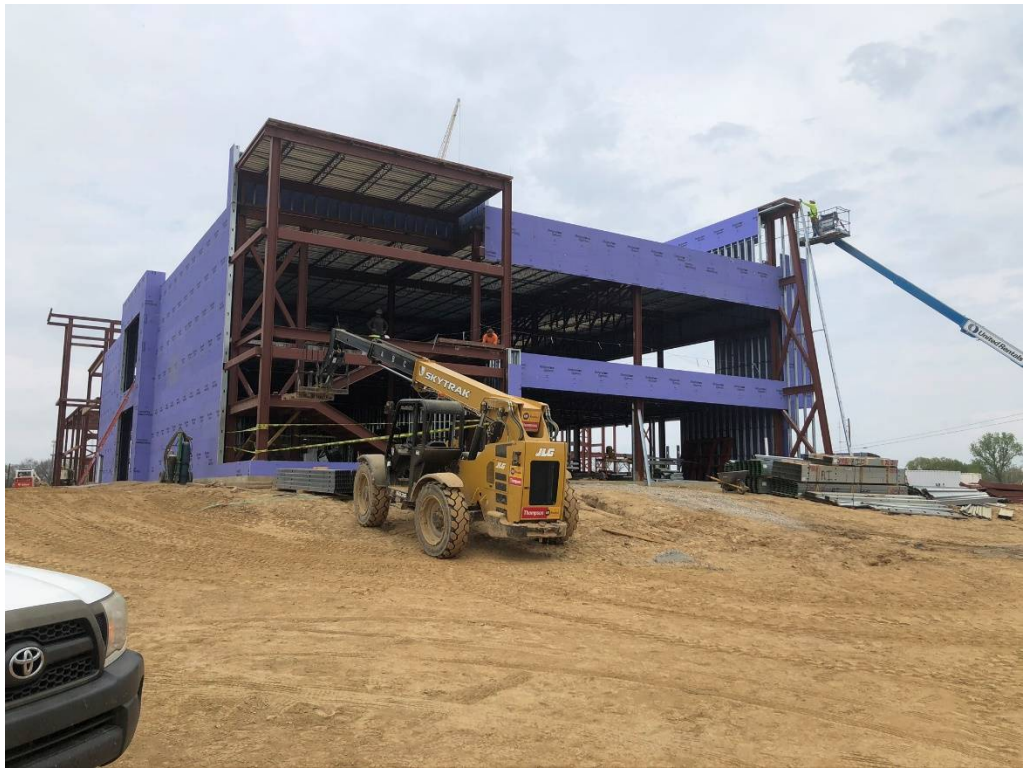
Figure 1 – East Building Erected

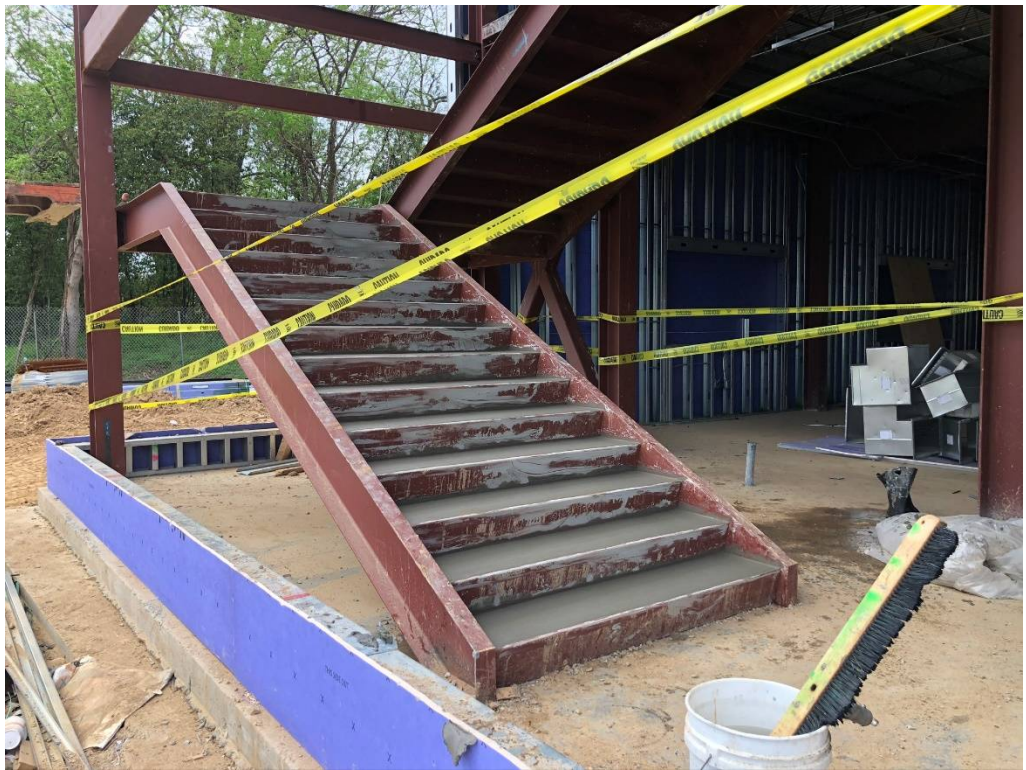
Concrete work was being performed at stair on Southeast corner. Finishers were troweling and applying texture.

Figure 2 – Concrete Work at Pan Stairs

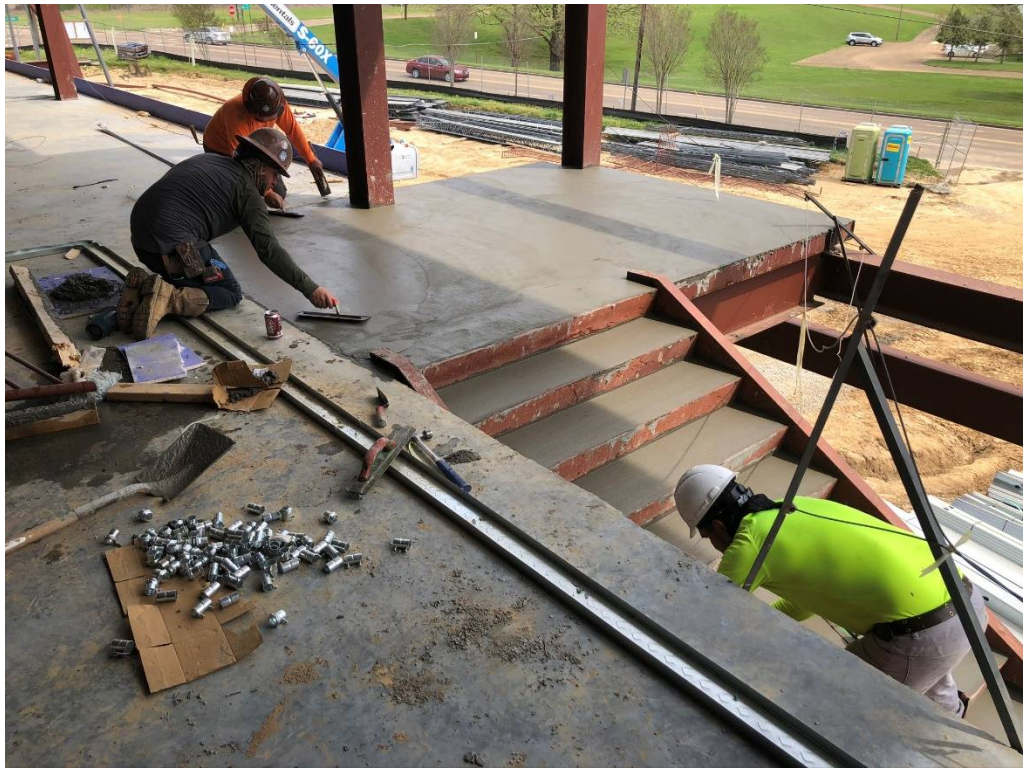
Figure 3 – Upper Floor Concrete Work at Pan Stairs

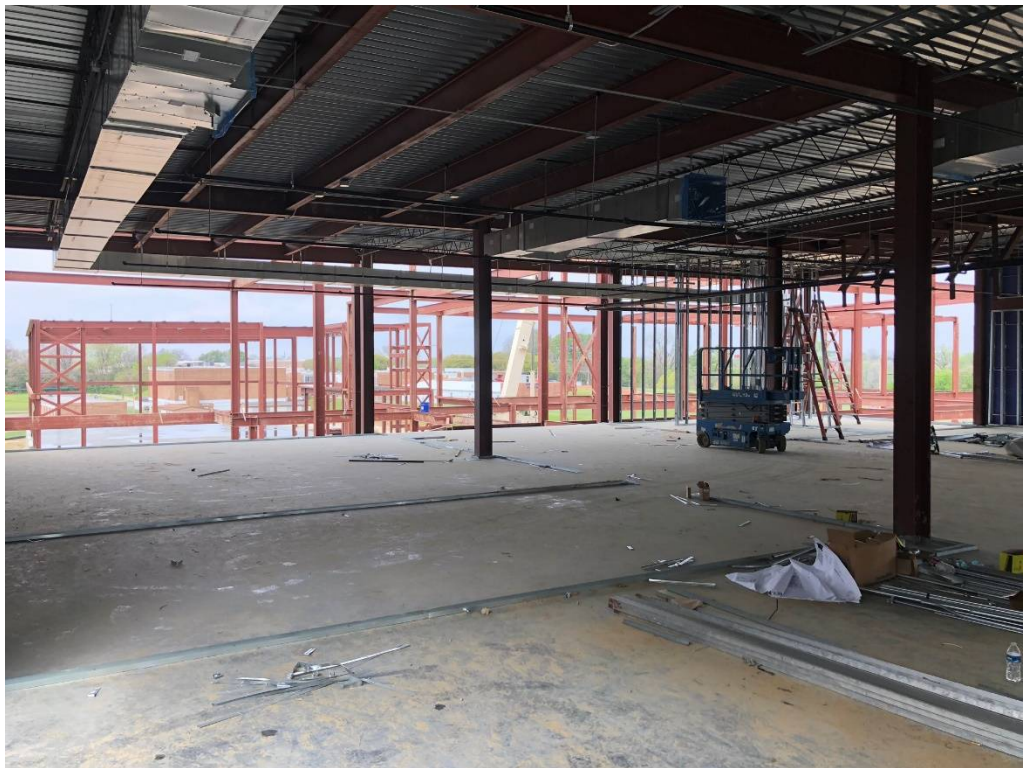
Framers were inside installing light gauge steel framing. Light gauge framing has begun on the top floor in the east wing.

Figure 6 – East Section of Building Upper Floor Light Gauge Framing Laid Out

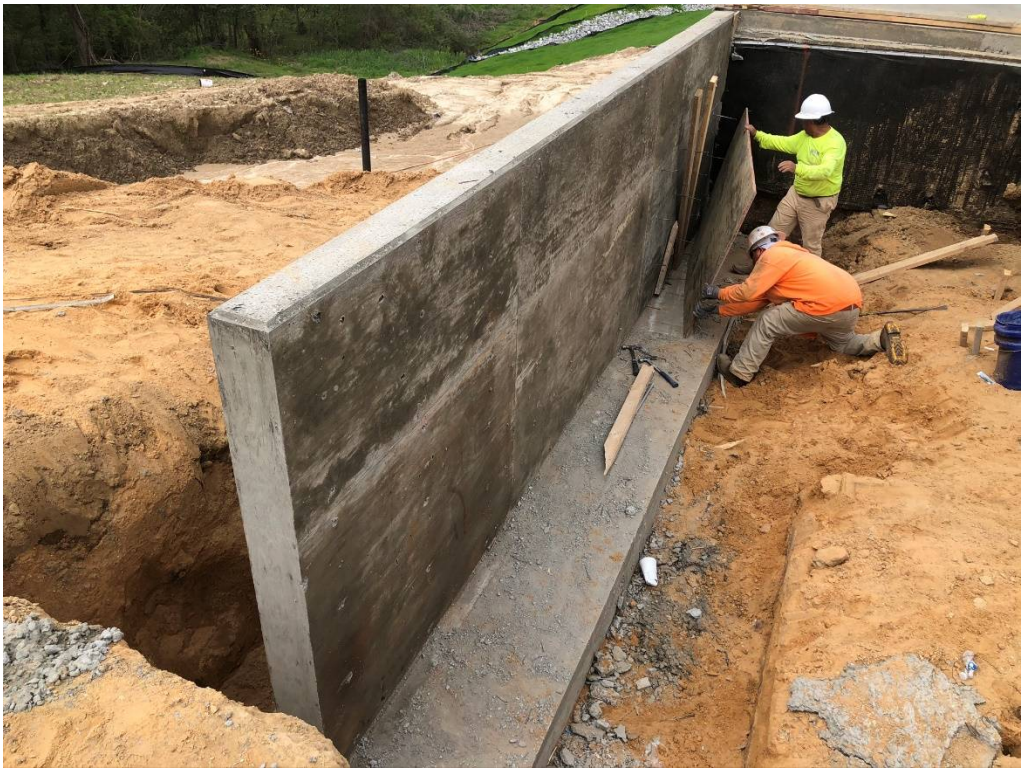
The south-central Footing that had a higher elevation than other sections of the adjacent retaining wall has been poured. Workers were removing forms there.

Figure 11 – Footing Complete at South Center of Building

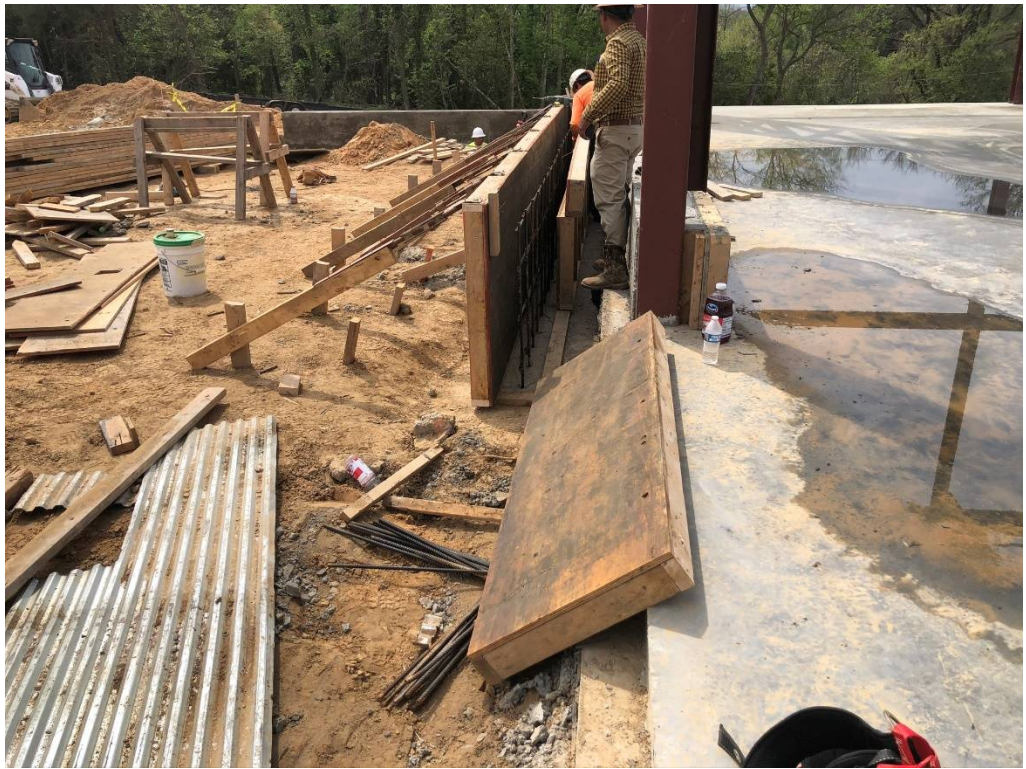
Figure 19 – Formwork at East Side Upper Floor West Section of Building
