15094 Community bank Headquarters – Precast review

COMMUNITY BANK HDQTRS.
 FLOWOOD, MISSISSIPPI

FIELD MODIFICATION

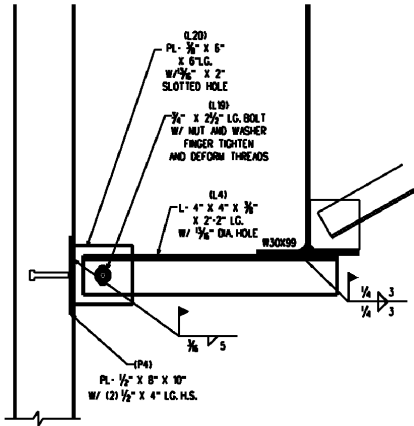
DETAIL (21)

POCKET IS 2" TOO LOW
 & P7 MISSING ADJACENT PANEL

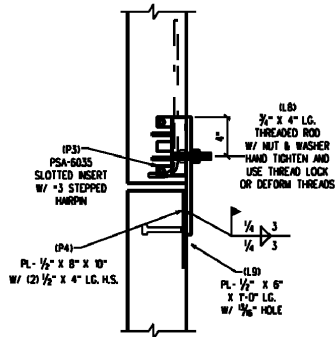
DETAIL (16)

PSA INSERT MISSING FROM PANEL

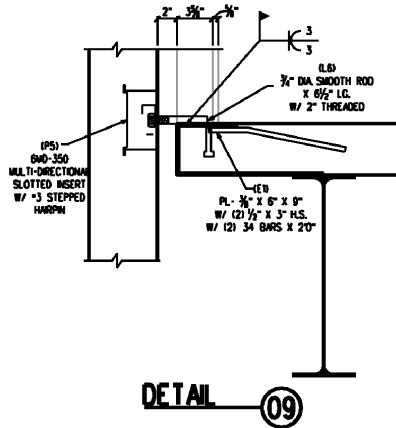
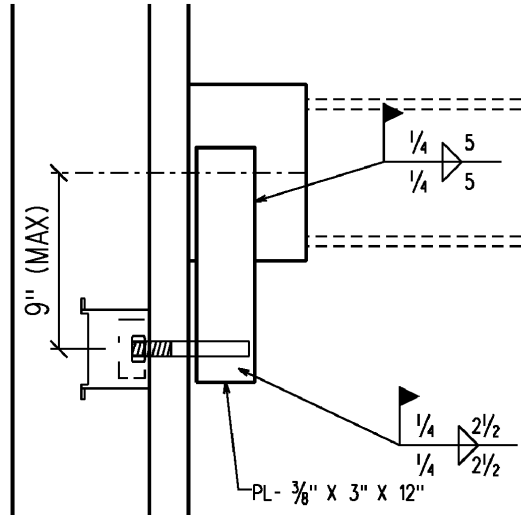
DESCRIPTION OF PROBLEM

6MD-350 INSERT NOT ALIGNED W/ EMBED

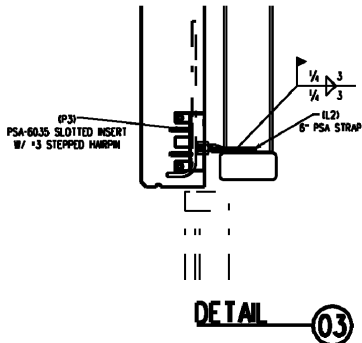
DESCRIPTION OF PROBLEM

WELD VARIED FROM DETAIL

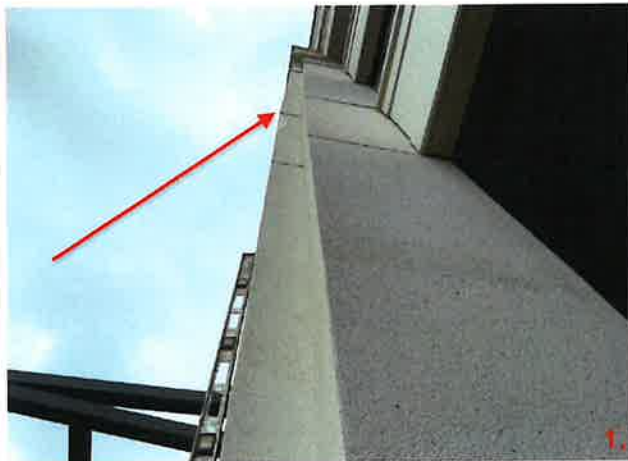
Panel 107 at grid line D is approximately 1" out of plumb over a span of 6'. It appears that adjusting panel 107 at the top will produce proper alignment of the panels.

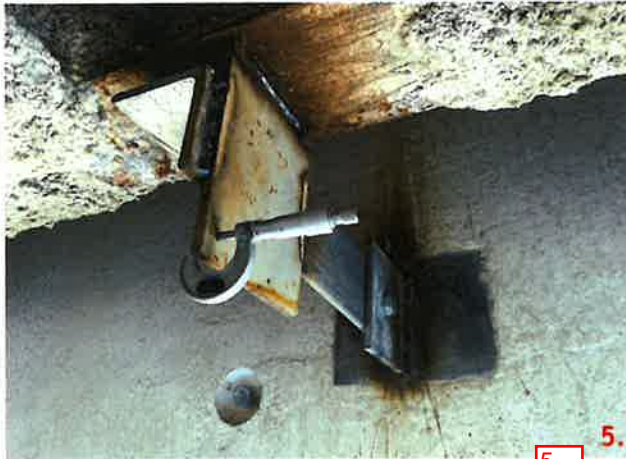
5.

Panels 109B and 109A have connecting points detailed 11 that were field modified using FM 11-1. Instead of using a L4x4x3/8" a PL8x6x3/8" was used at these connections.

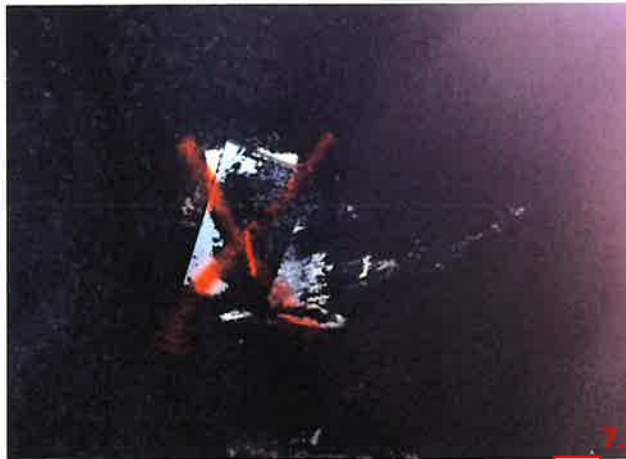
7.

Connection points of panel 107 to 112 at grid line F has one connection detailed 16 that is not complete. The 1/2" plate is not welded to the embed plate in panel 107.

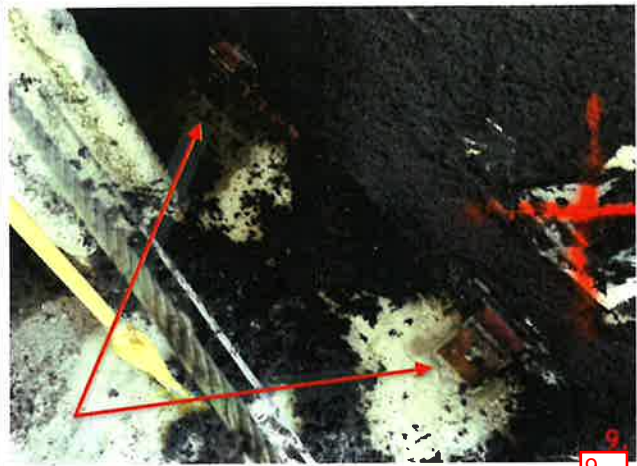
Panel 108 at grid line C has two connection points detailed 10 that have been modified using FM 10-5. These connections meet the requirements of this FM.

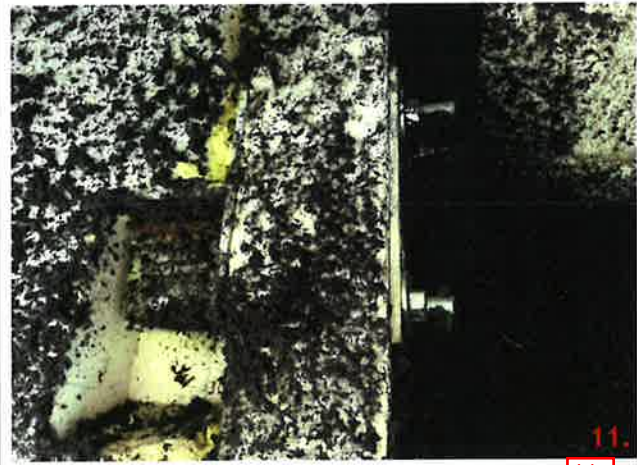
11

5- Panel 112 at grid line D has one connection point detailed 18 that has been modified using a combination of FM 18-2 and FM 18-3. Approximately 2" was cut from the HSS6x3x3/8 and a 3/8" plate was welded to the HSS and installed with the plate side up. The P7 plate was also missing from panel 112 and a PL 3/8"x6"x10" was installed with (4) 3/4" diameter threaded rods. EOR, is this structurally acceptable? (photo 11) **Modifications made at JPI Plant**

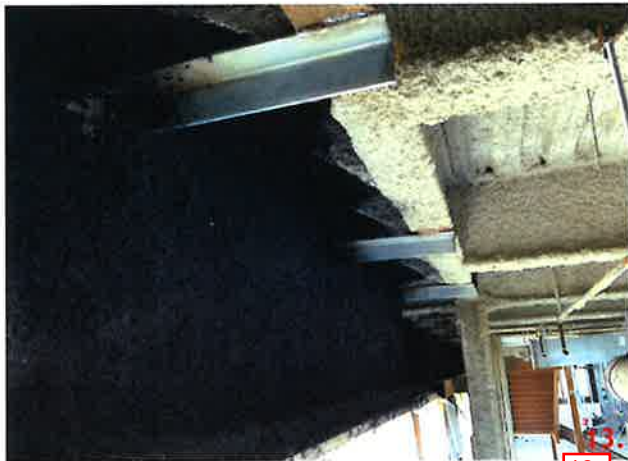
13

2- Panel 118 has four connections detailed 11. The L4x4x3/8" is welded directly to the embedded plate. The detail calls for the angle to be bolted to a PL 3/8x6x6 and that plate welded to the embed with a 4" long 1/4" fillet. EOR, is this condition structurally acceptable? (photo 13) *** Note # 1 Below**

Panel 118 has four connections detailed 11. The L4x4x3/8" is welded directly to the embedded plate.

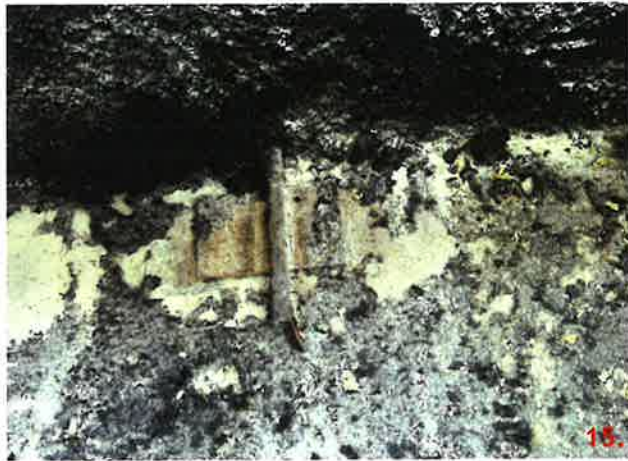
15

1- Panel 114 has two connections detailed 09 that have been field modified similar to FM 10-4. A FM has not been provided for the condition of these two connections. EOR, is this structurally acceptable? (photo 15)

Panel 114 has two connections detailed 09 that have been field modified similar to FM 10-4.

4th Floor					
4/29/21	Panel 114 has two connections detailed 09 that have been field modified similar to FM 10-4. A FM has not been provided for the condition of these two connections. EOR, is this structurally acceptable?	BCD-CBH-019

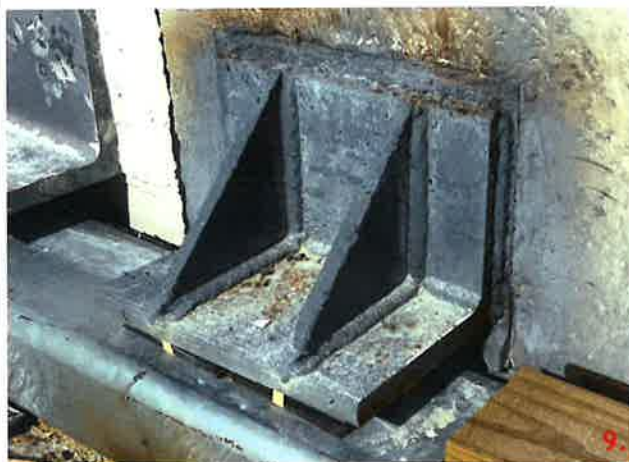
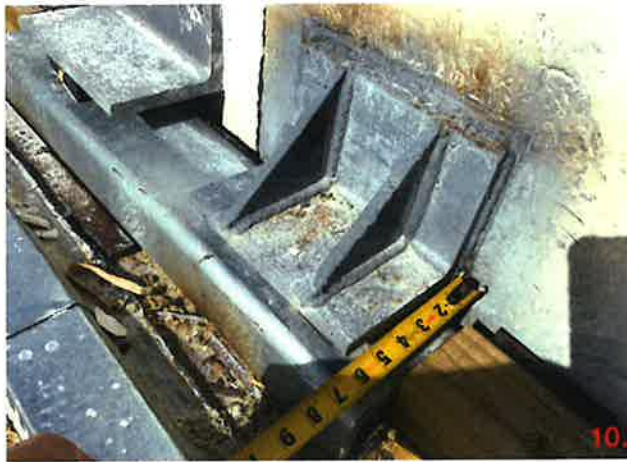
Panel 122-1, at connection point 22 the embedded angle was installed too high but not 4" high. The bottom leg of the angle was cut off and a new L6x6 angle with gussets was welded to the embedded angle all around. A field modification was not provided for this connection.

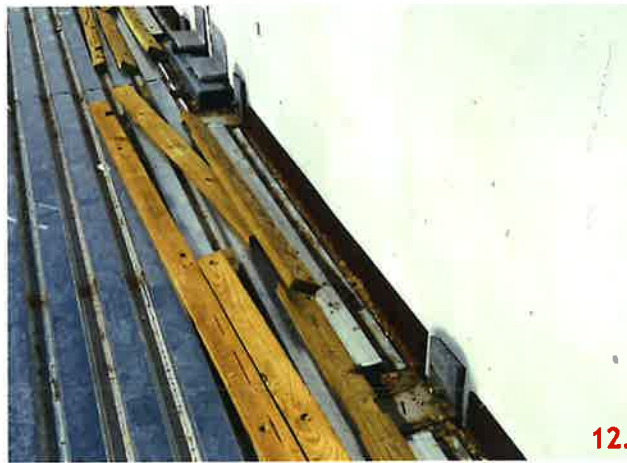
Panels 123-2, 124-2, 125-1 and 126-1 have modifications at the 07 and 02 connections. It does not appear that these connections needed a modification as the threaded rod is screwed into the PSA clip at an elevation that would have permitted the 3/4" diameter smooth rod and 6" PSA strap to be welded to the perimeter angle.

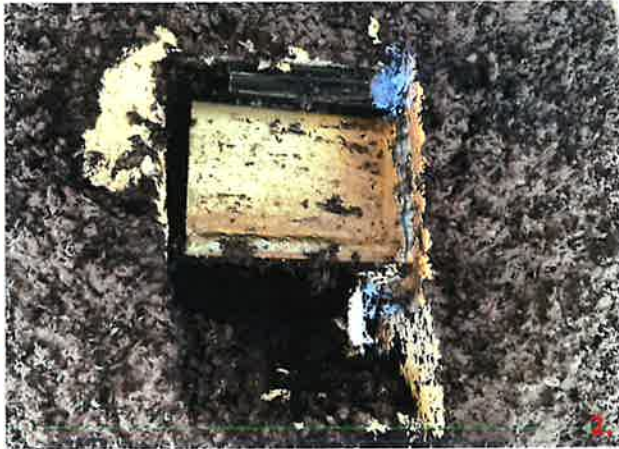
An example of FM18.2 on panels 109 that have been completed as detailed.

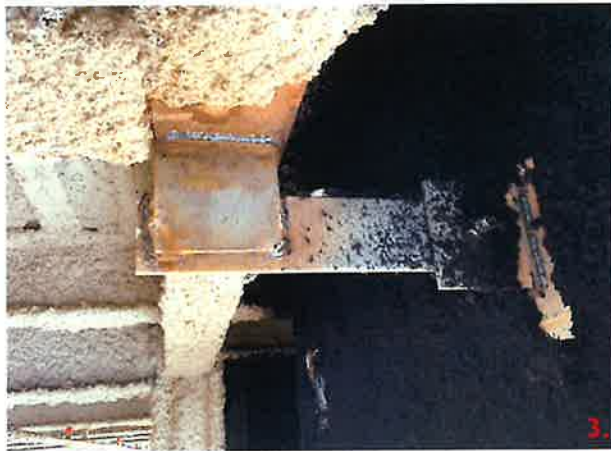
Panel 109A has been modified with FM-11.1. This detail requires the use of a L4x4x3/8 to be welded to the structural steel. This connection has a 6x6x3/8 plate instead.

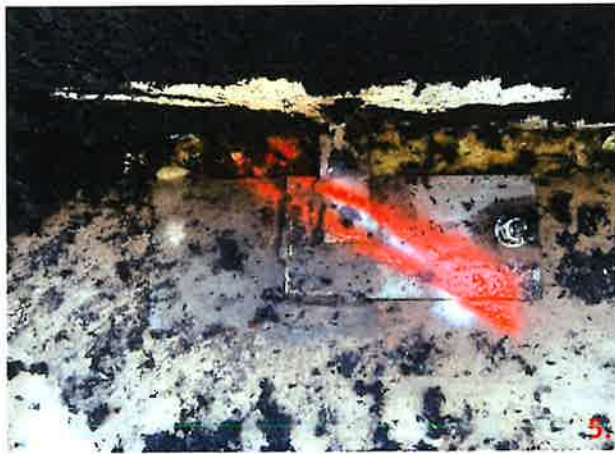
An example of connection points detailed 10 that have been field modified on panel 109B and 109A.

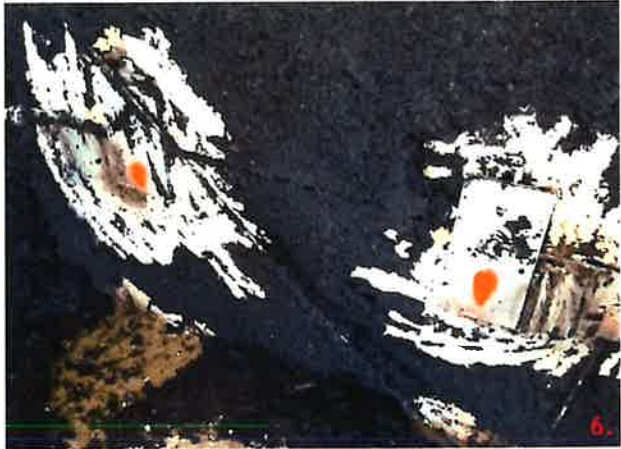
Panels 107-6 and 112 have connection points detailed 16 where PSA insets and embed plates that do not align. The plates are only welded on one side to the embed plate.

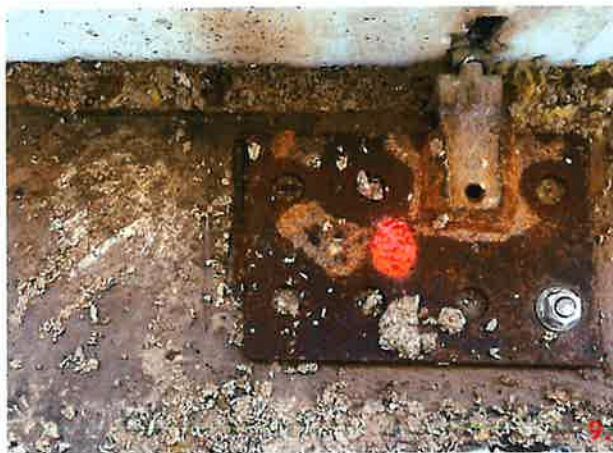
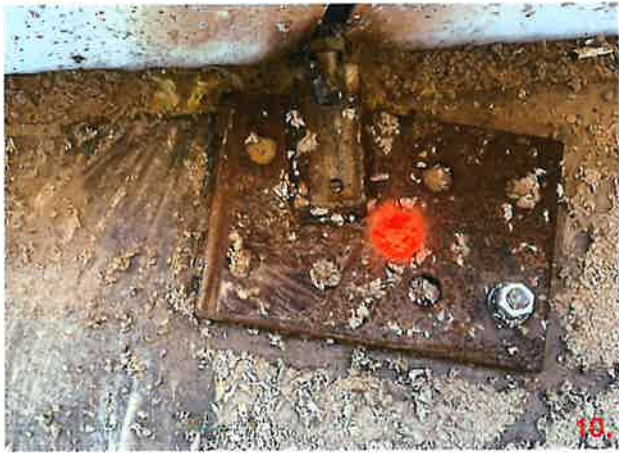
Panel 109-13 and 109-10 have two connection points detailed 10 that have been field modified. The PSA strap is welded to a plate 1/2x7x10 that is welded to the embed on one side and anchored to the slab on the other side. FM 10.4 and FM 10.3 could have been used for these connections.

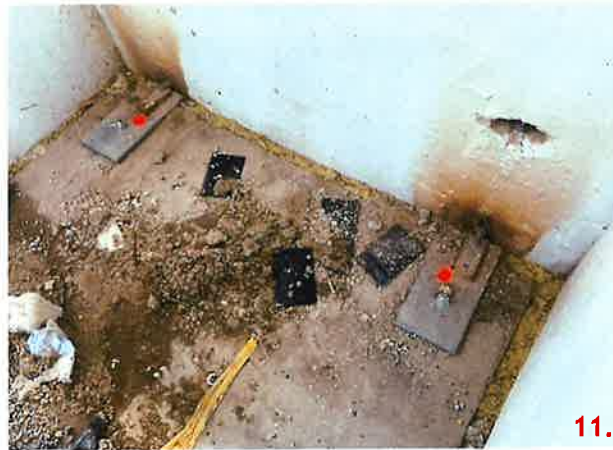
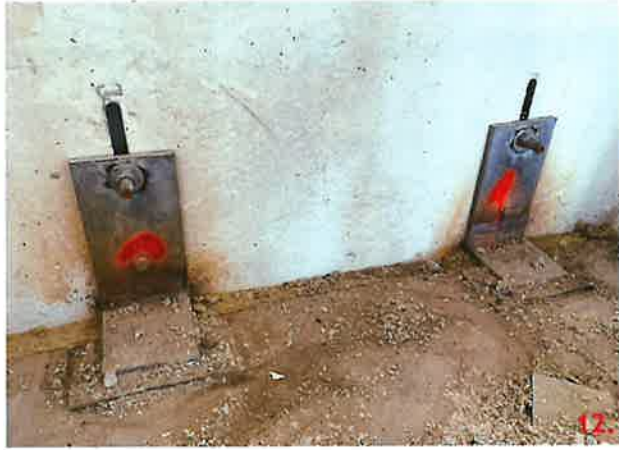
Panel 112 has been field modified at connection point detailed 10.

Panel 112-1 has been field modified at connection point detailed 10.

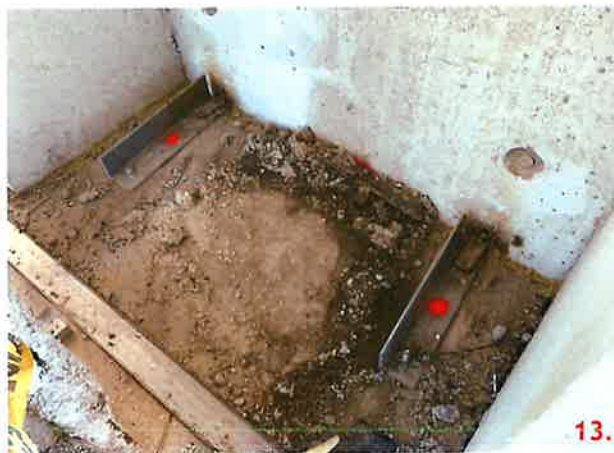
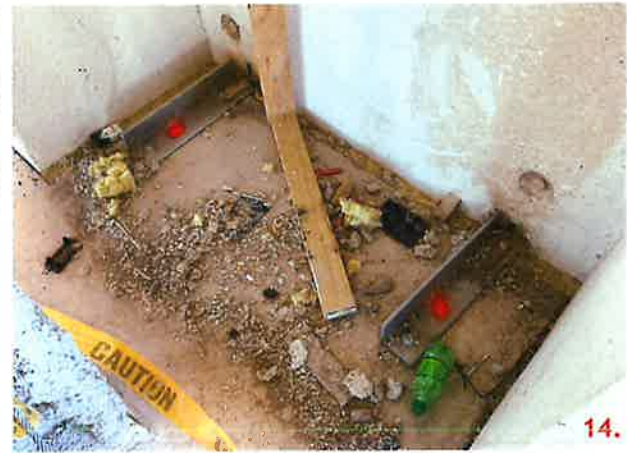
Panel 112-6 and 112-9 have been field modified. A section of the slab has been cut off. A L4x4x3/8 19" length is welded to the remainder of the embeds and a 5/8 anchor is installed in the slab approximately 16" from the edge. The PSA strap is welded to the 1/2x6x12 plate. A FM was not provided for these connections.

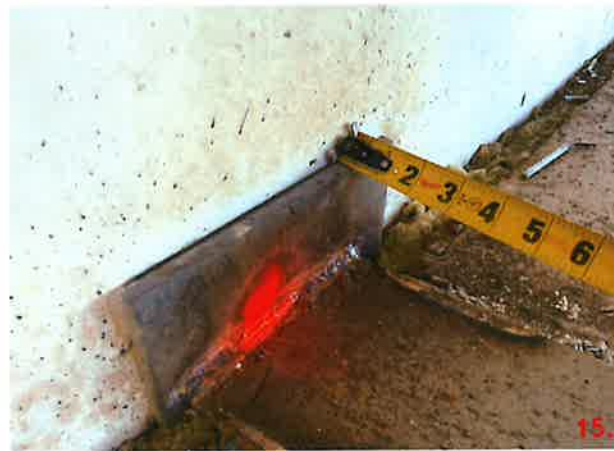
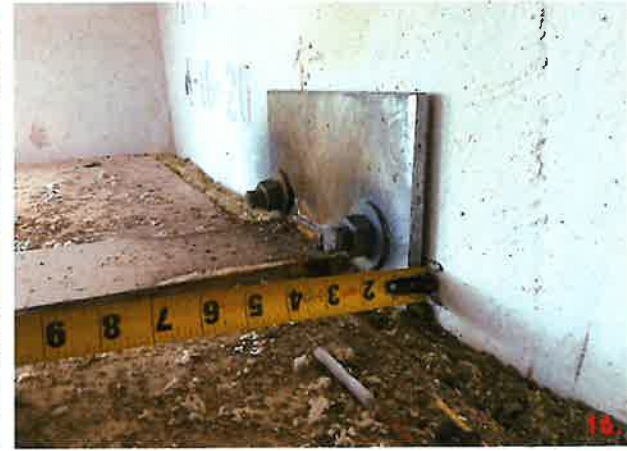
Panel 117-1 and 116-2 have two connection points detailed 10 that have been field modified using FM 10.2. The field modification requires a 3/4" thick vertical plate and a 1/2" thick plate was used.

Panel 117-1 and 116-2 have two connection points detailed 9 that have been field modified using FM 9.2. The field modification requires a 3/4" thick vertical plate and a 1/2" thick plate was used.

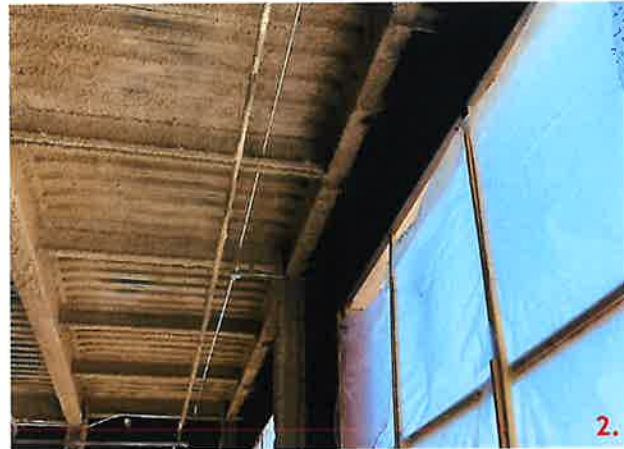
Panel 248-1, 203A-3, 217-2, 245, 244, 245-1, 217-1, 203B-1 & 249-4 connection points detailed 11 do not have 3/8x6x6 plates with slotted holes welded to the embedded plate.

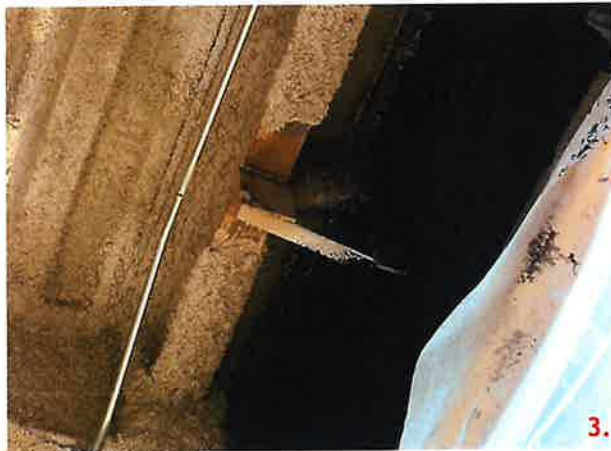
Panel 217-2 & 217-1 have been modified with FM-11.1. This detail requires the use of a L4x4x3/8 to be welded to the structural steel. This connection has a 6x8x3/8 plate instead.

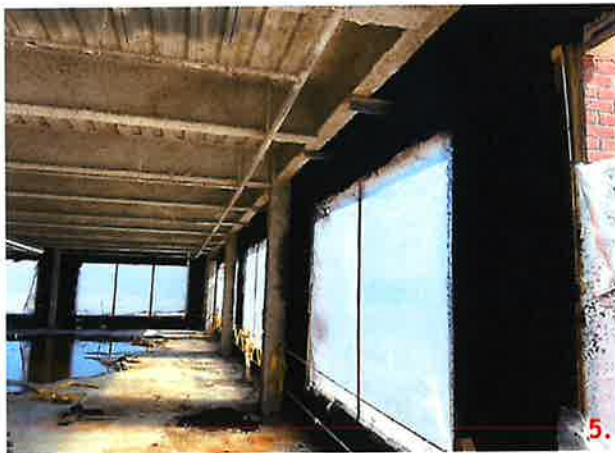
Panel 248-4, 203A-2, 217-4, 217-6, 222-2, 217-5, 217-3, 249-2 & 203B-2 connection points detailed 11 do not have 3/8x6x6 plates with slotted holes welded to the embedded plate.

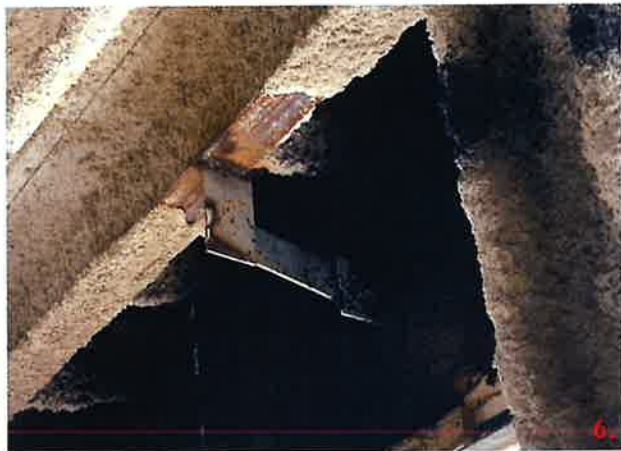
3- Previously noted on report BCD-CBH-013 (1.h.), "Panel 217 at elevation 34'-0" at grid line 6 has one L4x4x3/8 that is installed at an angle due to misalignment of the embed plate." Panel 217-4 & 217-3 have been modified with FM-11.1. This detail requires the use of a L4x4x3/8 to be welded to the structural steel. This connection has a 6x8x3/8 plate instead. EOR, is this structurally acceptable?

Panel 217-4 & 217-3 have been modified with FM-11.1. This detail requires the use of a L4x4x3/8 to be welded to the structural steel. This connection has a 6x8x3/8 plate instead.

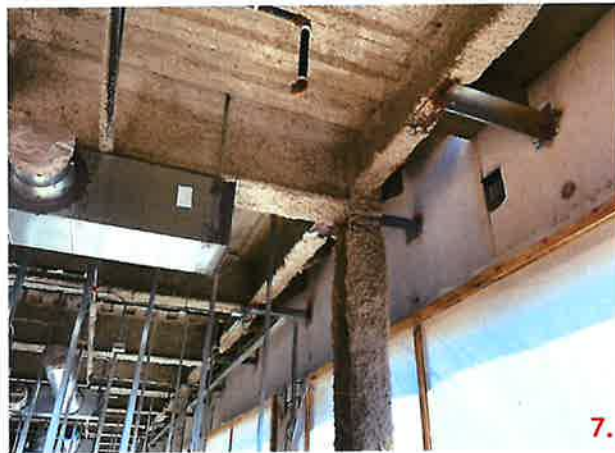
Panel 225-1, 226-1, 227-2, 228-2, connection points detailed 11 do not have 3/8x6x6 plates with slotted holes welded to the embedded plate. These connections are welded directly to the embedded plate and Structural steel.

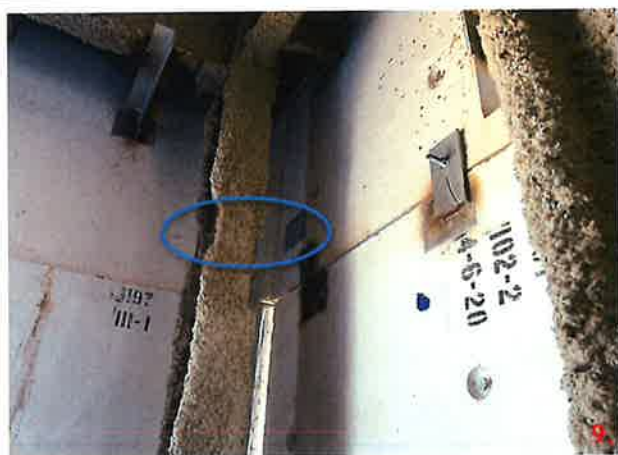
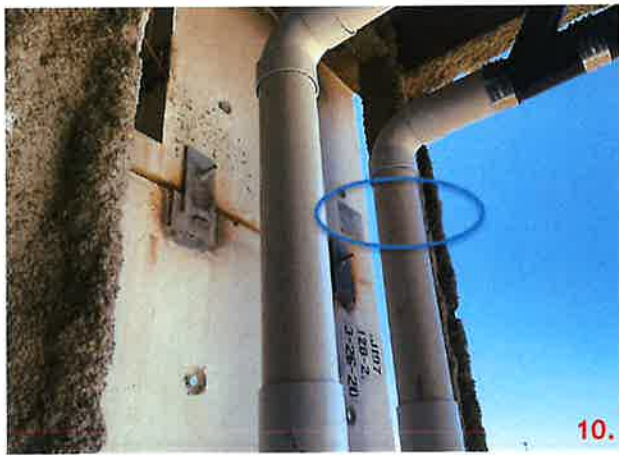
Panel 103-1 & 129-1 are not connected to the structural steel as detailed on 28.

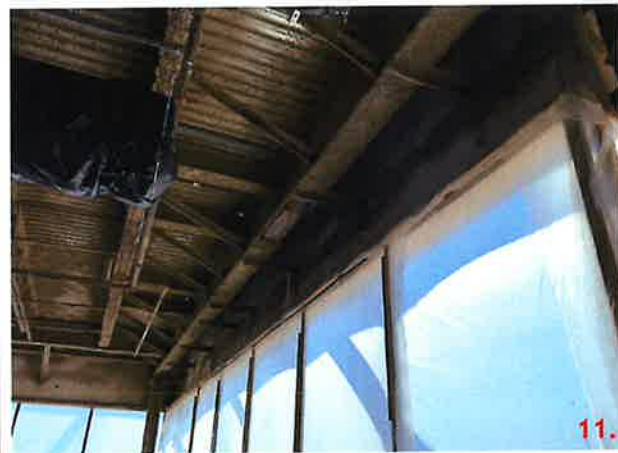
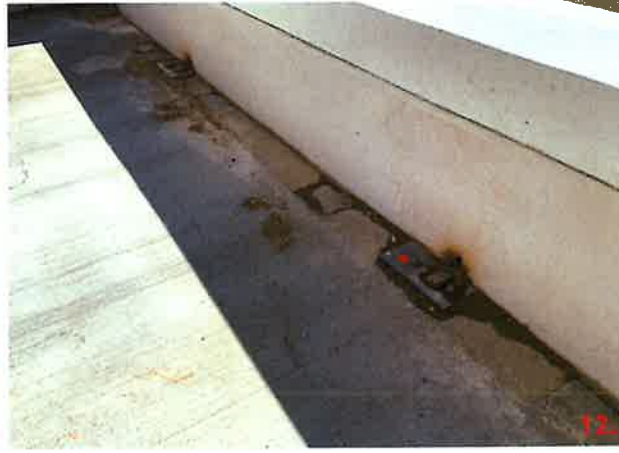
Panel 208, 209, connection points detailed 21 do not have 3/8x6x6 plates with slotted holes welded to the embedded plate. These connections are welded directly to the embedded plate and Structural steel.

Panel 207-2 is connected to the slab at two connections with a PSA strap that is welded to plate 1/2"x6"x12". This plate is anchored to the slab with (2) 5/8" anchors. These anchors are approximately 4" from the edge of the slab.

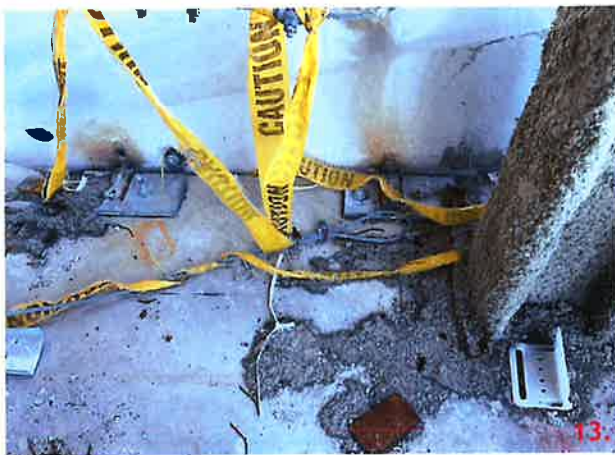
Panel 129-2 is connected to the slab at two connections with a PSA strap that is welded to plate 1/2"x6"x12". This plate is anchored to the slab with (2) 5/8" anchors. These anchors are approximately 4" from the edge of the slab.

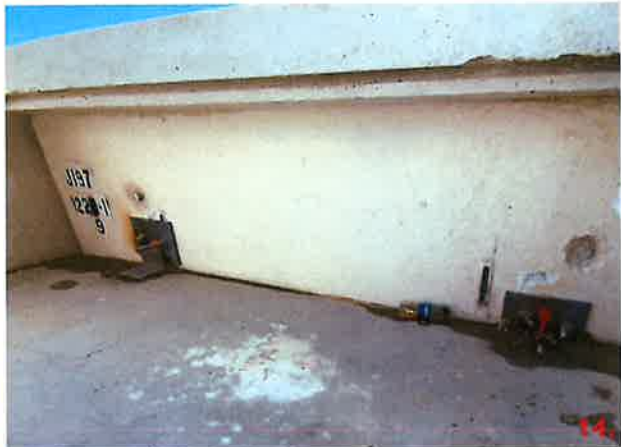
Panel 229-1 has two connections detail 10 that have been field modified.

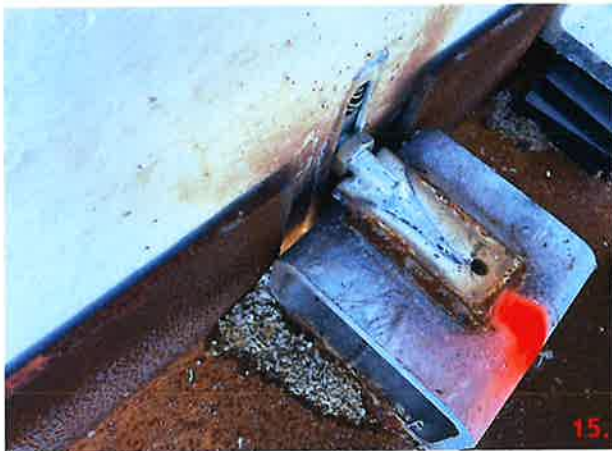
Panel 104-2 has a connection point detailed 02 that has a HSS6x3x3/8 6" length below the PSA strap.

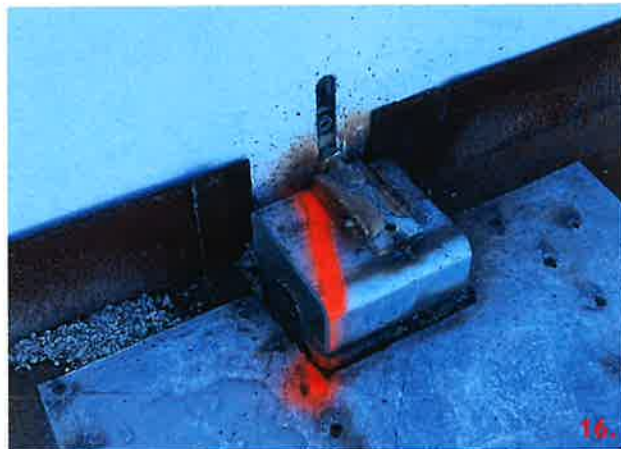
Panel 130-1 has a connection point detailed 02 that has a HSS6x3x3/8 6" length below the PSA strap. A FM was not provided for this connection.

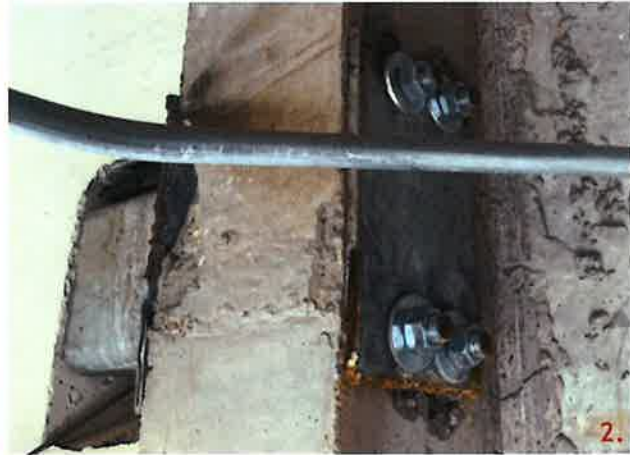
FM-18.3 modification of Panel 210-2

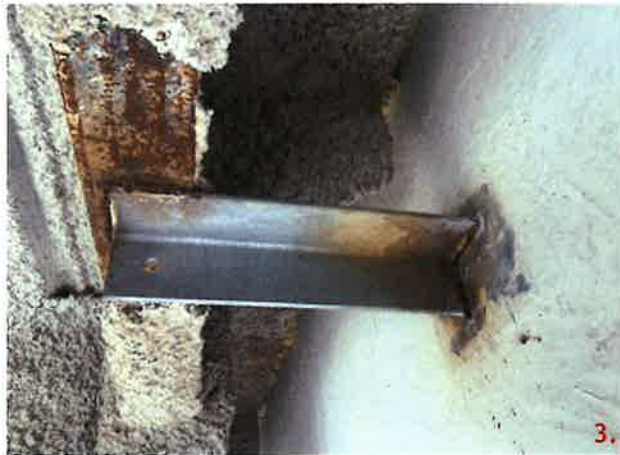
Panel 217A-2, connection points detailed 11 do not have 3/8x6x6 plates with slotted holes welded to the embedded plate. These connections are welded directly to the embedded plate and structural steel.

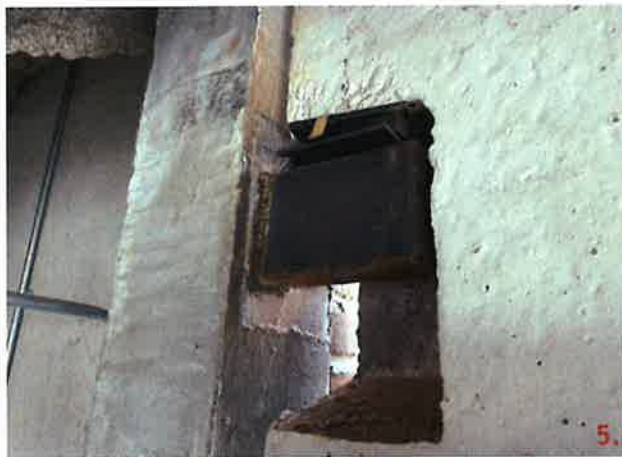
FM-18.10 modification of Panel 212-1

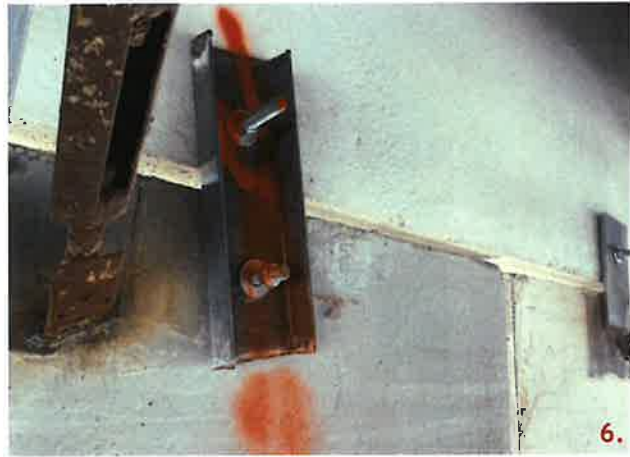
One connection point of panel 214 was field modified in similarity to FM-16.2. This connection is not installed with the appropriate hardware and does not meet the requirements of the approved FM.

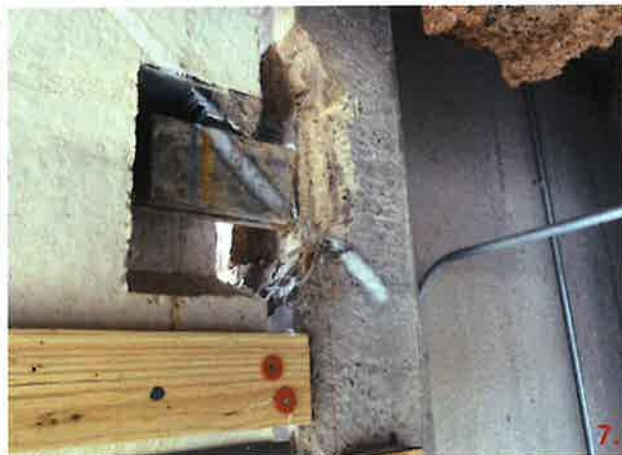
FM-18.10 modification of panel 215-1.

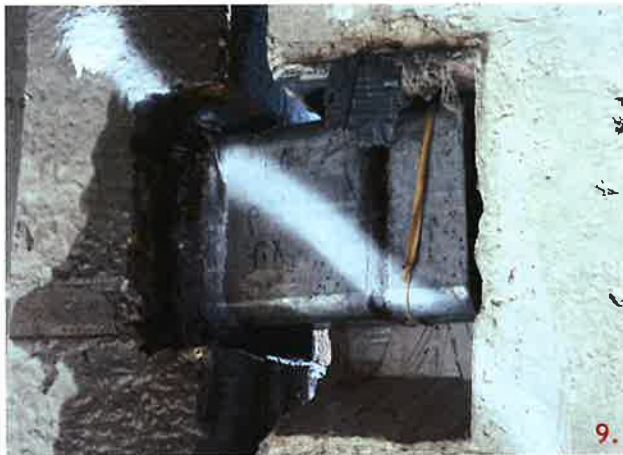
FM-18.9 modification of panel 216-1.

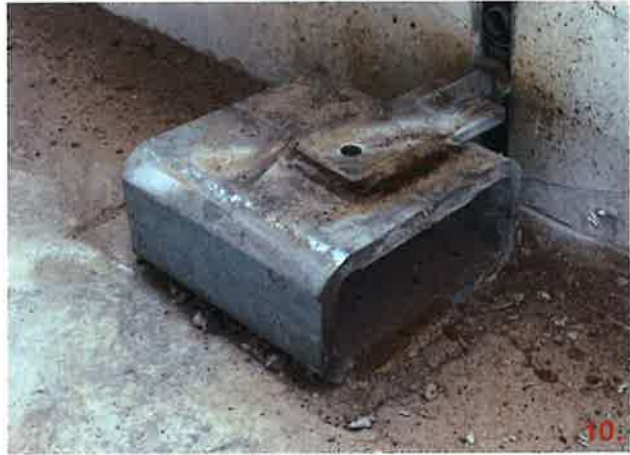
- EOR** 1- Panel 217A-2 has a PSA insert that is installed too high. A HSS3x6X6" is welded to the embedded plate with a 3" 3/16 fillet each side. The PSA strap is welded to the HSS. A field modification was not provided for this condition. EOR, is this structurally acceptable? (photo 10)

Panel 217A-2 has a PSA insert that is installed too high. A HSS3x6X6" is welded to the embedded plate with a 3" 3/16 fillet each side. The PSA strap is welded to the HSS.

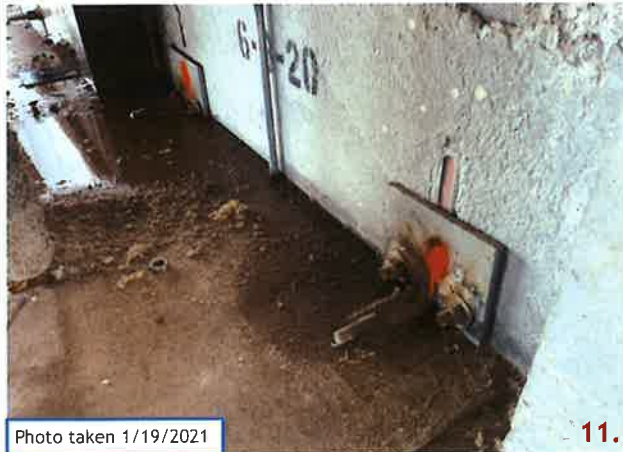
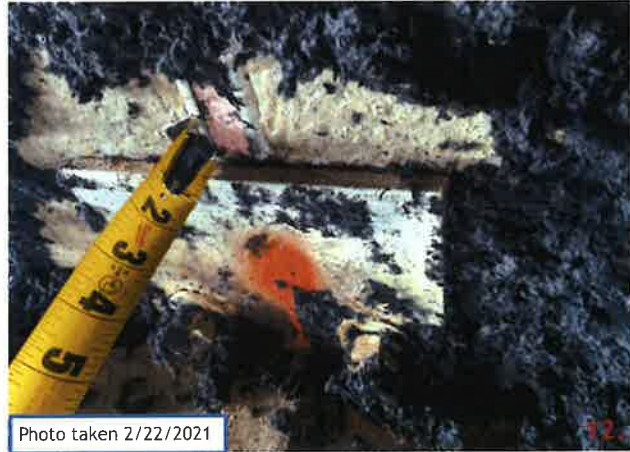
Panel 215-1 has two connection points that have been field modified similar to FM-10.1. A 6" PSA strap was used at this connection instead of a 3/8x3x5 plate. The plates attached to the panel are 1/2" thick. FM10.1 requires 3/4" plates.

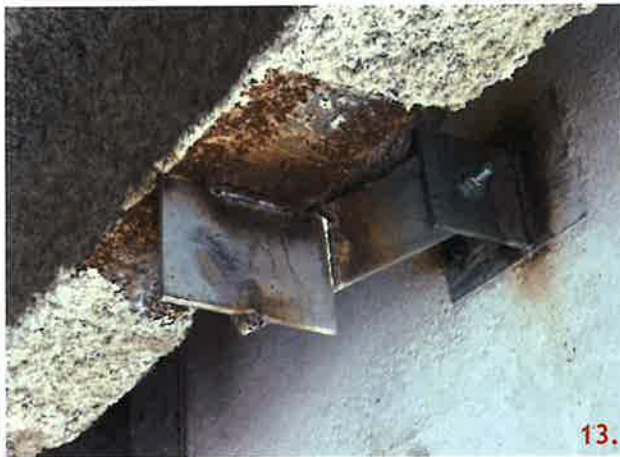
Panel 217B-3 at the east end, has been modified with FM-11.1. This detail requires the use of a L4x4x3/8 to be welded to the structural steel. This connection has a 6x8x3/8 plate instead.

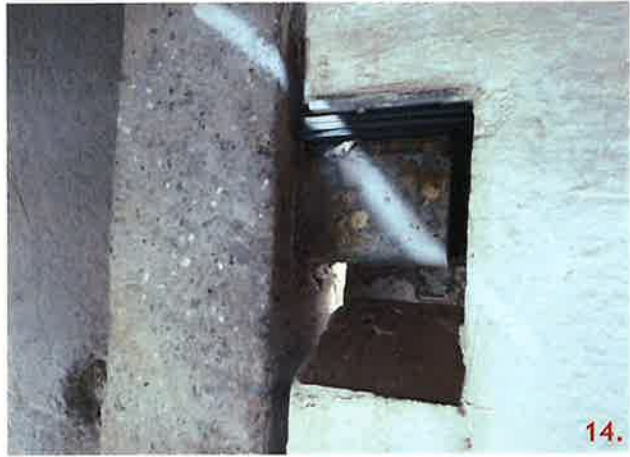
FM-18.2 modification of panel 223-1.

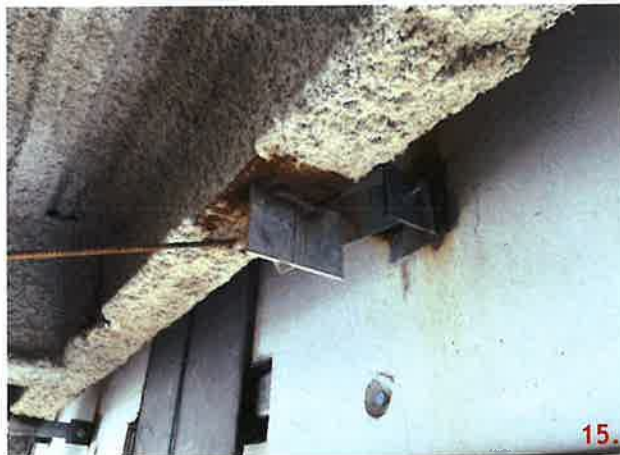
Panel 217B-1 and 203B-2 have been modified with FM-11.1. This detail requires the use of a L4x4x3/8 to be welded to the structural steel. This connection has a 6x8x3/8 plate instead.

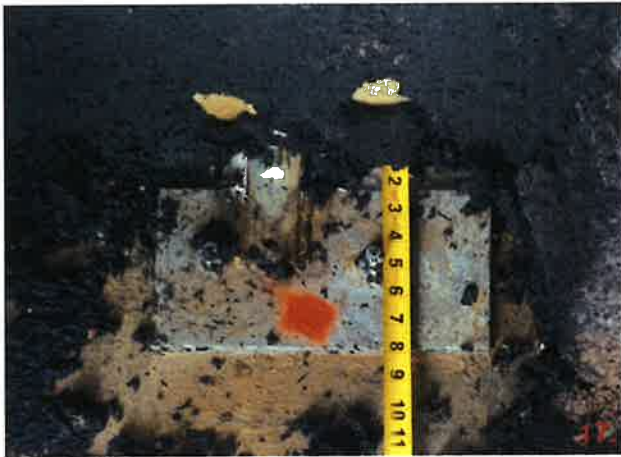
Panel 202-2 and 233-1 are connected to the slab with a PSA strap that is welded to plate 1/2"x6"x12". This plate is anchored to the slab with (2) 5/8" anchors. These anchors are approximately 5" from the edge of the slab.

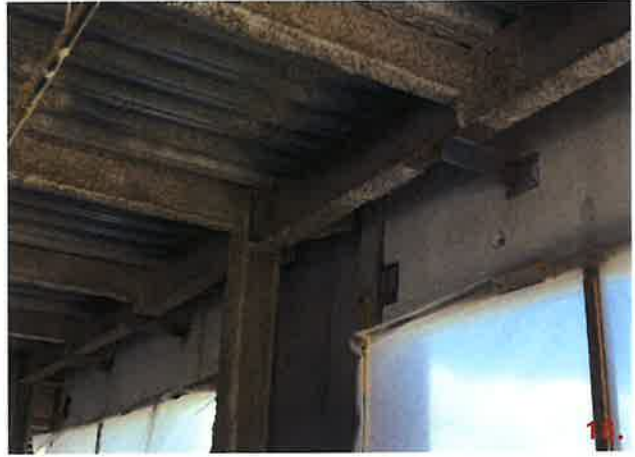
Panels 203B-2 & 249-3, connection points detailed 11 do not have 3/8x6x6 plates with slotted holes welded to the embedded plate.

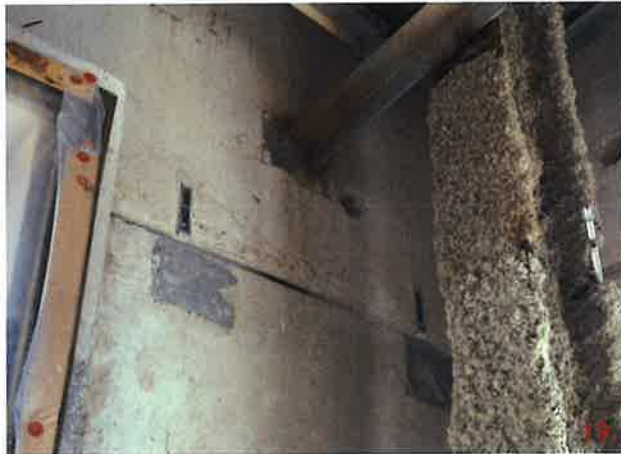
Panel 225-2 is not connected to panel 219-1 as detailed on 16.

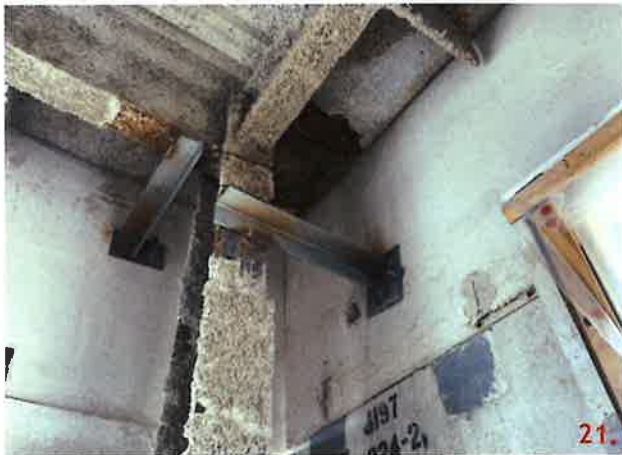
Panel 229 is not connected as detailed on 28. The embedded plate was not installed in the panel. A plate has been anchored to the panel.

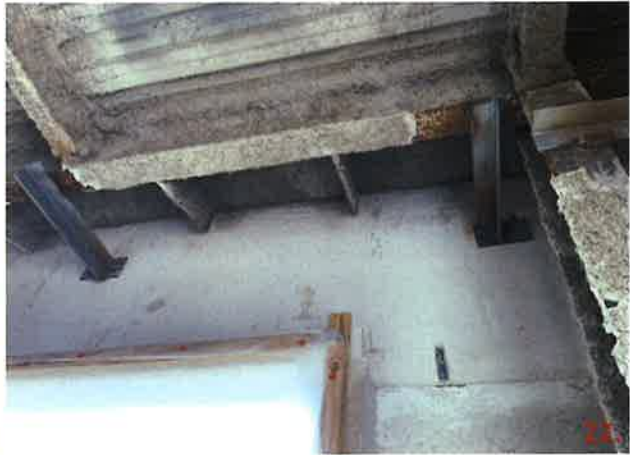
Panels 235-2 & 236-2 have several connections that are not installed as detailed on 23. A plate was used to weld to the angle instead of the PSA strap.

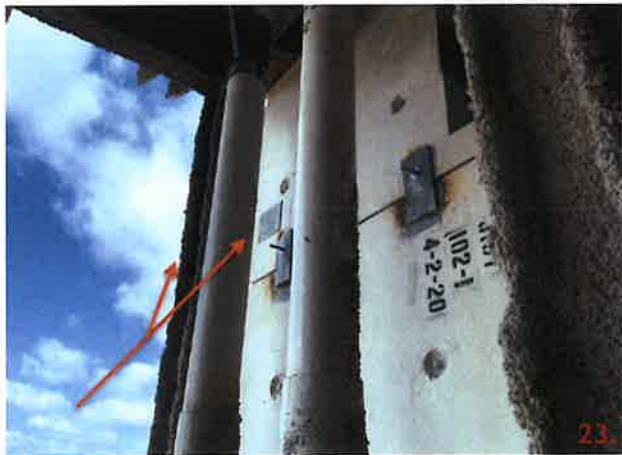
Panel 103-2 is not connected to the structural steel as detailed on 28.

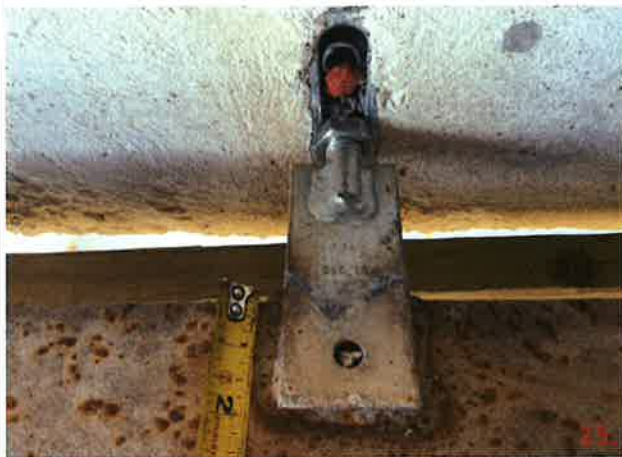
Panel 104 and 130 at connection points 03 have PSA straps that have a weld length of approximately 2" on each side and the end of the strap (three sides).

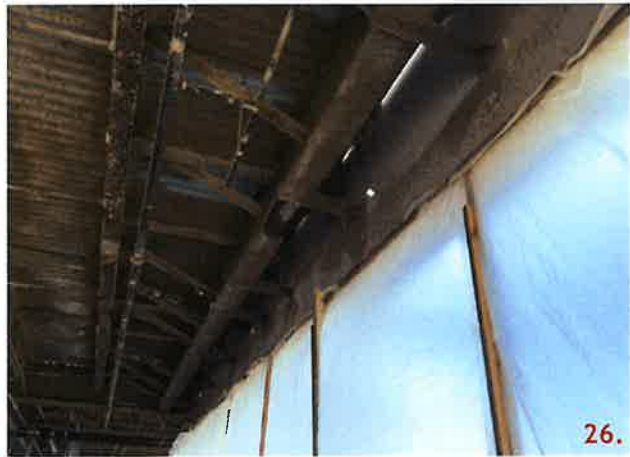
Panel 208, 209, 237, 238 connection points detailed 21 do not have 3/8x6x6 plates with slotted holes welded to the embedded plate. These connections are welded directly to the embedded plate and Structural steel.

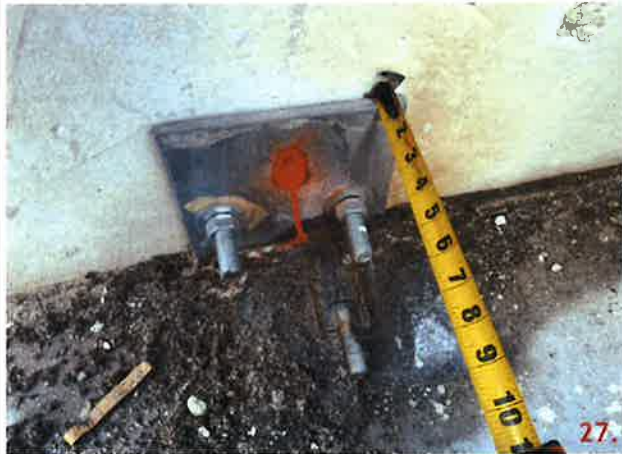
Panel 207-2 & 235-2 have connection points that has been field modified similar to FM-9.2. A 6" PSA strap was used at this connection instead of a 3/8x3x5 plate. The plates attached to the panel are 1/2" thick. FM9.2 requires 3/4" plates.

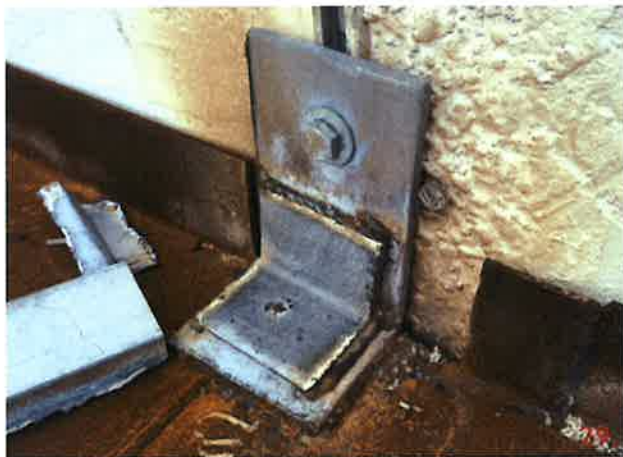
Panel 104-1 has two PSA inserts that are too high.

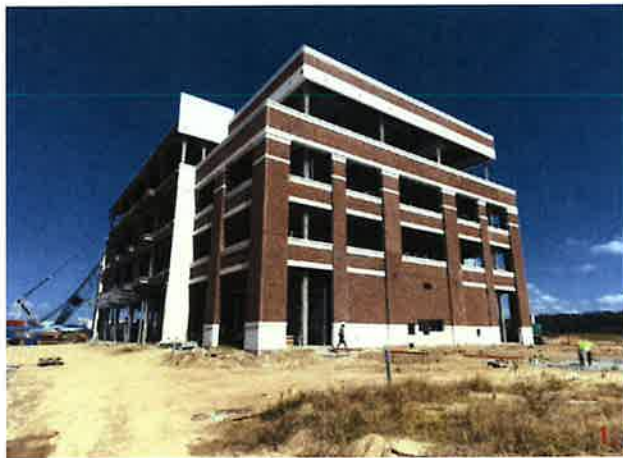
Progress as of 10/7/2020.

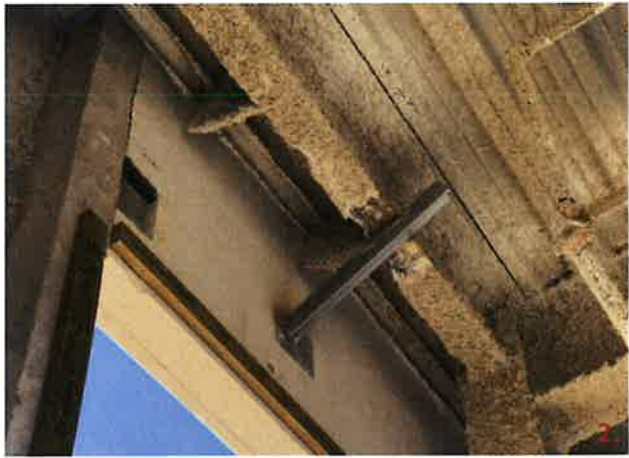
Panel 217 at elevation 20'-0" at grid line 3 has one L4x4x3/8 that is installed at an angle due to misalignment of the embed plate.

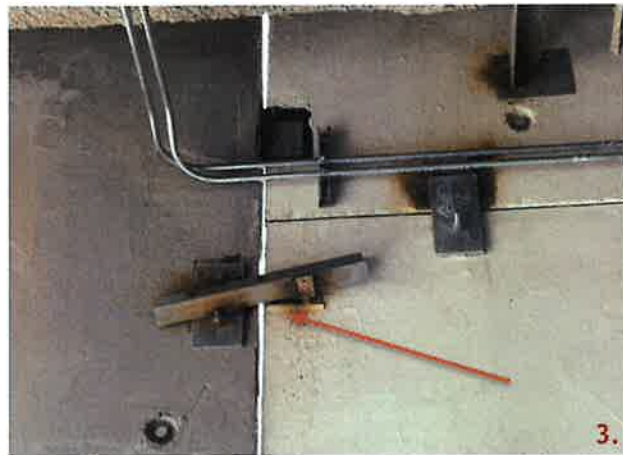
- a. Several welded connections of the precast panels have not been cleaned of welding slag. This condition does not allow for proper examination of welded connections. The slag should be removed from these connections and future welded connections.
- b. Panel 217 at elevation 20'-0" at grid line 3 has one L4x4x3/8 that is installed at an angle due to misalignment of the embed plate. This connection does not meet the requirements of the approved drawings (Photograph 2).
- c. Panel 211B has a plate anchored to the panel and an angle welded to the plate and the 6" PSA strap. This connection is not connected as detailed on the

approved drawings. **Engineer of Record should determine if this condition structurally acceptable** (Photograph 3)?

Panel 211B has a plate anchored to the panel and an angle welded to the plate and the 6" PSA strap.

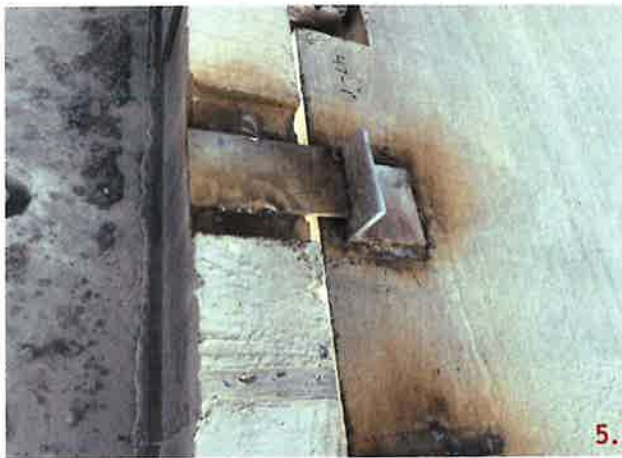
e. On panels 239 and 240 below elevation 20'-0" between grid lines 4 and 5, plates and angles were used as spacers to achieve the desired placement of the panels. **Engineer of Record should determine if this condition structurally acceptable** (Photographs 5 and 6)?

On panels 239 and 240 below elevation 20'-0" between grid lines 4 and 5, plates and angles were used as spacers to achieve the desired placement of the panels.

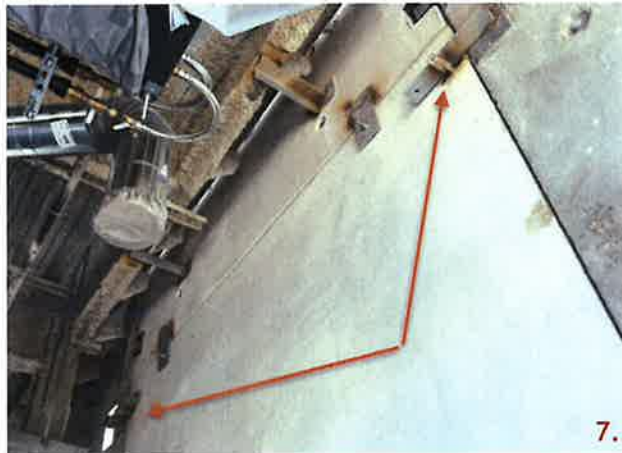
f. Panel 242 between grid lines 5 and 6 at elevation 16'-0" has two connections with angles welded to the plate and the 6" PSA strap. **Engineer of Record should determine if this condition structurally acceptable** (Photograph 7)?

Panel 242 between grid lines 5 and 6 at elevation 16'-0" has two connections with angles welded to the plate and the 6" PSA strap.

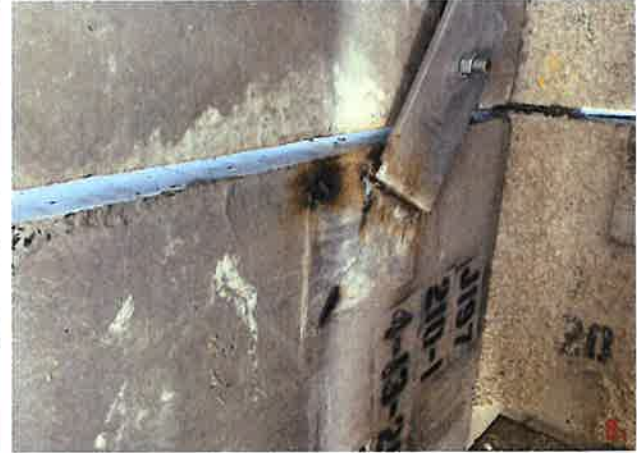
g. Panel connections of 210 and 219 at elevation 22'-0" at grid line 7 are skewed. The connections have 6" of 1/4" fillet weld on the plate but not in the detailed locations. **Engineer of Record should determine if this condition structurally acceptable** (Photograph 8)?

Panel connections of 210 and 219 at elevation 22'-0" at grid line 7 are skewed.

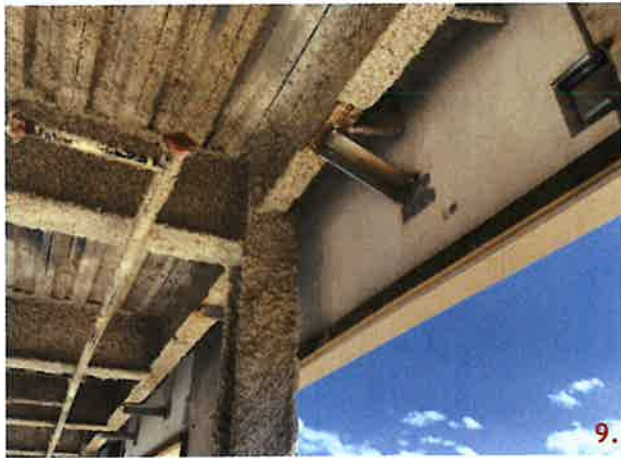
Panel 217 at elevation 34'-0" at grid line 6 has one L4x4x3/8 that is installed at an angle due to misalignment of the embed plate.

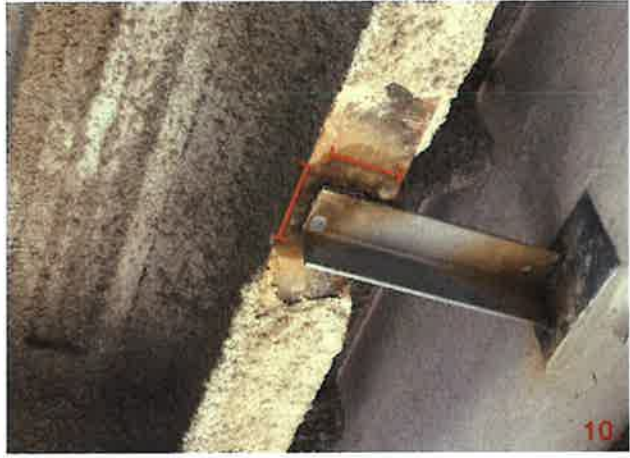
i. Both panels 217 at elevation 34'-0" near grid line 5 and 6 have L4x4x3/8 that are welded with 6" of 1/4" fillet weld to the beam but not in the detailed locations. **Engineer of Record should determine if this condition structurally acceptable** (Photograph 10)?

Both panels 217 at elevation 34'-0" near grid line 5 and 6 have L4x4x3/8 that are welded with 6" of 1/4" fillet weld to the beam but not in the detailed locations.
