15094 Community bank Headquarters – Precast review

COMMUNITY BANK HDQTRS.
 FLOWOOD, MISSISSIPPI

FIELD MODIFICATION

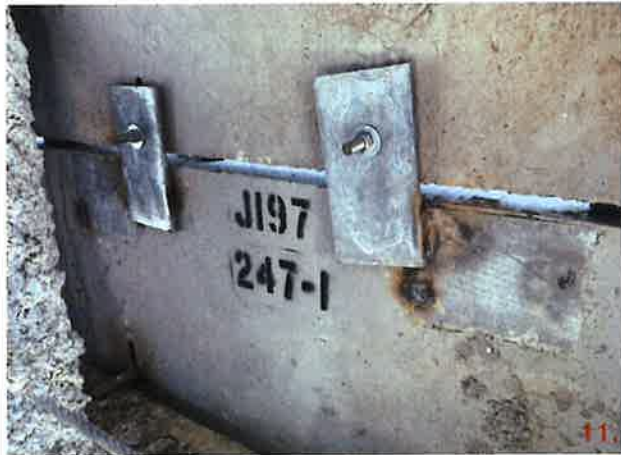
Panel connections of 247 and 223 at elevation 34'-0" at grid line 4 are not aligned with the embed plate. The plates are only welded on one side.

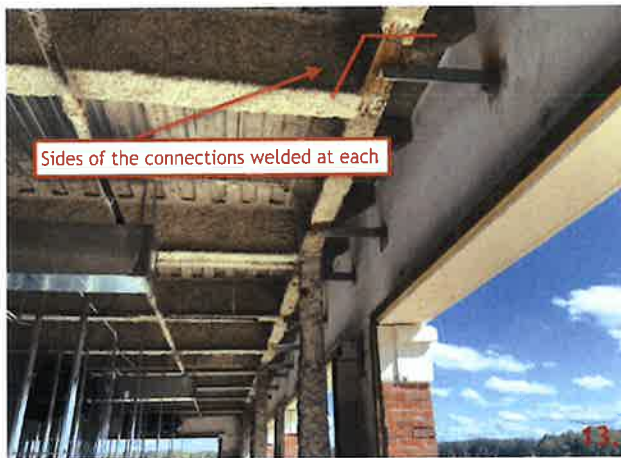
l. L4x4x3/8 angels at elevation 49'-4" are welded with 6" of 1/4" fillet weld to the beam but not in the detailed locations. **Engineer of Record should determine if this condition structurally acceptable** (Photograph 13)?

L4x4x3/8 angels at elevation 49'-4" are welded with 6" of 1/4" fillet weld to the beam but not in the detailed locations.

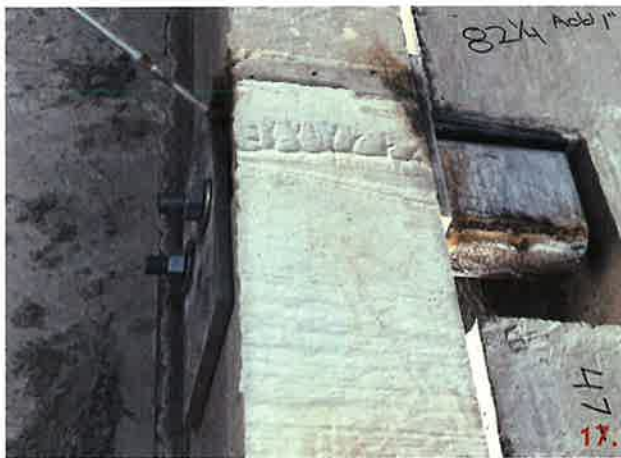
Panel 247 at grid line 4 has two HSS6x3x3/8 and p7 plate bolted through the panel edge. The lower connection at approximately elevation of 6" only has two (2) 3/4 threaded rods at this connection.
